# ACCESSIBILITY ASSESSMENT

**DATE OF REPORT:**  
March 4, 2025

## **ADA TITLE II ASSESSMENT**

Riverbend Elementary School  
320 51st Street  
Springfield, Oregon 97478

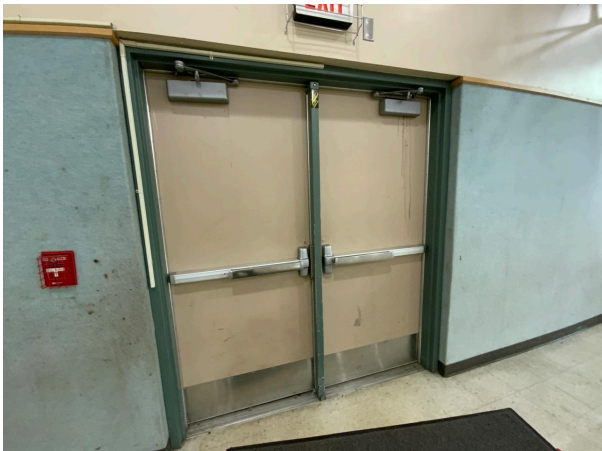
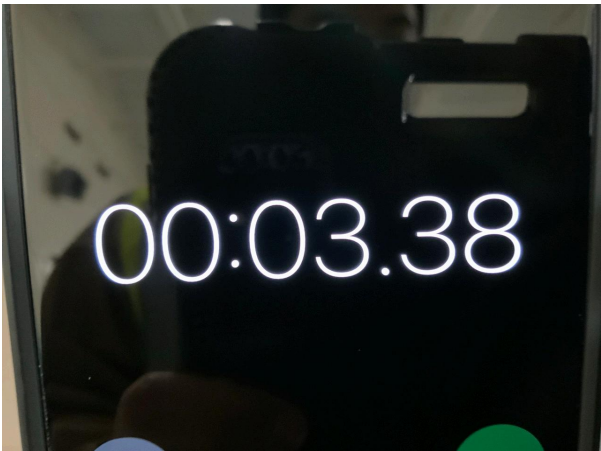
Photos for Barrier ID: AX555544

Site Conditions

Adjust closer or remove and replace closer to ensure that the door has a closure time of at least 5 seconds within 12 degrees of the latch. Door closers and gate closers shall be adjusted so that from an open position of 90 degrees, the time required to move the door to a position of 12 degrees from the latch is 5 seconds minimum.

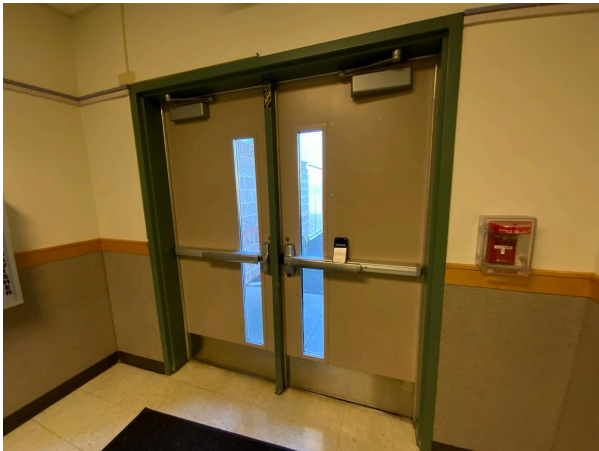
Photos for Barrier ID: AX555539

| Site Conditions | | |

| Adjust closer or remove and replace closer to ensure that the door has a closure time of at least 5 seconds within 12 degrees of the latch. Door closers and gate closers shall be adjusted so that from an open position of 90 degrees, the time required to move the door to a position of 12 degrees from the latch is 5 seconds minimum. | | |

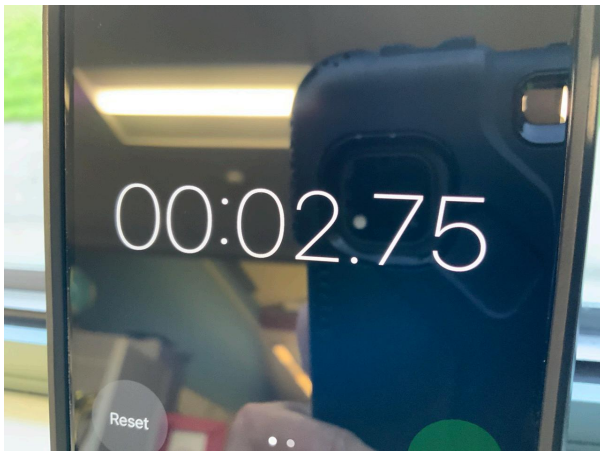
Photos for Barrier ID: AX555538

**Site Conditions**

Adjust closer or remove and replace closer to ensure that the door has a closure time of at least 5 seconds within 12 degrees of the latch. Door closers and gate closers shall be adjusted so that from an open position of 90 degrees, the time required to move the door to a position of 12 degrees from the latch is 5 seconds minimum.

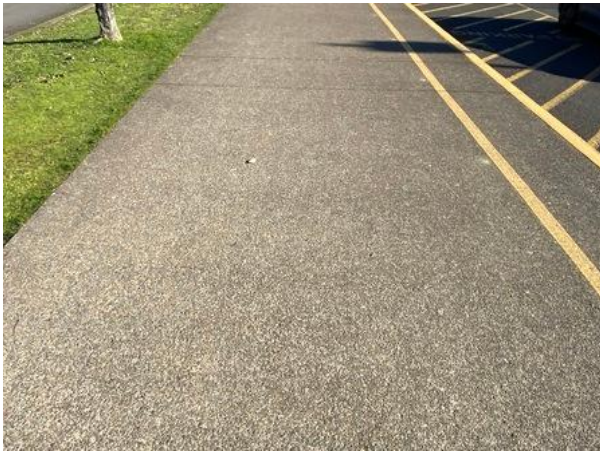
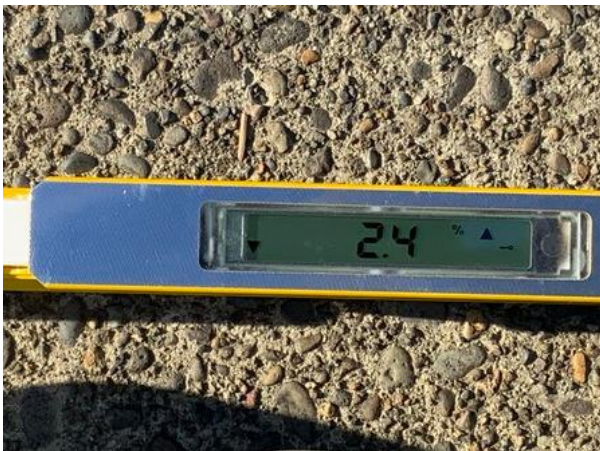
Photos for Barrier ID: AX555521

| <b>Site Conditions</b> | The accessible route has cross slopes of 2.4% for a length of 10' by 7' wide. |

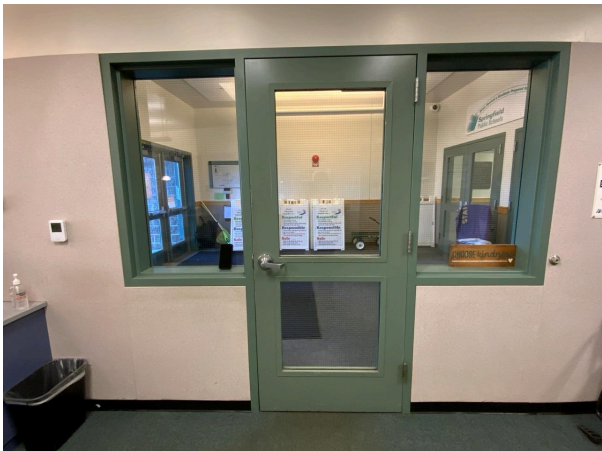
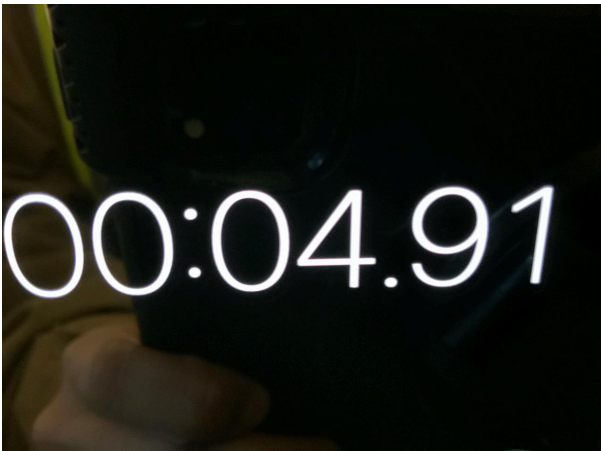
Photos for Barrier ID: AX555523

Site Conditions

Adjust closer or remove and replace closer to ensure that the door has a closure time of at least 5 seconds within 12 degrees of the latch. Door closers and gate closers shall be adjusted so that from an open position of 90 degrees, the time required to move the door to a position of 12 degrees from the latch is 5 seconds minimum.

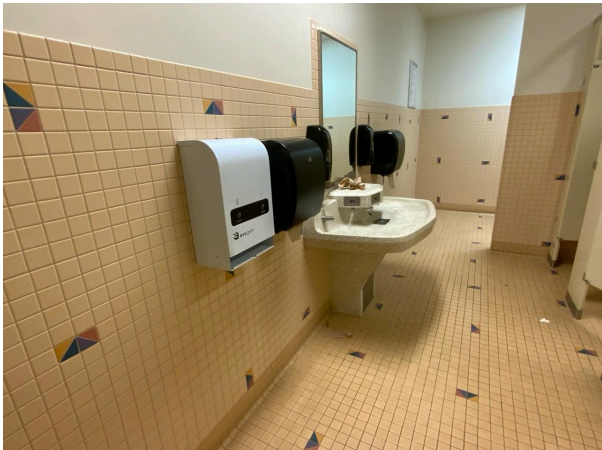
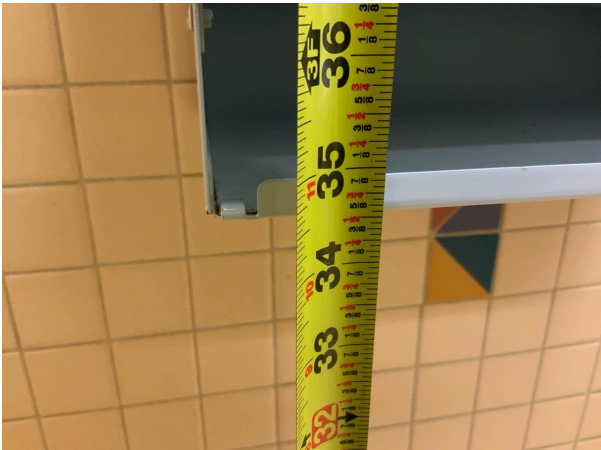
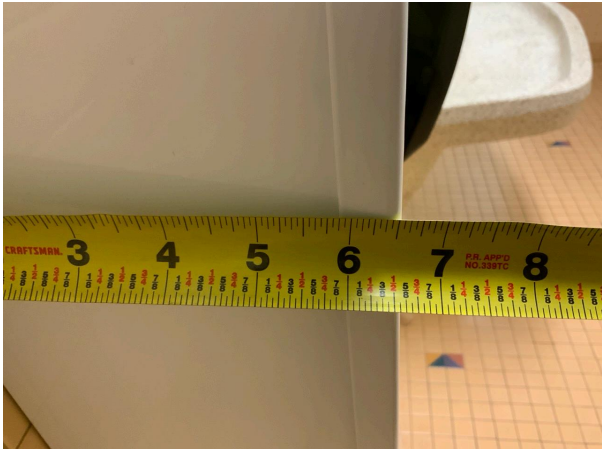
## Site Conditions

Replace the hand dryer and feminine product dispenser with a hand dryer and feminine product dispenser with a maximum of 4" deep to provide a restroom circulation path which does not have objects protruding more than 4" from wall in the space between 27" and 80" height above finish floor.

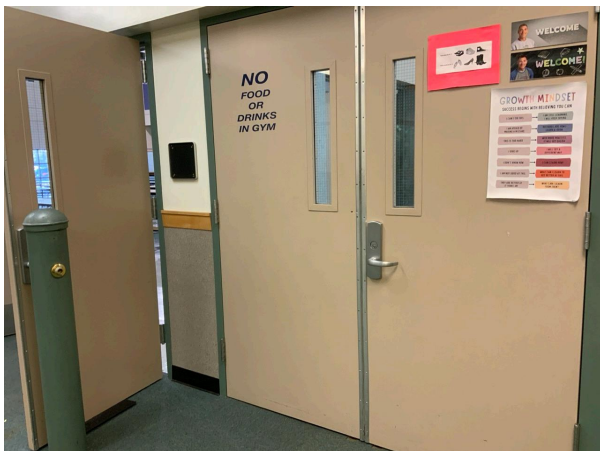
## Photos for Barrier ID: AX555543

| Site Conditions | The bottom of the entry door vision light is 47" above the finished floor. |

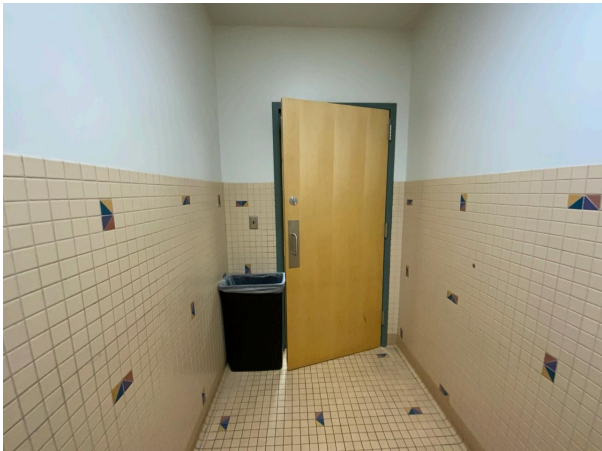
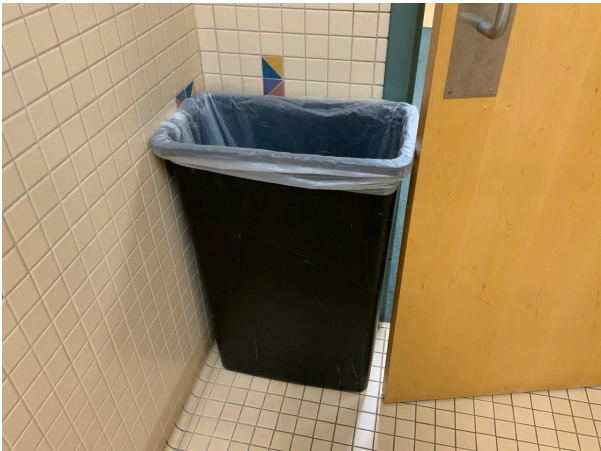
Photos for Barrier ID: AX555562

| Site Conditions | The trash can is in the required maneuvering clearance at the door. |

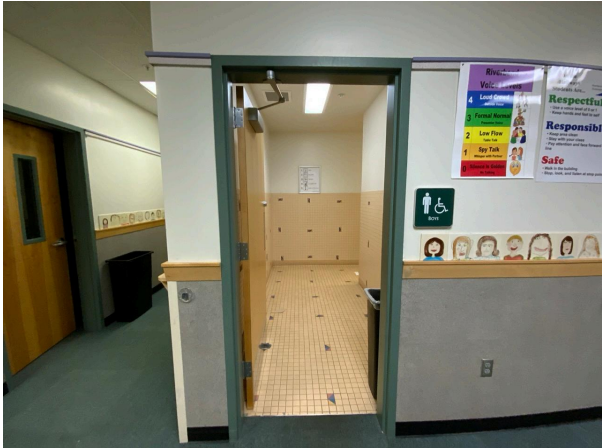
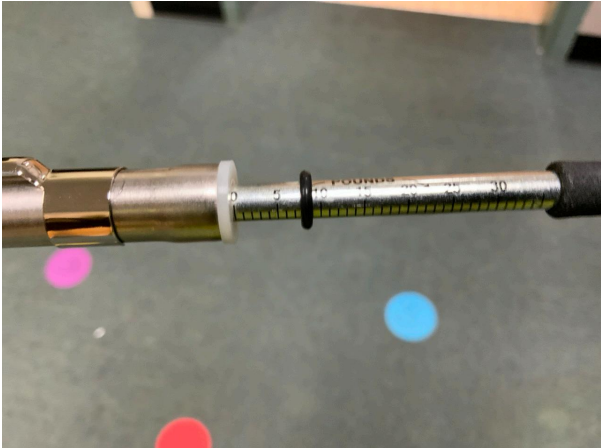
Photos for Barrier ID: AX555563

| Site Conditions | The opening force is 8 pounds. |

Adjust closer or replace with an closer that requires no more 5 pounds of force to stop the door motion. The maximum force for pushing or pulling open a door shall be for interior hinged doors: 5 lbs (22.2N). The force for pushing or pulling open a door or gate other than fire doors shall be as follows: 1. Interior hinged doors and gates: 5 pounds (22.2 N) maximum. 2. Sliding or folding doors: 5 pounds (22.2 N) maximum. These forces do not apply to the force required to retract latch bolts or disengage other devices that hold the door or gate in a closed position. Note: Fire doors shall have a minimum opening force allowable by the appropriate administrative authority.

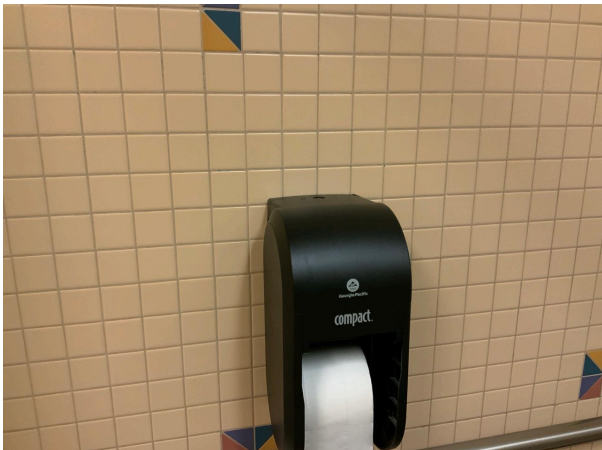
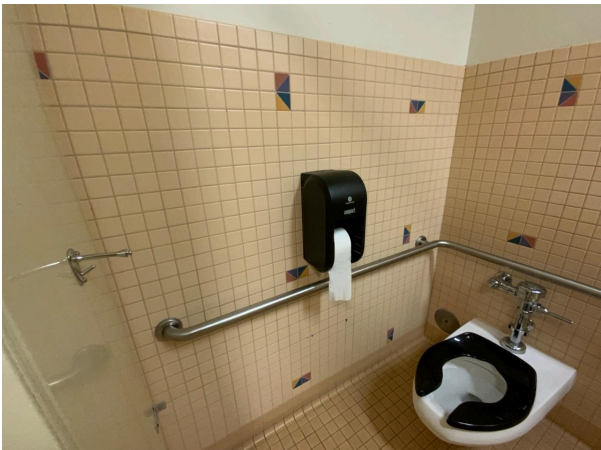
Photos for Barrier ID: AX555557

| Site Conditions | A vertical side grab bar is not present in the wheelchair stall. |

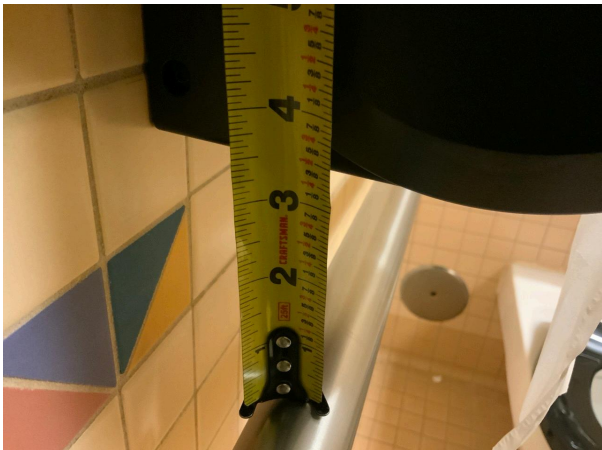
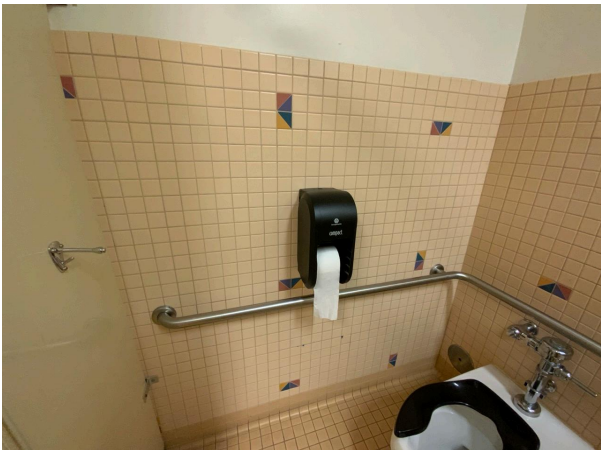
Photos for Barrier ID: AX555558

| Site Conditions | The space between the side grab bar and the toilet paper dispenser is 3 1/2". |

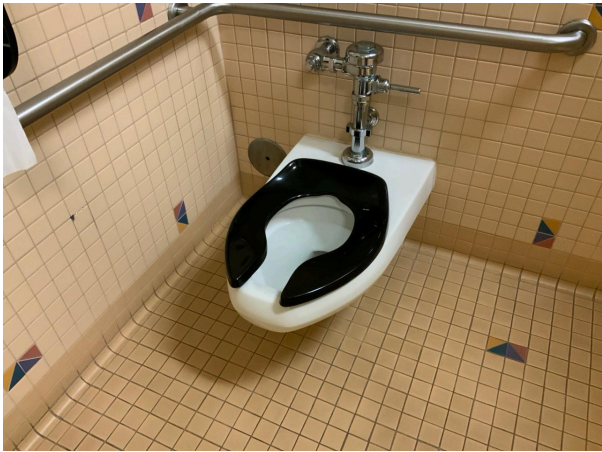
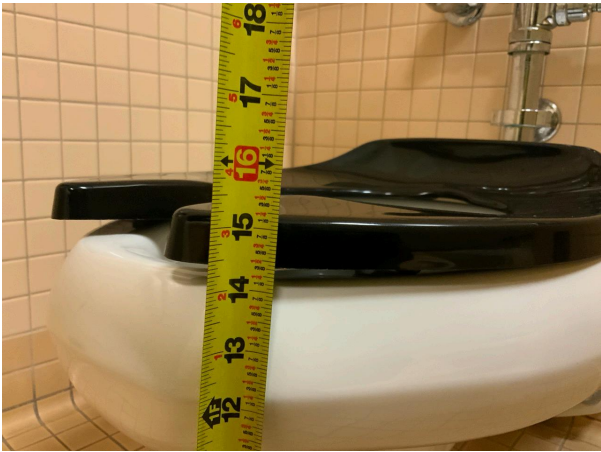
| Site Conditions | The top of the water closet seat is 15 1/4" above the floor. | |

| Remove and replace with a toilet that has a compliant seat height. The seat height of a water closet shall be 17" minimum and 19" maximum above the finish floor, measured to the top of the seat. Seats shall not be sprung to return to a lifted position. [EXCEPTIONS: 1. A water closet in a toilet room for a single occupant accessed only through a private office and not for common use or public use shall not be required to comply. 2. In residential dwelling units, the height of water closets shall be permitted to be 15" minimum and 19" maximum above the finish floor measured to the top of the seat.] [ADVISORY: It is advisable, but not required, to use the specifications for children where children are the primary users of the restroom. Guidance in applying the specifications for children according to the age group served reflects the differences in the size, stature, and reach ranges of children ages 3 to 12. The specifications chosen should correspond to the age of the primary user group. The specifications of one age group should be applied consistently in the installation of a water closet and related elements. Water Closet Centerline: Ages 3 and 4- 12"; Ages 5 through 8- 12" to 15"; Ages 9 through 12- 15" to 18". Toilet Seat Height: Ages 3 and 4- 11" to 12"; Ages 5 through 8- 12" to 15"; Ages 9 through 12- 15" to 17". Grab Bar Height: Ages 3 and 4- 18" to 20"; Ages 5 through 8- 20" to 25"; Ages 9 through 12- 25" to 27"; Dispenser Height: Ages 3 and 4- 14"; Ages 5 through 8- 14" to 17"; Ages 9 through 12- 17" to 19"]. | | |

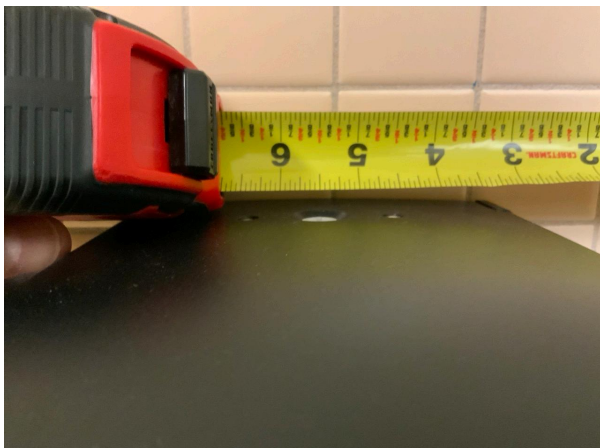
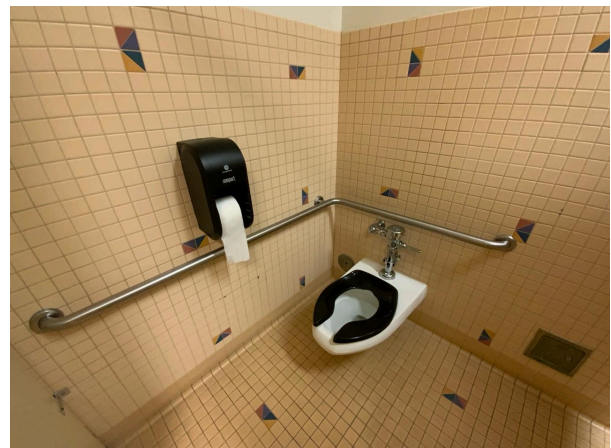
## Photos for Barrier ID: AX555559

| <b>Site Conditions</b> | The centerline of the toilet paper dispenser is 5" in front of the water closet. |

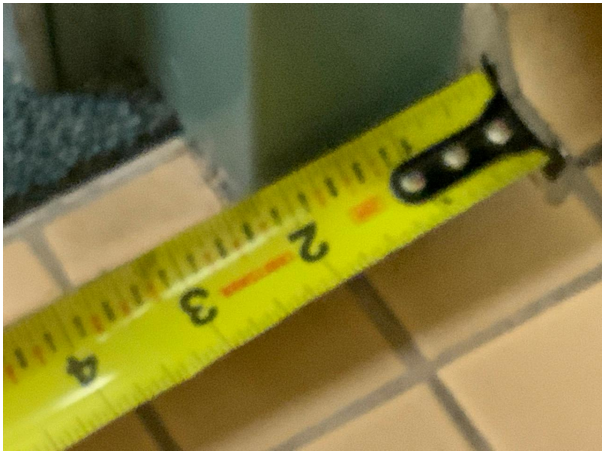
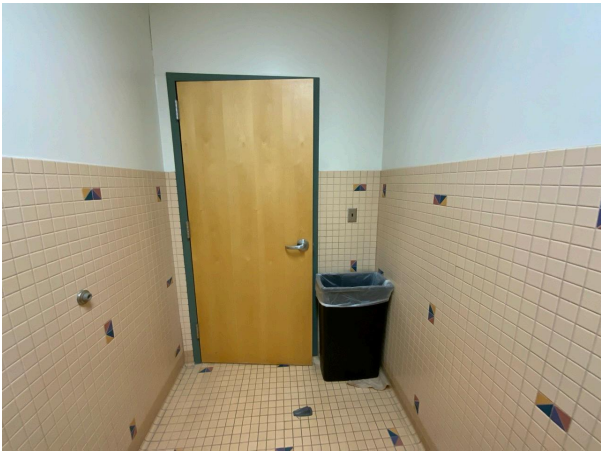
Photos for Barrier ID: AX555553

| Site Conditions | The trash can is in the required maneuvering clearance at the door. |

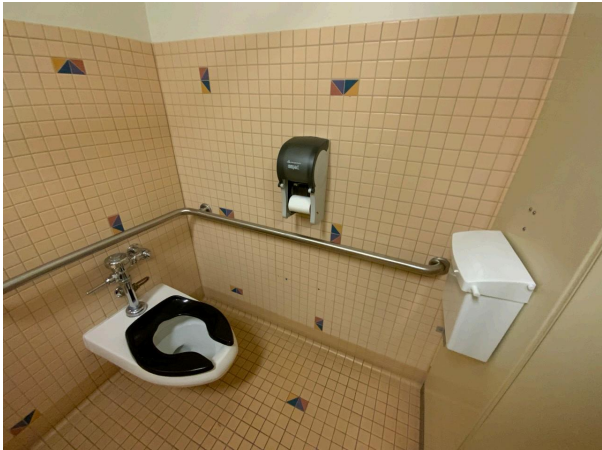
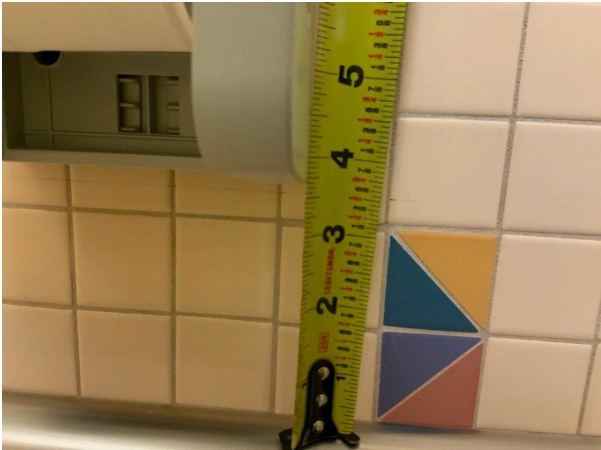
Photos for Barrier ID: AX555547

| Site Conditions | The space between the side grab bar and the toilet dispenser is 3 3/4". |

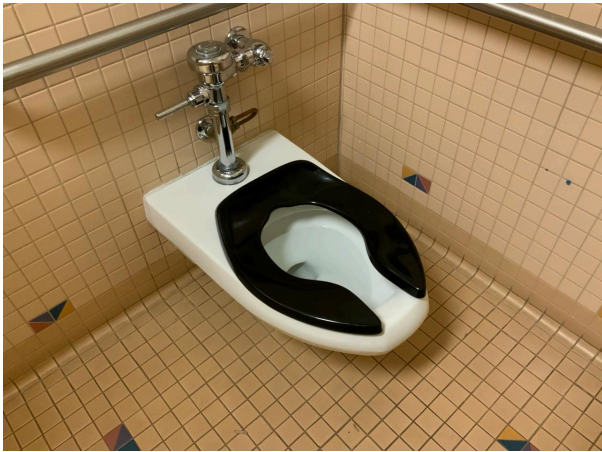
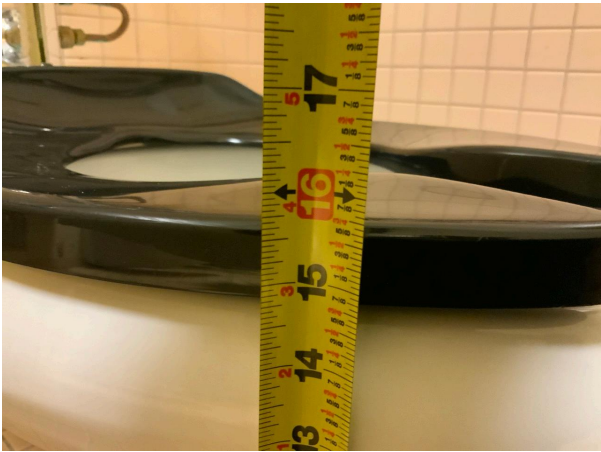
| Site Conditions | The top of the water closet seat is 15 1/2" above the floor. |

Remove and replace with a toilet that has a compliant seat height. The seat height of a water closet shall be 17" minimum and 19" maximum above the finish floor, measured to the top of the seat. Seats shall not be sprung to return to a lifted position. [EXCEPTIONS: 1. A water closet in a toilet room for a single occupant accessed only through a private office and not for common use or public use shall not be required to comply. 2. In residential dwelling units, the height of water closets shall be permitted to be 15" minimum and 19" maximum above the finish floor measured to the top of the seat.] [ADVISORY: It is advisable, but not required, to use the specifications for children where children are the primary users of the restroom. Guidance in applying the specifications for children according to the age group served reflects the differences in the size, stature, and reach ranges of children ages 3 to 12. The specifications chosen should correspond to the age of the primary user group. The specifications of one age group should be applied consistently in the installation of a water closet and related elements. Water Closet Centerline: Ages 3 and 4- 12"; Ages 5 through 8- 12" to 15"; Ages 9 through 12- 15" to 18". Toilet Seat Height: Ages 3 and 4- 11" to 12"; Ages 5 through 8- 12" to 15"; Ages 9 through 12- 15" to 17". Grab Bar Height: Ages 3 and 4- 18" to 20"; Ages 5 through 8- 20" to 25"; Ages 9 through 12- 25" to 27"; Dispenser Height: Ages 3 and 4- 14"; Ages 5 through 8- 14" to 17"; Ages 9 through 12- 17" to 19"].

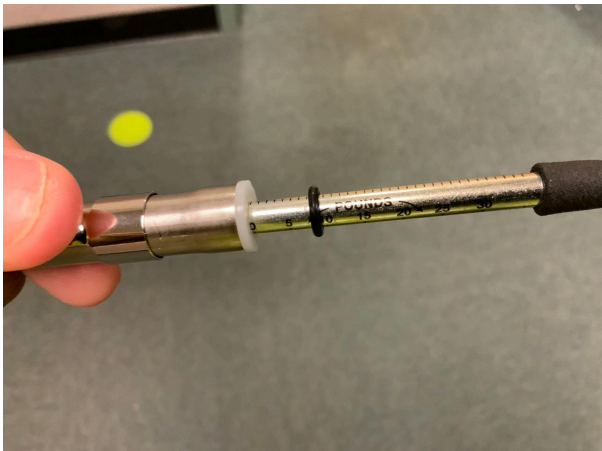
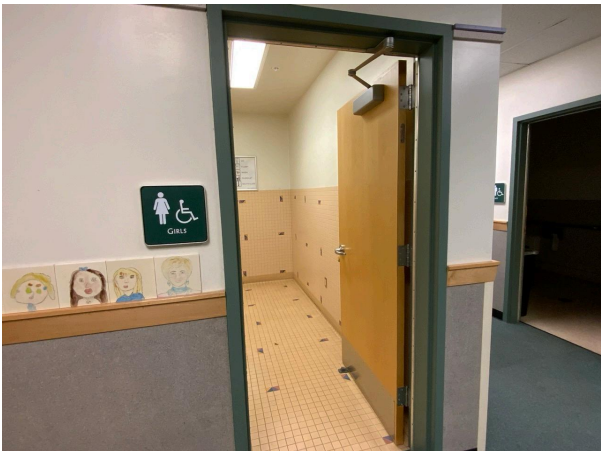
Photos for Barrier ID: AX555554

| Site Conditions | The opening force is 8 pounds. |

Adjust closer or replace with an closer that requires no more 5 pounds of force to stop the door motion. The maximum force for pushing or pulling open a door shall be for interior hinged doors: 5 lbs (22.2N). The force for pushing or pulling open a door or gate other than fire doors shall be as follows: 1. Interior hinged doors and gates: 5 pounds (22.2 N) maximum. 2. Sliding or folding doors: 5 pounds (22.2 N) maximum. These forces do not apply to the force required to retract latch bolts or disengage other devices that hold the door or gate in a closed position. Note: Fire doors shall have a minimum opening force allowable by the appropriate administrative authority.

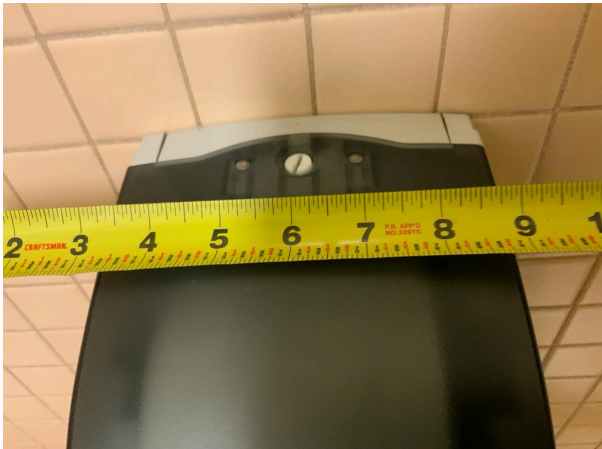
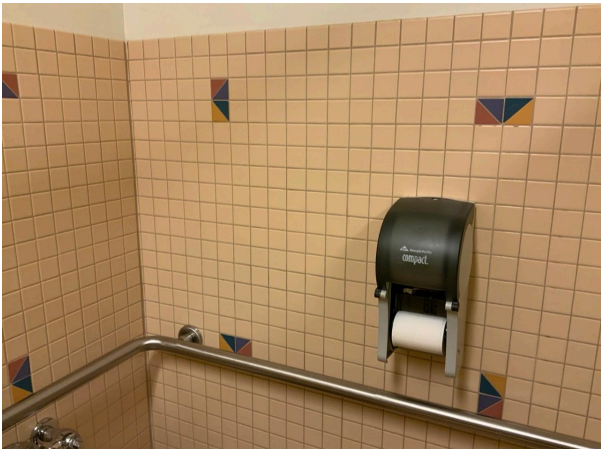
**Photos for Barrier ID: AX555549**

| Site Conditions | The centerline of the toilet paper dispenser is 6" in front of the water closet. |

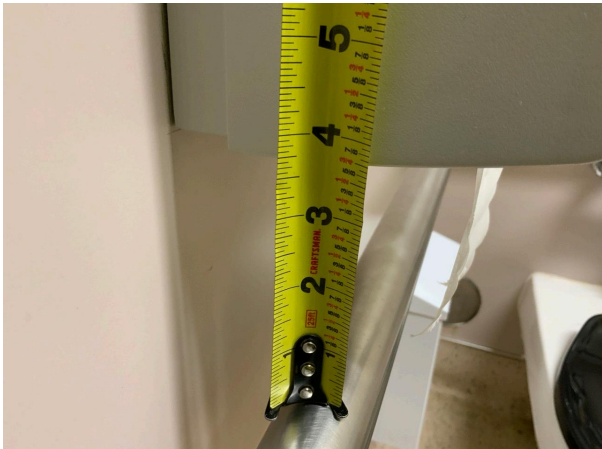
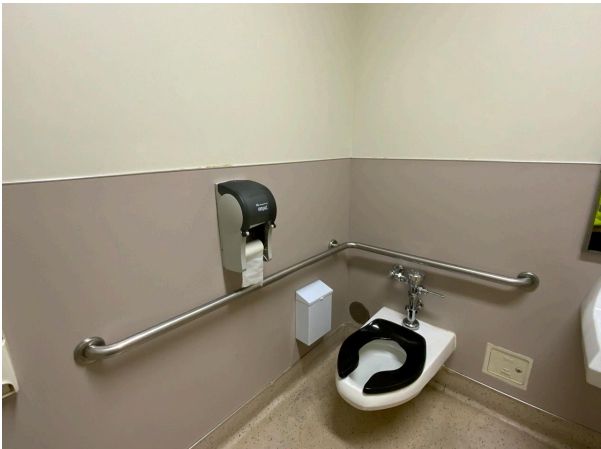
Photos for Barrier ID: AX555525

| Site Conditions | The space between the side grab bar and the toilet paper dispenser is 3 3/4". |

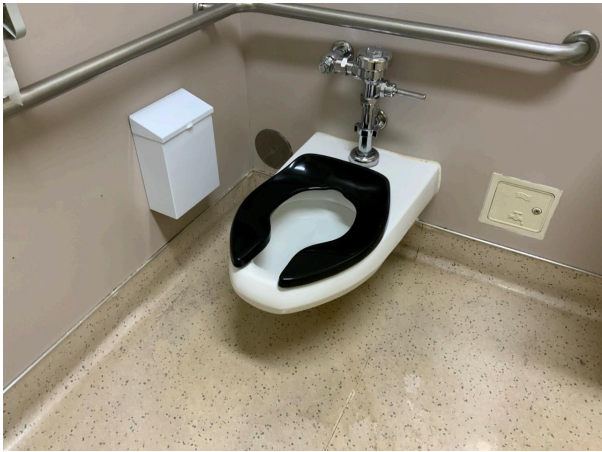
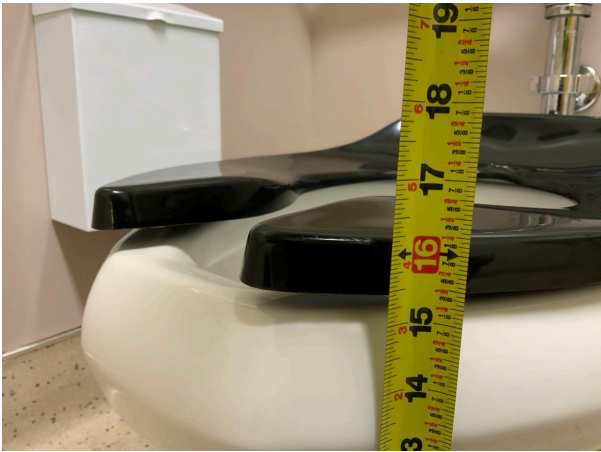
| Site Conditions | The top of the water closet seat is 16 1/4" above the floor. |

Remove and replace with a toilet that has a compliant seat height. The seat height of a water closet shall be 17" minimum and 19" maximum above the finish floor, measured to the top of the seat. Seats shall not be sprung to return to a lifted position. [EXCEPTIONS: 1. A water closet in a toilet room for a single occupant accessed only through a private office and not for common use or public use shall not be required to comply. 2. In residential dwelling units, the height of water closets shall be permitted to be 15" minimum and 19" maximum above the finish floor measured to the top of the seat.] [ADVISORY: It is advisable, but not required, to use the specifications for children where children are the primary users of the restroom. Guidance in applying the specifications for children according to the age group served reflects the differences in the size, stature, and reach ranges of children ages 3 to 12. The specifications chosen should correspond to the age of the primary user group. The specifications of one age group should be applied consistently in the installation of a water closet and related elements. Water Closet Centerline: Ages 3 and 4- 12"; Ages 5 through 8- 12" to 15"; Ages 9 through 12- 15" to 18". Toilet Seat Height: Ages 3 and 4- 11" to 12"; Ages 5 through 8- 12" to 15"; Ages 9 through 12- 15" to 17". Grab Bar Height: Ages 3 and 4- 18" to 20"; Ages 5 through 8- 20" to 25"; Ages 9 through 12- 25" to 27"; Dispenser Height: Ages 3 and 4- 14"; Ages 5 through 8- 14" to 17"; Ages 9 through 12- 17" to 19"].

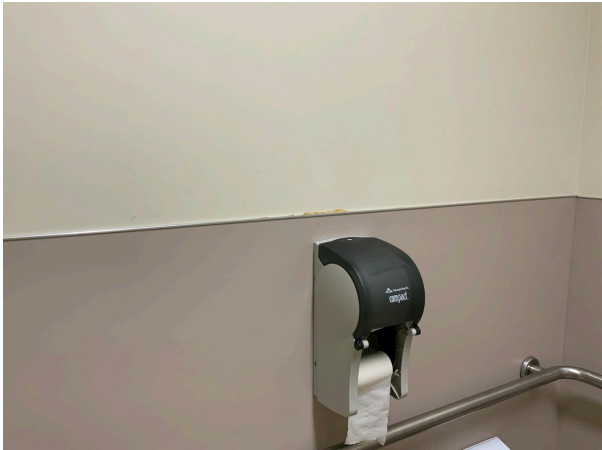
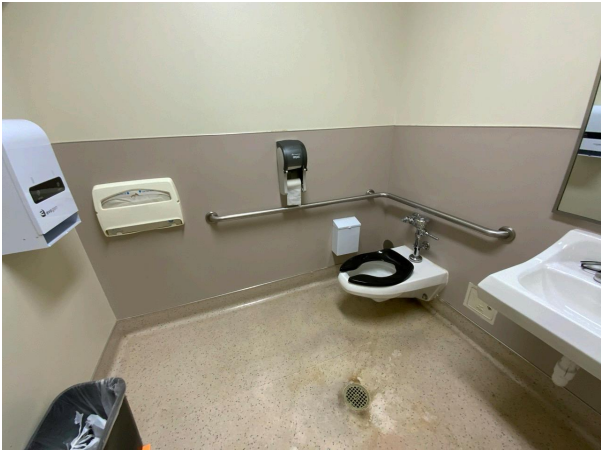
Photos for Barrier ID: AX555526

| Site Conditions | A vertical side grab bar is not present in the wheelchair stall. |

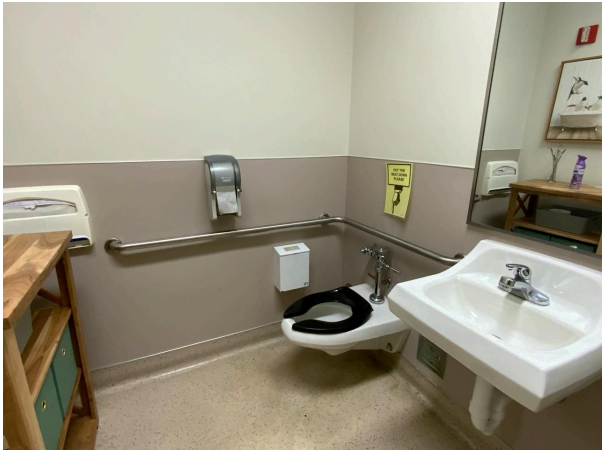
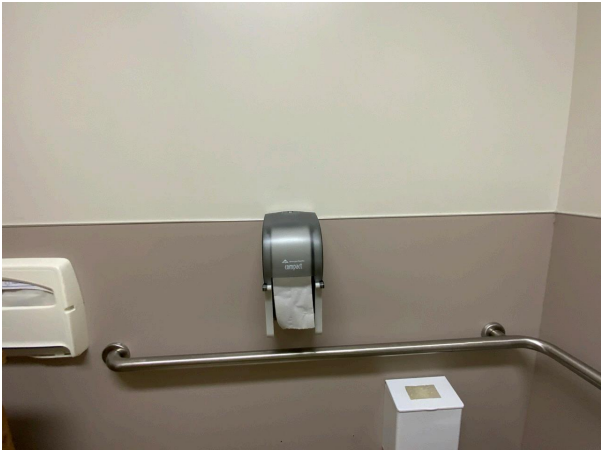
Photos for Barrier ID: AX555533

| Site Conditions | A vertical side grab bar is not present in the wheelchair stall. |
