# ACCESSIBILITY ASSESSMENT

*February 4, 2025*

## **ADA TITLE II ASSESSMENT**

**Agnes Stewart Middle School**

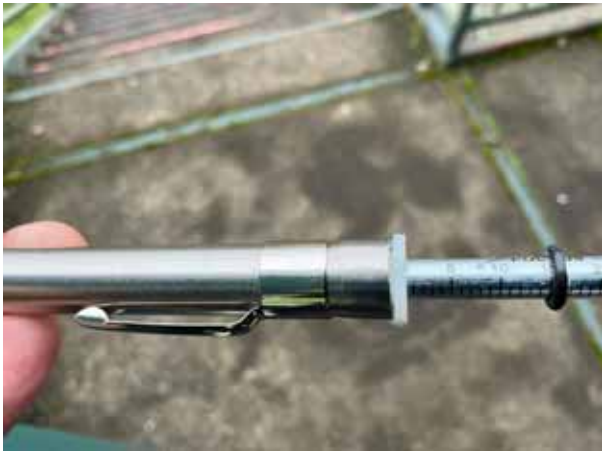
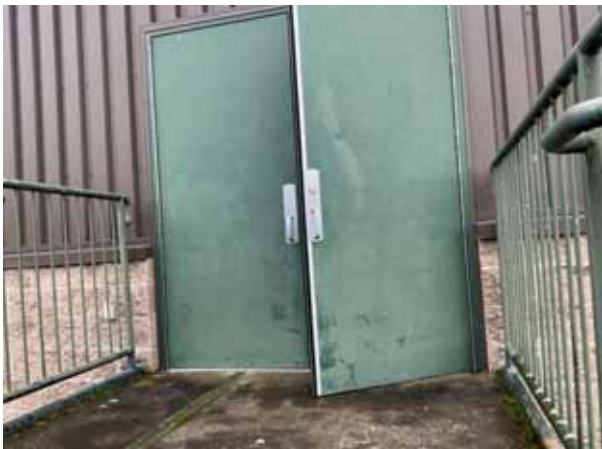
Photos for Barrier ID: AX556919

| Site Conditions | The opening force of the fire doors is 16 pounds. | |

| Adjust the closer/opener or replace with a door which requires no more force to open and close than the minimum allowable force required by the appropriate administrative authority. The force at the latch, the force to set the door in motion, and the force to fully open the door shall be the minimum allowable. These forces do not apply to the force required to retract latch bolts or disengage other devices that hold the door or gate in a closed position. | | |

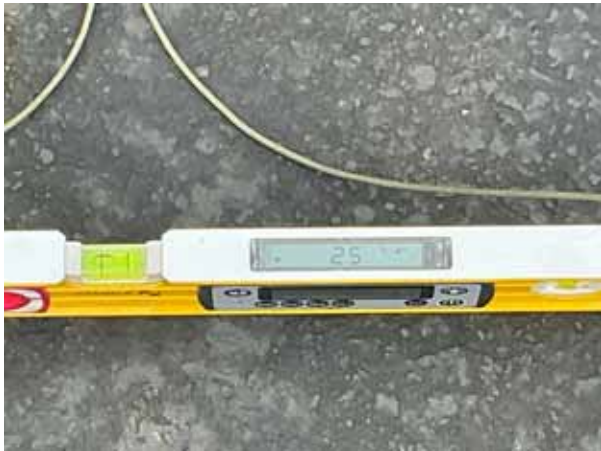
Photos for Barrier ID: AX556912

| <b>Site Conditions</b> | Accessible parking P1-A has a cross slope of 2.5%. |

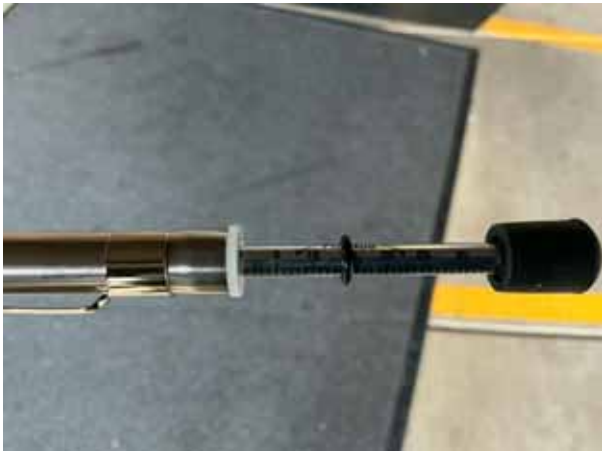
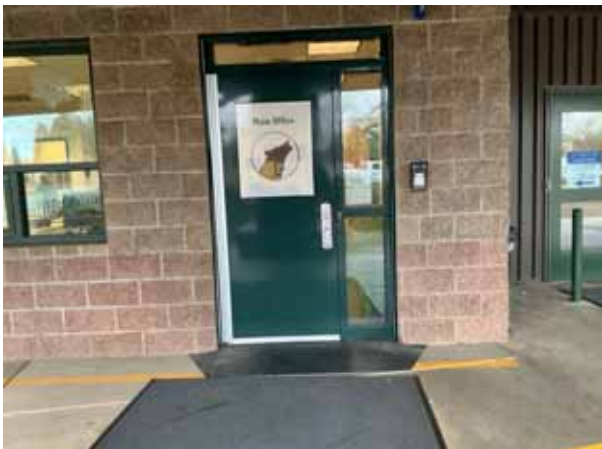
Photos for Barrier ID: AX556879

| Site Conditions | The opening force of the fire door is 14 pounds. | |

| Adjust the closer/opener or replace with a door which requires no more force to open and close than the minimum allowable force required by the appropriate administrative authority. The force at the latch, the force to set the door in motion, and the force to fully open the door shall be the minimum allowable. These forces do not apply to the force required to retract latch bolts or disengage other devices that hold the door or gate in a closed position. | | |

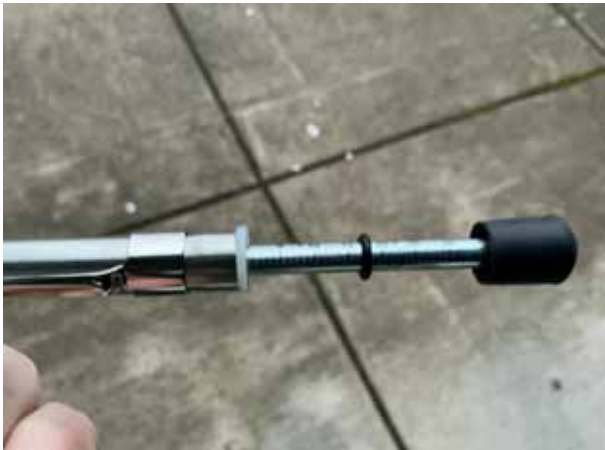
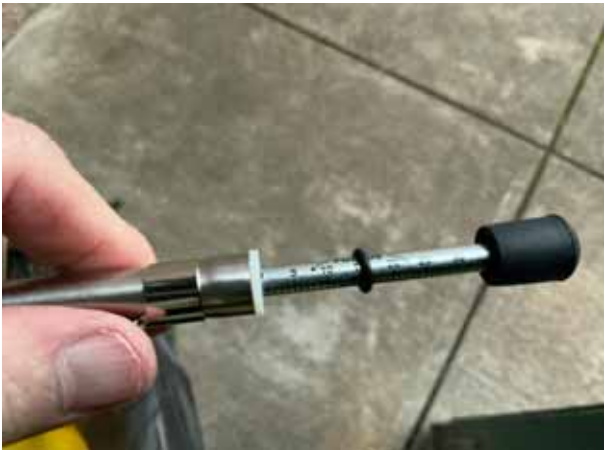
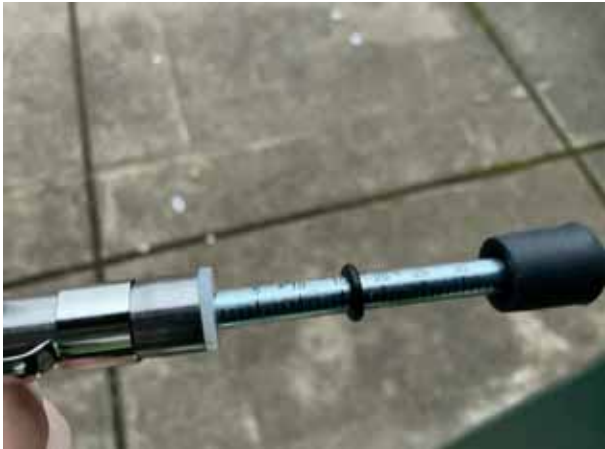
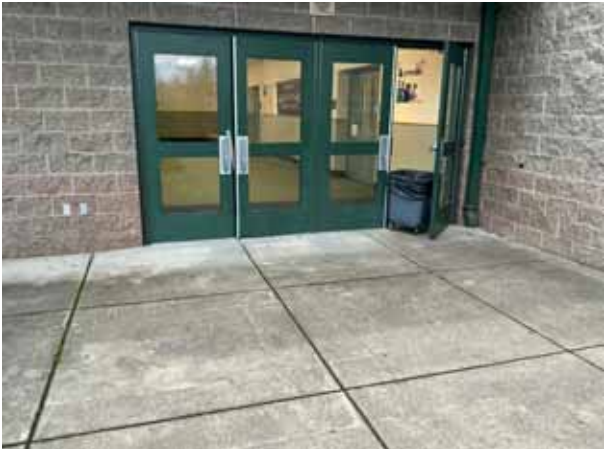
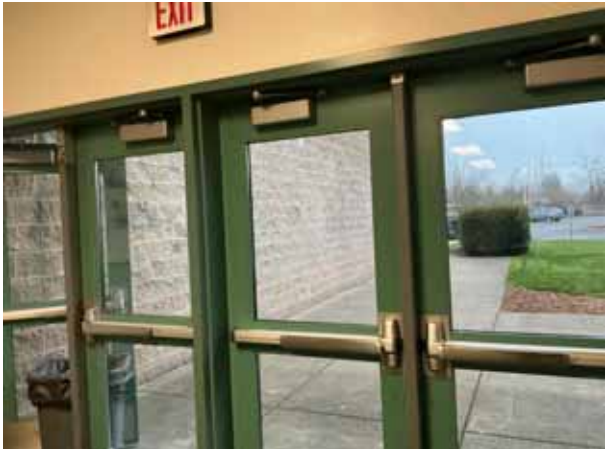
| Site Conditions | The opening force of the fire doors is 16 to 18 pounds. | |

| Adjust the closer/opener or replace with a door which requires no more force to open and close than the minimum allowable force required by the appropriate administrative authority. The force at the latch, the force to set the door in motion, and the force to fully open the door shall be the minimum allowable. These forces do not apply to the force required to retract latch bolts or disengage other devices that hold the door or gate in a closed position. | | |

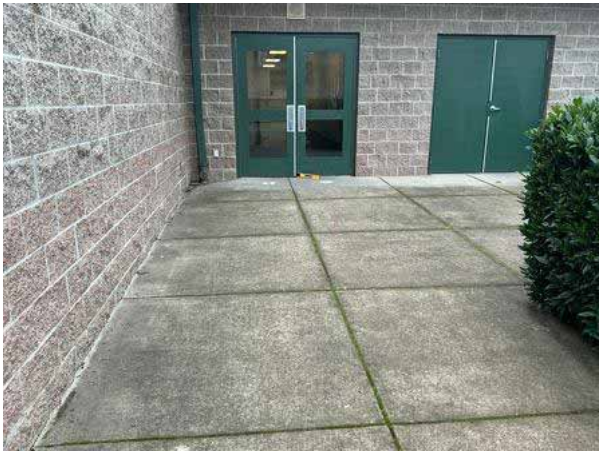
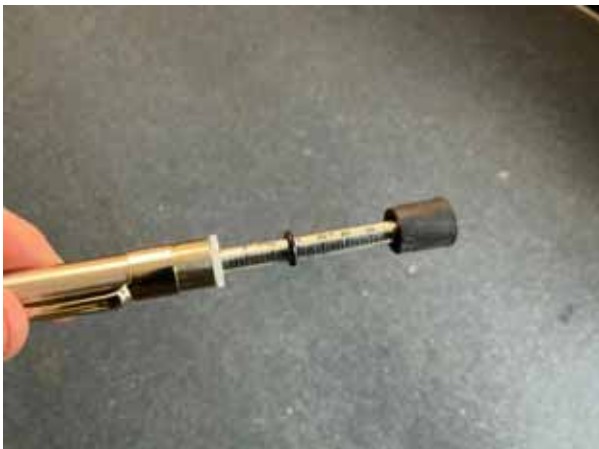
Photos for Barrier ID: AX556917

| Site Conditions | The opening force of the fire door is 14 pounds. | |

| Adjust the closer/opener or replace with a door which requires no more force to open and close than the minimum allowable force required by the appropriate administrative authority. The force at the latch, the force to set the door in motion, and the force to fully open the door shall be the minimum allowable. These forces do not apply to the force required to retract latch bolts or disengage other devices that hold the door or gate in a closed position. | | |

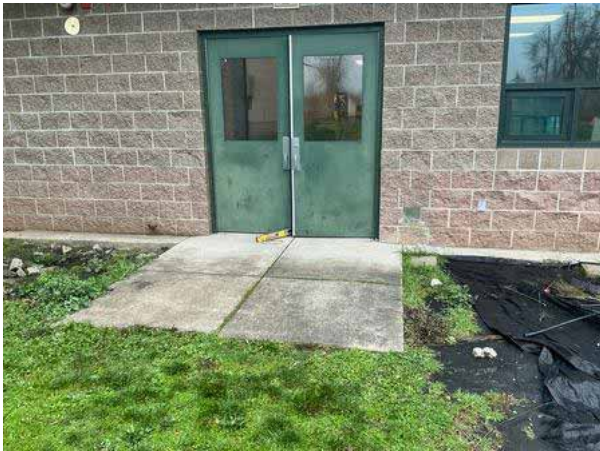
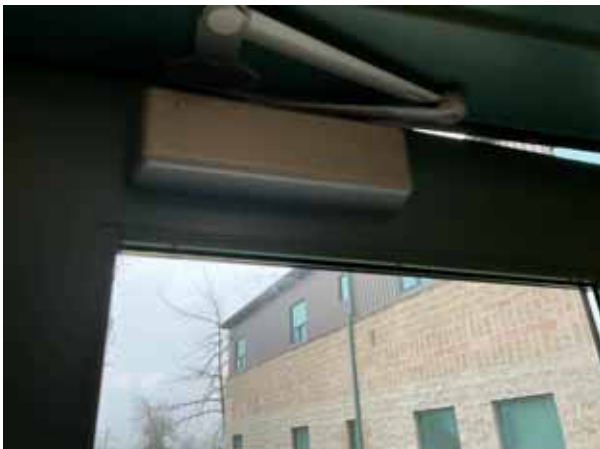
Photos for Barrier ID: AX556914

| Site Conditions | The opening force of the fire door is 12 pounds. | |

| Adjust the closer/opener or replace with a door which requires no more force to open and close than the minimum allowable force required by the appropriate administrative authority. This barrier must be removed in conjunction with barrier ID 556915. The cost of this barrier removal is covered under ID 556915 and therefore, the cost of this ID is shown as \$0. The force at the latch, the force to set the door in motion, and the force to fully open the door shall be the minimum allowable. These forces do not apply to the force required to retract latch bolts or disengage other devices that hold the door or gate in a closed position. | | |

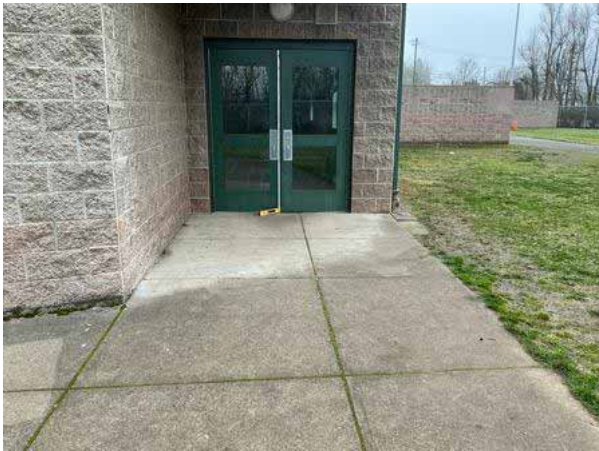
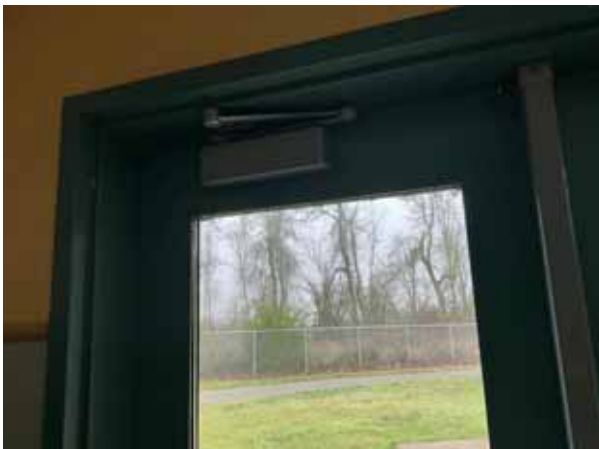
Photos for Barrier ID: AX556918

| Site Conditions | The opening force of the fire doors is 15 to 23 pounds. | |

| Adjust the closer/opener or replace with a door which requires no more force to open and close than the minimum allowable force required by the appropriate administrative authority. The force at the latch, the force to set the door in motion, and the force to fully open the door shall be the minimum allowable. These forces do not apply to the force required to retract latch bolts or disengage other devices that hold the door or gate in a closed position. | | |

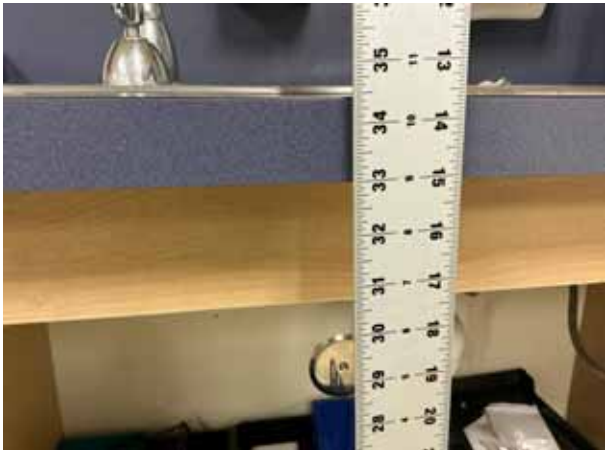
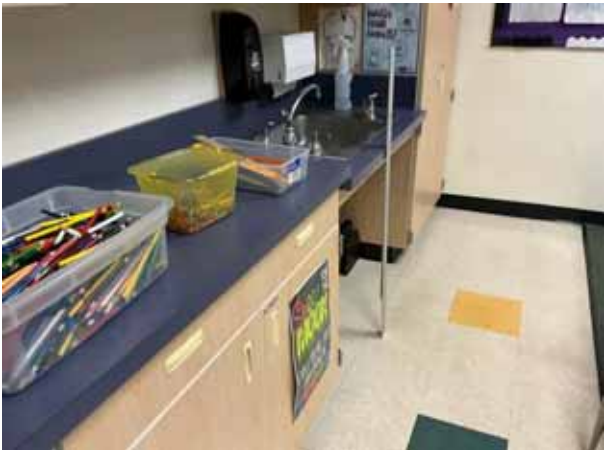
| Site Conditions | The rim of the sink is 34-5/8" above the finished floor. |

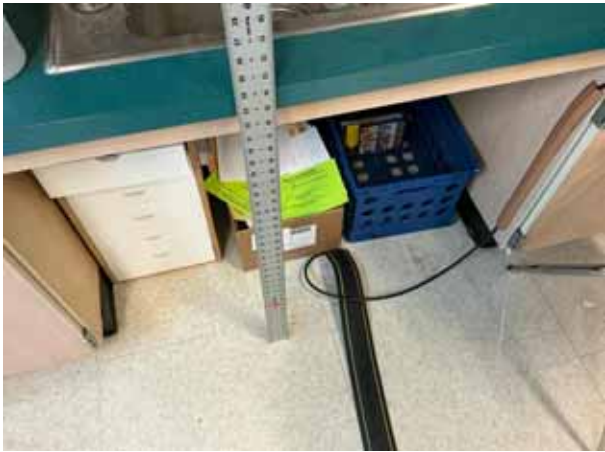
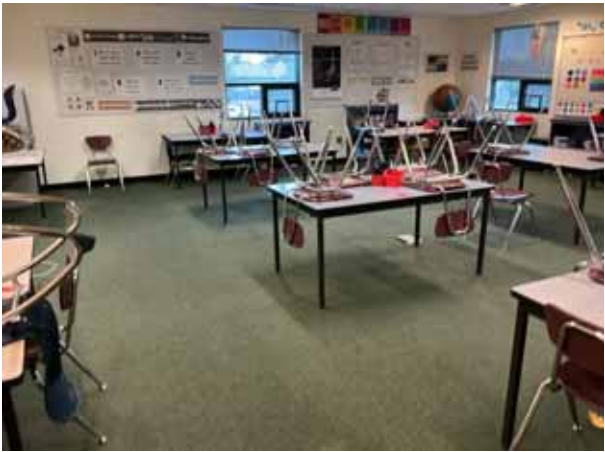
| Site Conditions | Items are stored in the required knee and toe clearance. |

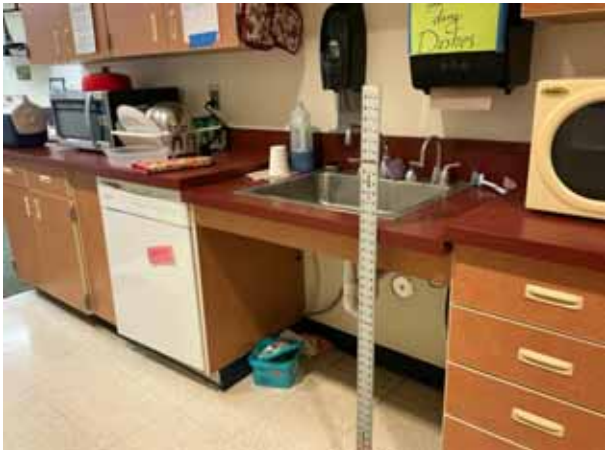
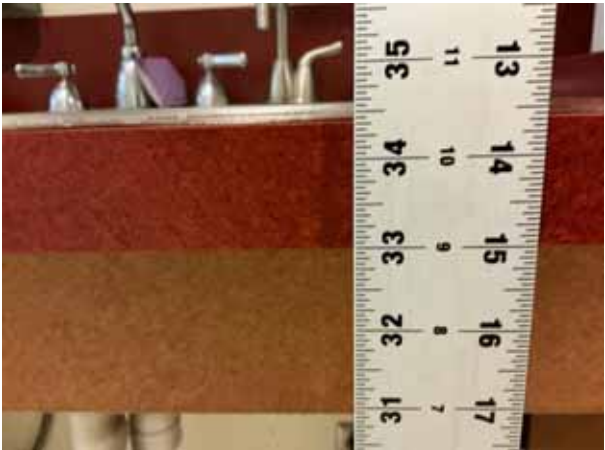
| Site Conditions | The rim of the sink is 34-5/8" above the finished floor. |

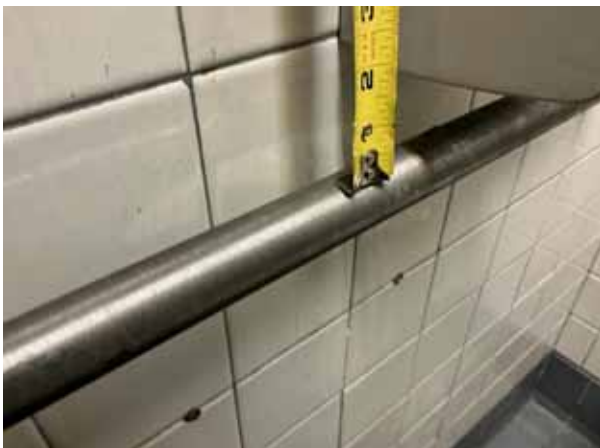
## Photos for Barrier ID: AX556889

| Site Conditions | The toilet paper dispenser is installed behind the rim of the toilet. |

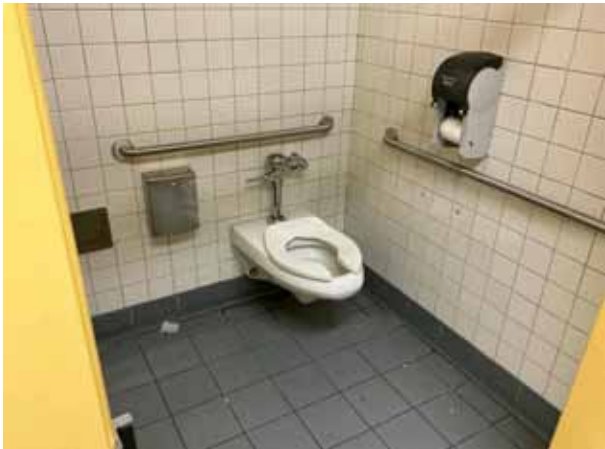
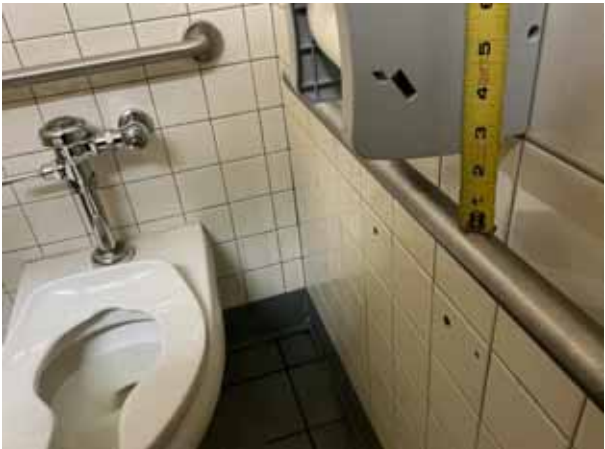
Photos for Barrier ID: AX556896

| Site Conditions | The toilet paper dispenser is installed 2-3/8" above the grab bar. |

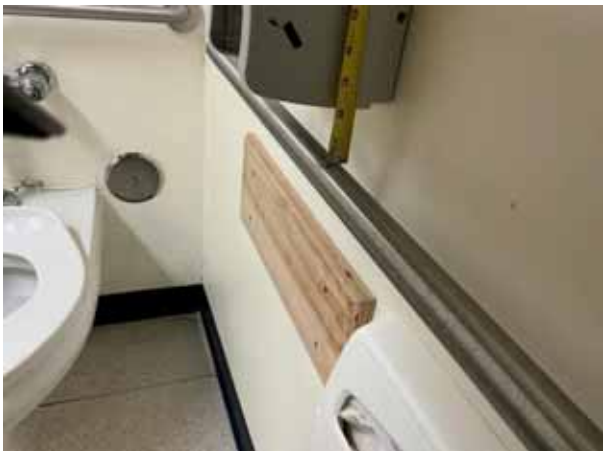
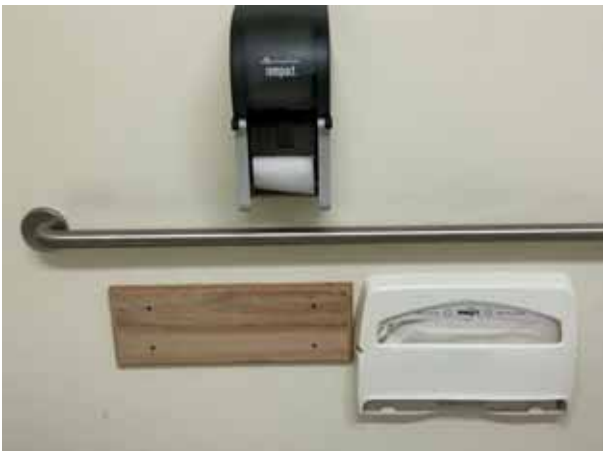
Photos for Barrier ID: AX556899

| Site Conditions | The toilet paper dispenser is installed 2" above the grab bar. |

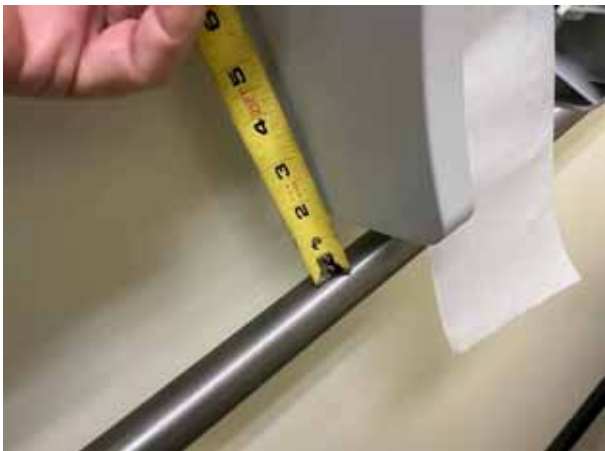
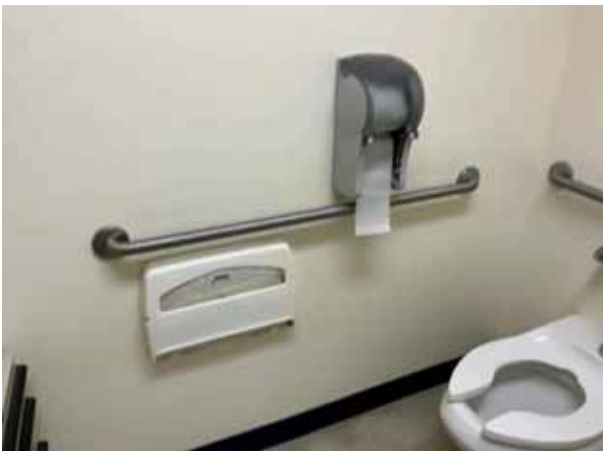
Photos for Barrier ID: AX556907

| Site Conditions | The toilet paper dispenser is installed 1-1/4" above the grab bar. |

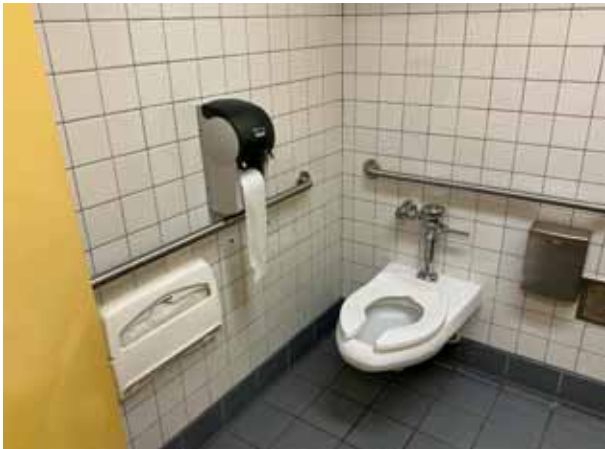
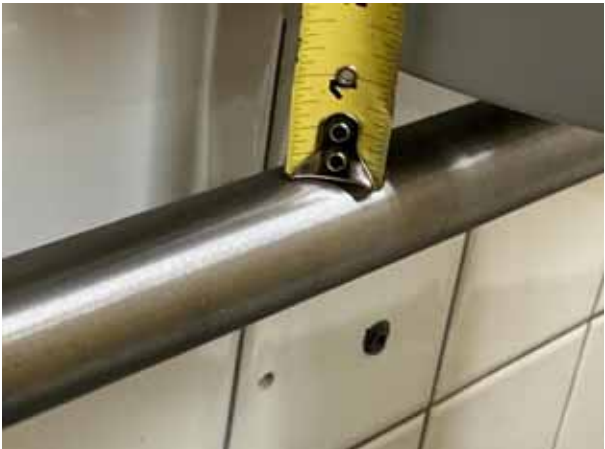
Photos for Barrier ID: AX556901

| Site Conditions | The toilet paper dispenser is installed 1-1/4" above the grab bar. |
