# ACCESSIBILITY ASSESSMENT

December 10, 2024

## **ADA TITLE II ASSESSMENT**

Hamlin Middle School  
326 Centennial Boulevard  
Springfield, Oregon 97477

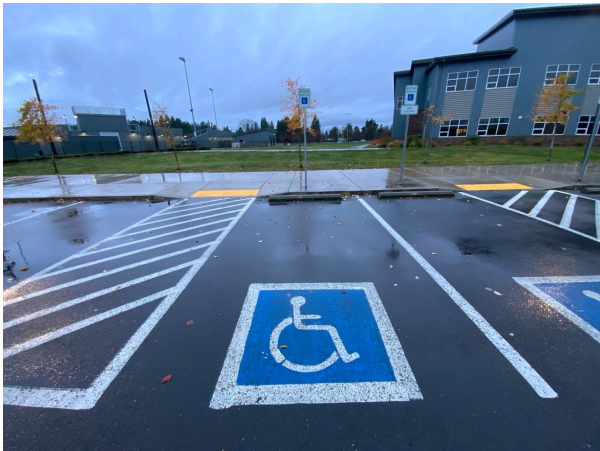
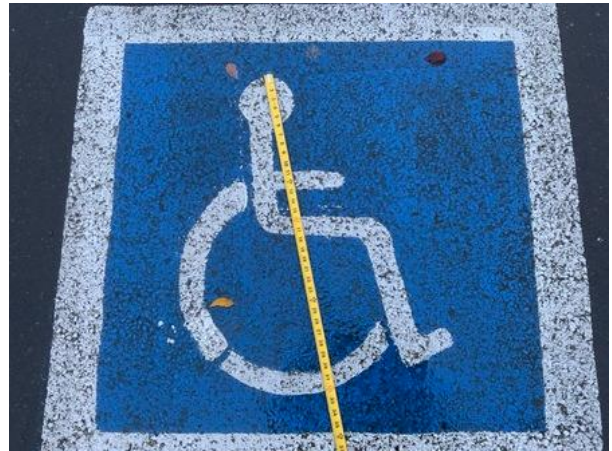
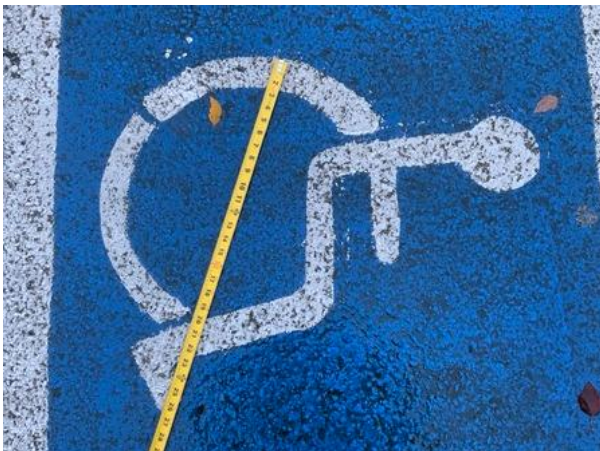
Photos for Barrier ID: AX527454

| Site Conditions | The pavement markings measure 32" in height and 26-1/2" in width. |

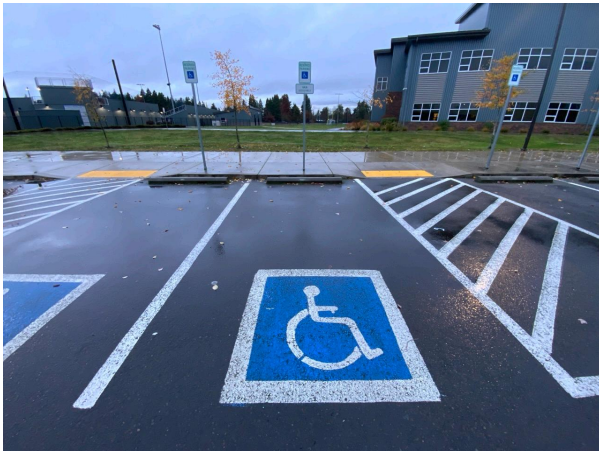
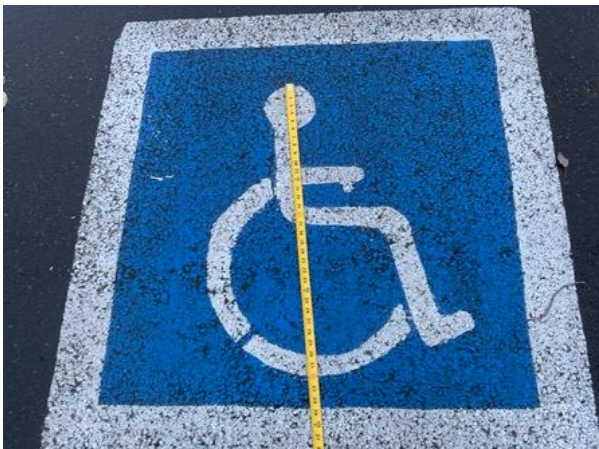
Photos for Barrier ID: AX527456

| Site Conditions | The pavement markings measure 32" in height and 26-1/2" in width. |

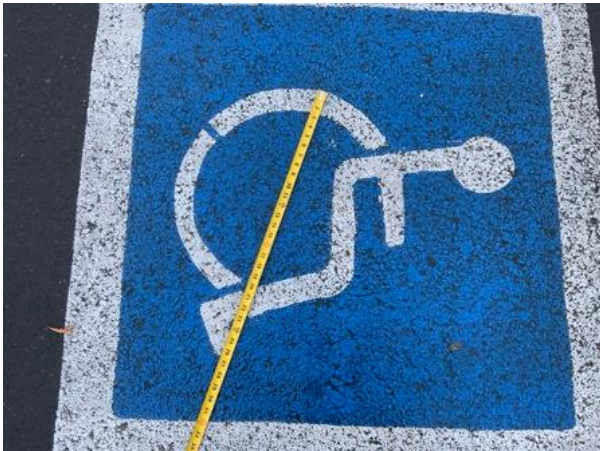
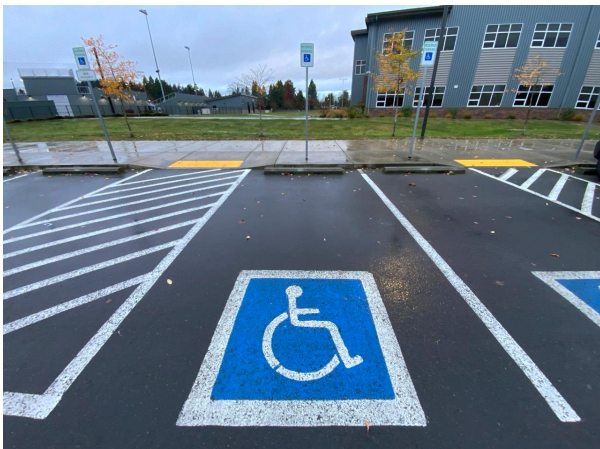
Photos for Barrier ID: AX527457

| Site Conditions | The pavement markings measure 32" in height and 26-1/2" in width. |

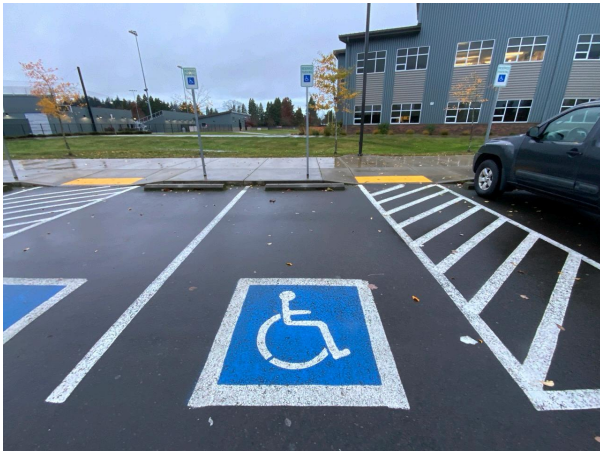
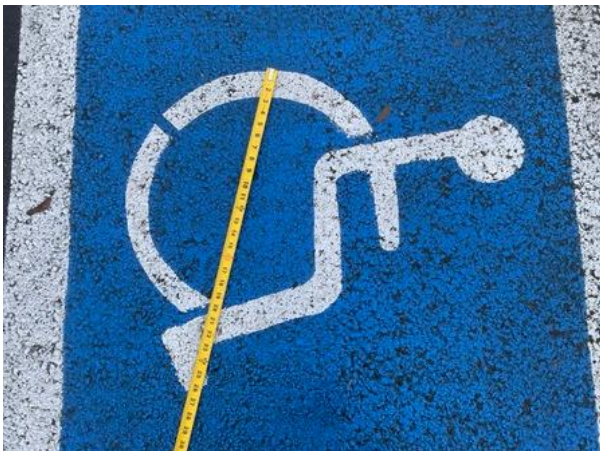
Photos for Barrier ID: AX527458

| Site Conditions | The pavement markings measure 32" in height and 26-1/2" in width. |

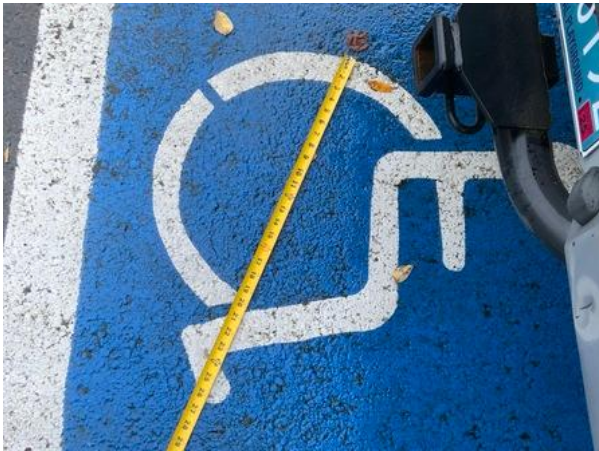
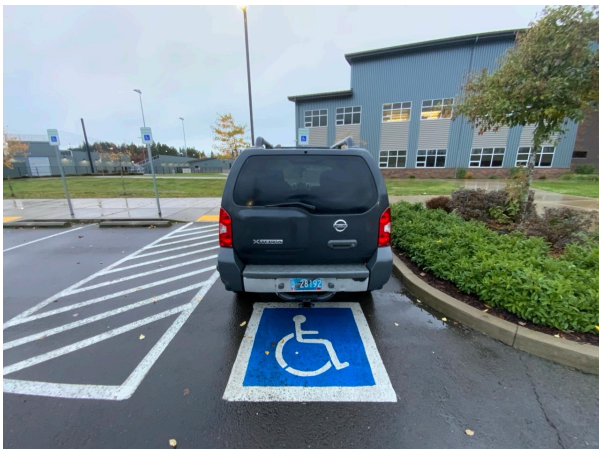
Photos for Barrier ID: AX527459

| Site Conditions | The pavement markings measure 32" in height and 26-1/2" in width. |

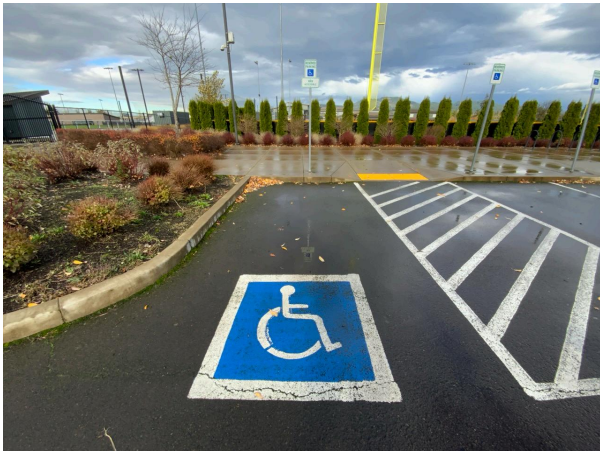
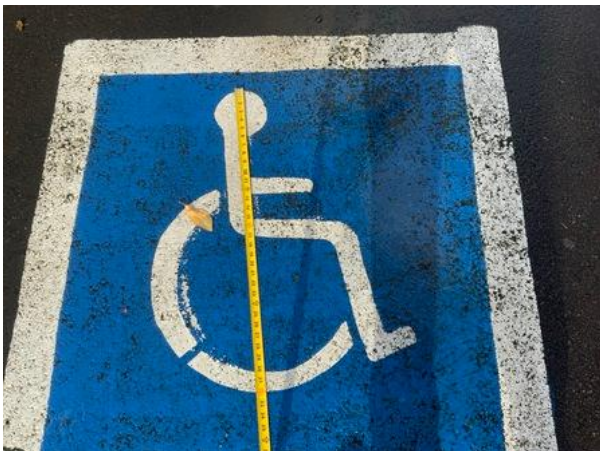
Photos for Barrier ID: AX527473

| Site Conditions | The pavement markings measure 32" in height and 26-1/2" in width. |

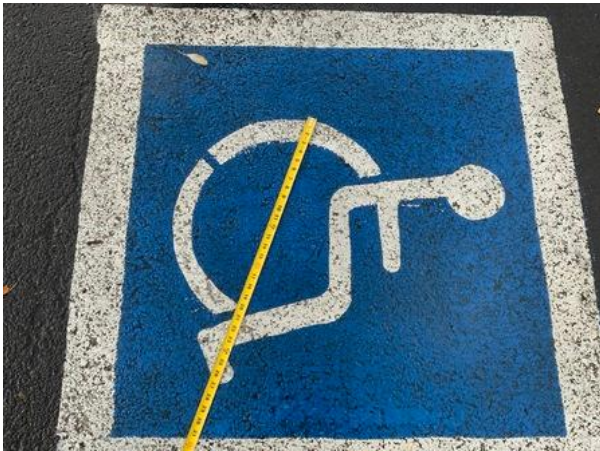
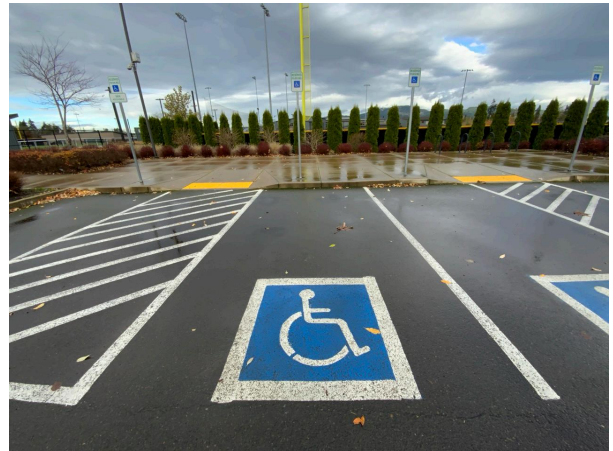
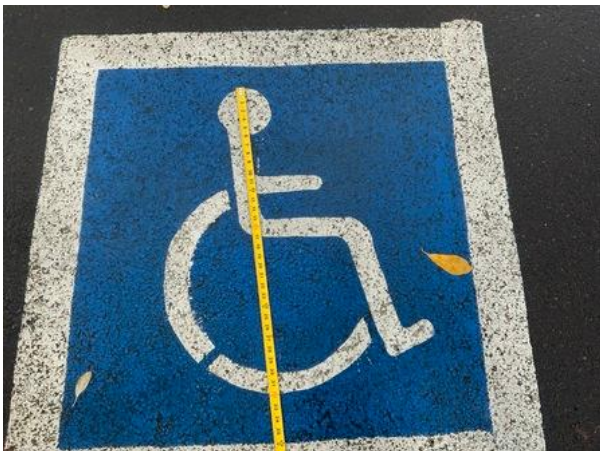
Photos for Barrier ID: AX527477

| Site Conditions | The pavement markings measure 32" in height and 26-1/2" in width. | |

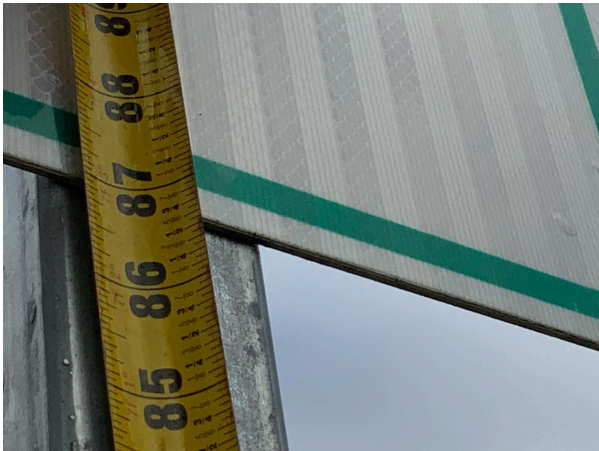
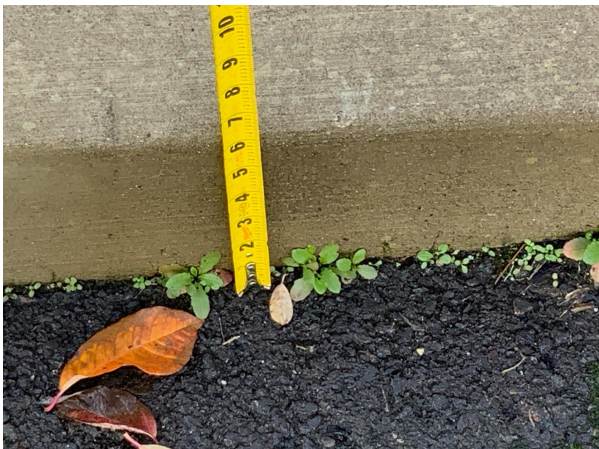
Photos for Barrier ID: AX527481

| Site Conditions | The accessible route has 1/2" to 1" wide gaps for a total of 20 linear feet. |

Repair the accessible route to eliminate openings in the surface greater than 1/2" wide. Openings in the ground surface of the accessible route shall not allow passage of a sphere more than 1/2" diameter. Elongated openings shall be placed so that the long dimension is perpendicular to the dominant direction of travel.

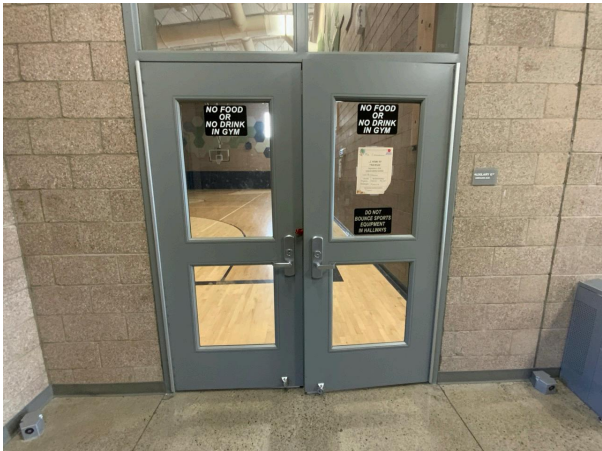
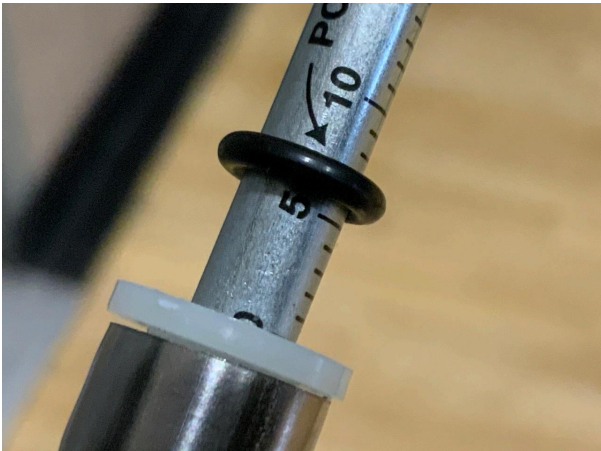
Photos for Barrier ID: AX527404

| Site Conditions | The door opening force is 5.5 pounds. |

Adjust the closer or replace with a door that requires no more than 5 pounds of force for pushing or pulling the door open. This barrier must be removed in conjunction with barrier ID 527405. The force at the latch, the force to set the door in motion, and the force to fully open the door shall be maximum 5 pounds. These forces do not apply to the force required to retract latch bolts or disengage other devices that hold the door or gate in a closed position.

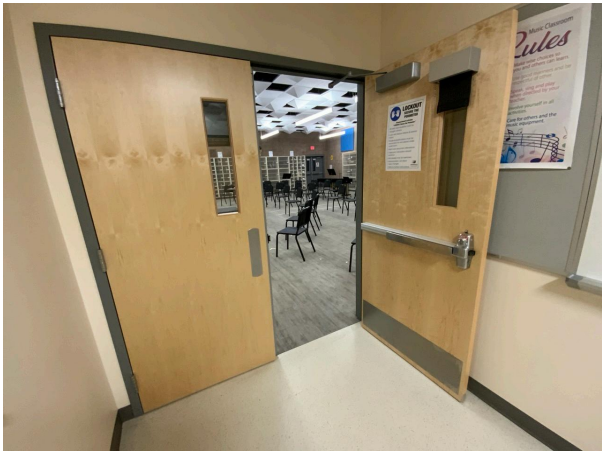
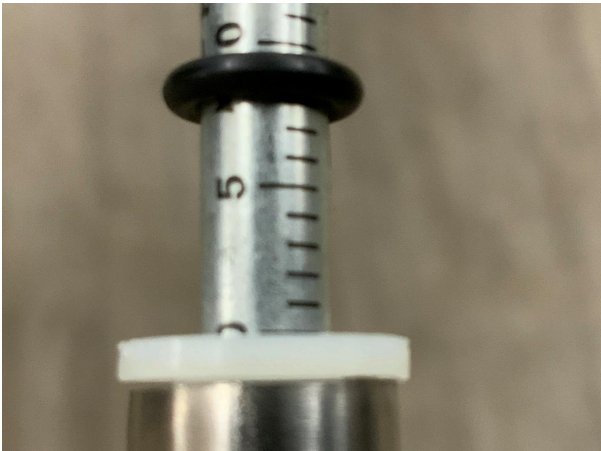
Photos for Barrier ID: AX527394

| Site Conditions | The door opening force is 8 pounds. |

Adjust the closer or replace with a door that requires no more than 5 pounds of force for pushing or pulling the door open. This barrier must be removed in conjunction with barrier ID 527395. The force at the latch, the force to set the door in motion, and the force to fully open the door shall be maximum 5 pounds. These forces do not apply to the force required to retract latch bolts or disengage other devices that hold the door or gate in a closed position.

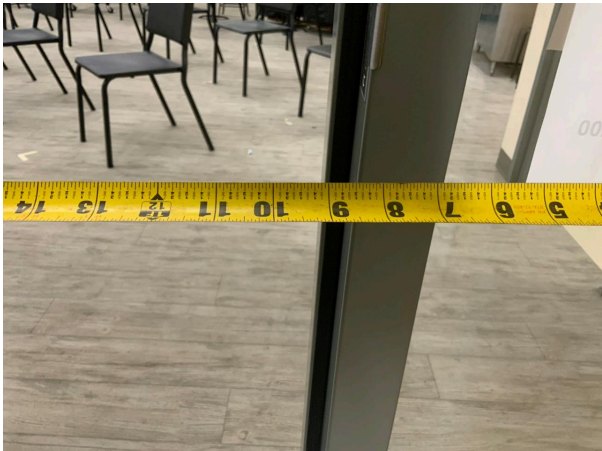
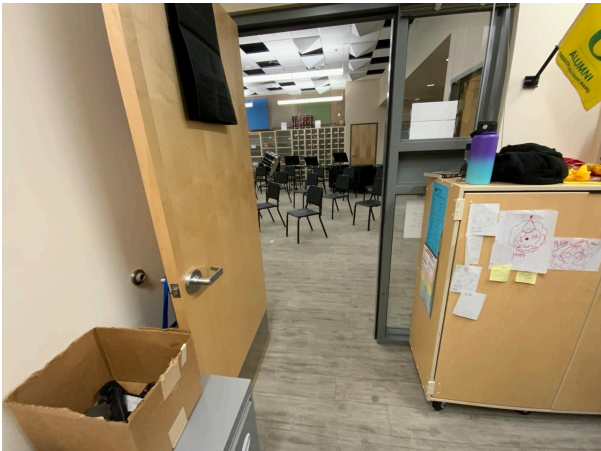
Photos for Barrier ID: AX527399

| Site Conditions | The side maneuvering clearance is 8-1/2" on the pull side of the door. |

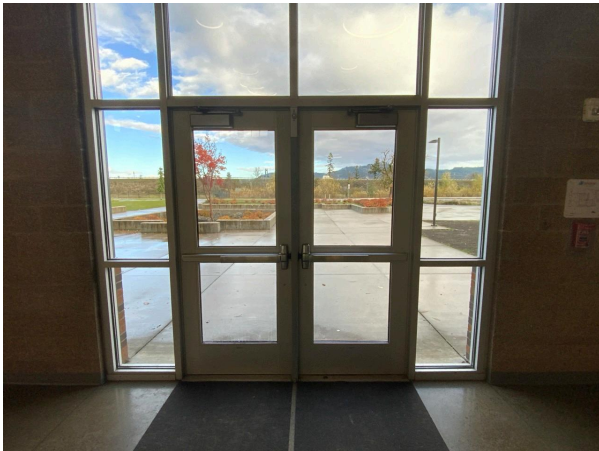
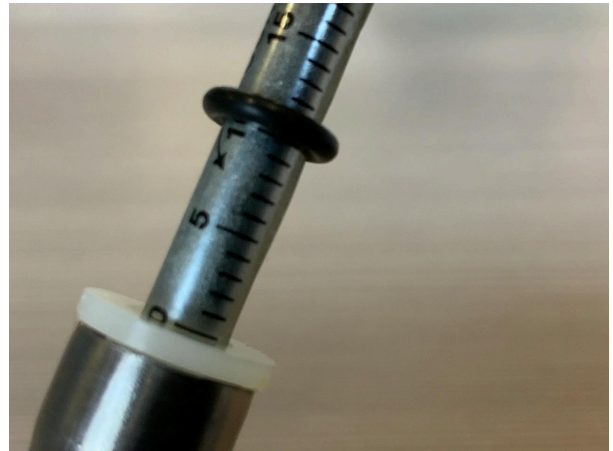
Photos for Barrier ID: AX527392

| Site Conditions | The door opening force is 12.5 pounds. | |

| Adjust the closer/opener or replace with a door that requires no more 5 pounds of force for pushing or pulling the door open. The force for pushing or pulling open a door or gate other than fire doors shall be as follows: 1. Interior hinged doors and gates: 5 pounds (22.2 N) maximum. 2. Sliding or folding doors: 5 pounds (22.2 N) maximum. These forces do not apply to the force required to retract latch bolts or disengage other devices that hold the door or gate in a closed position. Note: Fire doors shall have a minimum opening force allowable by the appropriate administrative authority. | | |

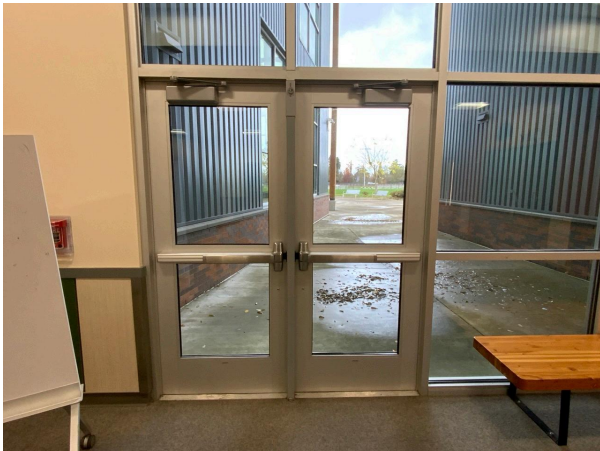
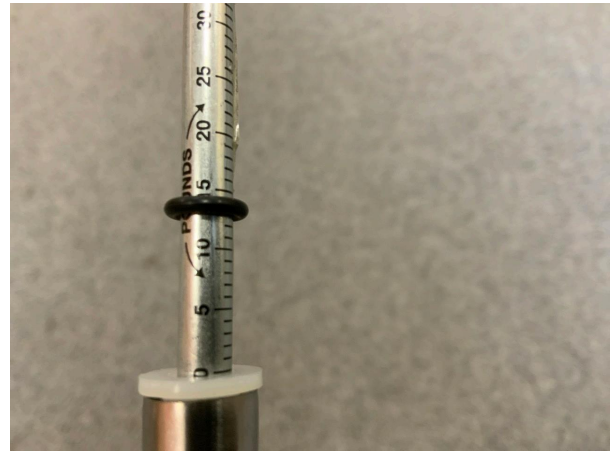
Photos for Barrier ID: AX527436

| Site Conditions | The door opening force is 8.5 pounds. | |

| Adjust the closer/opener or replace with a door that requires no more 5 pounds of force for pushing or pulling the door open. The force for pushing or pulling open a door or gate other than fire doors shall be as follows: 1. Interior hinged doors and gates: 5 pounds (22.2 N) maximum. 2. Sliding or folding doors: 5 pounds (22.2 N) maximum. These forces do not apply to the force required to retract latch bolts or disengage other devices that hold the door or gate in a closed position. Note: Fire doors shall have a minimum opening force allowable by the appropriate administrative authority. | | |

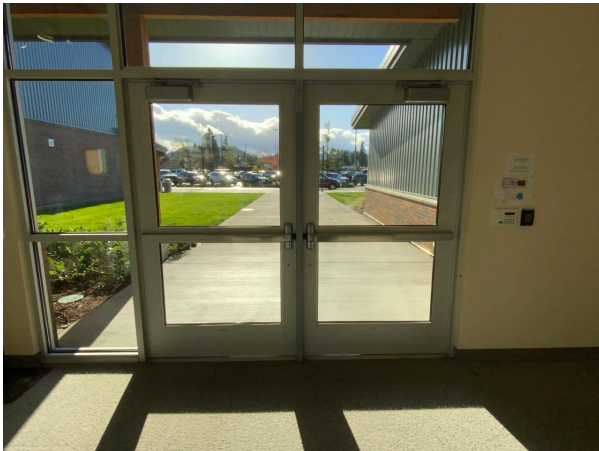
Photos for Barrier ID: AX527426

| Site Conditions | The door opening force is 8 pounds. |

Adjust the closer or replace with a door that requires no more than 5 pounds of force for pushing or pulling the door open. The force at the latch, the force to set the door in motion, and the force to fully open the door shall be maximum 5 pounds. These forces do not apply to the force required to retract latch bolts or disengage other devices that hold the door or gate in a closed position.

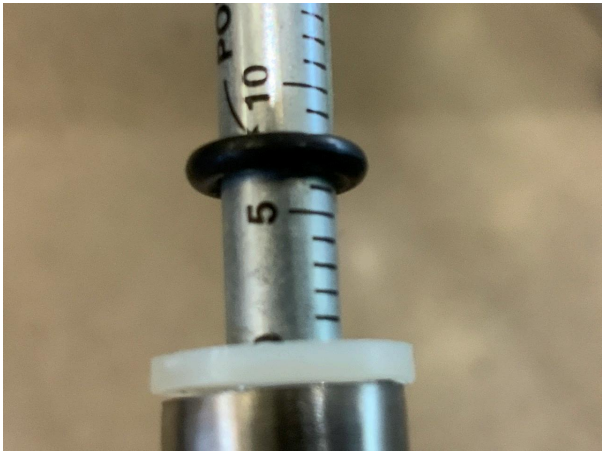
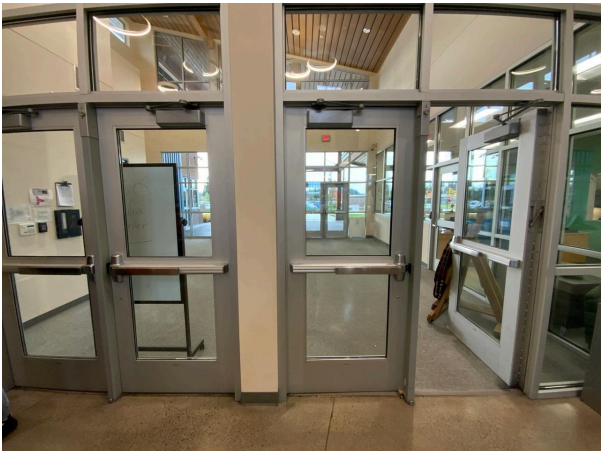
Photos for Barrier ID: AX527383

| Site Conditions | The door opening force is 9 pounds. | |

| Adjust the closer/opener or replace with a door that requires no more 5 pounds of force for pushing or pulling the door open. The force for pushing or pulling open a door or gate other than fire doors shall be as follows: 1. Interior hinged doors and gates: 5 pounds (22.2 N) maximum. 2. Sliding or folding doors: 5 pounds (22.2 N) maximum. These forces do not apply to the force required to retract latch bolts or disengage other devices that hold the door or gate in a closed position. Note: Fire doors shall have a minimum opening force allowable by the appropriate administrative authority. | | |

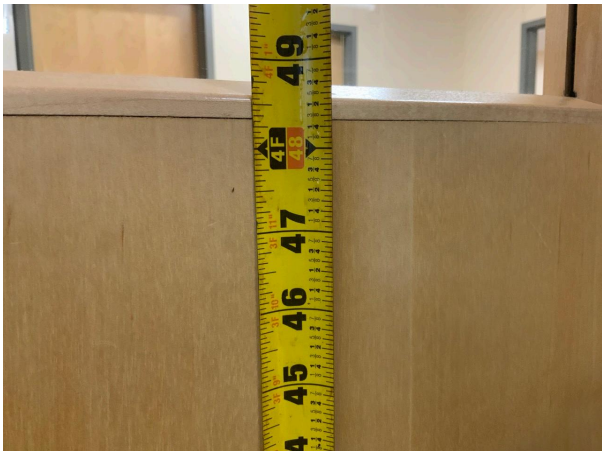
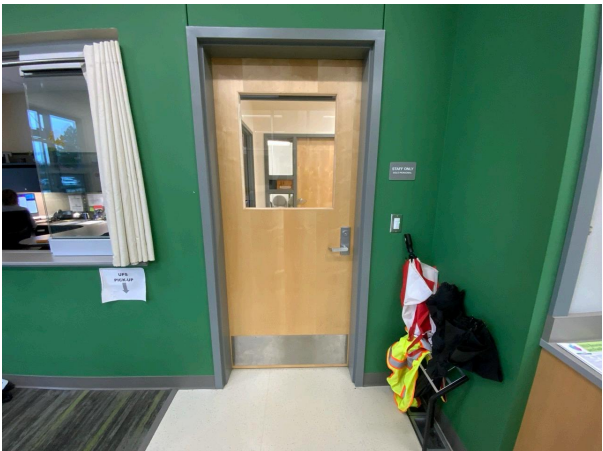
Photos for Barrier ID: AX527372

| Site Conditions | The bottom of the vision light is at a height of 48-3/4". | |

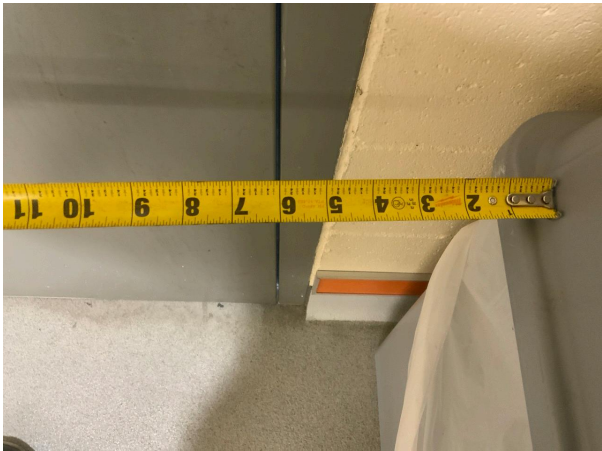
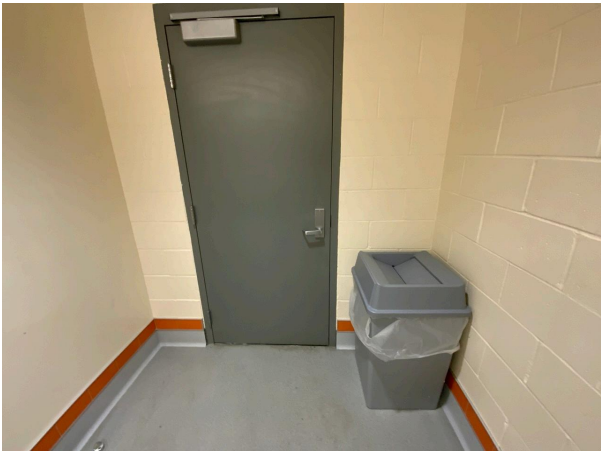
Photos for Barrier ID: AX527415

| Site Conditions | The side maneuvering clearance is 6" on the pull side of the door. |

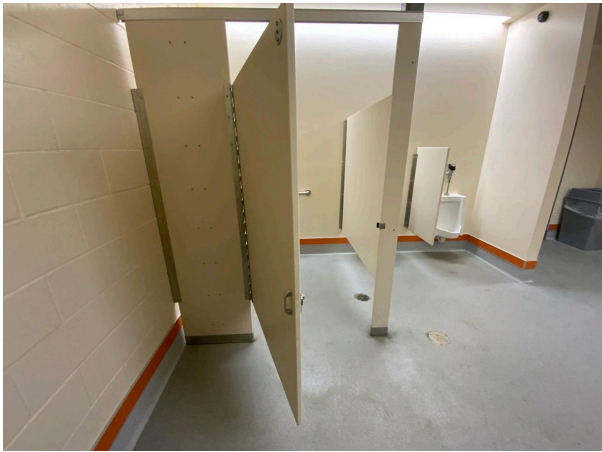
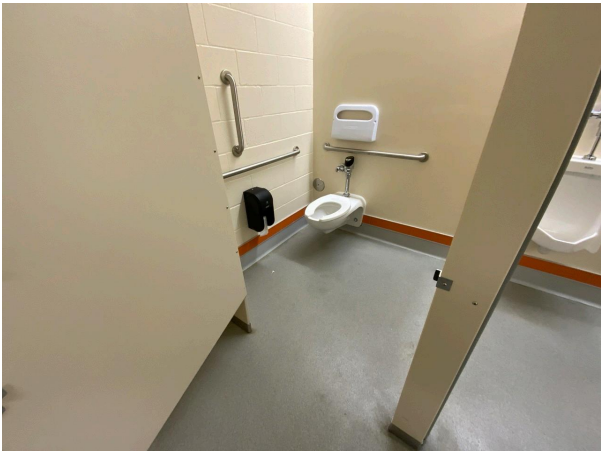
Photos for Barrier ID: AX527421

| Site Conditions | The wheelchair stall door is not self-closing. |

Remove hinge hardware and replace with hardware which provides self-closing of the door.

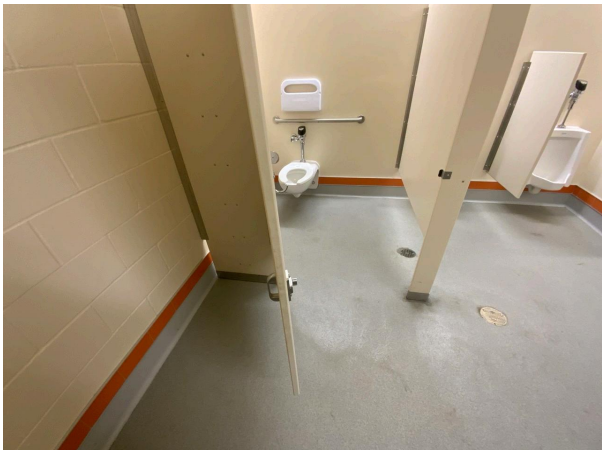
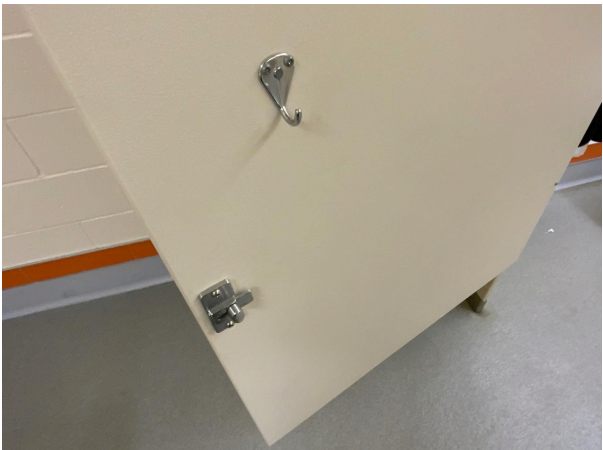
Photos for Barrier ID: AX527422

| Site Conditions | The inside of the stall door does not have pull hardware. |

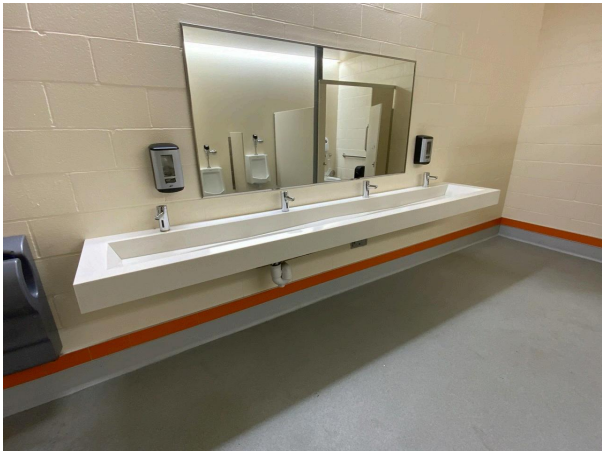
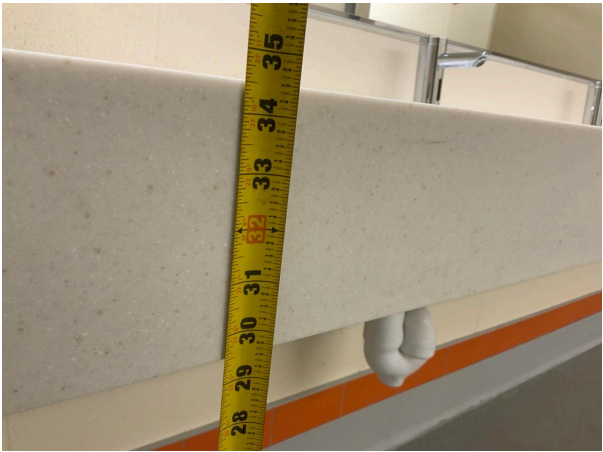
| Site Conditions | The sink rim measures 34-1/2" in height from the finished floor. |

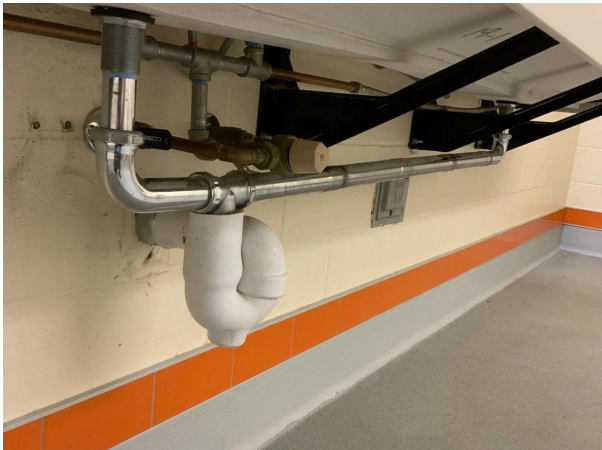
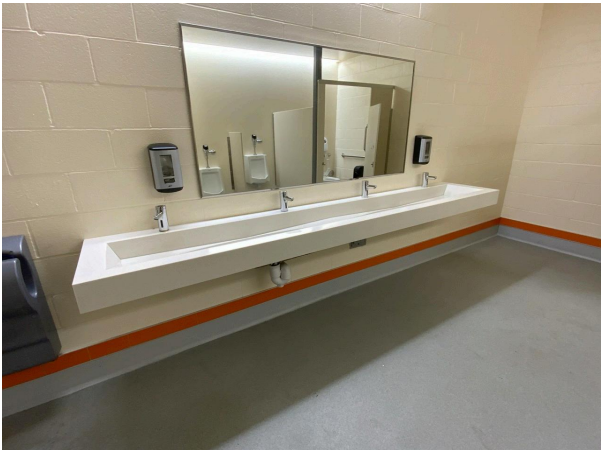
Photos for Barrier ID: AX527417

| Site Conditions | Pipes underneath the sink are not insulated. |

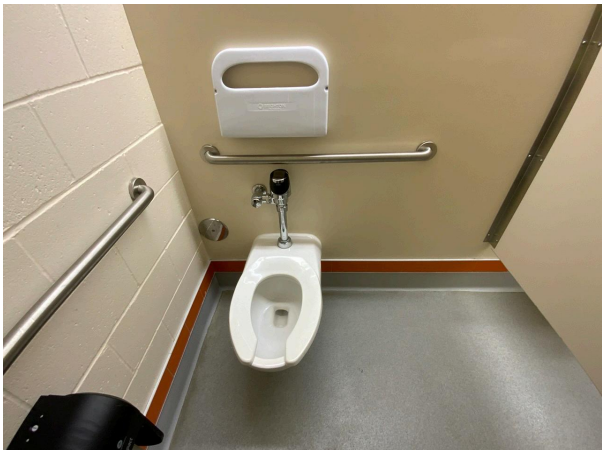
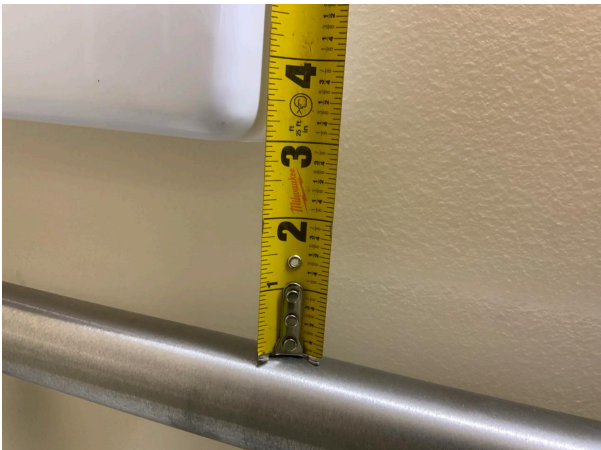
Photos for Barrier ID: AX527420

| Site Conditions | The projecting object is 3" above the grab bar. |

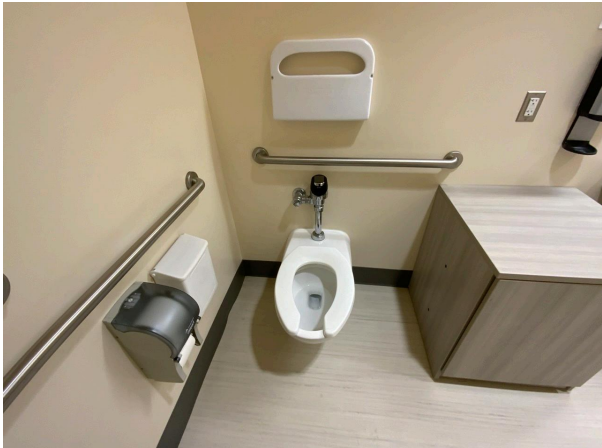
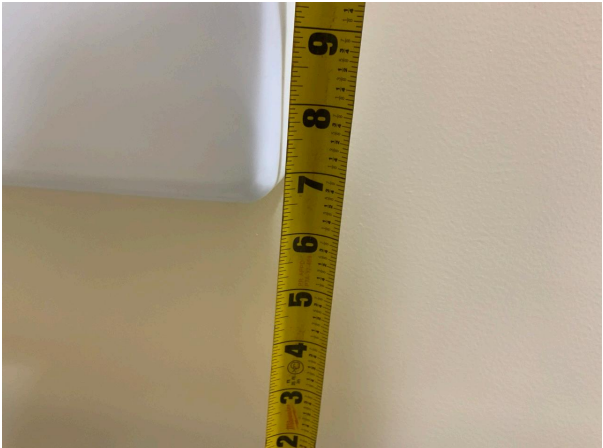
Photos for Barrier ID: AX527413

| Site Conditions | The projecting object is 6-1/2" above the grab bar. | |

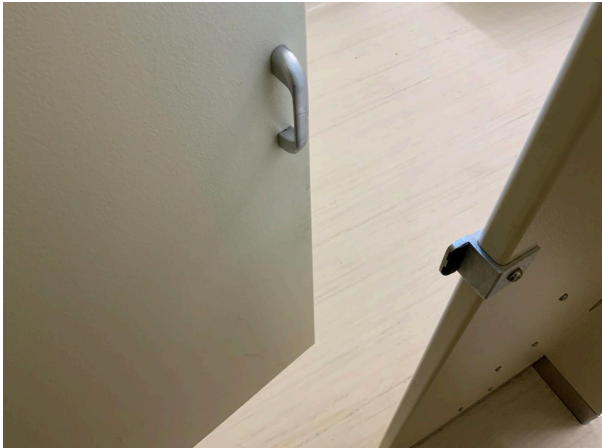
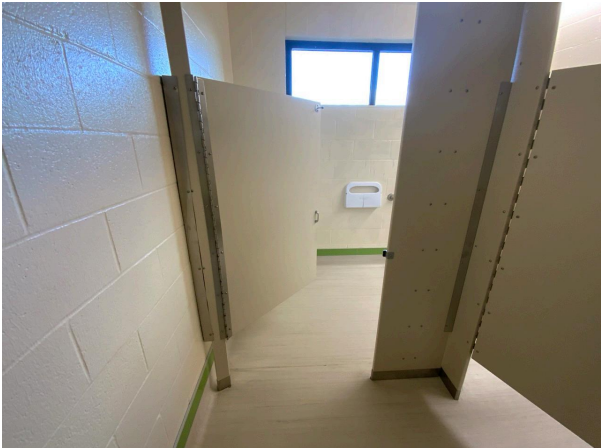
Photos for Barrier ID: AX527432

The wheelchair stall door is not self-closing. The door has been damaged and will not be able to close fully and lock (Door swings into the stall).

Remove hinge hardware and replace with hardware which provides self-closing of the door.

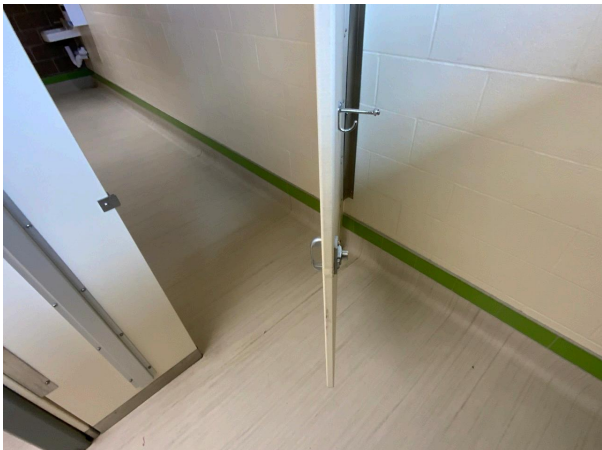
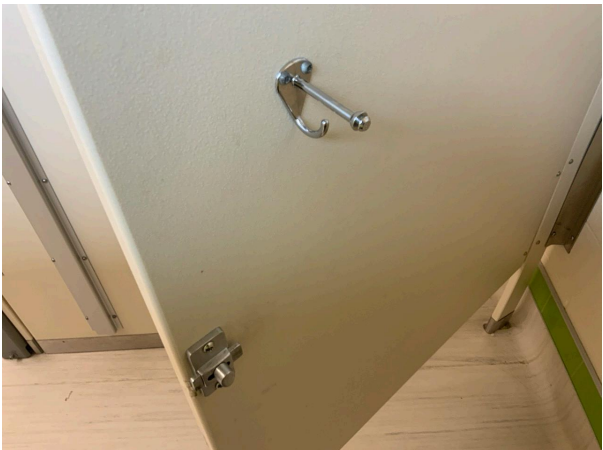
**Photos for Barrier ID: AX527433**

| Site Conditions | The inside of the stall door does not have a pull hardware. |

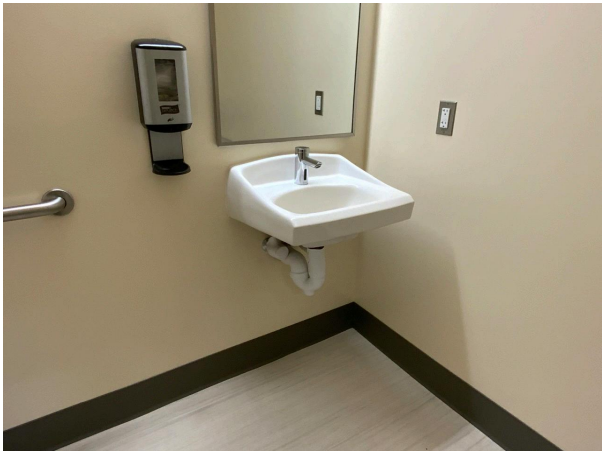
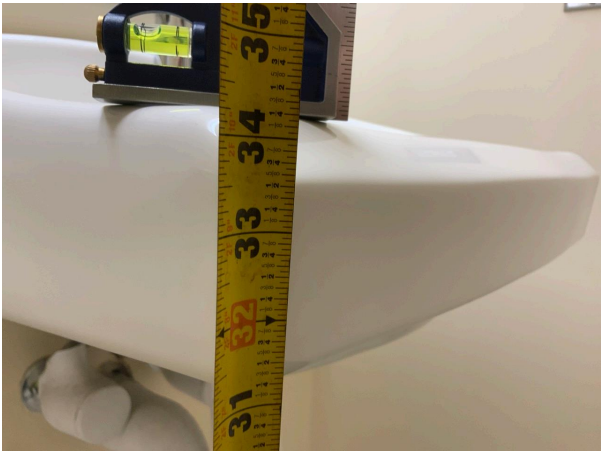
| Site Conditions | The sink rim measures 34-1/4" in height from the finished floor. |

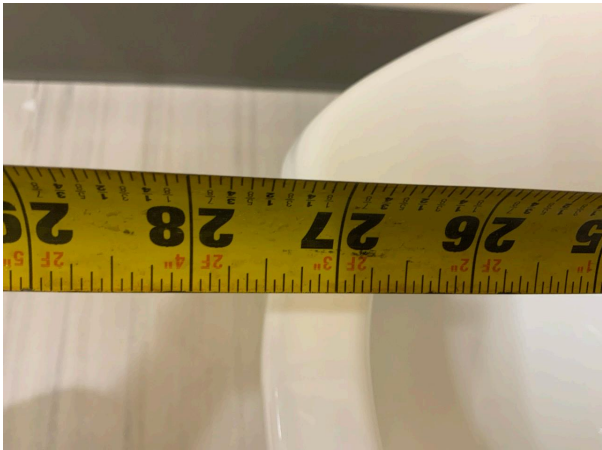
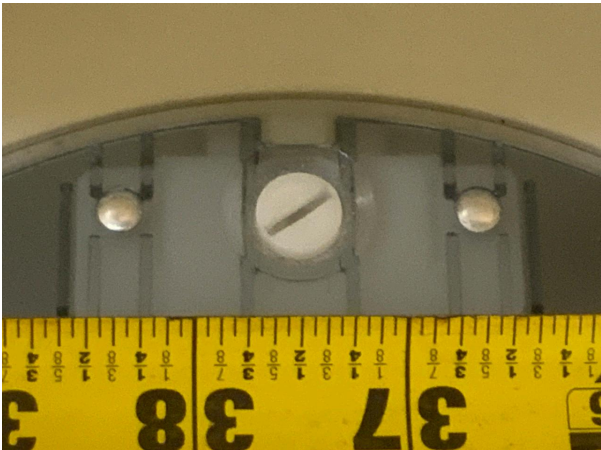
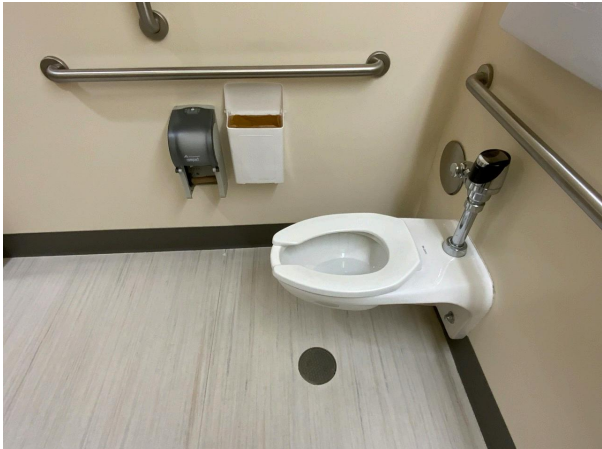
| Site Conditions | The centerline of the toilet paper dispenser is 10" in front of the water closet. |

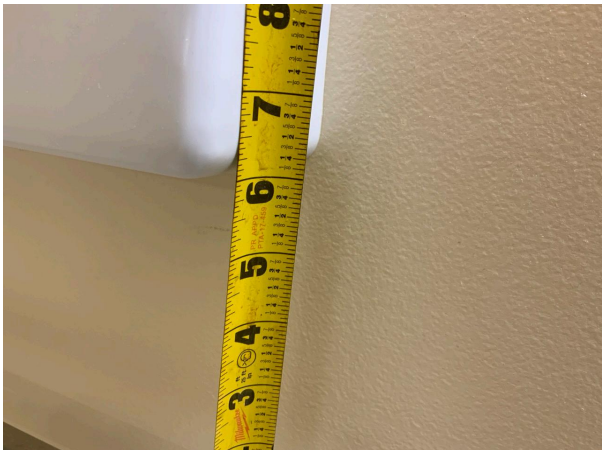
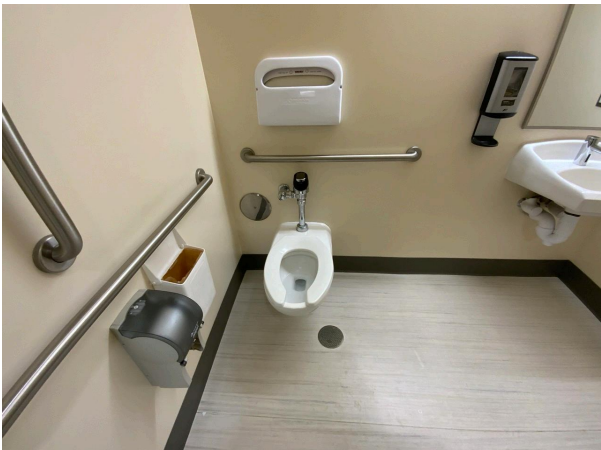
Photos for Barrier ID: AX527379

| Site Conditions | The projecting object is 6" above the grab bar. | |

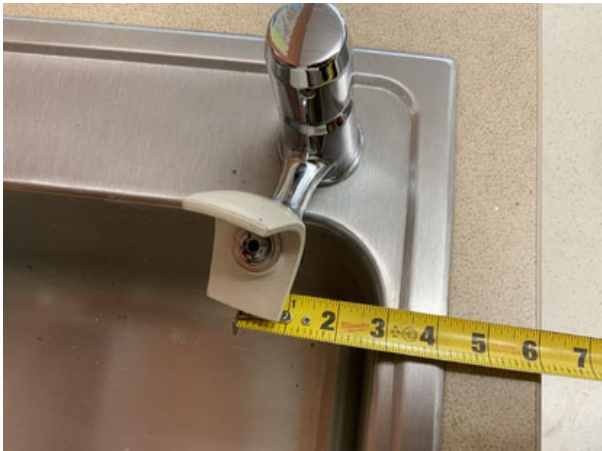
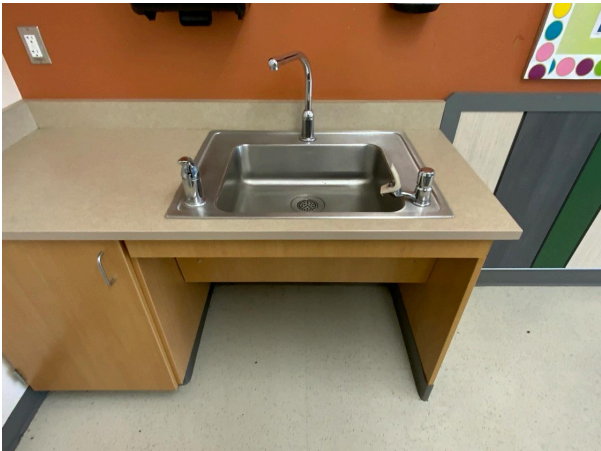
Photos for Barrier ID: AX527434

| Site Conditions | The drinking fountain spout measures 5-1/4" in depth from the front edge. |

Remove and replace with a lower level drinking fountain that has a spout located 5" maximum from the front edge of the fountain. The spout shall be located 15" minimum from the vertical support and 5" maximum from the front edge of the unit, including bumpers. The spout shall provide a flow of water 4" high minimum and shall be located 5" maximum from the front of the unit. The angle of the water stream shall be measured horizontally relative to the front face of the unit. Where spouts are located less than 3" of the front of the unit, the angle of the water stream shall be 30 degrees maximum. Where spouts are located between 3" and 5" maximum from the front of the unit, the angle of the water stream shall be 15 degrees maximum. [EXCEPTION: A parallel approach shall be permitted at units for children's use where the spout is 30" maximum above the finish floor or ground and is 3-1/2" maximum from the front edge of the unit, including bumpers.]

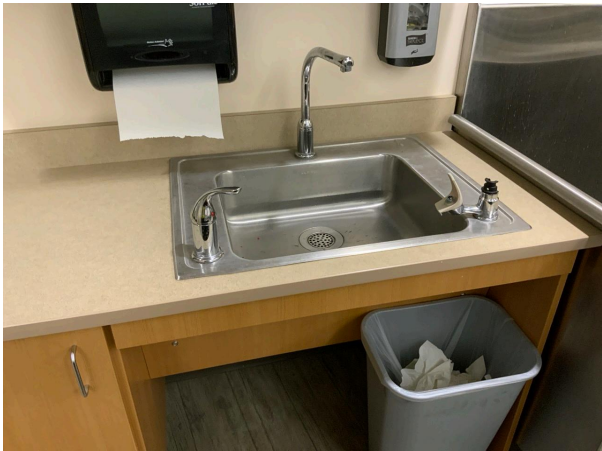
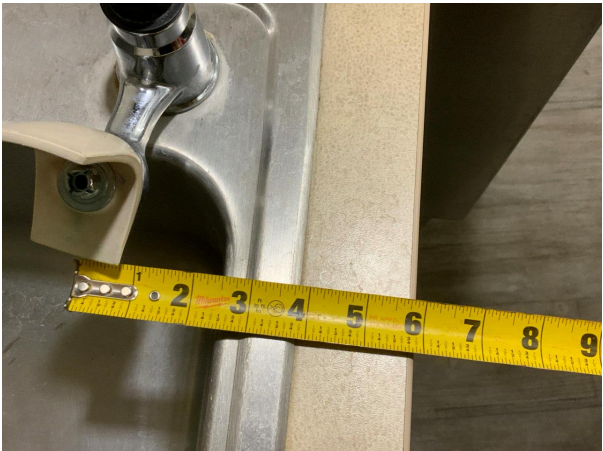
Photos for Barrier ID: AX527398

| Site Conditions | The drinking fountain spout measures 5-7/8" in depth from the front edge. |

Remove and replace with a lower level drinking fountain that has a spout located 5" maximum from the front edge of the fountain. The spout shall be located 15" minimum from the vertical support and 5" maximum from the front edge of the unit, including bumpers. The spout shall provide a flow of water 4" high minimum and shall be located 5" maximum from the front of the unit. The angle of the water stream shall be measured horizontally relative to the front face of the unit. Where spouts are located less than 3" of the front of the unit, the angle of the water stream shall be 30 degrees maximum. Where spouts are located between 3" and 5" maximum from the front of the unit, the angle of the water stream shall be 15 degrees maximum. [EXCEPTION: A parallel approach shall be permitted at units for children's use where the spout is 30" maximum above the finish floor or ground and is 3-1/2" maximum from the front edge of the unit, including bumpers.]
