# FACILITY CONDITION ASSESSMENT

**Oregon Department of Education**  
255 Capitol Street NE  
Salem, OR 97310  
Adam Krein

Thurston High School  
333 N 58<sup>th</sup> Street  
Springfield, OR 97478

October 20, 2025

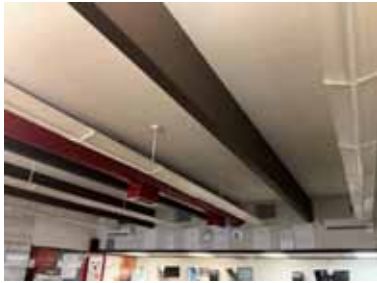
### Fire Suppression System

Full System Install/Retrofit, Medium  
Density/Complexity  
Thurston High School - Main  
Throughout Building

Uniformat Code: D4010  
Recommendation: **Renovate in 2029**

Retrofit fire suppression system. - AssetCALC ID: 8707019
