# FACILITY CONDITION ASSESSMENT

**Oregon Department of Education**

Springfield High School  
875 N 7th Street  
Springfield, OR 97477

*March 5, 2025*

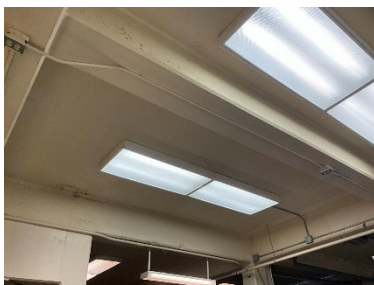
### Wall Finishes in Poor Condition.

Paint is peeled off - AssetCALC ID: 8959991

Uniformat Code: C2010  
Recommendation: **Prep & Paint in 2026**

Cost Estimate: \$35,300

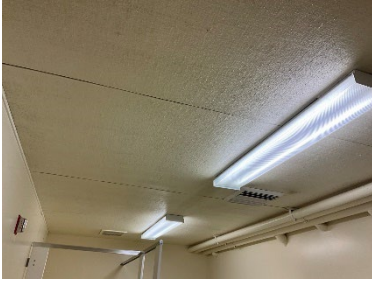
### Fire Suppression System

Full System Install/Retrofit, Medium Density/Complexity  
Health Center  
Throughout Building

There is currently no fire suppression system - AssetCALC ID: 9004712

Uniformat Code: D4010  
Recommendation: **Renovate in 2030**

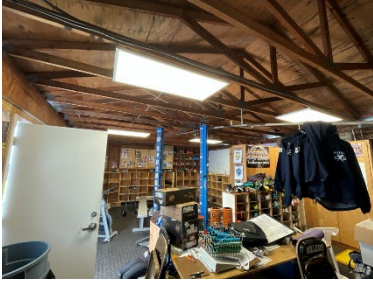
### Fire Alarm System

Full System Upgrade, Simple Addressable Storage Throughout Building

There is no fire alarm installed - AssetCALC ID: 8965784

Uniformat Code: D7050  
Recommendation: **Install in 2030**
