# FACILITY CONDITION ASSESSMENT

**Oregon Department of Education**  
255 Capitol Street NE  
Salem, OR 97310  
Adam Krein

Yolanda Elementary School  
2350 Yolanda Street  
Springfield, OR 97477

*December 3, 2024*

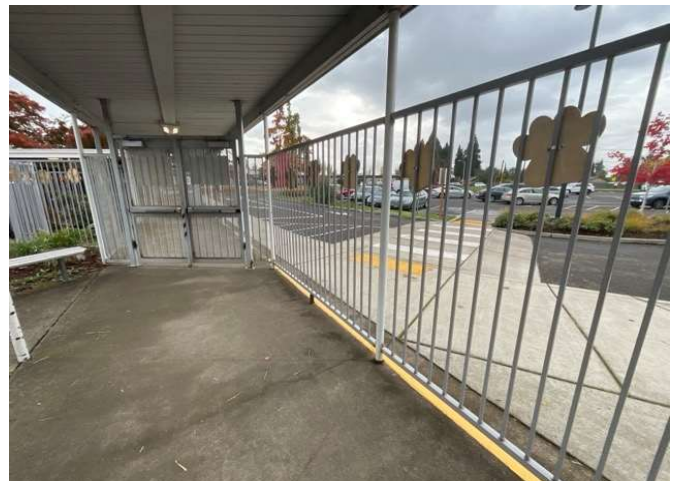
12 – FENCES &amp; GATES

### Fences & Gates in Poor condition.

Gates are oxidized - AssetCALC ID: 8564050

Uniformat Code: G2060  
Recommendation: **Replace in 2025**
