# FACILITY CONDITION ASSESSMENT

Thurston Elementary School  
7345 Thurston Road  
Springfield, OR 97478

169411.24R000-135.017

January 7, 2025

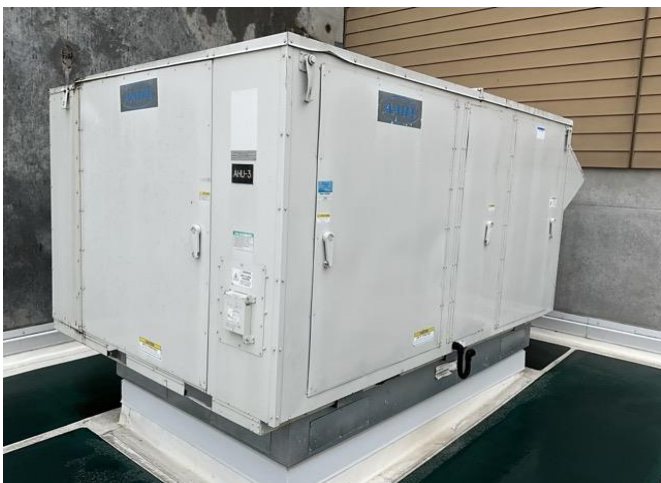
17 – AIR HANDLER

The school's central HVAC system consists of exterior air-handlers distributing air to the entire school. The package units RTU support the central system. All HVAC system components were observed to be adequately maintained with no visual or reported issues.
