# FACILITY CONDITION ASSESSMENT

160903.24R000-120.017

October 6, 2025

Riverbend Elementary School  
320 51st Street  
Springfield, OR 97478

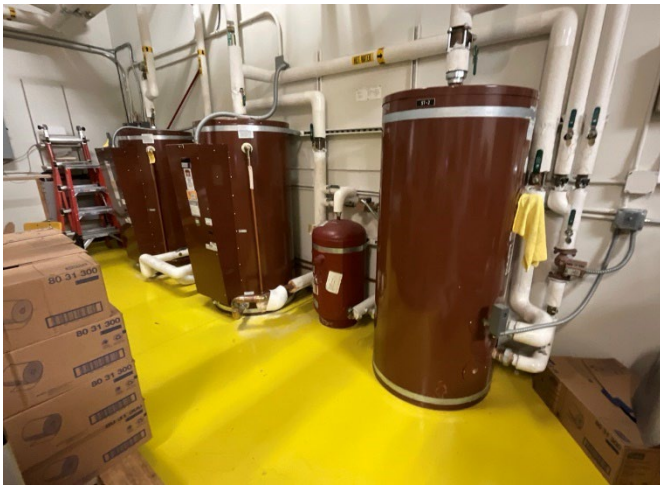
19 – DOMESTIC HOT WATER SUPPLY

Hot water is supplied by electric and gas water heaters located throughout the building. These heaters were installed when the school was built in 1997, and they've already exceeded their expected lifespan by seven years. They're at risk of failing soon, so replacement should be a priority. During the assessment, we found one of the water heaters in the kitchen leaking, and it needs immediate attention.

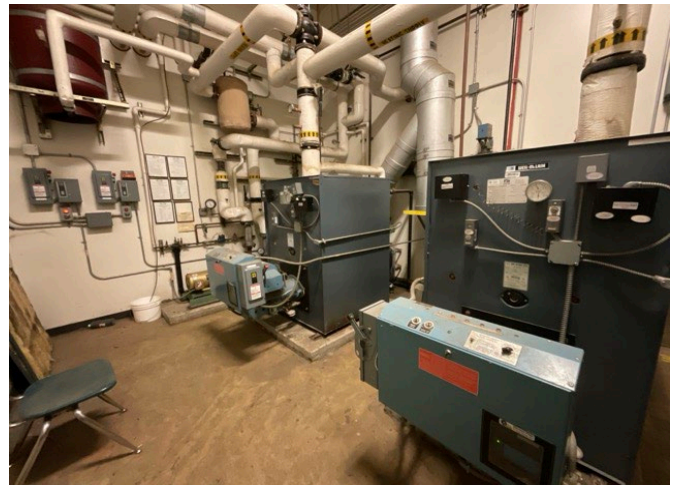
20 – BOILERS &amp; PUMPS

The HVAC system at Riverbend Elementary School is made up a couple components. The main system is a central hydronic system with a boiler, supported by roof-mounted packaged units and a ductless split system for specific areas. The boiler, installed in 1997, is holding up in fair condition, while the packaged units, replaced in 2023, are in good shape. The school's electrical system includes two main switchboards, one running at 120/208 volts and the other at 277/480 volts. A diesel generator with an Automatic Transfer Switch (ATS) is also on-site and is in fair condition. Most of the lighting inside the building uses linear fluorescent or compact fluorescent fixtures, except in the gymnasium and cafeteria, which have specialized lighting. Everything is currently working fine, and no immediate repairs are needed.

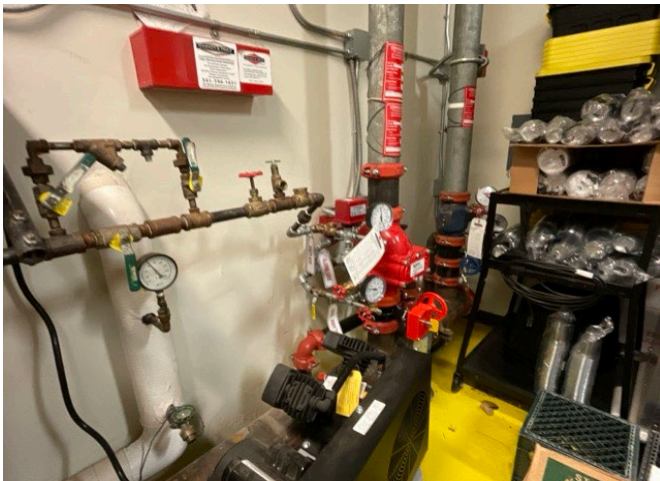
29 – FIRE SPRINKLER RISERS

The school is equipped with fire sprinklers, extinguishers, and a fire alarm system that includes smoke detectors, strobe lights, manual pull stations, and lit exit signs. There's also a security system with cameras in place. Everything is currently working as it should, and there were no problems reported by staff or the Point of Contact (POC). Repairs or updates will be needed as the systems age or if any issues arise.

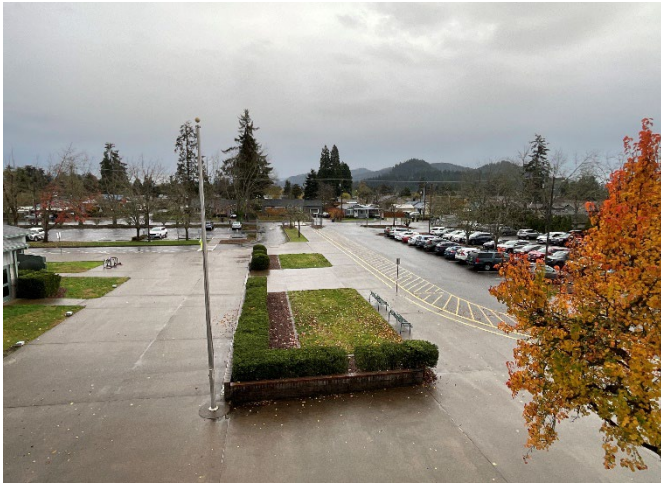
1 – PARKING LOTS

The parking lot, situated east of the school near the main entrance, is in good condition. There are no visible cracks, and the striping remains clear and does not require repainting at this time.

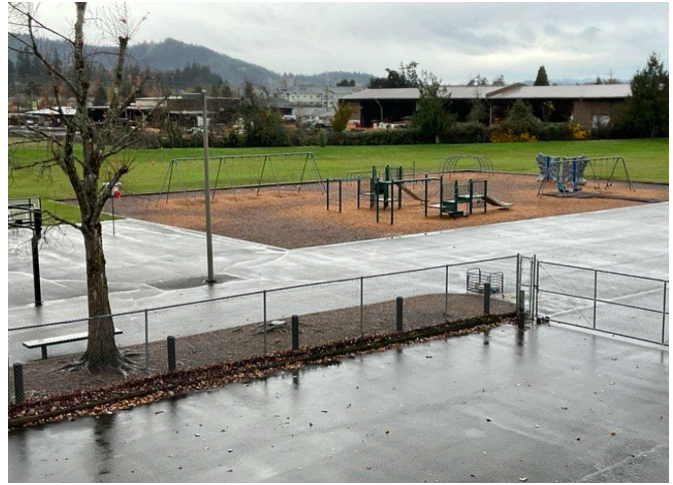
2 – PLAYGROUND

The playground structures, while aged, are functional but should be considered for replacement in the coming years. The wood chip surfacing needs replenishment to ensure compliance with safety standards.
