# FACILITY CONDITION ASSESSMENT

**Oregon Department of Education**  
255 Capitol Street NE  
Salem, OR 97310  
Adam Krein

*January 10, 2025*

Mt Vernon Elementary School  
935 Filbert Lane  
Springfield, OR 97478

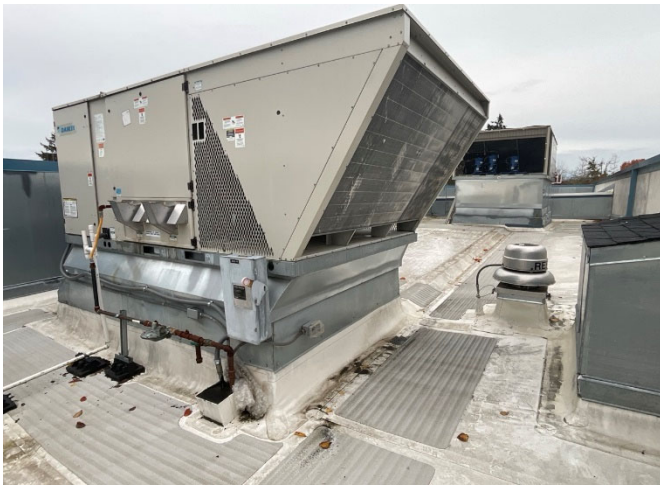
19 – ROOFTOP MECHANICAL EQ

The HVAC system at Mt. Vernon Elementary School is a combination of several components. The primary system is a central hydronic system with a boiler, complemented by roof-mounted packaged units and a ductless split system serving specific rooms. While the boilers, installed in 1997, remain in fair condition, the packaged units were replaced in 2023 and are in good condition. The electrical system comprises two main switchboards: one for 120/208 volts and the other for 277/480 volts. Both have over 13 years of remaining service life. A diesel generator with an Automatic Transfer Switch (ATS) is also present and in fair condition. Interior lighting predominantly utilizes linear fluorescent and compact fluorescent fixtures, except in the gymnasium and cafeteria, which feature specialized lighting systems. All components are in fair condition, with no immediate interventions required.

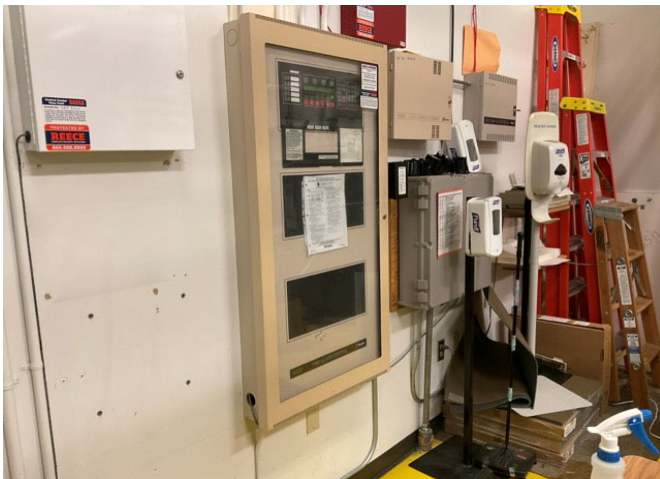
23 – FIRE ALARM PANEL

The school is equipped with a fire suppression system and fire extinguishers. Additionally, there is a surveillance and security camera system in place. The fire protection infrastructure includes a fire alarm panel with smoke detectors, strobe lights, manual pull stations, and illuminated exit signs. All components are functional, with no anomalies reported by the Point of Contact (POC) or staff. Repairs or upgrades will be required as they reach the end of their service life or as needed.

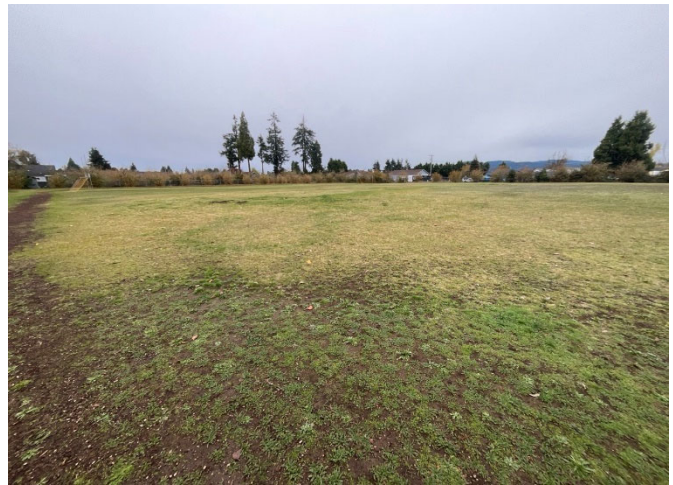
2 – SPORT FIELD

The playground structures are in fair condition. However, the wood chip surfacing requires replenishment to maintain compliance with safety standards. The outdoor fields lack bleachers and water fountains, which limits their functionality for supporting outdoor activities.

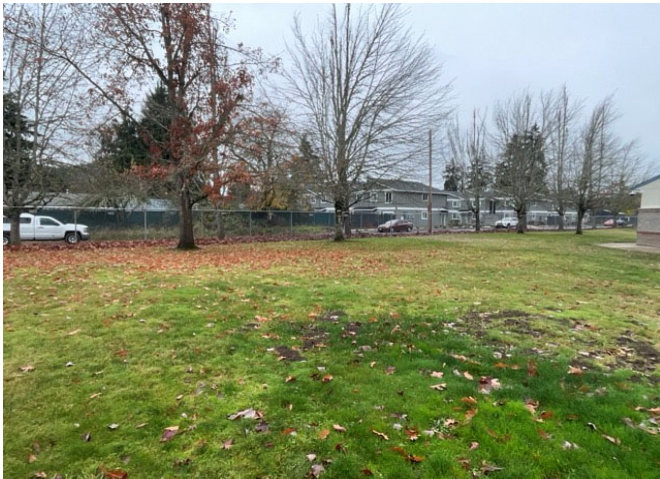
11 – LANDSCAPING

There is no irrigation system observed for the fields or landscaped areas, which could affect the long-term health and appearance of the property, particularly during dry seasons.
