# FACILITY CONDITION ASSESSMENT

**Oregon Department of Education**  
255 Capitol Street NE  
Salem, OR 97310  
Adam Krein

Guy Lee Elementary School  
755 Harlow Road  
Springfield, OR 97477

October 6, 2025

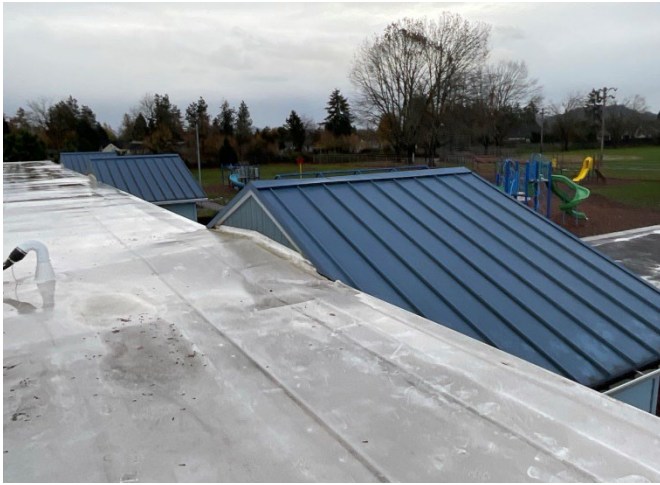
7 – ROOFING

This portion of roofing has a significant amount of holes that were drilled into it to install/replace equipment and parts of it are "squishy" for the lack of a better term. There were parts of the roof where I was u comfortable walking on due to this. - AssetCALC ID: 8634812

Recommendation: **Replace in 2025**
