# FACILITY CONDITION ASSESSMENT

**Oregon Department of Education**  
255 Capitol Street NE  
Salem, OR 97310  
Adam Krein

October 6, 2025

0544 - Centennial Elementary School  
1315 Aspen Street  
Springfield, OR 97477

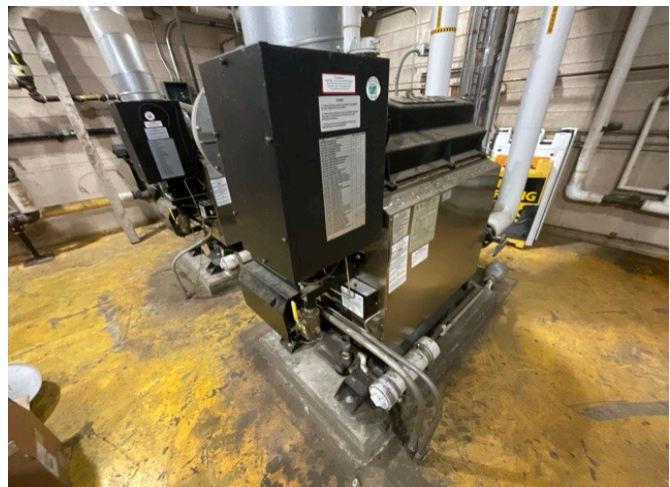
10 – HVAC SYSTEM

**HVAC System in Poor condition.**

The controls for the boilers were moved in Summer 2024 for the install of all the new ductless units and now the boilers don't work properly. - AssetCALC ID: 8653363

Uniformat Code: D3050  
Recommendation: **Repair in 2025**
