# Walking and Bicycling Audits

San Mateo-Foster City School District

# Bayside S.T.E.M. Academy Walking and Biking Audit

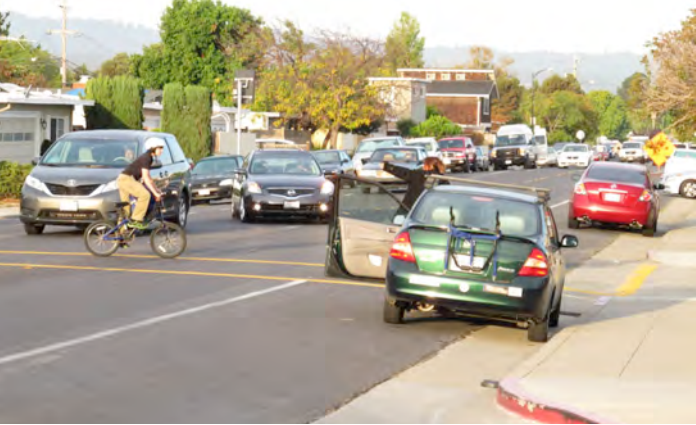
Curbside parking hinders the line of sight for pedestrians and drivers.

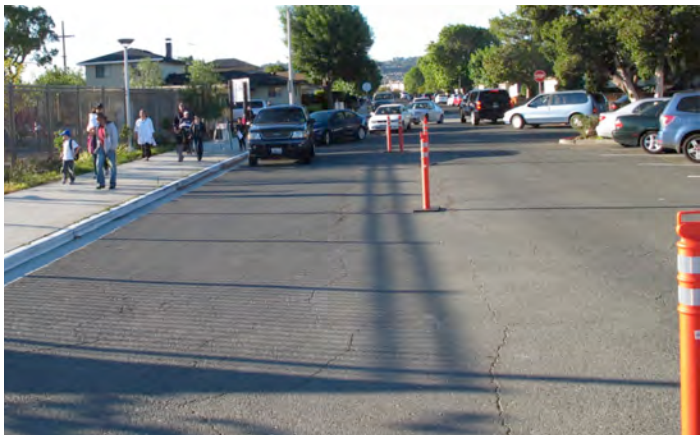
Cones separate loading traffic from the staff parking area.

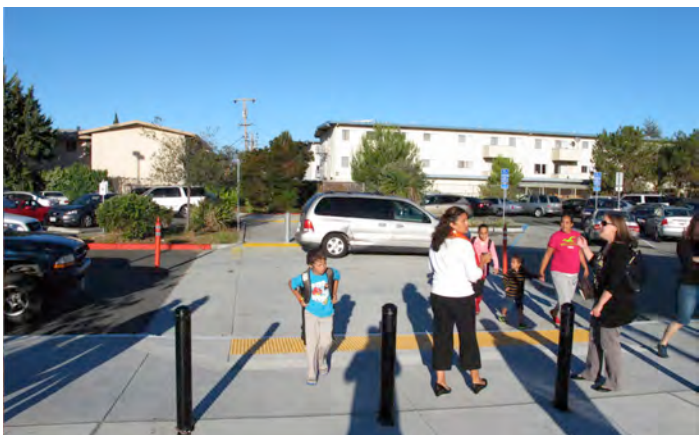
Raised crosswalks encourage slower travel speeds.

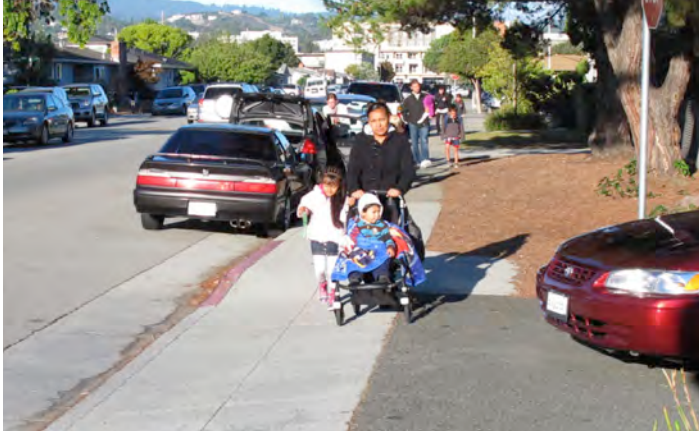
Driveway crossings without landings result in uncomfortable cross-slopes.

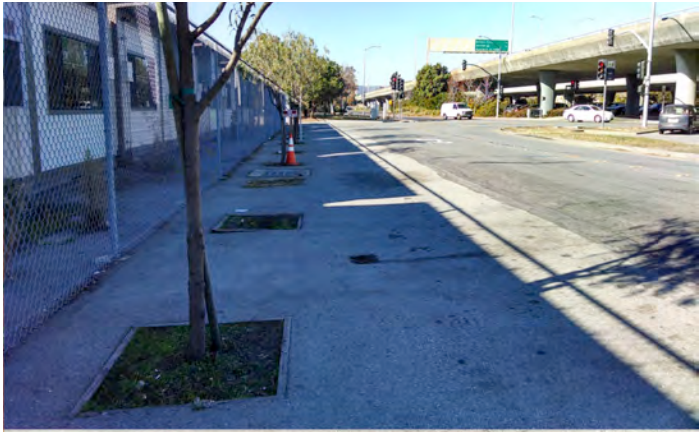
19th Avenue lacks designated crossings, sidewalks, and curbs.

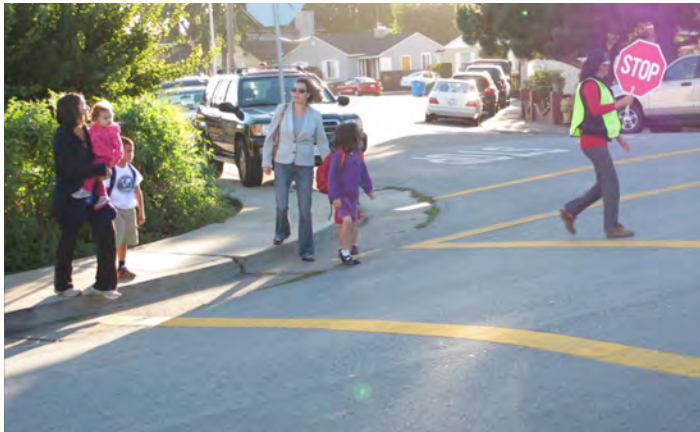
Several intersections near the school lack corner curb ramps.

- At Cypress and Norfolk:
- Construct curb ramps at all corners (19)
  - Consider corner bulb outs at the southeast and southwest corners (20)
  - Consider moving the light pole at the southeast corner

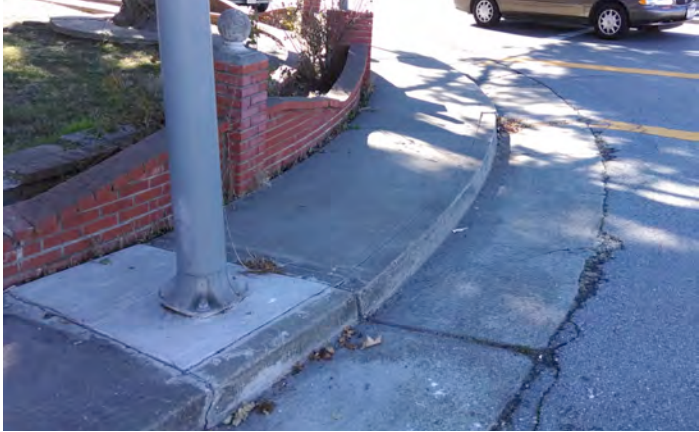
There are several utility poles obstructing the sidewalk.

Consider widening the sidewalk onto the asphalt section or moving the light pole on the north side of Cypress between Norfolk and Lindberg (21)

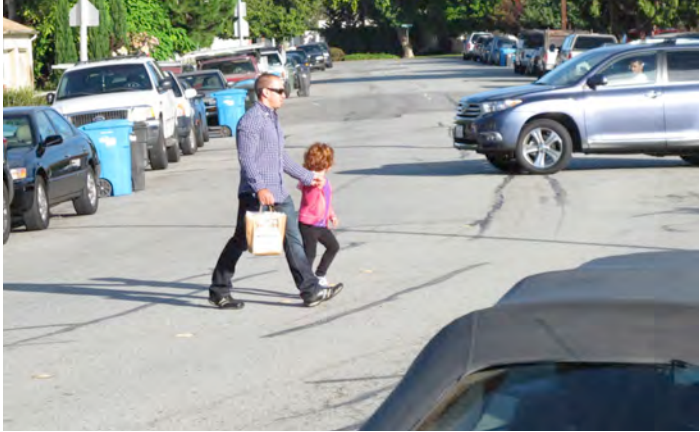
Parents and children crossing Kingston Street are exposed to traffic.

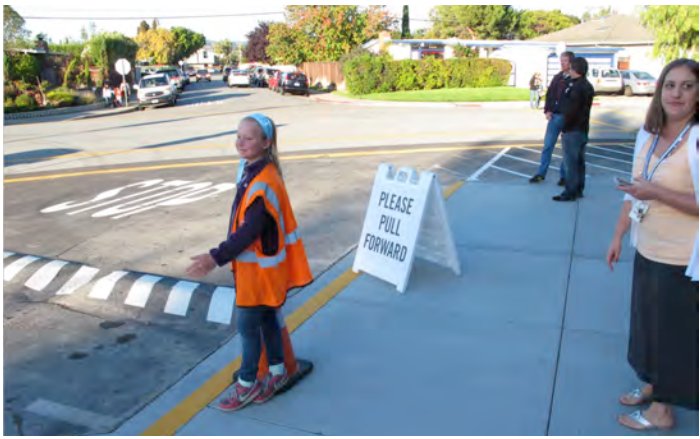
Pulling forward reduces driveway congestion.

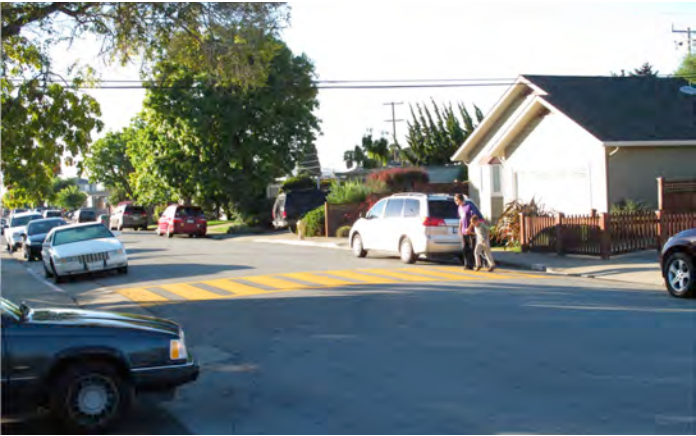
Parked cars impede the line of sight for crossing pedestrians at the uncontrolled crosswalk.
