# AMIGOS SCHOOL

15 Upton Street  
Cambridge, MA 02139

**Facilities Condition Assessment : October 14, 2022**

Facilities Condition Assessment, Capacity Analysis and Master Plan for CPS

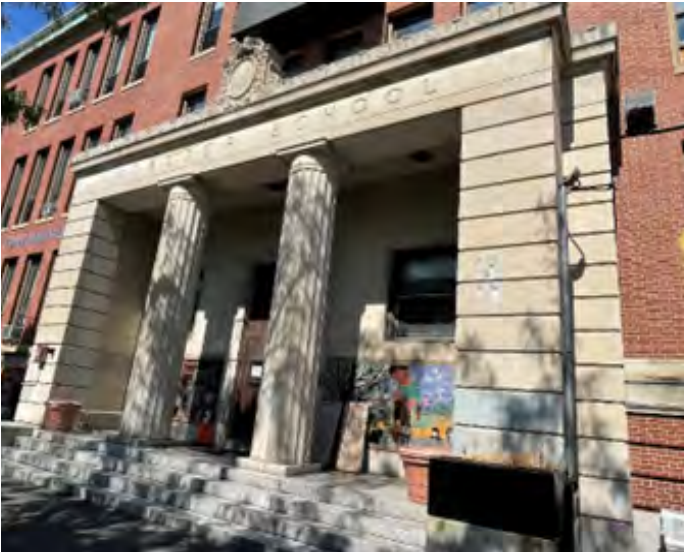
AE-A: Main Entrance at South Elevation

The exterior doors and associated window assemblies are hollow metal framed with surface rusting and peeling paint on the base of these frames at most locations. The hollow metal window assemblies at these entrances also exhibit rusting and peeling paint. (Ref: Photos AE-26-29)

Windows and Doors:  
The existing perimeter sealants at windows and doors should be replaced. Some of the surface rusting observed at the hollow metal doors and frames may be due to use of deicing salts during the winter months. Reduction in use of these materials against these metal assemblies should reduce potential for further damage. The replacement of doors and frames is recommended.

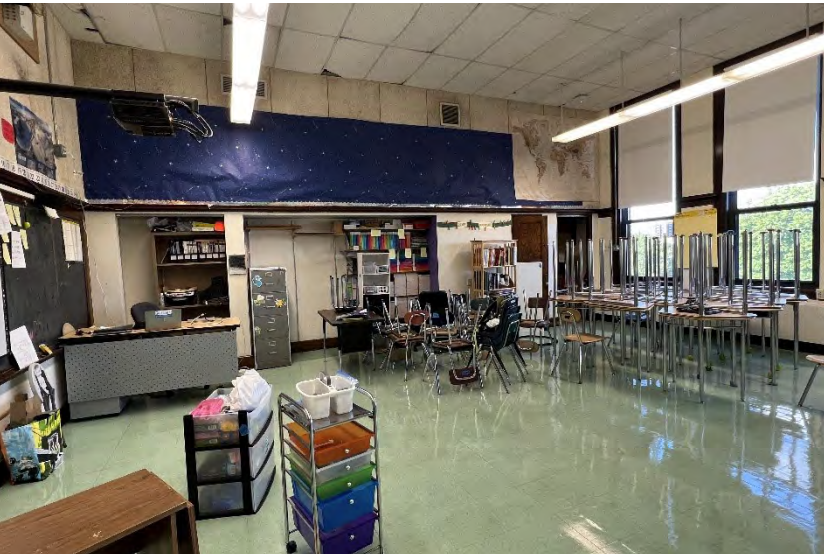
Amigos Typical Third Floor Classroom

The interior condition of the Amigos School has a majority of rooms in need of significant repair with a small portion in good/ new condition and another small portion failing.

Interior finishes are overall well past their useful life. This building is in need of renovations and would best be handled as a full scope project rather than done in isolated scopes.

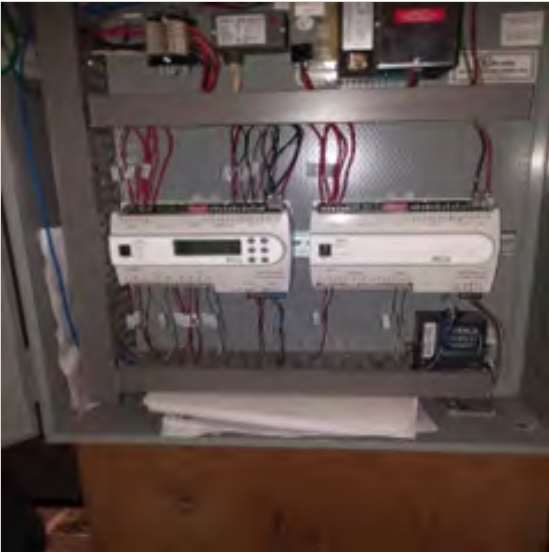
M-6: JCI Boiler System Controls

*Existing Condition*  
The existing building automation system is a hybrid of different age and manufacturer control systems which consist of vintage Barber Coleman controllers for the HV air handling units, Reliable/Vykon controllers for the kitchen exhaust system, and a relatively up-to-date JCI Facility Explorer system for the heating hot water plant. As noted above, the controls for the HV units do not appear to be functional. Given the age of this equipment, finding replacement/repair parts is not likely. The kitchen equipment controls are much more modern, though in the middle of anticipated service life (20 years) and appear to be functional with no operational issued noted. The more technologically current JCI Facility Explorer system interfacing with the heating hot water system was installed in 2017 and is fully functional.

*Recommendations*  
The existing HV unit’s DDC systems in their entirety should be replaced. They are well past the expected operational service life (20 years). This replacement should be concurrent with any replacement or upgrades of the air handling units and/or the occupied area heating/cooling equipment. The kitchen equipment DDC devices are in no need of replacement. However, if the HV system controls are to be replaced then it is recommended that the kitchen equipment controls be upgraded with equivalent controls at that time in order to provide a seamless building automation system. The heating hot water/boiler system DDC controls are technologically current and are still fully operational and interface with the current Cambridge School system BAS network. No recommendations are made for replacement/upgrades of this system. Any upgrades to the building’s BAS network should be fully compatible with the current Tridium Niagara platform. Any control system upgrades should include a complete system of DDC controllers, sensors, actuators, and head-end graphics with full integration to the campus-wide network.

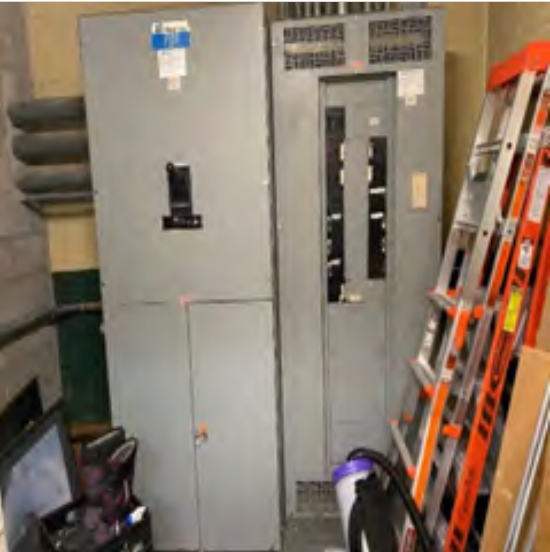
E-1: Main Electrical Service (Entrance)

*Electrical Systems*  
The existing electrical distribution, lighting, fire alarm, and IT systems are partially original to the 1982 building renovation and new construction project, approximately 40 years old, and have had only minor modifications to support program changes.

Most of the feeders in the electrical distribution system were not upgraded in the 1982 renovation and are original to 1938. This equipment is past its useful life.

*Recommendations*  
It is generally accepted that the life of an electrical system is thirty (30) years. Beyond that point, it becomes increasingly difficult to cost effectively maintain the system. Wire insulation and equipment failure becomes more common as the system ages, with an increase in outage longevity due to the design of the system and the availability of replacement parts. Often new systems need to be installed to bypass the old system without the benefit of a comprehensive plan designed for the needs of the building. With the aged electrical devices, the devices may not operate under faulty conditions.

The main electrical distribution provides 346KW with an area of 56,976 square feet or 6 W/SF. New highly efficient mechanical designs generally require 19- 24w/sq/ft. The main service would be required to be upgraded complete for a large-scale mechanical upgrade.

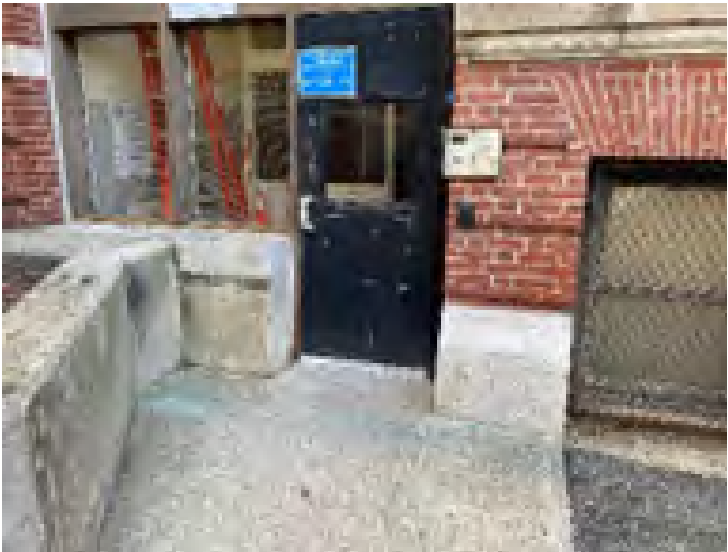
Entrance

The building has an accessible drinking fountain and toilet room. The entrance is functionally accessible but does not provide the fully clear floor space beyond the latch on the pull side of the door. If the cost of work exceeds \$100,000 the accessible entrance door would have to be modified by adding an automated power door operator.
