# BALDWIN SCHOOL

## Facilities Condition Assessment : October 19, 2022

Facilities Condition Assessment, Capacity Analysis and Master Plan for CPS

## 7.2 | BALDWIN SCHOOL BUILDING APPENDIX

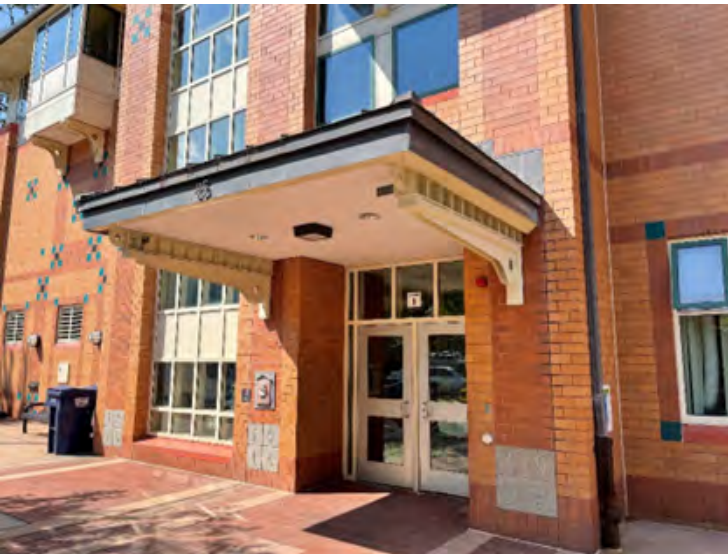
AE-A: Main Entrance, representative brick and curtain wall assemblies

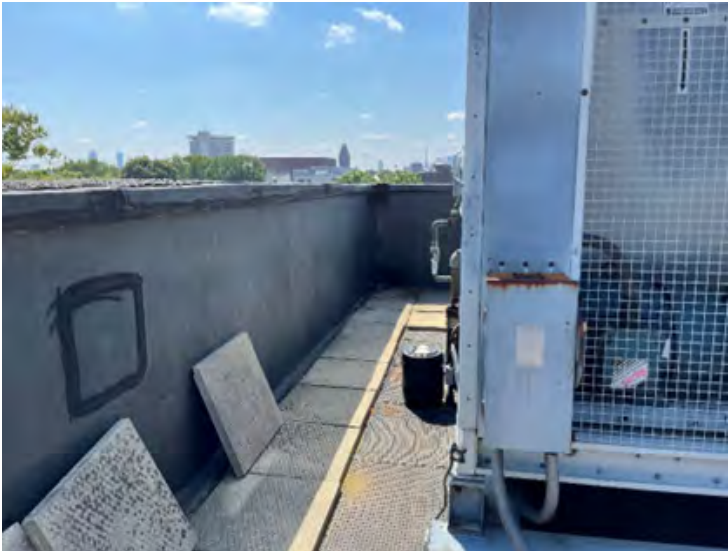
AE-C: Partial view of mechanical well

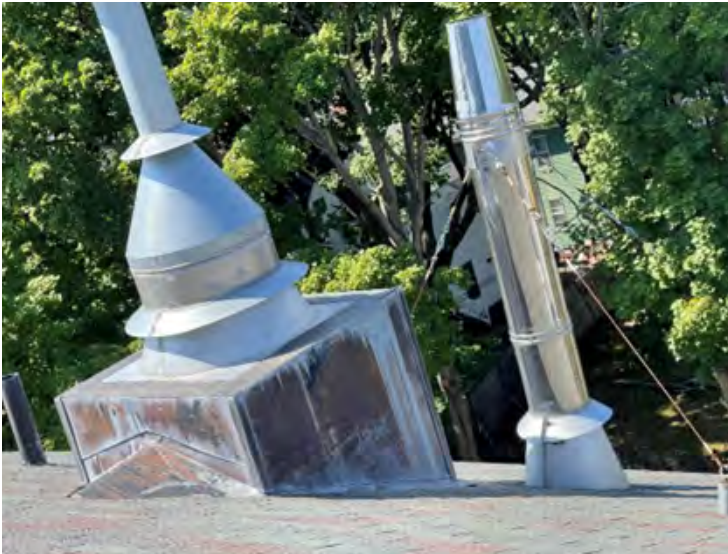
AE-D: Representative MEP penetrations in shingled roof

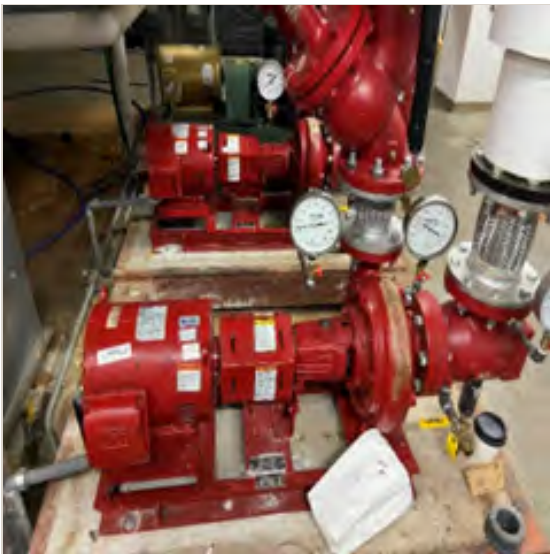
M-2: Existing Hot Water Pumps

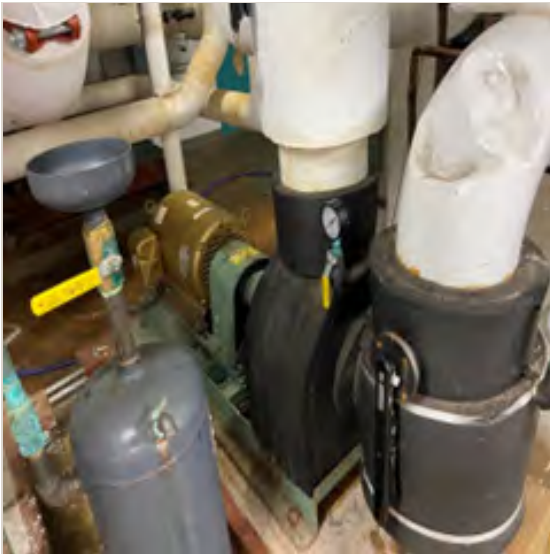
M-4: Original Chilled Water Pump

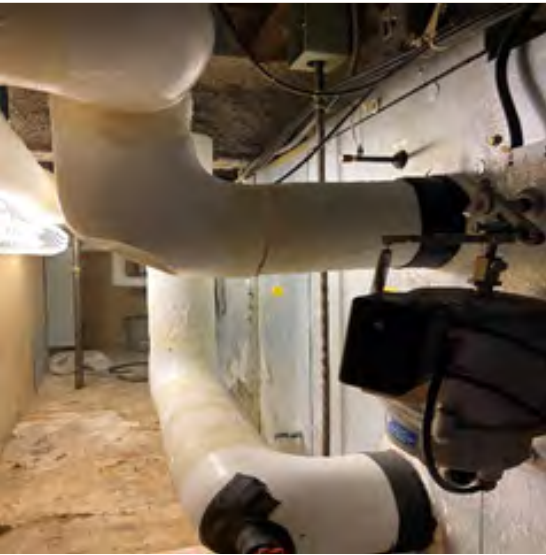
M-8: Original AHU in Mezzanine

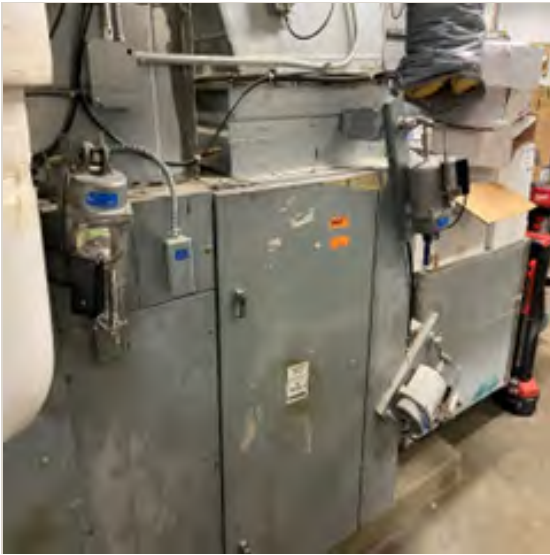
M-8: Air Handler Equipped With Pneumatic Controls

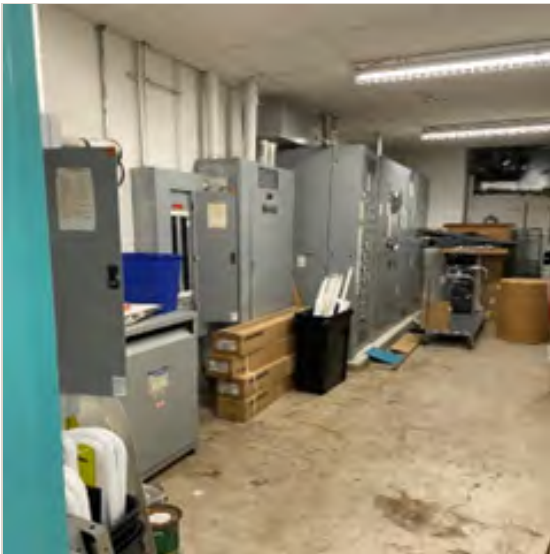
E-1: Main Electrical Service (Entrance)

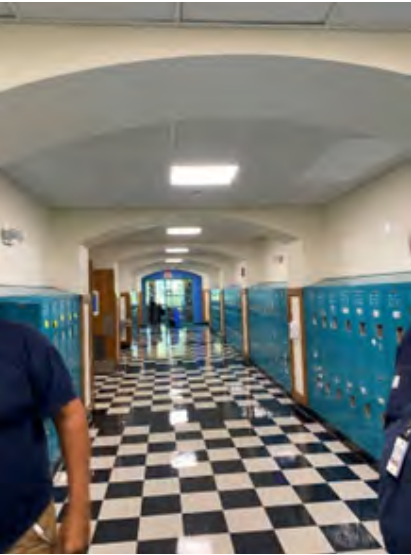
E-4: Typical Corridor (LED Upgrade w/ Emergency Lighting)

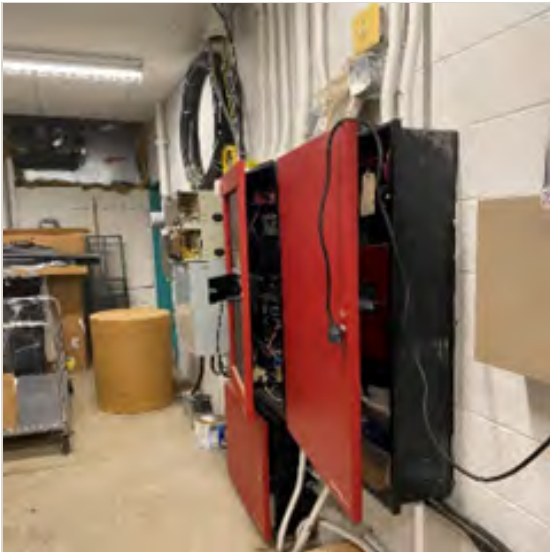
E-6: Fire Alarm Control Panel

*Recommendations*  
Provide all required testing and detailed review for a code compliant installation.

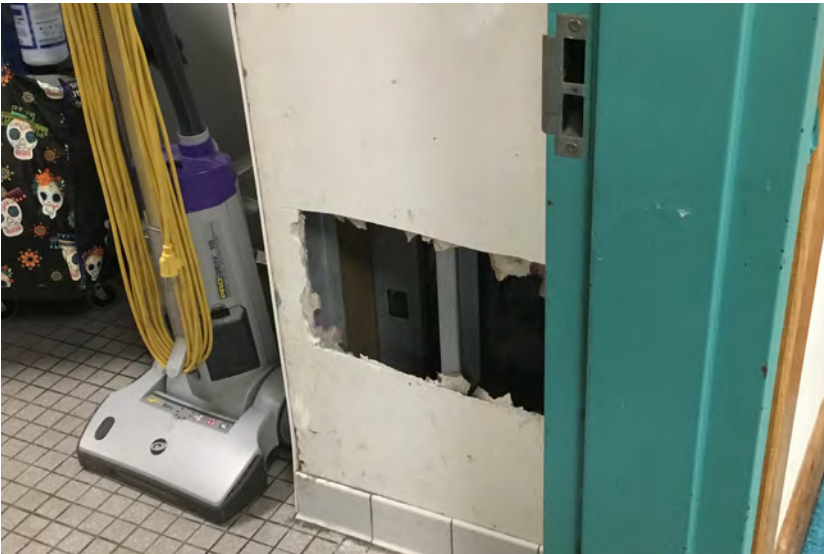
Unpatched hole in wall in Janitor Closet

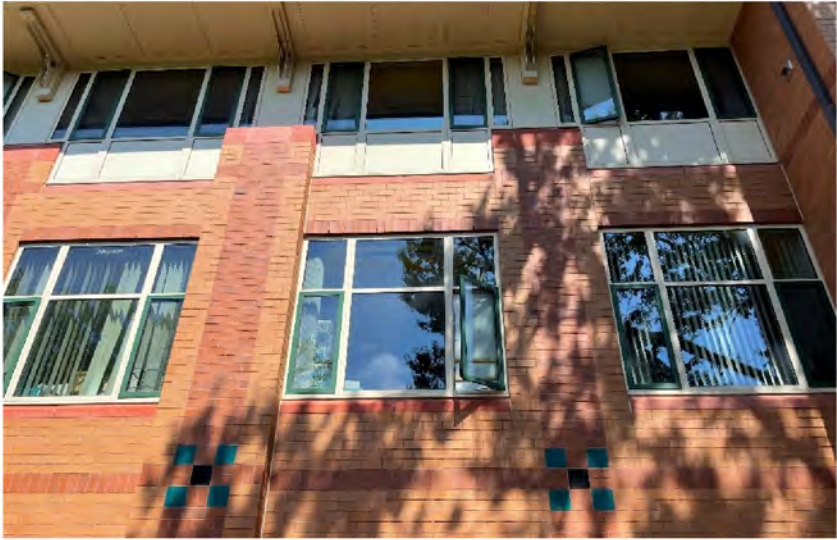
AE-5: Representative façade conditions: Metal soffit panels, brick masonry and storefront assemblies.

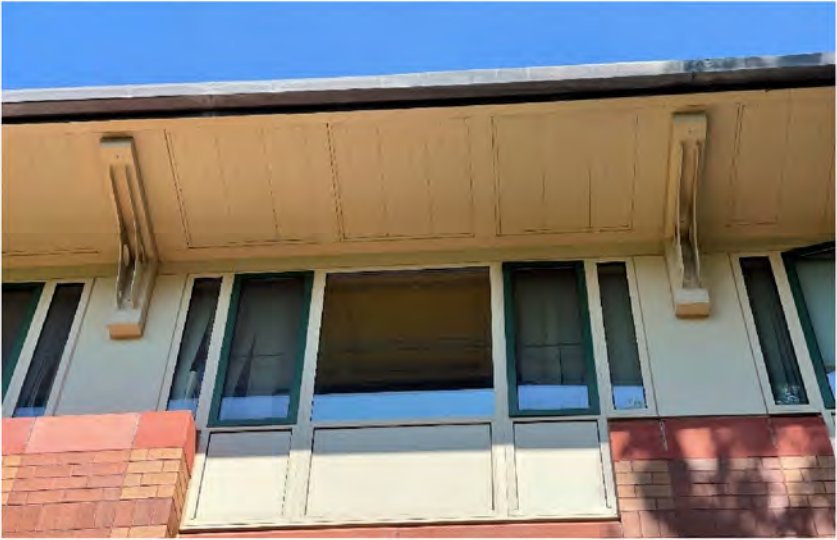
AE-6: Representative façade conditions: Metal soffit panels, brick masonry and storefront assemblies.

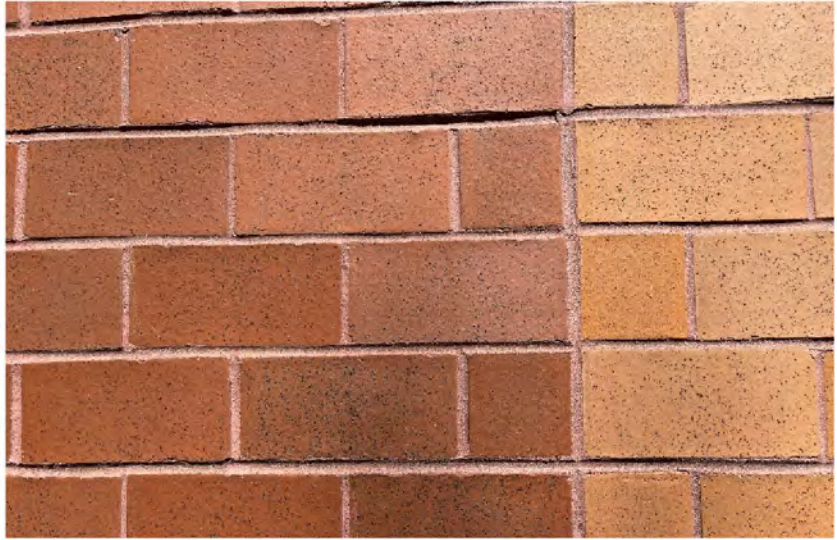
AE-7: Representative brick masonry facade

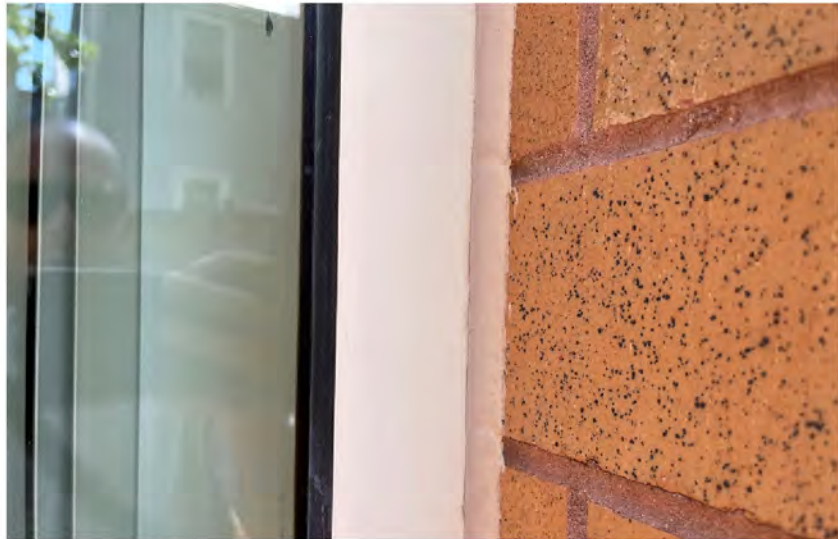
AE-12: Representative window perimeter sealants in good condition

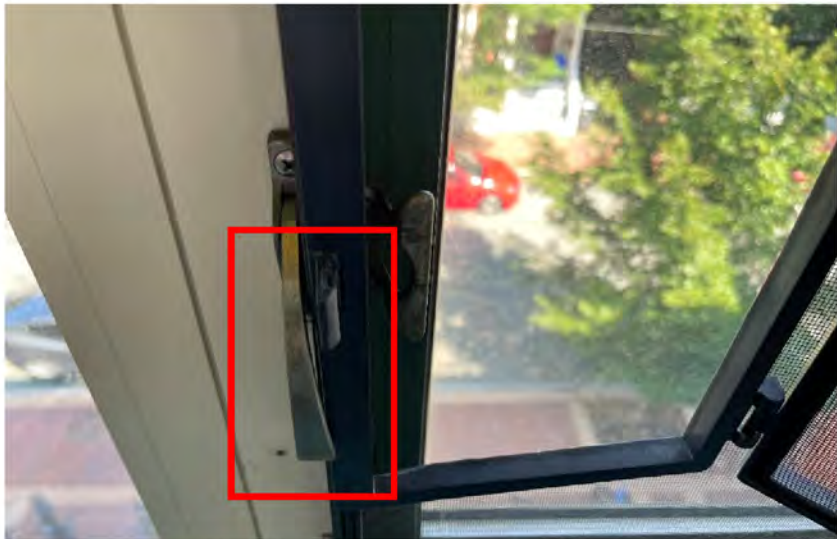
AE-15: Typical window operator that hits interior insect screen, unable to close/engage fully

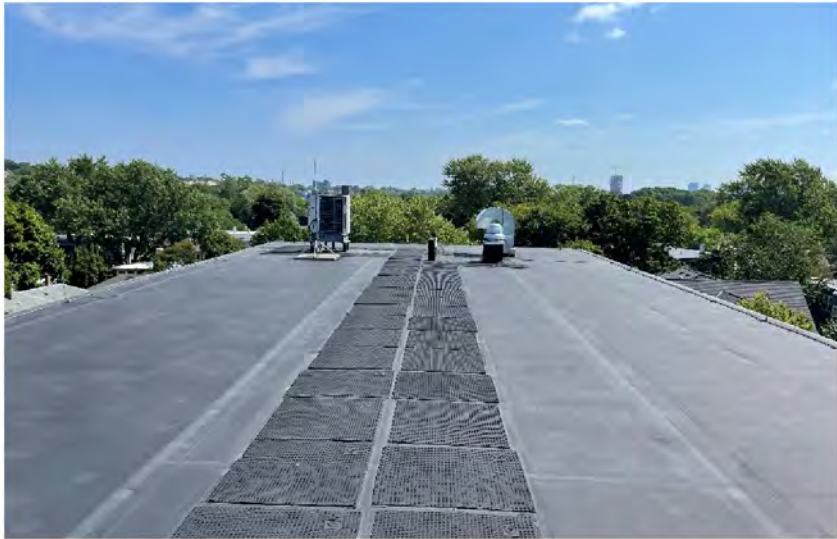
AE-21: General view of EPDM roof

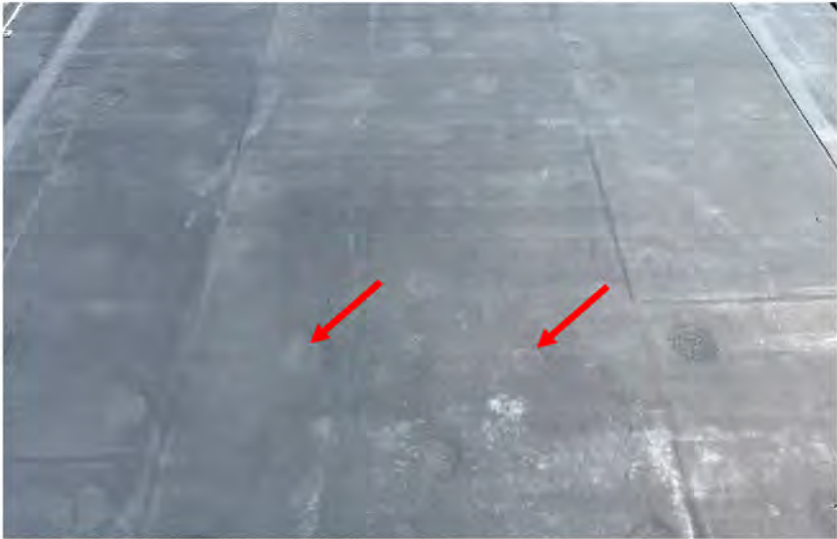
AE-22: Representative EPDM membrane, adhered to mechanically fastened substrate. Fastener plates visible from below membrane.

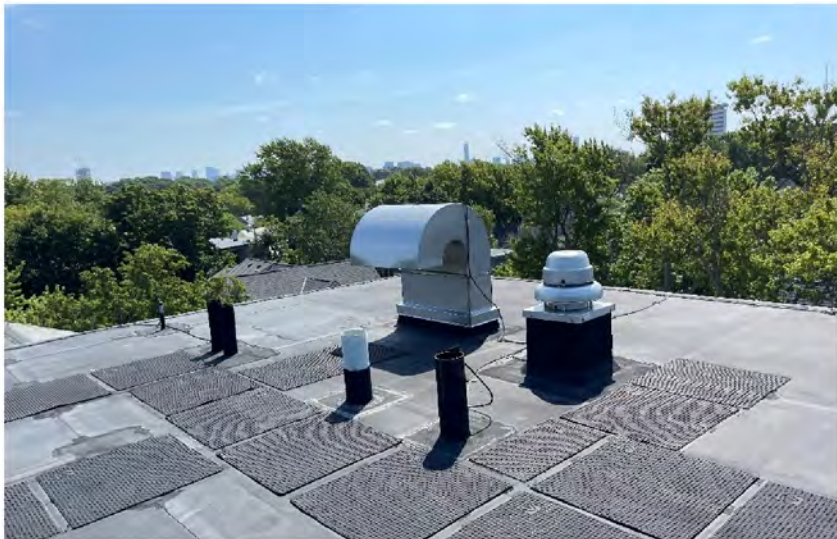
AE-23: Representative roof vent penetrations, vent hood on curb

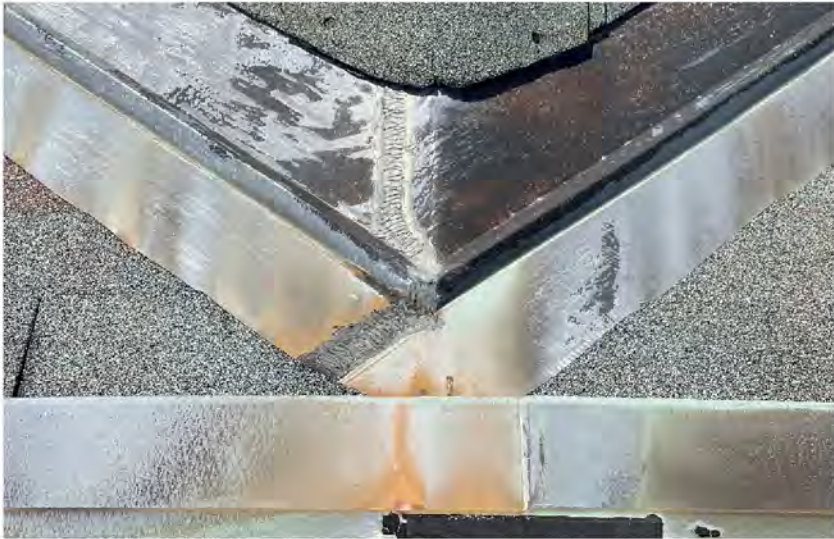
AE-26: Representative metal valleys, roof edge flashings within shingled roofing system

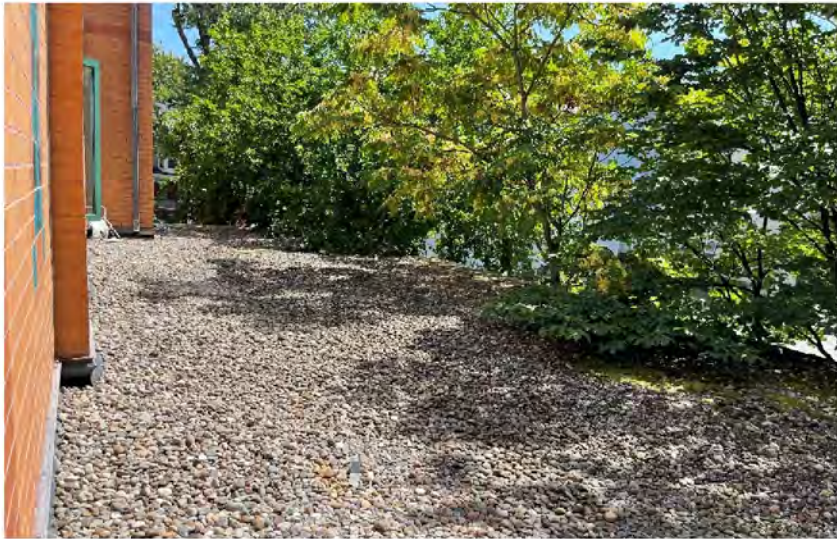
AE-29: Ballasted roof at South Elevation, looking East

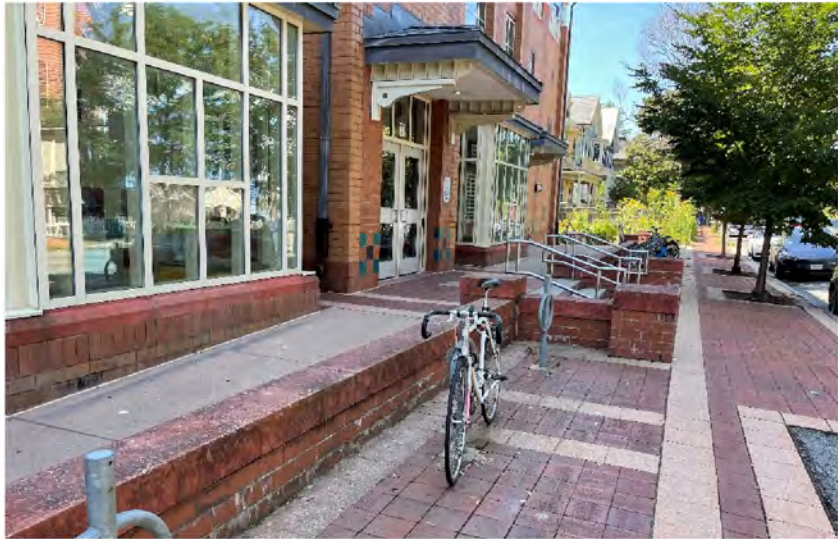
AE-33: Representative masonry walls along ramp at North Elevation
