# CAMBRIDGEPORT SCHOOL

## Facilities Condition Assessment : October 19, 2022

Facilities Condition Assessment, Capacity Analysis and Master Plan for CPS

# 7.3 | CAMBRIDGEPORT SCHOOL BUILDING APPENDIX

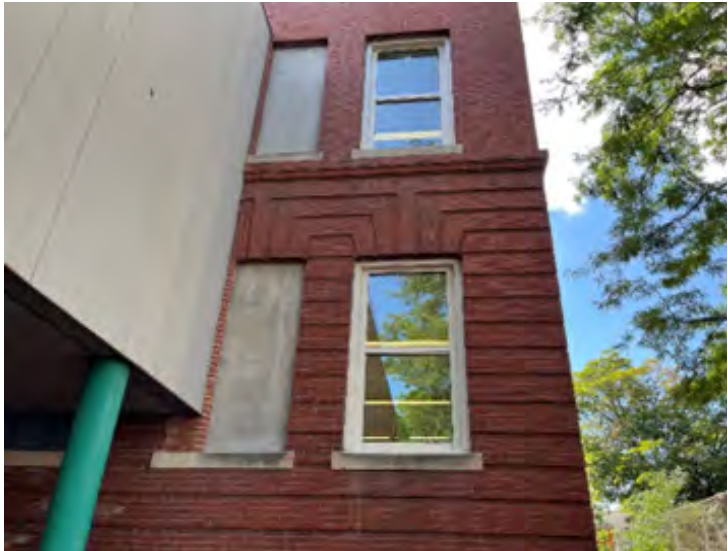
AE-B: Transition from original building to North addition along West Elevation

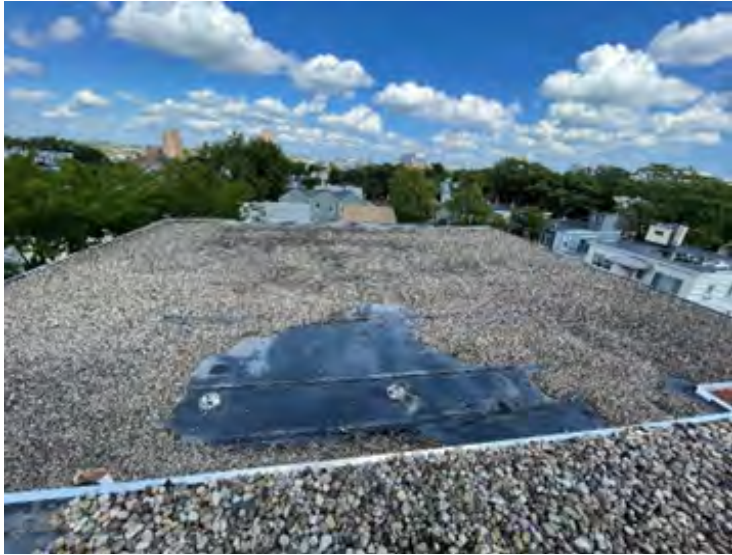
The low sloped roofs at the North wing addition are surfaced with loose laid EPDM covered with stone ballast. (Ref: Photos AE-29-33) Some of the stone ballast has been moved around the roof to expose the EPDM presumably to identify and repair sources of roof leakage. Isolated EPDM field repair patches are visible at various locations throughout the roof, with some failing lap sealants. Some areas of the EPDM appear to be secured to the face of the masonry façade with lap sealant and lacked mechanical means of termination. (Ref: Photo AE-33) The extent of insulation (if any) or other existing roofing systems below the EPDM is unknown.

Roof drainage is achieved via internal roof drains, however there is no secondary means of drainage on any roof level. The roof drains and strainers were recently replaced at the EPDM roof, but the drains at the tar and gravel roof appear to be original. (Ref: Photo AE-D)

AE-D: General view of ballasted EPDM roof at North addition over Gymnasium

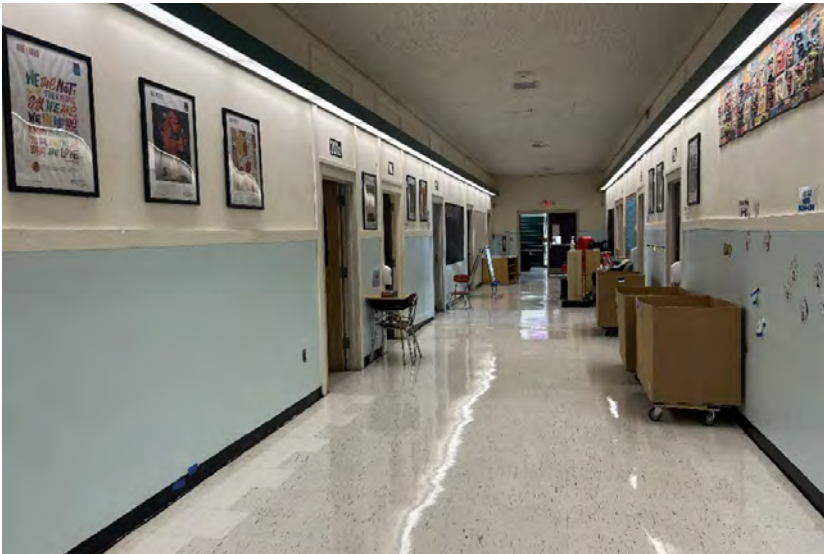
Typical Corridor – Second Floor

Floors:  
The predominant flooring material throughout the school is VCT, including in the stair towers. Ceramic tile is located in all restrooms. Having been installed over what is likely a wood floor structure, the VCT in the 1903 portions has apparent damage with cracking throughout. VCT in the 1980’s wing is in somewhat better condition. The gym has a rubber sports floor that has outlived its useful life.

The overall conditions rating for the Cambridgeport interiors was a D+ which indicates significant work needed throughout. Having just replaced the windows, a full interior modernization with repair/ replacement of the majority of interior finishes is warranted at this school and, with a priority rating if 3, that would indicate the need within the next 3-5 years. .

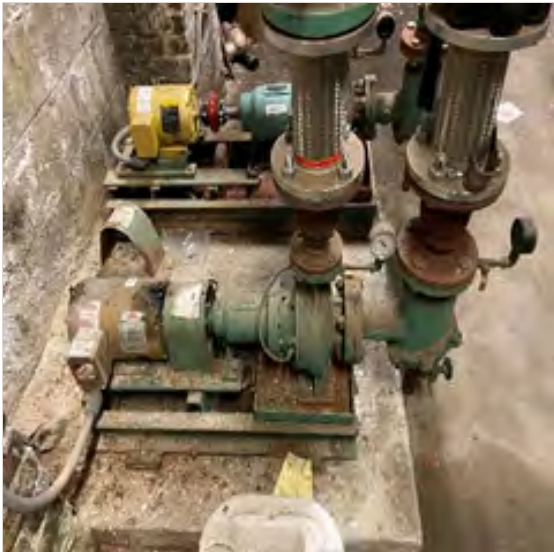
M-2: Hot Water Pumps

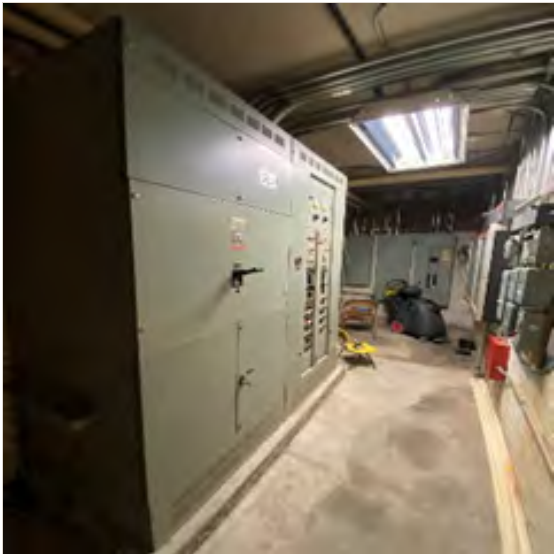
E-1: Main Electrical Service (Entrance)

| BUILDING SYSTEMS | CONDITION | PRIORITY |
|---|---|---|
| ◦ Replace old boiler – leaking at several header locations, replace electrical service and distribution systems – 44+ years old. Replace emergency generator and exhaust – causes fumes to neighbors. | E | 1-2 |

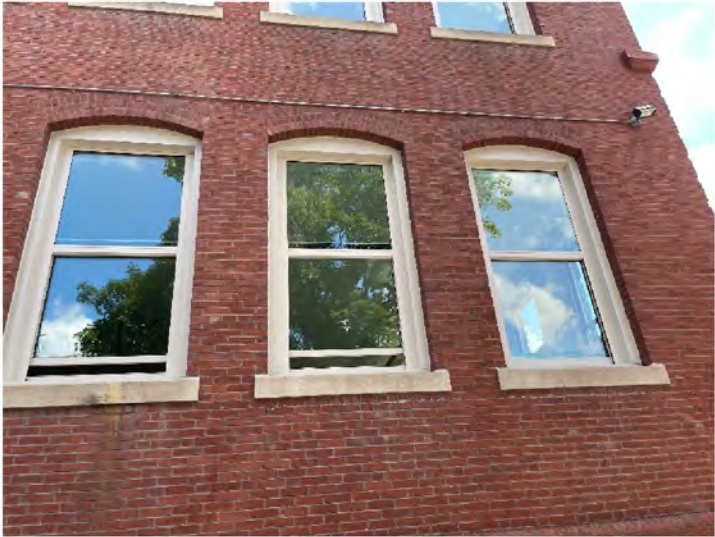
AE-7: Representative multiwythe brick masonry with limestone sills and new windows at South wing

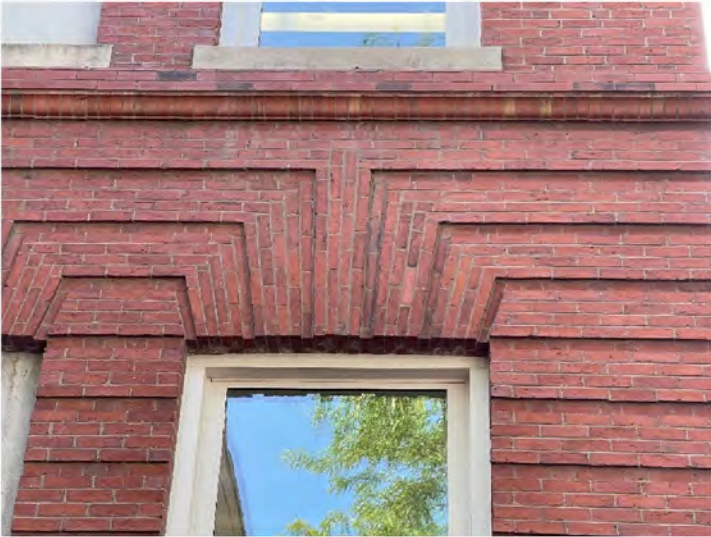
AE-8: Representative multiwythe masonry at South wing

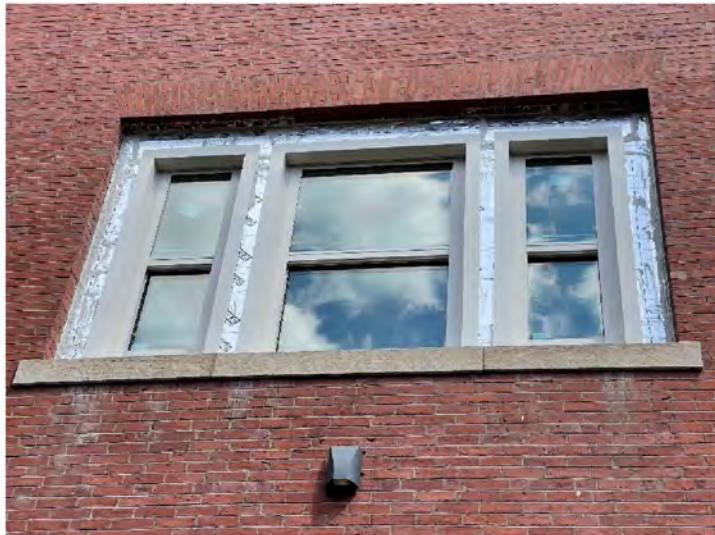
AE-9: Representative multiwythe masonry with limestone sills and new windows at South wing

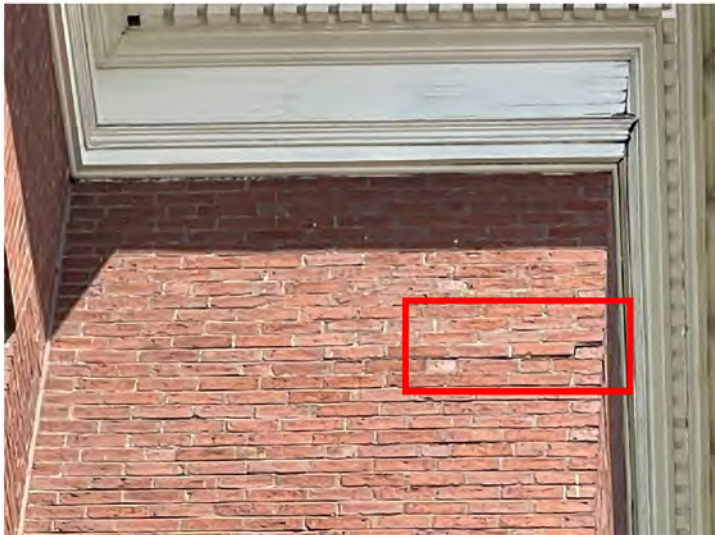
AE-10: Displaced masonry at East Elevation, South return

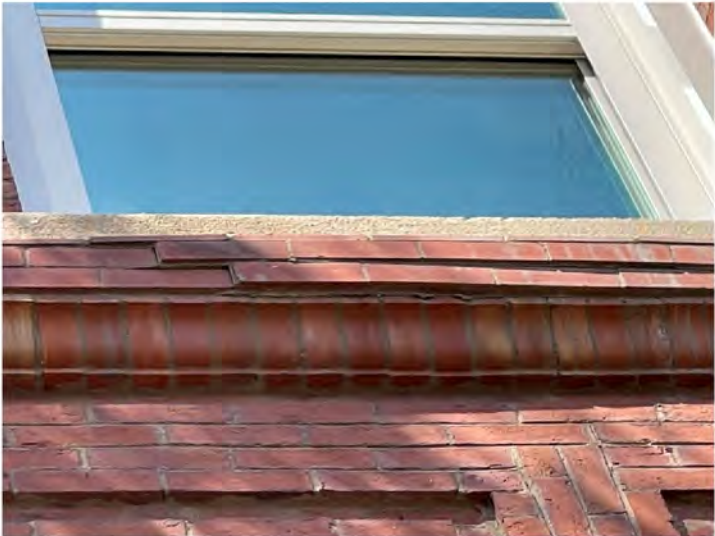
AE-13: Bulge in masonry at East Elevation, has been repointed

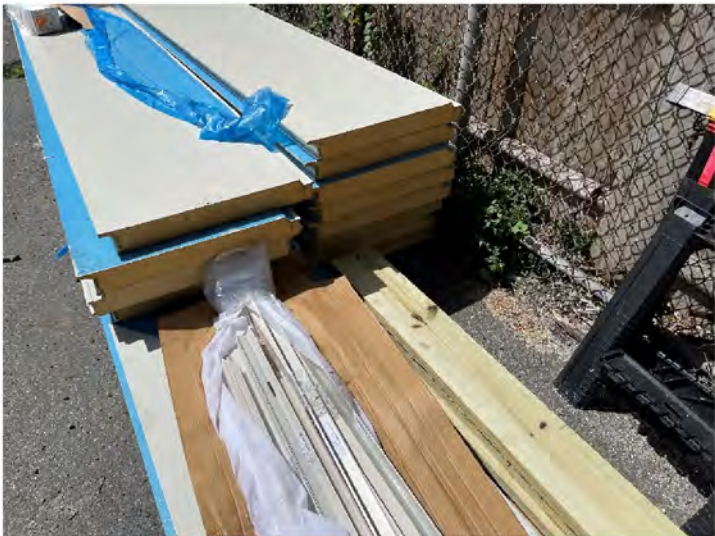
AE-23: New insulated metal panels stored on site for installation

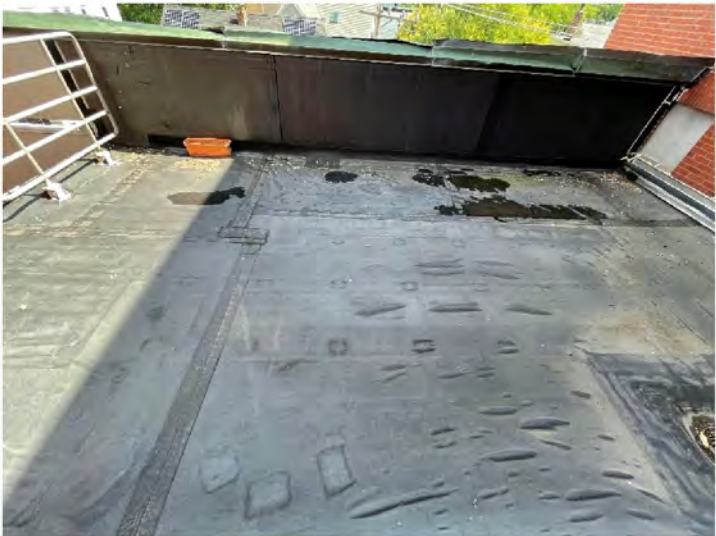
AE-28: Representative patches throughout East EPDM roof deck

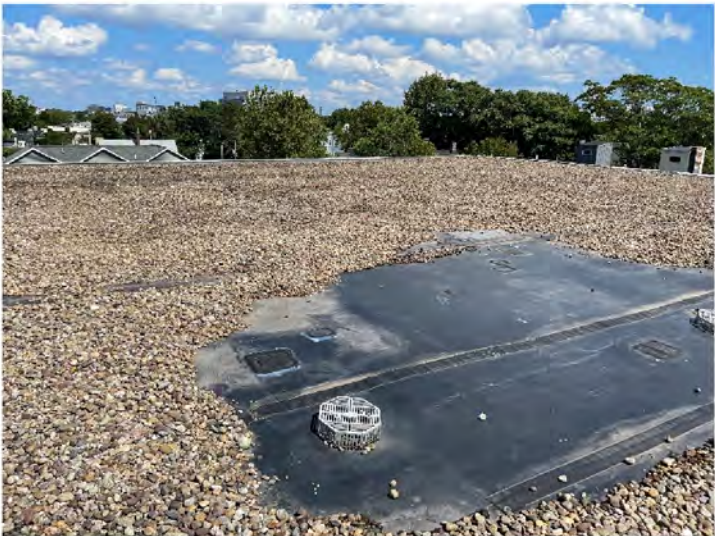
AE-31: Ballasted EPDM roof over Gymnasium, some ballast has been moved around

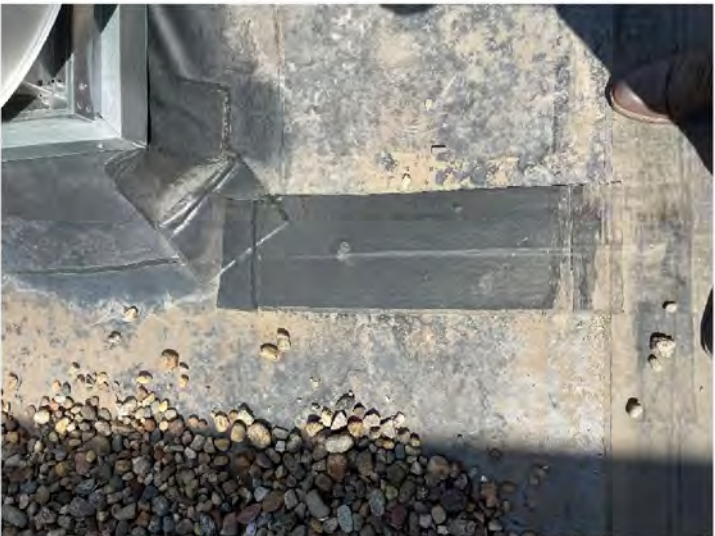
AE-32: Typical EPDM patches at Gymnasium roof, lacking lap sealant termination at perimeter.

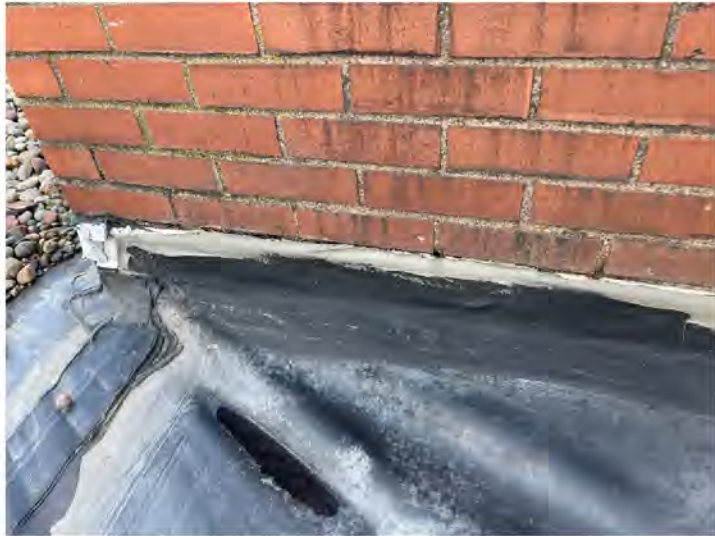
AE-33: Typical EPDM termination to base of masonry façade on Gymnasium roof with only sealant.

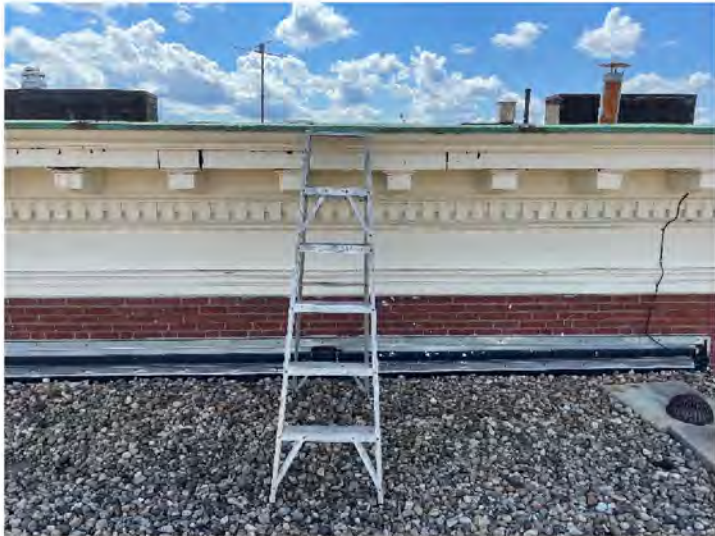
AE-34: Step ladder used to achieve roof access to South wing roof

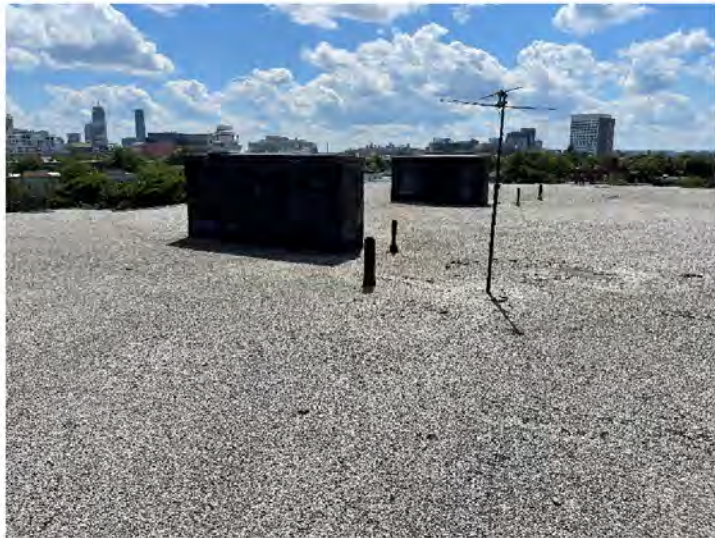
AE-35: General view of roof over South wing

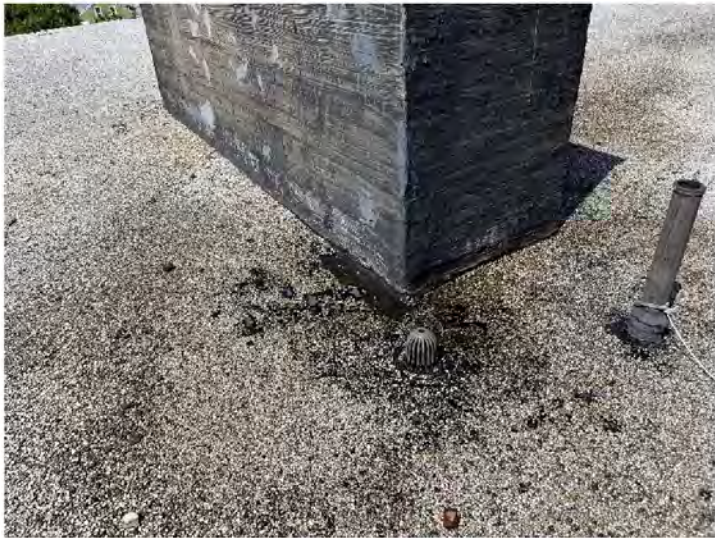
AE-36: Typical roof drain and penetrations in roof over South wing

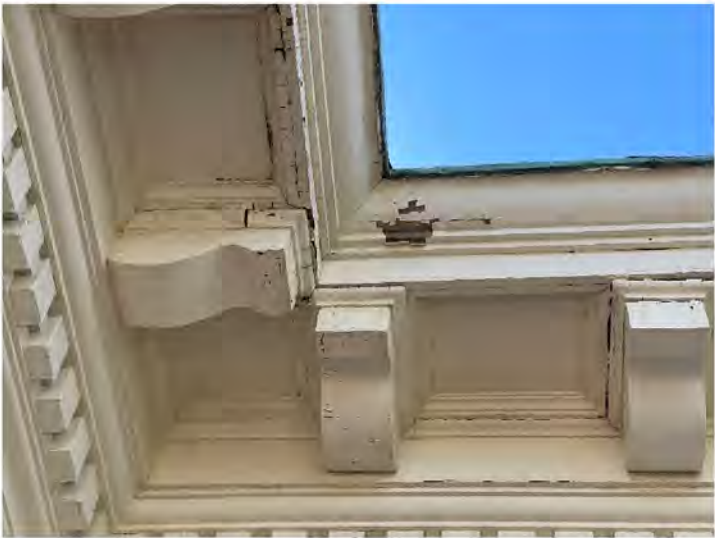
AE-39: Typical peeling paint on wood cornice surrounding South roof

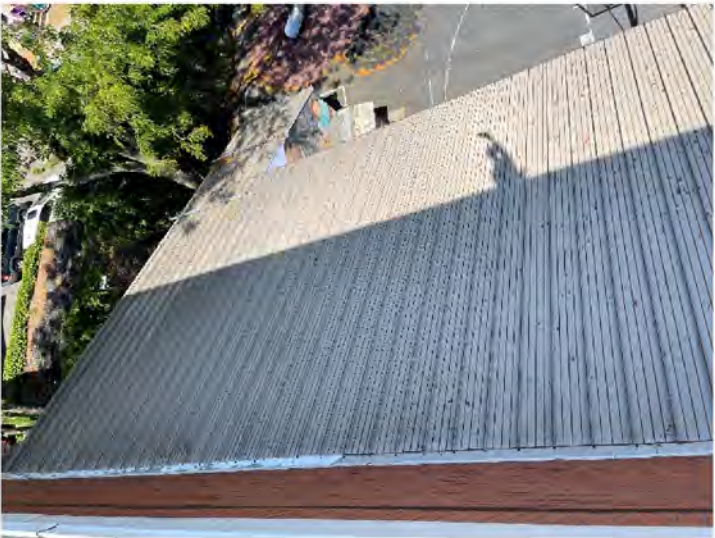
AE-40: Metal roofing over Stage and stair at North end of building
