# HAGGERTY SCHOOL

110 Cushing Street  
Cambridge, MA 02138

## Facilities Condition Assessment : October 14, 2022

# 7.6 | HAGGERTY SCHOOL BUILDING APPENDIX

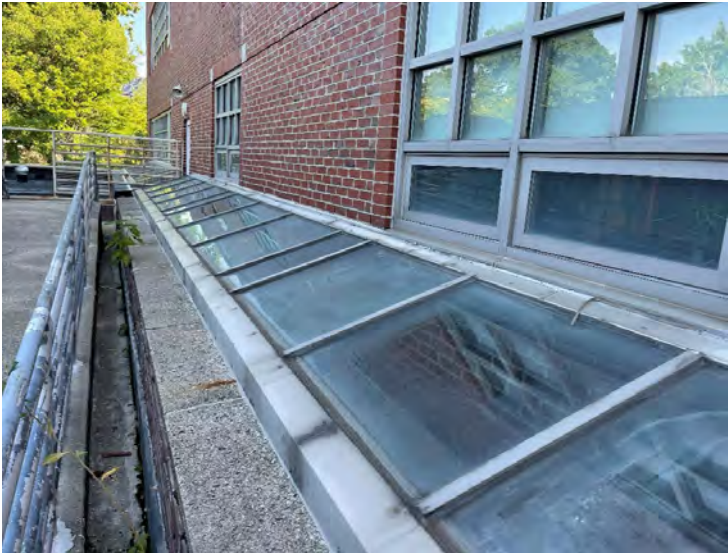
AE-B: Sloped glazing at transition from Main Building to West Wing

Aluminum framed sloped glazing assemblies are located at the transition from the Main Building to the West Wing. These sloped glazing are in fair condition overall, with failed IGU observed in multiple locations, as evidenced by condensation between the panes of glass. Multiple locations of active water leakage exist within the Corridor below the sloped glazing, as evidenced by damaged drywall, peeling paint and staining on the exposed masonry in this area. (Ref: Photos AE-29-32) The sill of the sloped glazing terminates at a masonry wall with a concrete cap, and it is possible that the leakage issues are a combination of masonry and glazing failures.

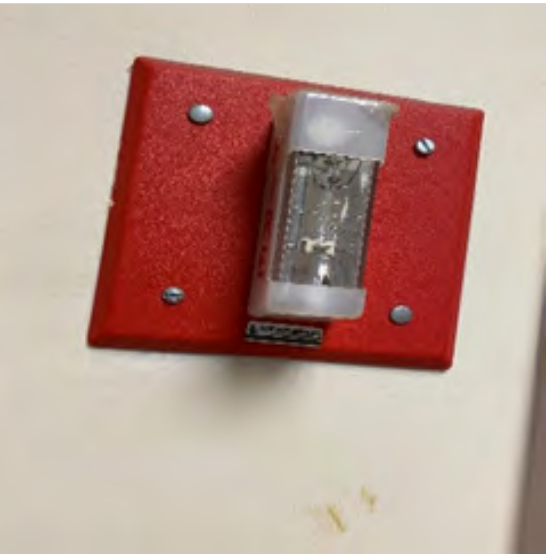
E-7: Existing Fire Alarm Device (1993)

It is recommended that a speaker type-system be provided for transmitting voice notifications in the event of a fire alarm and/or mass notification.

Install carbon monoxide devices in alarms devices in every classroom where carbon emitting devices are located. Verify all devices are provided as required by 527 CMR, NFPA 72, 780 CMR and the Mass Fire Alarm code (Missing pull stations, smoke detection not code compliant etc.)

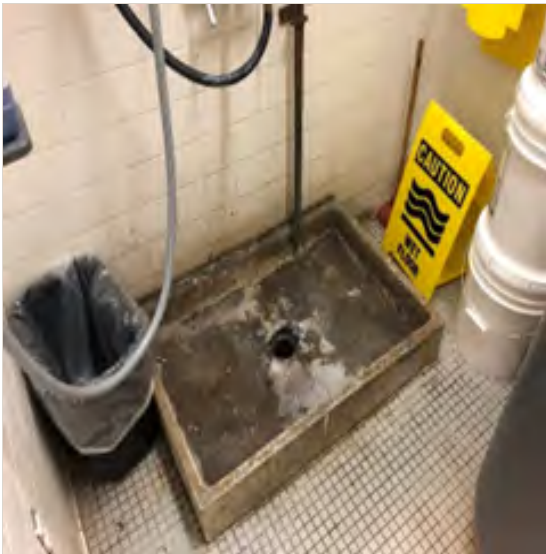
PL-2: Corroded Janitors Sink

Replace plumbing fixtures and floor drains which are heavily corroded and exceeded their useful service life. Replace existing Cafeteria Staff Bathroom Lavatory faucet. Urinals shall be side shielded for privacy as required by the Massachusetts Plumbing Code, 248 CMR.

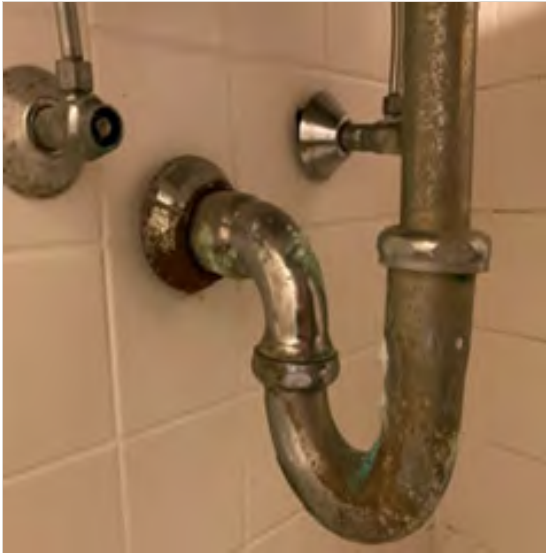
PL-3: Corroded Lavatory Piping

*Recommendations*  
Replace existing corroded piping as required.

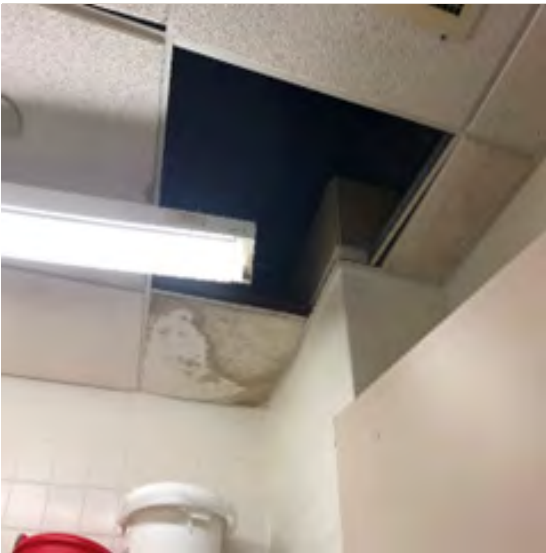
FP-1: Ceiling Tile shall be replaced

*Recommendations*  
Verify the existing standpipe system is maintained in conformance with the requirements of NFPA 25, Inspection, Testing and Maintenance of Water-Based Fire Protection Systems.

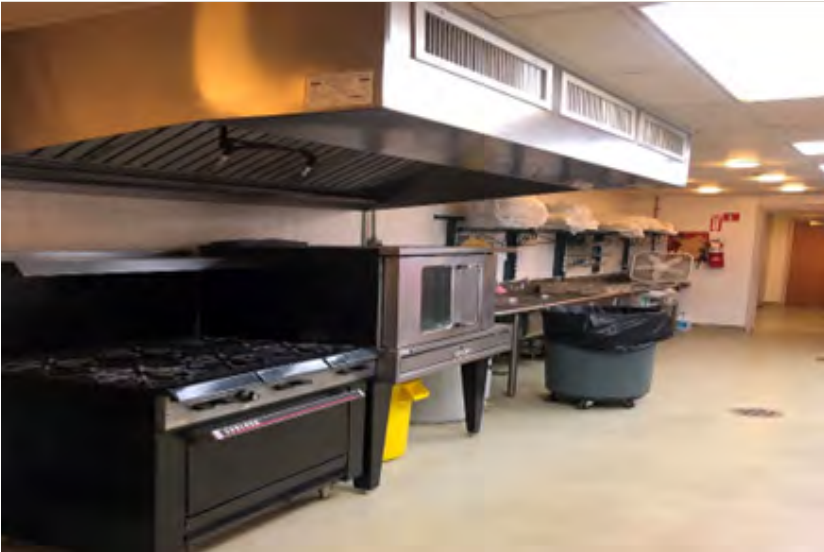
FS-3: Exhaust hood over the cooking equipment is extremely dated and original to the building. The grease filters are not nearly as efficient as the technology that’s available today and are more difficult to clean. The horizontal cast piping used for fire suppression is very difficult to keep clean. Efficient Design limits fire suppression to vertical drops only.

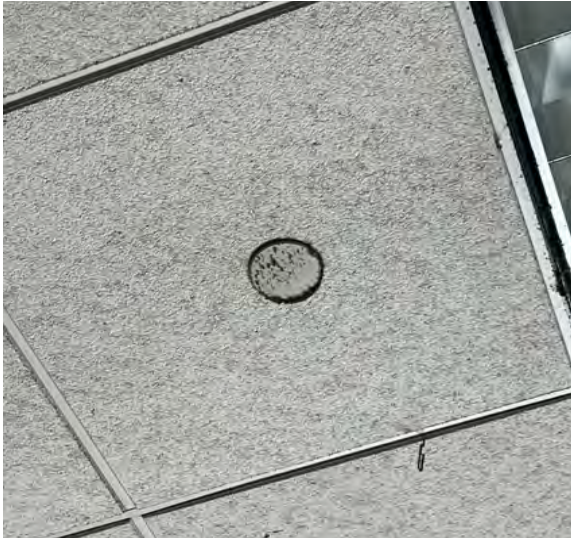
Mold on sprinkler

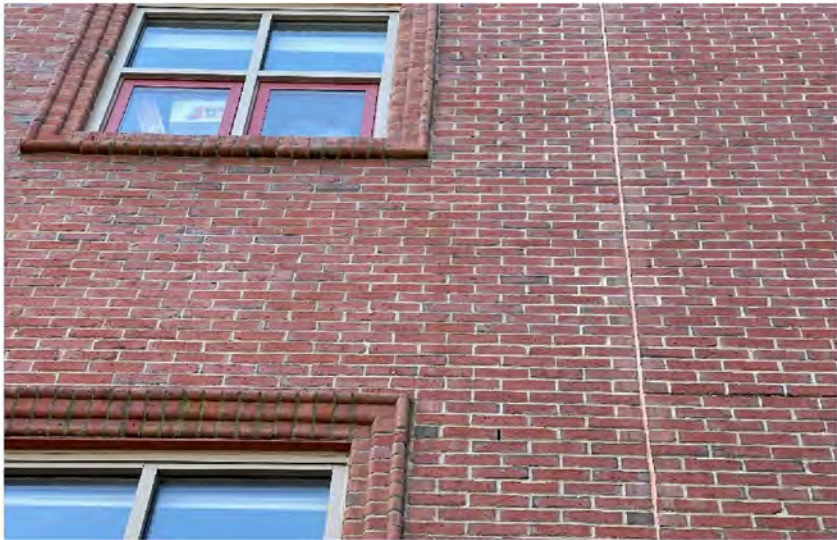
AE-6: Representative façade conditions: Brick veneer and aluminum window

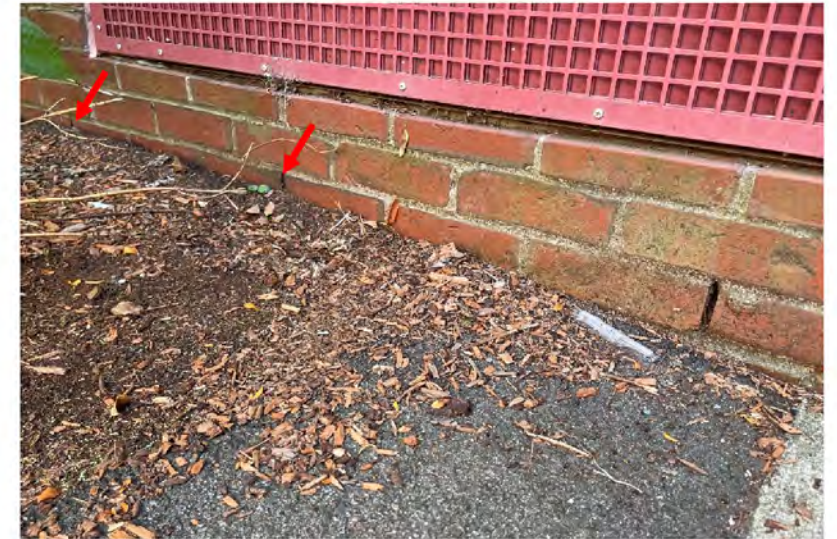
AE-7: North Elevation: Masonry weeps partially covered with mulch

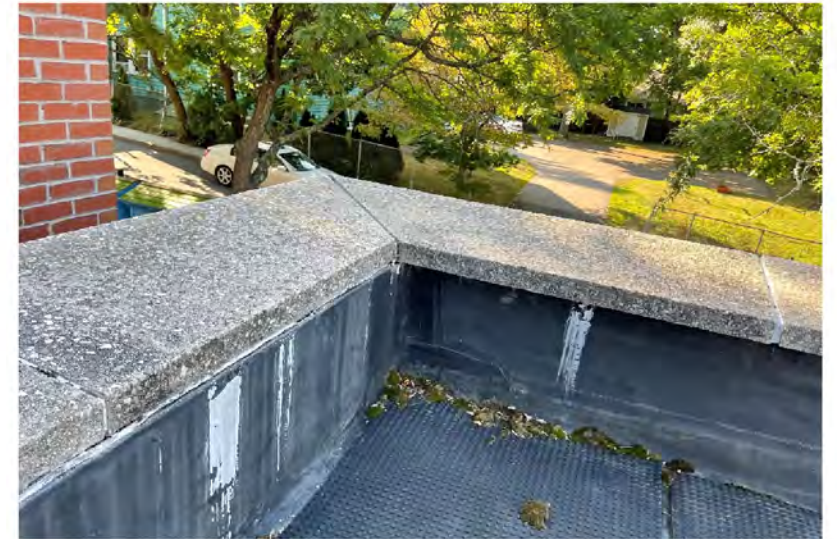
AE-8: Representative precast concrete coping cap at West Wing

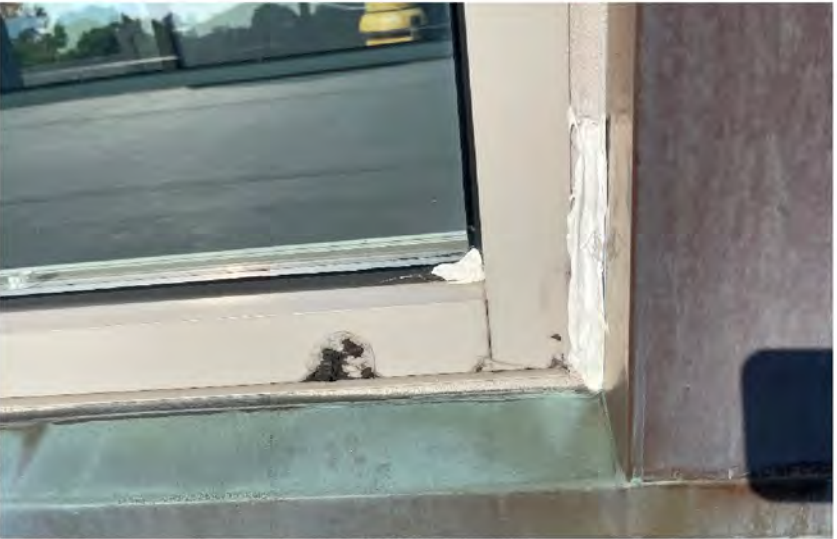
AE-22: Clerestory at Library/Media Center: Typical added sealants at perimeter and glazing of storefront units.

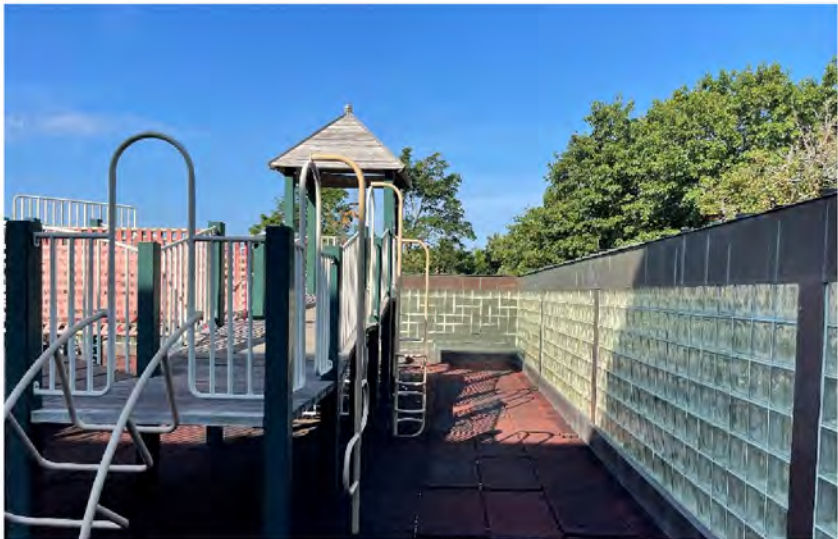
AE-19: Glass Block facades above roof at West Wing: These serve as clerestory for Gymnasium below

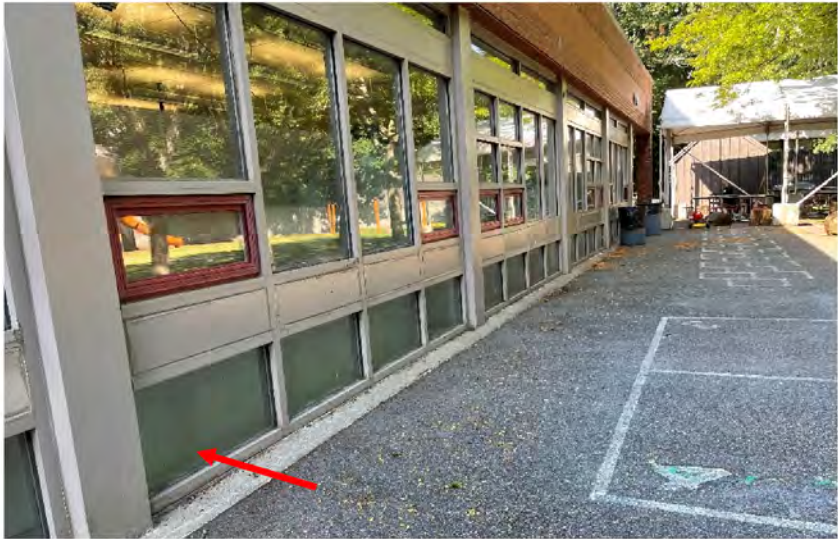
AE-25: Representative aluminum storefront at West Wing and East Classrooms below Main Entrance: Lower lites of storefront provide daylight into Cafeteria below.

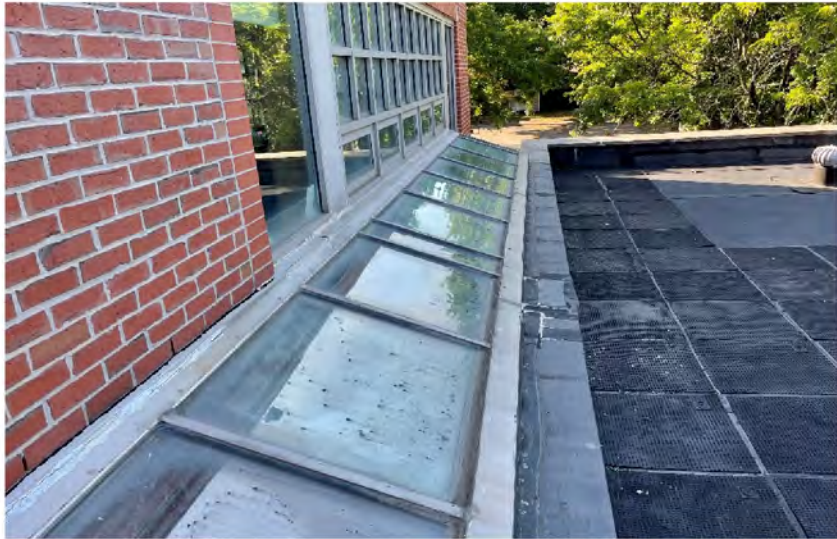
AE-29: Sloped glazing at transition between Main Building and West Wing, located above interior corridor

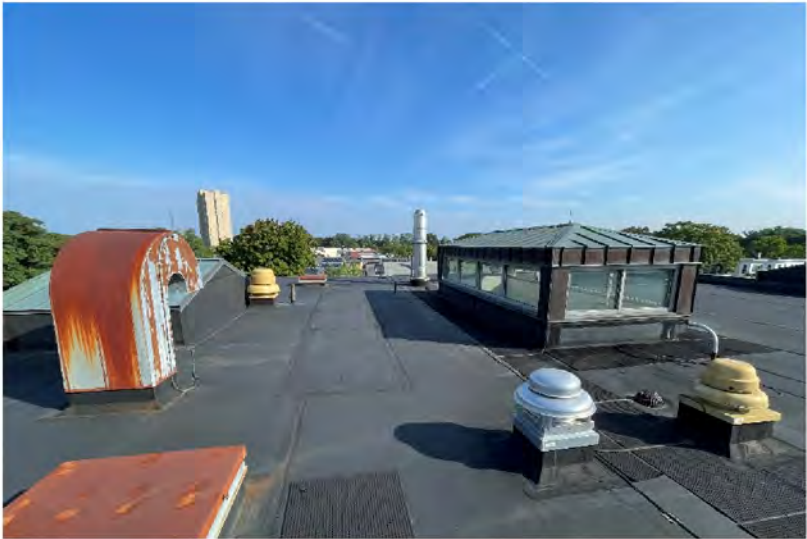
AE-37: General view of Main Roof

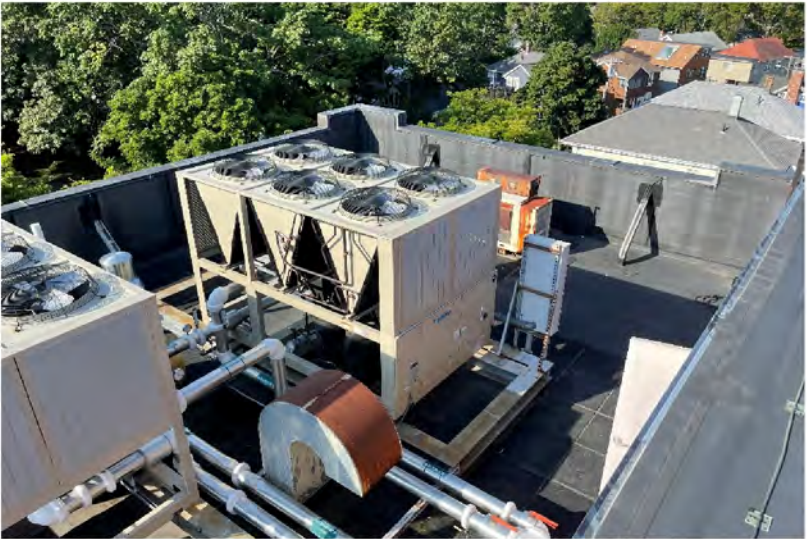
AE-38: Representative view of lower North EPDM roof at Main Building

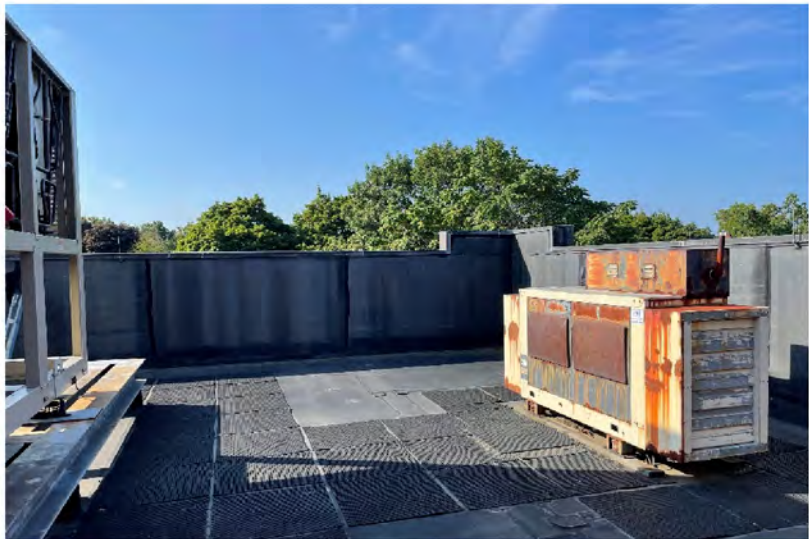
AE-36: Representative view of lower South EPDM roof at Main Building

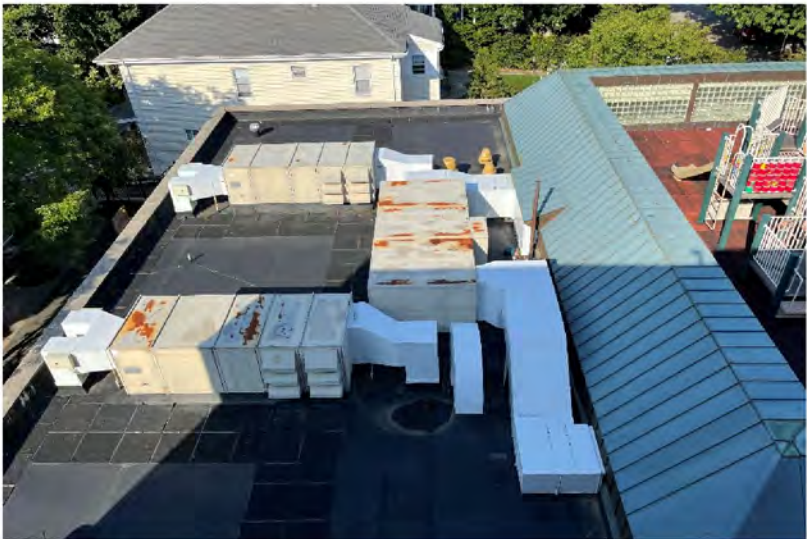
AE-39: General view at South portion of West Wing Roof: Note metal standing seam roofing over Gymnasium clerestory at perimeter of playroof

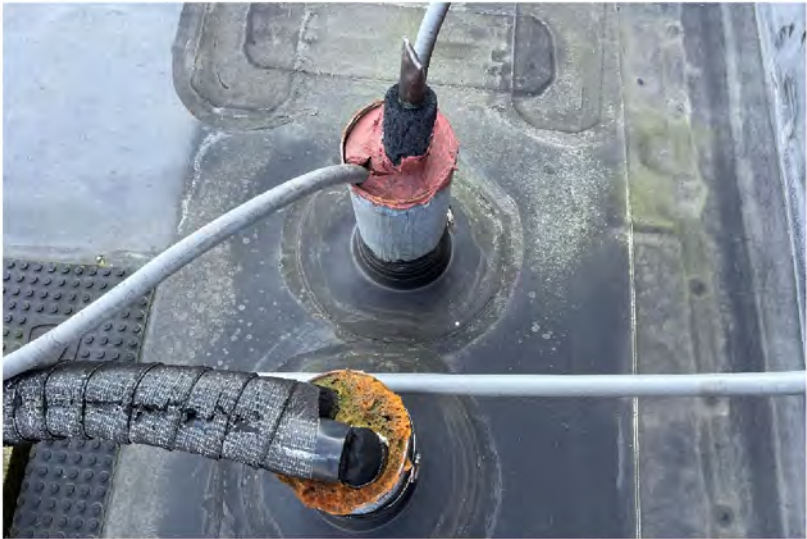
AE-45: Representative conduit penetrations in roof with spray foam and sealant applied around conduit.
