# KENNEDY-LONGFELLOW BUILDING

158 Spring Street  
Cambridge, MA 02141

## Facilities Condition Assessment : October 14, 2022

# 7.7 | KENNEDY-LONGFELLOW SCHOOL BUILDING APPENDIX

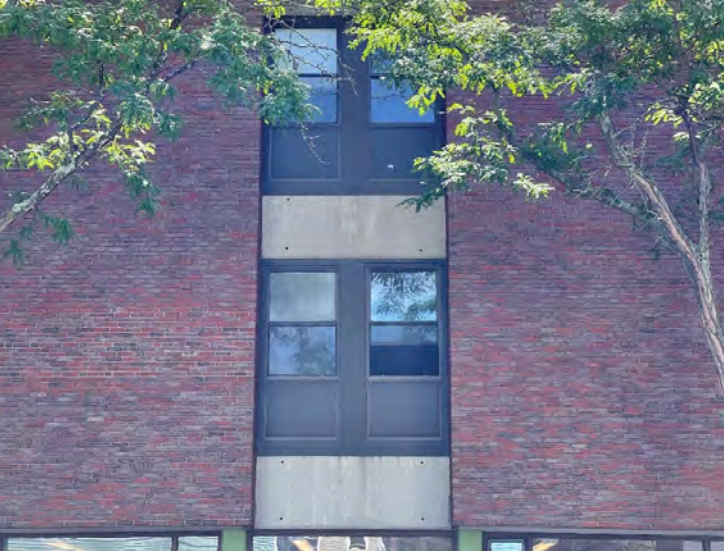
AE-B: Typical aluminum hung windows with aluminum spandrel panels

The newer aluminum windows are comprised of thermally broken frames with insulated glazing and are in fair to good condition. The condition of the aluminum spandrel panel below these windows varies as corrosion was observed within these panels in many areas of the building. (Ref: Photos AE-24-26, 33)

Replacement of all existing steel windows and door assemblies with new thermally broken aluminum assemblies with insulated glass and Low-E coatings is recommended. Consideration should also be given to replacement of the aluminum windows, or at least the spandrel panels that are corroded.

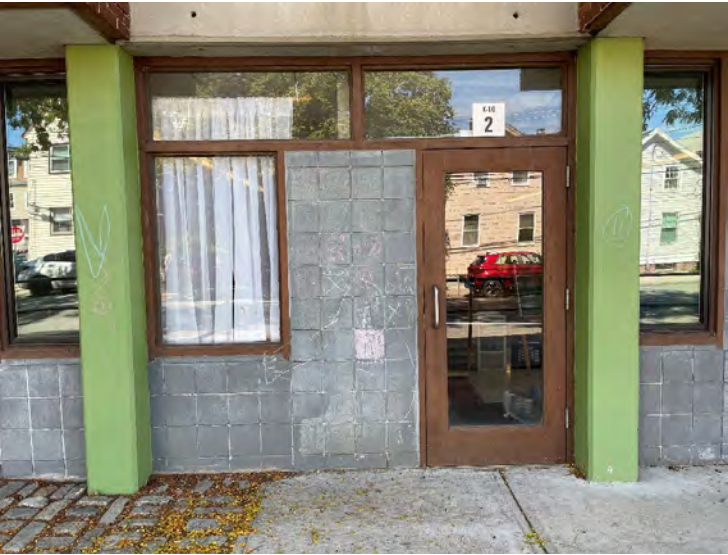
The steel windows are not thermally broken, have single pane glass and are in poor condition. Many are exhibiting rusting on the interior and exterior of the frames, and some have multiple sealants applied around the glazing to address leakage issues. There are operability issues with most of the steel windows. (Ref: Photos AE-23, 27-32) Most classrooms with steel windows have recently installed casement windows which were installed as part of the COVID-19 pandemic for ventilation requirements. (Ref: Photo AE-35)

AE-C: Representative steel window and door assembly with concrete block façade at exterior of typical ground level classroom.

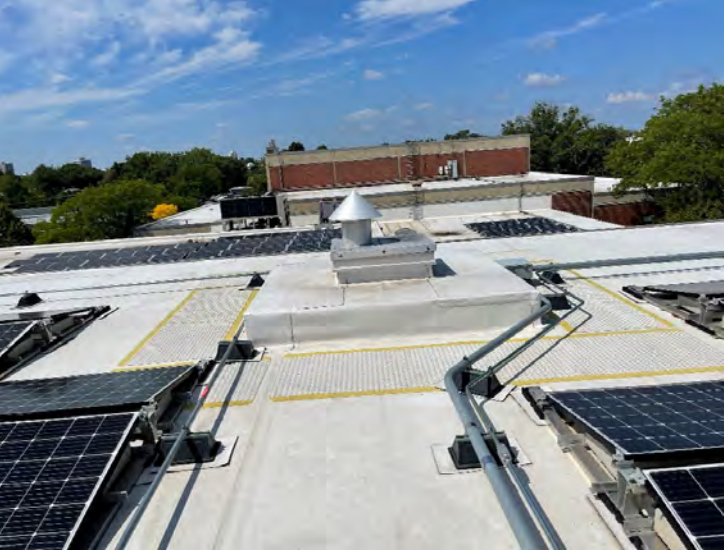
Roofing:  
All roof areas have recently been replaced with a fully adhered TPO roofing assembly. The extent of insulation (if any) or presence of other existing roofing systems below the current roofing assemblies is unknown. (Ref: Photos 43-60) PV solar panels are installed at portions of most roof areas.

AE-D: Representative newly installed TPO roof

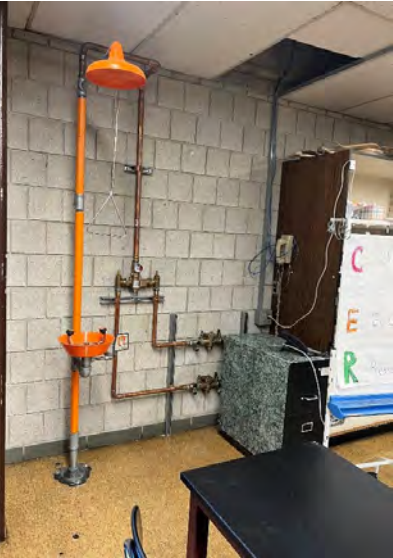
Exposed Piping in Science

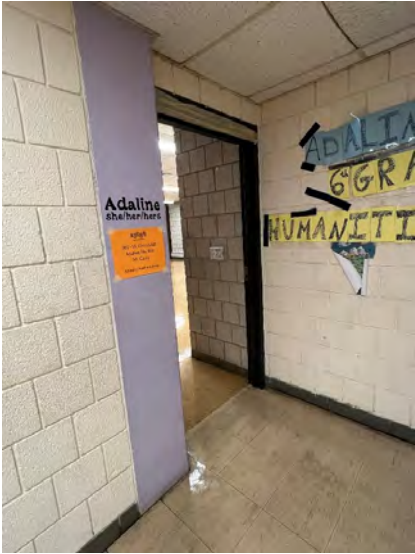
Third Floor- Worn out Flooring

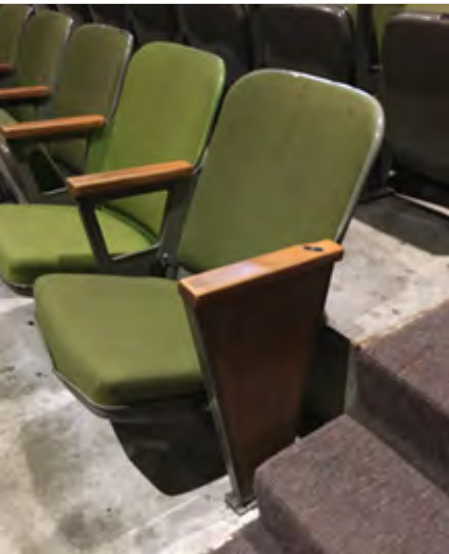
Damaged Auditorium Seat

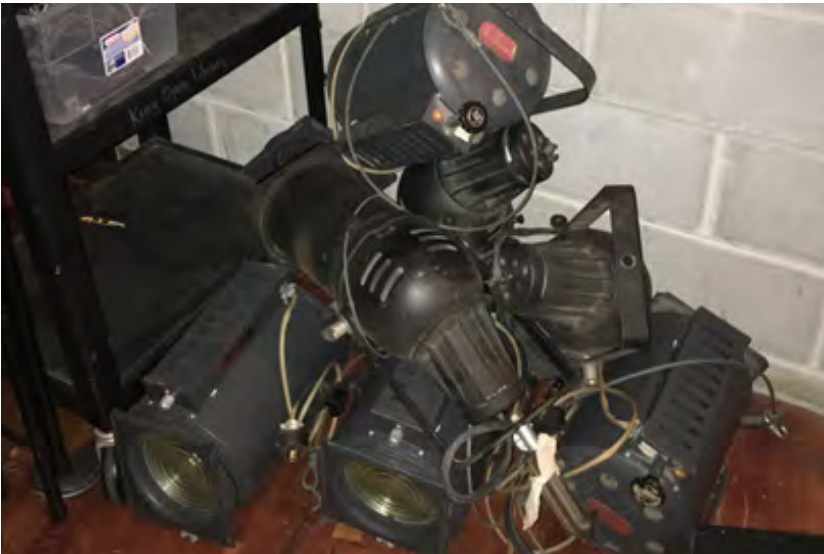
Obsolete Theatrical Lighting Fixtures

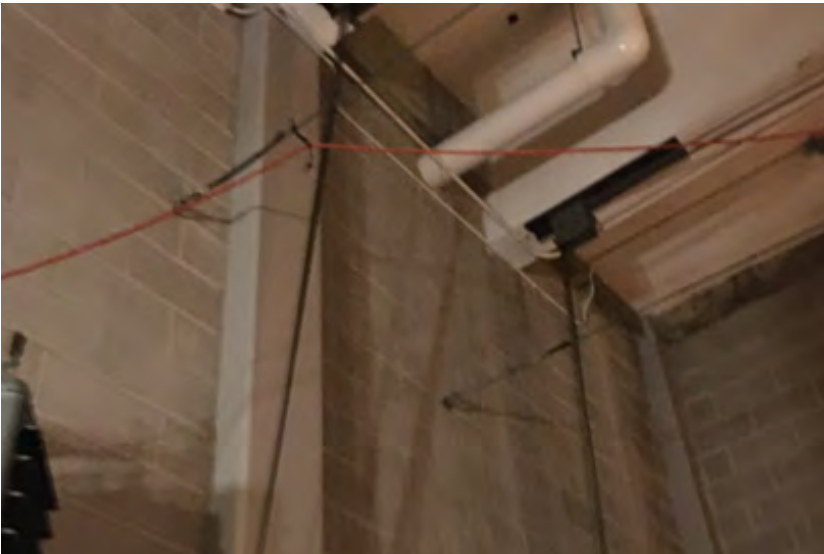
Temporary Cable Suspended Backstage

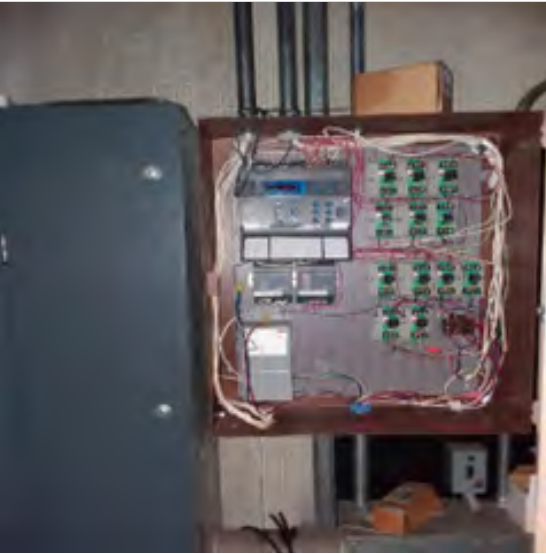
*Existing Condition*  
The existing building automation system is a hybrid of the original pneumatic control system and a newer, though vintage, direct digital control system (DDC). The pneumatic control system compressor appears to have been replace some time in the past though it is not clear exactly when. The current compressor appears to be in reasonable condition but is nearing the end of its service life. Run cycle time on the compressor is excessive, indicating possible pneumatic tubing leaks. It was reported to RFS by the custodian that the compressor dryer needs to be drained of condensate frequently though typically air dryers are equipped with automatic drain devices. The pneumatics system interfaces to the air handling unit damper heating valve actuators. Additionally, the pneumatics are responsible for control of the occupied space terminal units and associated room thermostats. The air handling units are provided with a minimal DDC interface via JCI Metasys controllers and components. Review of documents on site within the DDC control panels indicate that this DDC interface consists primarily with basic air handling unit start/stop, status, temperature monitoring, and nominal alarming. However it was noted that the air handling unit local motor starters were in the "hand" position, indicating that the DDC system is not actively providing automatic scheduling of these units. This is in line with statements by the custodian who reported that these units are regularly manually started and stopped. There appears to be a more current DDC JCI Metasys system interface to the heating hot water system. This JCI system is providing remote access to the heating hot water system via a JCI Facility Explorer device. This would have been installed during the boiler replacements and is approximately 20 years old.

M-5: JCI BAS Network Interface

M-6: JCI Air Handling Unit DDC Control Panel

*Recommendations*  
The existing pneumatic system in its entirety should be replaced. It is well past its expected operational service life. This replacement should be concurrent with any replacement or upgrades of the air handling units and/or the occupied area terminal units. Included in this would be the minimal control currently provided to the existing air handling units. The heating hot water/boiler system DDC controls are more technologically current and are still serviceable. However, the majority of the Cambridge School system BAS network resides on a more modern Tridium Niagara platform and ultimately a plan should be developed to transition to this newer platform as the older Metasys system is no longer supported and reaching the end of its expected median service life of 20-years. Control system upgrades should include a complete system of DDC controllers, sensors, actuators, and head-end graphics.

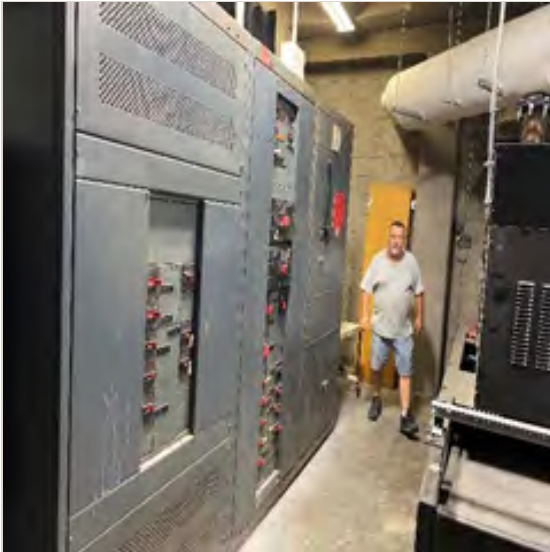
E-1: Main Electrical Service (Entrance)

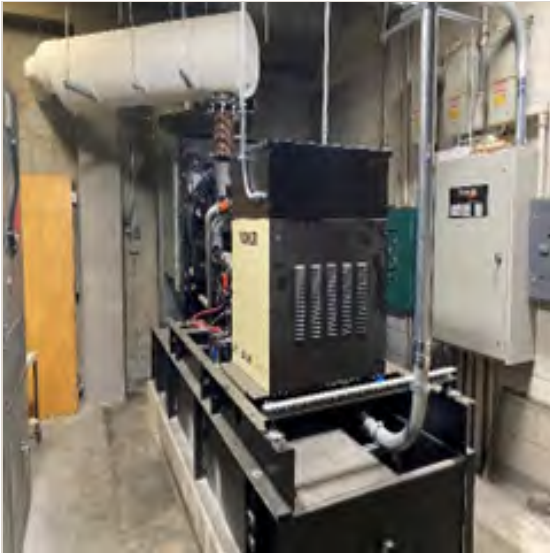
There were no indications of generator testing or general maintenance. Emergency lighting is provided by dedicated emergency lighting fixtures which energize upon loss of power.

E-2 Generator – Good Condition

Due to the age of the existing electrical distribution system, it is recommended that the existing systems be scanned with an infrared camera to identify any loose or weak electrical connections. The generator should be tested, and a testing regime should be established.

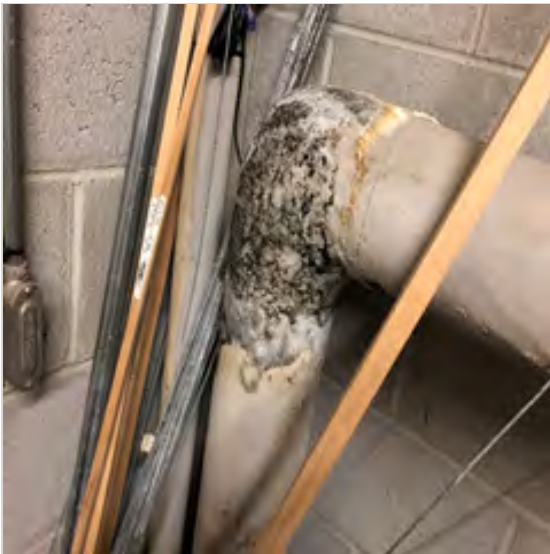
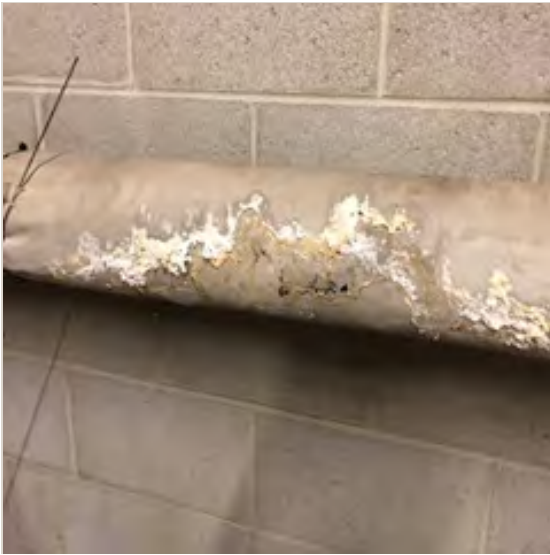
PL-3: Insulation with Mold

PL-4: Insulation with Mold

Check all piping insulation for asbestos containing materials. All existing domestic water piping should be provided with fiberglass insulation. Insulation with the presence of mold should be replaced.

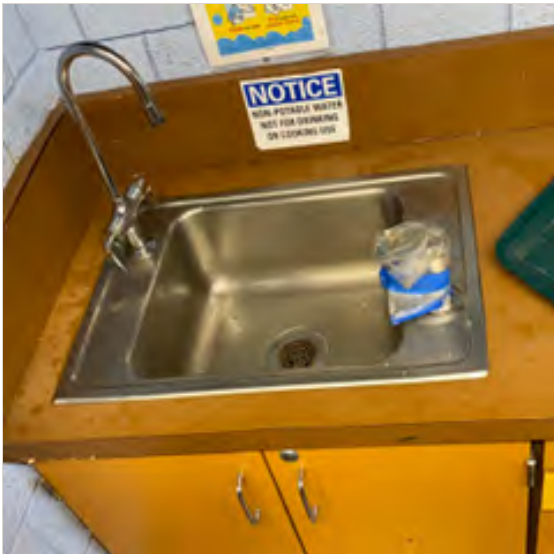
PL-5: Typical Classroom Sink Condition

Replace plumbing fixtures throughout the building with water conserving low-flow fixtures.

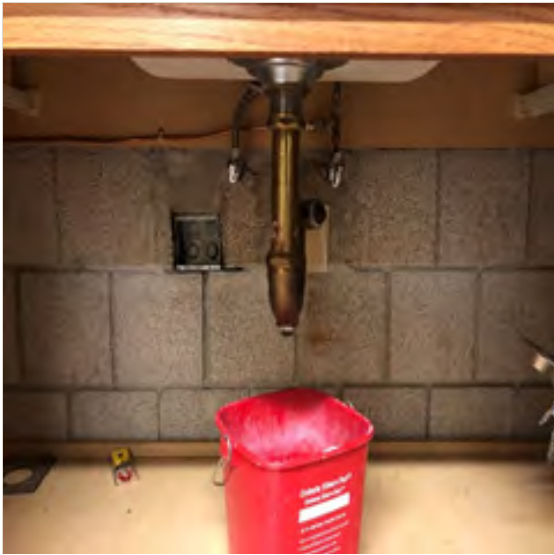
PL-6: Failed P-Trap at Teachers Room Sink

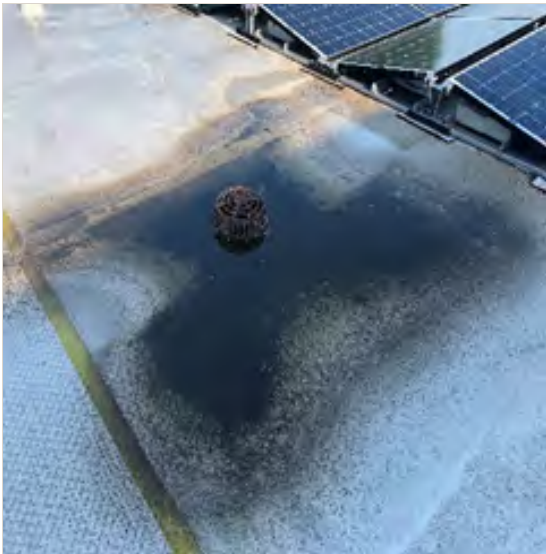
PL-9: Ponding at Roof Drain.

*Recommendations*  
There were visible areas of ponding at numerous roof drains. Assure roof insulation is adequate pitched to all roof drains and strainers are routinely cleaned to assure drain can properly function.

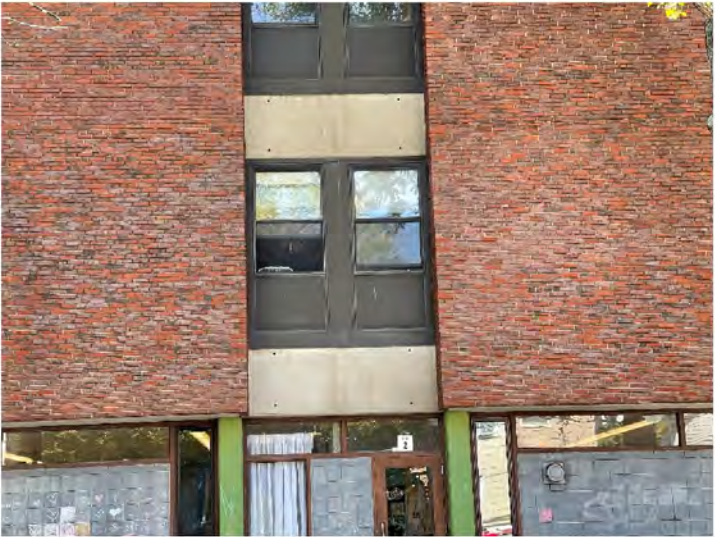
AE-6: Typical façade conditions with hung windows, exposed concrete floor at floor slabs and brick masonry veneer.

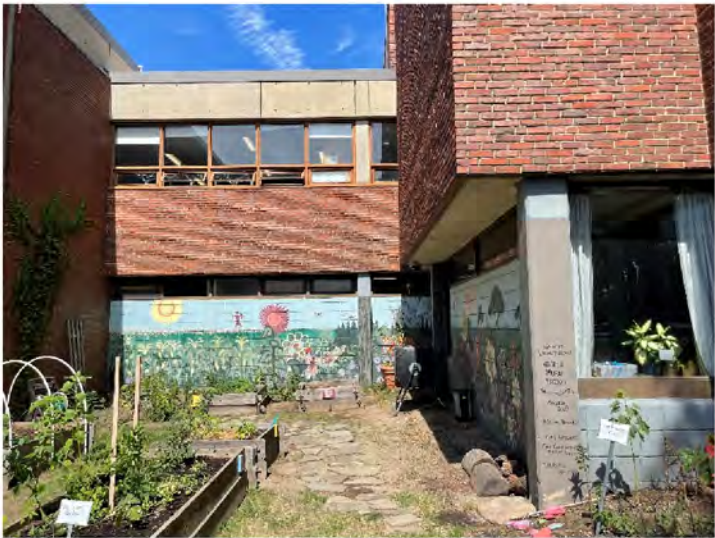
AE-7: Typical façade condition at lower level where concrete block provides façade infill between structural concrete elements.

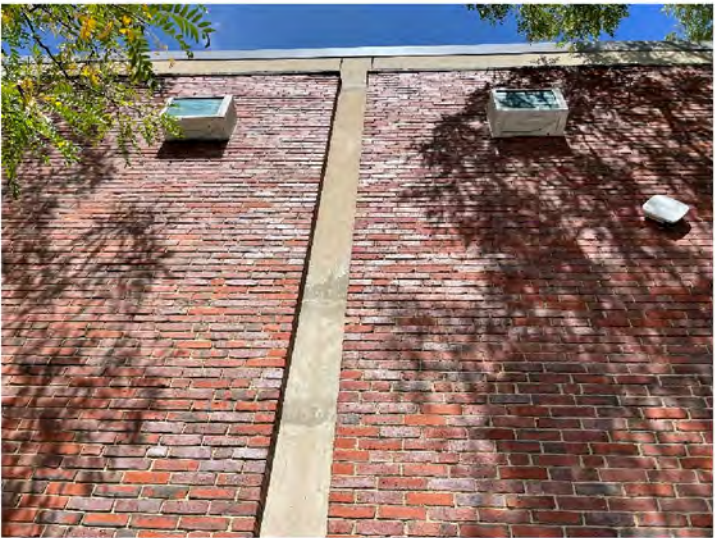
AE-8: Representative façade conditions with exposed cast in place structural concrete and brick infill facades.

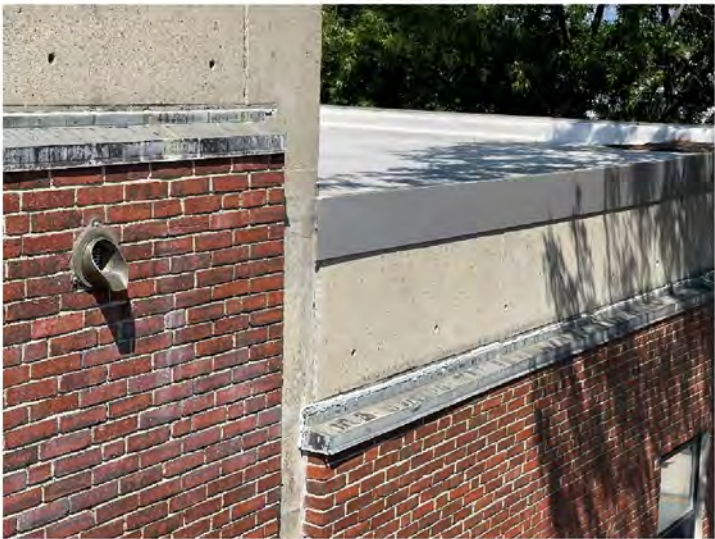
AE-13: Typical cast in place concrete structural elements and brick façade, with metal flashings along top of brick.

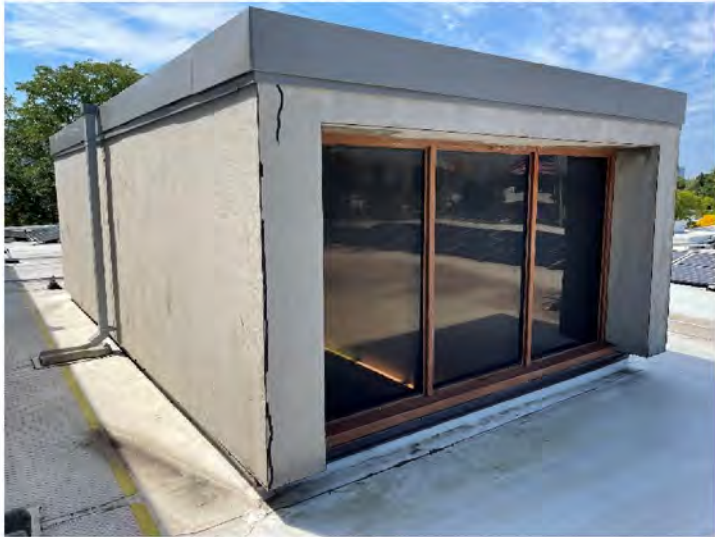
AE-20: Representative roof monitor with metal framed windows and clad with cementitious panels

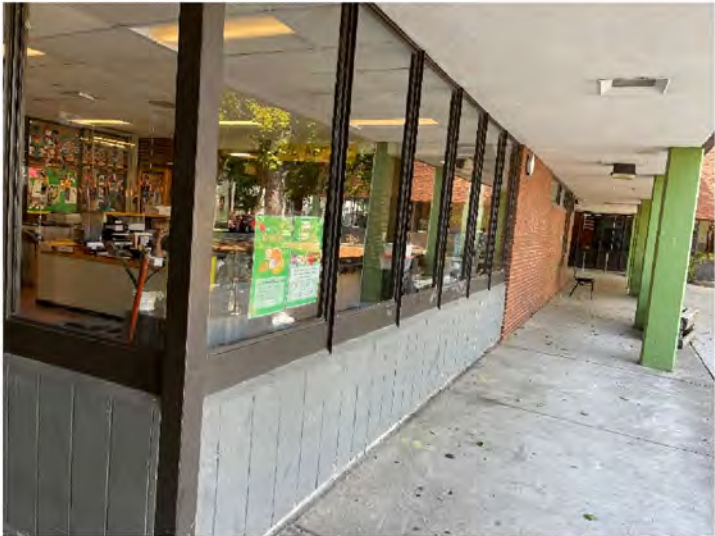
AE-29: Exterior of atypical steel framed window assemblies at front office

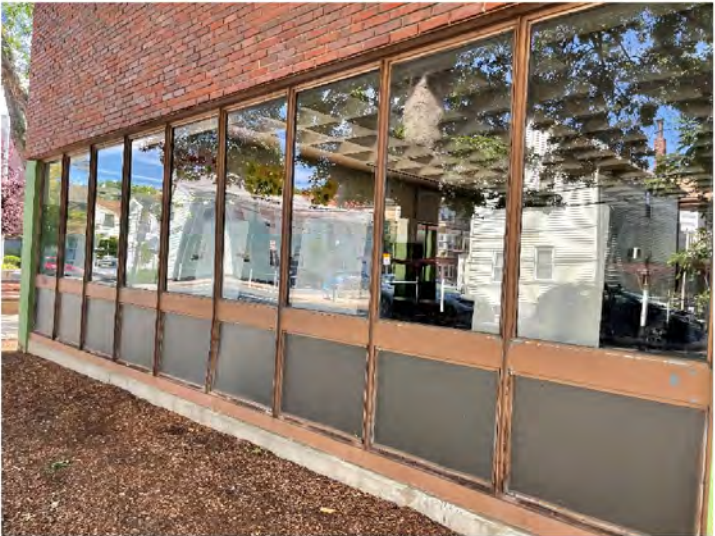
AE-30: Exterior of typical steel framed window assembly with fixed glass lites and metal spandrel panels.

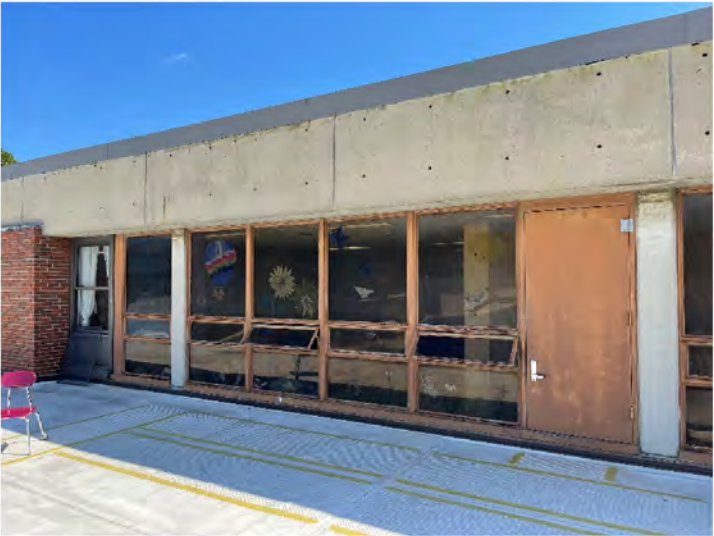
AE-27: Representative steel framed windows located above the roof.

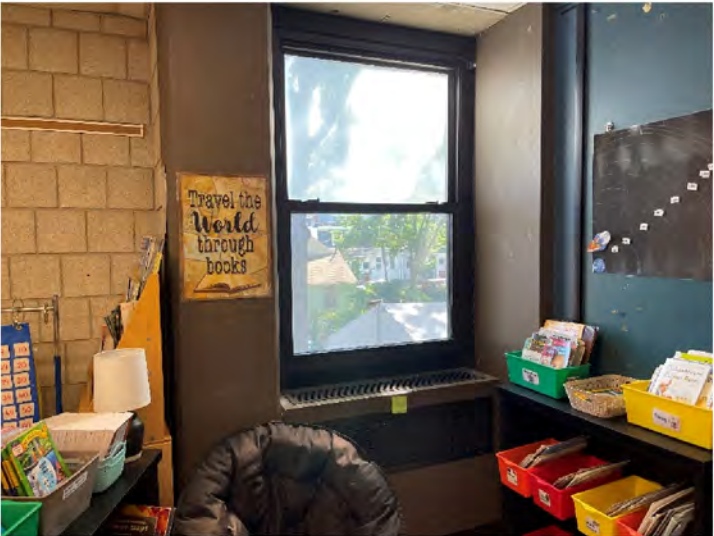
AE-33: Interior of typical aluminum window assembly within classroom

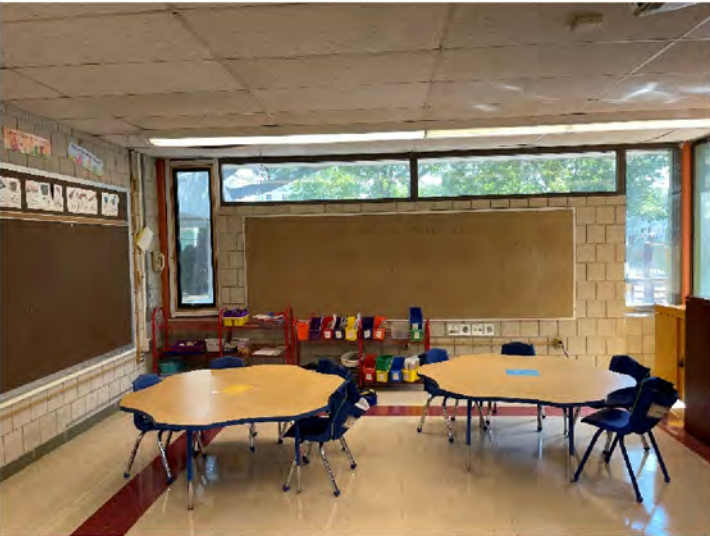
AE-34: Interior of typical classroom windows

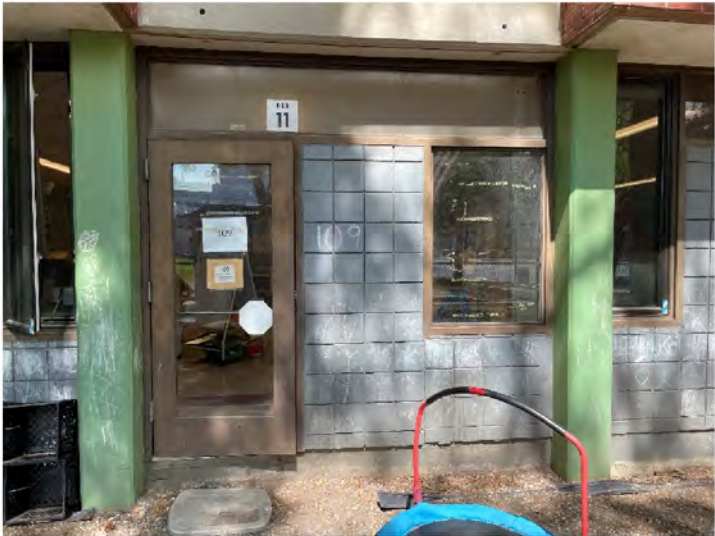
AE-37: Typical metal door with full glass lite in classroom condition

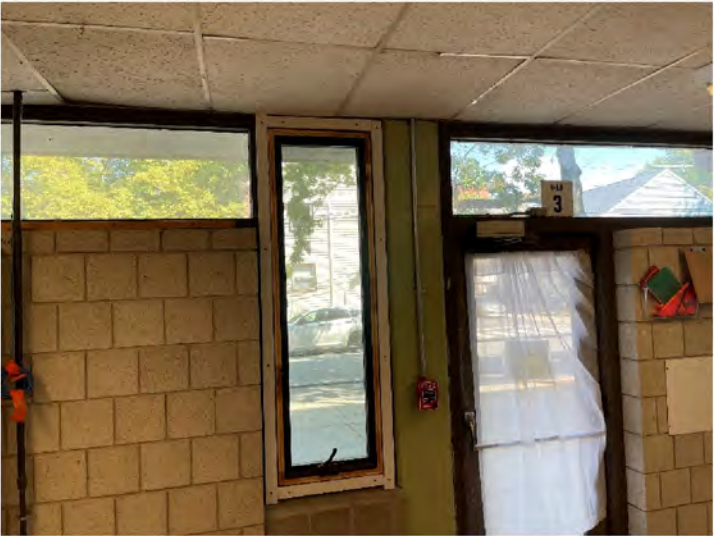
AE-35: Interior of typical newer operable casement window installed as part of COVID-19 pandemic.

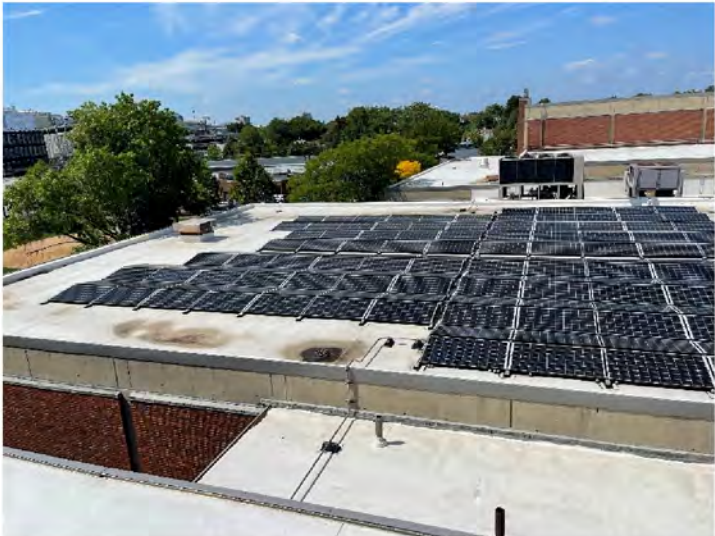
AE-45: Partial view of typical roof area, covered with PV panels

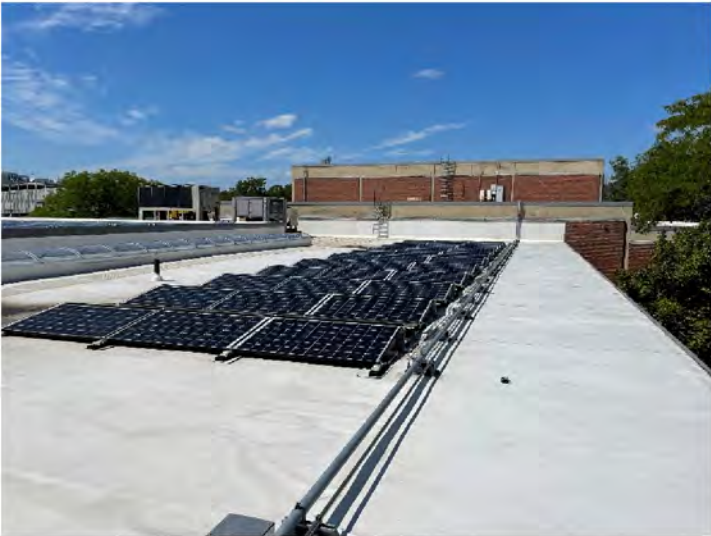
AE-46: Partial view of roof area over main lobby

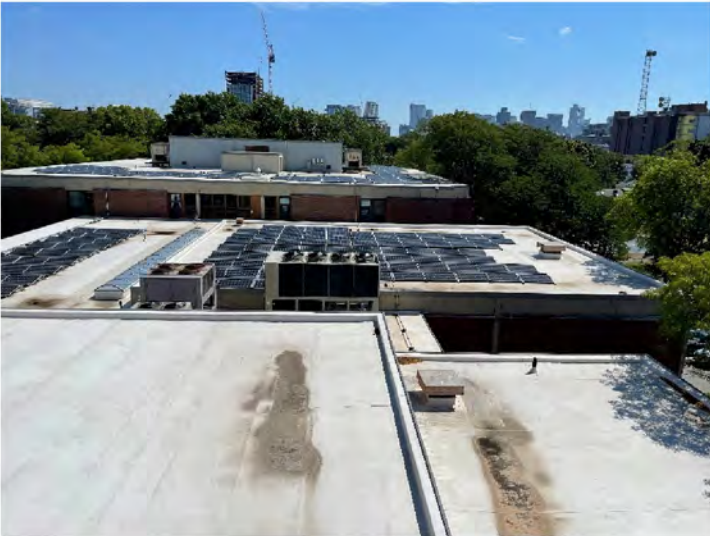
AE-43: General view of various roof areas comprising the school

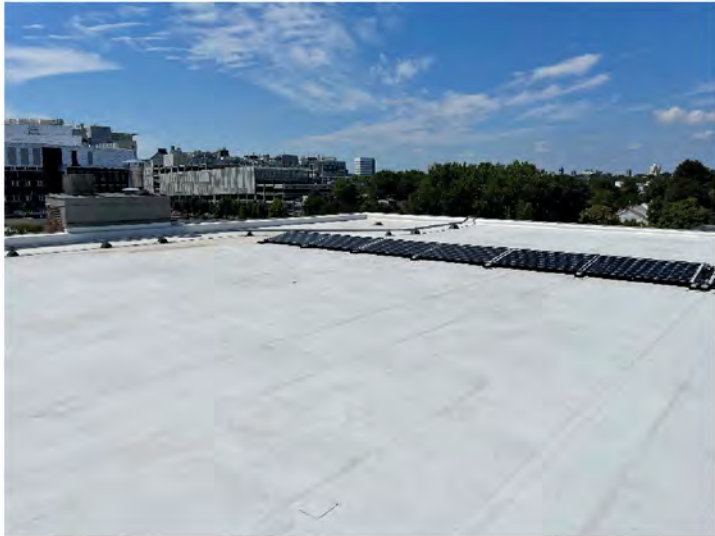
AE-44: Representative roof area

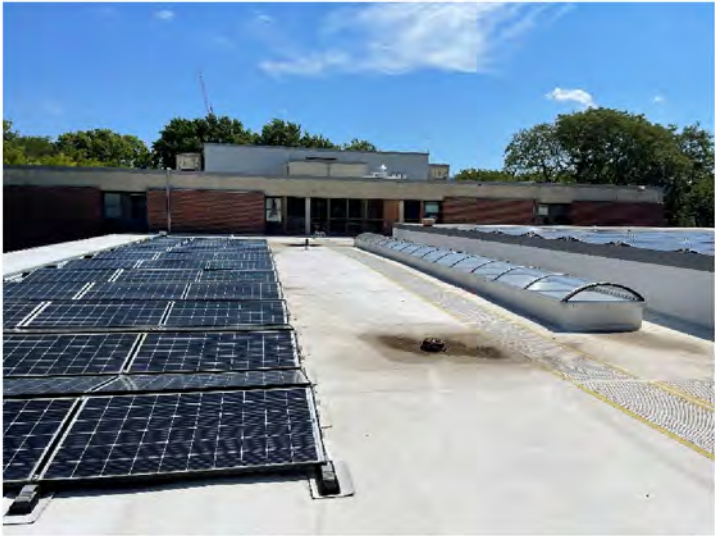
AE-47: Representative PV panels and skylight over main lobby

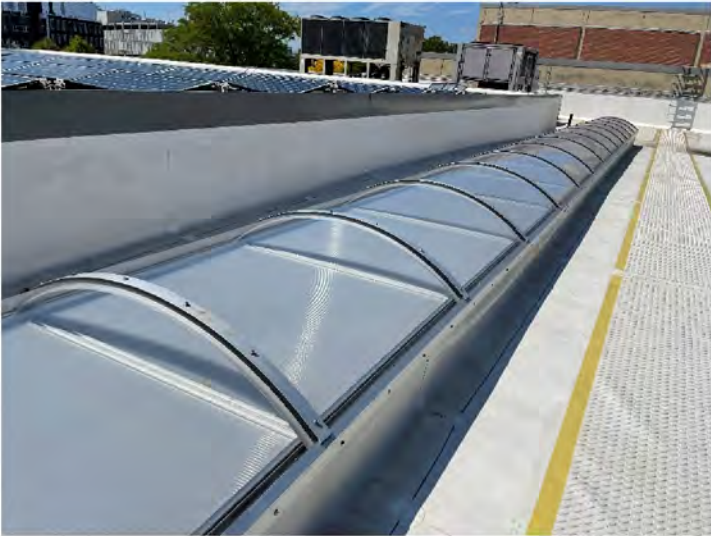
AE-48: Exterior of long unit skylight

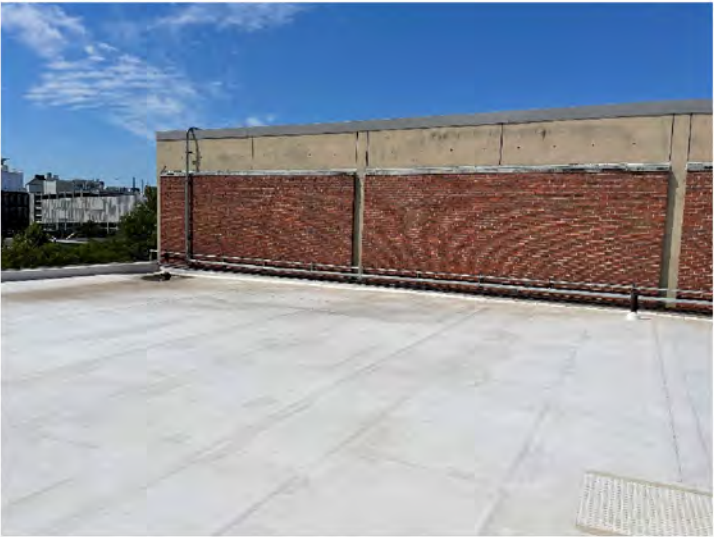
AE-49: Representative roof and façade area

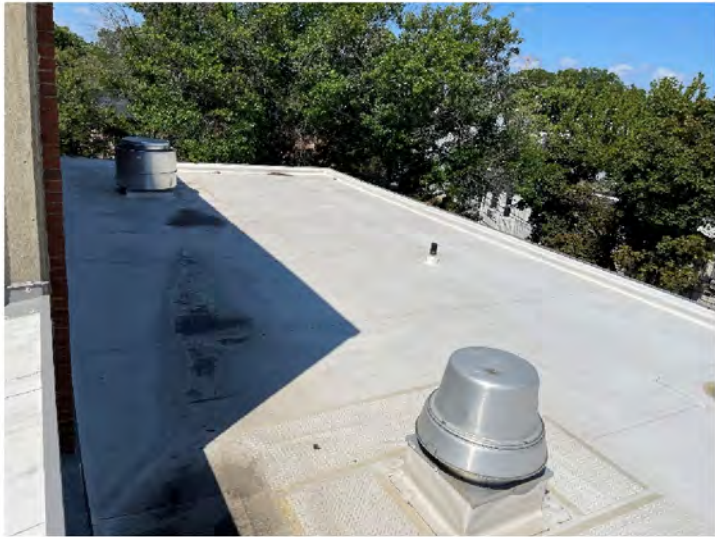
AE-50: Typical low roof, note some gathered sediment along cricket

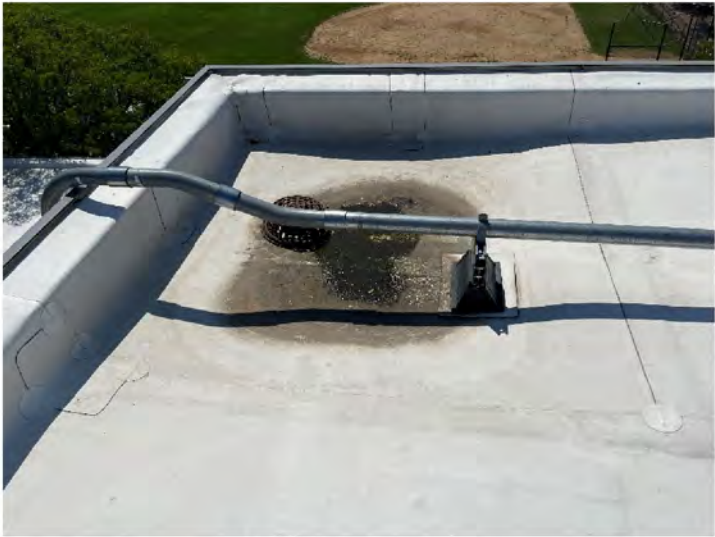
AE-53: Typical roof drain sump with some sediment build up

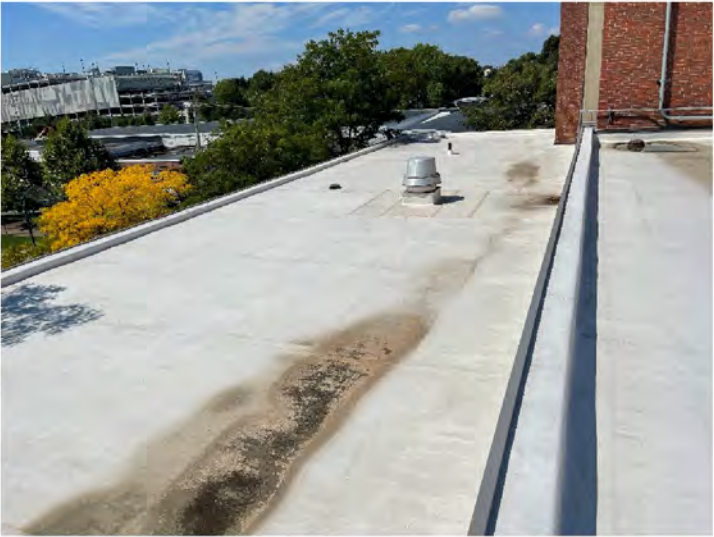
AE-51: Typical standing water and gathered sediment at low roof

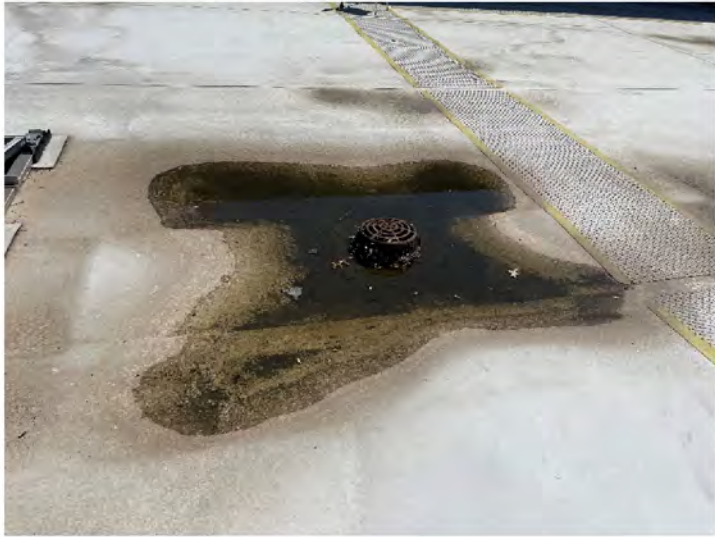
AE-52: Typical standing water and sediment build up at drain sump

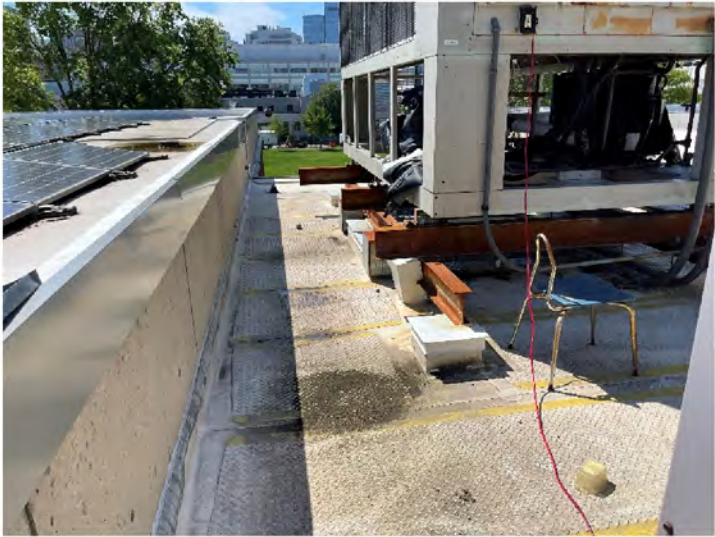
AE-55: Representative MEP unit on dunnage

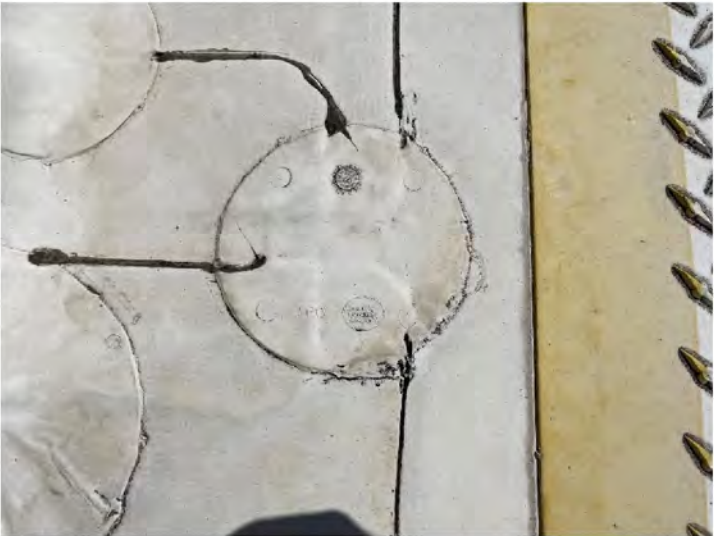
AE-57: Representative TPO patch at seam in roofing membrane

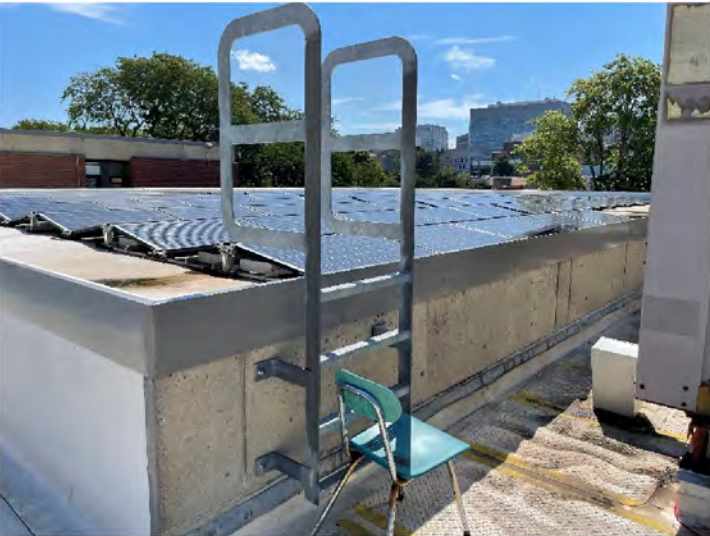
AE-58: Typical roof access ladder

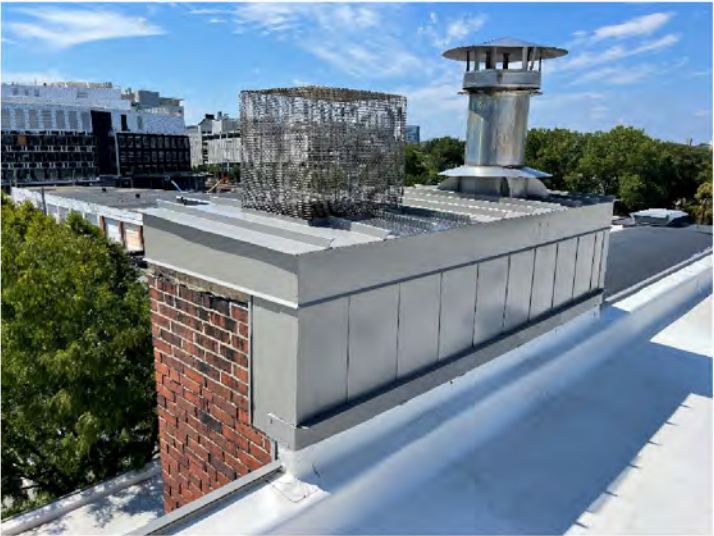
AE-59: Chimney with metal standing seam cap
