# LONGFELLOW BUILDING

359 Broadway  
Cambridge, MA 02139

**Facilities Condition Assessment : October 19, 2022**

## 7.8 | LONGFELLOW BUILDING BUILDING APPENDIX

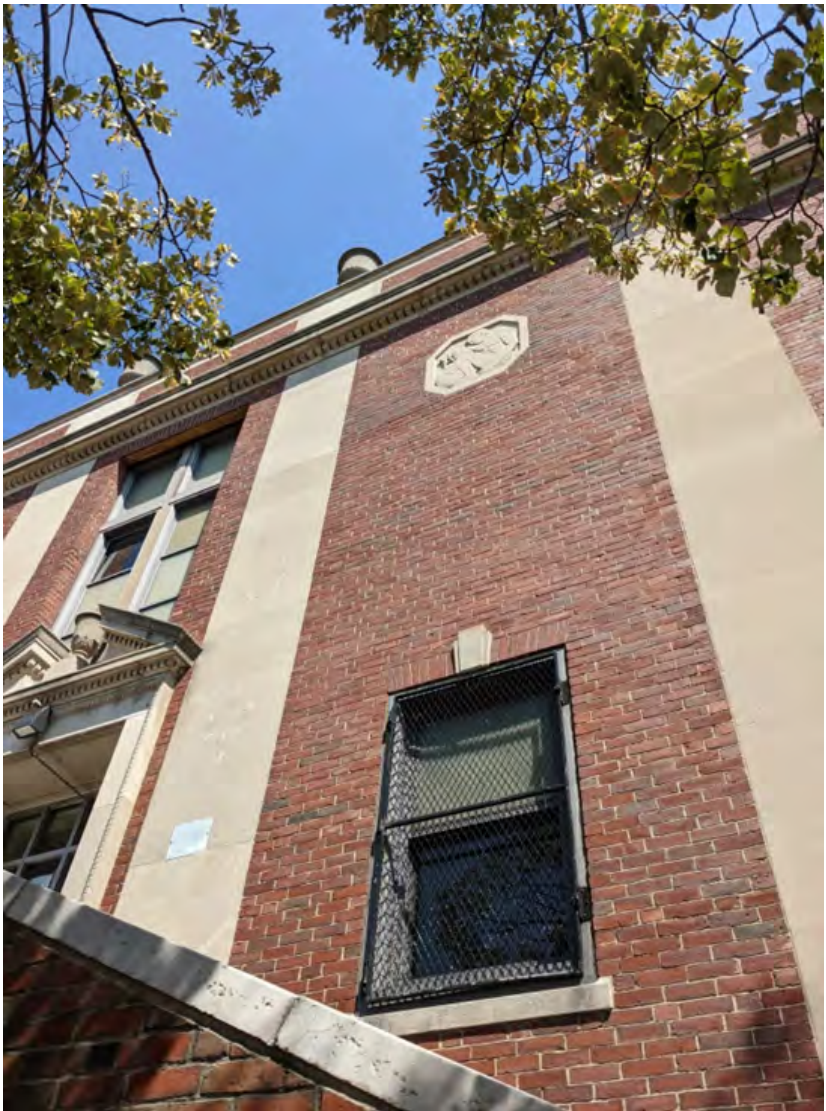
Photo ST-8: Bowing/Bulging Exterior Facade

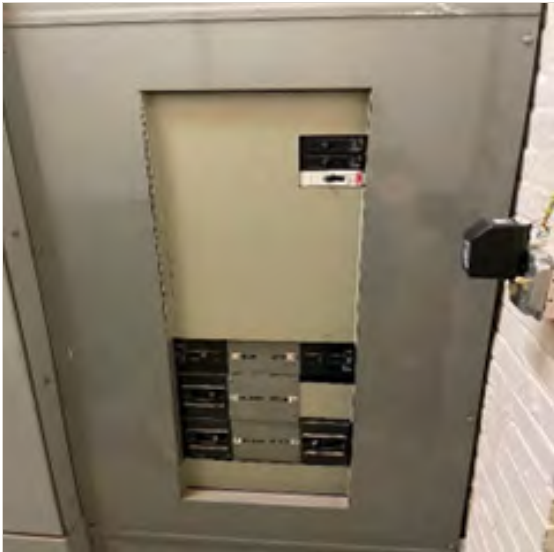
E-2: Existing ~1962 (Not replaced in 1982 Renovation)

It is generally accepted that the life of an electrical system is thirty (30) years. Beyond that point, it becomes increasingly difficult to cost effectively maintain the system. Wire insulation and equipment failure becomes more common as the system ages, with an increase in outage longevity due to the design of the system and the availability of replacement parts. Often new systems need to be installed to bypass the old system without the benefit of a comprehensive plan designed for the needs of the building. With the aged electrical devices, the devices may not operate under faulty conditions.

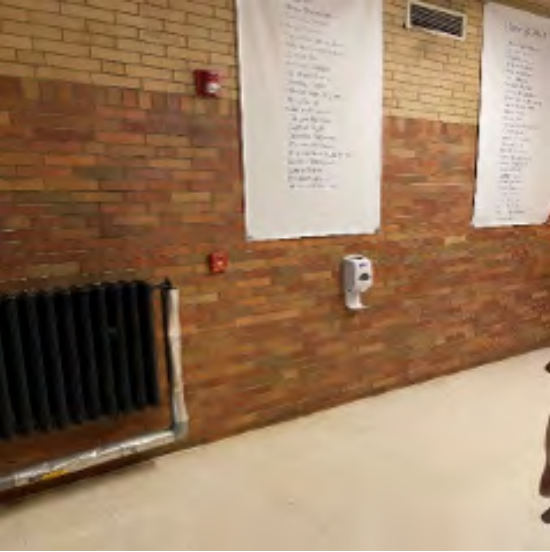
E-5: Existing Fire Alarm Device

Install carbon monoxide devices in alarms devices in every classroom where carbon emitting devices are located. Verify all devices are provided as required by 527 CMR, NFPA 72, 780 CMR, and the Mass Fire Alarm code (Missing pull stations, smoke detection not code compliant etc.)

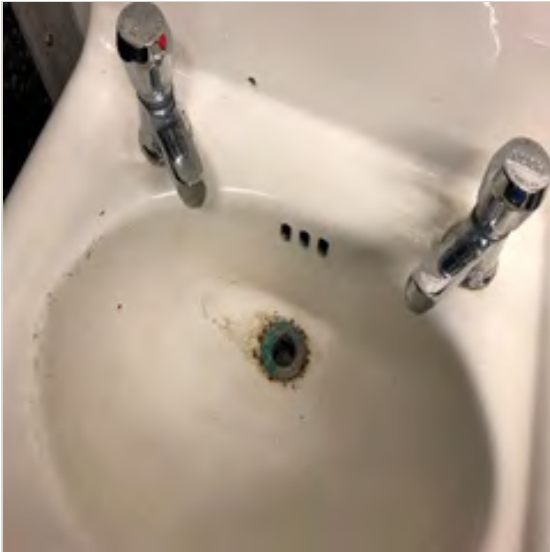
PL-3: Outdated Lavatory

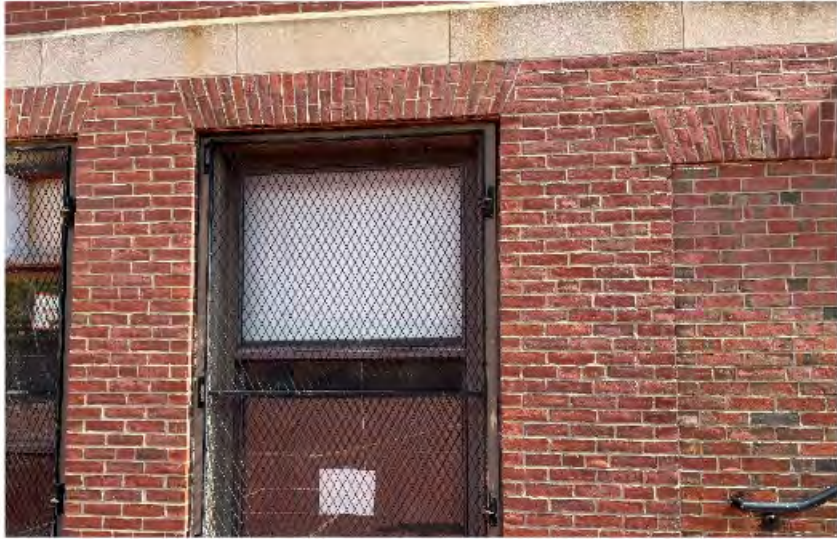
AE-21: Representative aluminum window. Note most lower level windows have security grilles.

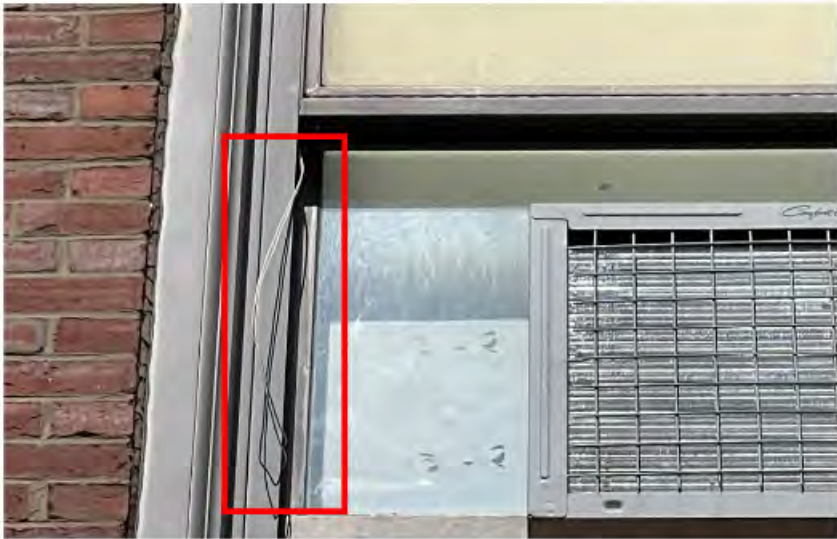
AE-24: Representative aluminum window where sash cord is not fully engaged within window frame, is exposed on exterior

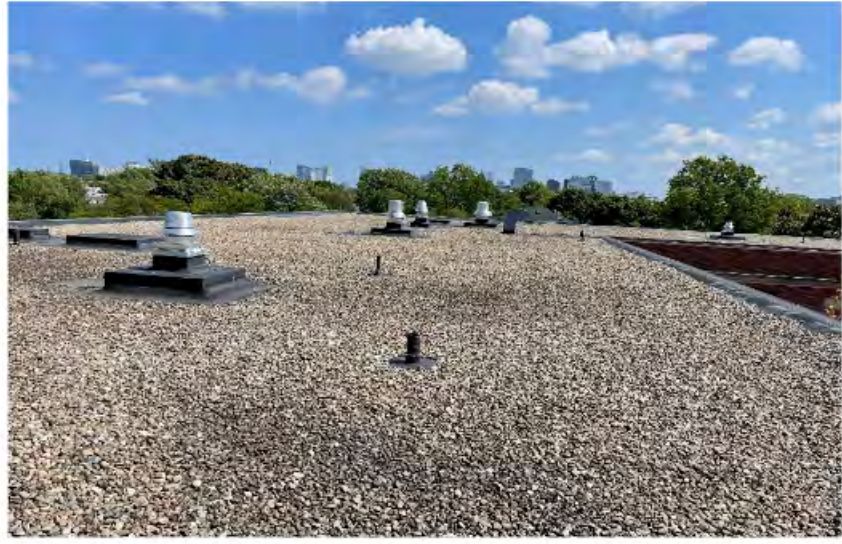
AE-27: Representative view of roof: Roof is ballasted EPDM

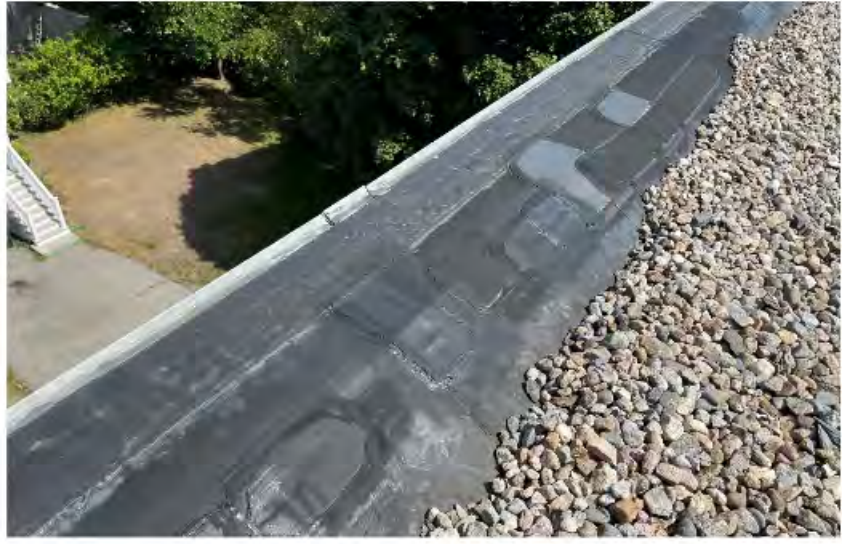
AE-28: Typical patches in EPDM along perimeter of roof
