# MORSE ELEMENTARY SCHOOL

## Facilities Condition Assessment : October 19, 2022

Facilities Condition Assessment, Capacity Analysis and Master Plan for CPS

# 7.9 | MORSE SCHOOL BUILDING APPENDIX

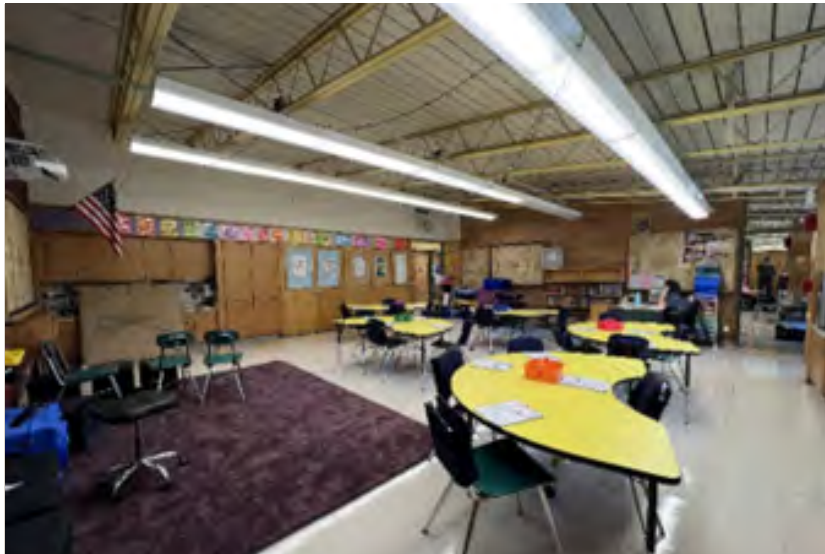
Floors:  
The predominant flooring material throughout the school is VCT. This is generally in good condition but is showing signs of wear. The VCT in the E wing has joints that are separating which may be due to moisture. Also, there are isolated areas of VCT damage; in particular, on the day of the assessment one failed mechanical unit had caused VCT to pop off. Ceramic tile is in all restrooms and is in good condition, as is the wood floor in the gymnasium. The carpet in the library is showing wear and is past its useful life. Corridors are consistently terrazzo which is overall in good condition. More significant cracking is present in the E Wing and may be due to moisture or settlement.

Typical Classroom – E Wing (note open VCT joints)

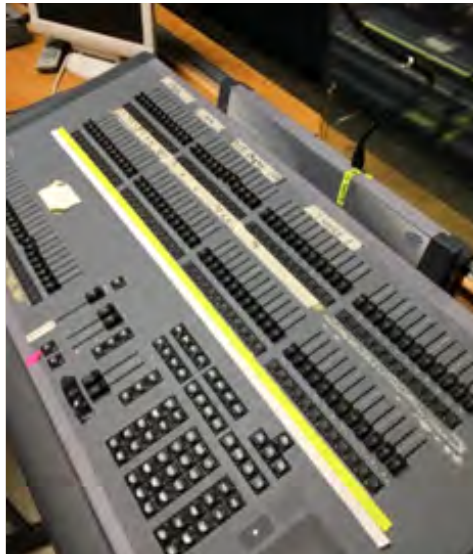
Theatrical Lighting Control Console

Theatrical Lighting:  
This system should be upgraded. Panelboards and/or dimmer racks serving theatrical lighting should be replaced with relay panels. Fixtures should be upgraded to LED spot and wash fixtures. Existing power infrastructure is likely to be able to be reused. Low-voltage control wiring (category cable) must be added to serve each lighting position.

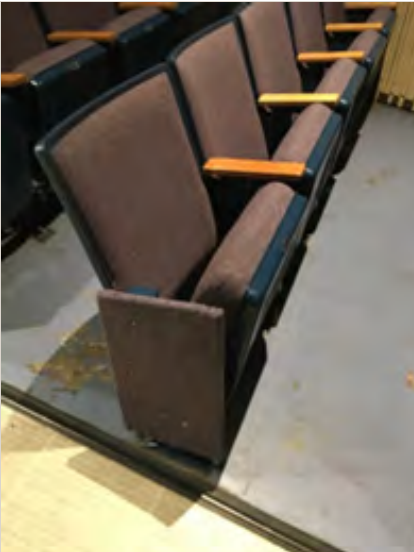
Damaged Auditorium Seat

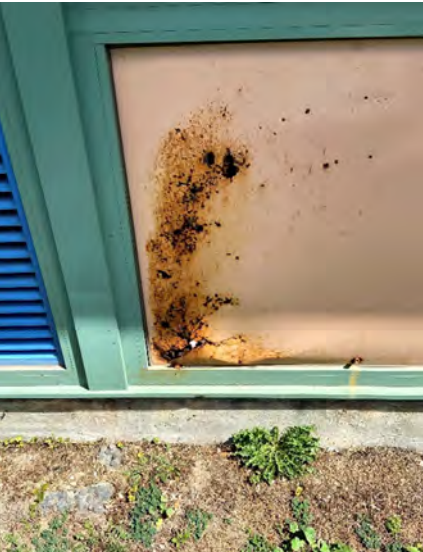
Photo ST-1: Rusting architectural panel at classroom wing

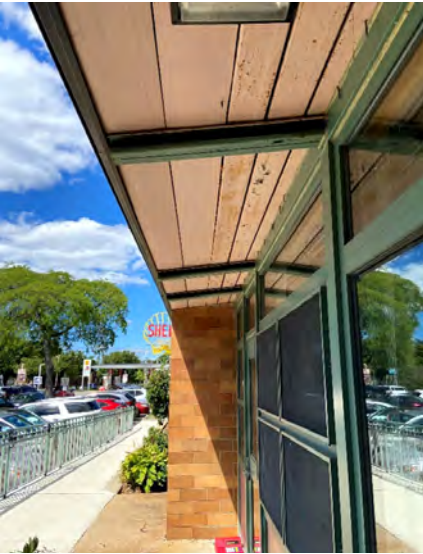
The underside of the metal roof deck is painted and exposed as soffits surrounding the perimeter of the building. The paint is peeling and there is surface rusting in many of these areas. Fasteners from the roof penetrate through the soffits and are exposed on the exterior in some locations. (Ref: Photos AE-51-53)

Photo ST-2: Rusting underside of steel roof deck at classroom roof overhang

Miscellaneous:  
Prepare, prime and paint all exterior soffits.

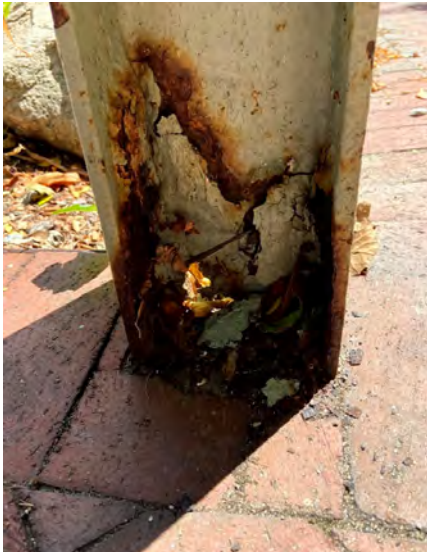
Photo ST-3: Deterioration at base of canopy column

| ARCHITECTURAL - EXTERIOR | CONDITION | PRIORITY |
|---|---|---|
| ◦ Repair roof deck at Art Room, repair front entry canopy columns | | 3 |

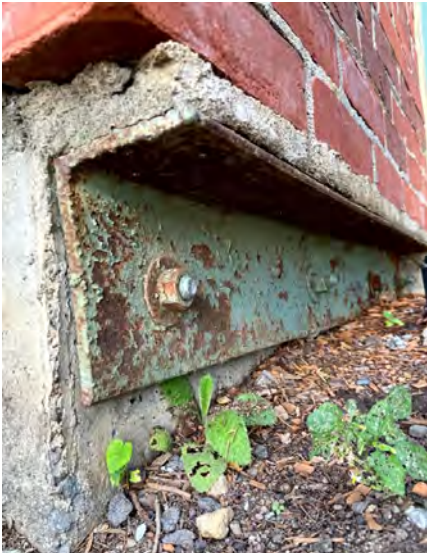
Photo ST-4: Rusting steel angle at base of masonry wall

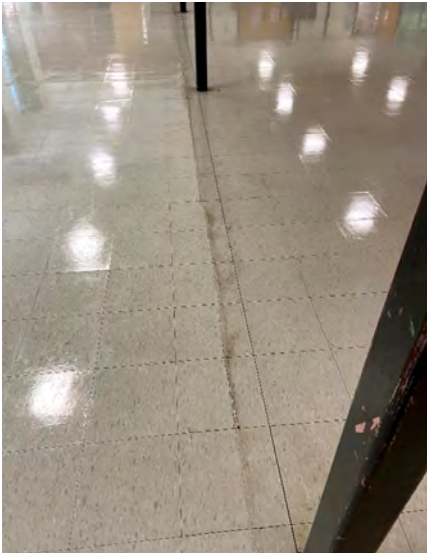
A crack in the floor finish was observed in the cafeteria, extending across the space. Refer to Photo ST-6. The crack appears to follow a construction joint in the concrete slab and is not an immediate structural concern. However, it may present a tripping hazard. It is recommended that the floor finish be repaired.

Photo ST-6: Crack in floor finish at cafeteria

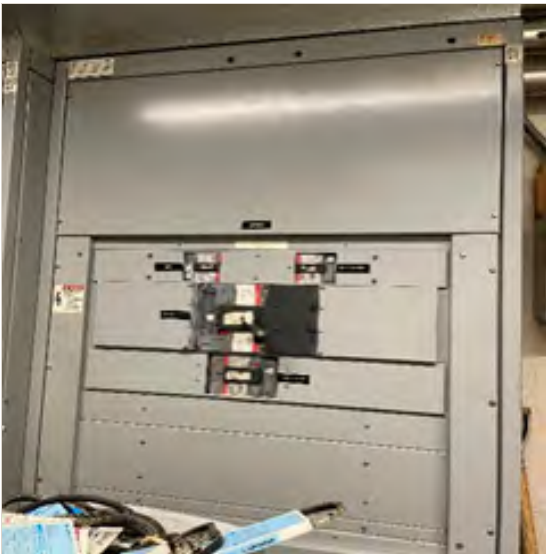
The main electrical distribution provides 678KW with an area of 84,021 square feet or 8W/SF. New highly efficient mechanical designs generally require 19- 24W/ SF. The main service would be required to be upgraded complete for a large-scale mechanical upgrade.

The electrical code now requires Arc Fault Protection labeling for the safety of the electrical staff. It is recommended that an Arc Fault/Coordination study be performed, and associated labeling be provided to meet today’s electrical code. Arc fault reduction is now a code requirement for electrical services 800A and larger to reduce the available Arc Fault, this is not available on the existing equipment.

E-1: Main Electrical Service (Entrance)

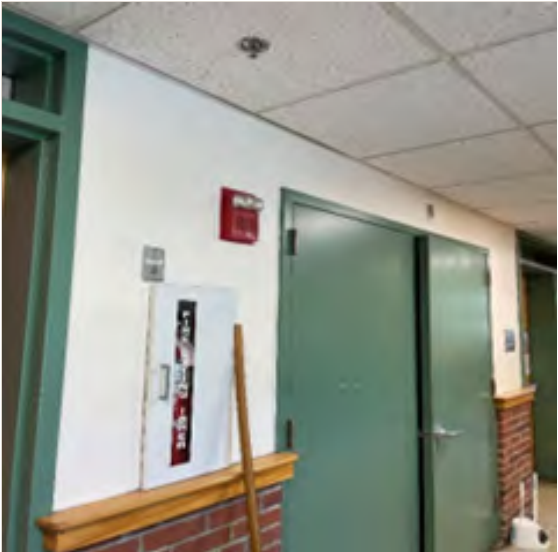
E-5: Existing Fire Alarm Device

It is recommended that a speaker type-system be provided for transmitting voice notifications in the event of a fire alarm and/or mass notification.

Install carbon monoxide devices in alarms devices in every classroom where carbon emitting devices are located. Verify all devices are provided as required by 527 CMR, NFPA 72, 780 CMR, and the Mass Fire Alarm code (Missing pull stations, smoke detection not code compliant etc.)

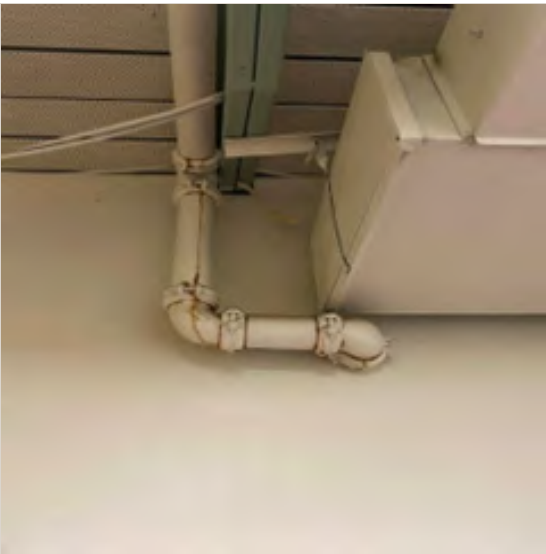
FP-1: Leaking Sprinkler Pipe

*Recommendations*  
It is recommended the existing sprinkler system be maintained in conformance with the requirements of NFPA 25, Inspection, Testing and Maintenance of Water-Based Fire Protection Systems.

Replace all sprinkler pipe that is corroded or leaking as required.

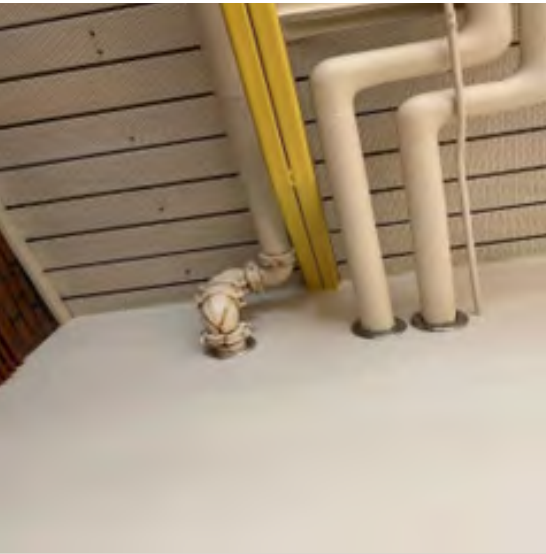
FP-2: Leaking Sprinkler Pipe

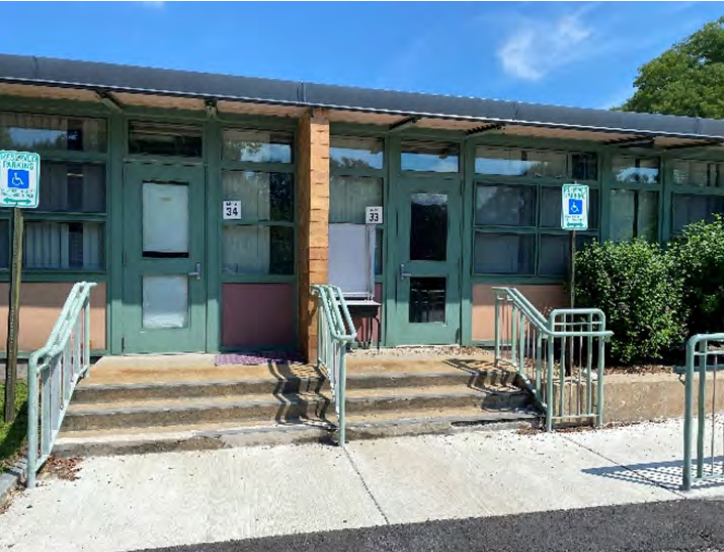
The building includes various exterior egress doors around the full perimeter. No hazardous egress conditions were noted during the site visit, with the possible exception of deterioration to the concrete in some exterior egress stair treads and risers that are in need of repair. Illuminated exit signs appear to be provided throughout, emergency lighting wasn’t regularly apparent but may be provided via normal light fixtures connected to an emergency circuit.

Exterior Egress Stairs

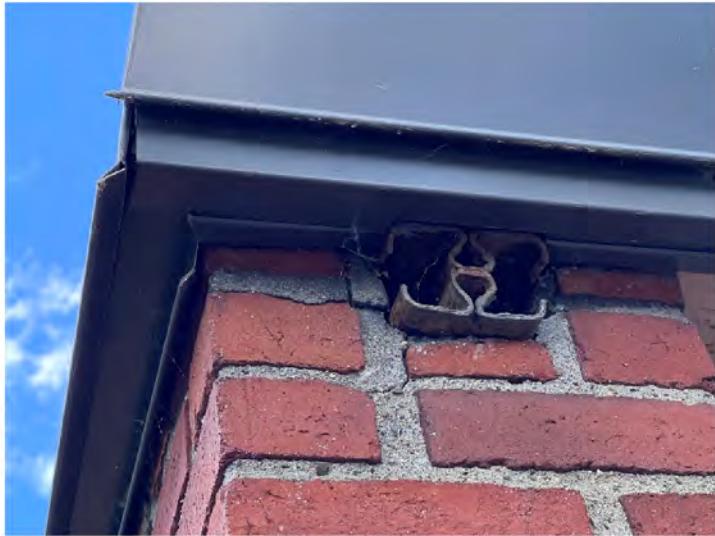
AE-22: Typical exposed metal roof truss at exterior of facade

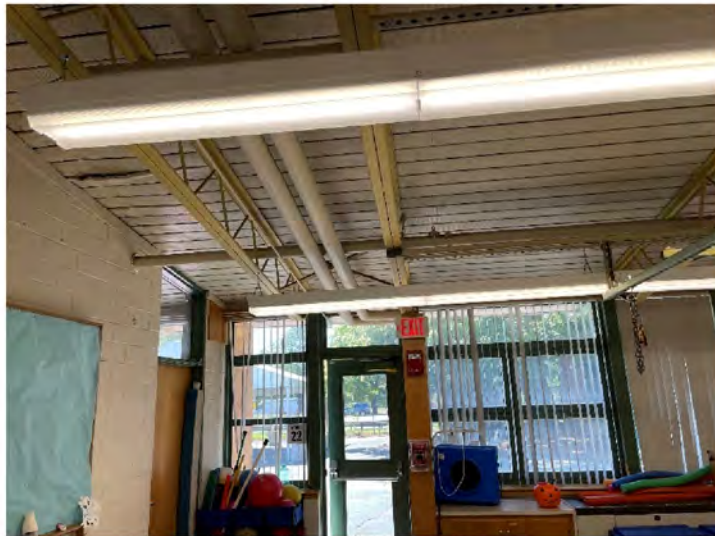
AE-23: Interior of typical classroom where roof trusses extend through facade.

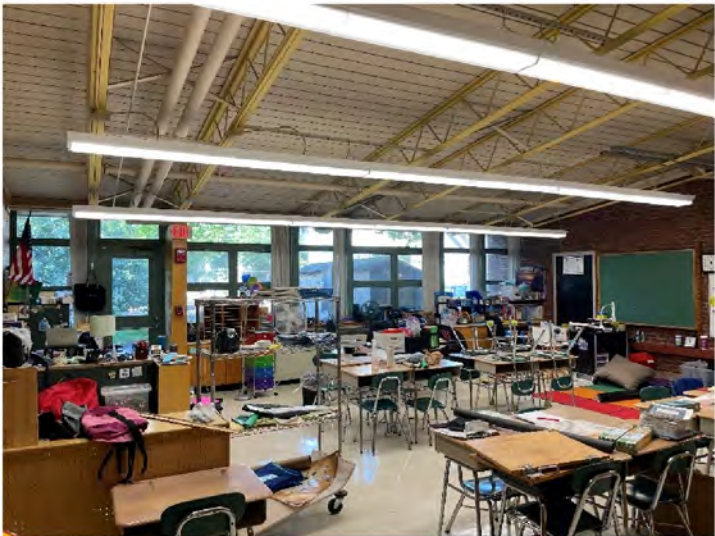
AE-39: Interior of typical classroom with storefront facade

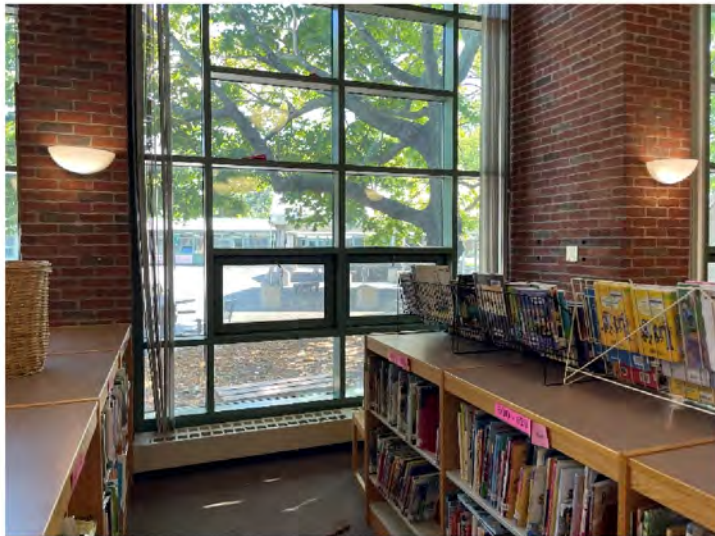
AE-40: Interior of curtain wall within Library

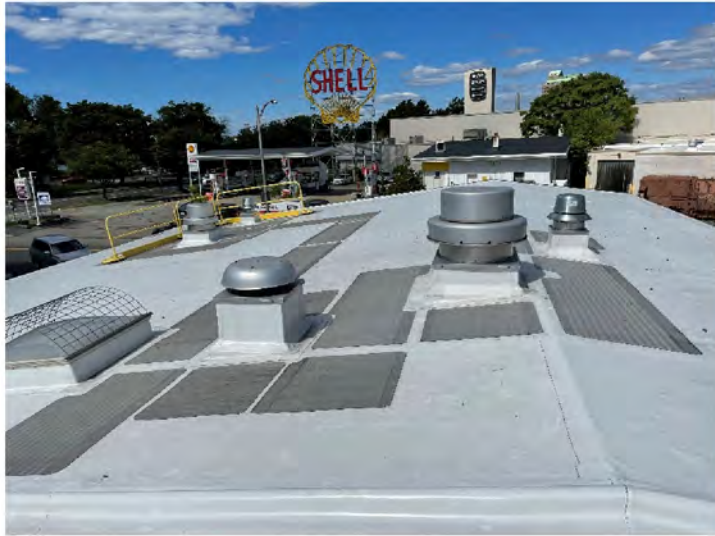
AE-56: Representative PVC roofing assembly with MEP units and unit skylight

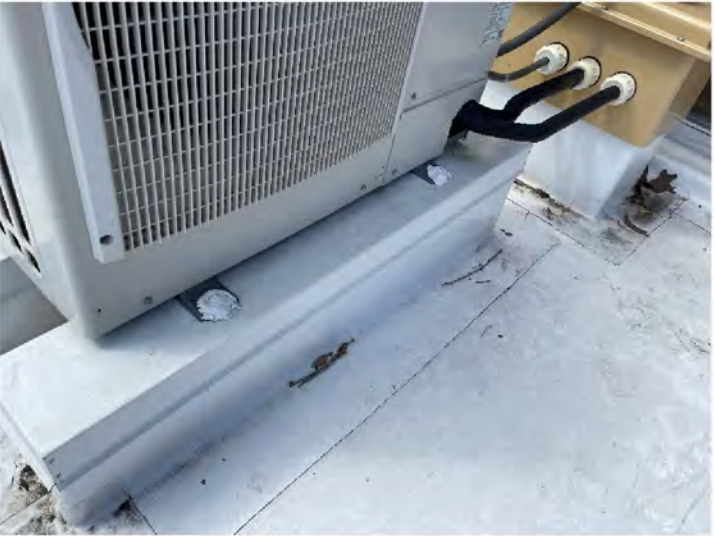
AE-60: Typical condenser unit on sleeper curb

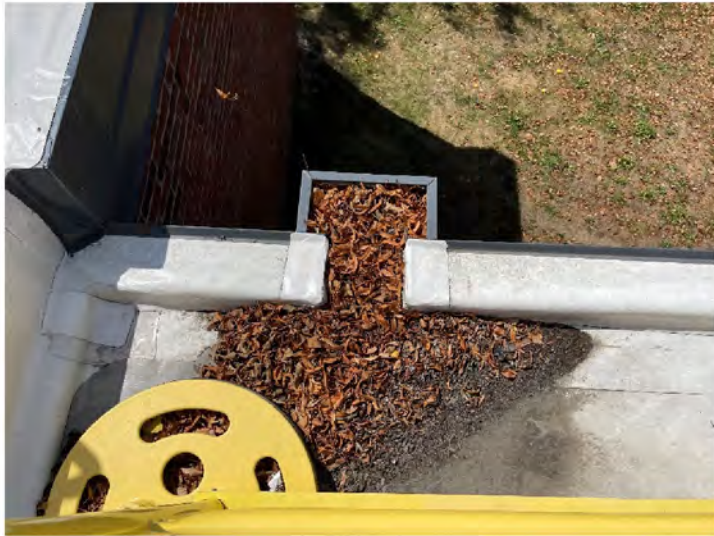
AE-65: Typical downspout clogged with leaves at West Elevation

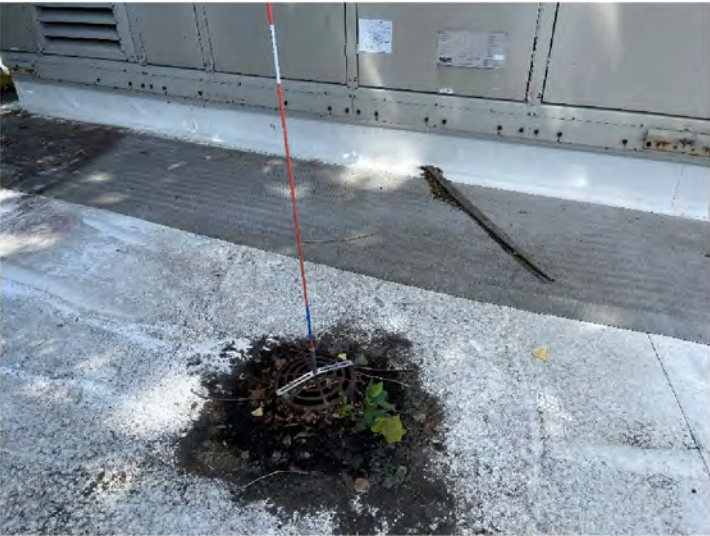
AE-66: Typical internal roof drain with leaves and sediment build up

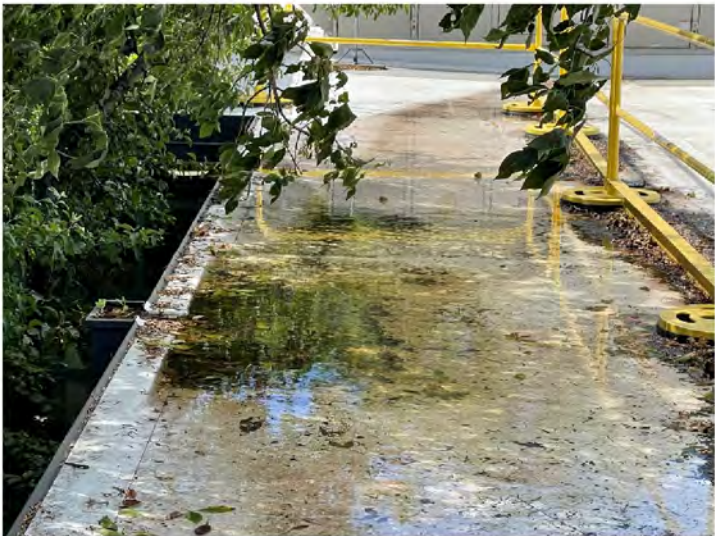
AE-63: Typical ponding of D Wing roof to North of Courtyard

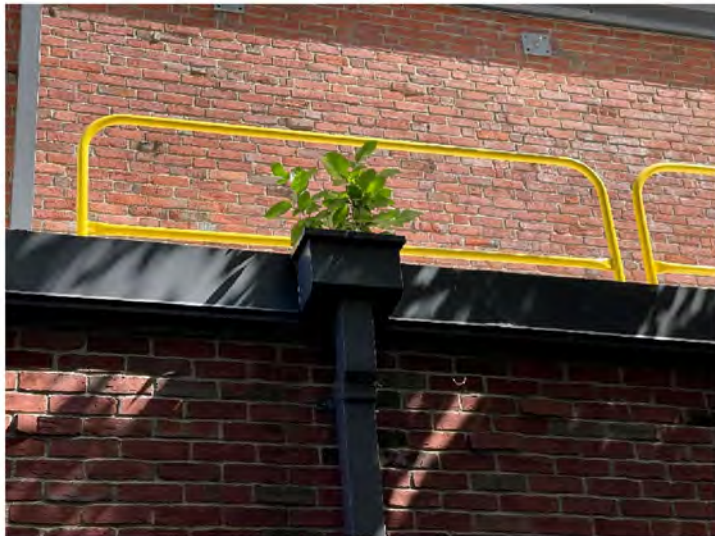
AE-64: Typical downspout at West Elevation with vegetation growth due to leaves filling top of downspout

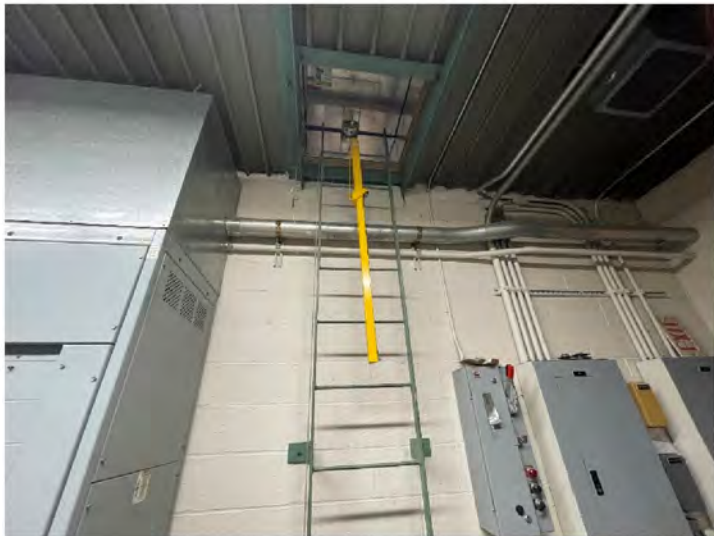
AE-67: Interior of wall mounted ladder at roof access hatch

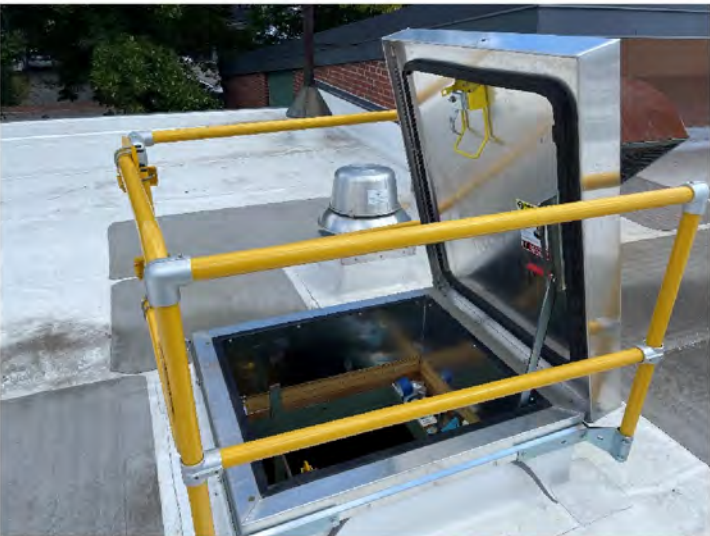
AE-68: Roof access hatch
