# PEABODY SCHOOL

## Facilities Condition Assessment : October 14, 2022

Facilities Condition Assessment, Capacity Analysis and Master Plan for CPS

## 7.10 | PEABODY SCHOOL BUILDING APPENDIX

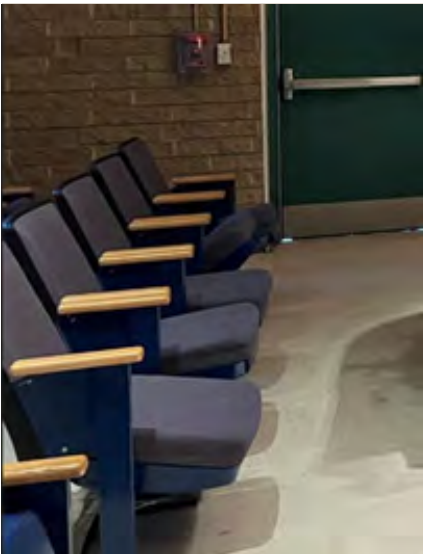
Auditorium Seating with Inoperable Return

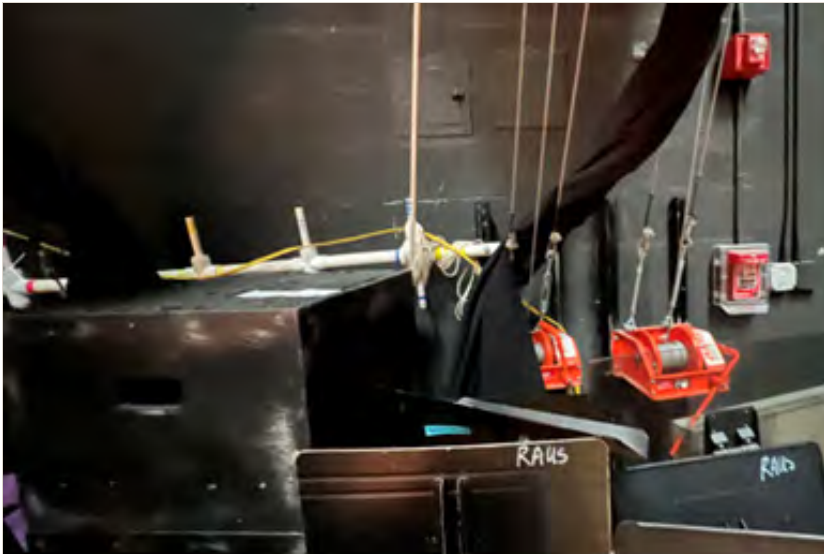
Existing Hand Winches and Makeshift Pinrail

Hand-winch suspended battens (lighting) should be replaced with industry standard motorized package hoists.

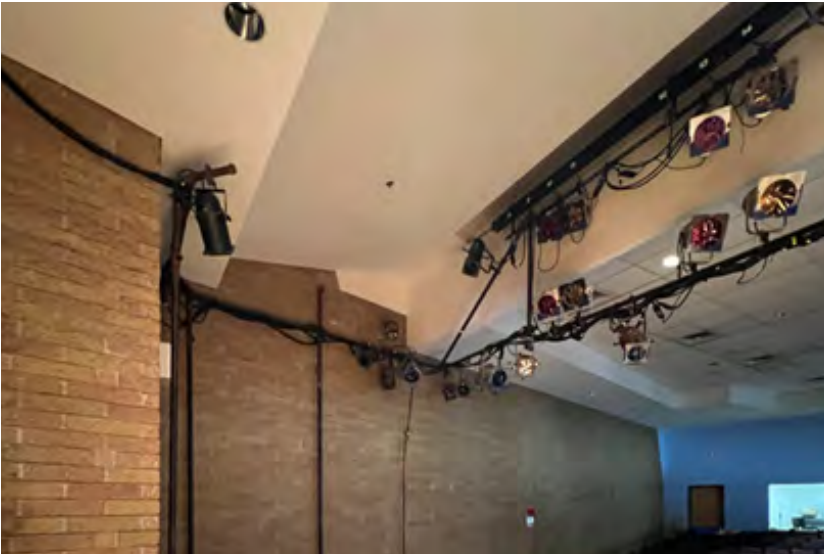
Additional Lighting Pipe at Front of House; Temporary Cable at Left

Front of house lighting positions in the auditorium should be similarly inspected. This position should be modified to accommodate additional fixtures needed, if possible.

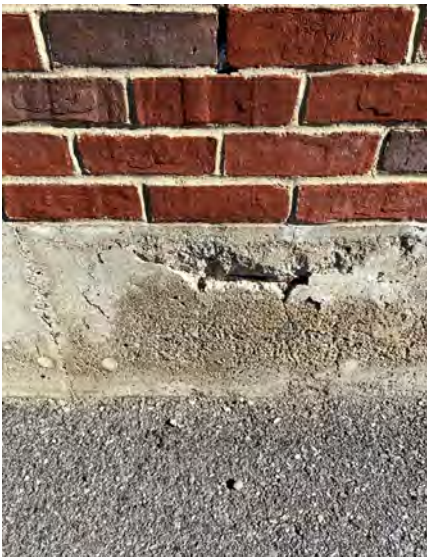
Isolated cracking, spalling and exposed steel rebar was noted at the foundation walls of the older portion of the building. (Ref: Photos 23-25) Some exposed concrete has been painted, with some peeling paint in these areas. (Ref: Photo AE-26) Above the roof, facades around the Youth Center have been clad in stucco and the roof penthouse and dormers are clad in metal panels. (Ref: Photos AE-27, 28) There are exposed steel beams at the top of the Southwest Stairwell, which likely contribute to thermal bridging through the façade. (Ref: Photo AE-33)

Photo ST-1: Concrete spalling at perimeter foundation wall

Preparation and patching of the spalled concrete foundation and façade areas is recommended. Coat any exposed reinforcing steel with a corrosion inhibiting coating prior to performing the concrete repair.  
Install rodent-proof mesh or alternative cladding along base of North Elevation, extending below grade to address issues related to rodents burrowing/nesting in this area.

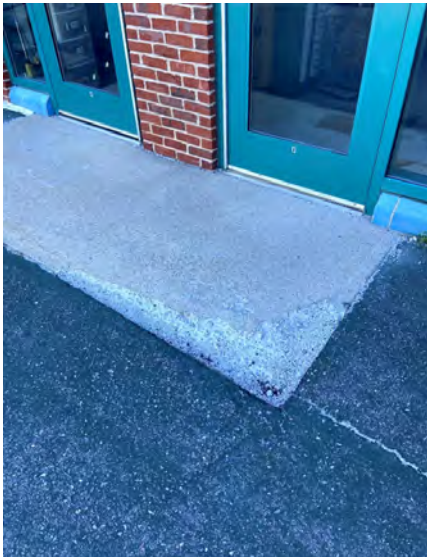
Photo ST-5: Deterioration of concrete approach slab

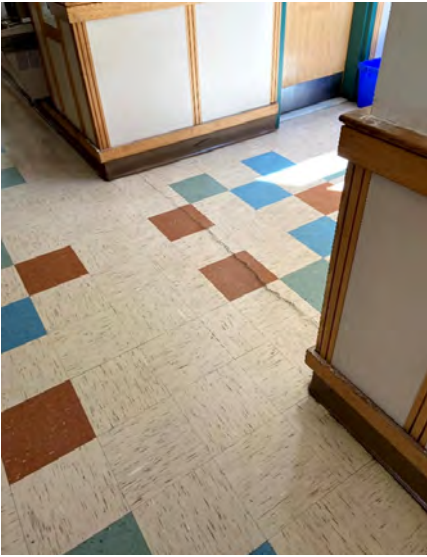
Photo ST-7: Crack at floor finish in 1995 addition corridor

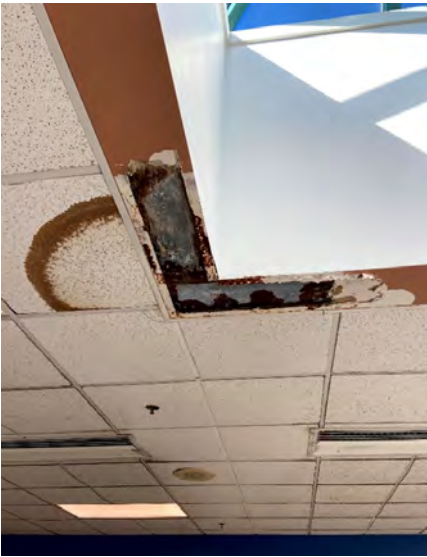
The shared use space such as gym and library are in good condition and appear to have had some upgrades over time. The cafeteria, however, is one of the area’s most in need of repair with immediate attention needed to roof leaks and associated water damage. The toilet rooms, which are predominantly multi-user, appear to be ADA compliant and have had some upgrades; they are in good condition.

Photo ST-6: Water damage at cafeteria skylight

Roofing:  
The existing metal-framed skylights should be reglazed. Unit skylights are 20 years old, are reaching the end of their expected service life and should be replaced.

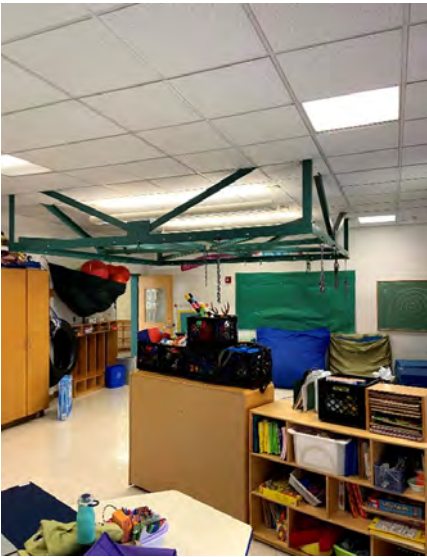
Photo ST-8: Hanging steel structure at OT/PT room

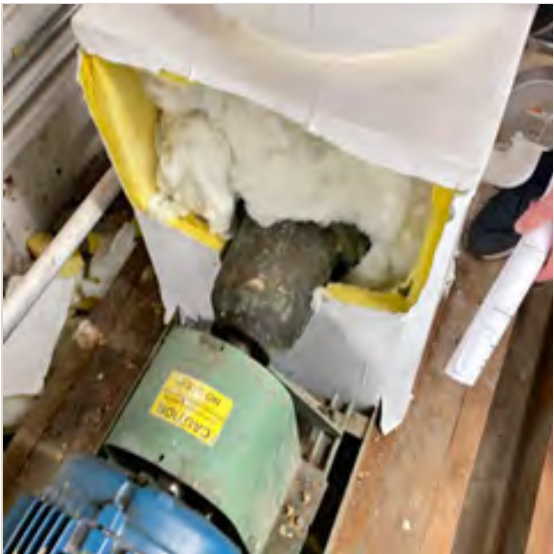
M-1: Exposed Pump Condition

Hot Water Pumps: Pumps should be replaced within the next 5 years. They are at the end of their service life.

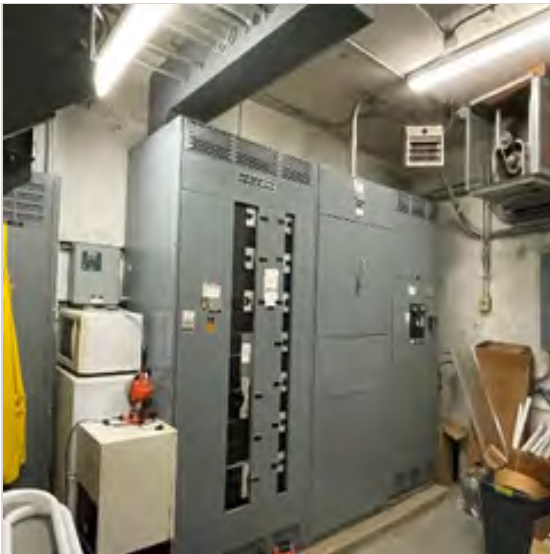
The main electrical distribution provides 1,413 kW with an area of 145,835 square feet or 9.6W/SF. New highly efficient mechanical designs generally require 19- 24W/ SF. The main service would be required to be upgraded complete for a large-scale mechanical upgrade.

E-1: Main Electrical Service (Entrance)

The electrical code now requires Arc Fault Protection labeling for the safety of the electrical staff. It is recommended that an Arc Fault/Coordination study be performed, and associated labeling be provided to meet today's electrical code. Arc fault reduction is now a code requirement for electrical services 800A and larger to reduce the available Arc Fault, this is not available on the existing equipment.

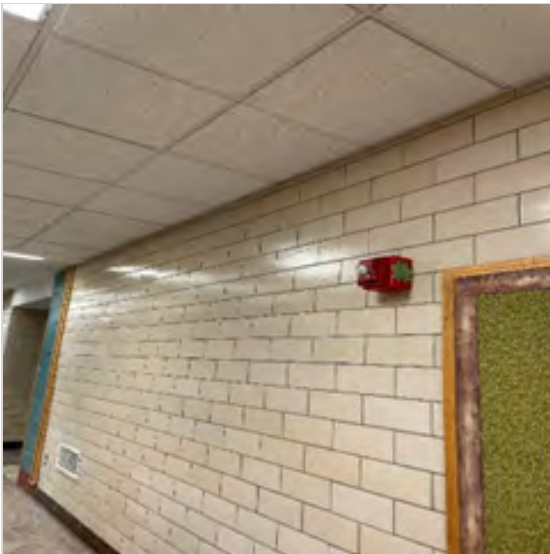
Horns/lights are installed in corridors and some common spaces to provide alarm notification to occupants. The devices appear in fair/poor working order with white strobe lenses in several areas, and not clear as required by code.

E-5: Existing Fire Alarm Device

*Recommendations*  
Provide all required testing and detailed review for a code compliant installation. Install carbon monoxide devices in alarms devices in every classroom where carbon emitting devices are located. Verify all devices are provided as required by 527 CMR, NFPA 72, 780 CMR, and the Mass Fire Alarm code (Missing pull stations, smoke detection not code compliant etc.)

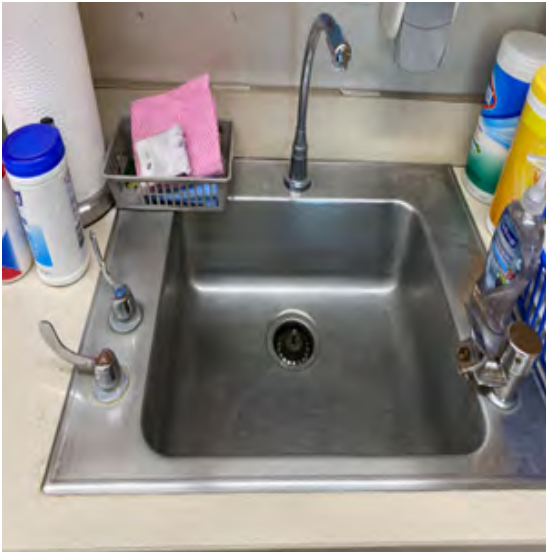
PL-3: Classroom sink

*Recommendations*  
Public lavatories shall be provided with thermostatic mixing valves to limit the outlet temperature to a maximum of 110-degrees. Insulation kits shall be provided at all ADA lavatories at the supplies, stops, p-trap and tailpiece.

Replace plumbing fixtures and floor drains which are heavily corroded and exceeded their useful service life.

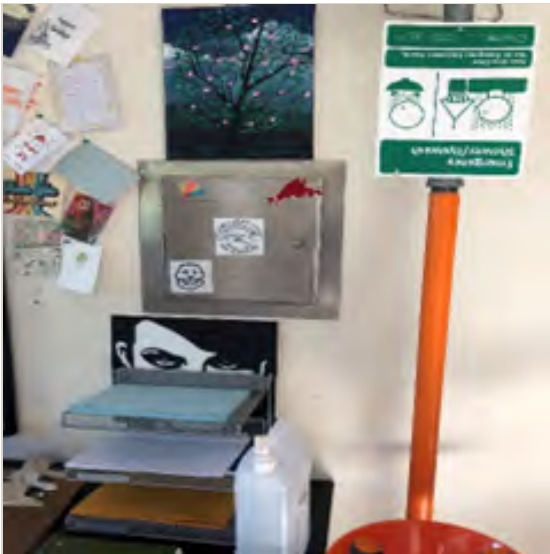
Recommendations  
The existing gas isolation valves located in each of the science classrooms are in a surface mounted cabinet with a hinged door. The Massachusetts Plumbing Code requires the gas valves to be readily accessible which would prevent the use of the cabinet door.

PL-4: Gas Valve Cabinet

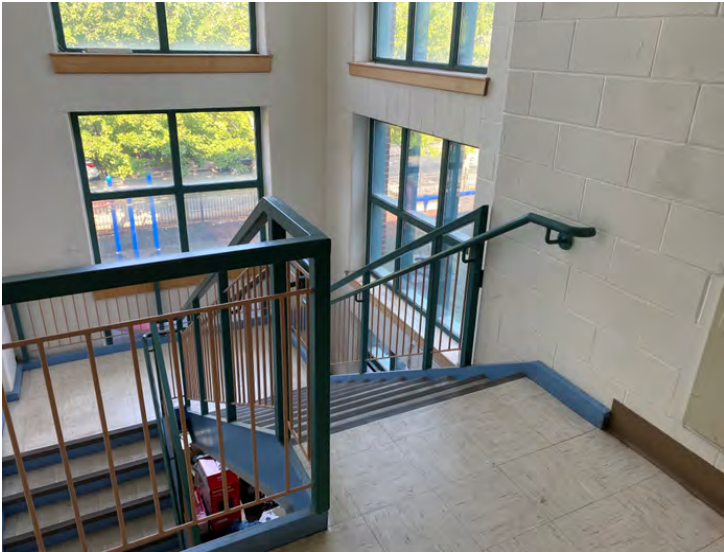
Typical Egress Stair

There are four primary egress stairs serving the second floor and multiple exterior egress doors from the first floor. No hazardous egress conditions were noted during the site visit. Illuminated exit signs and emergency lighting appear to be provided throughout.

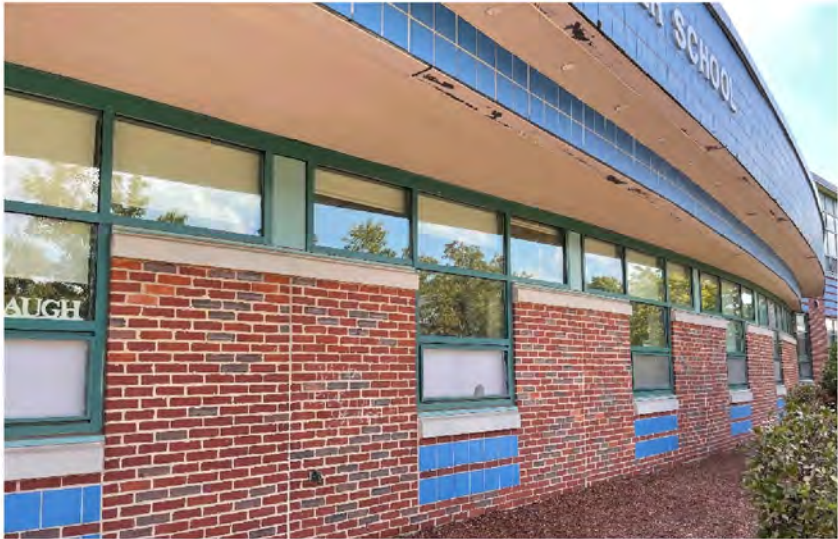
AE-9: Representative brick veneer, precast bands and aluminum windows

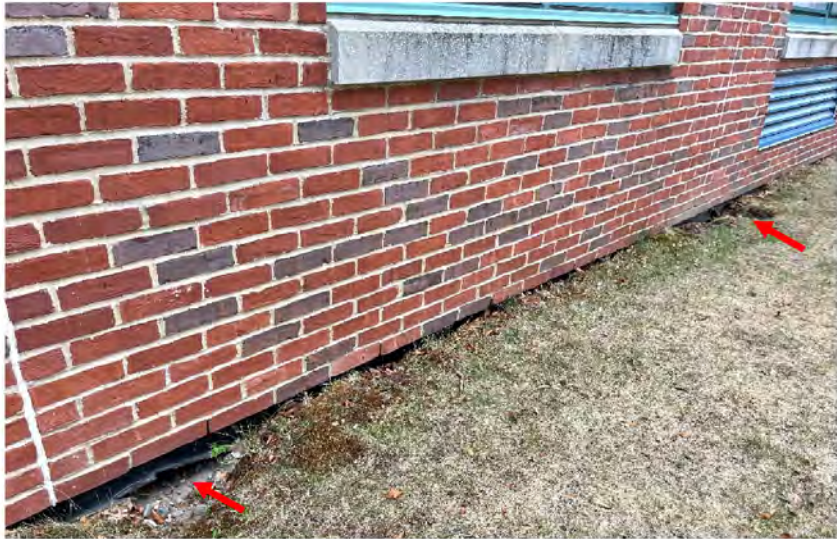
AE-21: Base of North Elevation where there is a cavity below the façade / building and rodents reportedly burrow and nest.

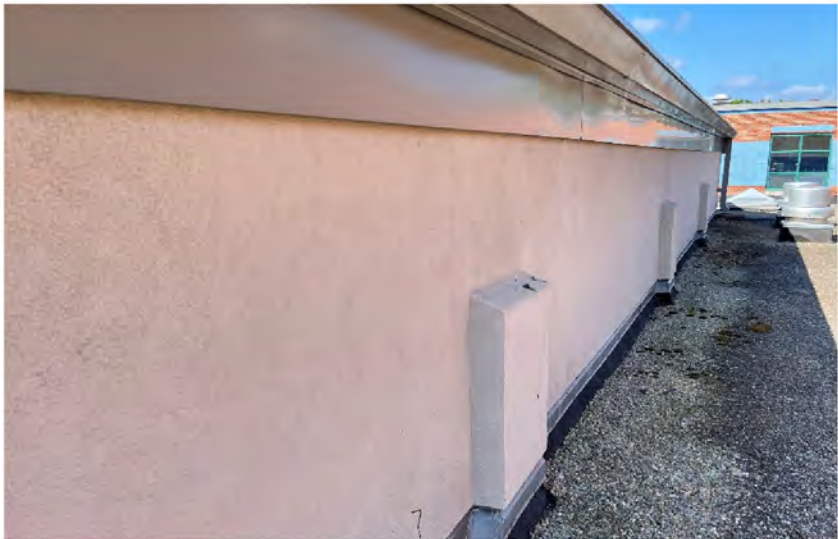
AE-27: Representative stucco façade above roof

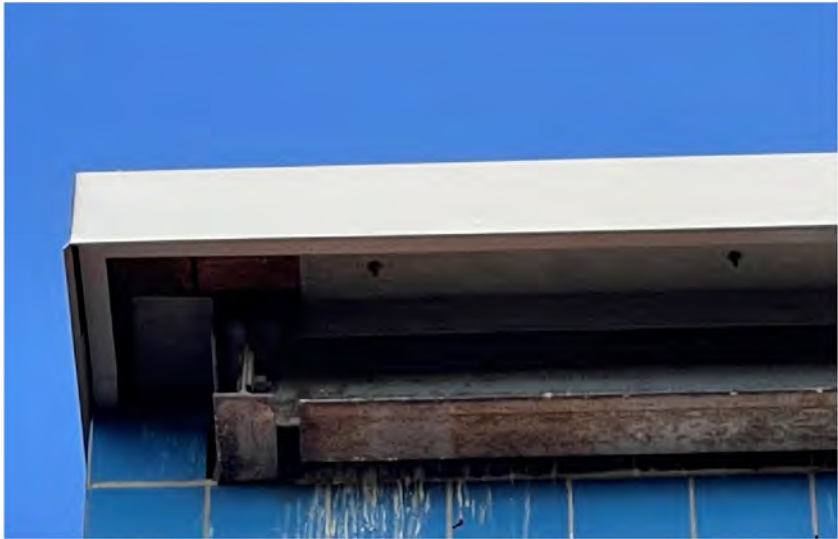
AE-33: Exposed steel beams on West Elevation

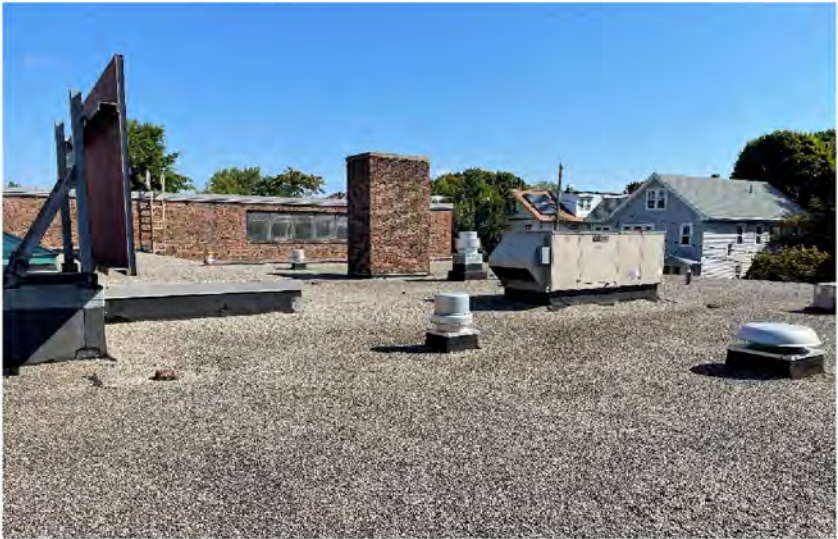
AE-42: Representative view of roofing at West side of building

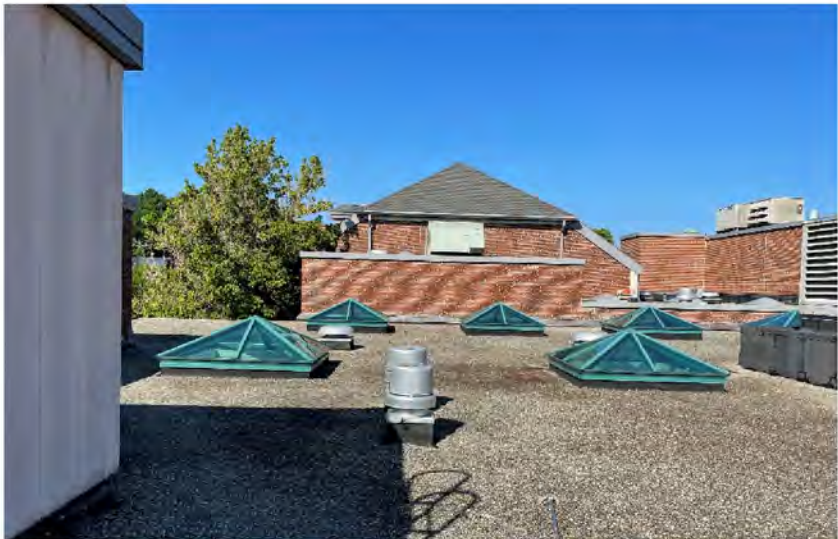
AE-43: General view of roof at center of West wing, typical metal framed skylights.

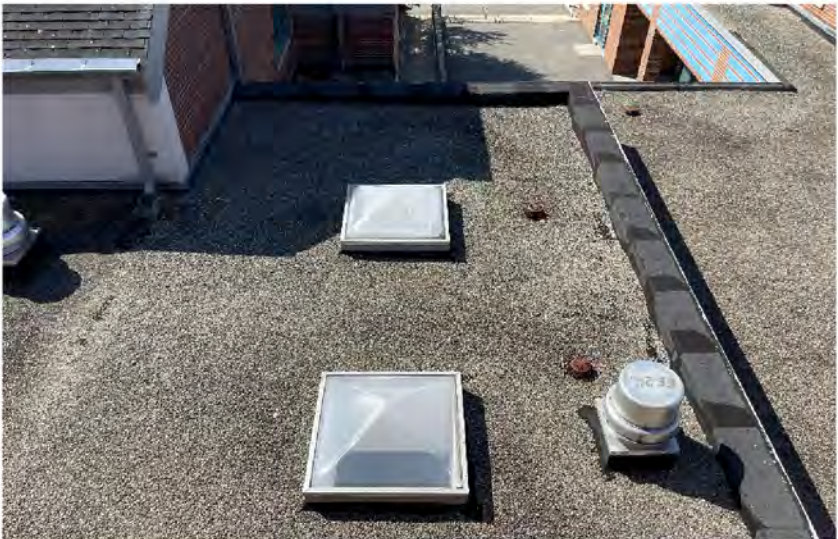
AE-44: General view at center of roof, typical unit skylights.

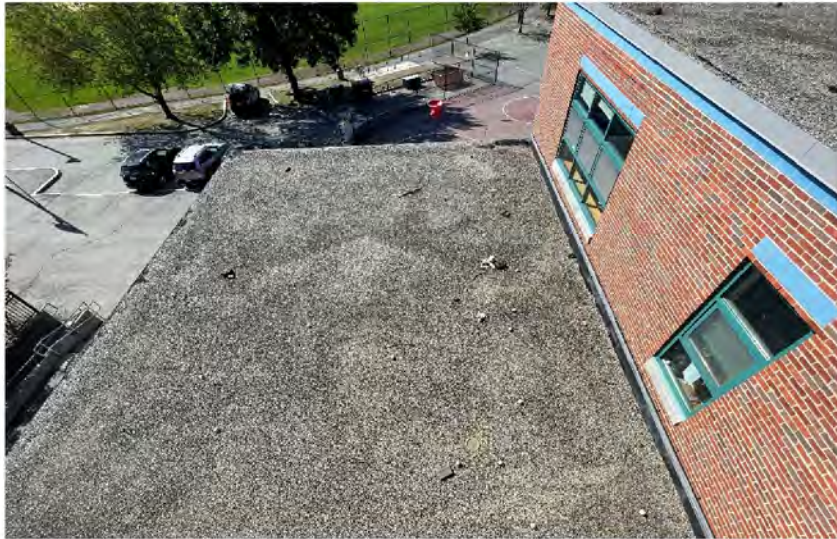
AE-45: View of low roof at Southeast corner of building

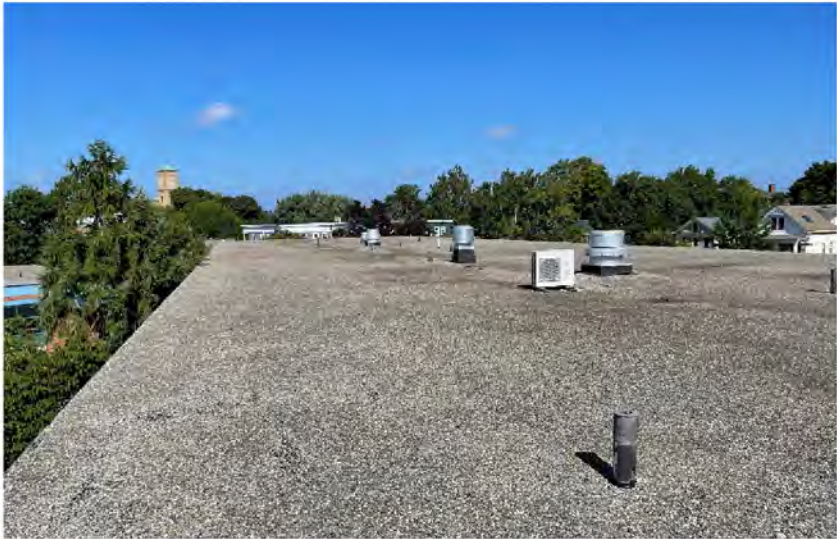
AE-46: View of roof along North end of building

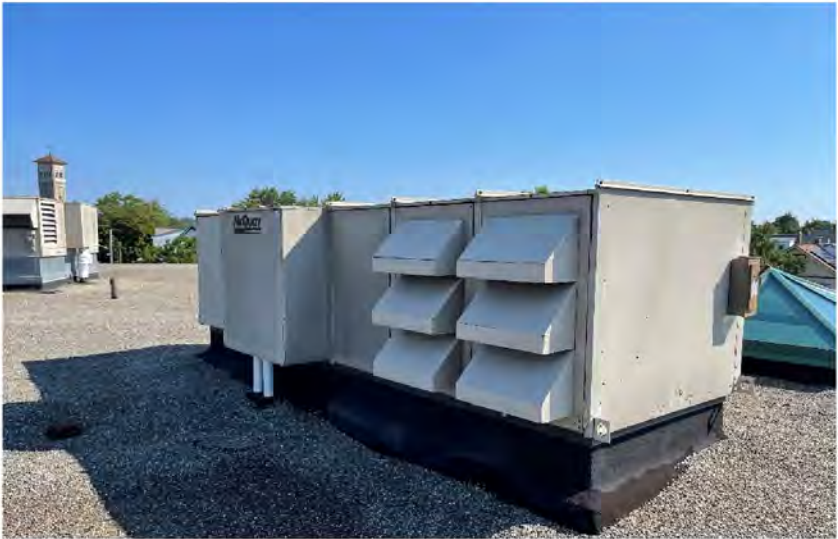
AE-50: Typical MEP unit on curb.

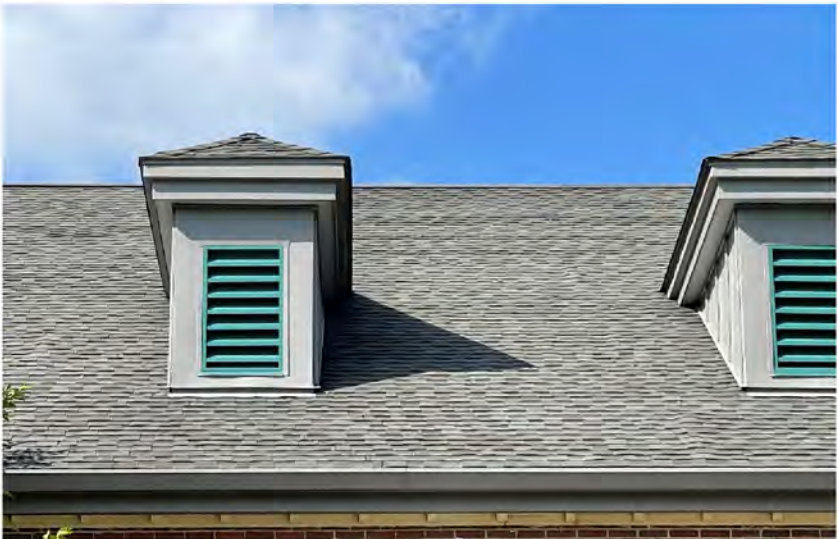
AE-52: Typical asphalt shingled roof and dormer assemblies.

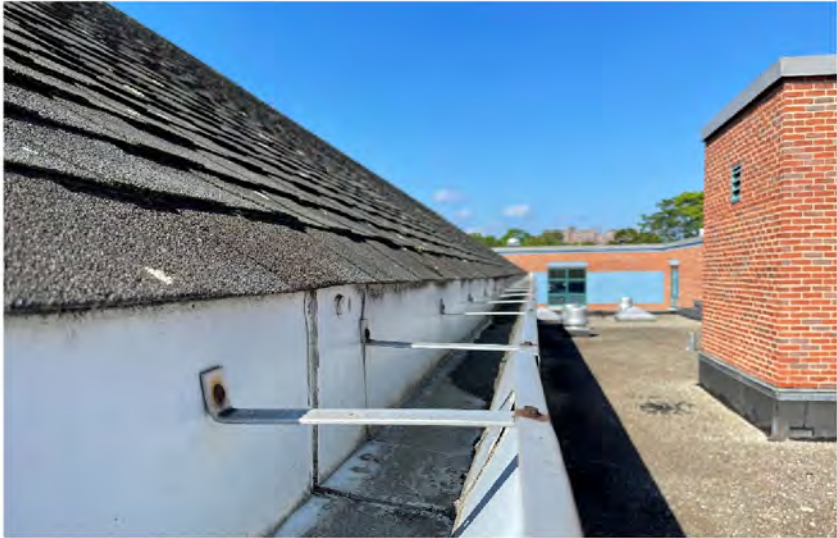
AE-54: Representative aluminum gutter along base of shingled roof.
