Crivitz School District

District-wide Facilities Study

STUDY DOCUMENT

November, 2023

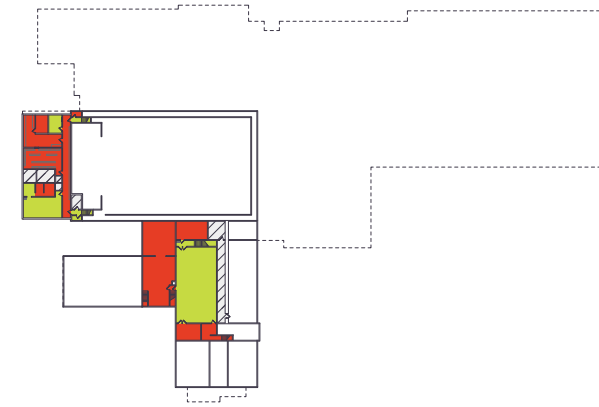
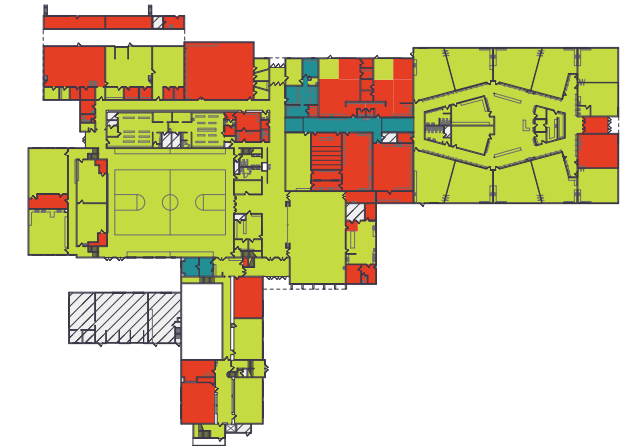
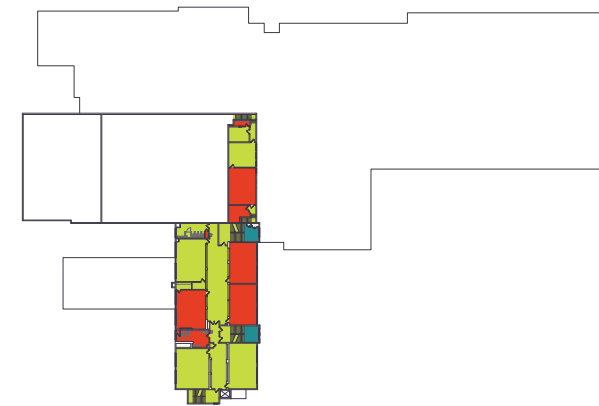
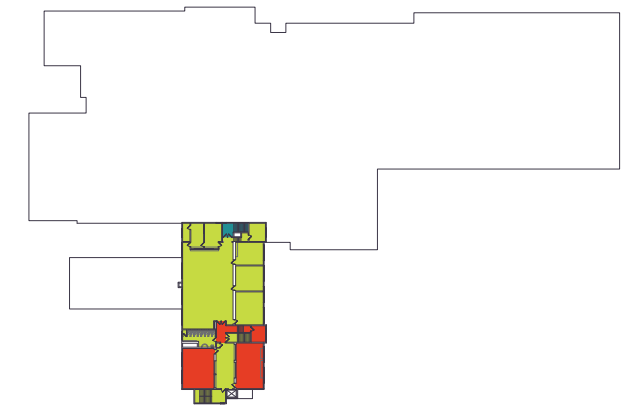
crivitz elementary flooring analysis

- Materials identified as potentially containing asbestos are considered to be in poor condition.
- 9" x 9" vinyl tile flooring is identified as potential asbestos tile.
- Concrete flooring and stairs located in lower level are in poor condition due to cracking, staining, and peeling paint.
- Vinyl Composite Tile (VCT) located in the southern vestibule of the 1968 Addition is in poor condition due to cracking.

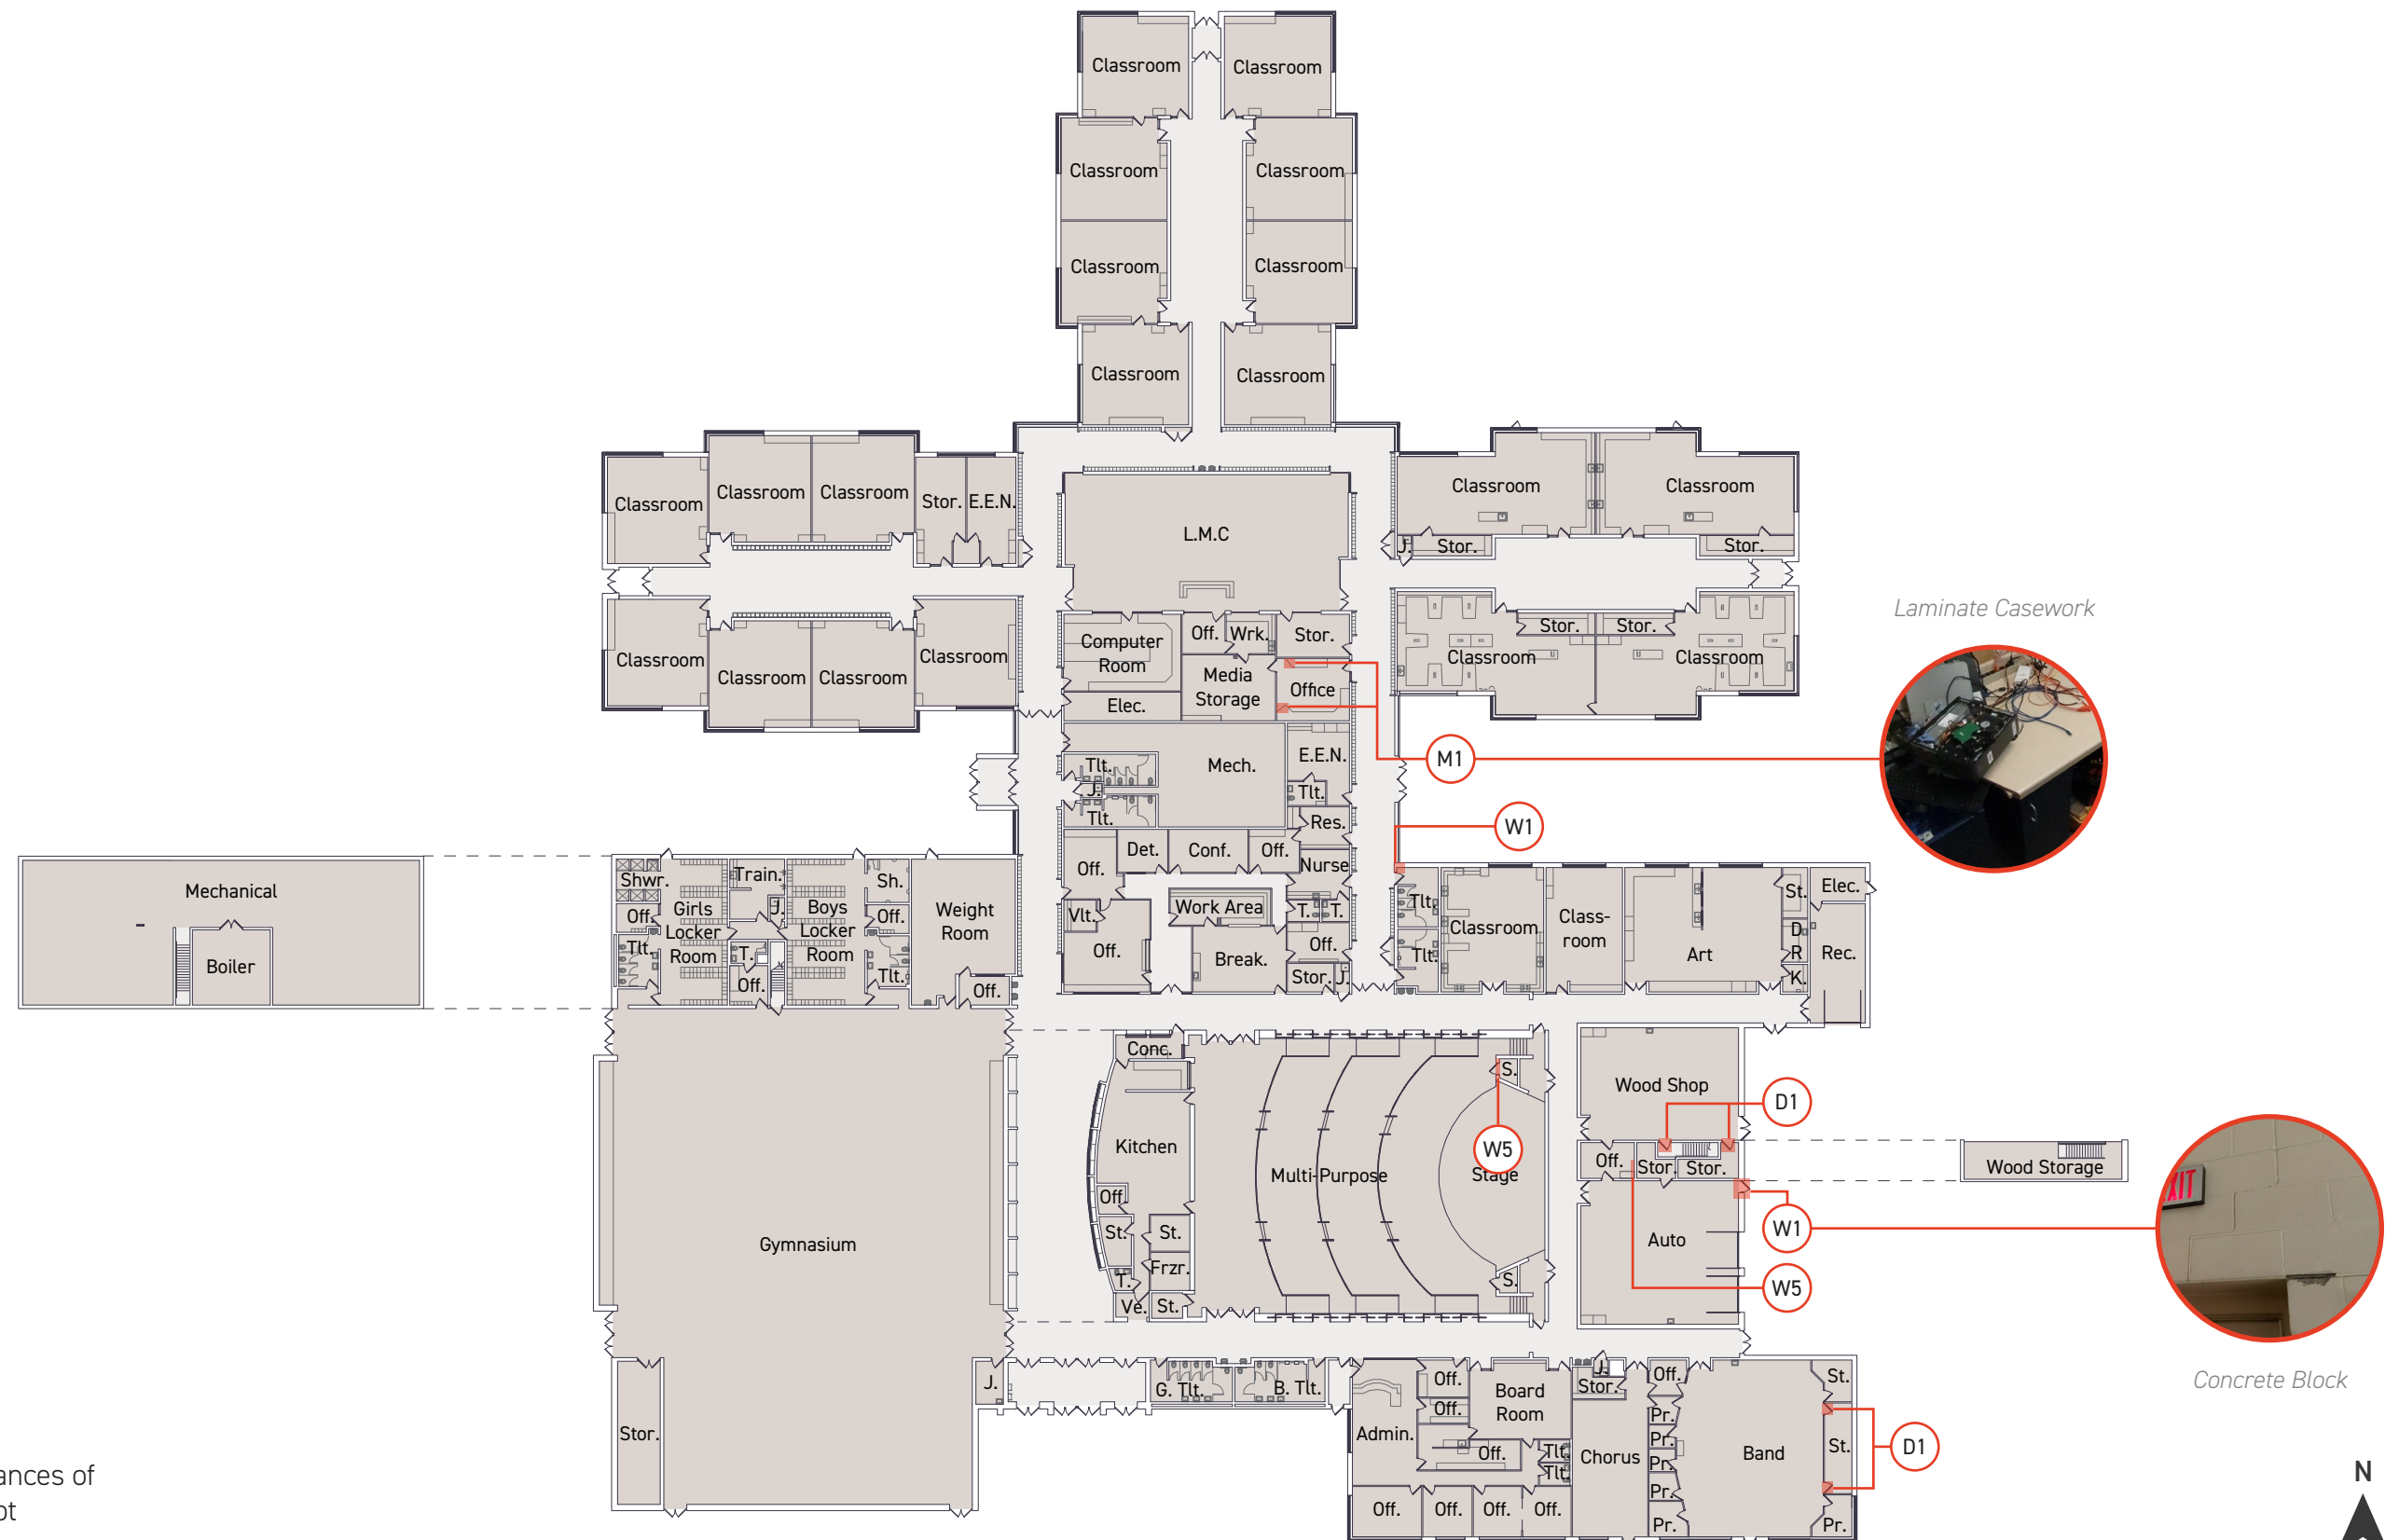
- There are instances of laminate casework in poor condition due to an exposed edge with no finish.
- Majority of concrete blocks are in fair condition. There are two instances of concrete block walls in poor condition due to cracking.
- Vinyl base located in the northeast storage room of the multi-purpose room is in poor condition due to peeling.
- There are instances of wood doors with hollow metal frames in poor condition due to closing improperly and striking the outside of the door jamb.

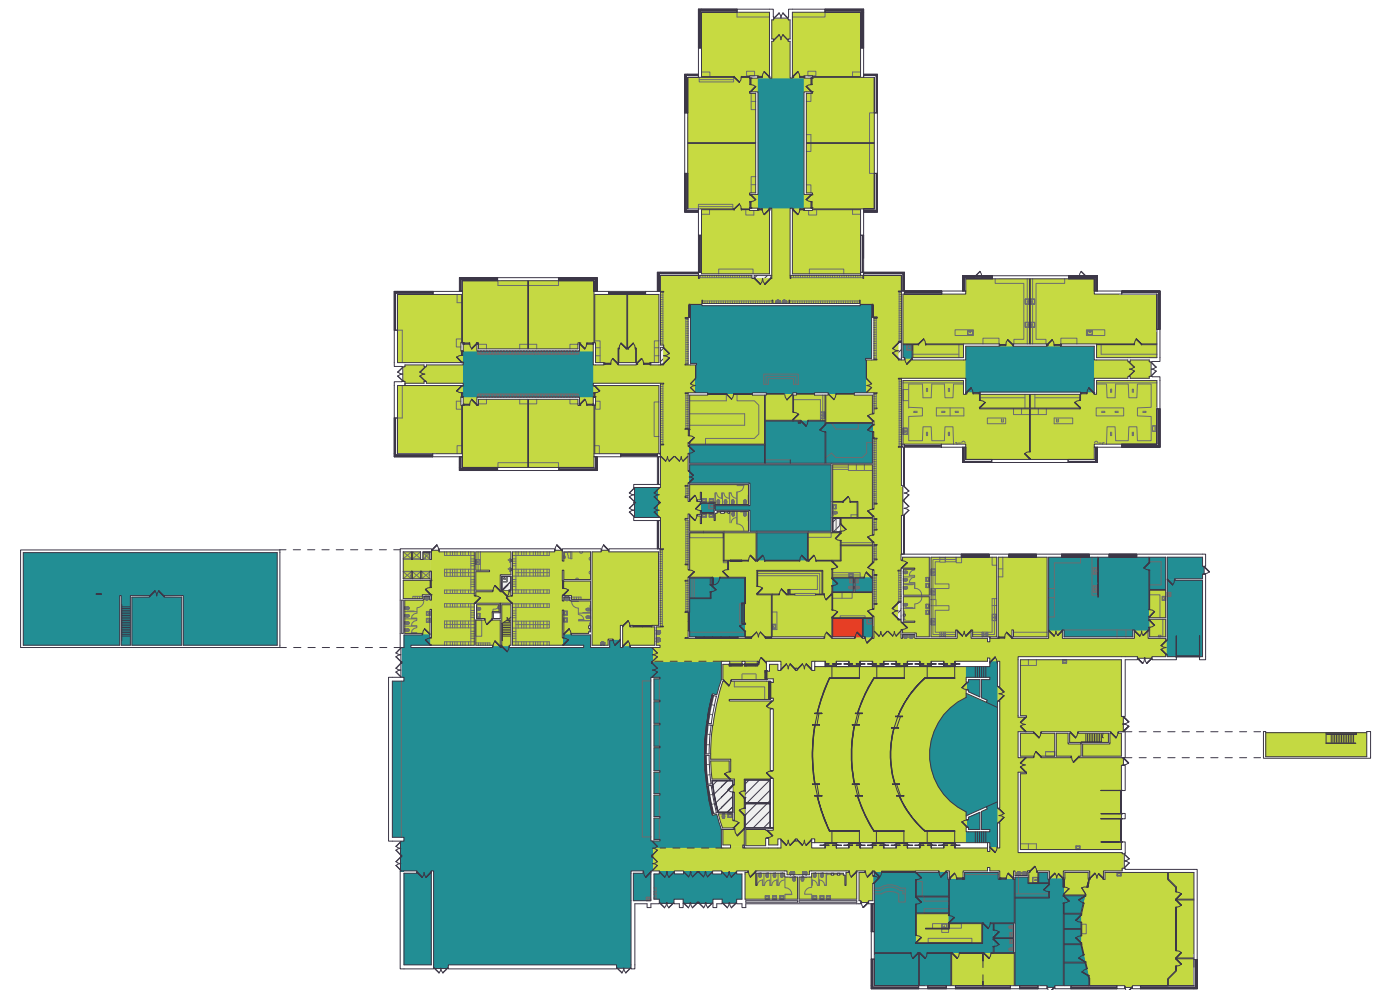
First Floor

- Majority of the acoustical ceiling tile (ACT) is in fair condition due to minor instances of staining.
- Acoustical ceiling tile (ACT) located in storage room north of the multi-purpose room is in poor condition due to staining.
- Majority of the exposed metal deck throughout the building is in good condition.

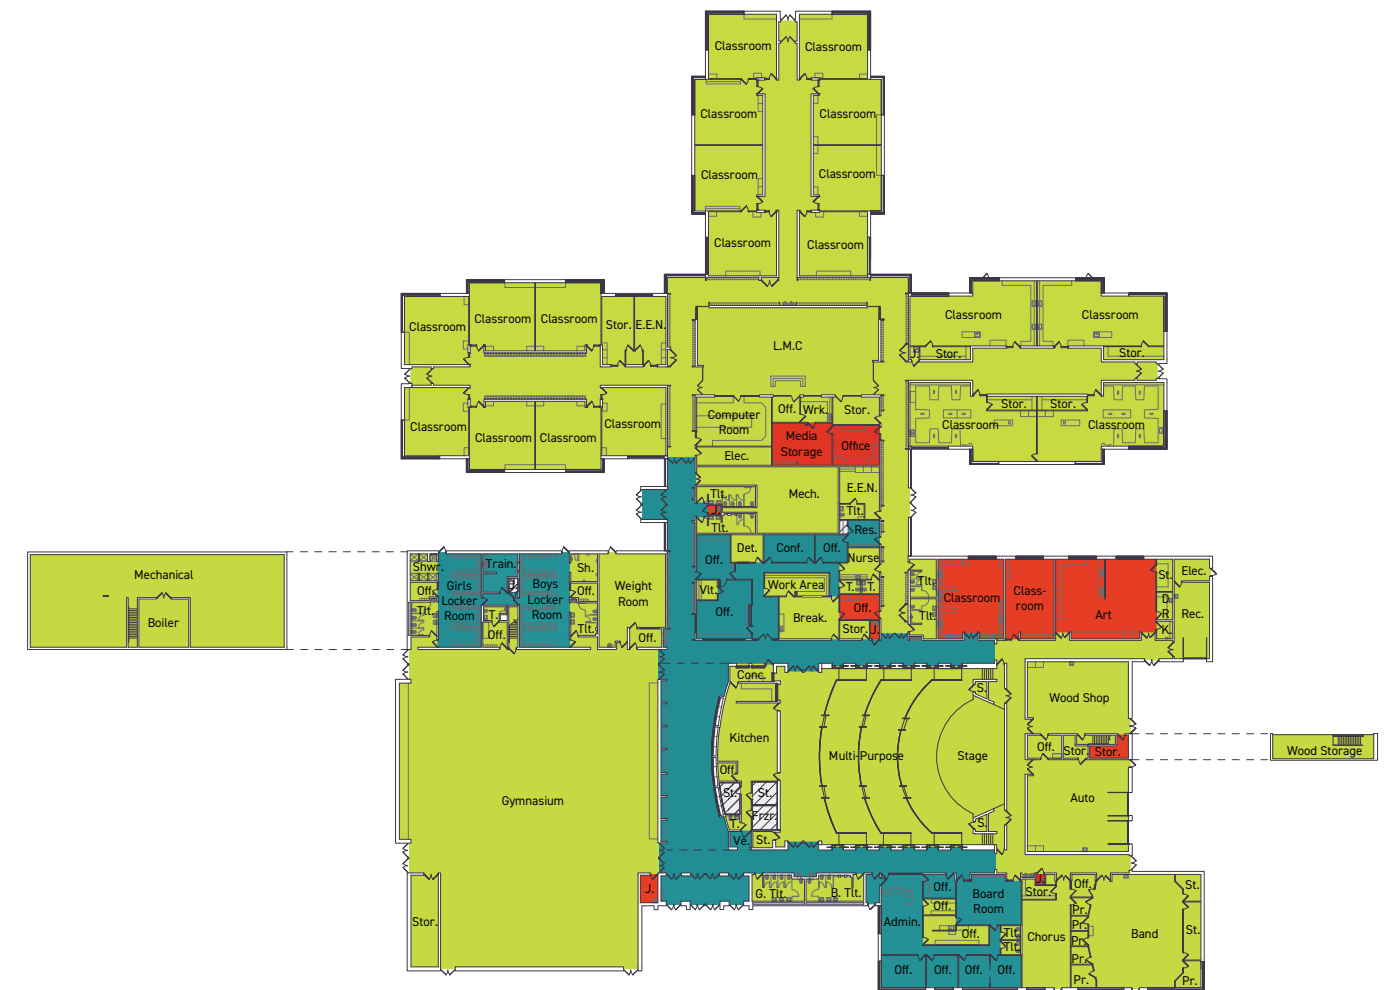
First Floor

- The vinyl composite tile (VCT) floor in the art room is in poor condition due to large gaps between tiles, chipping, and peeling.
- There is an instance of carpet in poor condition due to excessive wear.
- Majority of vinyl composite tile (VCT) is in fair condition due to minor scratching and wear.

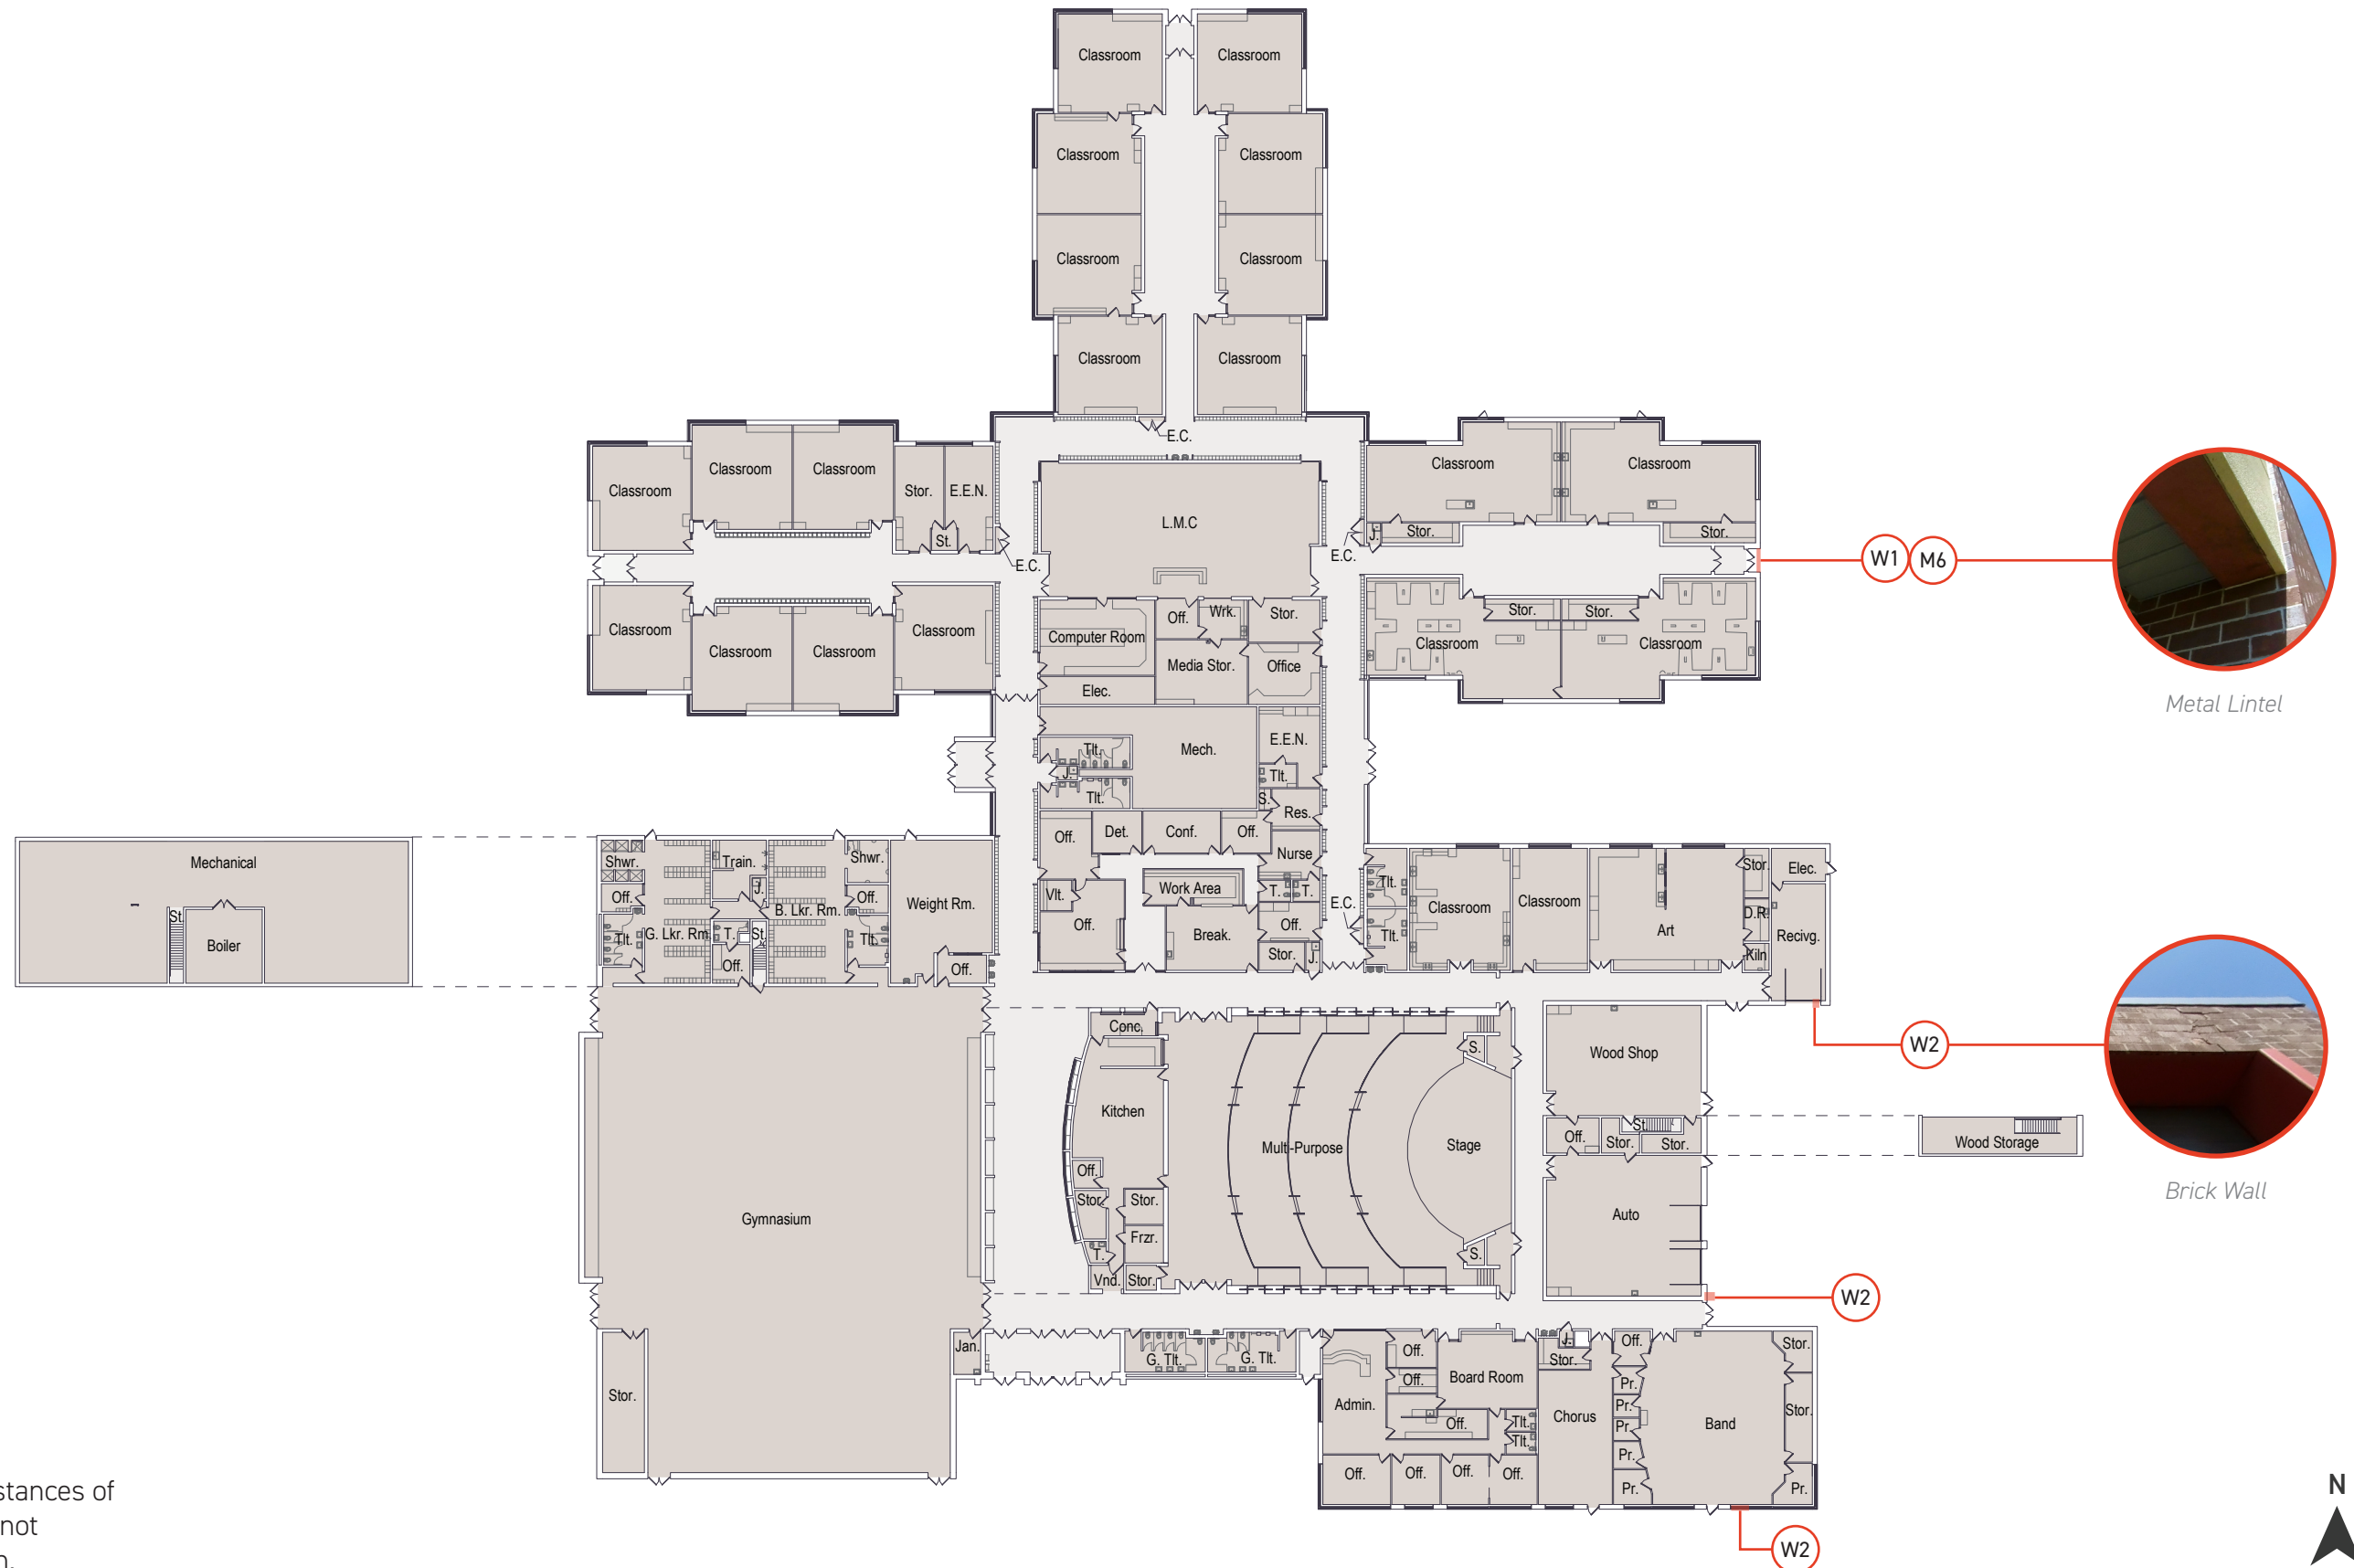
- Majority of the concrete panels are in fair condition due to staining.
- Majority of the metal lintels located above the doors have mild rust starting to form.
- Overall the brick is in fair condition with some isolated incidents of cracking or chipping.

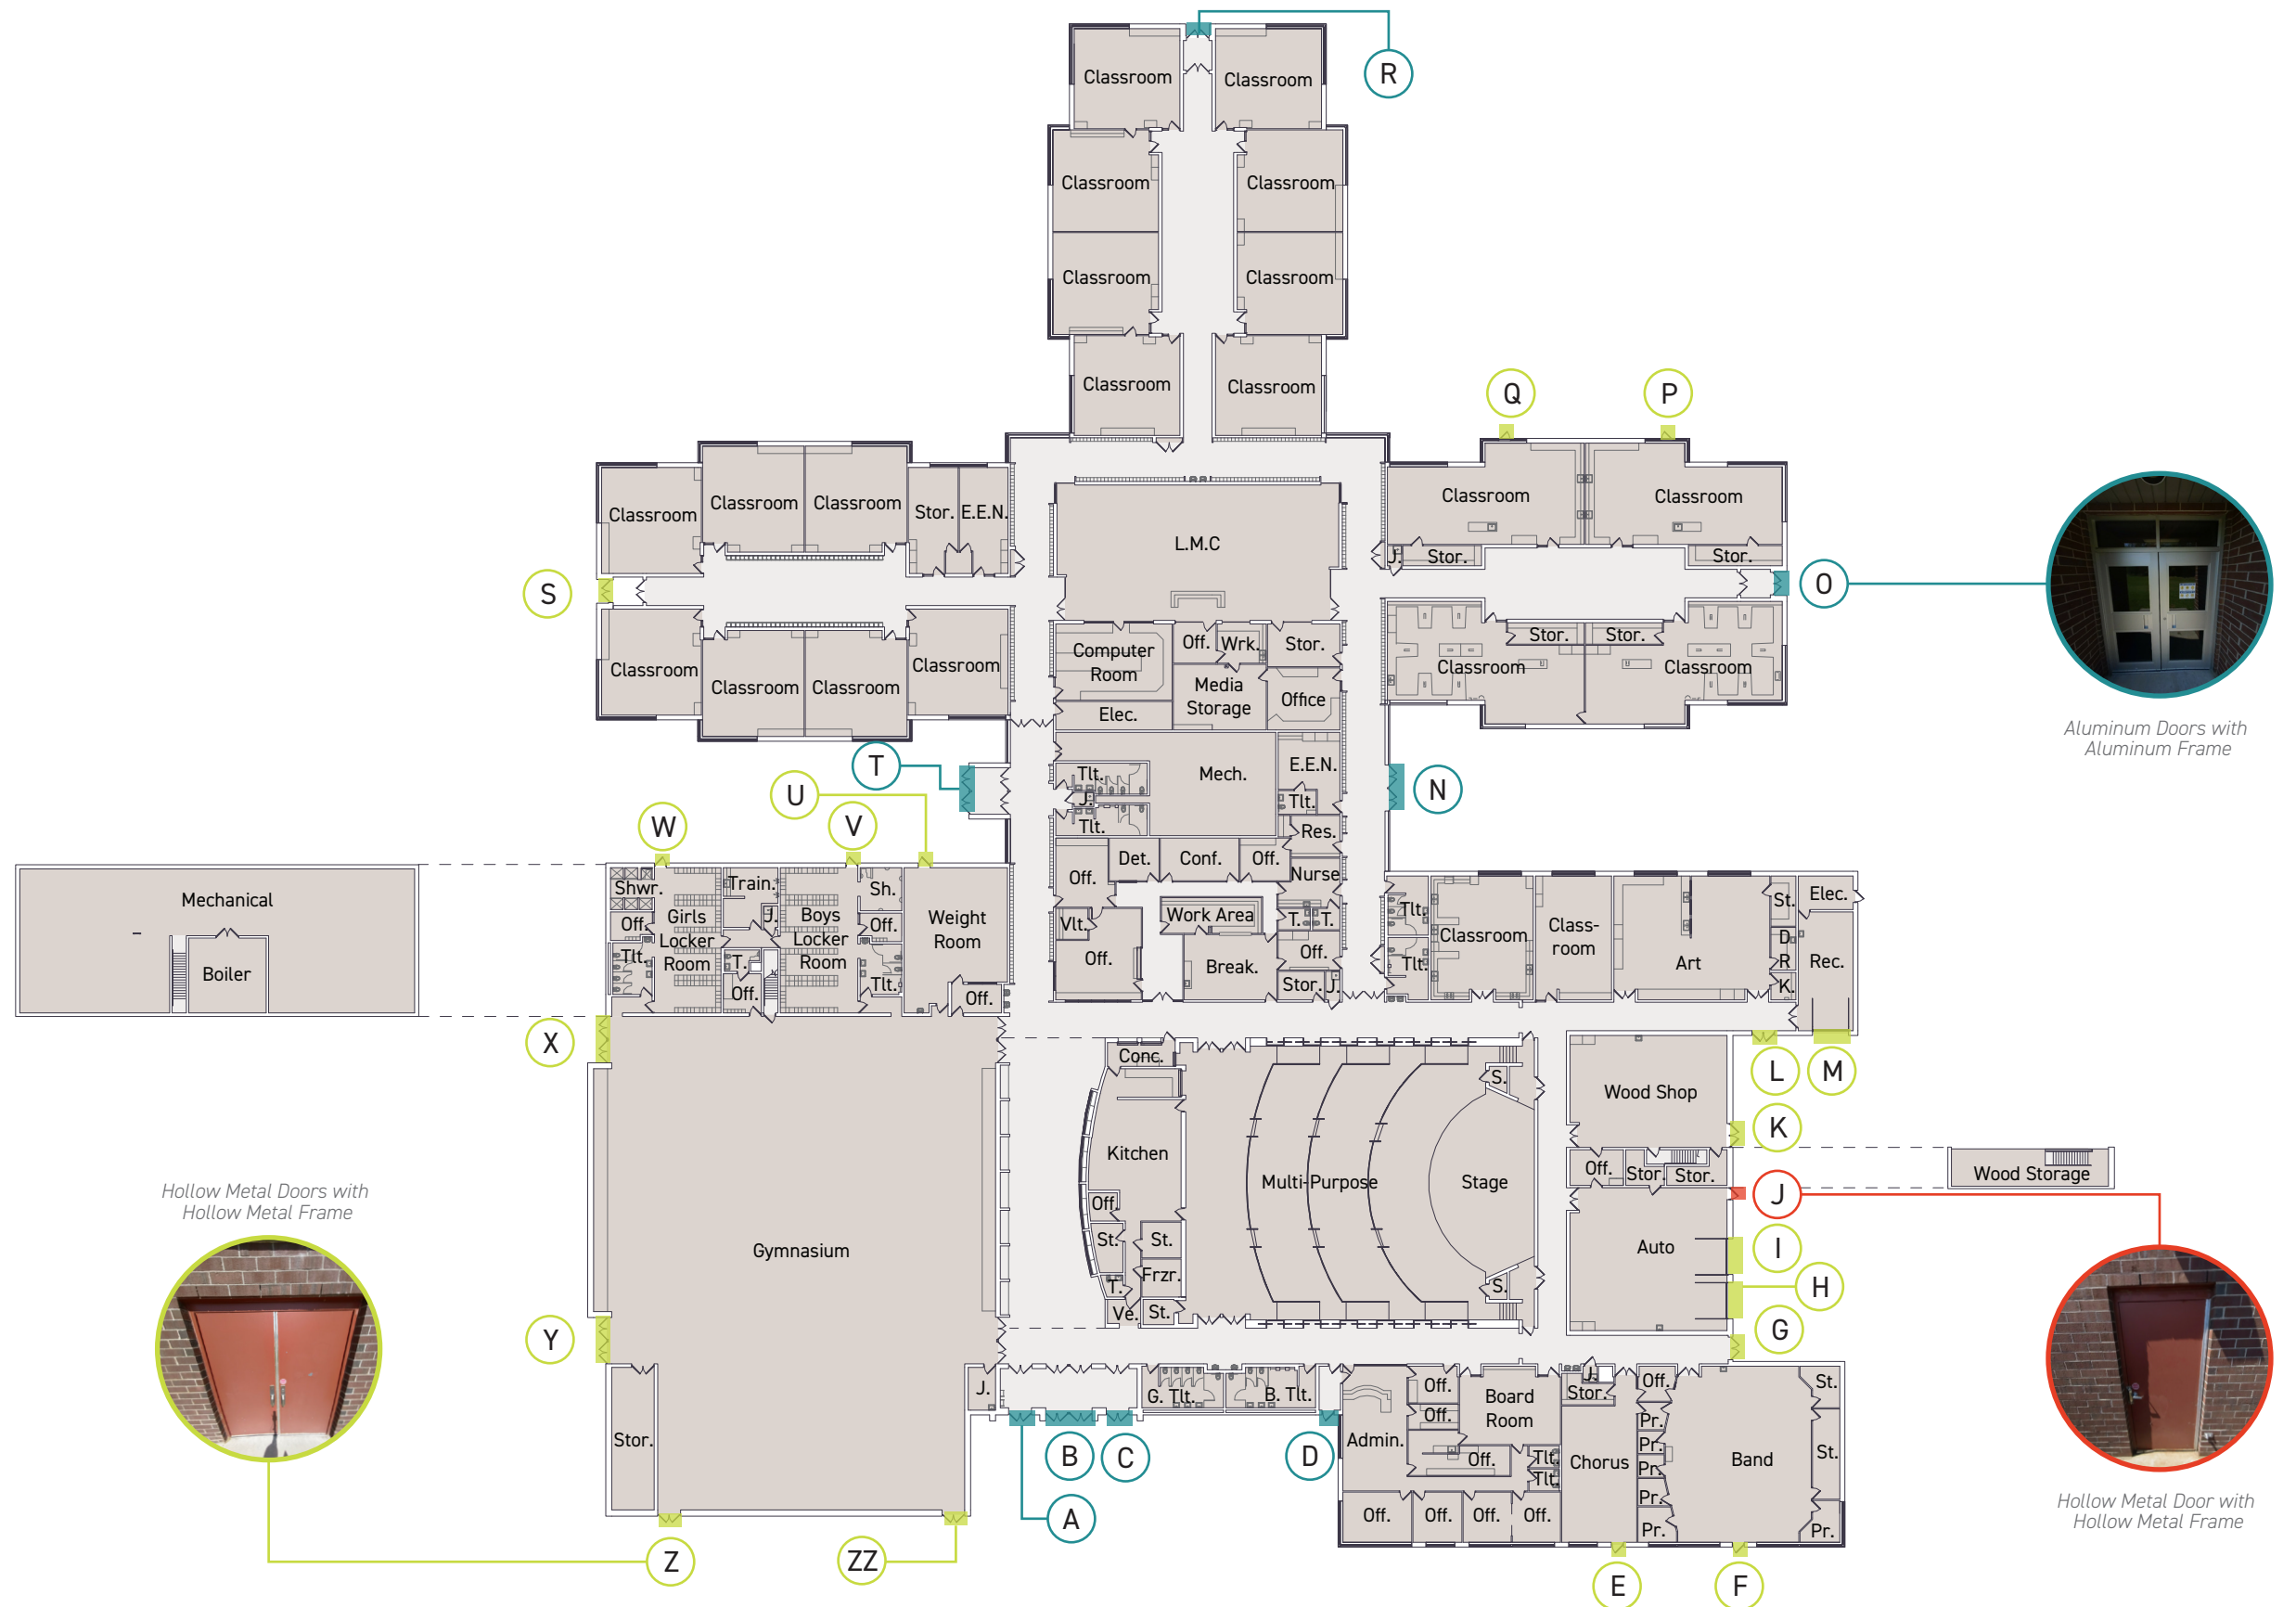
crivitz middle and high school exterior door analysis

- Majority of the hollow metal doors are in fair condition due to minor denting and paint chipping.
- Majority of aluminum doors with aluminum frames are in good condition with no visible wear.
- Door J is in poor condition due to visible rust, peeling finish, and bent drip cap.

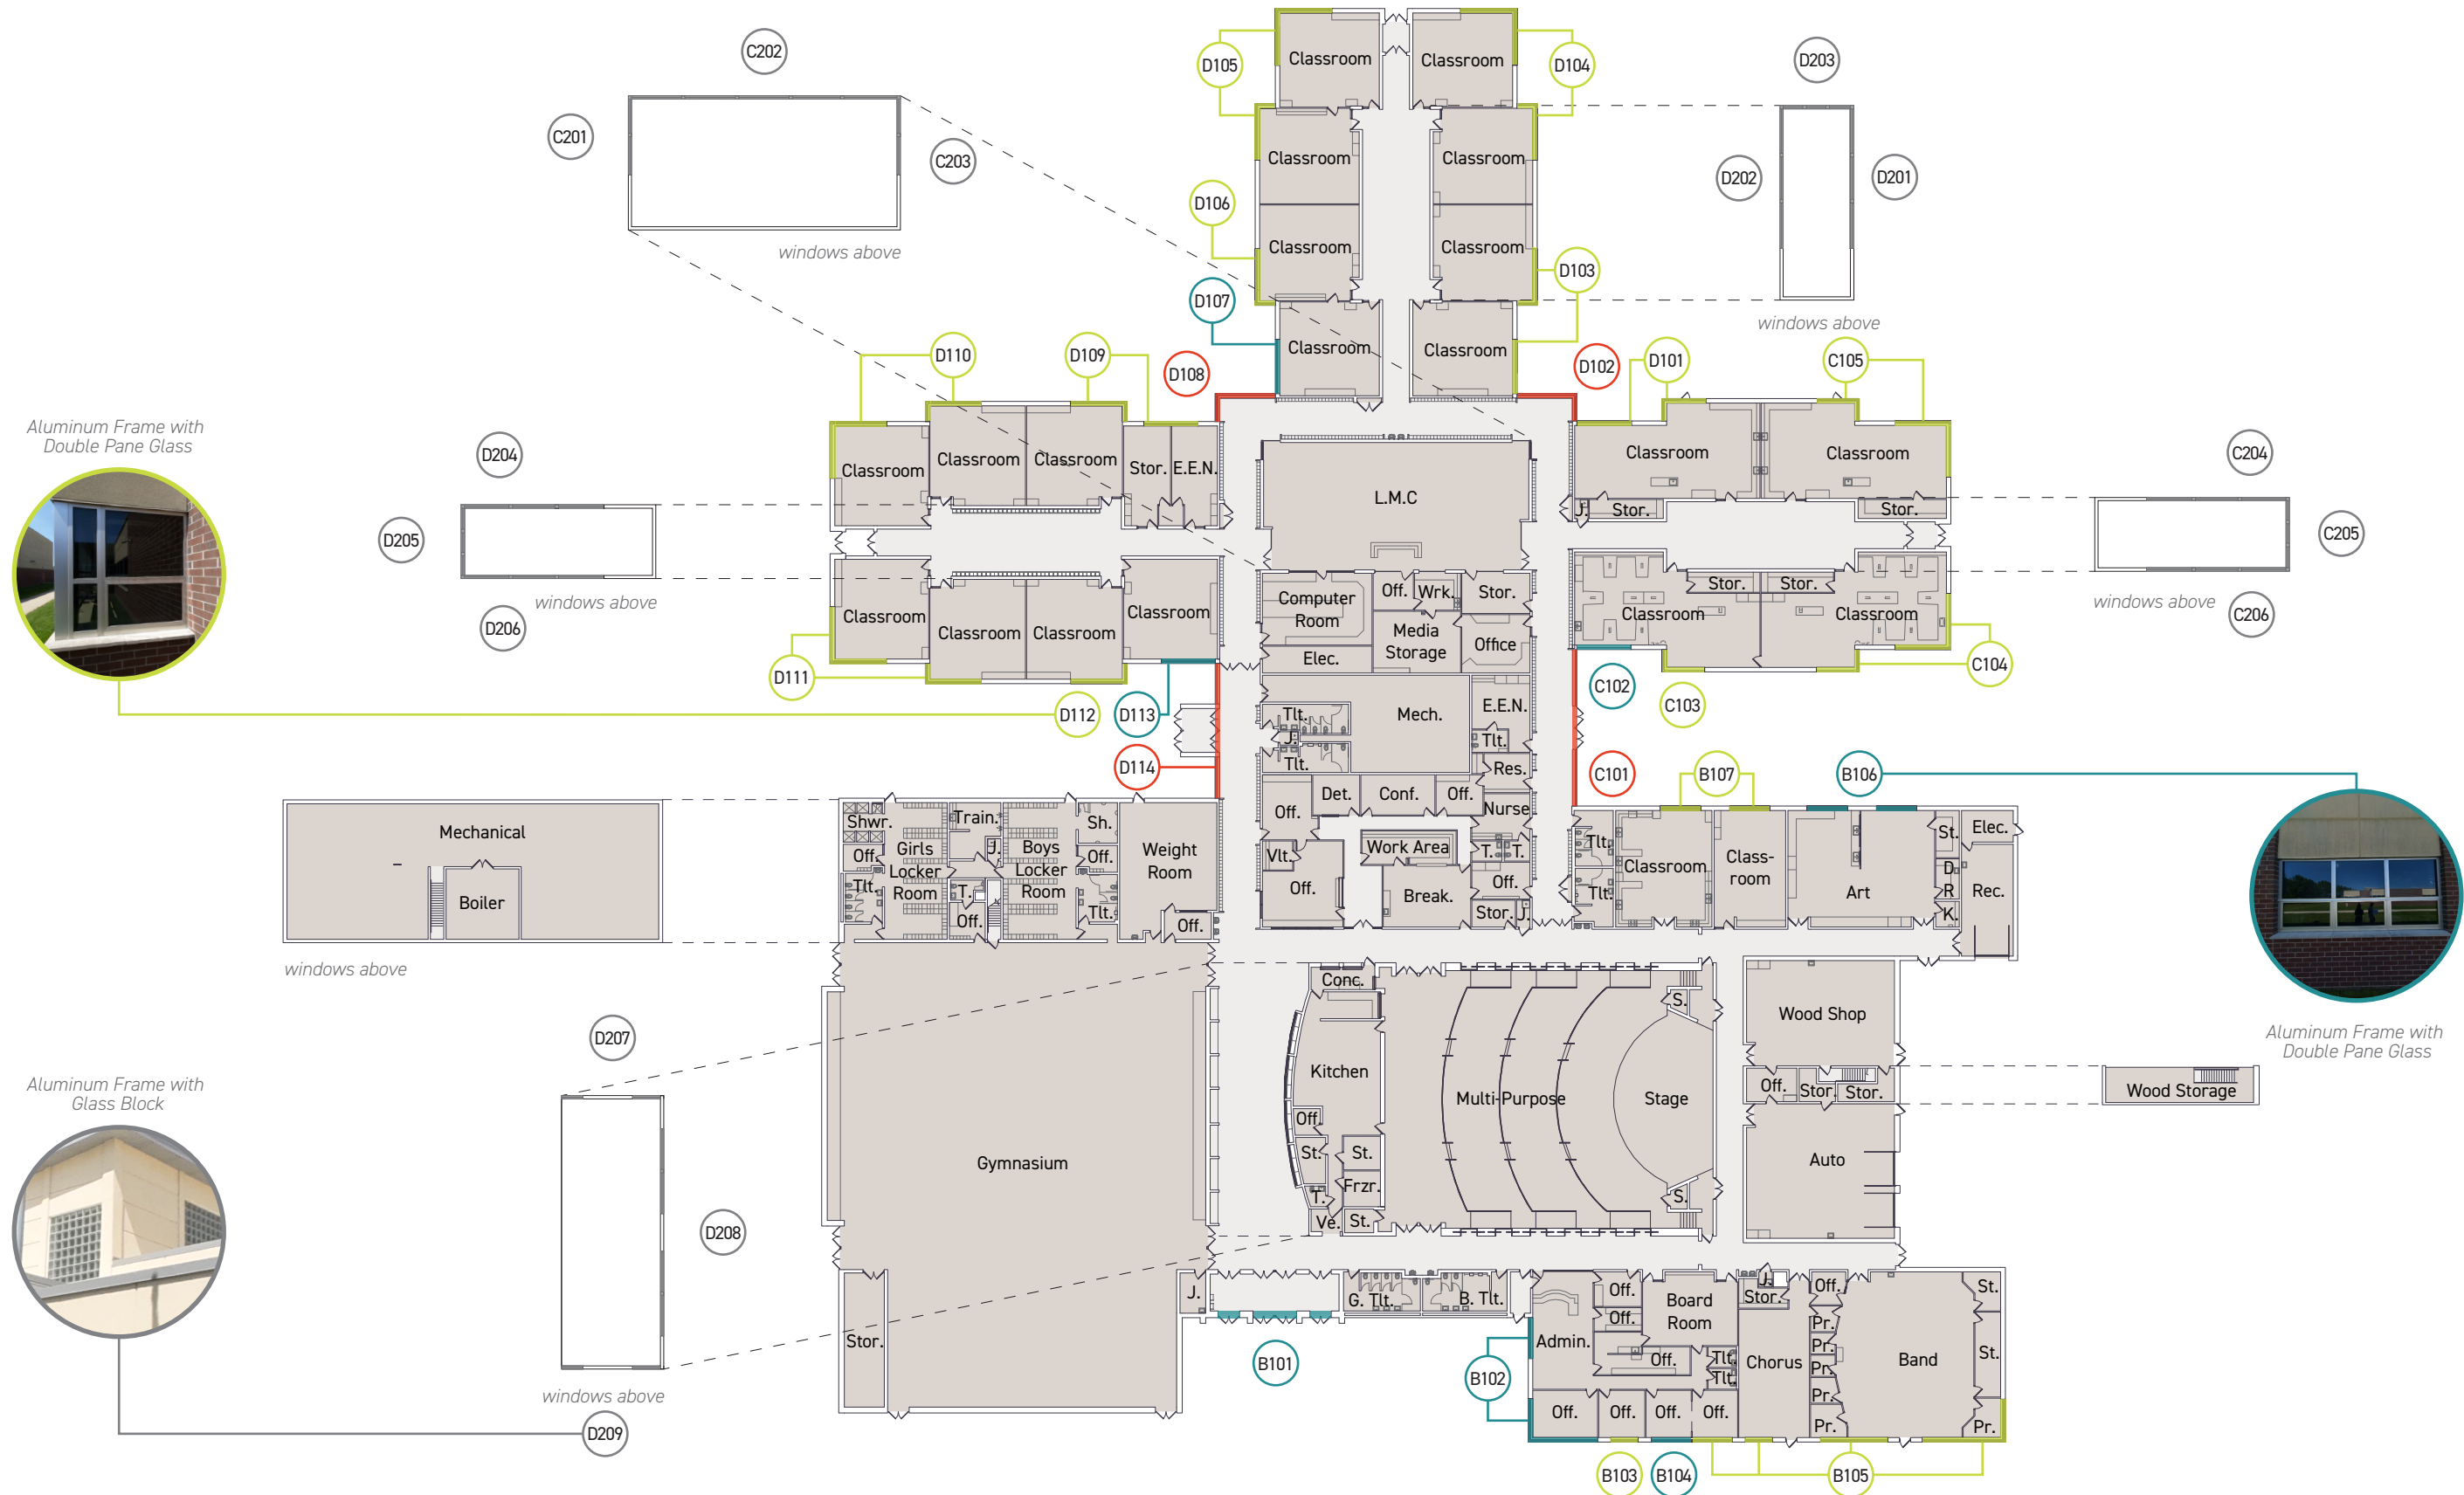
crivitz middle and high school exterior window analysis

- Majority of the aluminum framed windows with double pane glass are in fair condition due to minor staining.
- The condition of the glass block clerestory windows throughout the school is unknown.
