# HAZARDOUS MATERIALS SURVEY REPORT

## FORMER MARSHALL ELEMENTARY SCHOOL LIVONIA, MICHIGAN

December 16, 2025  
NTH Project No. 25002747-01

**RE: Report on Hazardous Materials Survey  
Former Marshall Elementary School  
33901 Curtis Road  
Livonia, Michigan**

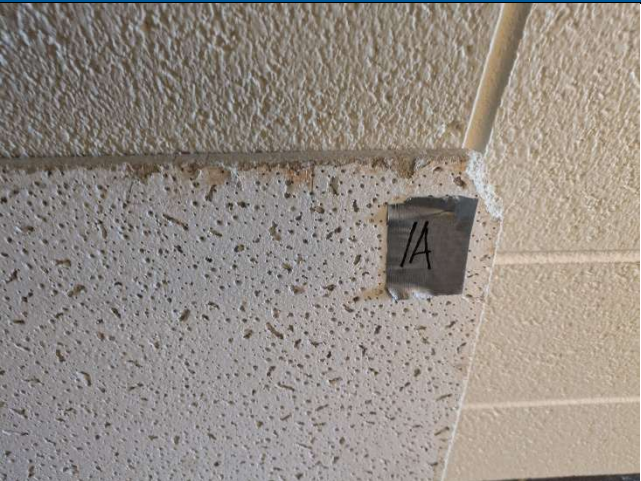
| Asbestos Samples | | | | | |
|---|---|---|---|---|---|
| 1A | 2'x4' Ceiling Tile with dugouts and pinholes | South Corridor, near Room 10 | None Detected | | |

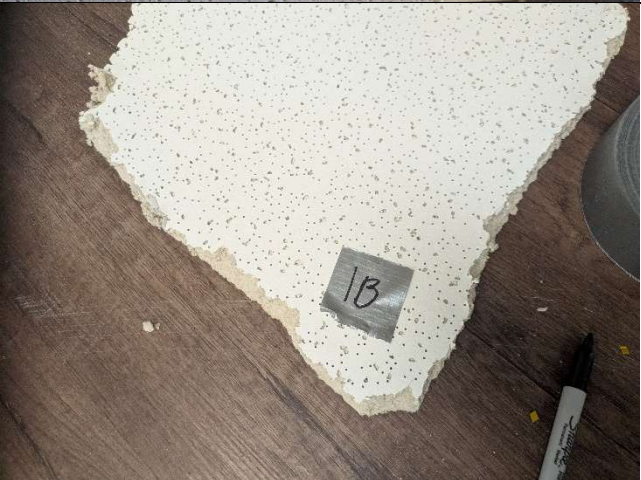
| Asbestos Samples | | | | | |
|---|---|---|---|---|---|
| 1B | | Room 12, SW Corner | None Detected | | |

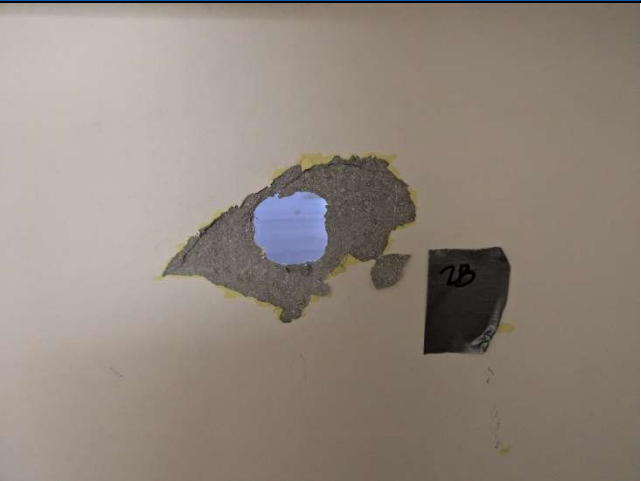
| Asbestos Samples | | | | |
|---|---|---|---|---|
| 2B | | Room 11, at office | Not Analyzed | |

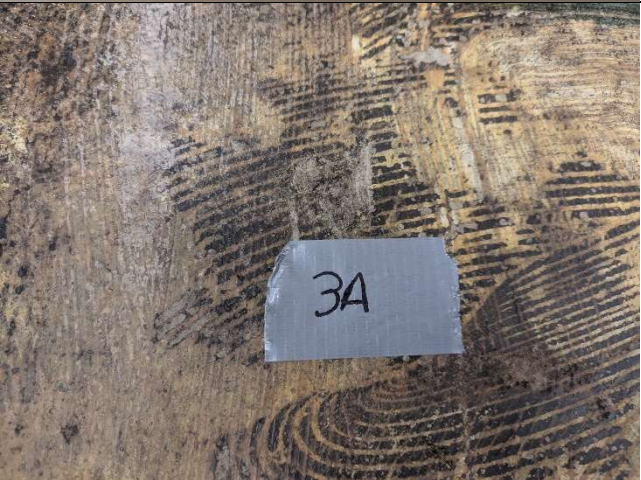
| Asbestos Samples | | | | |
|---|---|---|---|---|
| 3A | Floor Mastic | Room 9, west wall under carpet | None Detected | |

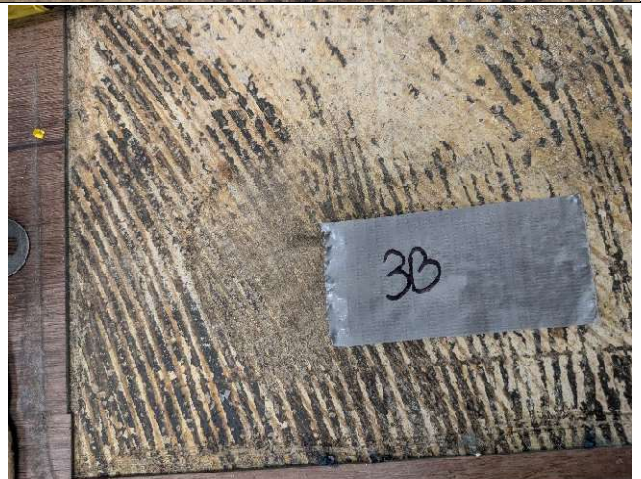
| Asbestos Samples | | | | |
|---|---|---|---|---|
| 3B | | Room 10, west wall under carpet | None Detected | |

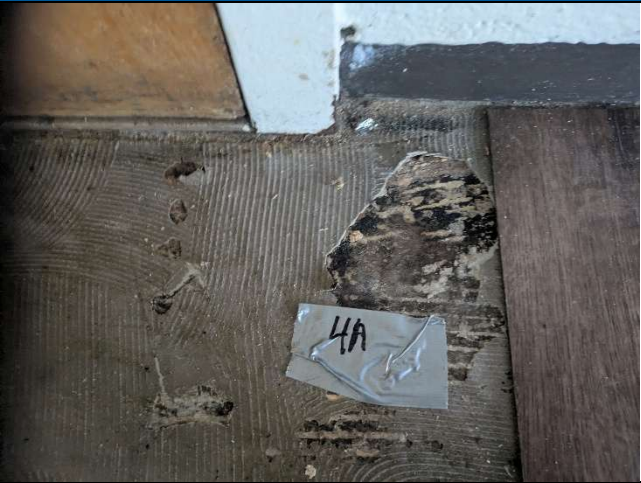
| Asbestos Samples | | | | | |
|---|---|---|---|---|---|
| 4A | Gray Floor Leveler Under Pergo | Room 10, south wall at drinking fountain | None Detected | | |

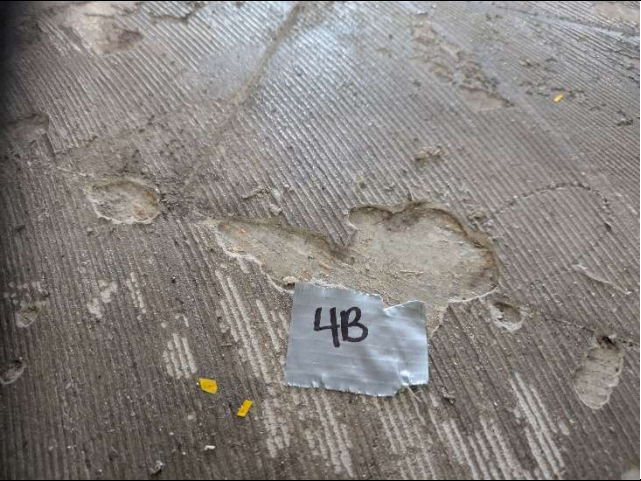
| Asbestos Samples | | | | | |
|---|---|---|---|---|---|
| 4B | | Room 11, middle | None Detected | | |

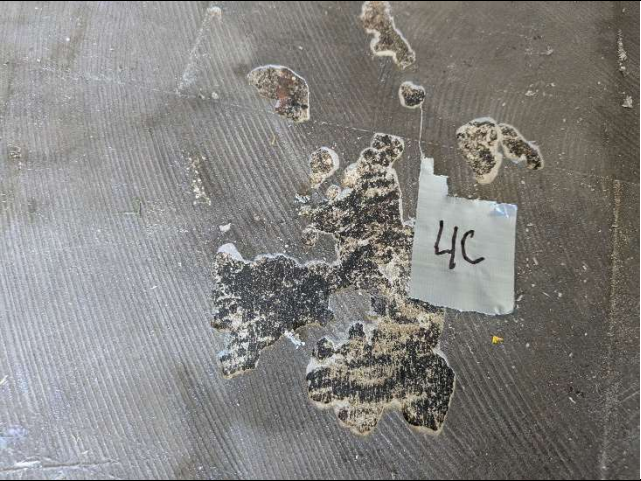
| Asbestos Samples | | | | | |
|---|---|---|---|---|---|
| 4C | | Room 18, middle | None Detected | | |

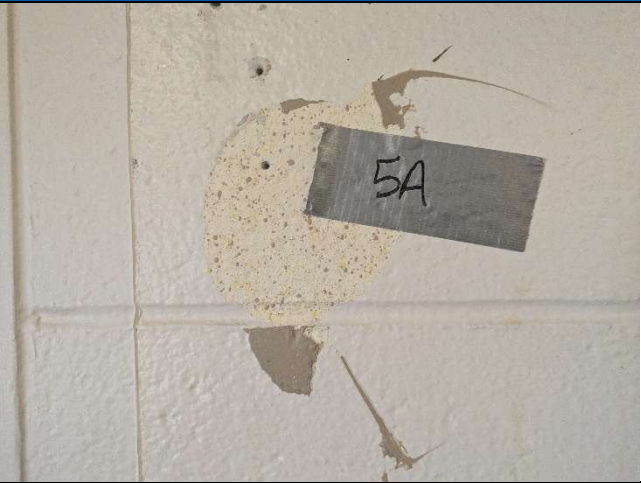
| Asbestos Samples | | | | |
|---|---|---|---|---|
| 5A | Mirror or bulletin board glue pod | Room 9, North wall near boys' bathroom | None Detected | |

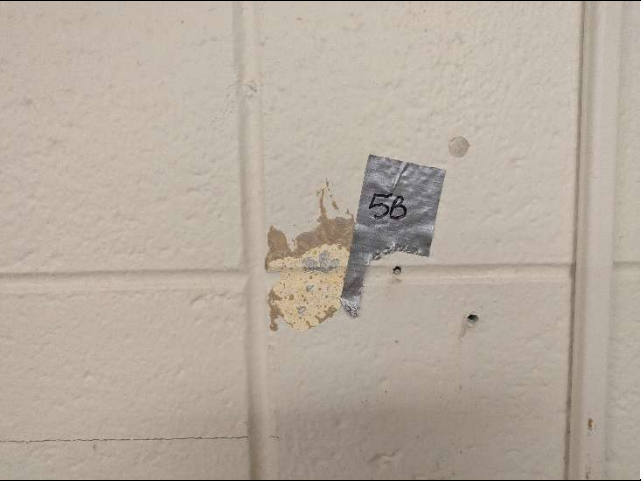
| Asbestos Samples | | | | |
|---|---|---|---|---|
| 5B | | Room 12, west wall at sink area | None Detected | |

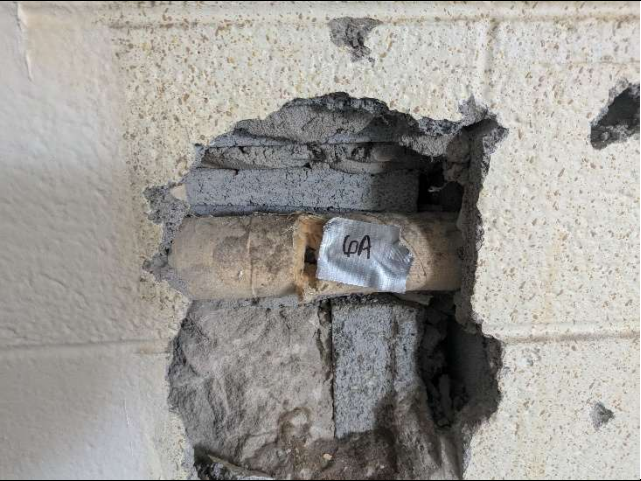
| Asbestos Samples | | | | |
|---|---|---|---|---|
| 6A | Fiberglass insulation | Room 10, South side at sink area | None Detected | |

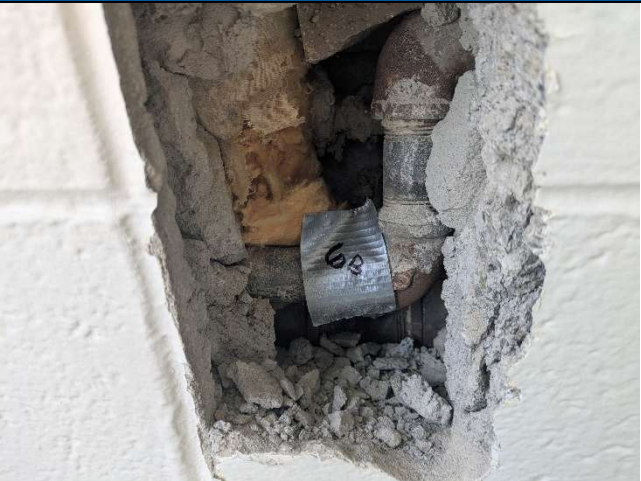
| Asbestos Samples | | | | |
|---|---|---|---|---|
| 6B | | South corridor chase, south end | None Detected | |

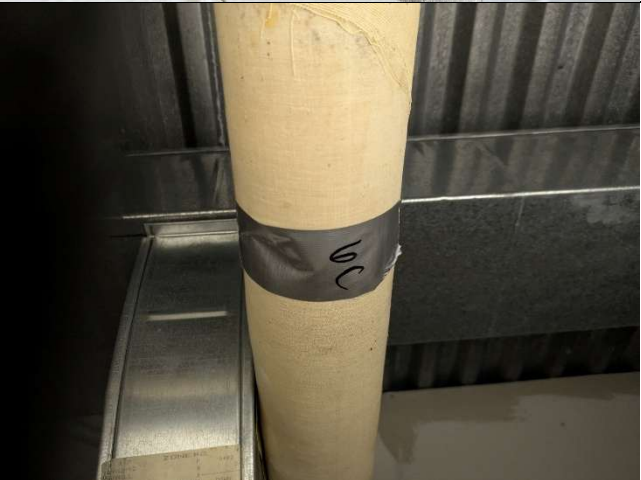
| Asbestos Samples | | | | |
|---|---|---|---|---|
| 6C | | Storage room across from Office 30 | None Detected | |

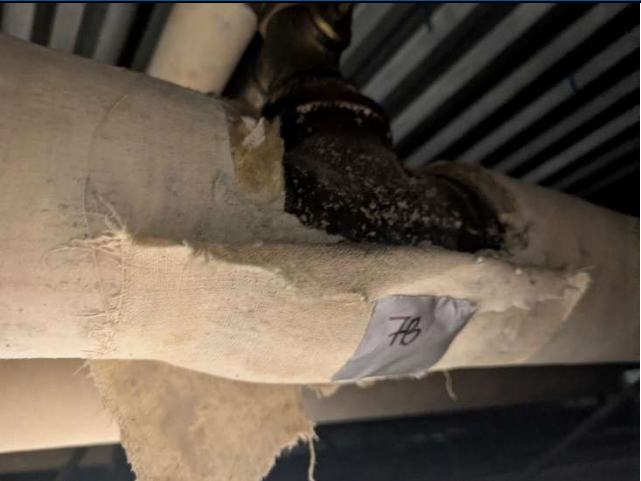
| Asbestos Samples | | | | |
|---|---|---|---|---|
| 7B | | Room 12, near bathrooms | None Detected | |

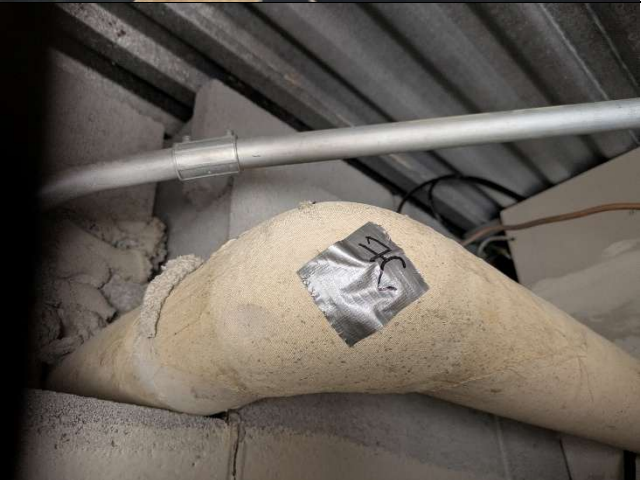
| Asbestos Samples | | | | |
|---|---|---|---|---|
| 7C | | Storage room across from Office 30 | None Detected | |

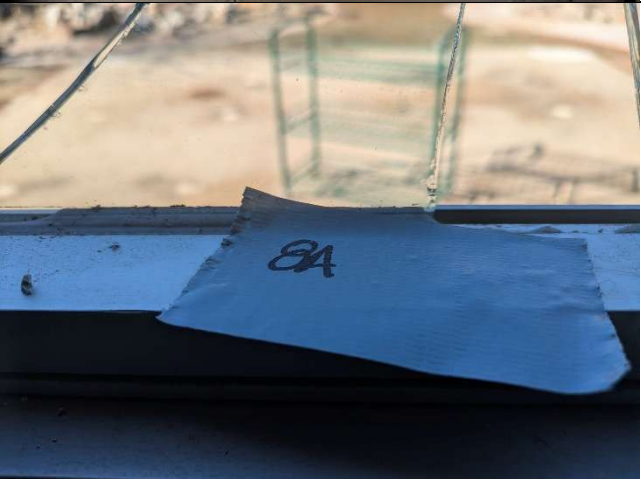
| Asbestos Samples | | | | |
|---|---|---|---|---|
| 8A | Interior window glaze | Room 9, west side | None Detected | |

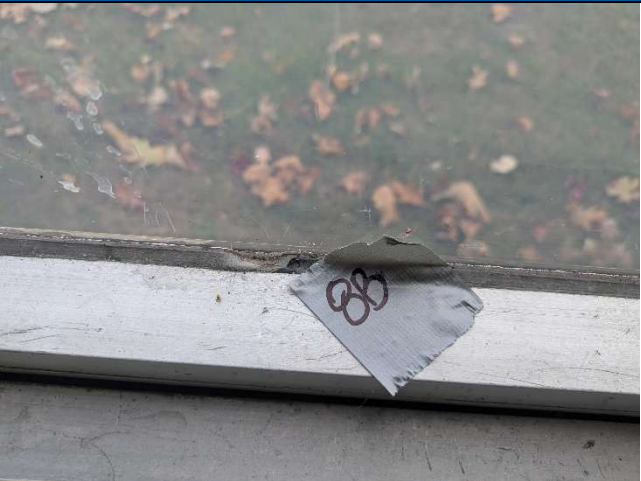
| Asbestos Samples | | | | |
|---|---|---|---|---|
| 8B | | Room 7, east side | None Detected | |

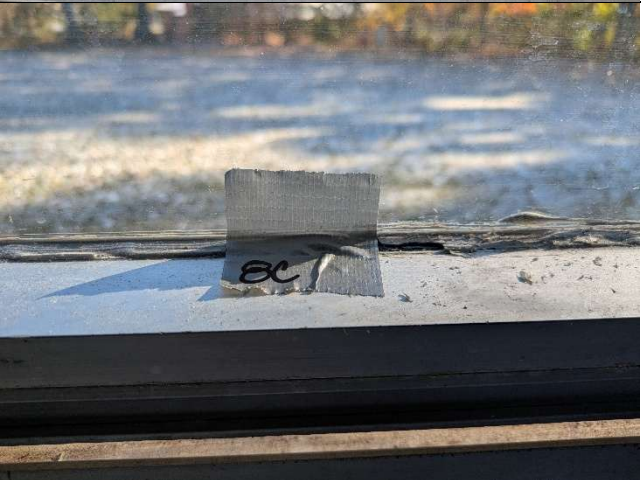
| Asbestos Samples | | | | |
|---|---|---|---|---|
| 8C | | Room 16, east side | None Detected | |

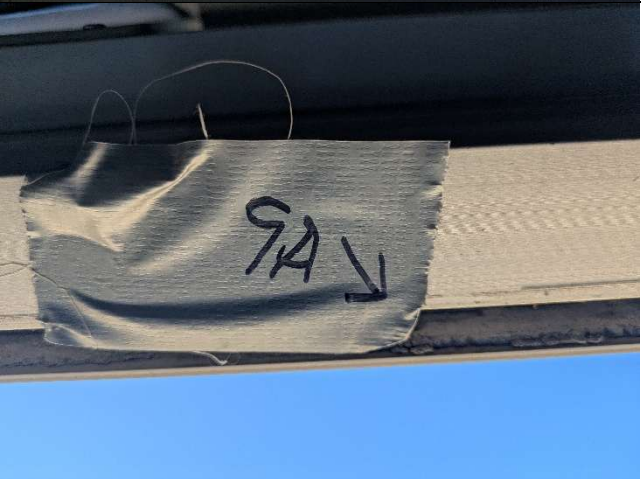
| Asbestos Samples | | | | |
|---|---|---|---|---|
| 9A | Thin white window glaze | Room 10, west side | None Detected | |

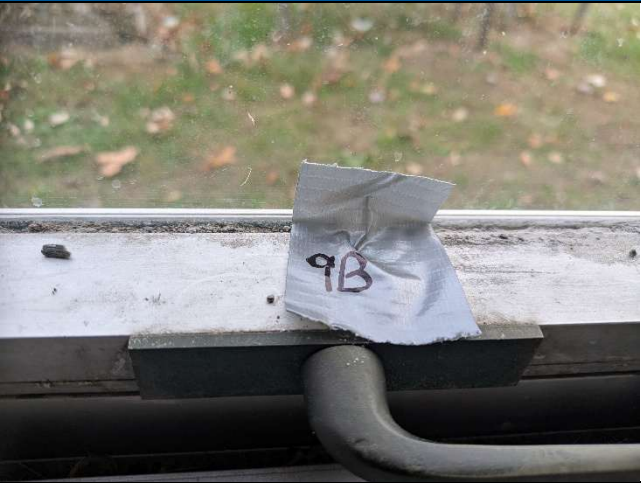
| Asbestos Samples | | | | |
|---|---|---|---|---|
| 9B | | Room 6, east side | None Detected | |

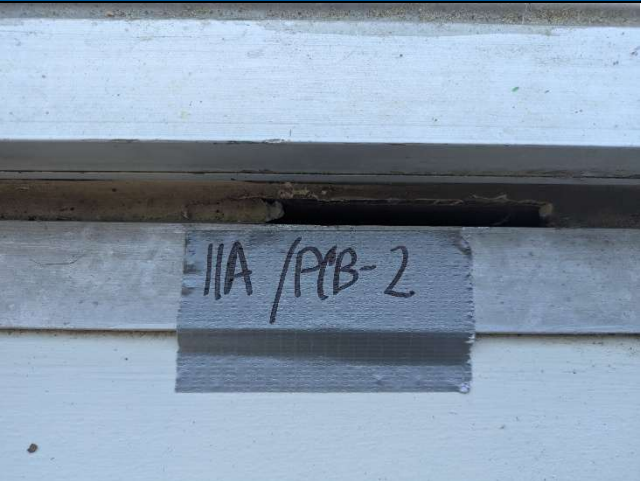
| Asbestos Samples | | | | |
|---|---|---|---|---|
| 11A | Glazing at base of windows | Room 9, west side | None Detected | |

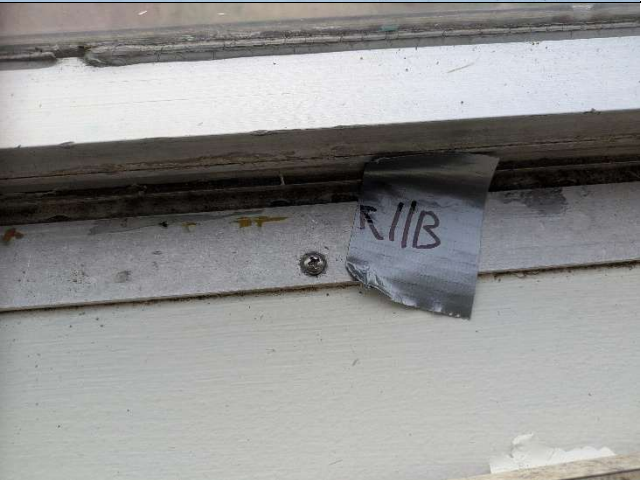
| Asbestos Samples | | | | |
|---|---|---|---|---|
| 11B | | Room 11, west side | None Detected | |

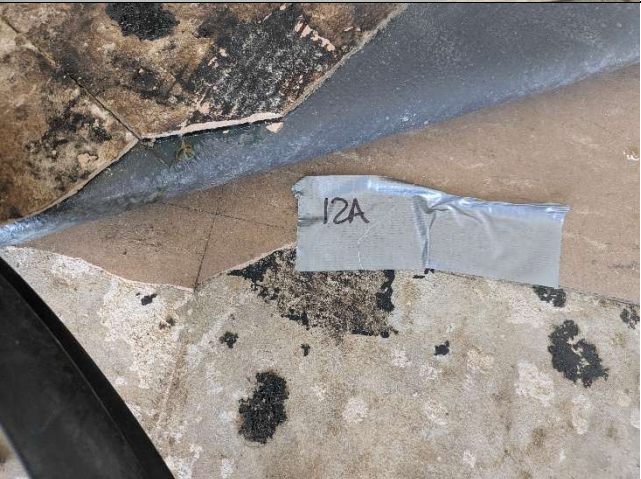
| Asbestos Samples | | | | |
|---|---|---|---|---|
| 12A | 9"x9" brown floor tile | South corridor near ext. doors | Tile:<br>10% Chrysotile<br>Mastic:<br>None Detected | |

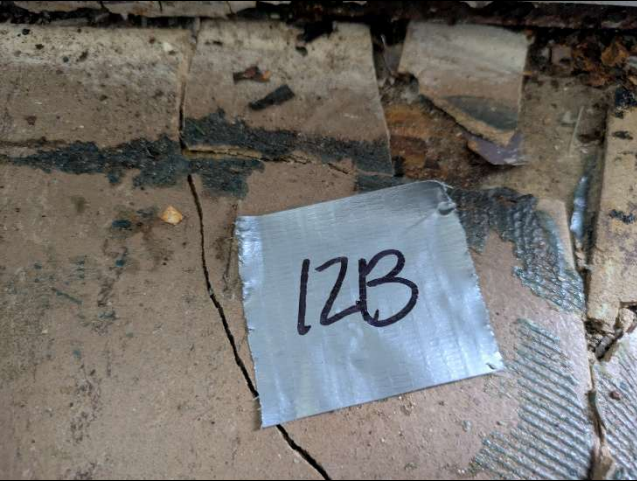
| Asbestos Samples | | | | |
|---|---|---|---|---|
| 12B | | N-S corridor across from Work Room | Tile:<br>Not Analyzed<br>Mastic:<br>None Detected | |

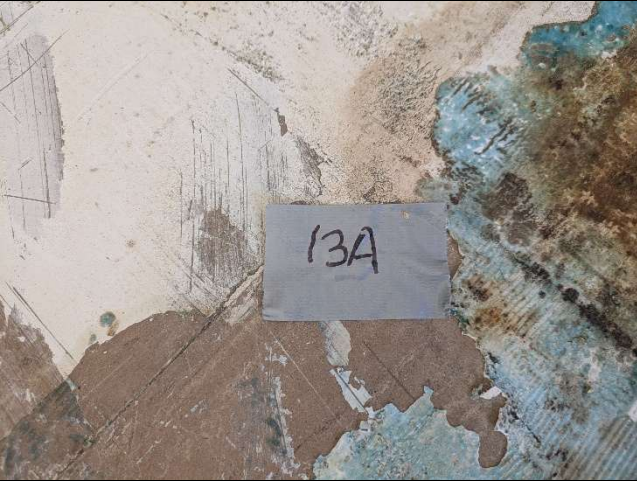
| Asbestos Samples | | | | |
|---|---|---|---|---|
| 13A | White Floor Leveler | South corridor near ext. doors | None Detected | |

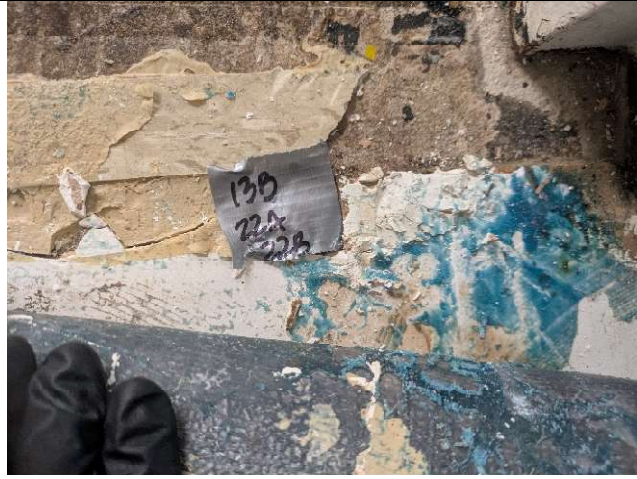
| Asbestos Samples | | | | |
|---|---|---|---|---|
| 13B | | South corridor at threshold to Room 12 | None Detected | |

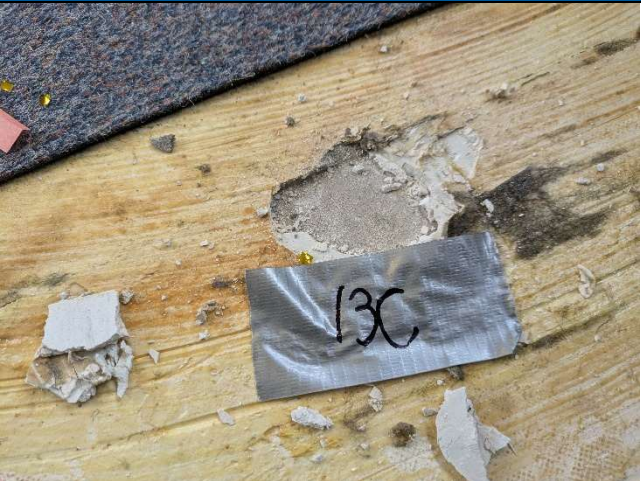
| Asbestos Samples | | | | |
|---|---|---|---|---|
| 13C | | Middle corridor at connector to 1962 | None Detected | |

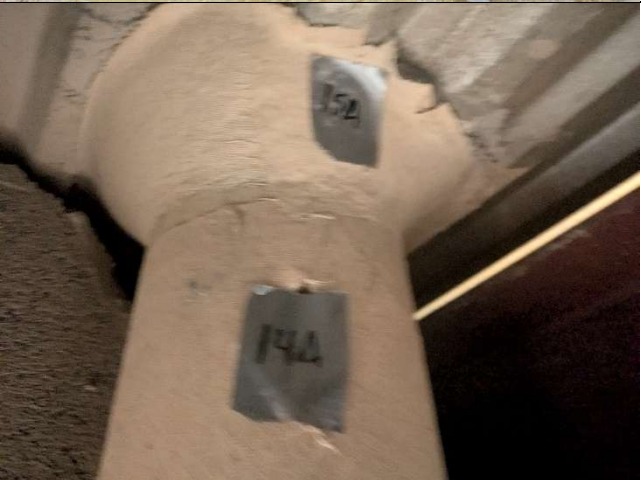
| Asbestos Samples | | | | |
|---|---|---|---|---|
| 14A | Roof drain pipe insulation (with black and foil wrap) | Room 10, NE | None Detected | |

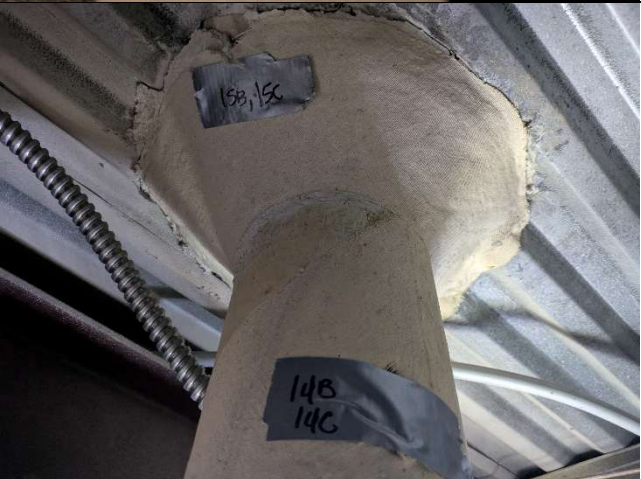
| Asbestos Samples | | | | |
|---|---|---|---|---|
| 14B | | Room 7, NW | None Detected | |

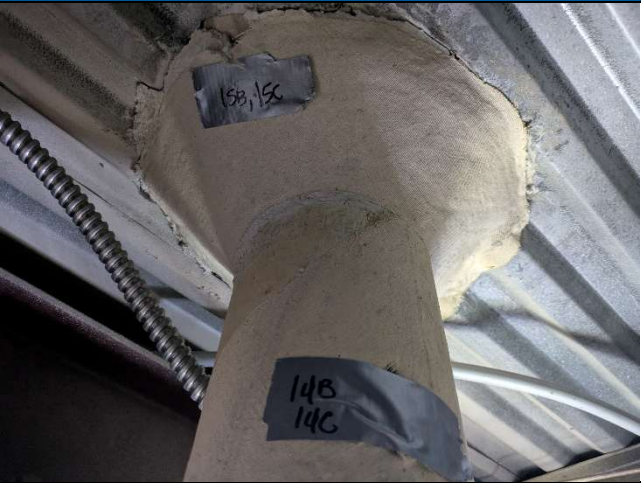
| Asbestos Samples | | | | | |
|---|---|---|---|---|---|
| 14C | Roof drain pipe insulation | Room 7, NW | None Detected | | |

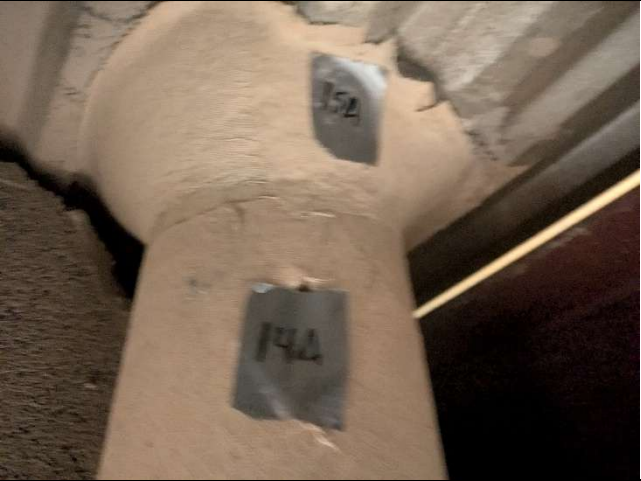
| Asbestos Samples | | | | | |
|---|---|---|---|---|---|
| 15A | | Room 10, NE | None Detected | | |

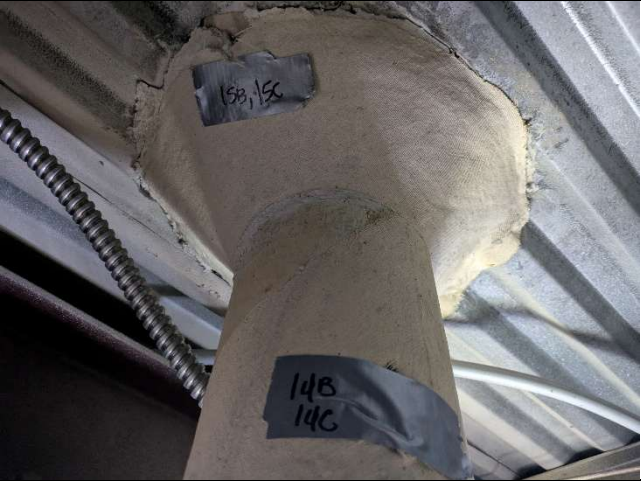
| Asbestos Samples | | | | | |
|---|---|---|---|---|---|
| 15B | | Room 7, NW | None Detected | | |

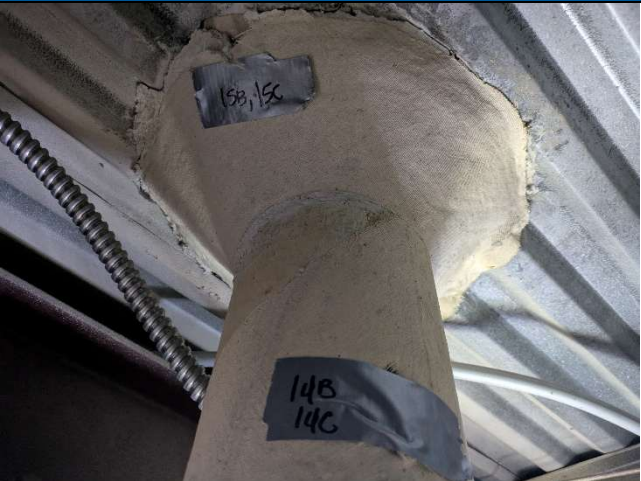
| Asbestos Samples | | | | |
|---|---|---|---|---|
| 15C | | Room 7, NW | None Detected | |

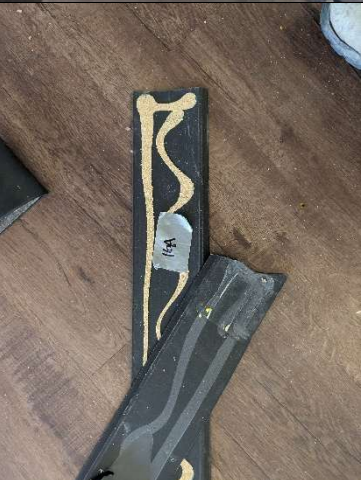
| Asbestos Samples | | | | |
|---|---|---|---|---|
| 16A | Black cove base and adhesive | Room 9 | None Detected | |

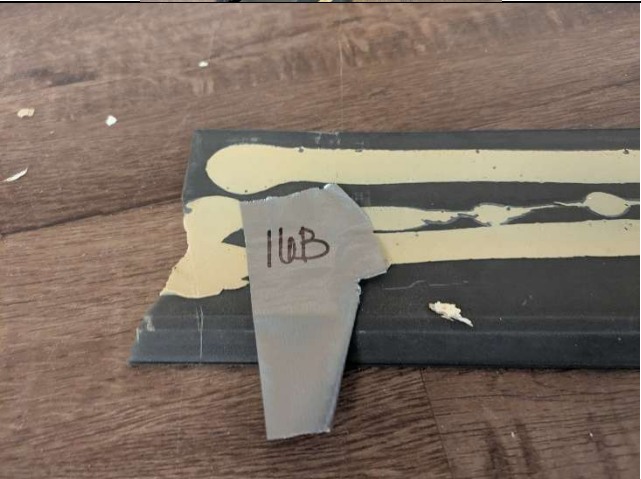
| Asbestos Samples | | | | |
|---|---|---|---|---|
| 16B | | Room 12 | None Detected | |

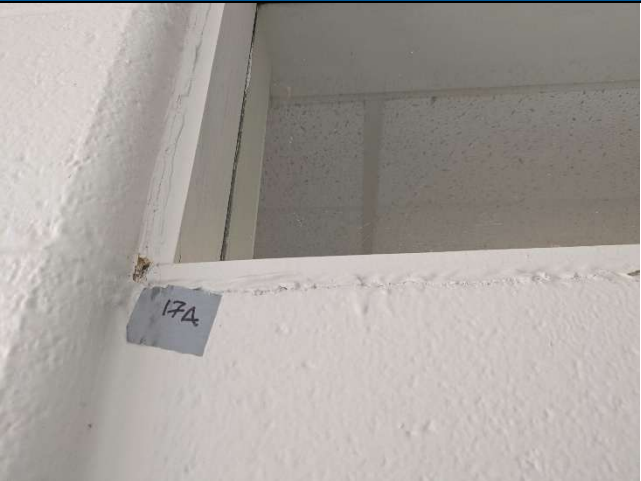
| Asbestos Samples | | | | |
|---|---|---|---|---|
| 17A | Window caulk around interior windows – hallway side | Hallway at Room 9, south end | 1.25% Chrysotile<br>(Point Count Result) | |

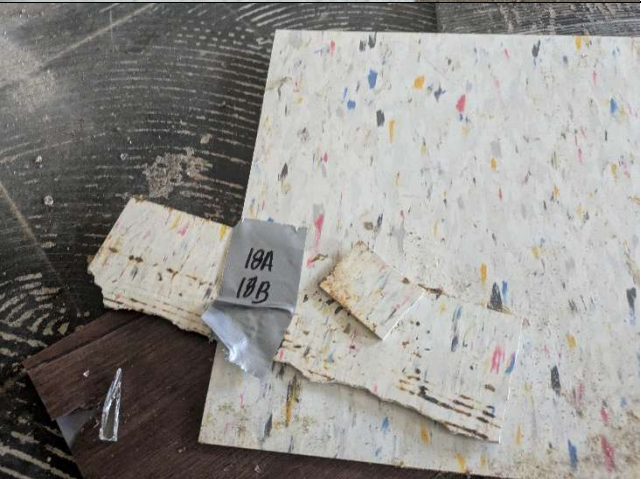
| Asbestos Samples | | | | |
|---|---|---|---|---|
| 18A | 12"x12" white floor tile with rainbow markings | Room 10, south wall at sink area | Tile:<br>None Detected<br><br>Mastic:<br>None Detected | |

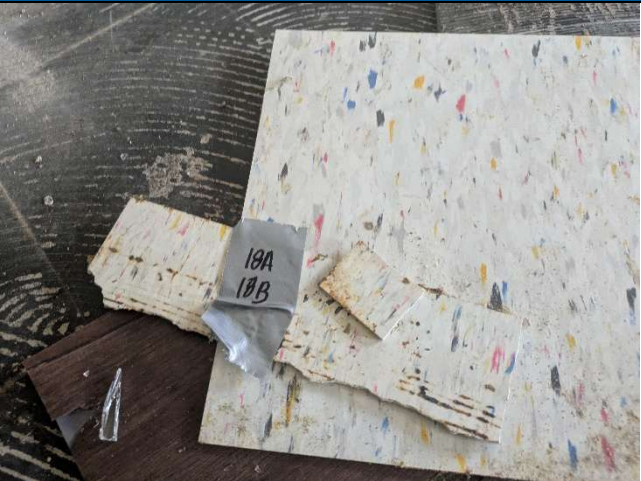
| Asbestos Samples | | | | |
|---|---|---|---|---|
| 18B | Plaster | Room 10, south wall at sink area | Tile:<br>None Detected<br><br>Mastic:<br>None Detected | |

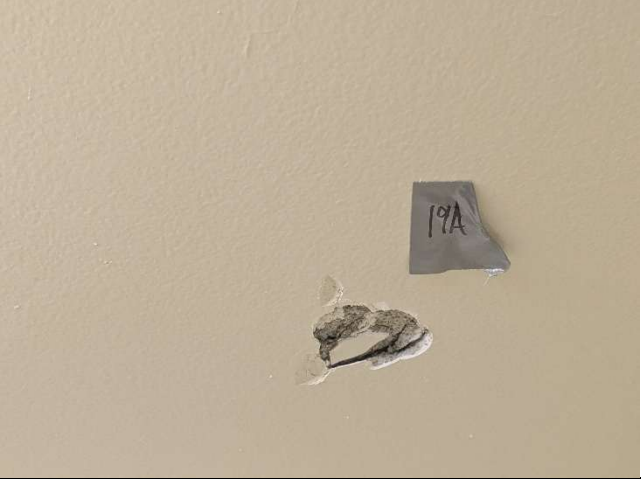
| Asbestos Samples | | | | |
|---|---|---|---|---|
| 19A | | Boys' bathroom between Rooms 9 and 10 | Finish Coat:<br>None Detected<br><br>Base Coat:<br>None Detected | |

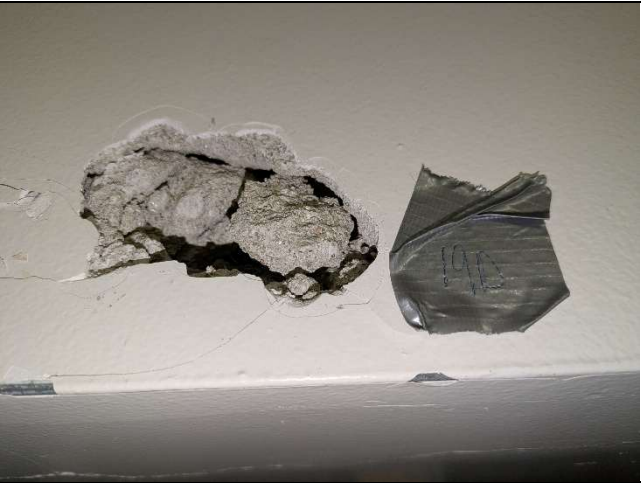
| Asbestos Samples | | | | |
|---|---|---|---|---|
| 19D | | Room 3, lower ceiling at entrance | Finish Coat:<br>None Detected<br><br>Base Coat:<br>None Detected | |

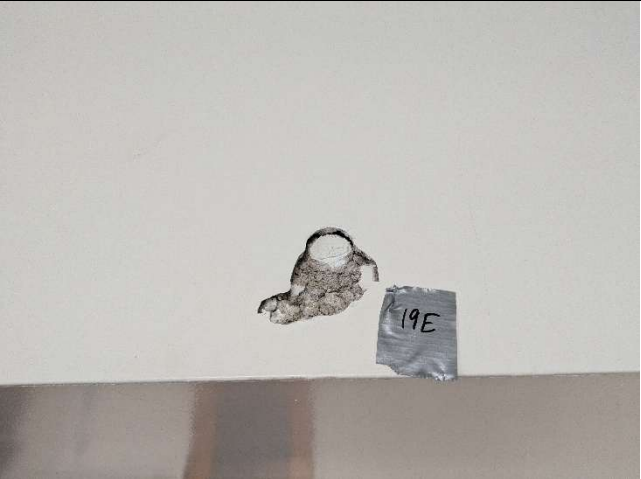
| Asbestos Samples | | | | |
|---|---|---|---|---|
| 19E | | Room 4, lower ceiling – north side | Finish Coat:<br>None Detected<br><br>Base Coat:<br>None Detected | |

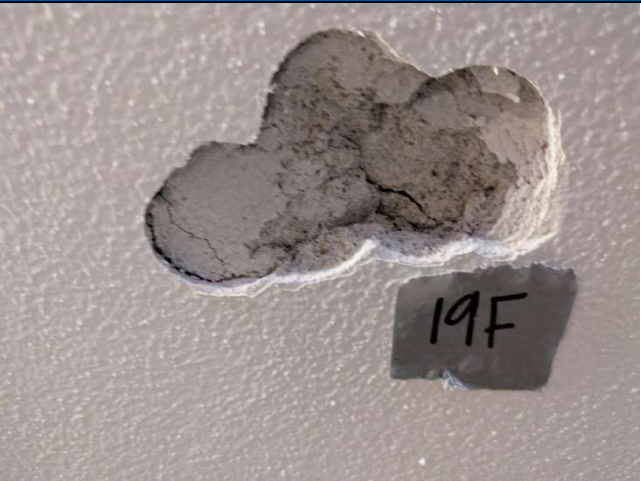
| Asbestos Samples | | | | | |
|---|---|---|---|---|---|
| 19F | | Lobby | Finish Coat:<br>None Detected<br><br>Base Coat:<br>None Detected | | |

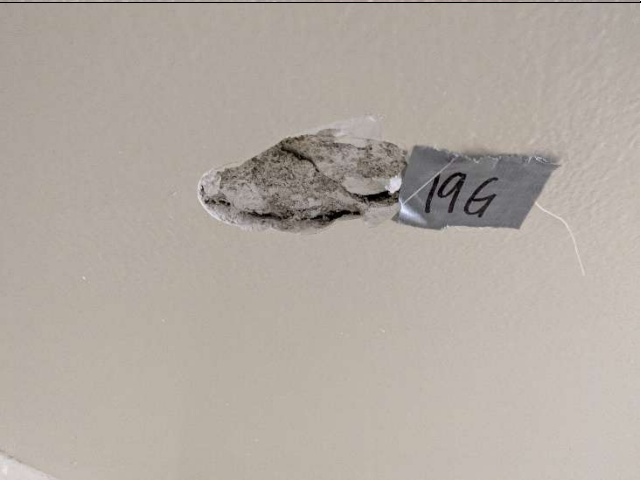
| Asbestos Samples | | | | | |
|---|---|---|---|---|---|
| 19G | | Lobby, boys' bathroom | Finish Coat:<br>None Detected<br><br>Base Coat:<br>None Detected | | |

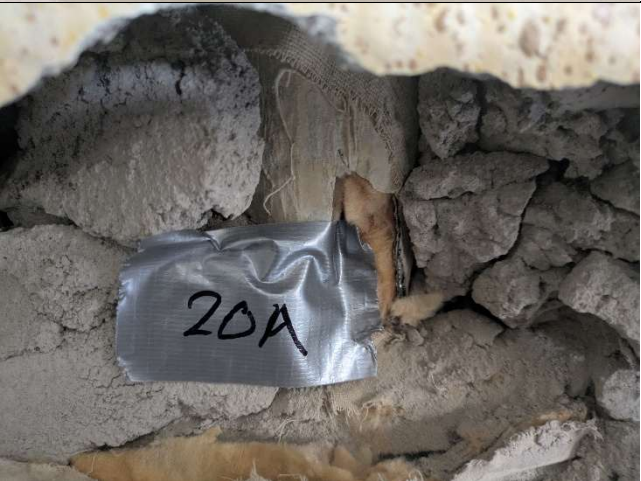
| Asbestos Samples | | | | | |
|---|---|---|---|---|---|
| 20A | | Room 10, south wall at sink area | None Detected | | |

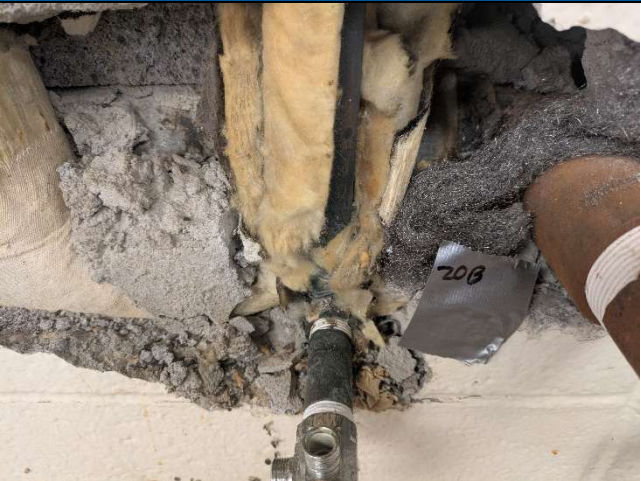
| Asbestos Samples | | | | |
|---|---|---|---|---|
| 20B | | Room 12, west wall at sink area | None Detected | |

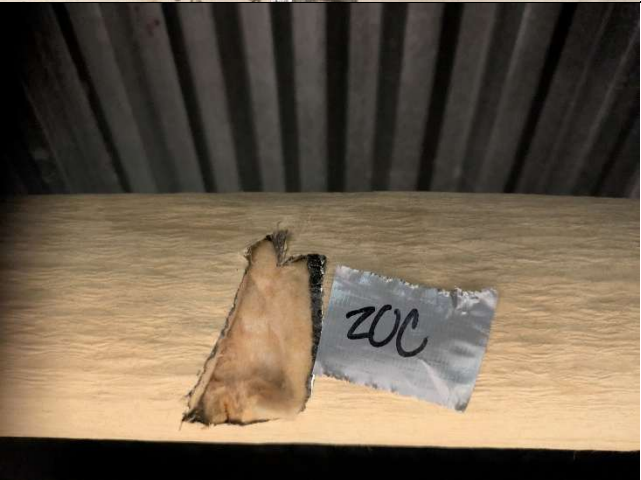
| Asbestos Samples | | | | |
|---|---|---|---|---|
| 20C | | Custodial closet at south end of N-S Hallway | None Detected | |

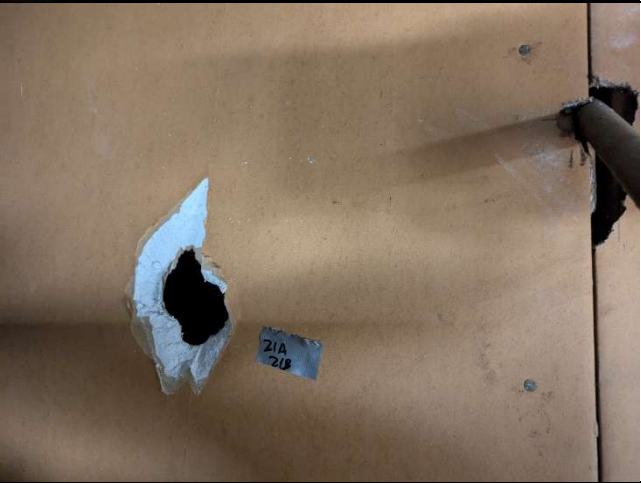
| Asbestos Samples | | | | |
|---|---|---|---|---|
| 21A | Drywall | Room 12, upper northeast wall | None Detected | |

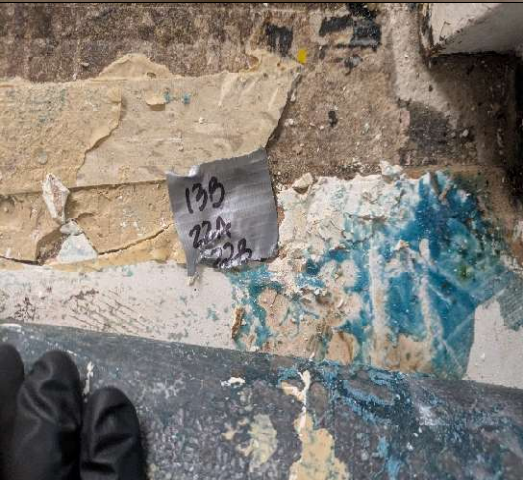
| Asbestos Samples | | | | |
|---|---|---|---|---|
| 22A | Beiger mottle floor tile | At threshold to Room 12 | Tile:<br>None Detected<br><br>Mastic:<br>None Detected | |

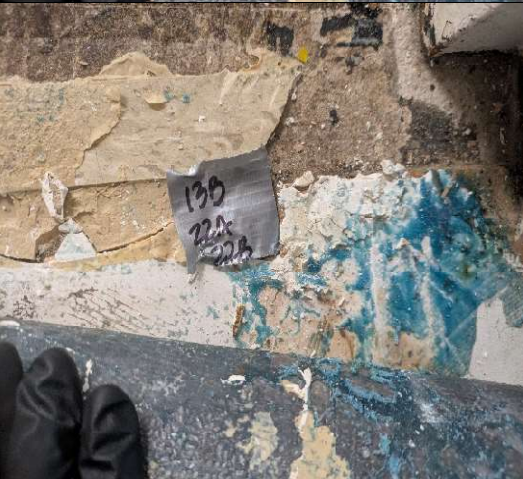
| Asbestos Samples | | | | |
|---|---|---|---|---|
| 22B | | At threshold to Room 12 | Tile:<br>None Detected<br><br>Mastic:<br>None Detected | |

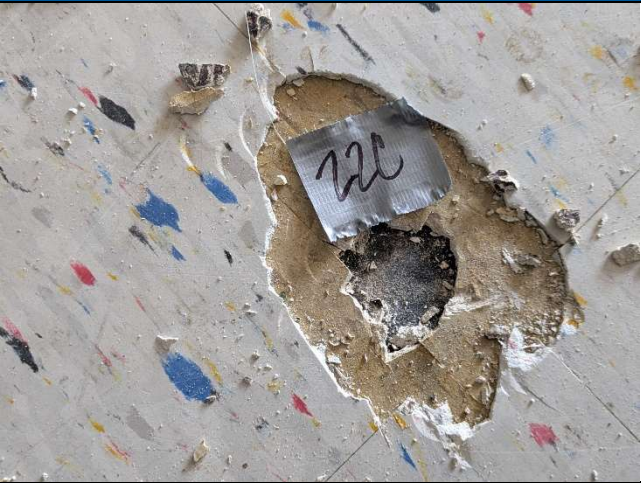
| Asbestos Samples | | | | |
|---|---|---|---|---|
| 22C | White sink caulking | Room 19, middle (under HA 19) | Tile:<br>None Detected<br><br>Mastic:<br>None Detected | |

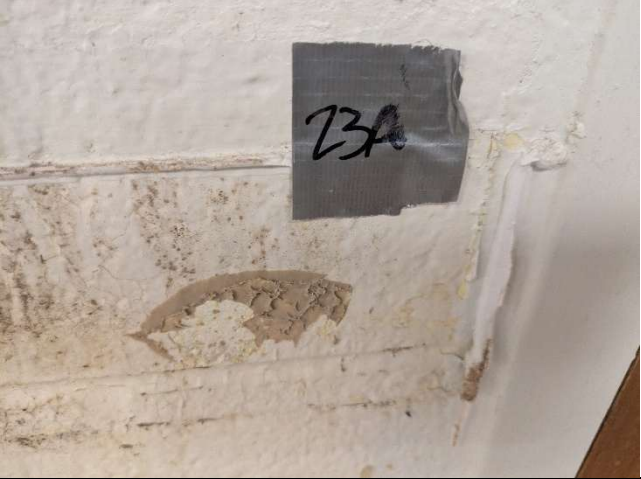
| Asbestos Samples | | | | |
|---|---|---|---|---|
| 23A | | Room 12, west wall | None Detected | |

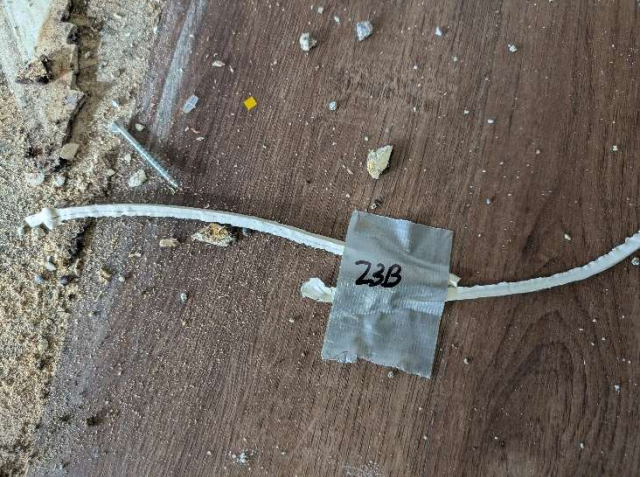
| Asbestos Samples | | | | |
|---|---|---|---|---|
| 23B | | Room 9, north side | None Detected | |

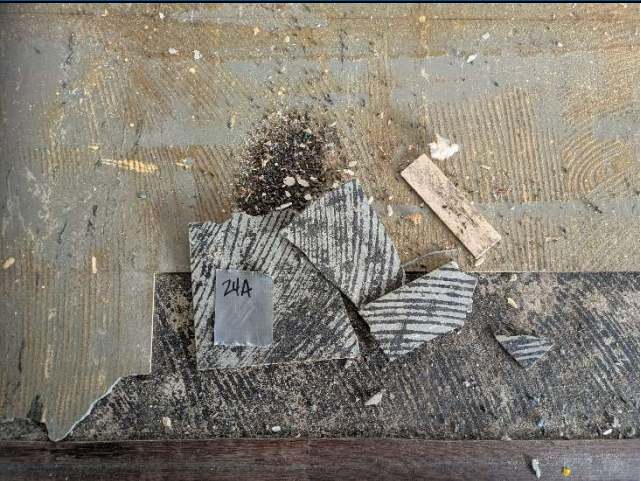
| Asbestos Samples | | | | |
|---|---|---|---|---|
| 24A | 9"x9" gray floor tile | Room 8, east wall | Glue:<br>None Detected<br><br>Tile:<br>10% Chrysotile<br><br>Mastic:<br>None Detected | |

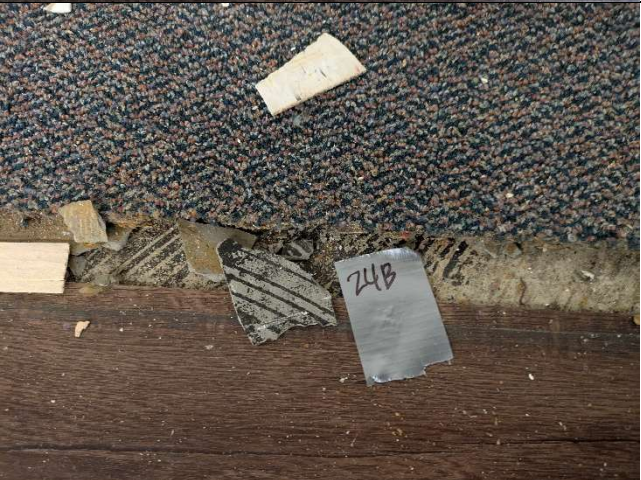
| Asbestos Samples | | | | |
|---|---|---|---|---|
| 24B | | Room 7, west side | Glue:<br>None Detected<br><br>Tile:<br>Not Analyzed<br><br>Mastic:<br>None Detected | |

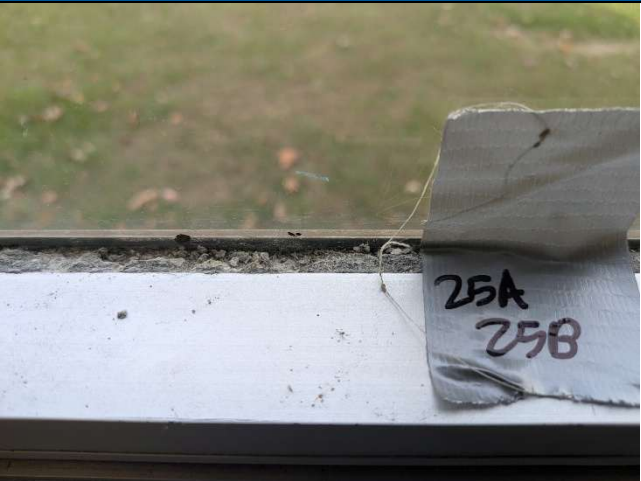
| Asbestos Samples | | | | |
|---|---|---|---|---|
| 25B | | Room 7, east side | Not Analyzed | |

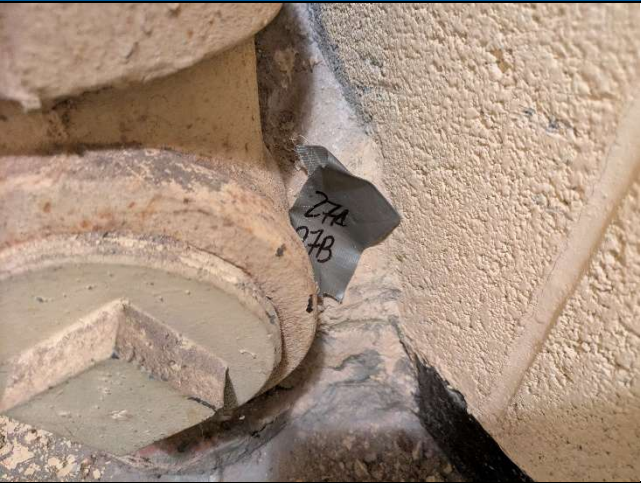
| Asbestos Samples | | | | |
|---|---|---|---|---|
| 27A | Packing at base of sanitary drain | Custodial closet in south corridor | None Detected | |

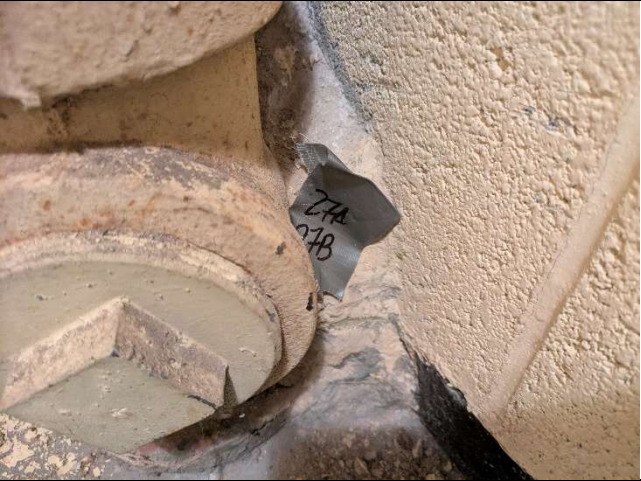
| Asbestos Samples | | | | |
|---|---|---|---|---|
| 27B | | Custodial closet in south corridor | None Detected | |

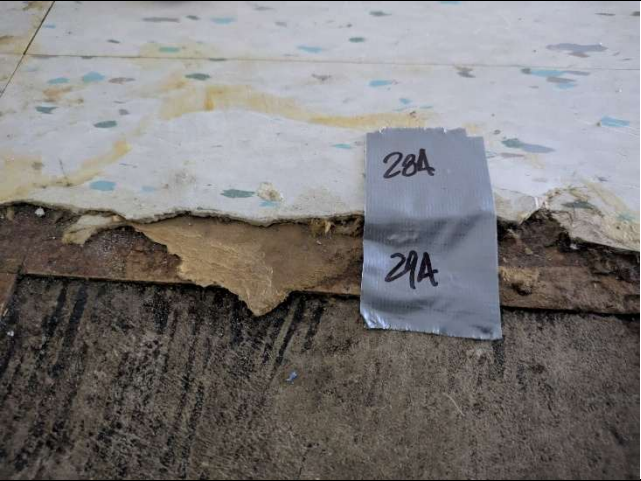
| Asbestos Samples | | | | |
|---|---|---|---|---|
| 28A | 12"x12" white floor tile with pastel markings | Storage room across from Office 29 | Tile:<br>None Detected<br><br>Glue:<br>None Detected | |

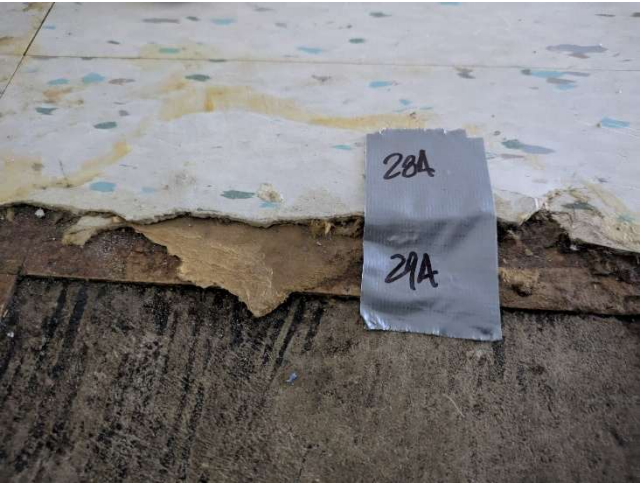
| Asbestos Samples | | | | |
|---|---|---|---|---|
| 29A | Paper under HA 28 and over HA 12 | Storage room across from Office 29 | None Detected | |

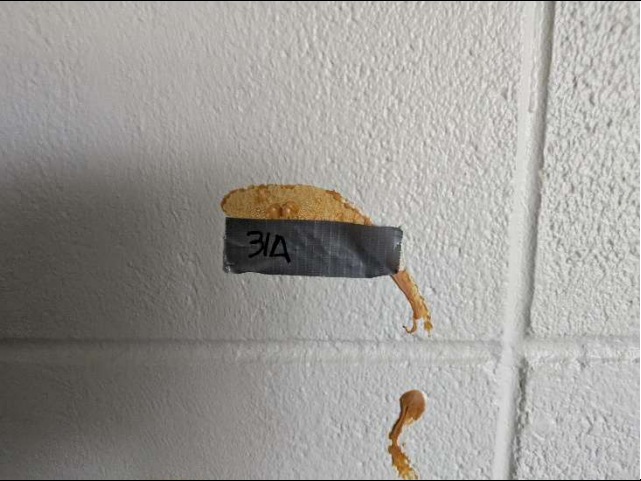
| Asbestos Samples | | | | |
|---|---|---|---|---|
| 31A | Tan chalkboard caulk | Room 5, north wall | None Detected | |

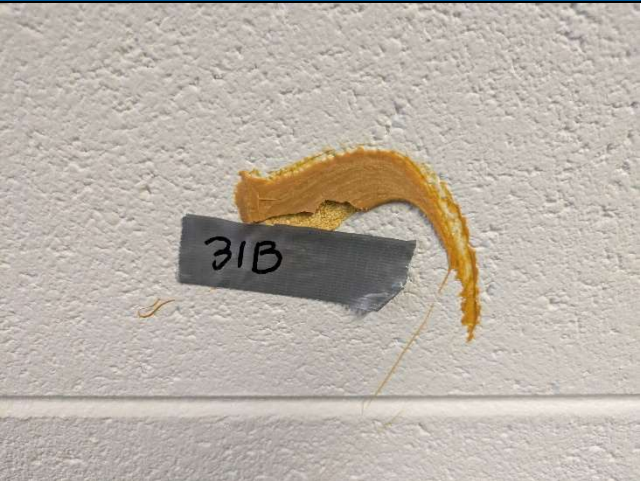
| Asbestos Samples | | | | |
|---|---|---|---|---|
| 31B | | Room 25, north wall | None Detected | |

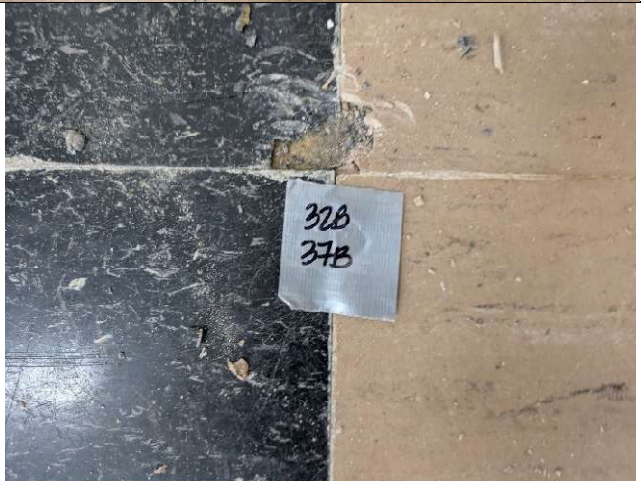
| Asbestos Samples | | | | |
|---|---|---|---|---|
| 32B | | Gym, SW at drinking fountain | Tile:<br>Not Analyzed<br>Mastic:<br>None Detected | |

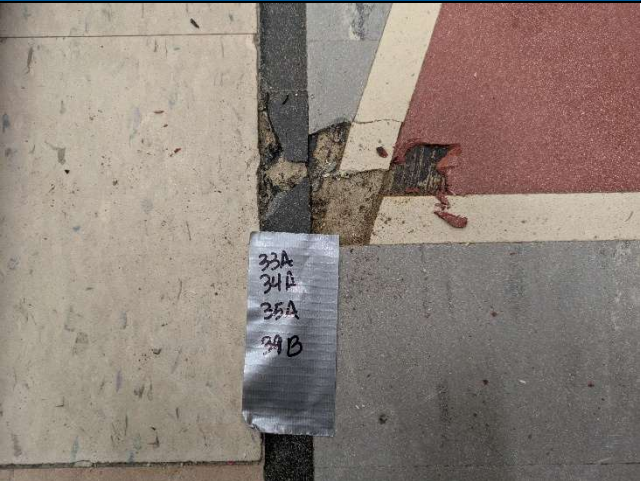
| Asbestos Samples | | | | |
|---|---|---|---|---|
| 33A | 9"x9" light gray floor tile | Gym, NE at shuffleboard | Tile:<br>2.75% (Point Count Result)<br><br>Mastic:<br>None Detected | |

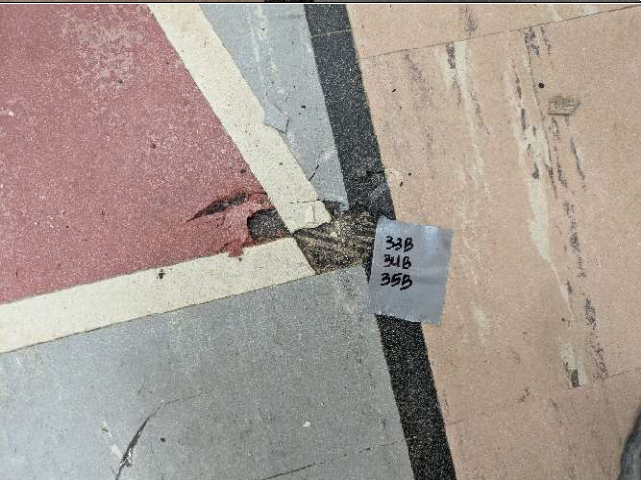
| Asbestos Samples | | | | |
|---|---|---|---|---|
| 33B | | Gym, SW at shuffleboard | Tile:<br>Not Analyzed<br><br>Mastic:<br>None Detected | |

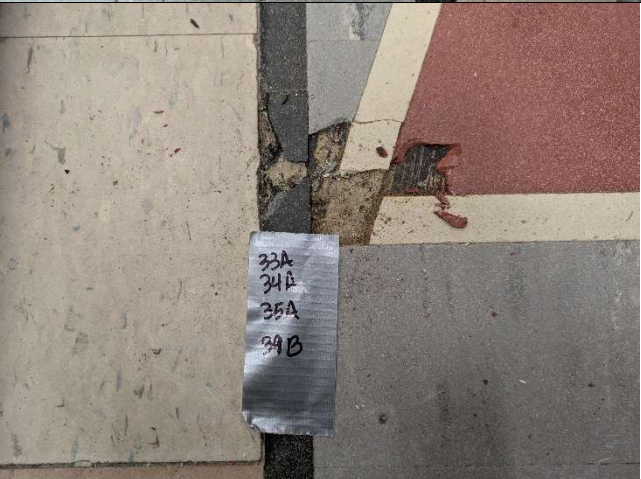
| Asbestos Samples | | | | |
|---|---|---|---|---|
| 34A | Red shuffleboard tile | Gym, NE at shuffleboard | Tile:<br>3.5% (Point Count Result)<br><br>Mastic:<br>None Detected | |

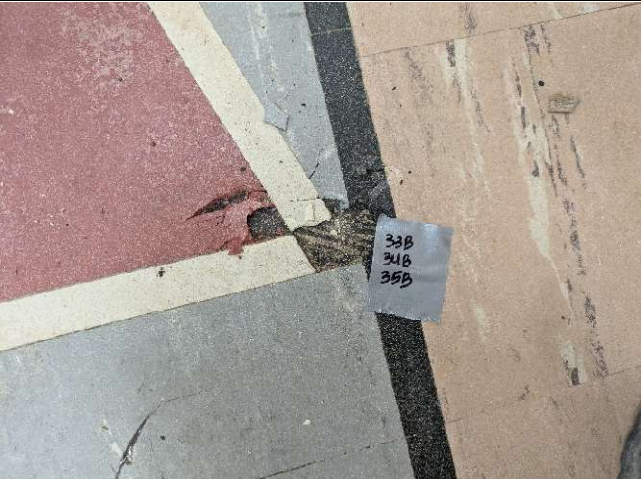
| Asbestos Samples | | | | |
|---|---|---|---|---|
| 34B | White shuffleboard trim tile | Gym, SW at shuffleboard | Tile:<br>Not Analyzed<br>Mastic:<br>None Detected | |

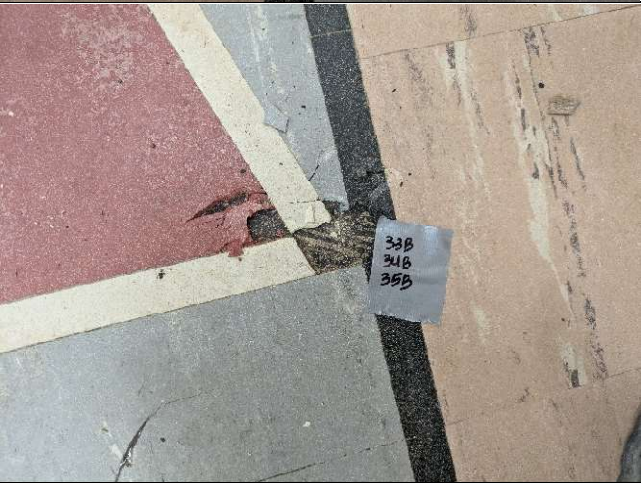
| Asbestos Samples | | | | |
|---|---|---|---|---|
| 35B | | Gym, SW at shuffleboard | Tile:<br>Not Analyzed<br>Mastic:<br>None Detected | |
