# HAZARDOUS MATERIALS SURVEY REPORT

## FORMER MARSHALL ELEMENTARY SCHOOL LIVONIA, MICHIGAN

December 16, 2025  
NTH Project No. 25002747-01

**RE: Report on Hazardous Materials Survey  
Former Marshall Elementary School  
33901 Curtis Road  
Livonia, Michigan**

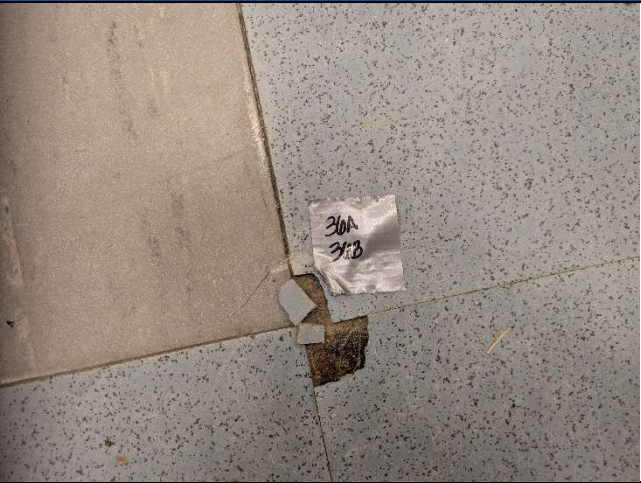
| Asbestos Samples | | | | | |
|---|---|---|---|---|---|
| 36A | Blue speckled replacement tile | Gym, Middle | Tile:<br>None Detected<br><br>Mastic:<br>None Detected | | |

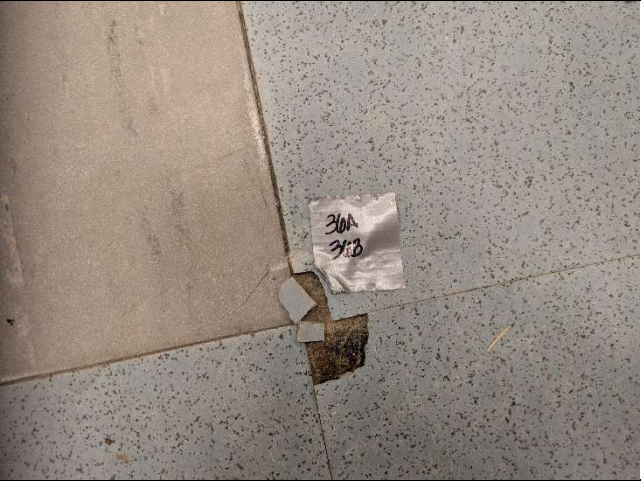
| Asbestos Samples | | | | | |
|---|---|---|---|---|---|
| 36B | | Gym, Middle | Tile:<br>None Detected<br><br>Mastic:<br>None Detected | | |

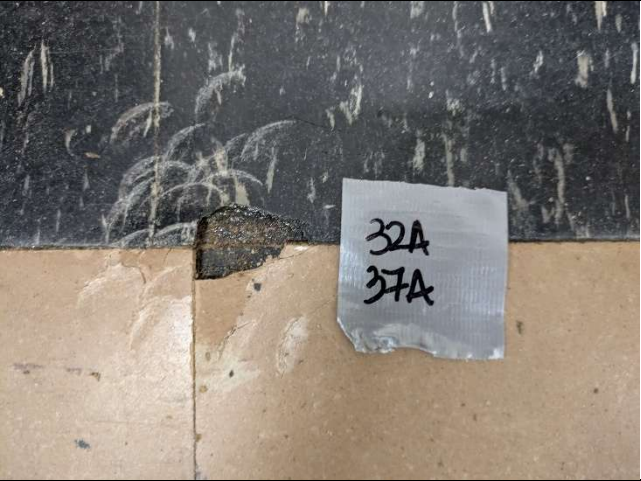
| Asbestos Samples | | | | | |
|---|---|---|---|---|---|
| 37A | Black Floor Tile | Gym, north side, middle | Tile:<br>None Detected<br><br>Mastic:<br>None Detected | | |

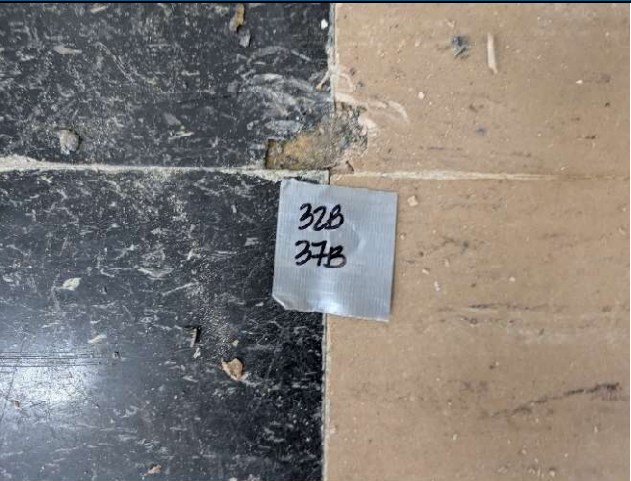
| Asbestos Samples | | | | |
|---|---|---|---|---|
| 37B | | Gym, SW at drinking fountain | Tile:<br>None Detected<br><br>Mastic:<br>None Detected | |

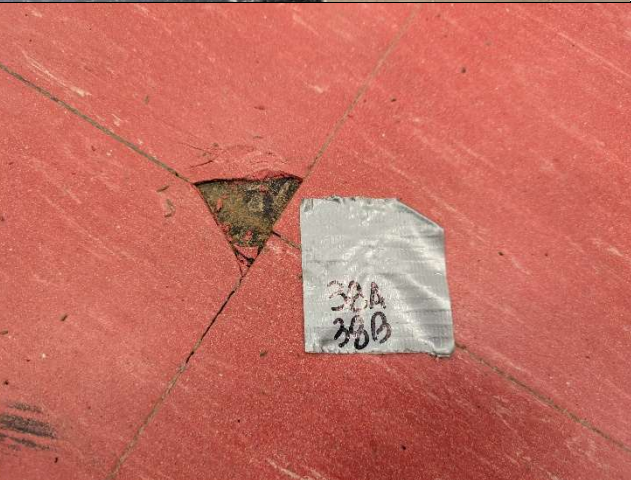
| Asbestos Samples | | | | |
|---|---|---|---|---|
| 38A | Red replacement tile | Gym, Middle | Tile:<br>None Detected<br><br>Mastic:<br>None Detected | |

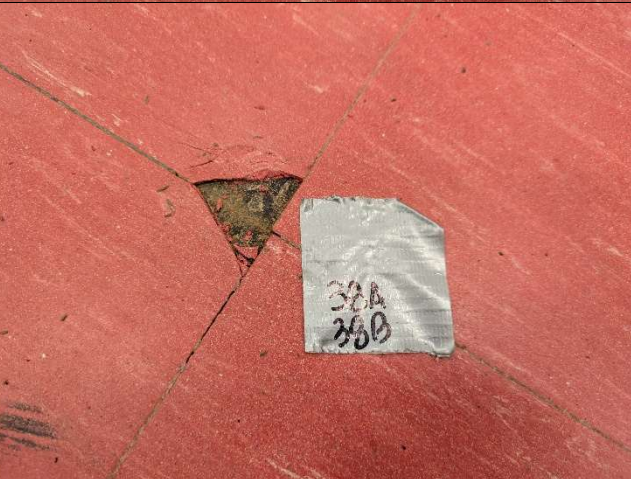
| Asbestos Samples | | | | |
|---|---|---|---|---|
| 38B | | Gym, Middle | Tile:<br>None Detected<br><br>Mastic:<br>None Detected | |

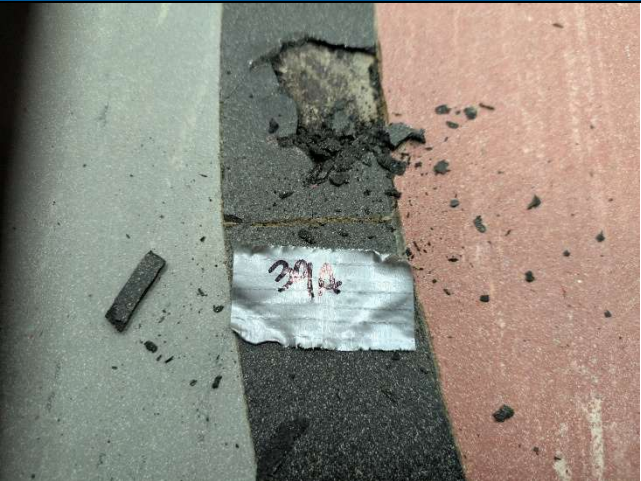
| Asbestos Samples | | | | |
|---|---|---|---|---|
| 39A | Black trim floor tile | Gym, Middle | Tile:<br>3.0% (Point Count Result)<br><br>Mastic:<br>None Detected | |

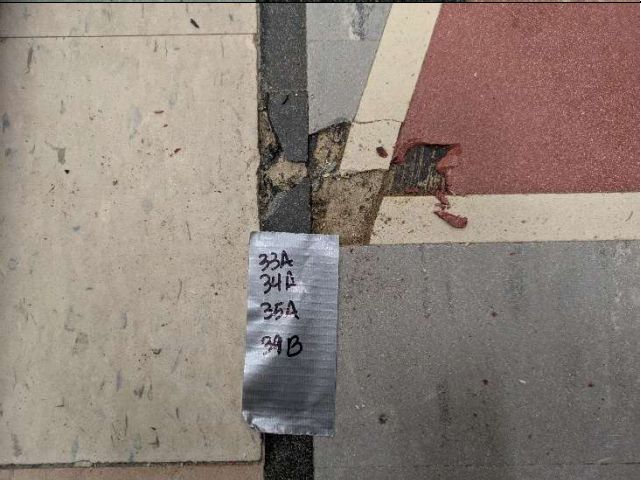
| Asbestos Samples | | | | |
|---|---|---|---|---|
| 39B | | Gym, NE at shuffleboard | Tile:<br>Not Analyzed<br><br>Mastic:<br>None Detected | |

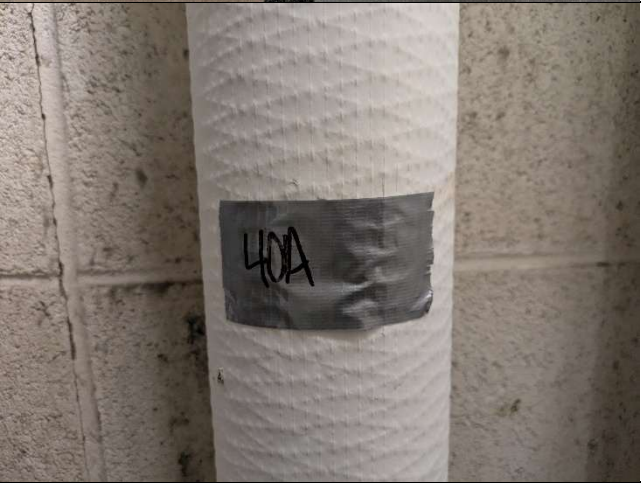
| Asbestos Samples | | | | |
|---|---|---|---|---|
| 40A | New fiberglass pipe insulation | Fan Room | None Detected | |

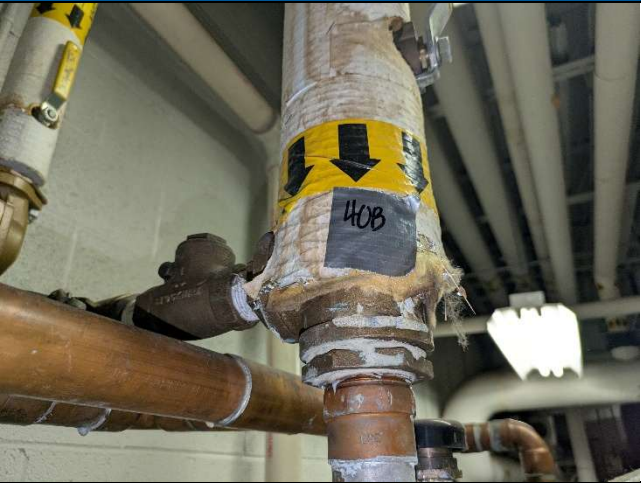
| Asbestos Samples | | | | |
|---|---|---|---|---|
| 40B | | Boiler Room, SW | None Detected | |

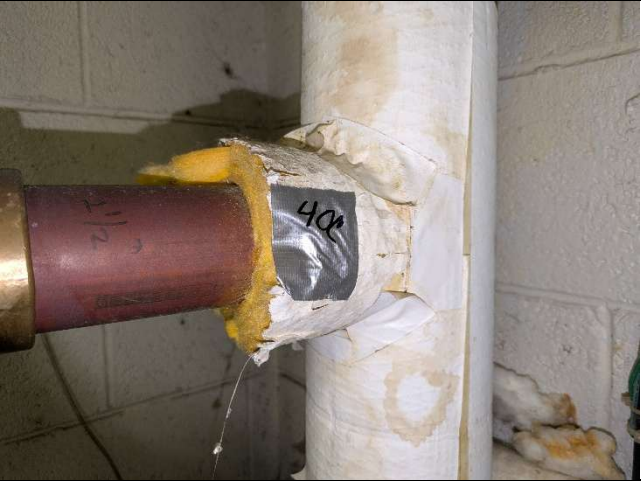
| Asbestos Samples | | | | |
|---|---|---|---|---|
| 40C | | Boiler Room, SE | None Detected | |

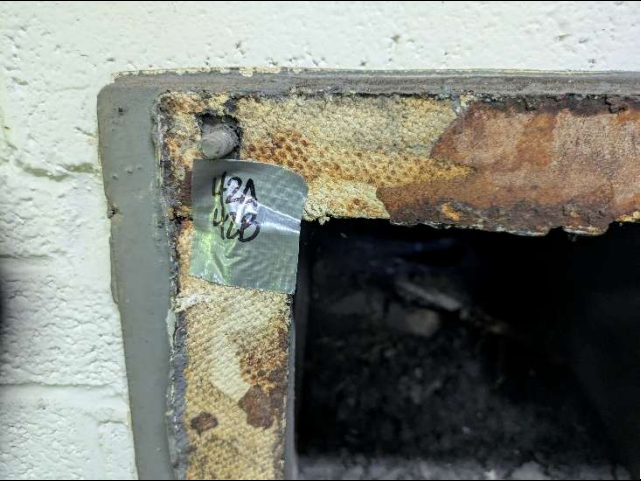
| Asbestos Samples | | | | |
|---|---|---|---|---|
| 42A | Incinerator-chimney door gasket | Boiler Room, SW, lower door | 50% Chrysotile | |

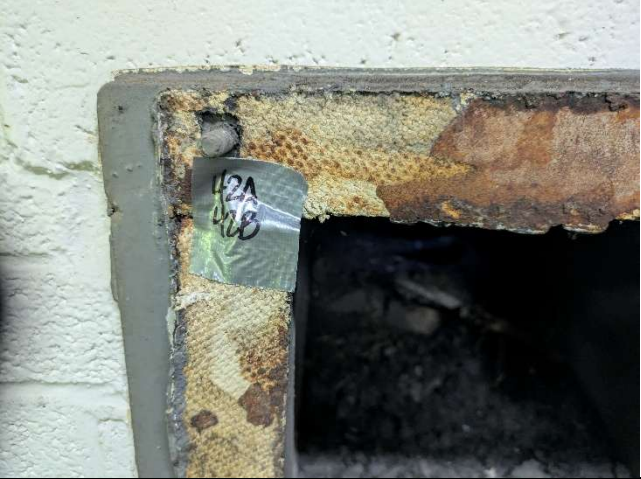
| Asbestos Samples | | | | |
|---|---|---|---|---|
| 42B | | Boiler Room, SW, lower door | Not Analyzed | |

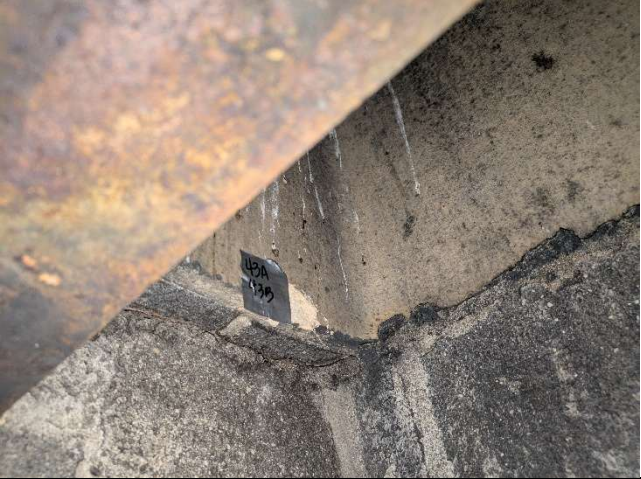
| Asbestos Samples | | | | |
|---|---|---|---|---|
| 43A | Yellow interior chimney tile | Boiler Room, SW | None Detected | |

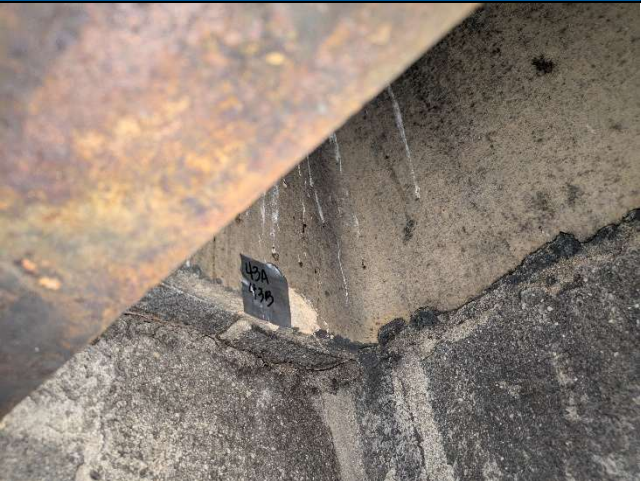
| Asbestos Samples | | | | | |
|---|---|---|---|---|---|
| 43B | | Boiler Room, SW | None Detected | | |

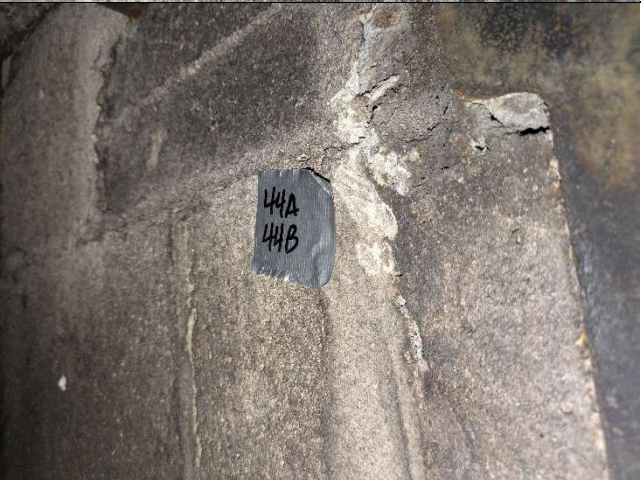
| Asbestos Samples | | | | | |
|---|---|---|---|---|---|
| 44A | Chimney masonry block | Boiler Room, SW | None Detected | | |

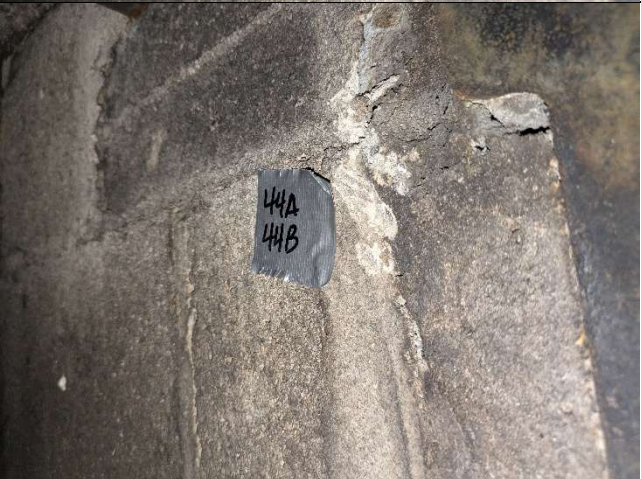
| Asbestos Samples | | | | | |
|---|---|---|---|---|---|
| 44B | | Boiler Room, SW | None Detected | | |

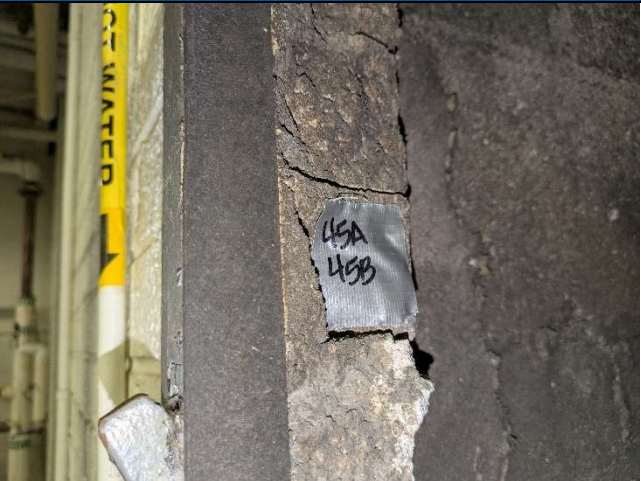
| Asbestos Samples | | | | | |
|---|---|---|---|---|---|
| 45A | Chimney brick | Boiler Room, SW | None Detected | | |

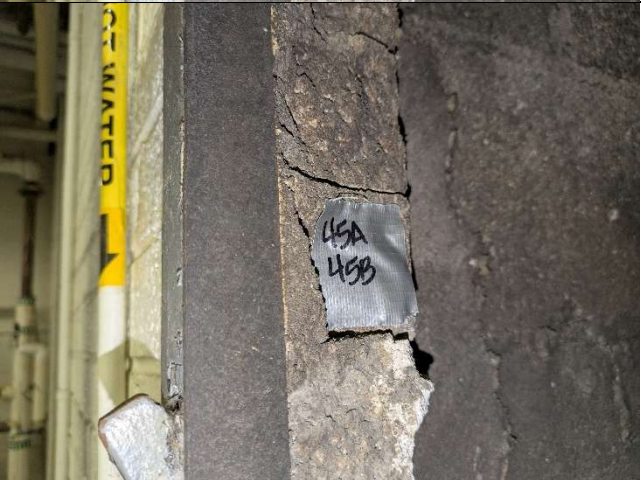
| Asbestos Samples | | | | | |
|---|---|---|---|---|---|
| 45B | | Boiler Room, SW | None Detected | | |

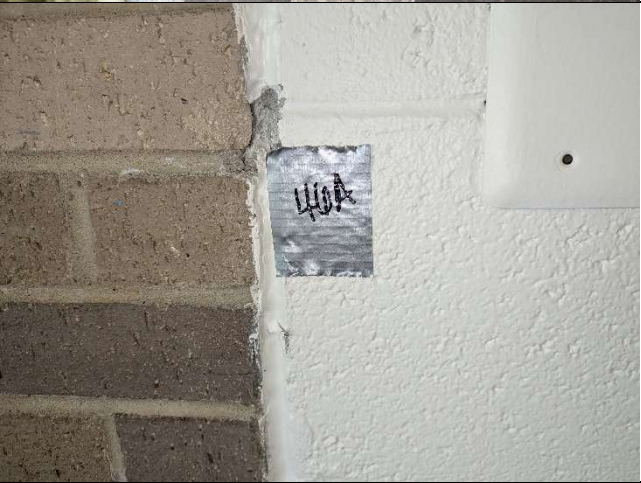
| Asbestos Samples | | | | | |
|---|---|---|---|---|---|
| 46A | Wall sealant, between brick & block | Middle hallway, east end of 1960 wing | None Detected | | |

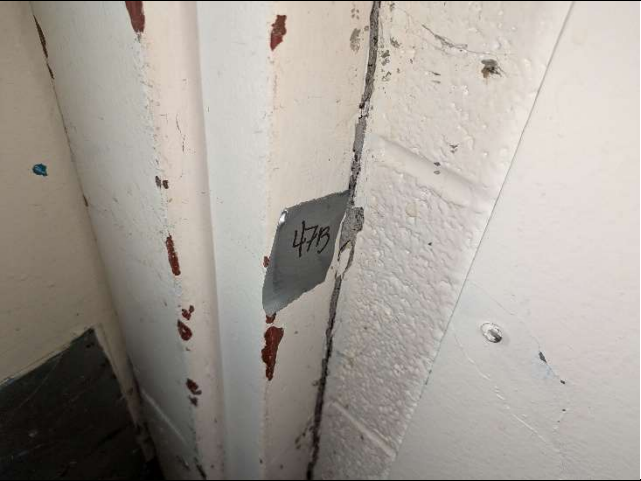
| Asbestos Samples | | | | |
|---|---|---|---|---|
| 47B | | Room 1, east exterior door | Not Analyzed | |

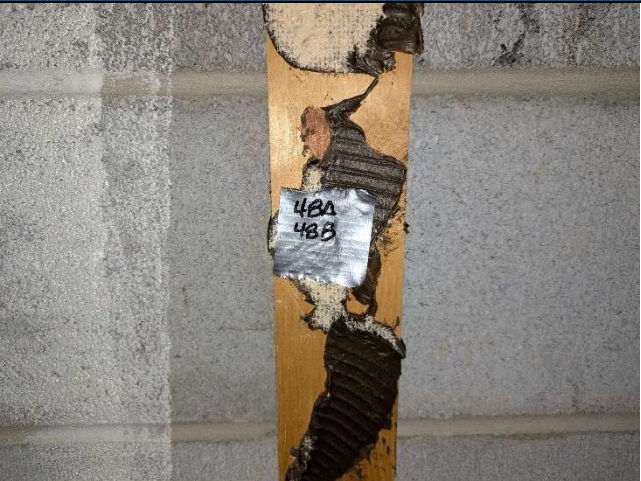
| Asbestos Samples | | | | | |
|---|---|---|---|---|---|
| 48A | Dark brown glue pods for canvas boards | Room 4, east wall | None Detected | | |

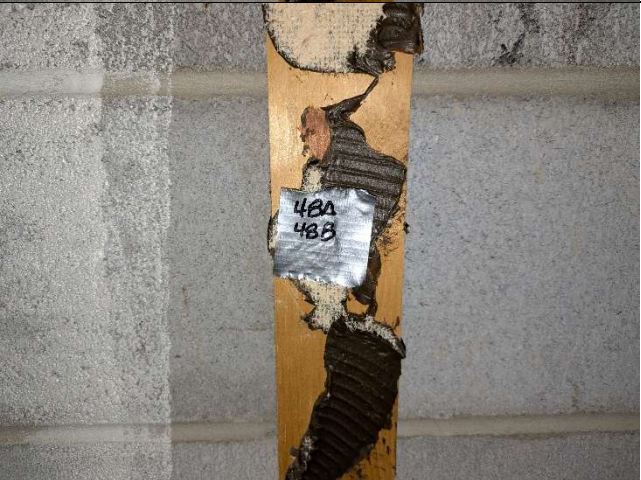
| Asbestos Samples | | | | | |
|---|---|---|---|---|---|
| 48B | | Room 4, east wall | None Detected | | |

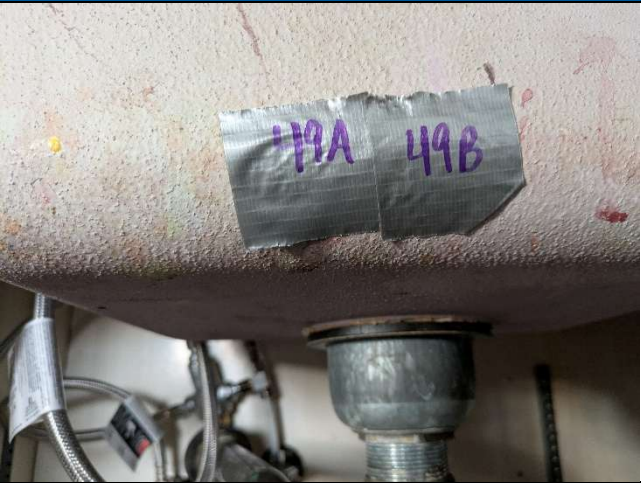
| Asbestos Samples | | | | |
|---|---|---|---|---|
| 49B | | Room 2, north side | Not Analyzed | |

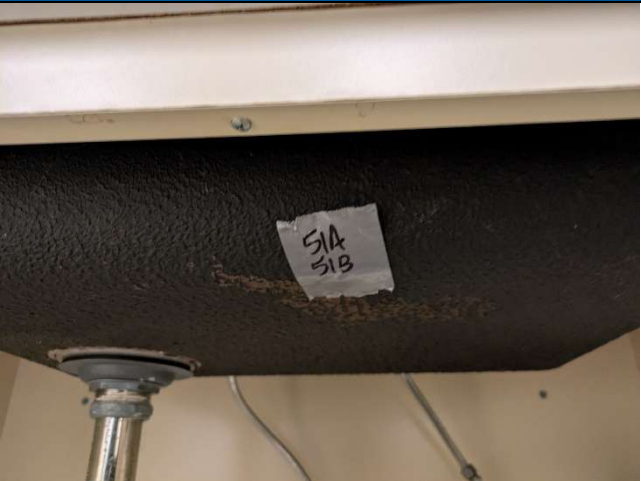
| Asbestos Samples | | | | |
|---|---|---|---|---|
| 51A | Black sink undercoating | Kitchen | None Detected | |

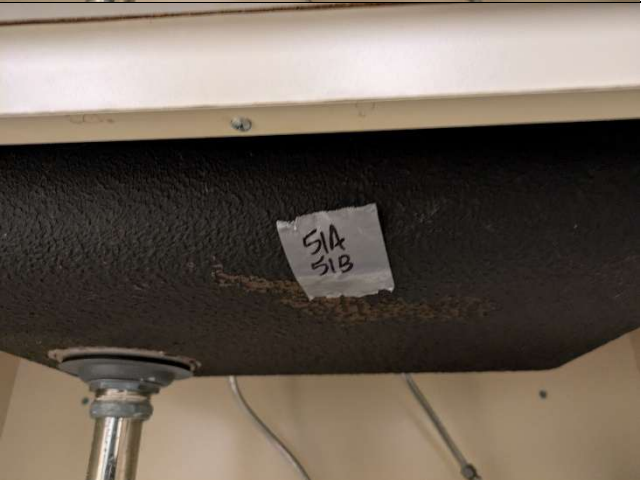
| Asbestos Samples | | | | |
|---|---|---|---|---|
| 51B | | Kitchen | None Detected | |

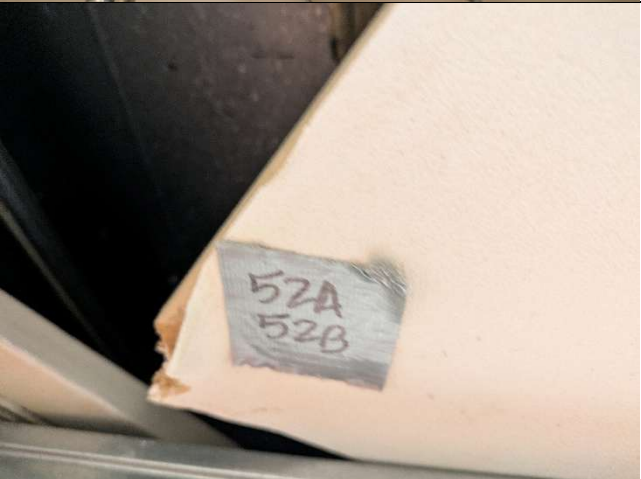
| Asbestos Samples | | | | |
|---|---|---|---|---|
| 52A | 2'x2' gypsum ceiling tile | Kitchen | None Detected | |

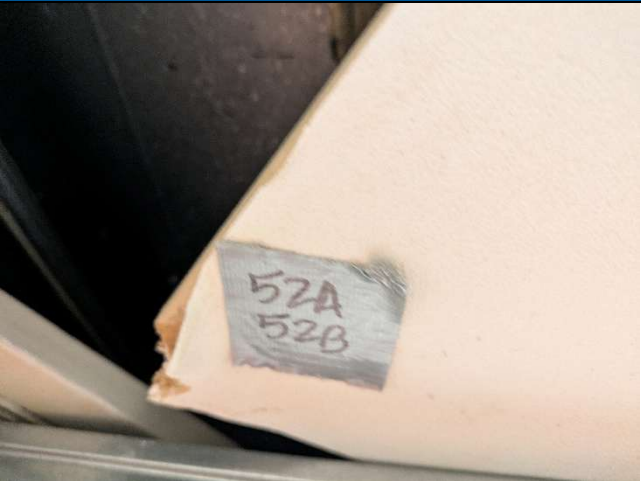
| Asbestos Samples | | | | |
|---|---|---|---|---|
| 52B | | Kitchen | None Detected | |

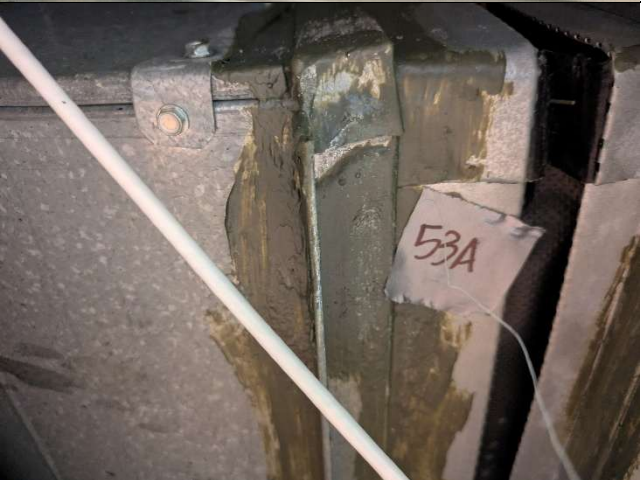
| Asbestos Samples | | | | |
|---|---|---|---|---|
| 53A | Gray duct sealant | Kitchen, middle | None Detected | |

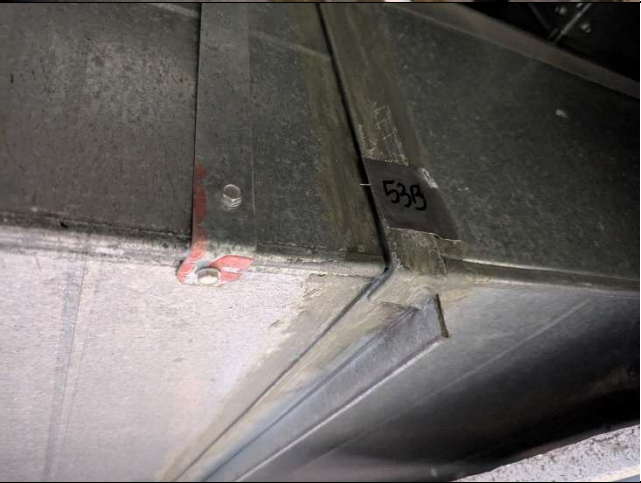
| Asbestos Samples | | | | |
|---|---|---|---|---|
| 53B | | Library, west end | None Detected | |

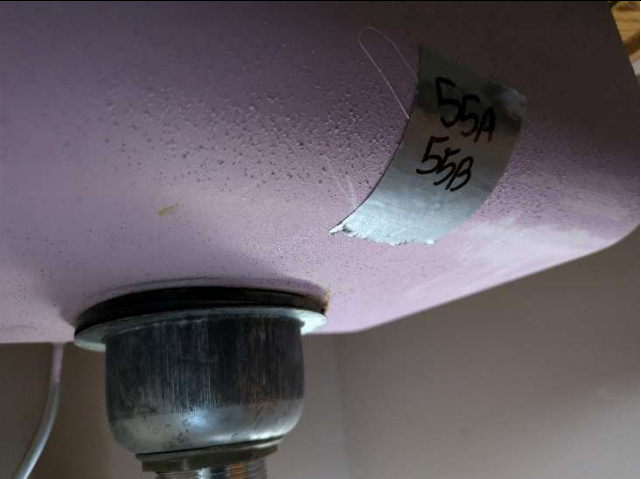
| Asbestos Samples | | | | |
|---|---|---|---|---|
| 55B | | Office Clinic | Not Analyzed | |

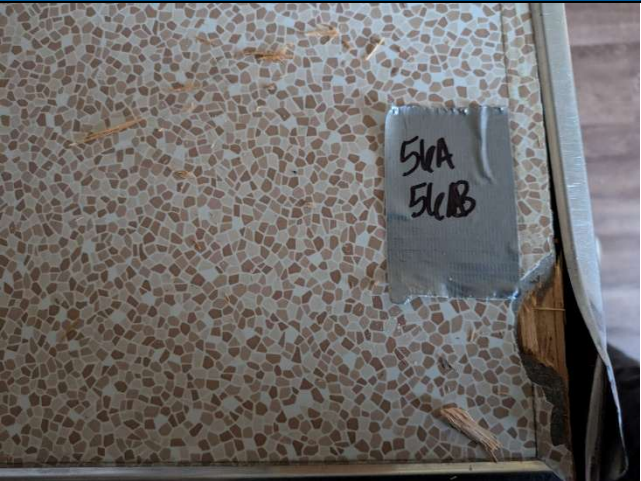
| Asbestos Samples | | | | |
|---|---|---|---|---|
| 56A | Brown pebble pattern countertop | Office Clinic | Countertop:<br>None Detected<br><br>Glue:<br>None Detected | |

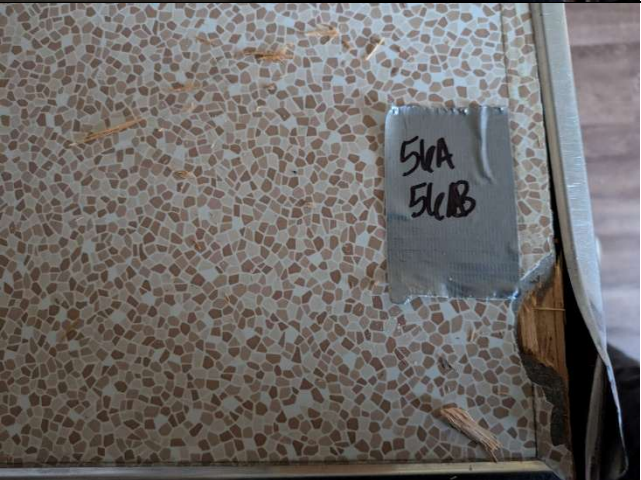
| Asbestos Samples | | | | |
|---|---|---|---|---|
| 56B | | Office Clinic | Countertop:<br>None Detected<br><br>Glue:<br>None Detected | |

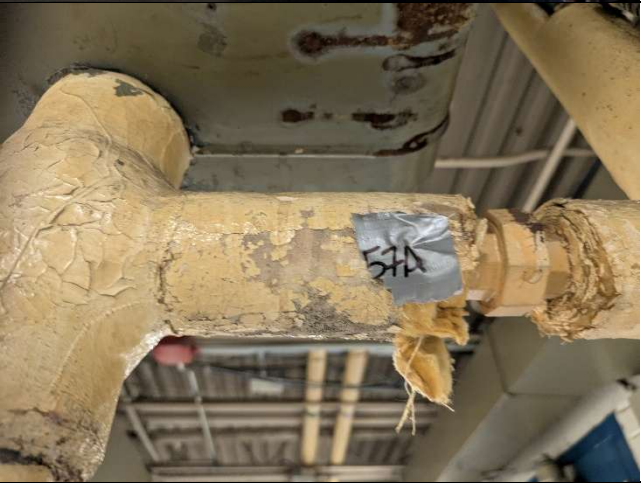
| Asbestos Samples | | | | |
|---|---|---|---|---|
| 57A | Exposed pipe insulation | Receiving Room at heater | None Detected | |

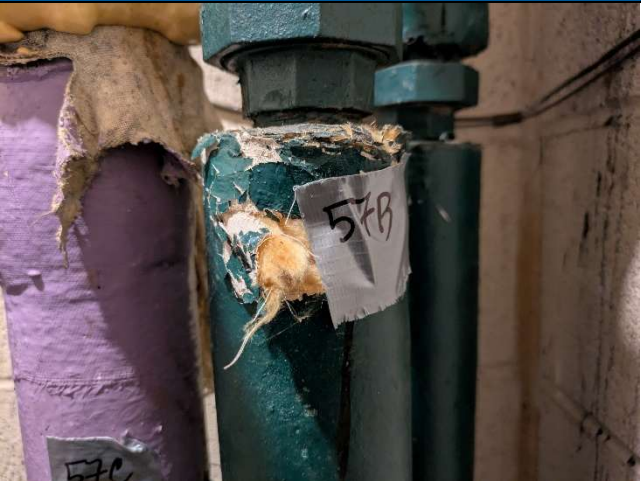
| Asbestos Samples | | | | |
|---|---|---|---|---|
| 57B | | Room 1 Closet, purple line | None Detected | |

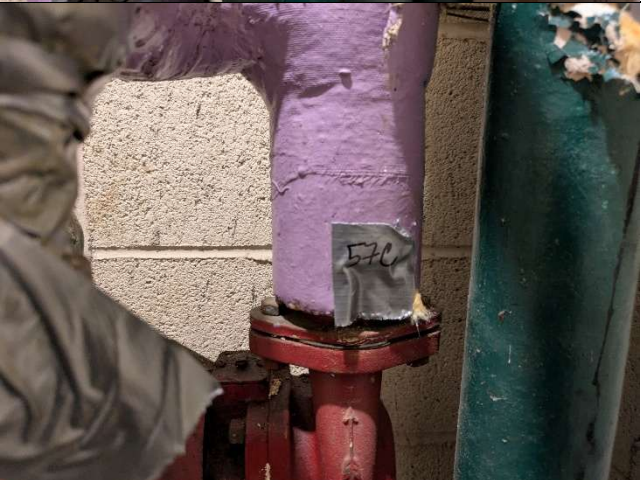
| Asbestos Samples | | | | |
|---|---|---|---|---|
| 57C | | Room 1 Closet, green line | None Detected | |

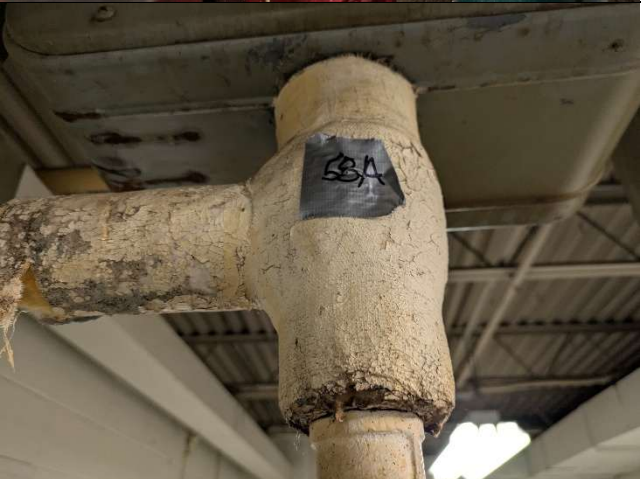
| Asbestos Samples | | | | |
|---|---|---|---|---|
| 58A | Exposed pipe fitting | Receiving Room at heater | None Detected | |

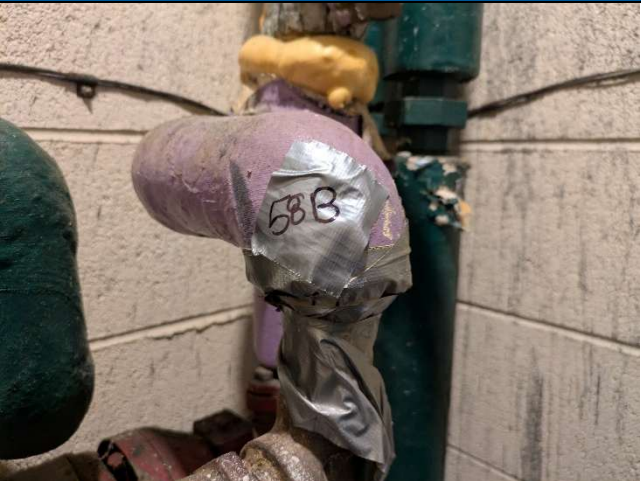
| Asbestos Samples | | | | |
|---|---|---|---|---|
| 58B | | Room 1 Closet, green line | None Detected | |

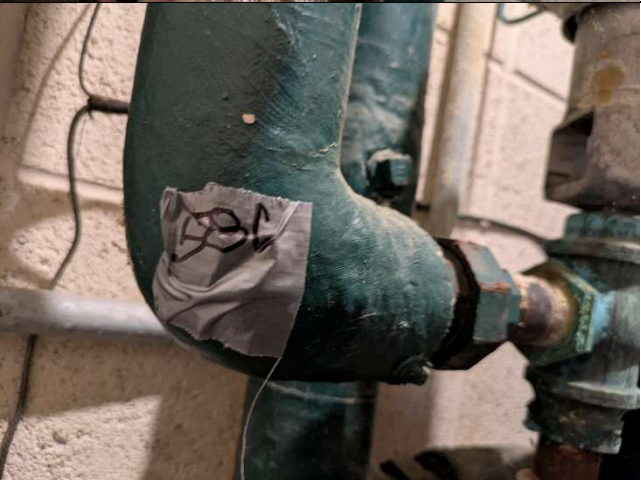
| Asbestos Samples | | | | |
|---|---|---|---|---|
| 58C | | Room 1 Closet, purple line | None Detected | |

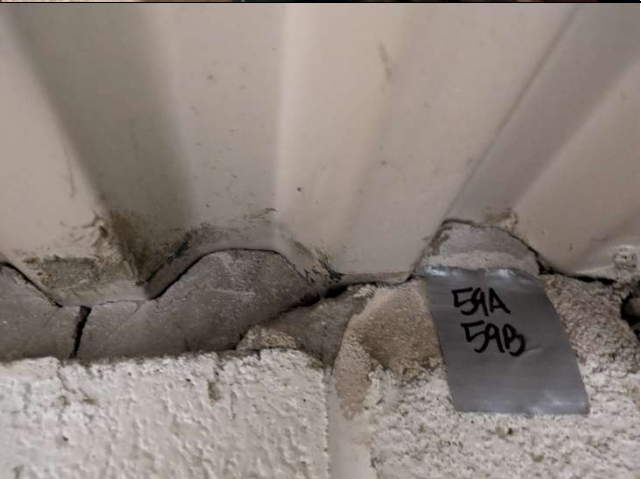
| Asbestos Samples | | | | |
|---|---|---|---|---|
| 59A | Lightweight concrete between upper block wall & metal ceiling | Receiving Room, West side | None Detected | |

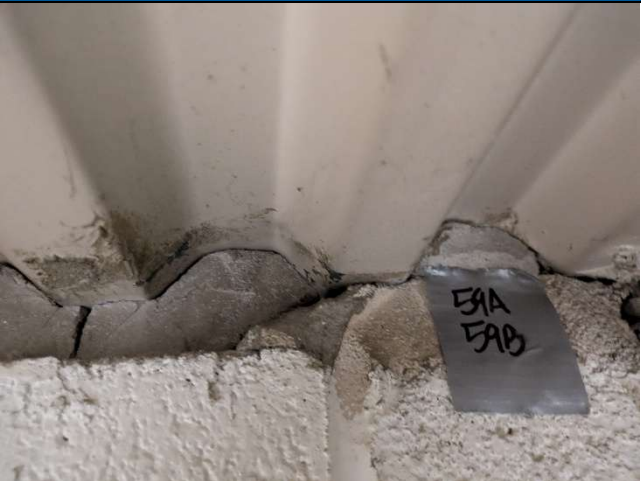
| Asbestos Samples | | | | |
|---|---|---|---|---|
| 59B | | Receiving Room, West side | None Detected | |

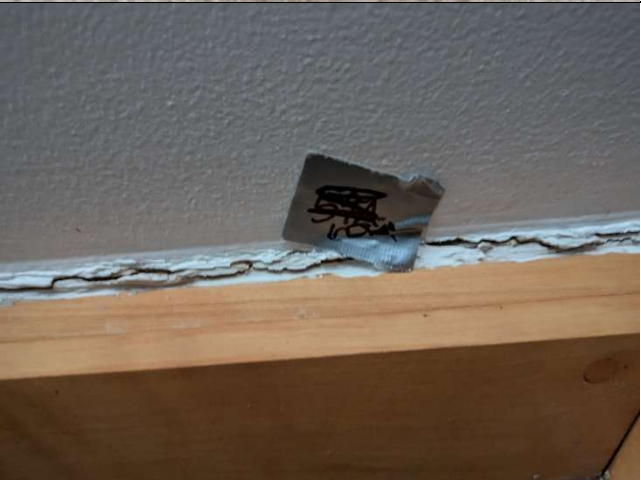
| Asbestos Samples | | | | |
|---|---|---|---|---|
| 60A | Door caulk | Room 1, above east door | 2.75% Chrysotile (Point Count Result) | |

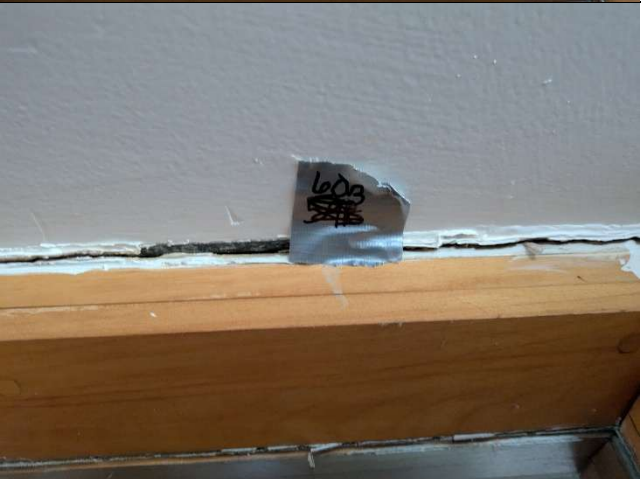
| Asbestos Samples | | | | |
|---|---|---|---|---|
| 60B | | Room 2, above east door | Not Analyzed | |

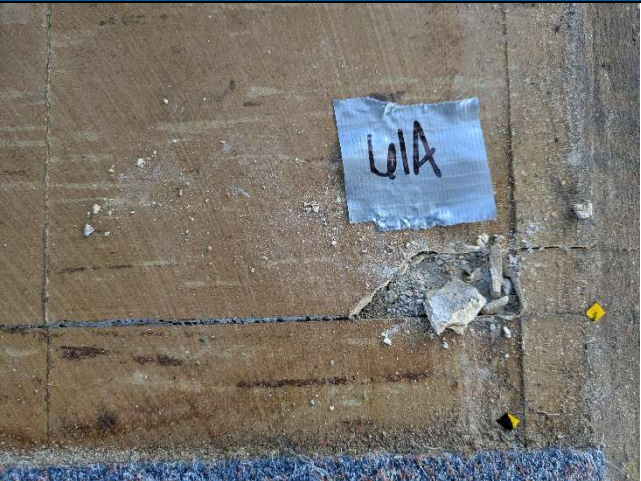
| Asbestos Samples | | | | |
|---|---|---|---|---|
| 61A | 9"x9" tan floor tile with brown markings | Corridor between 1960 and 1962 wings | Tile:<br>10% Chrysotile<br><br>Mastic:<br>None Detected | |

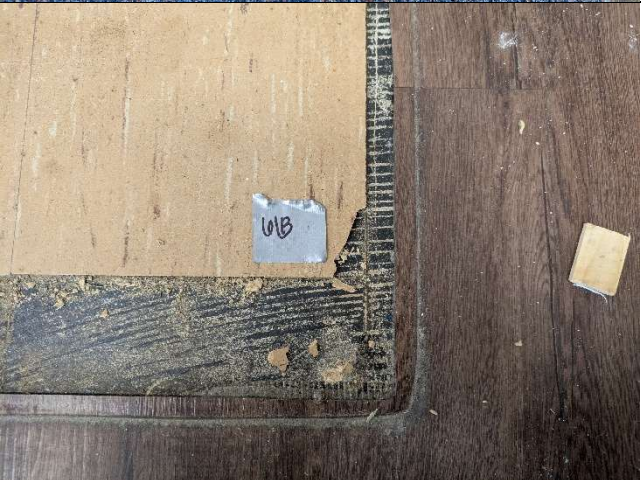
| Asbestos Samples | | | | |
|---|---|---|---|---|
| 61B | | Room 20, east side | Tile:<br>Not Analyzed<br><br>Mastic:<br>None Detected | |

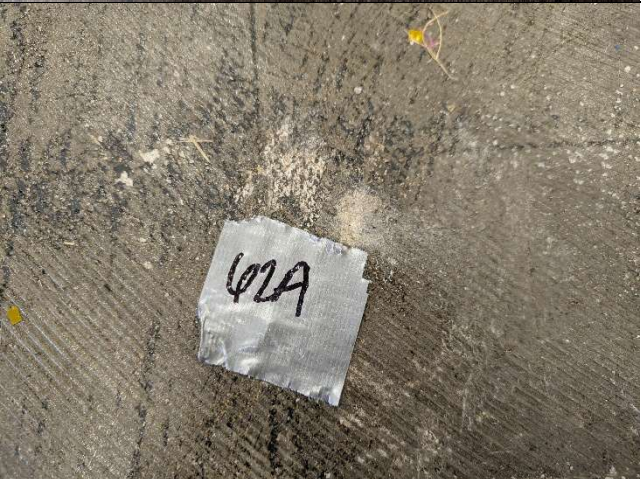
| Asbestos Samples | | | | |
|---|---|---|---|---|
| 62A | Mastic under pergo floor | Room 20, middle | None Detected | |

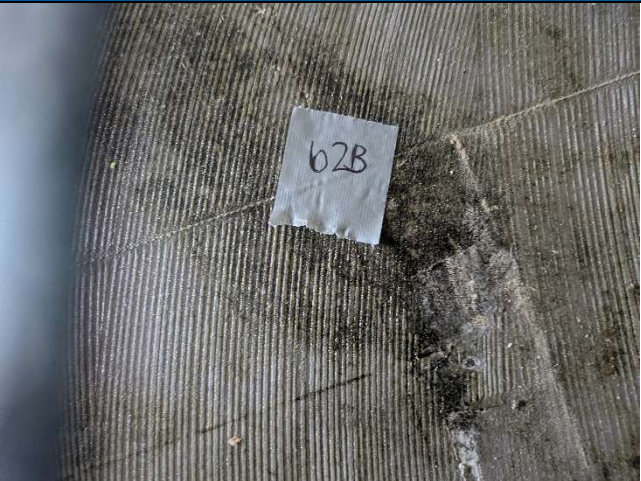
| Asbestos Samples | | | | |
|---|---|---|---|---|
| 62B | Window glazing, thin | Room 13, middle | None Detected | |

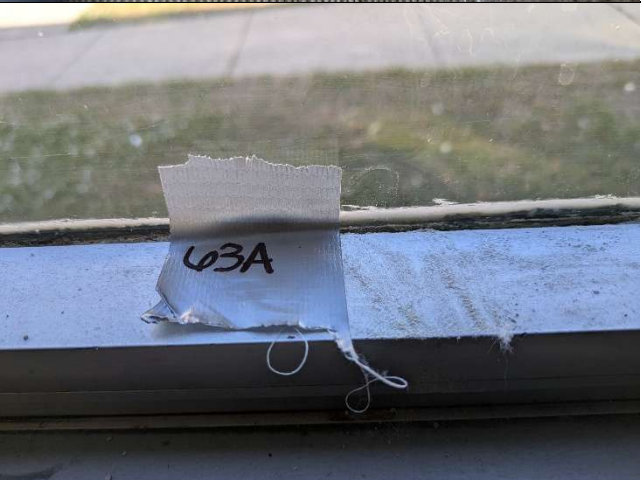
| Asbestos Samples | | | | |
|---|---|---|---|---|
| 63A | | Room 20, west side | None Detected | |

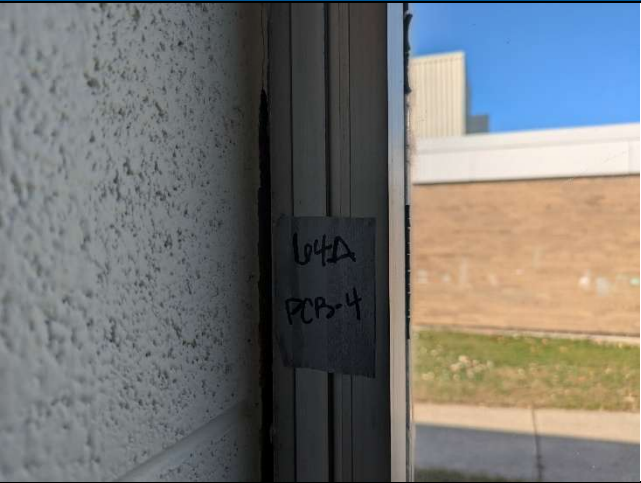
| Asbestos Samples | | | | |
|---|---|---|---|---|
| 64A | Window caulking, interior | Room 20, west side | 1.75% Chrysotile (Point Count Result) | |

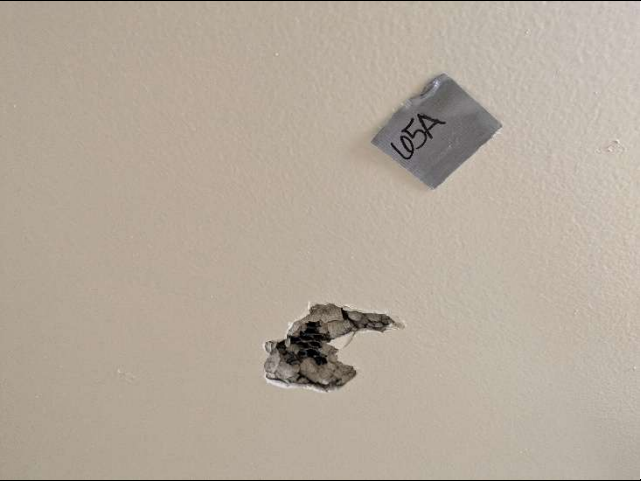
| Asbestos Samples | | | | |
|---|---|---|---|---|
| 65A | Plaster | Room 20, boys' bathroom | Finish Coat:<br>None Detected<br><br>Base Coat:<br>None Detected | |

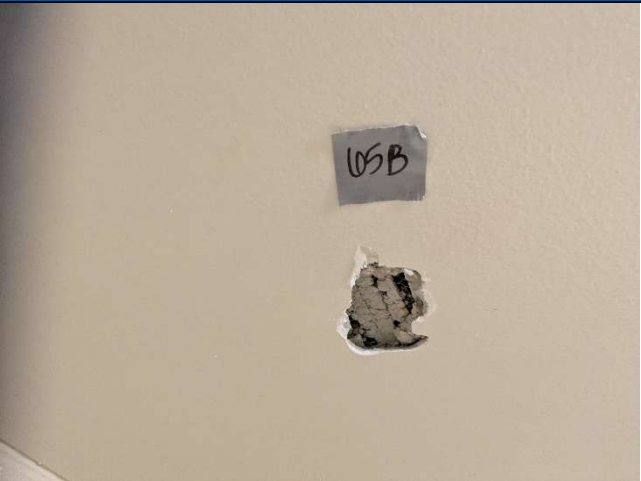
| Asbestos Samples | | | | |
|---|---|---|---|---|
| 65B | | Room 16, boys' bathroom | Finish Coat:<br>None Detected<br><br>Base Coat:<br>None Detected | |

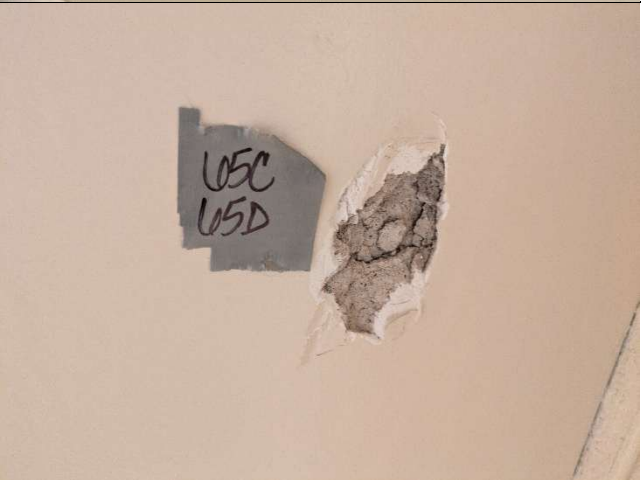
| Asbestos Samples | | | | |
|---|---|---|---|---|
| 65C | | Custodial closet | Finish Coat:<br>None Detected<br><br>Base Coat:<br>None Detected | |

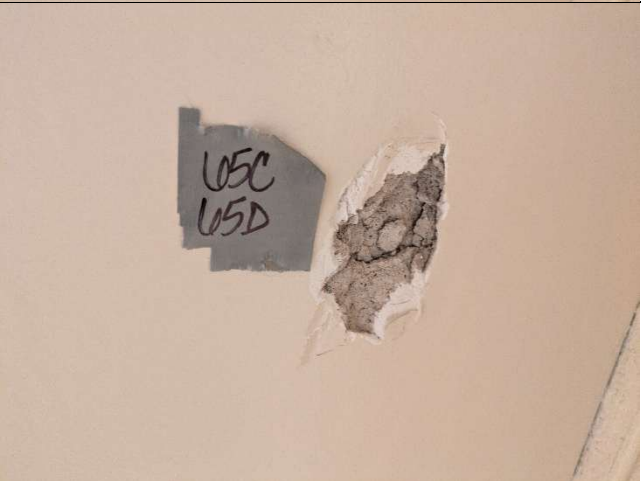
| Asbestos Samples | | | | |
|---|---|---|---|---|
| 65D | | Custodial closet | Finish Coat:<br>None Detected<br><br>Base Coat:<br>None Detected | |

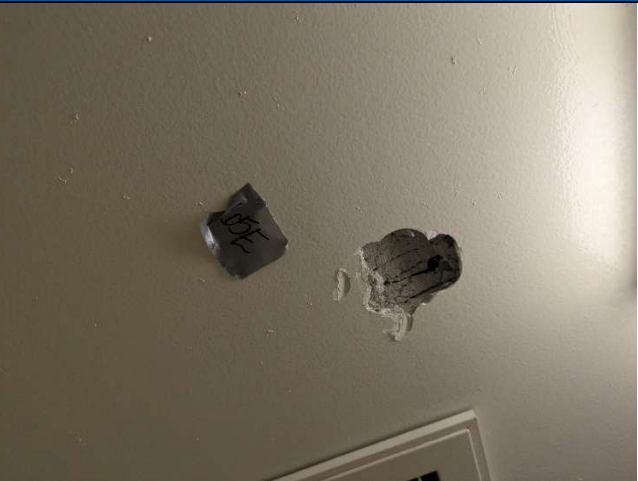
| Asbestos Samples | | | | |
|---|---|---|---|---|
| 65E | | Room 13, girls' bathroom | Finish Coat:<br>None Detected<br><br>Base Coat:<br>None Detected | |

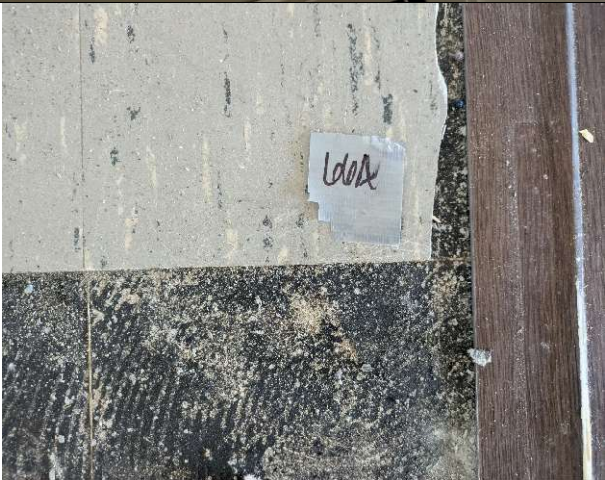
| Asbestos Samples | | | | |
|---|---|---|---|---|
| 66A | 9"x9" gray floor tile with black markings | Room 18, NE corner | Tile:<br>10% Chrysotile<br><br>Mastic:<br>None Detected | |

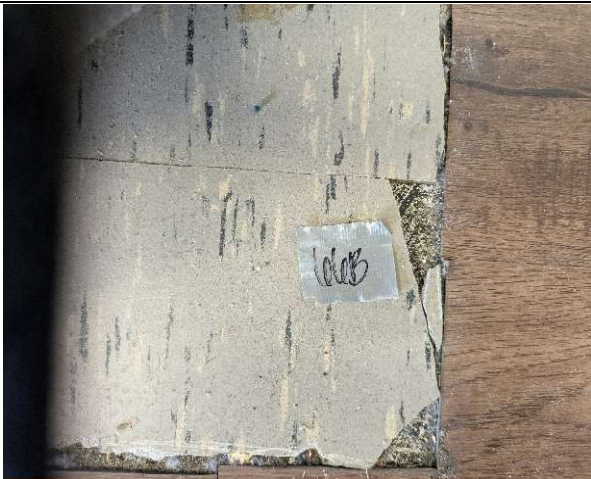
| Asbestos Samples | | | | |
|---|---|---|---|---|
| 66B | | Room 14, east side | Tile:<br>Not Analyzed<br><br>Mastic:<br>None Detected | |

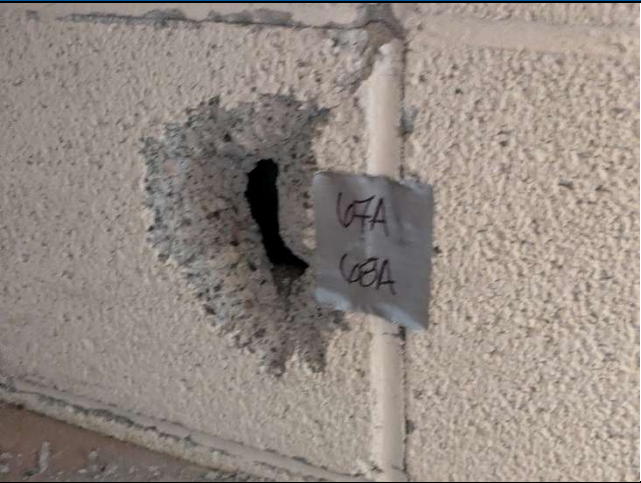
| Asbestos Samples | | | | | |
|---|---|---|---|---|---|
| 67A | Masonry block | Room 19, closet | None Detected | | |

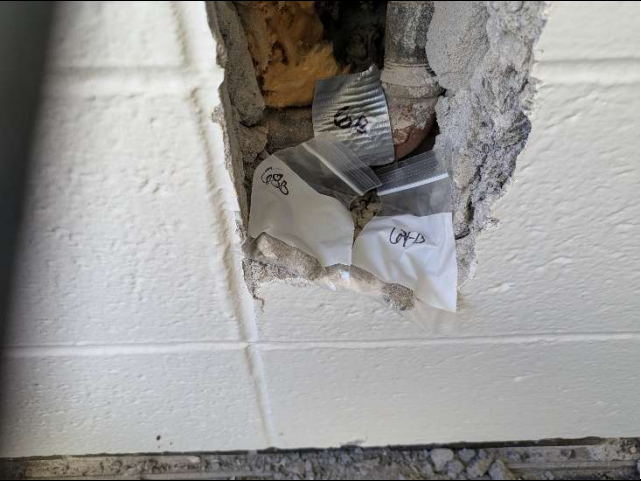
| Asbestos Samples | | | | | |
|---|---|---|---|---|---|
| 67B | | South Hallway, chase at south door | None Detected | | |

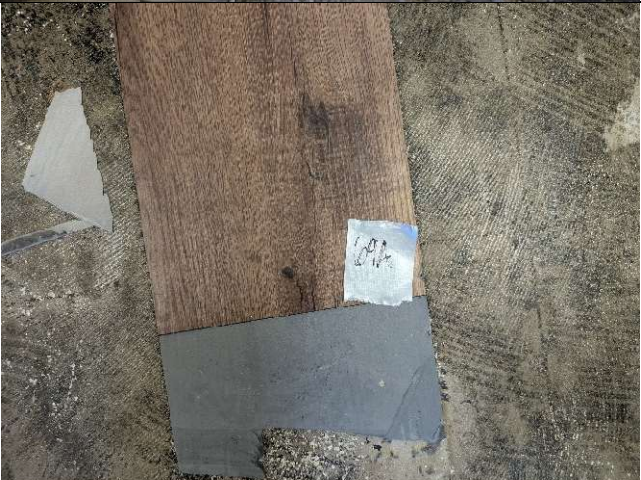
| Asbestos Samples | | | | |
|---|---|---|---|---|
| 69A | | Room 15, middle | None Detected | |

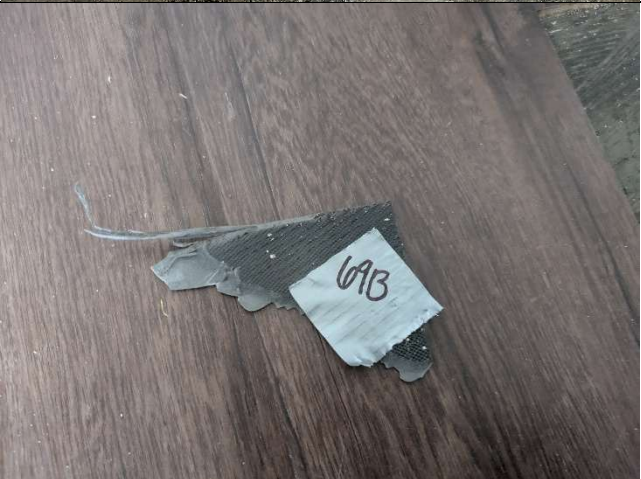
| Asbestos Samples | | | | |
|---|---|---|---|---|
| 69B | | Room 16, south side | None Detected | |

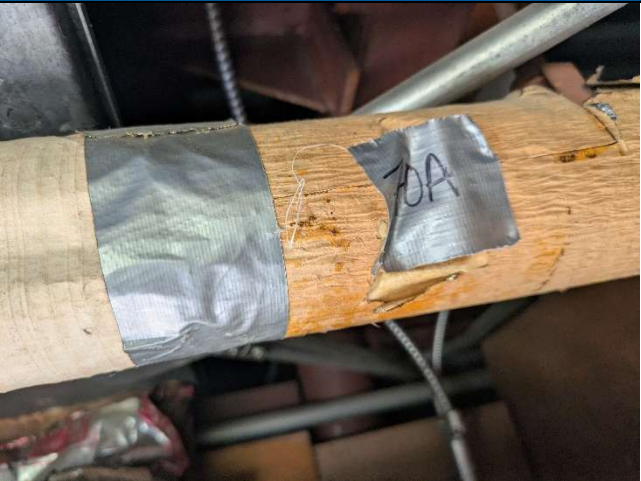
| Asbestos Samples | | | | |
|---|---|---|---|---|
| 70A | Fiberglass pipe insulation with black and foil wrap | Corridor between 1960 & 1962 wings | None Detected | |

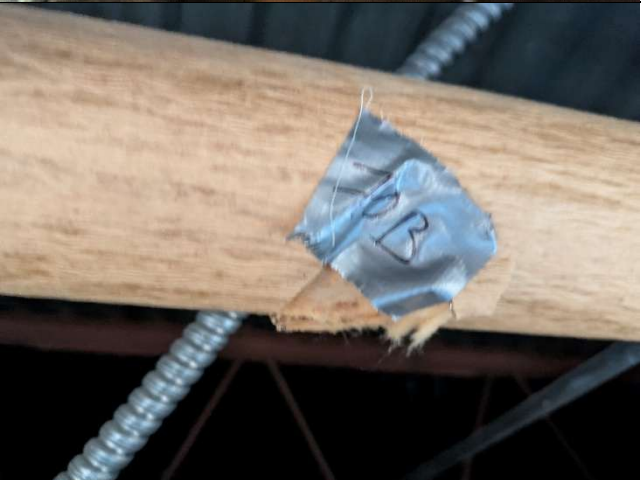
| Asbestos Samples | | | | |
|---|---|---|---|---|
| 70B | | Room 13 | None Detected | |

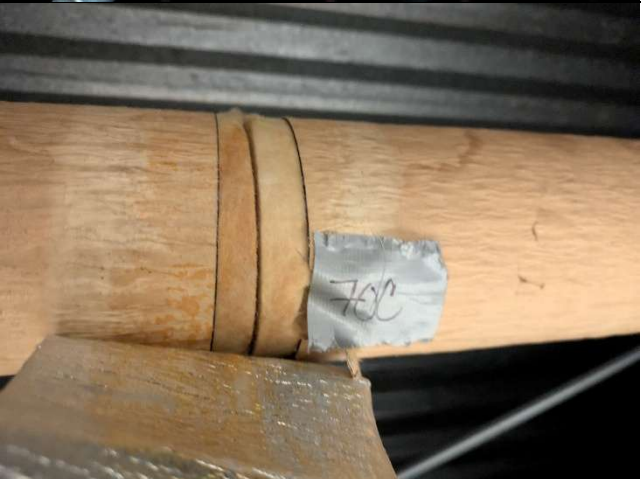
| Asbestos Samples | | | | |
|---|---|---|---|---|
| 70C | | Room 16, NE | None Detected | |

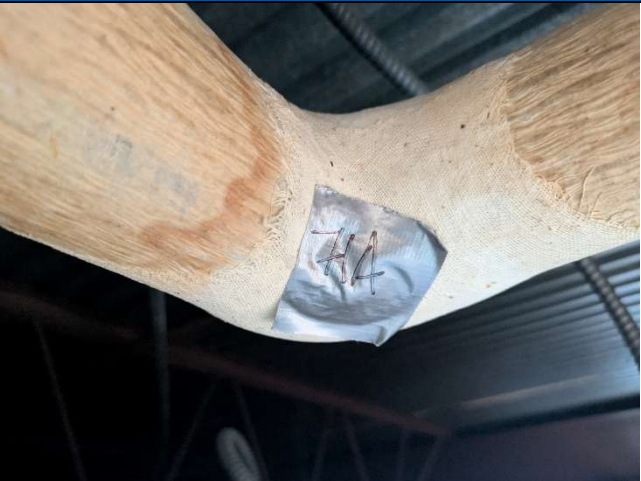
| Asbestos Samples | | | | |
|---|---|---|---|---|
| 71A | Fittings associated with HA 70 | Room 13 | None Detected | |

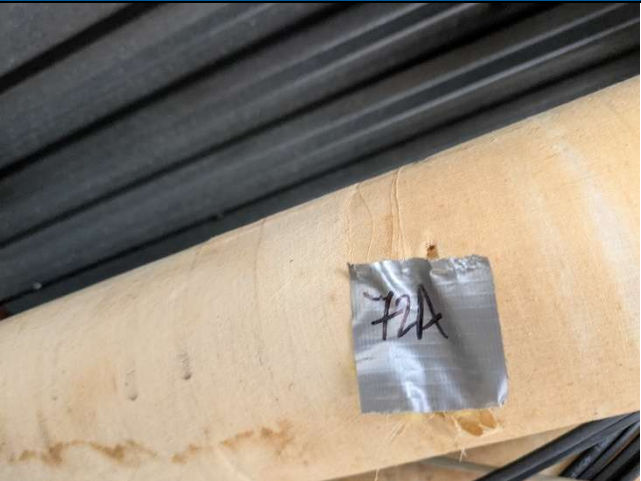
| Asbestos Samples | | | | |
|---|---|---|---|---|
| 72A | Fiberglass pipe insulation | Corridor outside of Room 20 | None Detected | |

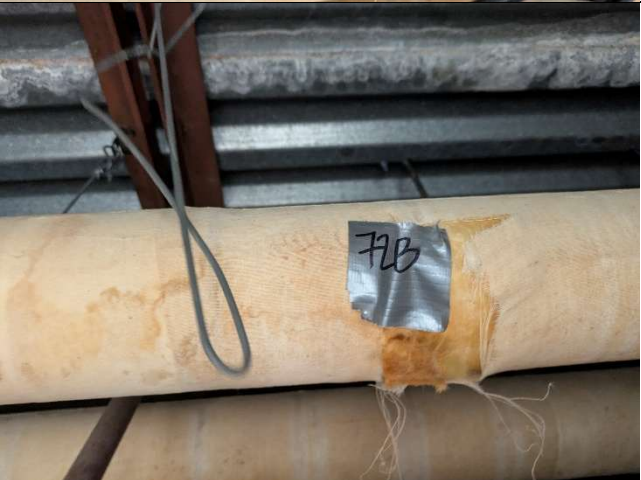
| Asbestos Samples | | | | |
|---|---|---|---|---|
| 72B | | Room 20, SW | None Detected | |

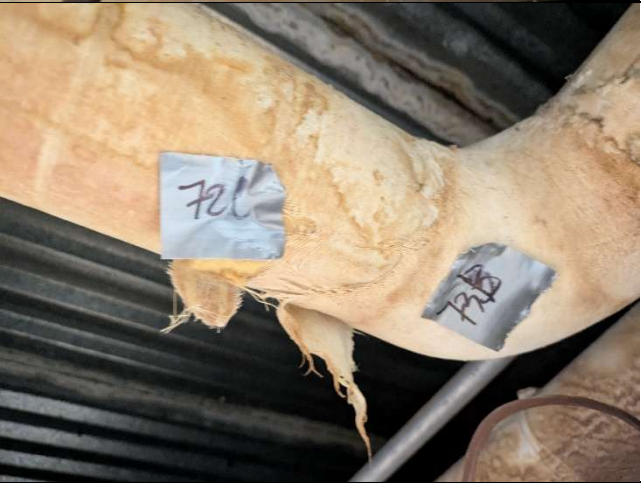
| Asbestos Samples | | | | |
|---|---|---|---|---|
| 72C | | Room 20, SE | None Detected | |
