# HAZARDOUS MATERIALS SURVEY REPORT

## FORMER MARSHALL ELEMENTARY SCHOOL LIVONIA, MICHIGAN

December 16, 2025  
NTH Project No. 25002747-01

**RE: Report on Hazardous Materials Survey  
Former Marshall Elementary School  
33901 Curtis Road  
Livonia, Michigan**

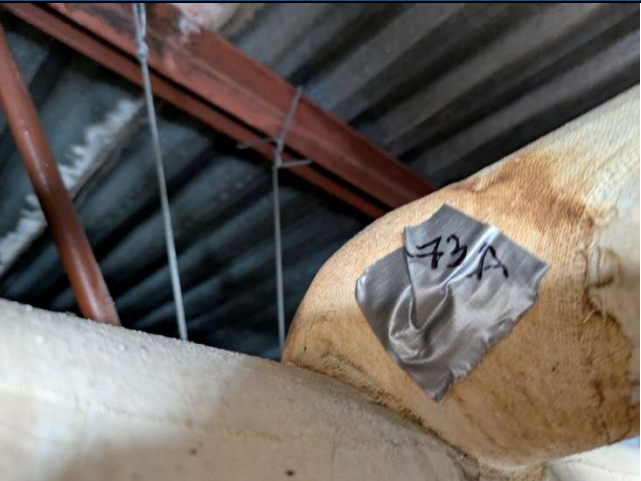
| Asbestos Samples | | | | |
|---|---|---|---|---|
| 73A | Fittings associated with HA 72 | Room 20, north of baths | None Detected | |

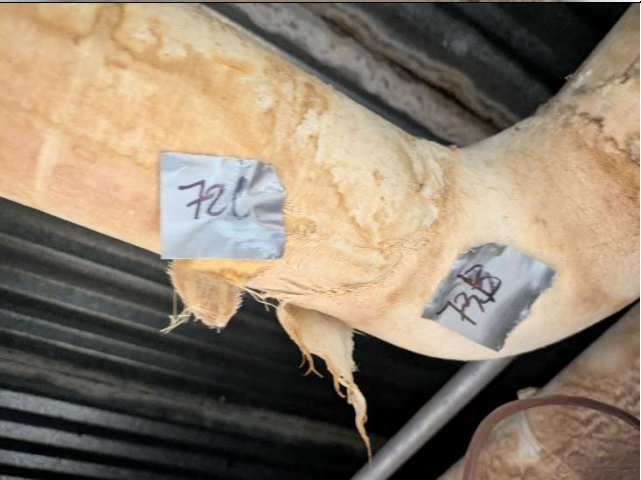
| Asbestos Samples | | | | |
|---|---|---|---|---|
| 73B | | Room 20, SE | None Detected | |

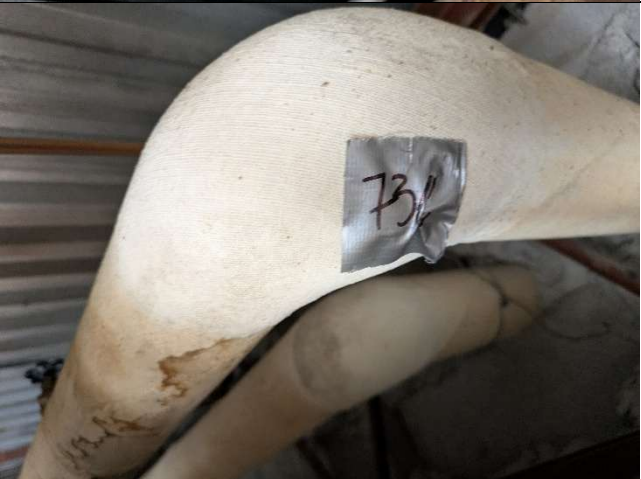
| Asbestos Samples | | | | |
|---|---|---|---|---|
| 73C | | Room 18, SE | None Detected | |

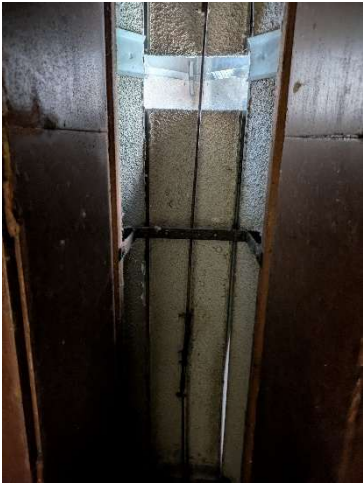
| Asbestos Samples | | | | |
|---|---|---|---|---|
| 74A | Coating of roof vent | 1962, corridor, middle | 10% Chrysotile | |

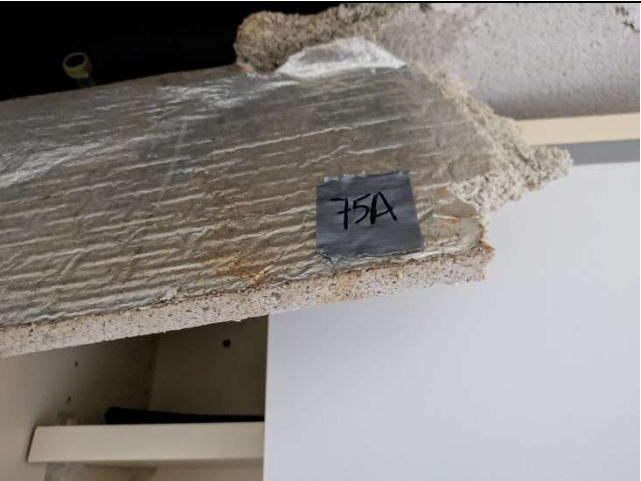
| Asbestos Samples | | | | |
|---|---|---|---|---|
| 75A | 2'x2' ceiling tile, textured | Room 25, west side | None Detected | |

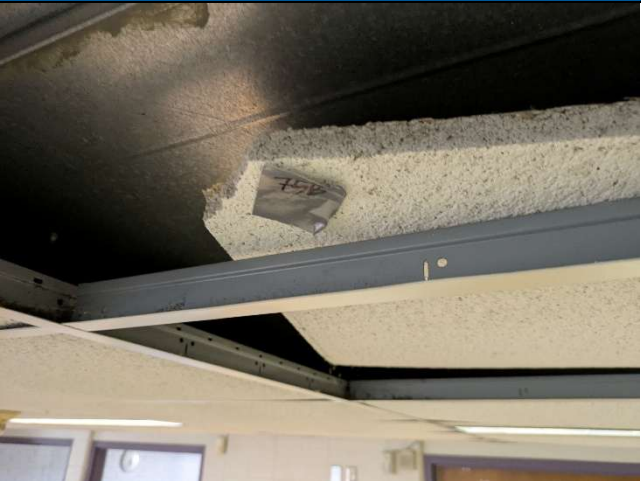
| Asbestos Samples | | | | |
|---|---|---|---|---|
| 75B | | Library, west side | None Detected | |

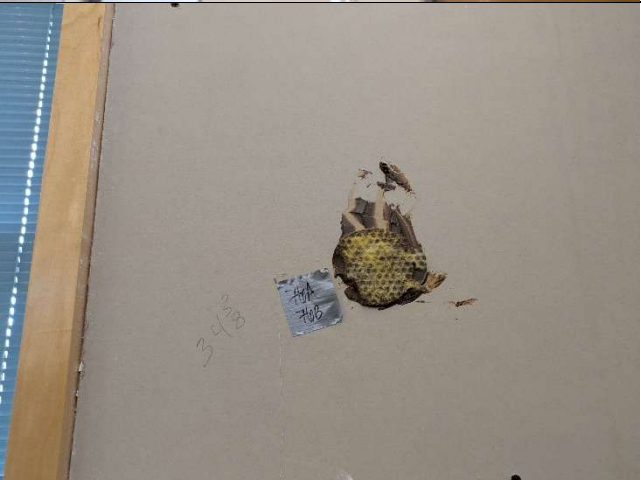
| Asbestos Samples | | | | |
|---|---|---|---|---|
| 76A | Brown glue pods under soundproofing panels | Library, south side | None Detected | |

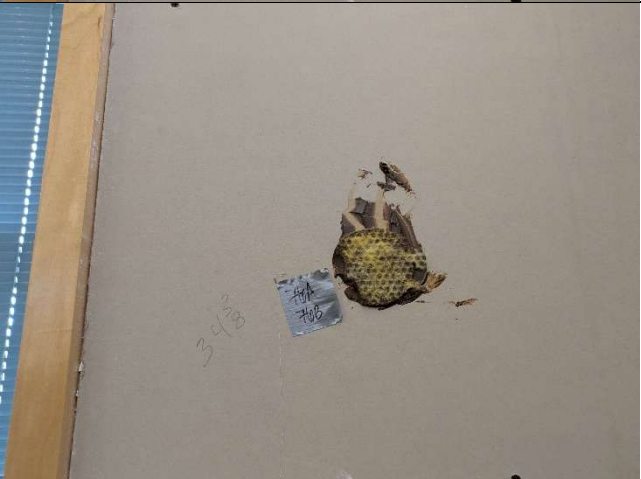
| Asbestos Samples | | | | |
|---|---|---|---|---|
| 76B | | Library, south side | None Detected | |

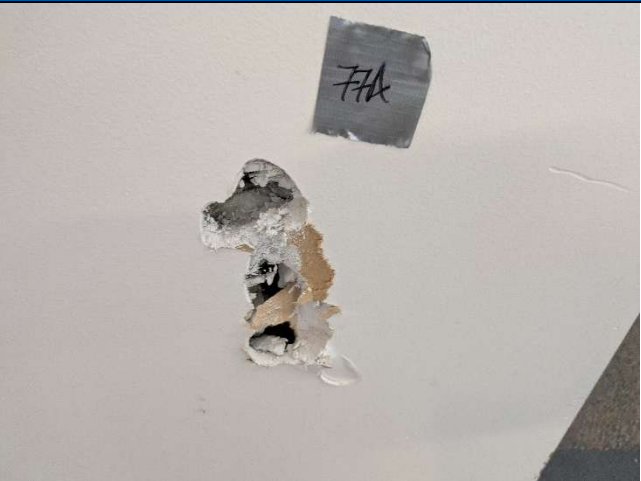
| Asbestos Samples | | | | |
|---|---|---|---|---|
| 77A | Drywall | Library, south side | None Detected | |

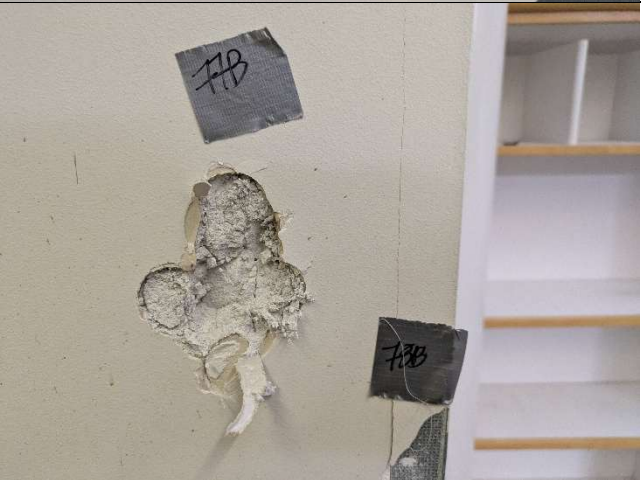
| Asbestos Samples | | | | |
|---|---|---|---|---|
| 77B | | Library, east side | None Detected | |

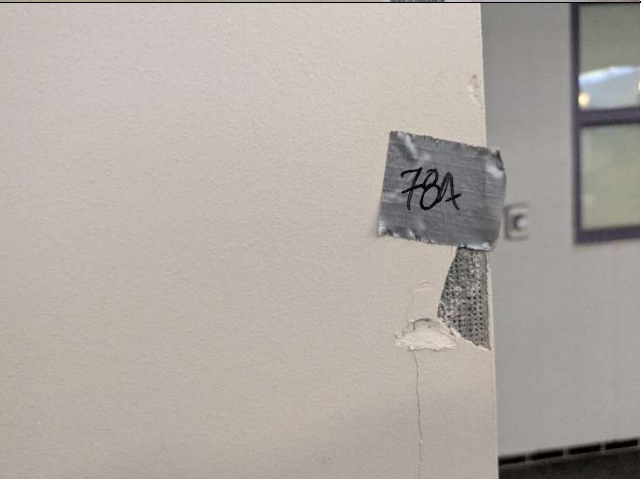
| Asbestos Samples | | | | |
|---|---|---|---|---|
| 78A | Joint Compound | Library, south side | None Detected | |

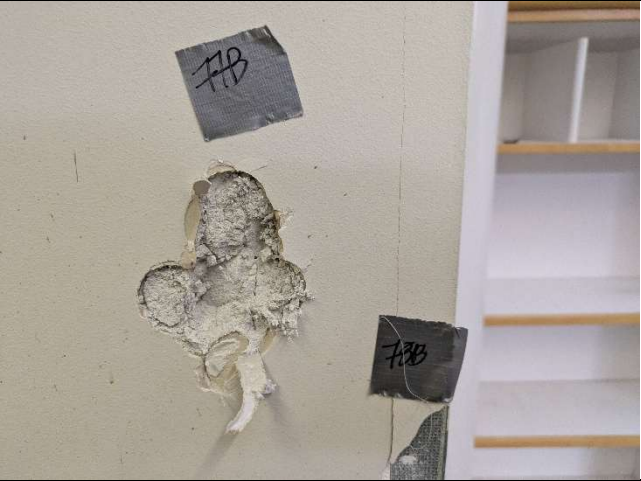
| Asbestos Samples | | | | |
|---|---|---|---|---|
| 78B | | Library, east side | None Detected | |

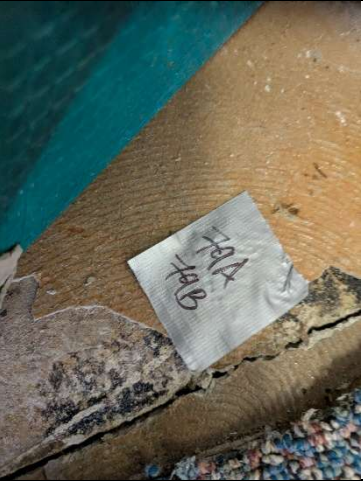
| Asbestos Samples | | | | |
|---|---|---|---|---|
| 79A | Light gray floor leveler | Library, east side | None Detected | |

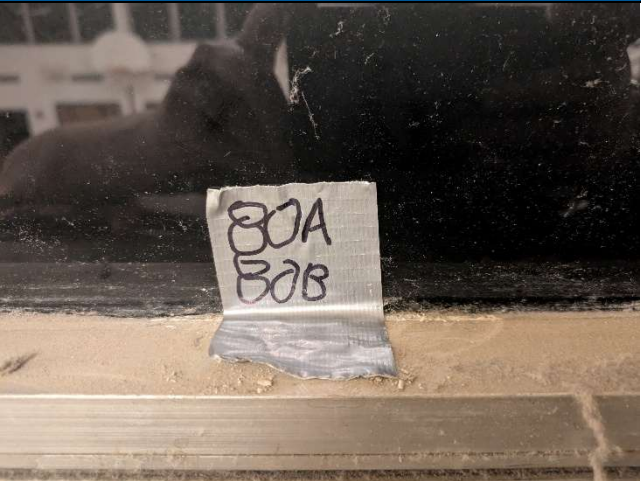
| Asbestos Samples | | | | |
|---|---|---|---|---|
| 80A | Gymnasium window glazing | Gym, north side | None Detected | |

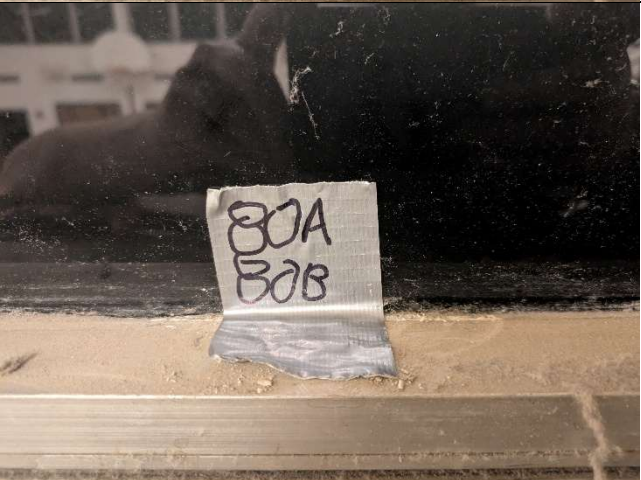
| Asbestos Samples | | | | |
|---|---|---|---|---|
| 80B | | Gym, north side | None Detected | |

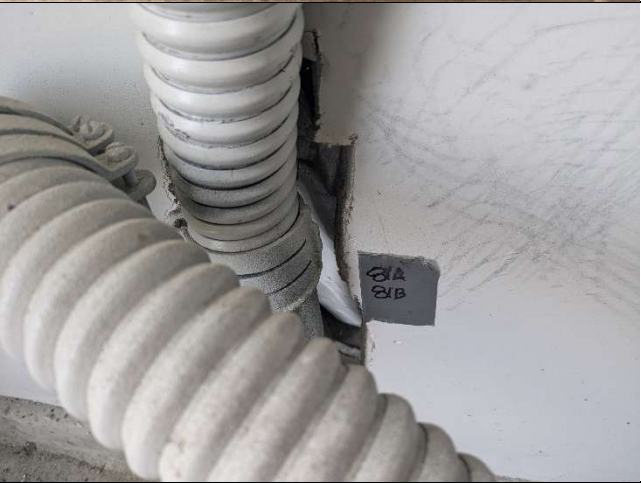
| Asbestos Samples | | | | |
|---|---|---|---|---|
| 81A | Drywall and paper | Rooftop Mechanical Room, east side | Drywall & Paper:<br>None Detected<br>Tape:<br>None Detected<br>Mud:<br>None Detected | |

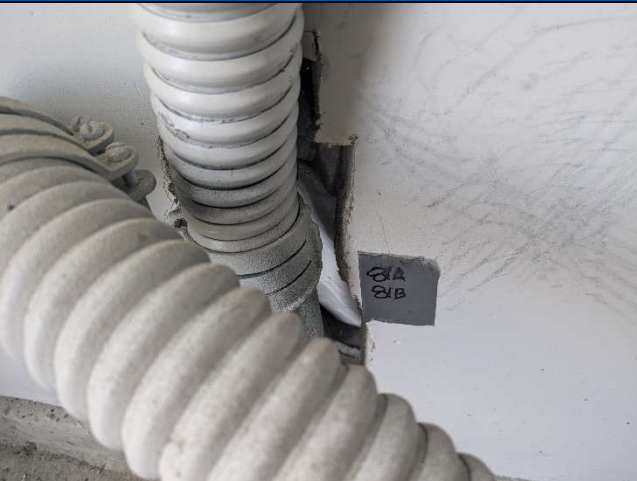
| Asbestos Samples | | | | |
|---|---|---|---|---|
| 81B | | Rooftop Mechanical Room, east side | Drywall & Paper:<br>None Detected<br>Tape:<br>None Detected<br>Mud:<br>None Detected | |

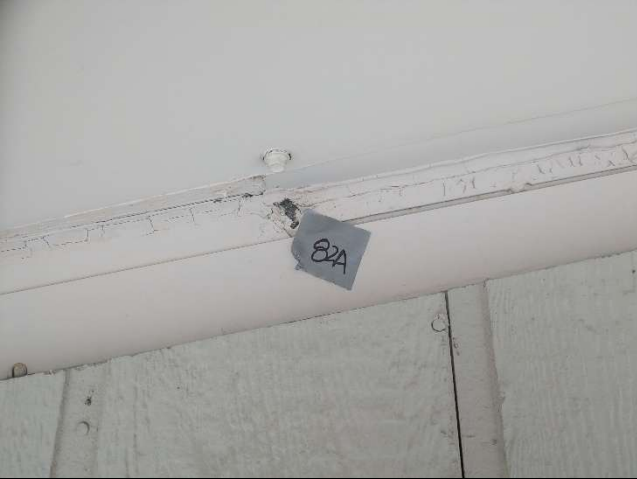
| Asbestos Samples | | | | |
|---|---|---|---|---|
| 82A | White sealant around gym windows | Roof, south side of gym | None Detected | |

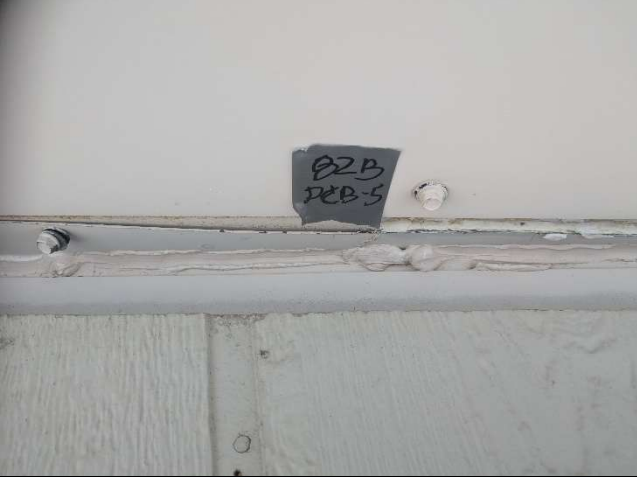
| Asbestos Samples | | | | |
|---|---|---|---|---|
| 82B | | Roof, south side of gym | None Detected | |

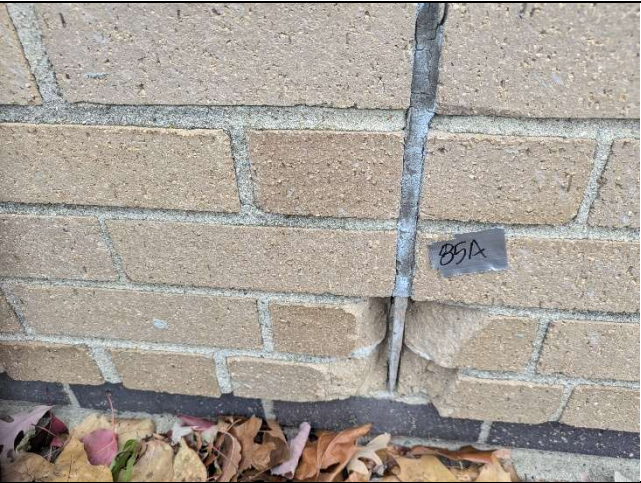
| Asbestos Samples | | | | |
|---|---|---|---|---|
| 85A | Gray expansion joint | Near main entrance | None Detected | |

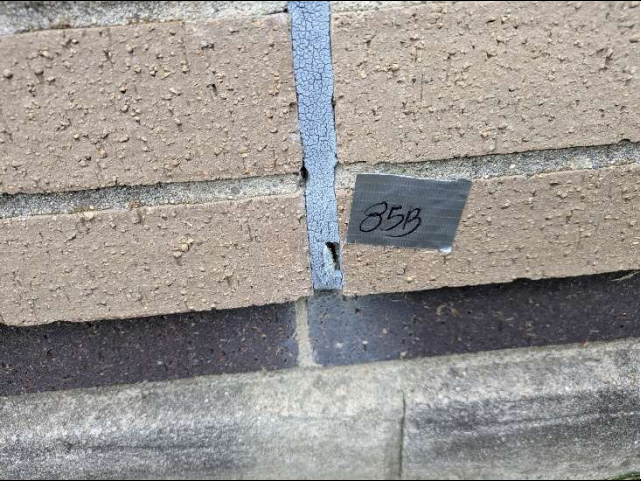
| Asbestos Samples | | | | |
|---|---|---|---|---|
| 85B | | North side of Room 11 | None Detected | |

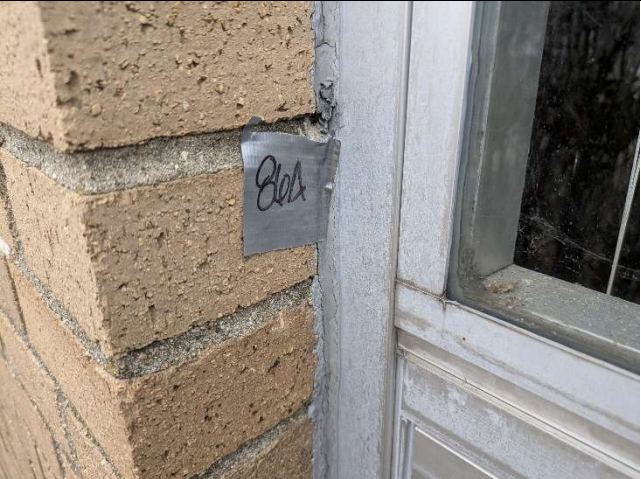
| Asbestos Samples | | | | |
|---|---|---|---|---|
| 86A | Gray exterior window caulking | North side, west of entrance | None Detected | |

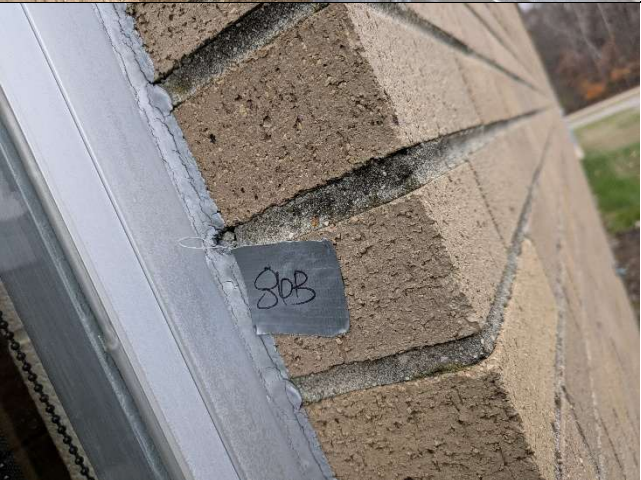
| Asbestos Samples | | | | |
|---|---|---|---|---|
| 86B | | Exterior of Room 12 | None Detected | |

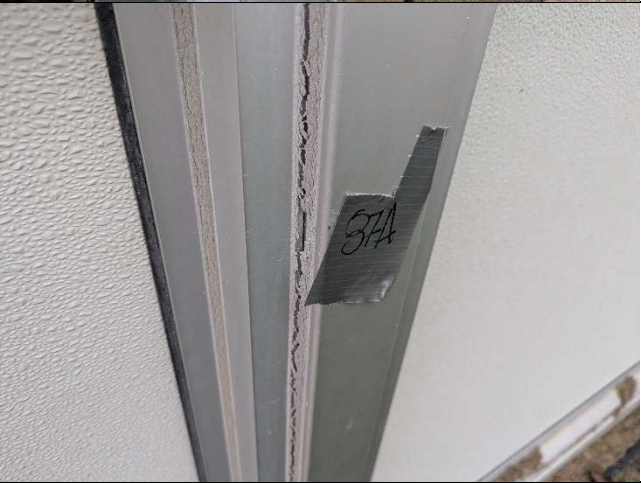
| Asbestos Samples | | | | |
|---|---|---|---|---|
| 87A | Door and window caulk at connectors | West side of 1960 connector | None Detected | |

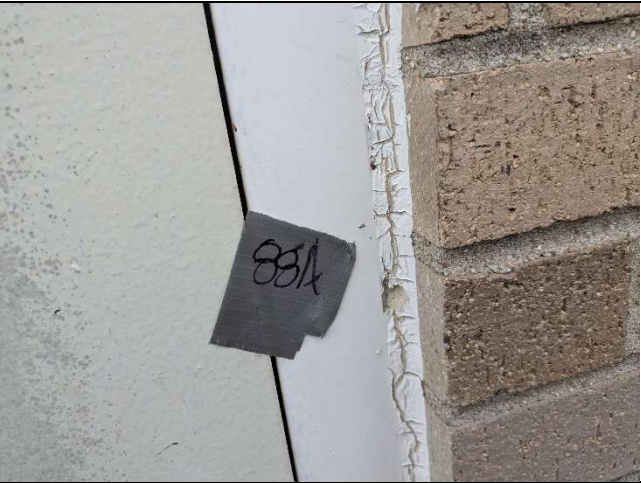
| Asbestos Samples | | | | |
|---|---|---|---|---|
| 88A | White door caulk | Exterior of Room 7 | None Detected | |

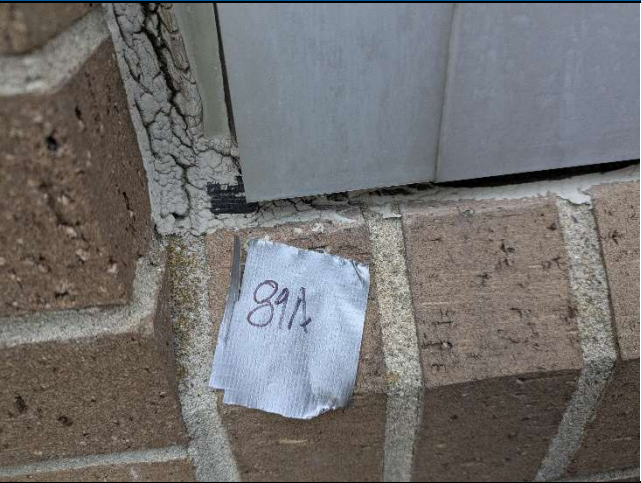
| Asbestos Samples | | | | |
|---|---|---|---|---|
| 89A | White exterior window caulk (1992) | Library, south | None Detected | |

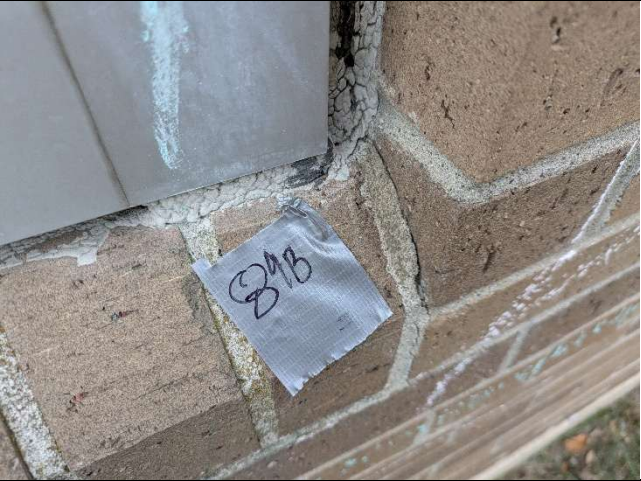
| Asbestos Samples | | | | |
|---|---|---|---|---|
| 89B | | Library, east | None Detected | |

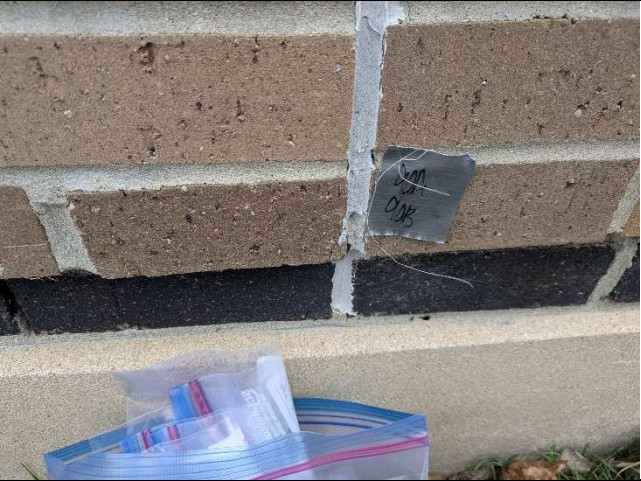
| Asbestos Samples | | | | |
|---|---|---|---|---|
| 90A | Light gray exterior expansion joint | Library, south | None Detected | |

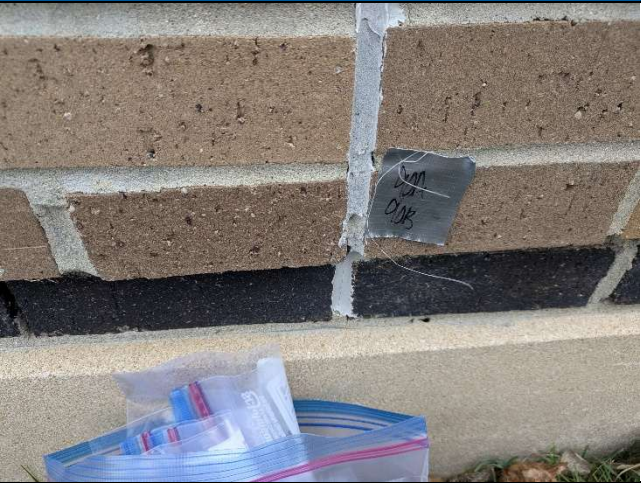
| Asbestos Samples | | | | |
|---|---|---|---|---|
| 90B | | Library, south | None Detected | |

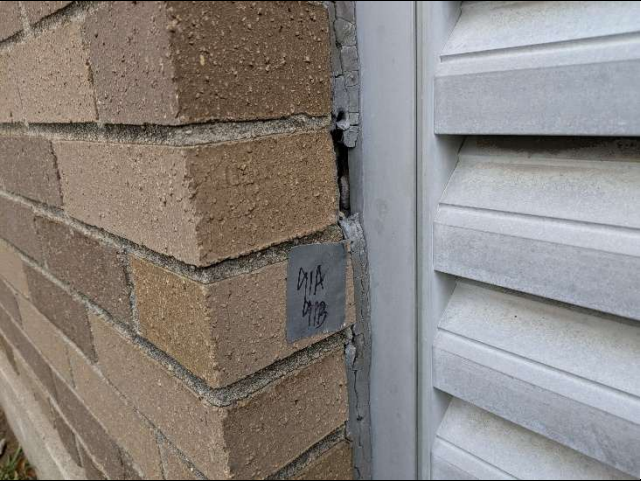
| Asbestos Samples | | | | |
|---|---|---|---|---|
| 91A | Gray exterior window caulk | Room 20 | None Detected | |

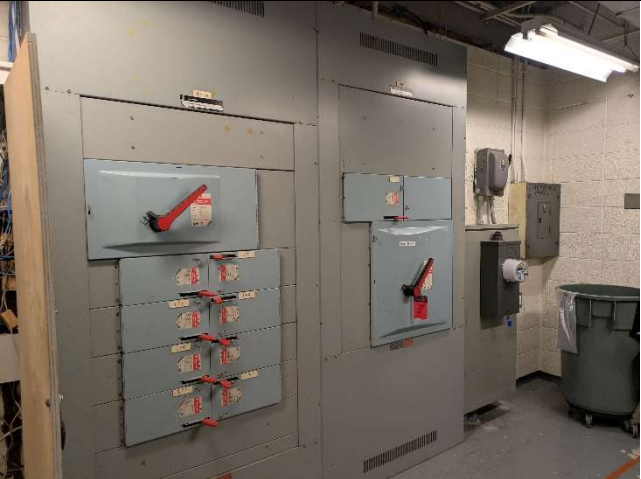
| Asbestos Samples | | | | |
|---|---|---|---|---|
| Not Sampled<br>(HA-95) | Switchgear components | Not sampled | Assumed | |

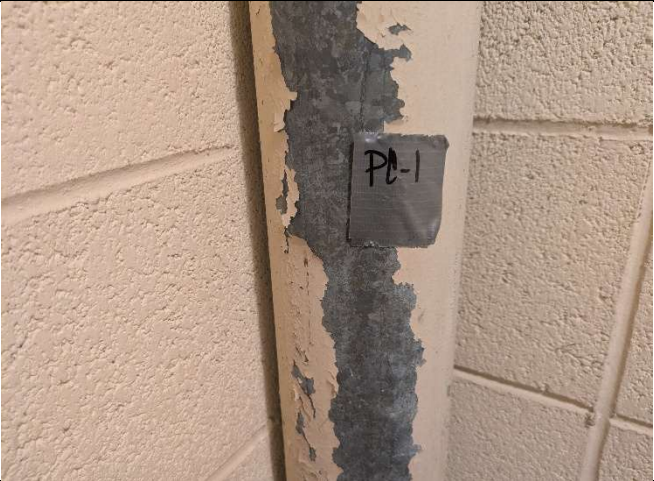
| Paint Chip Samples | | | | | | |
|---|---|---|---|---|---|---|
| PC-1 | Off-White Metal Pipe | 1960 Custodial Closet | <0.01 | 0.48 | | |

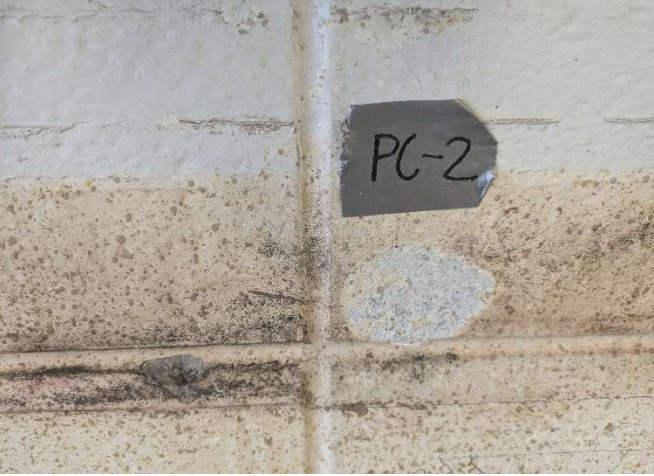
| Paint Chip Samples | | | | | | |
|---|---|---|---|---|---|---|
| PC-2 | White with Off-White below | Room 9, North Wall | <0.01 | 0.02 | | |

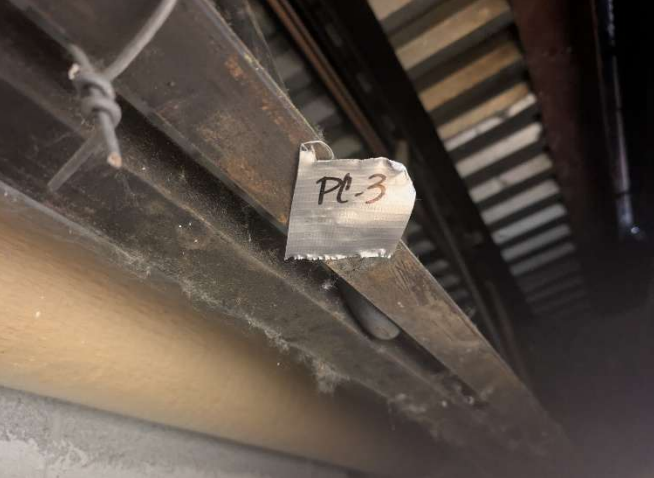
| Paint Chip Samples | | | | | | |
|---|---|---|---|---|---|---|
| PC-3 | Black Structural Metal | Office 30 | <0.02 | <0.02 | | |

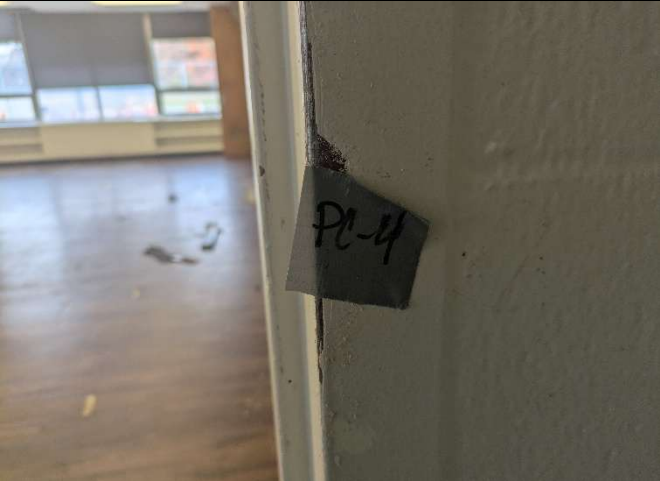
| Paint Chip Samples | | | | | | |
|---|---|---|---|---|---|---|
| PC-4 | White with Red below Metal Door Frame | Room 9 | <0.01 | <0.01 | | |

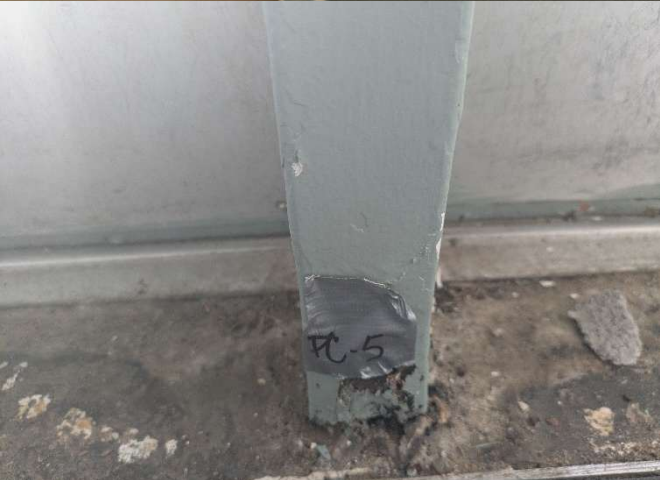
| Paint Chip Samples | | | | | | |
|---|---|---|---|---|---|---|
| PC-5 | Light Blue with Off-White and Black below Metal Door Frame | 1960 South Hallway, South Door | <0.01 | <0.01 | | |

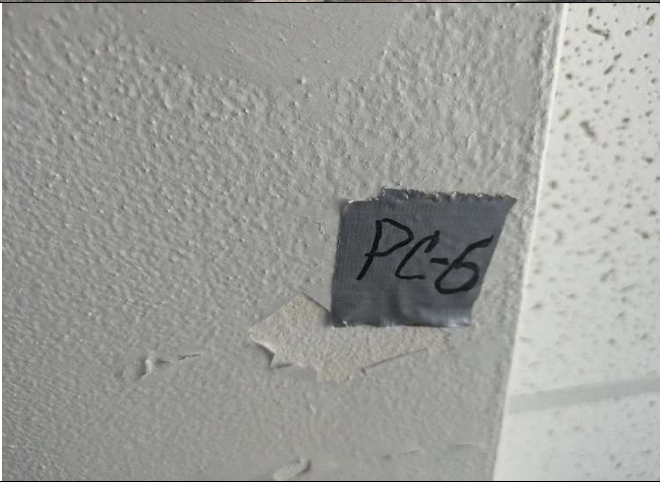
| Paint Chip Samples | | | | | | |
|---|---|---|---|---|---|---|
| PC-6 | White Plaster Ceiling | Lobby, West Side | <0.01 | <0.01 | | |

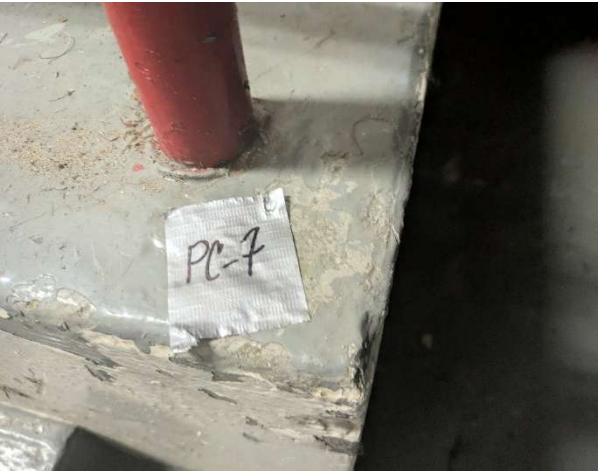
| Paint Chip Samples | | | | | | |
|---|---|---|---|---|---|---|
| PC-7 | Gray Concrete Floor | Boiler Room, South End Landing | <0.01 | 0.04 | | |

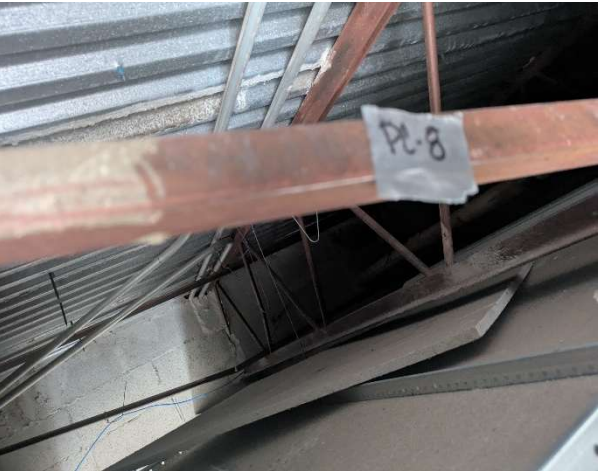
| Paint Chip Samples | | | | | | |
|---|---|---|---|---|---|---|
| PC-8 | Red Structural Metal Primer | Room 16, East Side | <0.03 | <0.03 | | |

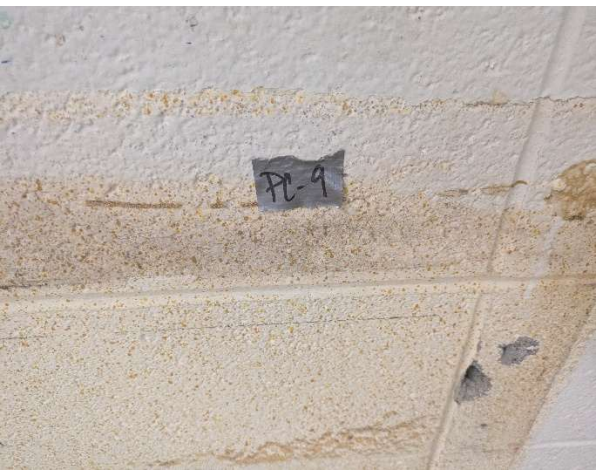
| Paint Chip Samples | | | | | | |
|---|---|---|---|---|---|---|
| PC-9 | White with Off-White below Block Wall | Room 15, South Side | 0.01 | <0.01 | | |

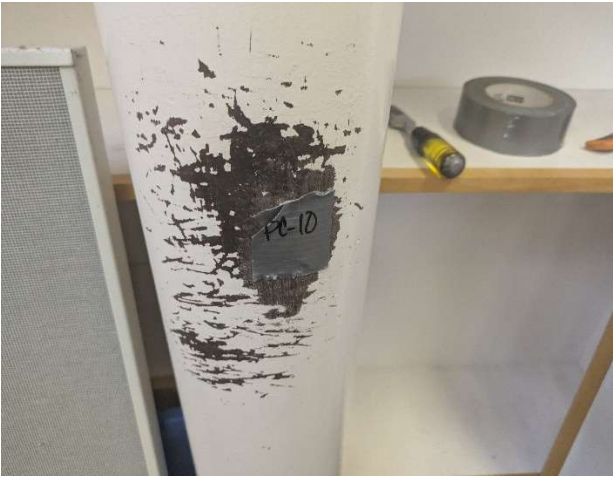
| Paint Chip Samples | | | | | | |
|---|---|---|---|---|---|---|
| PC-10 | White Metal Pole | Library | <0.02 | 0.47 | | |

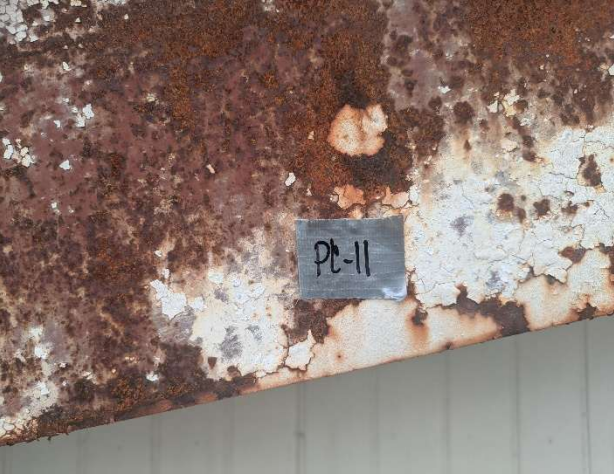
| Paint Chip Samples | | | | | | |
|---|---|---|---|---|---|---|
| PC-11 | White Metal Beam on Gym Roof | Roof, South Side of Gym | <0.01 | 4.79 | | |

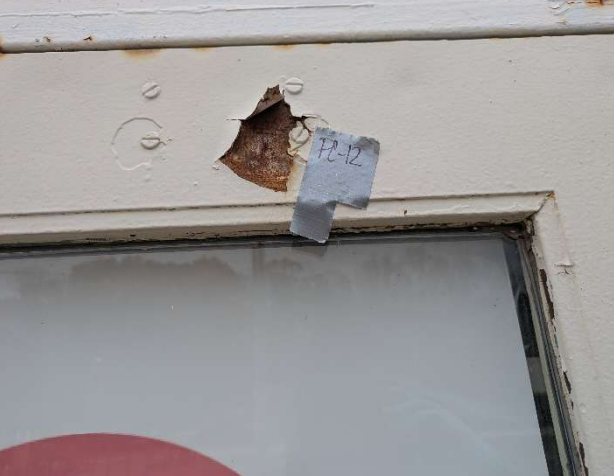
| Paint Chip Samples | | | | | | |
|---|---|---|---|---|---|---|
| PC-12 | White Metal Exterior Door | West Side, North End | <0.01 | 0.77 | | |

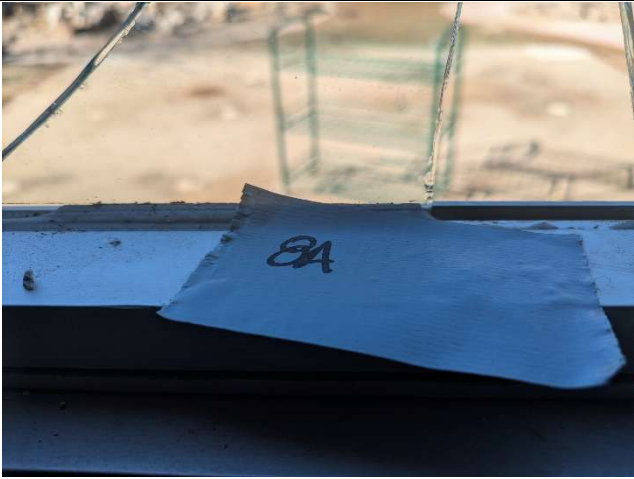
| PCB Samples | | | |
|---|---|---|---|
| PCB-1 | Interior Window Glaze | Room 9, West Side (Same location as asbestos sample 8A) | |

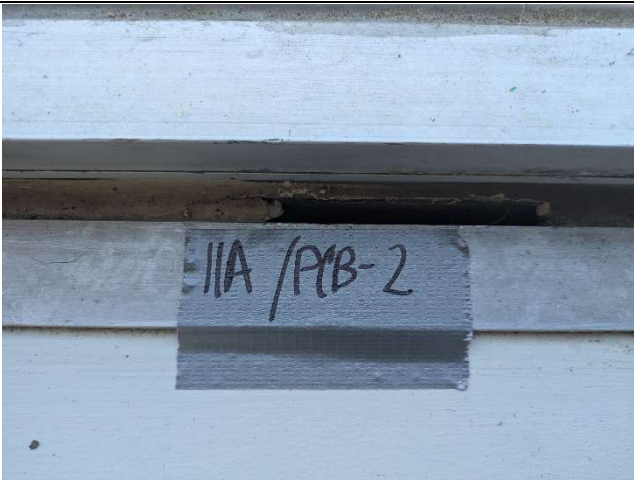
| PCB Samples | | | |
|---|---|---|---|
| PCB-2 | Glazing at Base of Windows | Room 9, West Side | |

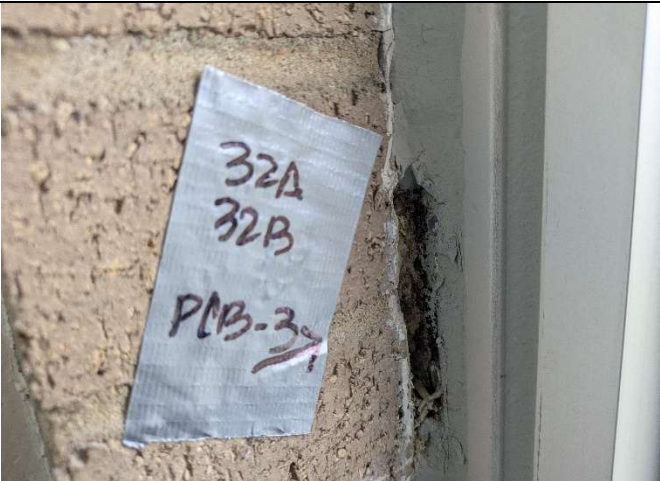
| PCB Samples | | | |
|---|---|---|---|
| PCB-3 | Gray Interior Door Caulk | Main N-S Hallway at Double Doors & Windows | |

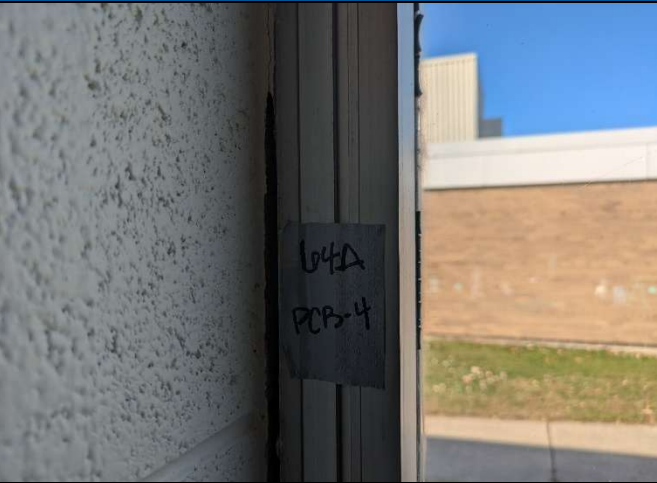
| PCB Samples | | | |
|---|---|---|---|
| PCB-4 | Interior Window Caulking | Room 20, West Side | A photograph showing the interior of a room with a window. A black tag with white text "04A" and "PCB-4" is attached to the window frame. The window is partially open, showing a view of the outside. |

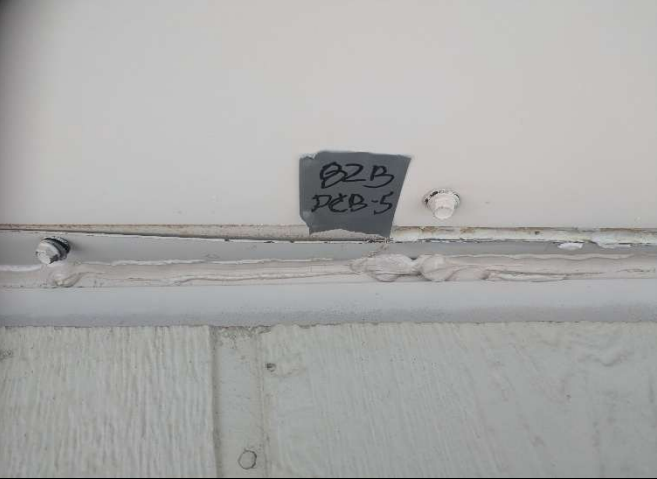
| PCB Samples | | | |
|---|---|---|---|
| PCB-5 | Gray Exterior Expansion Joint | Room 11, North Side | A photograph showing a gray exterior expansion joint on a wall. A black tag with white text "02B" and "PCB-5" is attached to the joint. |

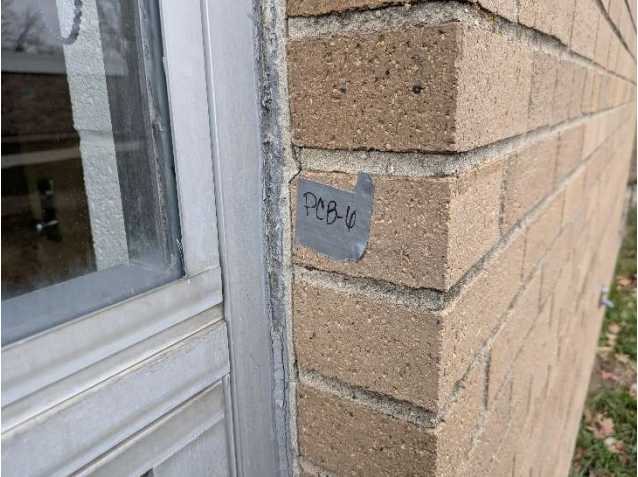
| PCB Samples | | | |
|---|---|---|---|
| PCB-6 | Gray Exterior Window Caulk | Room 6 | A photograph showing a gray exterior window caulk on a brick wall. A black tag with white text "PCB-6" is attached to the caulk. |

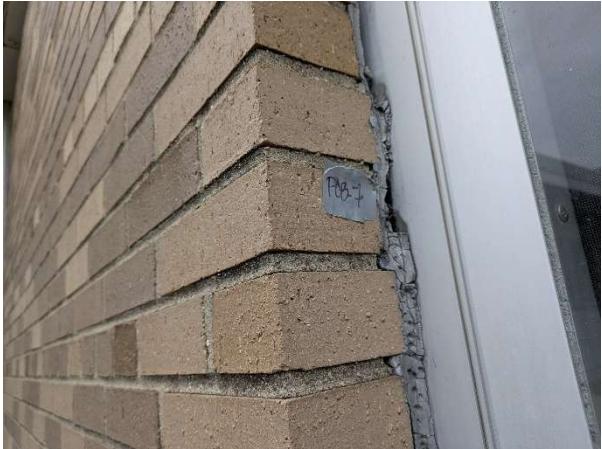
| PCB Samples | | | |
|---|---|---|---|
| PCB-7 | Gray Exterior Window Caulk | Room 20 | |
