WESTPORT PUBLIC SCHOOLS  
COLEYTOWN ELEMENTARY SCHOOL  
65 Easton Road, Westport, Connecticut

Preliminary Assessment  
January 2023

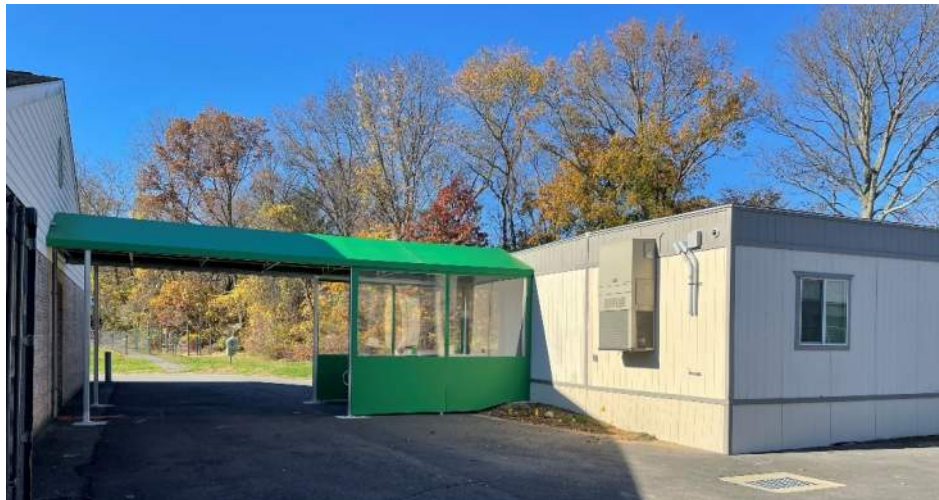
*Portable classrooms recently added to Coleytown Elementary to address recent enrollment increases.*

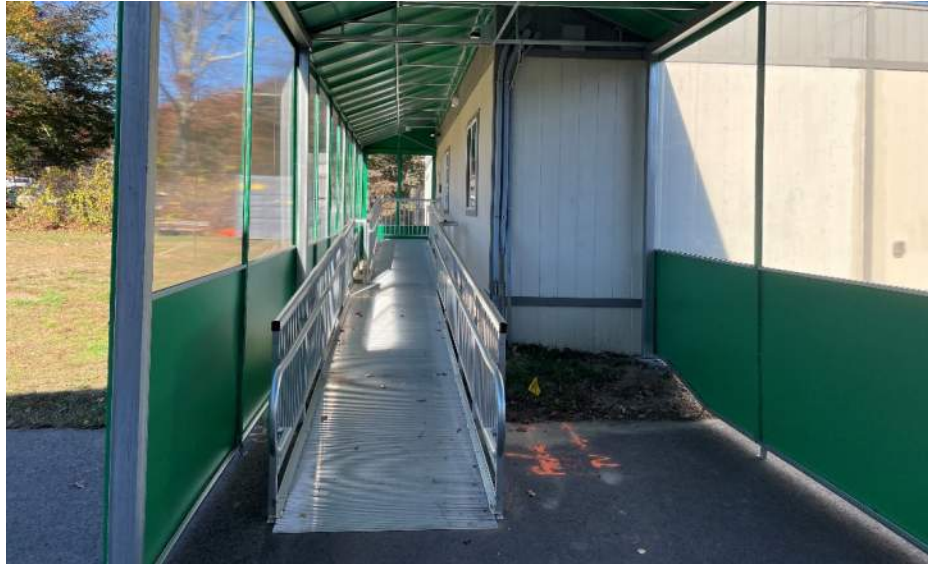
*A view of the accessible ramp leading to the elevated entrance of the portable classrooms.*

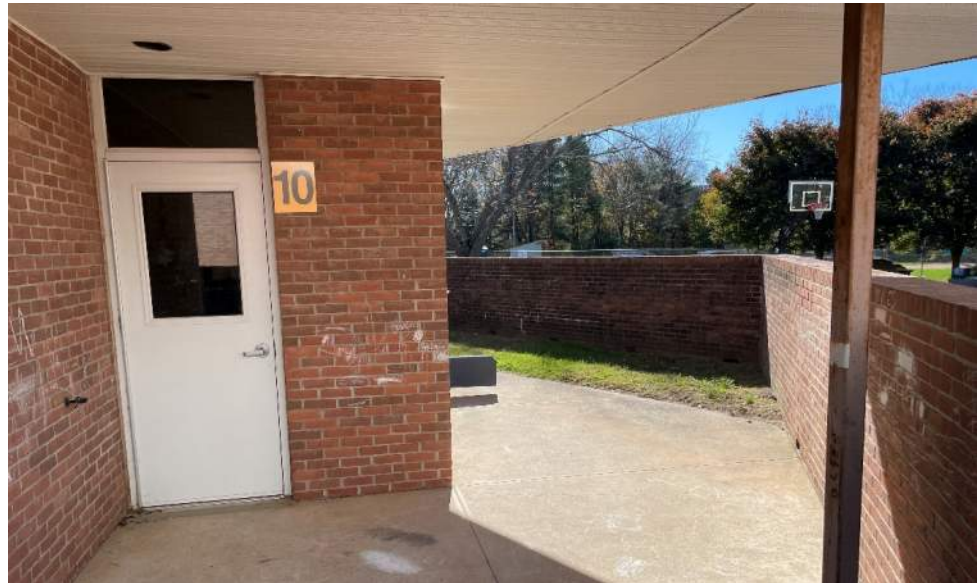
*Exterior classroom doors fitted with level handles to facilitate re-entry.*

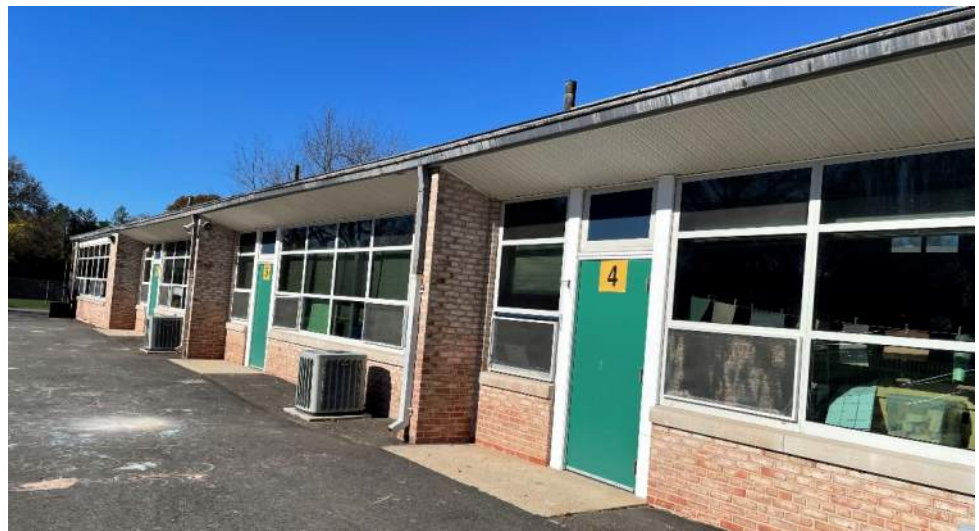
*An alternative exit door configuration with flush landing transition to a paved exterior walk surface.*

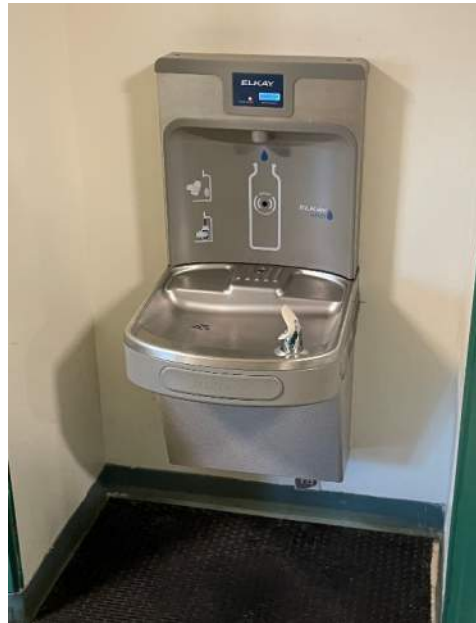
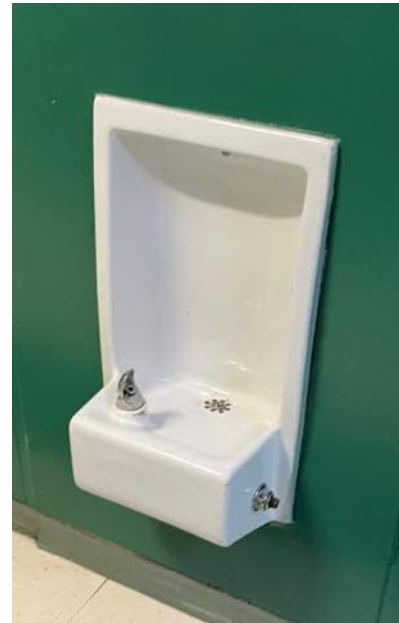
The provision of drinking fountains are required by code for a facility based upon the number of building occupants derived from building area and use classifications. Facility Staff report the replacement of existing non-accessible drinking fountains with models that provide bottle fillers. Strick compliance with accessible requirements would dictate a high/low drinking fountain configuration in order that individuals with issues bending, as well as those in wheelchairs, have access to potable water. Bottle fillers are have grown in popularity to address public health concerns and the avoidance of opportunities to transmit communicable diseases.

*An example of a newly installed drinking fountain with bottle filler (left), and a traditional drinking fountain (right).*

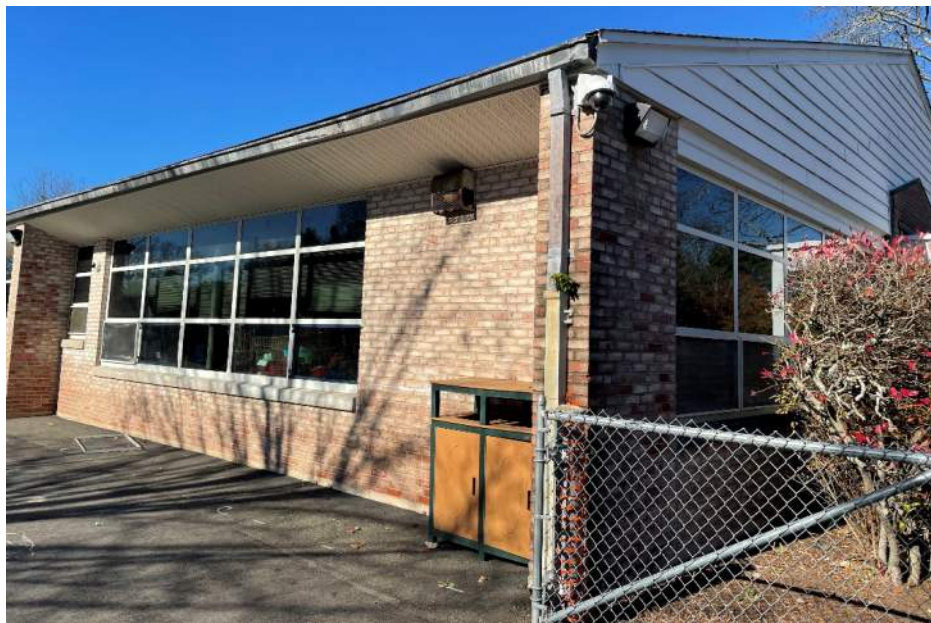
*A gutter and leader connected to a below grade storm system.*

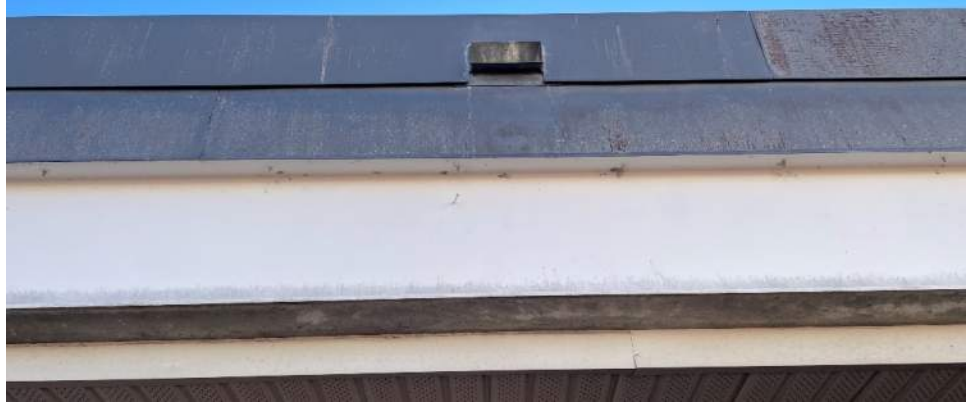
*A field fashioned roof scupper in the metal fascia.*

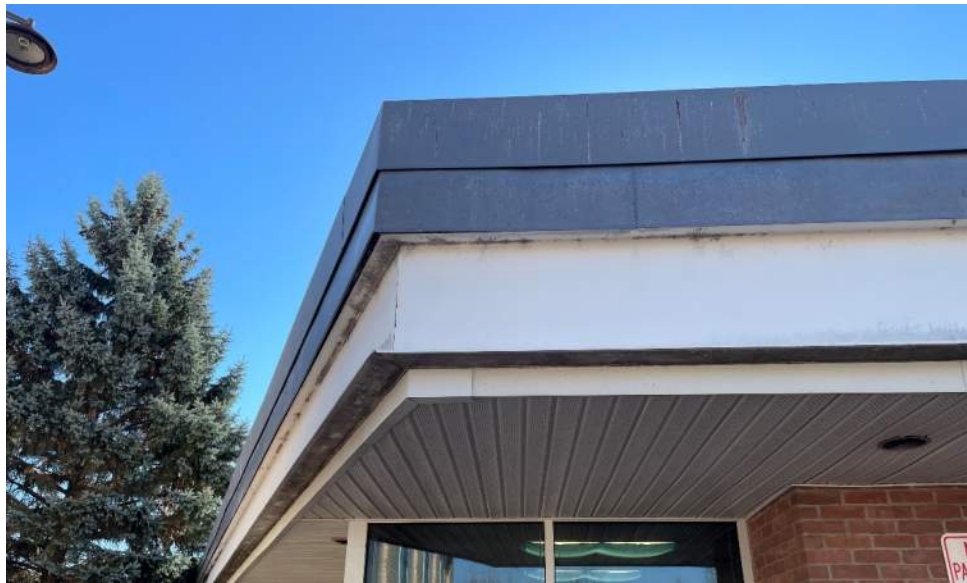
*A typical roof eave at the perimeter of a low-slope roof system.*

Unless a roof has been recently replaced, or has an extended warranty period, it is common to anticipate the full roof replacement when applying for *Renovation Status*. Roof replacements are common non-priority list State grant funded projects. Determining whether any open State funded roof replacement projects will aid the district in forecasting a prorated funding penalty that might exist under a *Renovation Status* roof replacement.

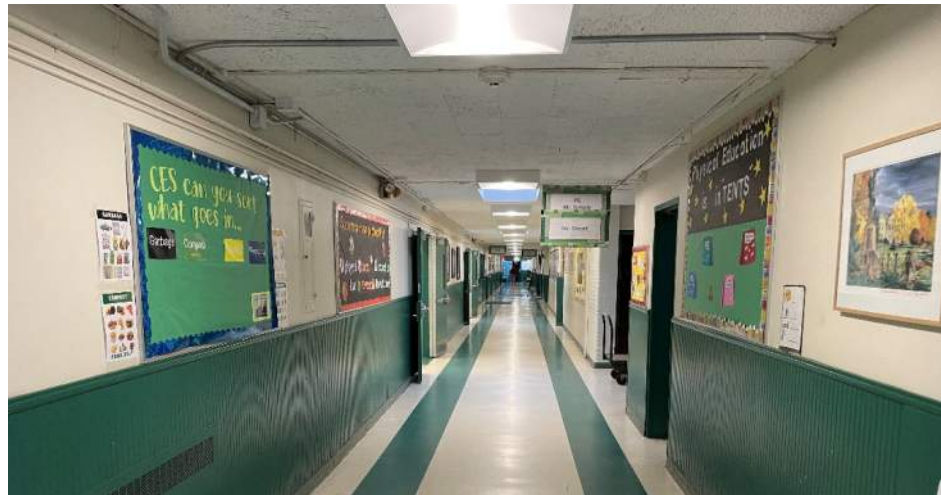
*A central corridor within the original school with resilient floor finish and base. A painted wood wainscot has been installed in this portion of the school to protect the wall surfaces.*

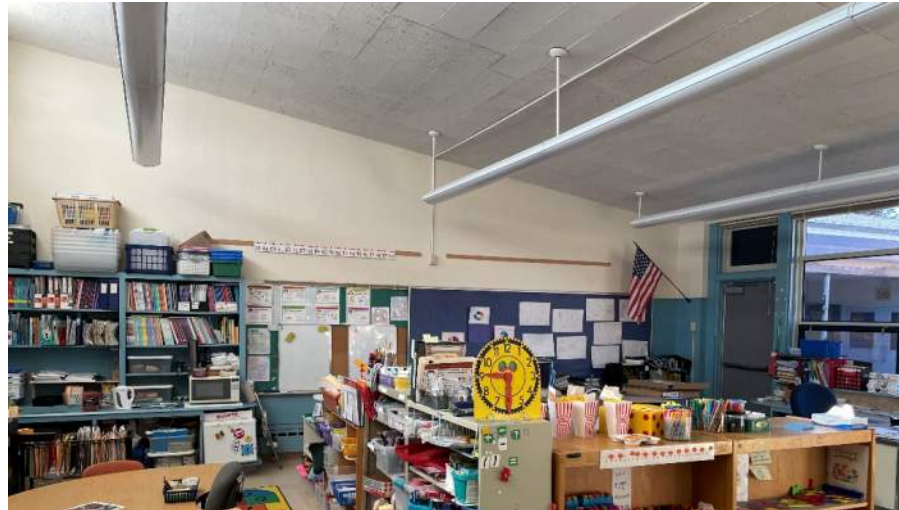
*Direct applied 12-inch square acoustic ceiling tiles over a vaulted classroom ceiling.*

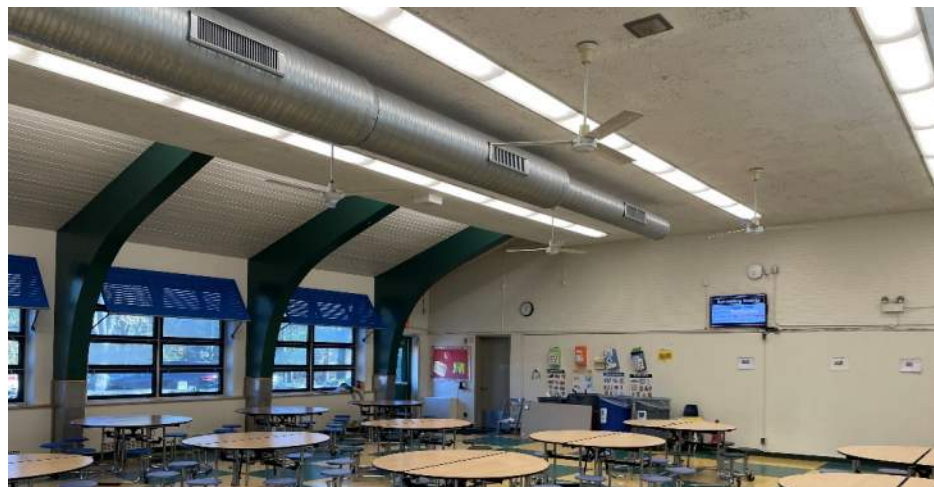
*A view of the cafeteria with 12-inch square acoustic tiles in the foreground and exposed plank wood deck beyond.*

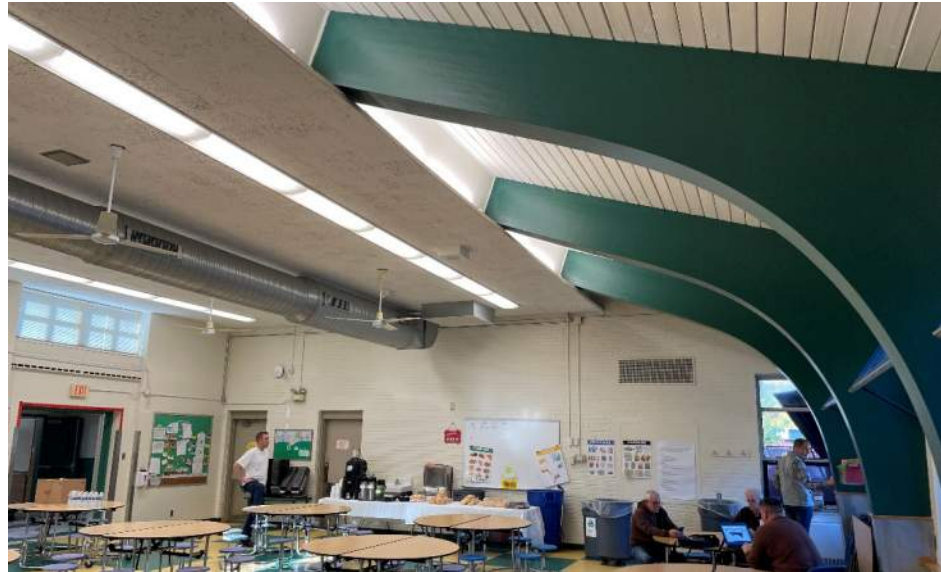
*A view of the plank wood deck supported above laminated wood timbers at the east exterior wall of the cafeteria.*

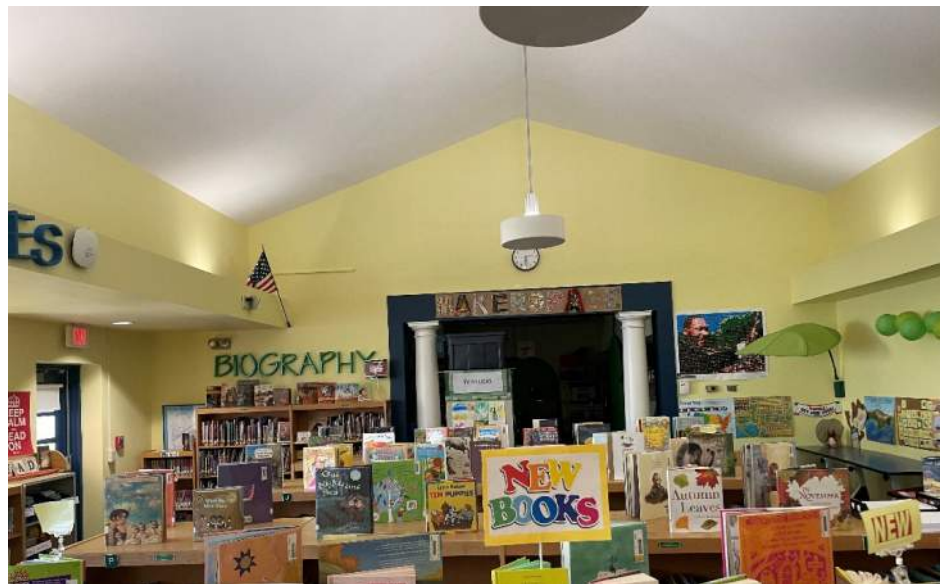
*The vaulted gypsum board ceiling above the Media Center.*

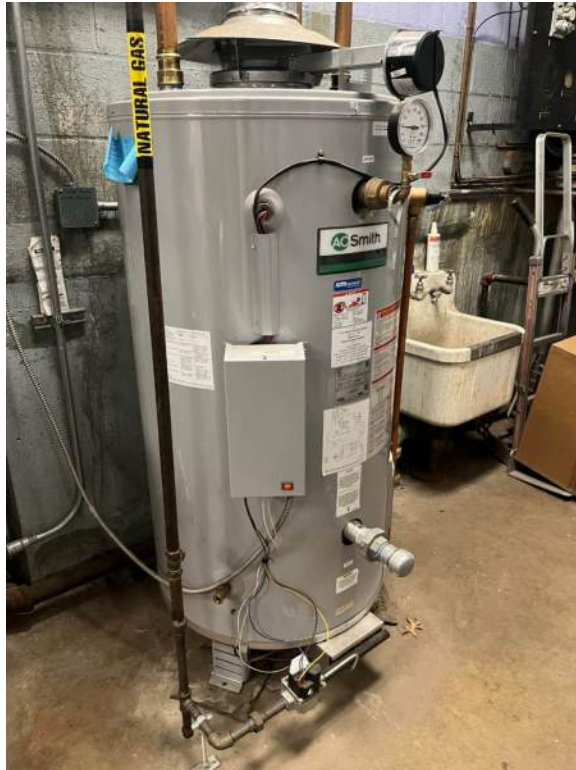
Domestic hot water is provided by a A.O. Smith “BTR-120 118” gas-fired storage tank water heater with a capacity of 120,000 BTU/h input. This unit was installed roughly 5 years ago and is in good condition.

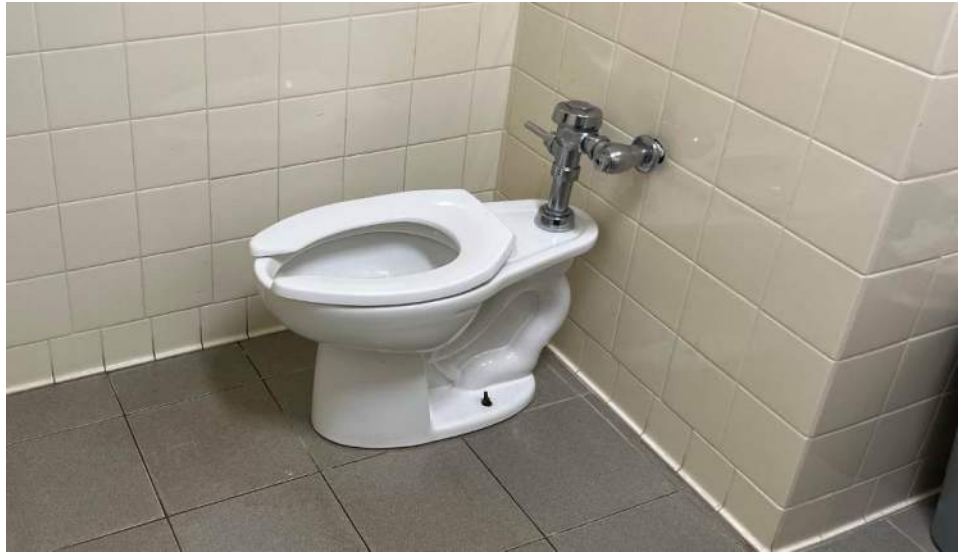
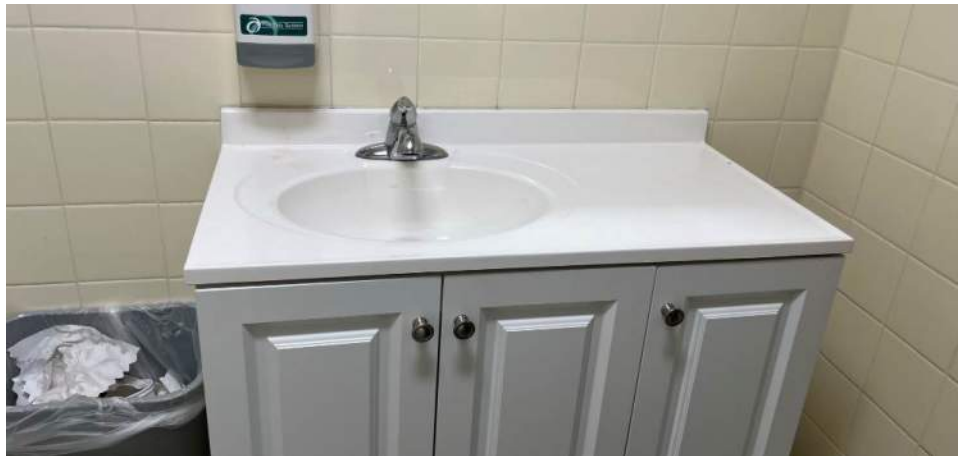
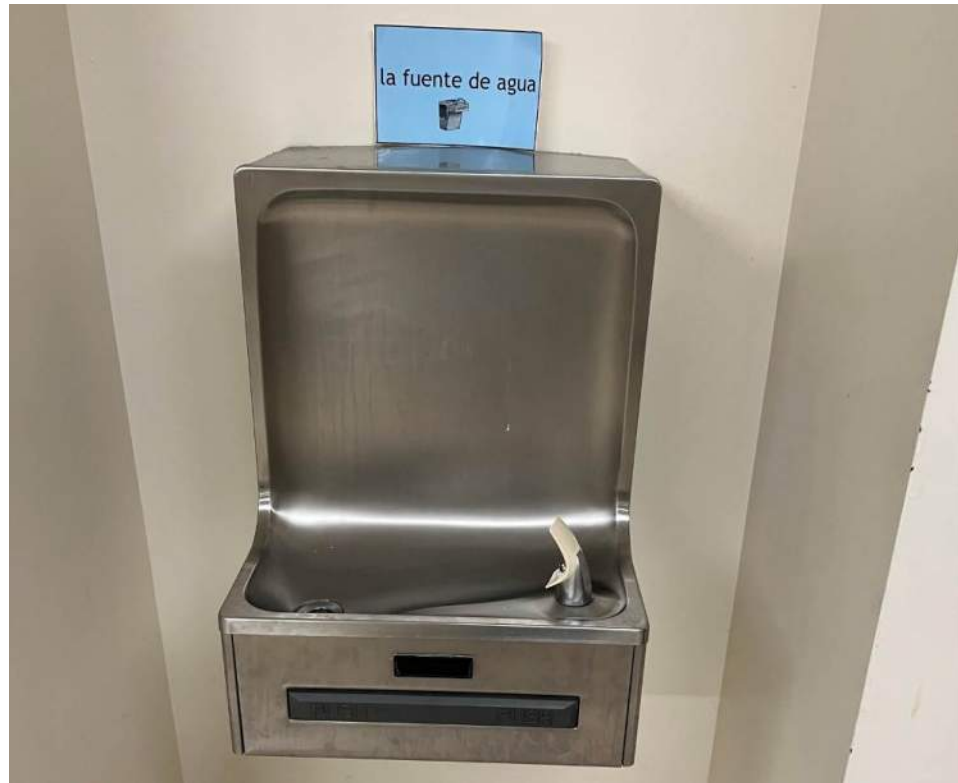
Plumbing fixtures within the building all appear to be in good condition, however generally have manual flush valves and faucets that are likely not low flow.

All plumbing fixtures should be replaced as part of any major renovation to newer more efficient units with water saving features.

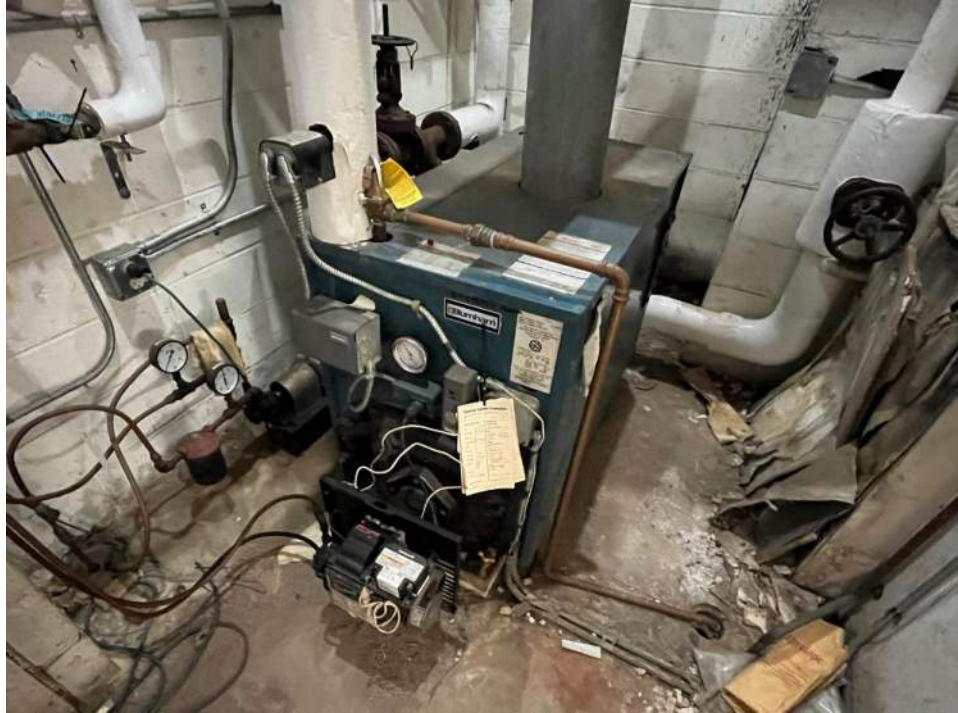
The North 1970's wing is fed from a dedicated oil-fired hot water boiler within that wing of the building, in a small mechanical room. The boiler has a gross output capacity of 300,000 BTU/h.

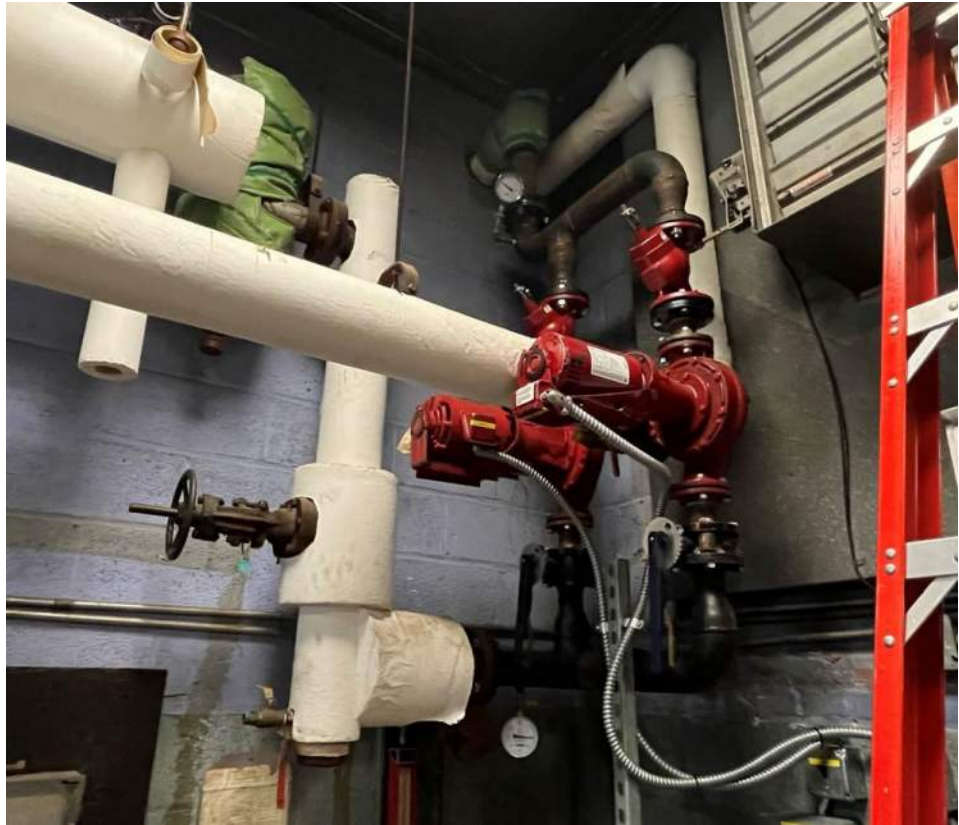
Steam boilers replaced ~12 years ago, gas fired. Previously were dual-fuel, but oil is no longer used.

The condensate pump set and motor serving the main steam system are new.

Hot water pumps feeding the hot water portion of the building have either been replaced recently or re-built. They are all in good condition.

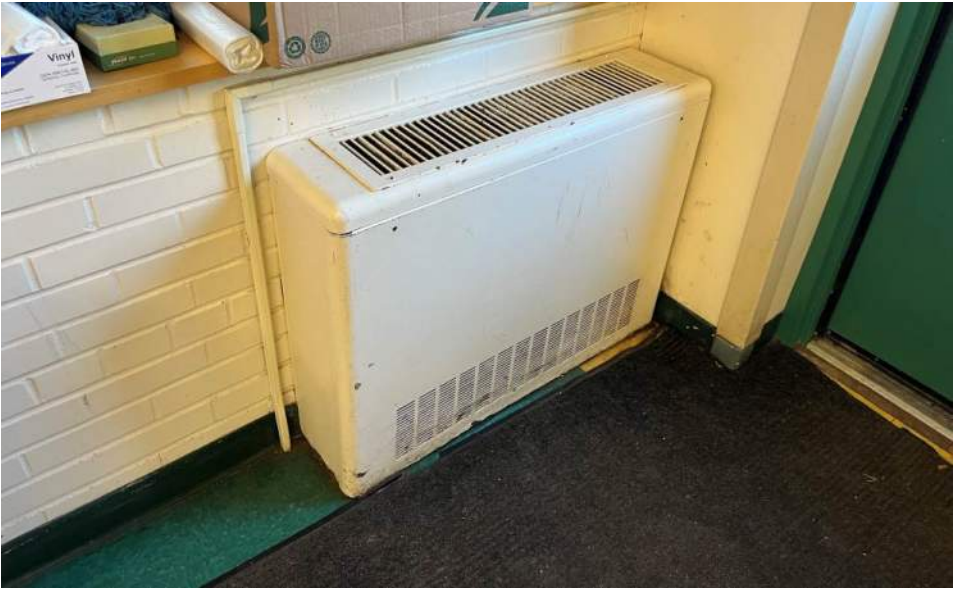
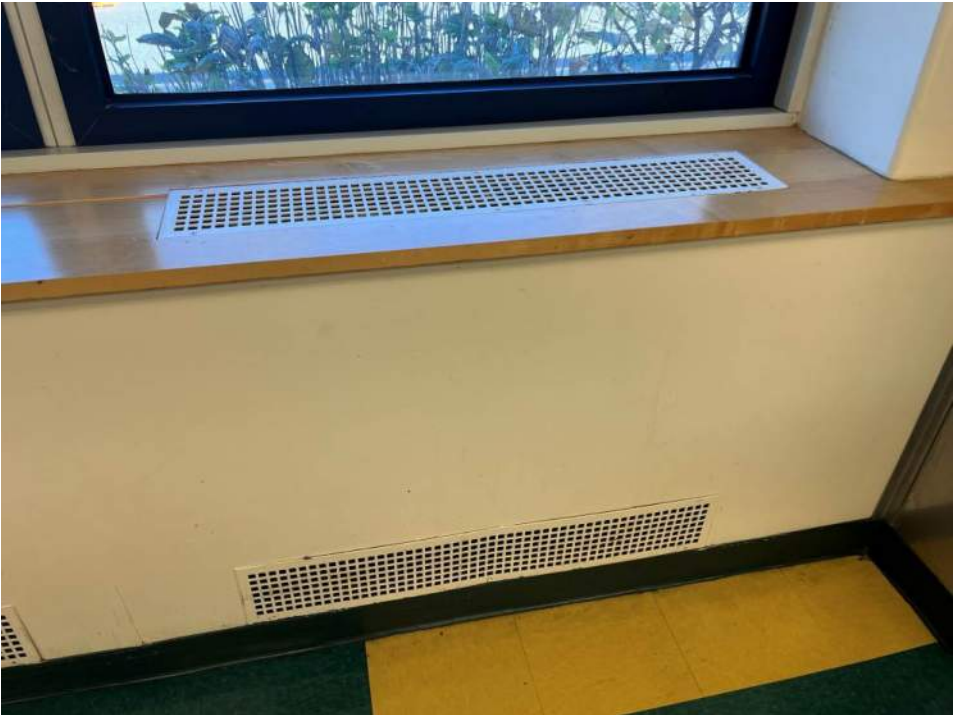
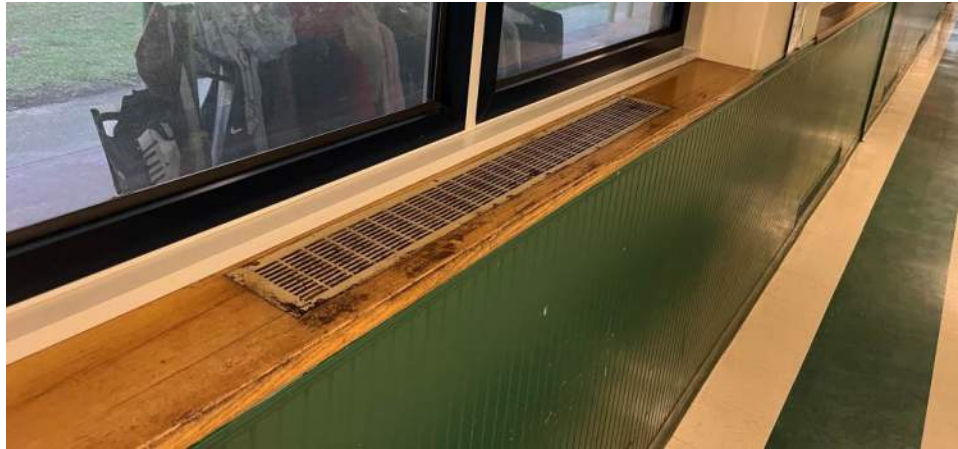
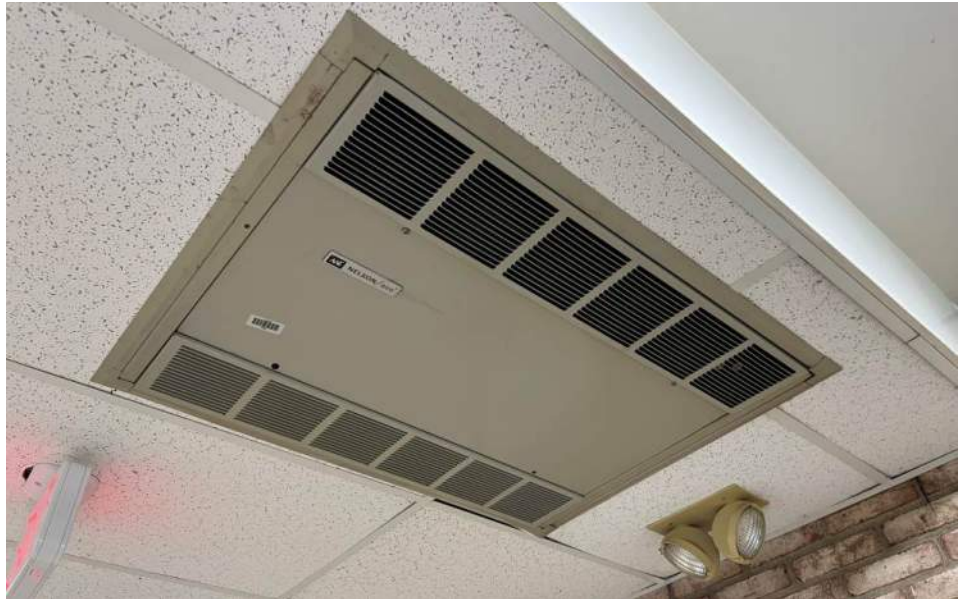
repaired or replaced over the years to maintain functionality. All units are said to be in good working order.

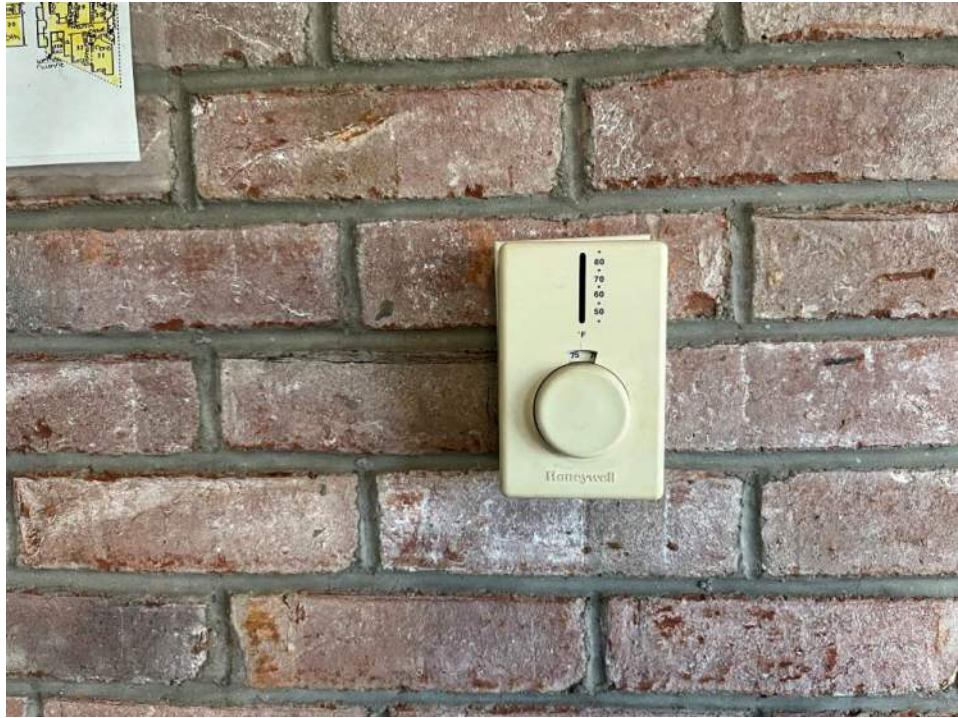
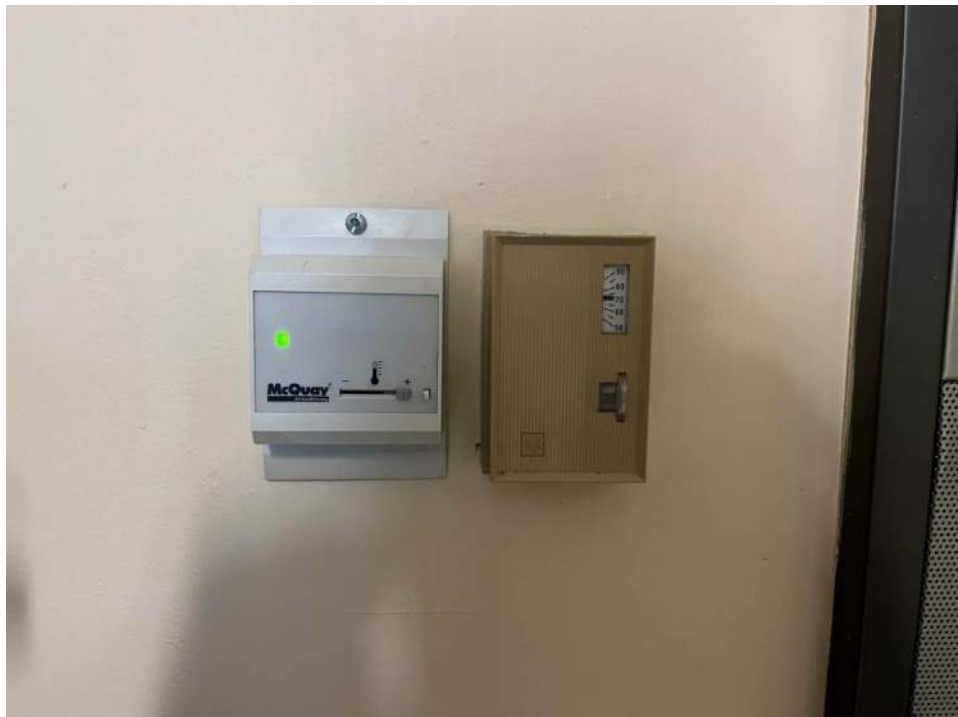
Controls

Control systems throughout the school are mixed, with much of it being outdated.

As with other systems throughout the building, the HVAC systems and equipment have been well cared for and maintained and replaced over the years. However, as part of any major renovation or a new building, modern and highly efficient HVAC systems should be installed both for energy efficiency and to comply with the State requirement for systems to be certified to have at least a 20 year life. Additionally, a new more efficient HVAC system will be required to comply with CT High Performance Building standards. The existing steam boilers are in good condition having been recently been replaced, however steam is now an antiquated and inefficient method to heat buildings. The current infrastructure of the existing building is not well suited to serve modern systems and equipment so would have to be removed. As well, the tunnel systems serving the steam and condensate piping are not fit to be reused as part of a newer HVAC system. We recommend considering all electric or mostly electric systems for any major renovation or new school such as Variable Refrigerant Flow. Additionally, we recommend considering highly efficient ventilation and exhaust systems that will properly filter, condition, and dehumidify ventilation air, such as Dedicated Outdoor Air Systems (DOAS).

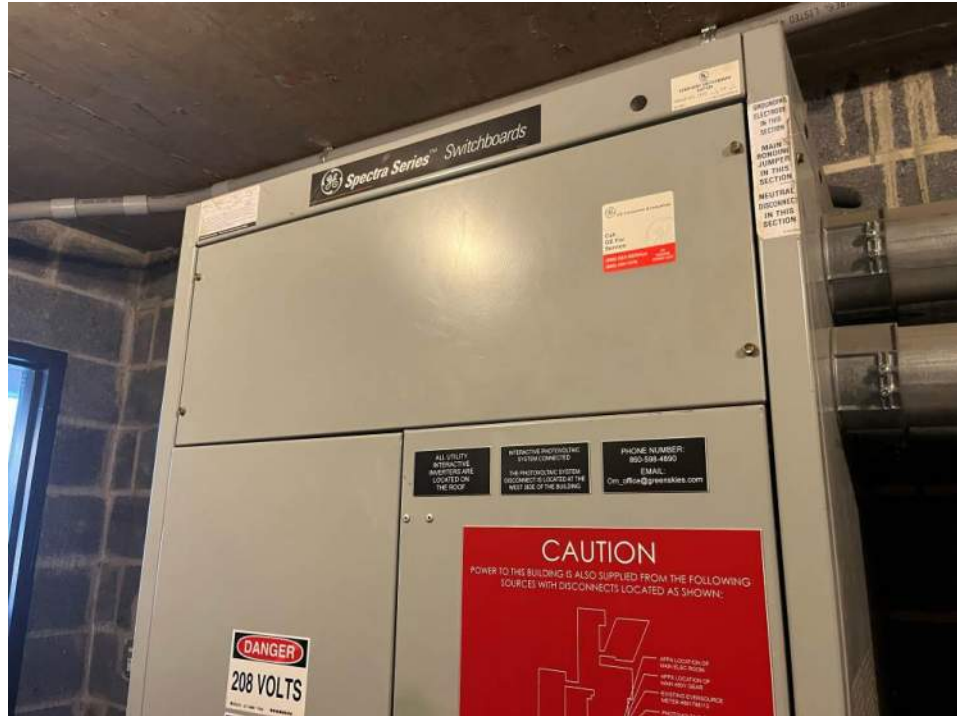
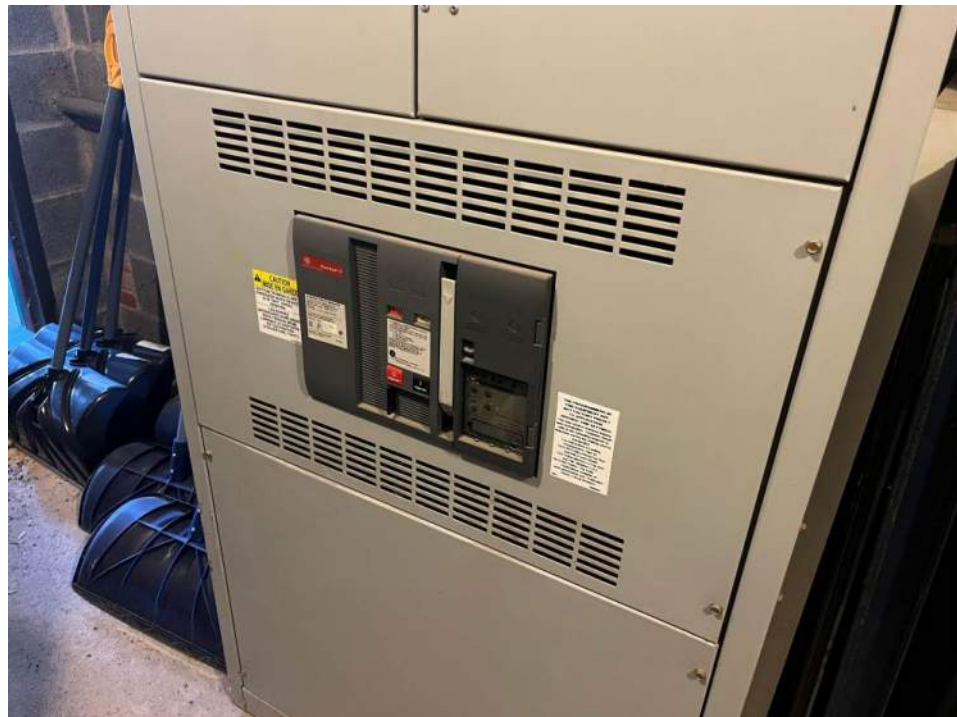
The Main Service Switchgear is rated at 1,600A, 208/120V, 3-phase, 4-wire and is manufactured by General Electric. It appears to be in good condition and still has at least 10 years of useful life left.

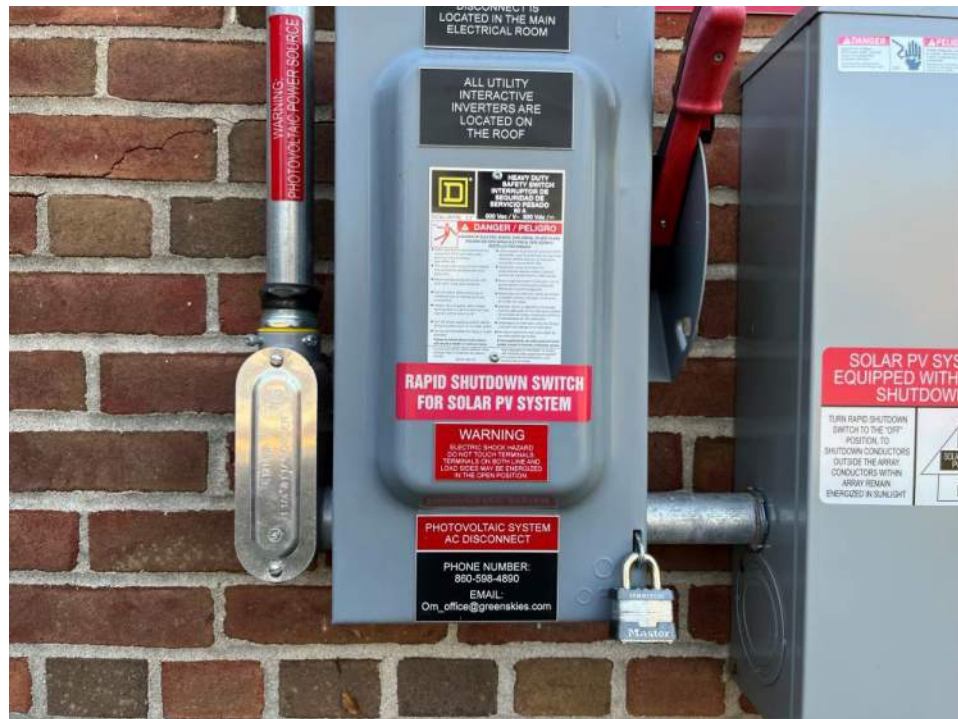
### Power Generation

There is a solar photovoltaic (PV) system on the roof that generates power heback to the main switchgear. There is a disconnect and dedicated meter for the third party entity, Greenskies, that owns and maintains this system. It is not owned and maintained by the owner.

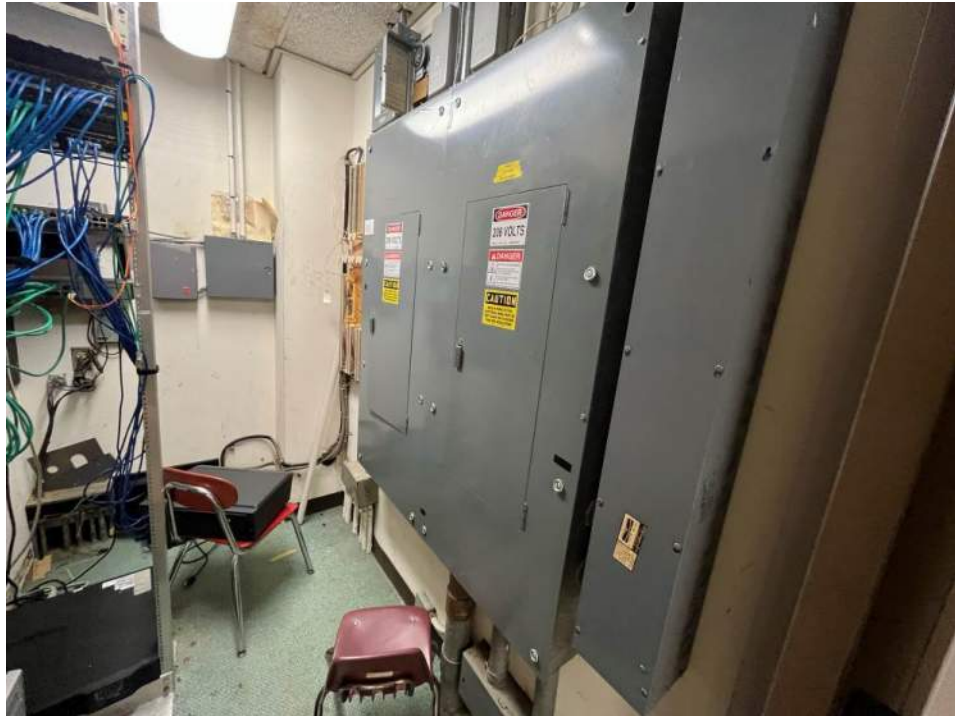
Most of the electrical equipment (branch panelboards, disconnect switches, motor starters, etc.) appears to be in good condition but will be at their end of their useful life in 10-20 years.

Branch panelboards are manufactured by General Electric and are of the molded case circuit breaker type. Disconnect switches, motor starters, etc. are mainly by General Electric.

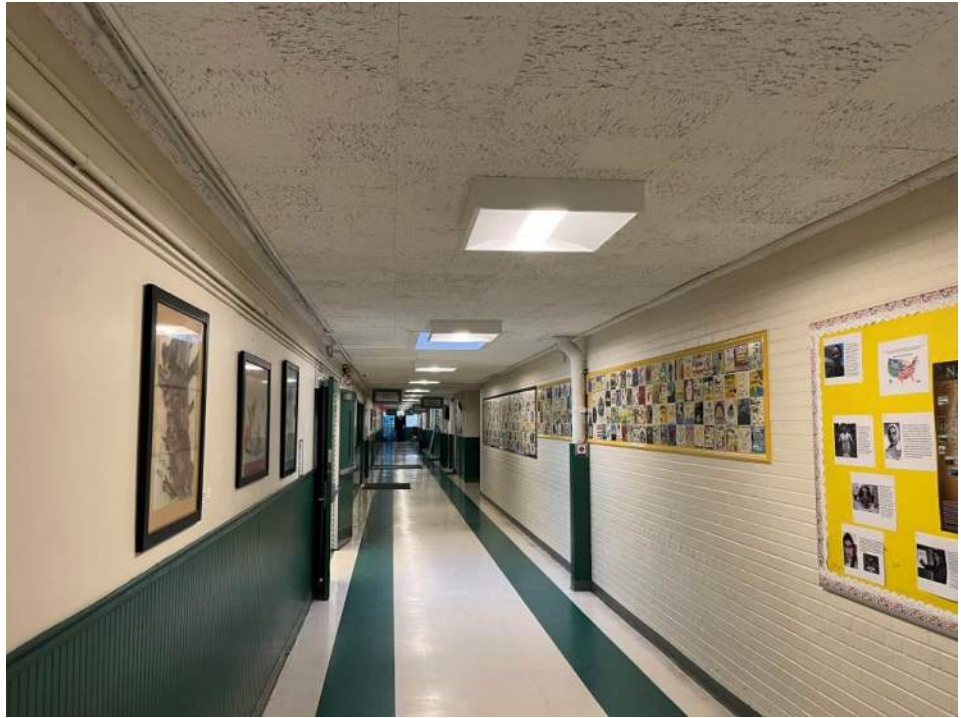
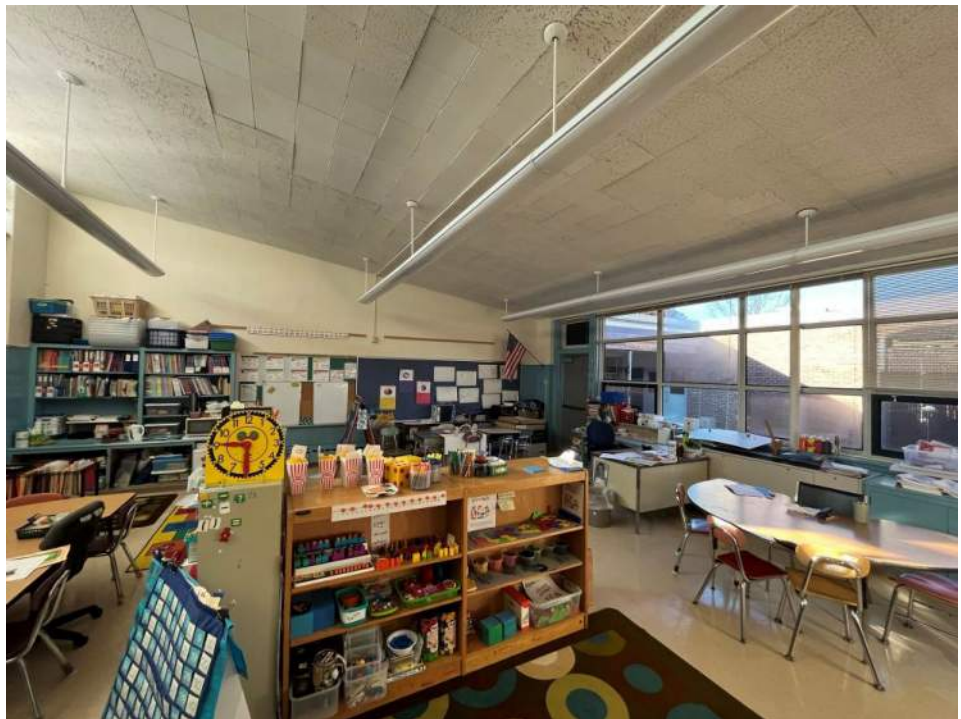
Interior lighting throughout the building has been recently upgraded to LED. The existing lighting controls do not appear to have been upgraded as part of this work, however.

The electrical infrastructure appears to be in overall good condition, with the exception of lighting controls and emergency lighting fixtures. As part of any major renovation, we would recommend full replacement of the existing lighting controls and emergency lights. Classrooms should have new low voltage wall dimmer switches and ceiling mounted occupancy/vacancy sensors and using daylight sensing for fixtures that are closest to windows. This practice follows current energy code guidelines and CT High Performance Building standards, and will increase energy savings over the long term while providing better light quality. While the main switchgear and distribution appears to be in good condition, it is not adequately sized to support air conditioning and proper outdoor air dehumidification and conditioning that is recommended as part of any major renovation or new building. As such, a new electrical service and distribution would need to be installed as part of a renovation or new building.

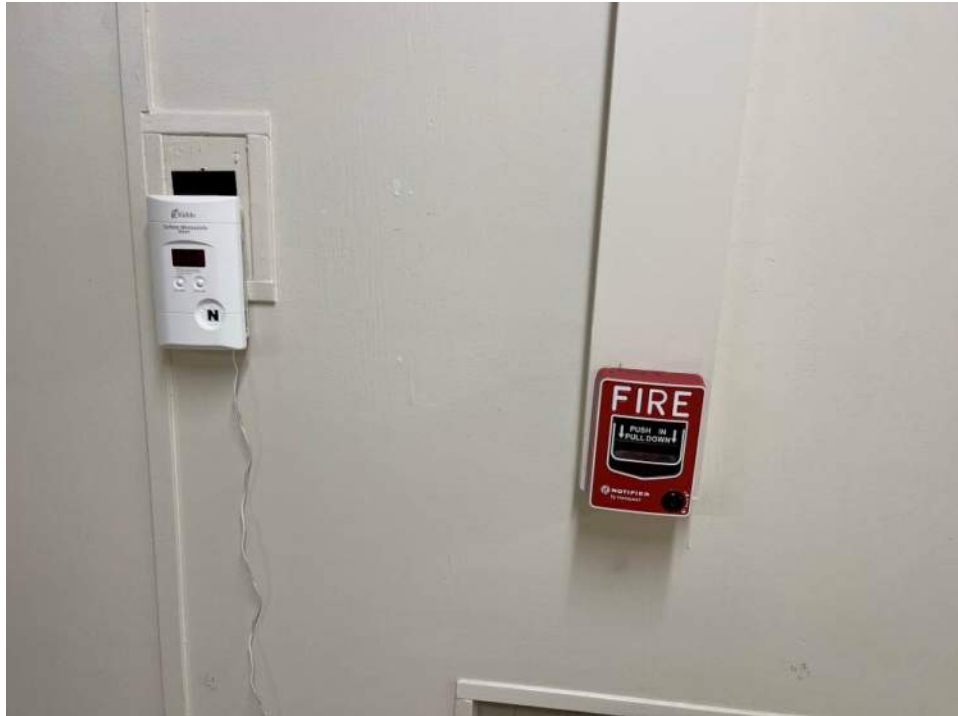
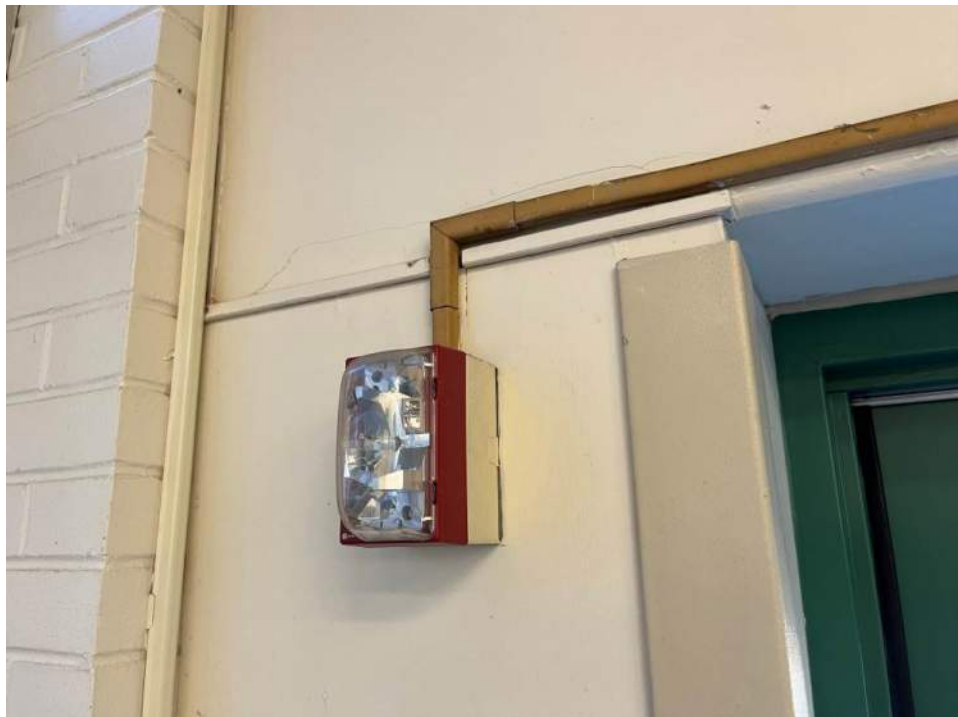
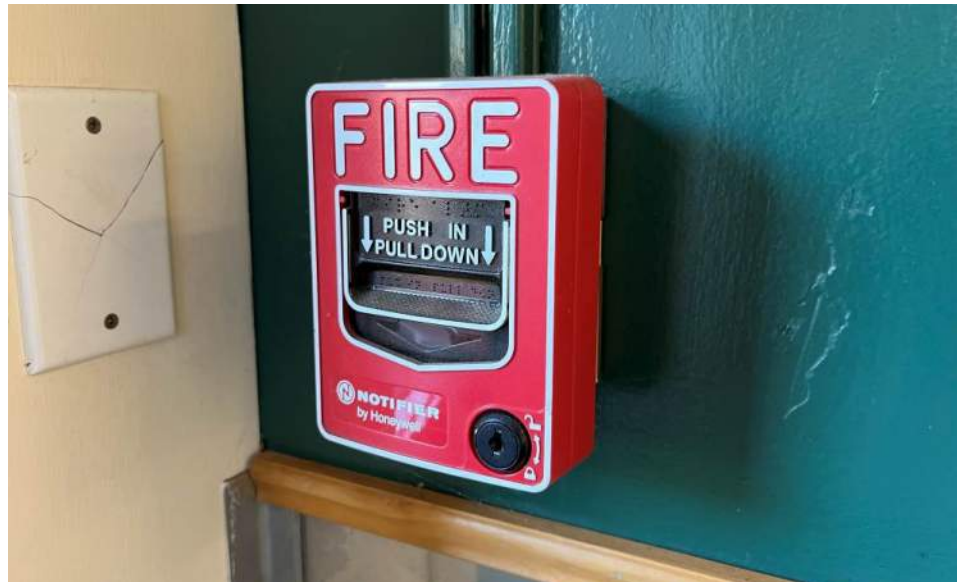
The building is equipped with a Notifier addressable fire alarm system. Pull stations and horn strobes throughout appear newer, however the quantity and placement may not be adequate per current code. Full replacement of this system is recommended as part of any major renovation.

The building is not fully sprinklered, so current code would require smoke detection throughout the building. This does not appear to be the case, however, so any major renovation or a new building would need to address this.
