WESTPORT PUBLIC SCHOOLS  
COLEYTOWN ELEMENTARY SCHOOL  
65 Easton Road, Westport, Connecticut

Preliminary Assessment  
January 2023

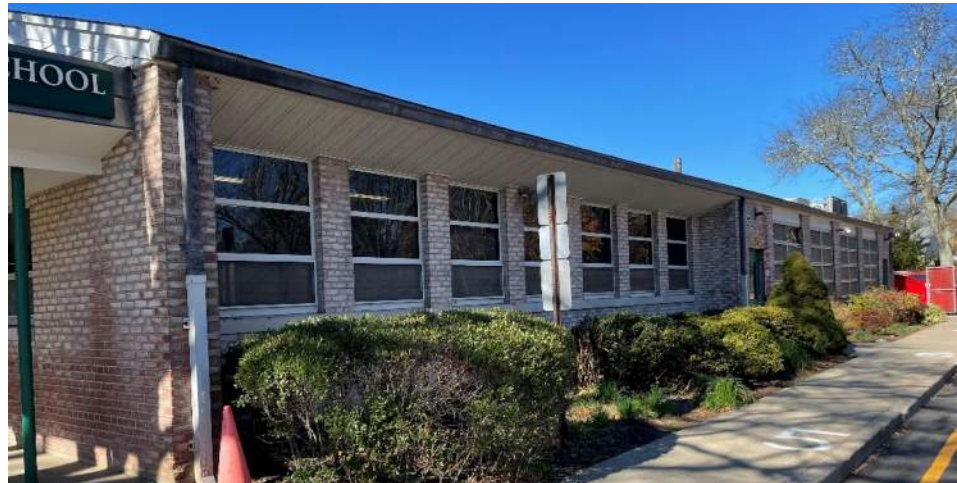
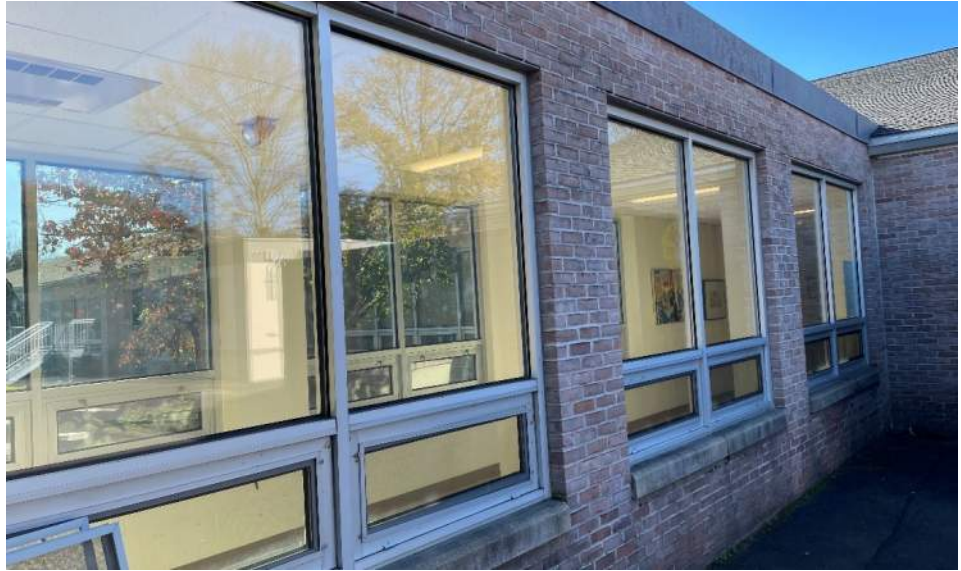
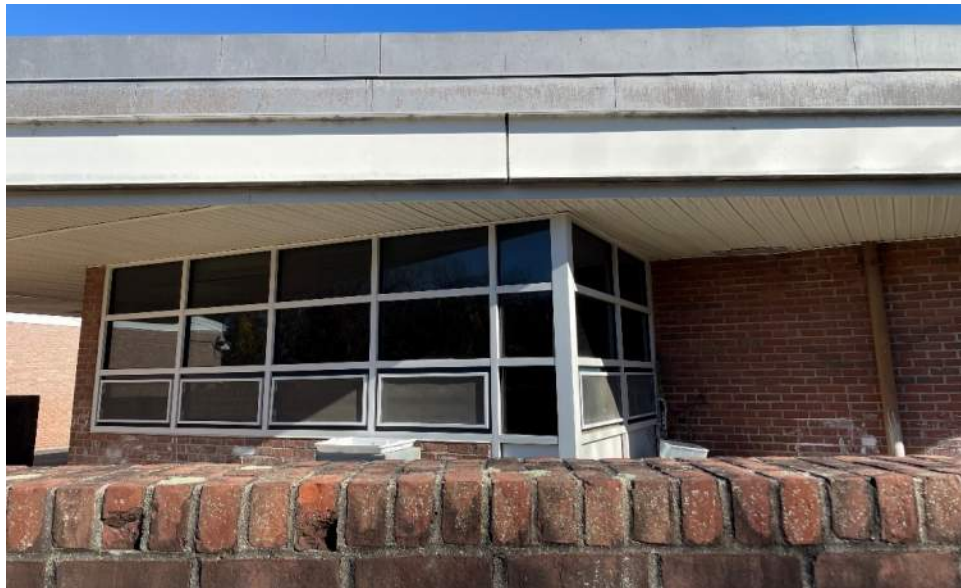
It is evident upon field observation that the existing exterior windows have been replaced with contemporary, aluminum-framed storefront assemblies that incorporate insulated glazing units (IGUs) throughout the facility. Both fixed and operable units have been installed within classrooms, office spaces and corridors. The operable units are typically inward swinging hopper units that have been outfitted with exterior mounted insect screens. Fixed storefront window assemblies have been combined with translucent fiberglass wall panels in the gymnasium-auditorium.
