# Upper Darby High School Auditorium

## ROOM ACOUSTICS REPORT – REVISION 1

August 1, 2025

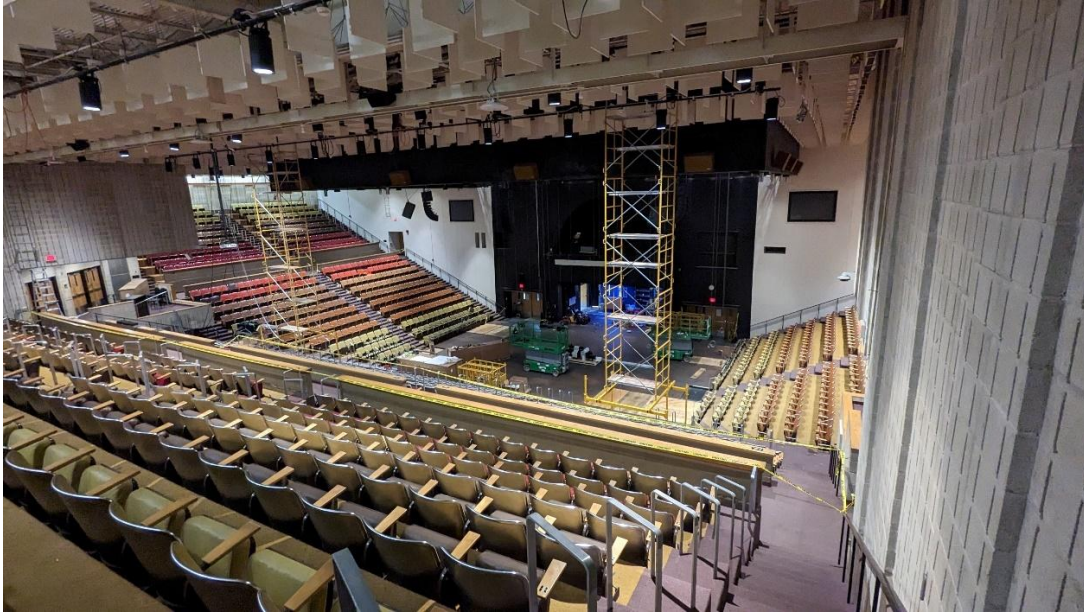
Figure 1. Pre-renovation conditions in auditorium

- Ceiling: metal deck, suspended plywood baffles
- Walls: unpainted acoustic CMU, gypsum board (GWB), unpainted CMU
- Floor: carpet, wood stage
- Seating:
  - Lower center seating section: fabric upholstered seats
  - Upper center and wing seating sections: vinyl covered seats

Figure 1 through Figure 3 show the pre-renovation conditions in the auditorium, including the plywood baffles and unpainted acoustic CMU.

The baffles suspended from the ceiling in the pre-renovation condition were composed of plywood. Plywood does not provide much, if any, acoustical absorption in the high frequencies where the increased reverberation was observed. We do not believe the removal of the baffles caused the change in reverberation.

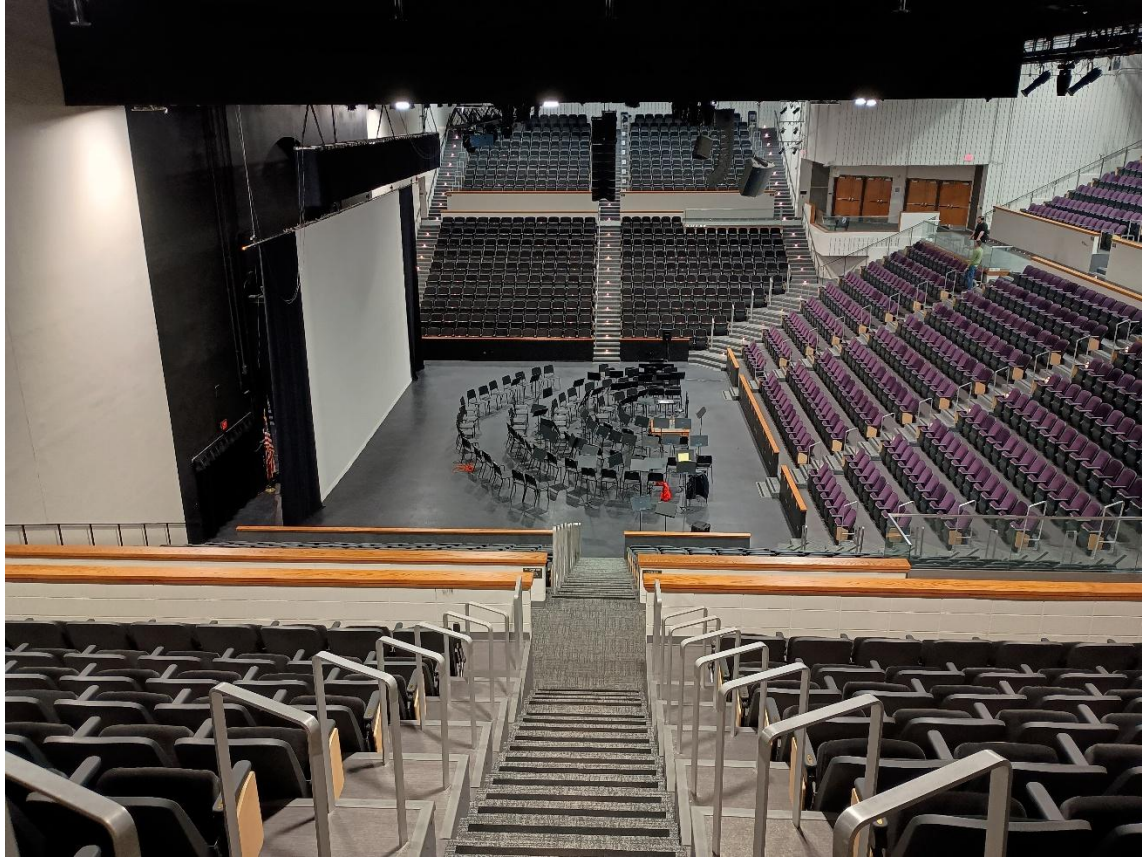
*Figure 4. Current conditions in auditorium*

As part of the renovations, the first row of seats by the stage was removed, as well as some of the seats in the last row of the lower seating sections. Additionally, the last row of seats in the upper middle section was removed to construct a larger sound and light booth.

Figure 4 through Figure 6 show the current conditions in the auditorium.

As shown in the table and figure above, the RT in the auditorium did not change much in the low to mid frequencies (500 Hz and below) after renovation. However, the current RT in the high frequencies (1,000 Hz and above) is higher than the pre-renovation condition by 0.6-0.8 seconds.

Due to the volume of the space, the acoustic properties of a large surface area would need to have changed to observe such an increase in high-frequency reverberation time. The large areas that were modified during renovation were the removal of the suspended plywood baffles, the replacement of all of the seats, and the painting of the acoustic CMU. Each is discussed below.
