# TOWN OF SUFFIELD

## CONDITIONS ASSESSMENT & MASTER PLAN

**EXISTING CONDITIONS NARRATIVE .....C**

## FIRE DEPARTMENT 1 (HQ) - 73 MOUNTAIN RD, SUFFIELD, CT

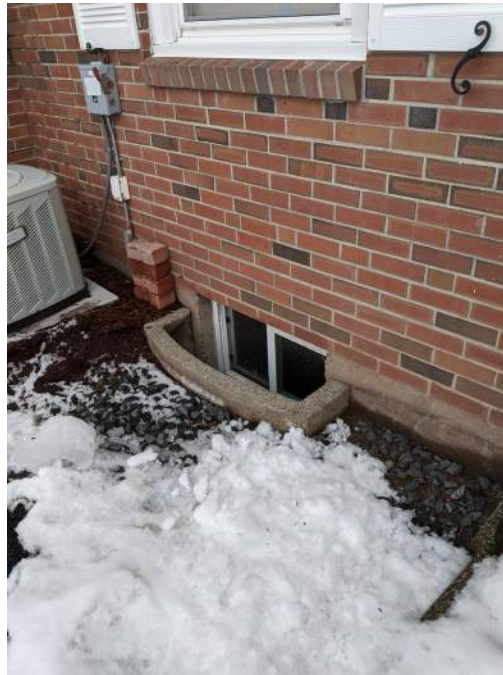
● D1. 3: Window well to lower level

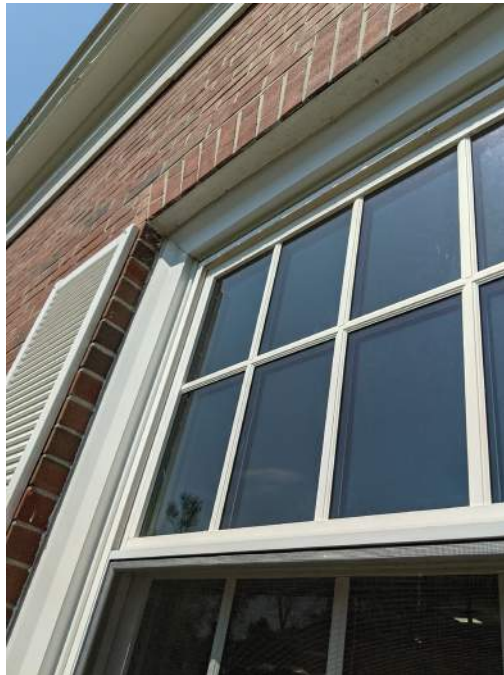
● D1. 9: Aluminum windows located throughout

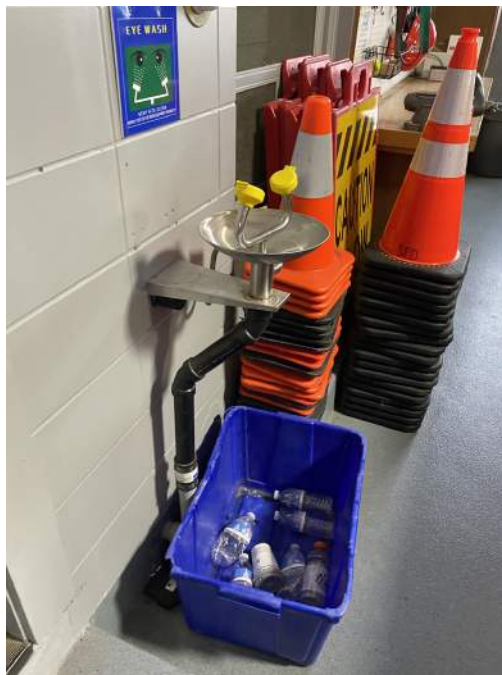
● D2. 14: Eyewash Station in Fair Condition

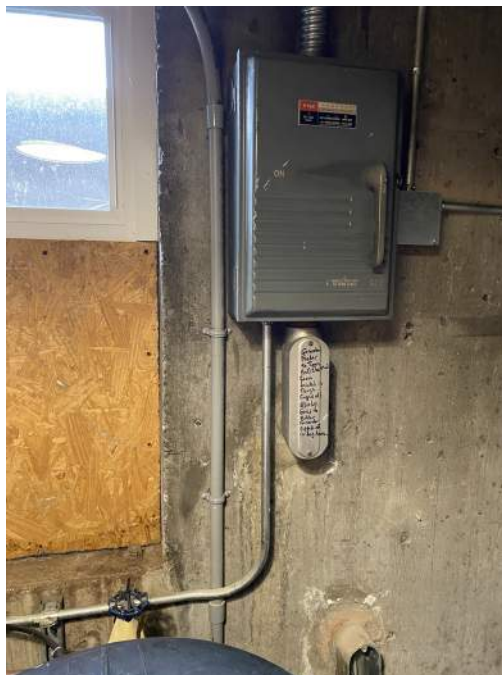
● D2. 30: Old Generator Feed to Town Hall

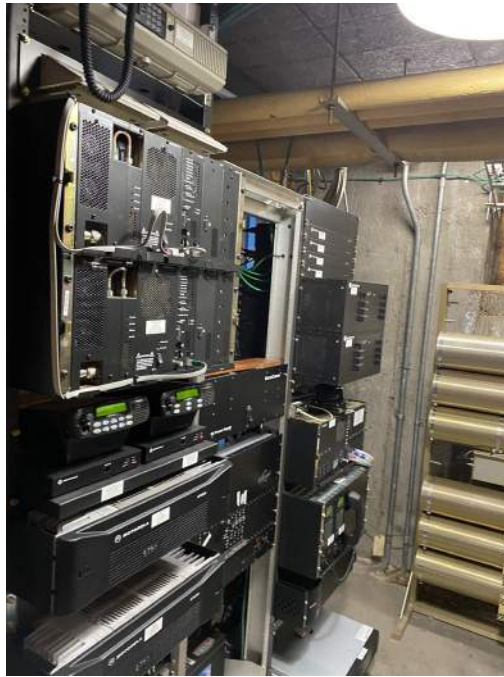
● D2. 37: Radio Equipment Rack

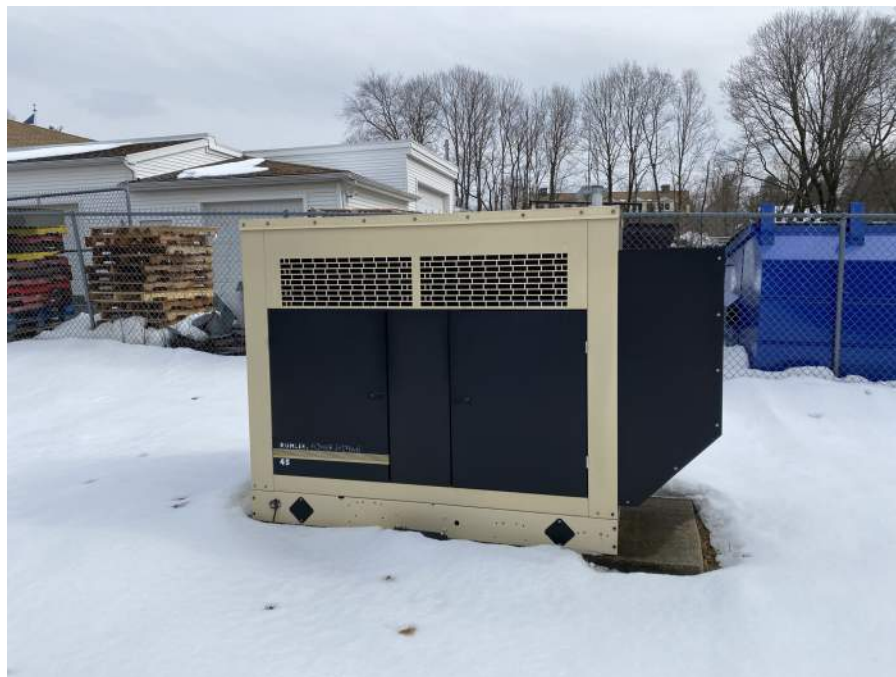
● D2. 40: Standby Generator

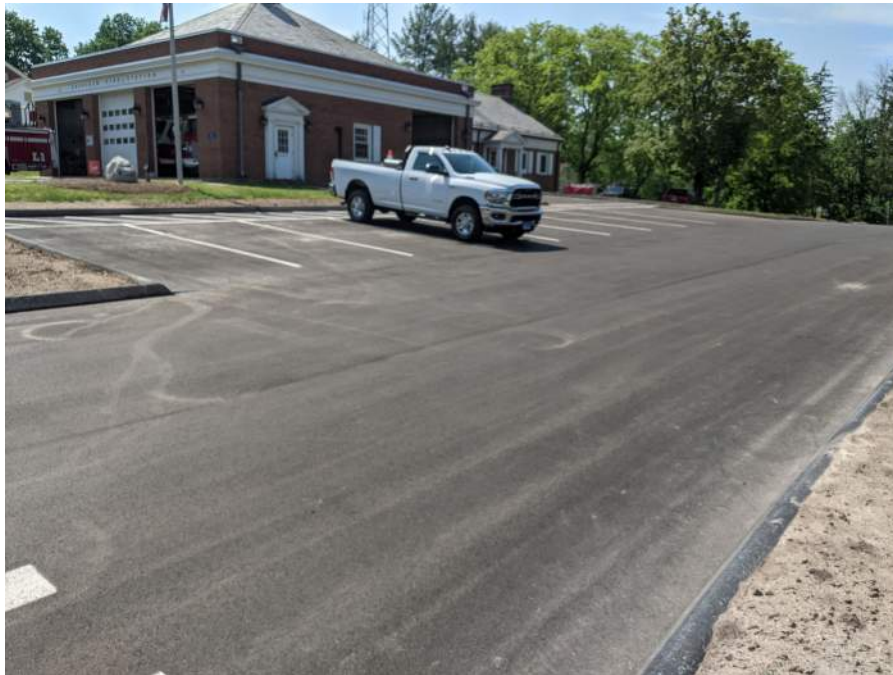
● D3. 1: Parking area and drive aisle West of the building has been recently replaced
