# New Hartford Public Schools Utilization Study- Facility Conditions Assessment

MARCH 25, 2026

Prepared for:  
**New Hartford Public Schools**  
**530 Main Street PO Box 315**  
**New Hartford, CT 06057**

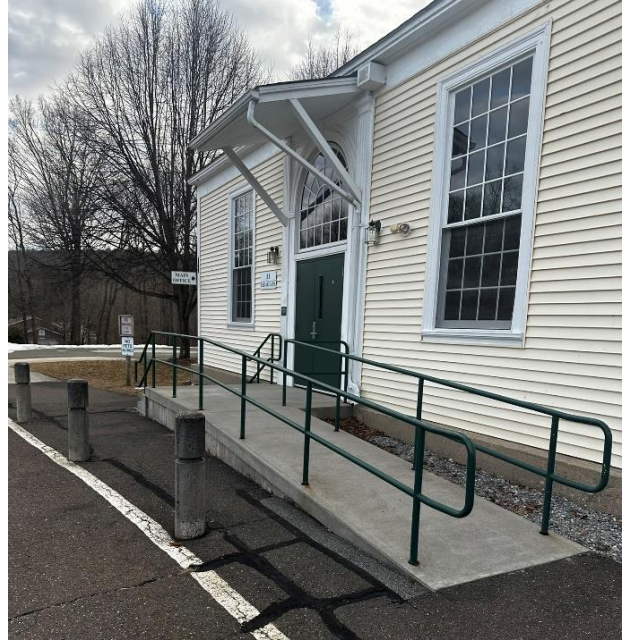
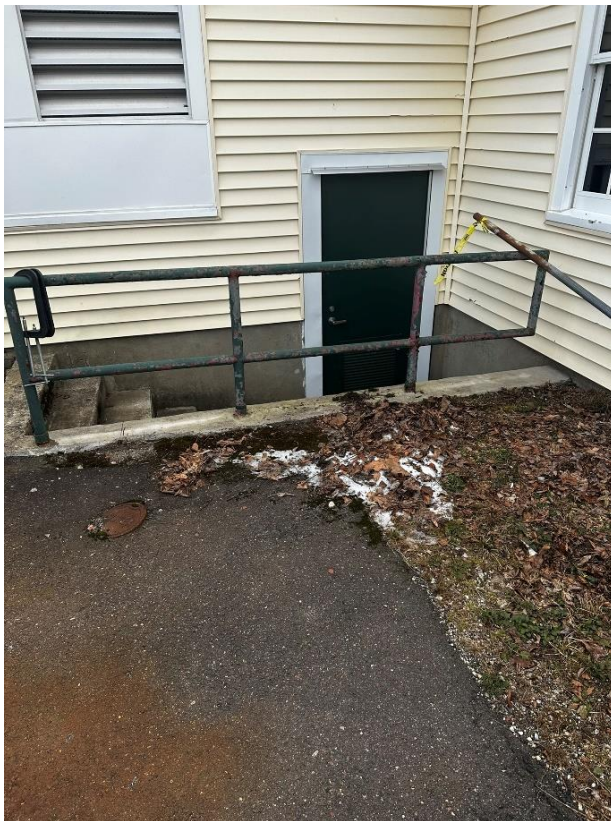
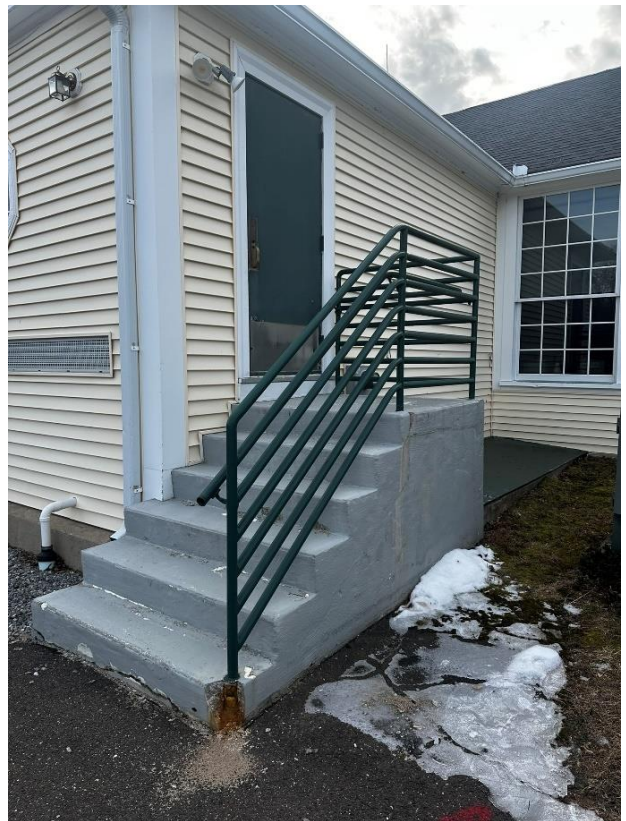
The stairs from the stage or teachers work room lack a compliant handrail on one side and do not include proper extensions. A code-compliant handrail with required returns and extensions should be installed, welded, and painted to match existing finishes.

The boiler room stairs lack required guardrails and handrails. Compliant guardrails and handrails should be installed and painted to match.

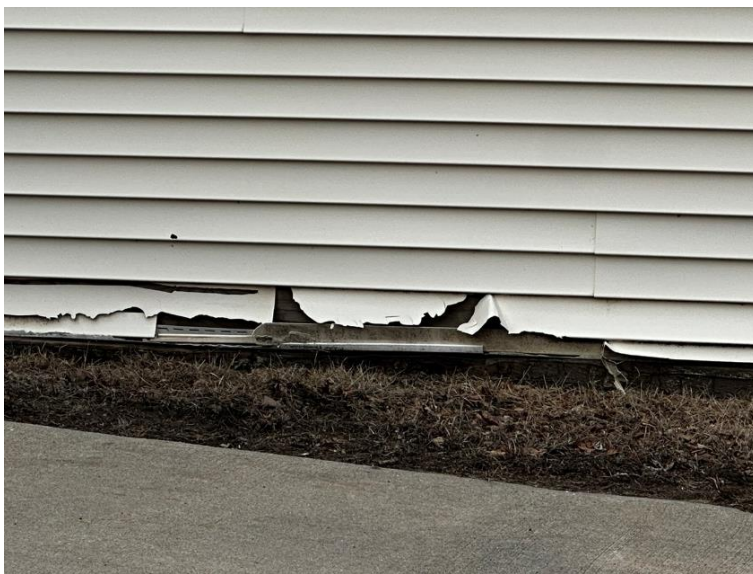
The structure consists of conventional light wood framing with wood stud walls and floor framing. Roof framing is dimensional lumber rafters with ridge boards forming pitched gable systems.

The exterior is clad primarily in yellow horizontal vinyl siding. While generally in fair condition, numerous areas exhibit holes, wear, and deterioration. The siding is installed close to grade in several locations, which may accelerate moisture-related deterioration due to splash-back. Trim components show denting and paint failure.

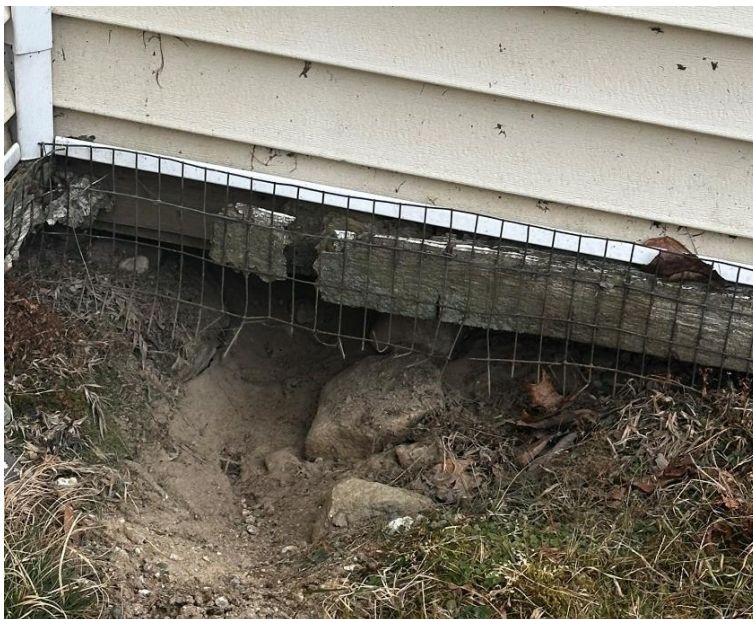
At portions of the modular structure lacking a permanent foundation, wire mesh has been installed to deter pests. The mesh is attached to deteriorated wood skirt boards that are decaying and require replacement. The mesh should be removed and properly reinstalled after skirt board replacement.

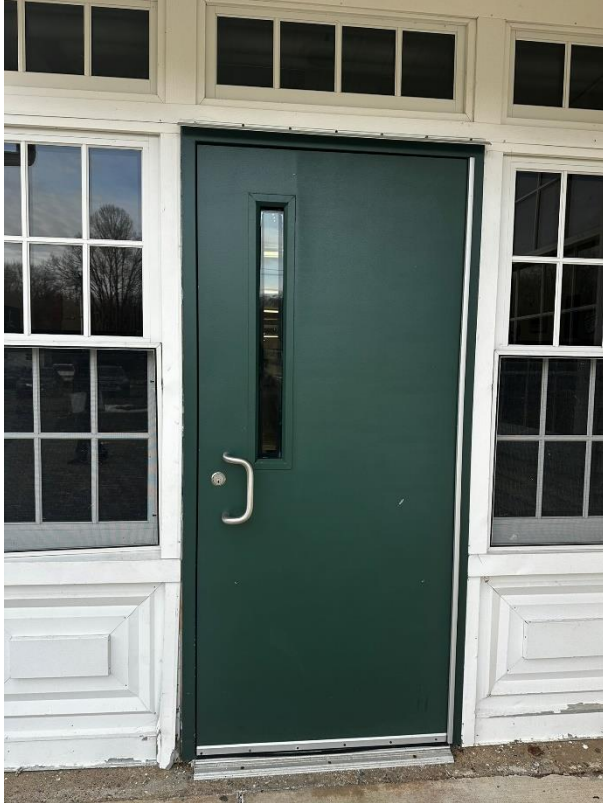
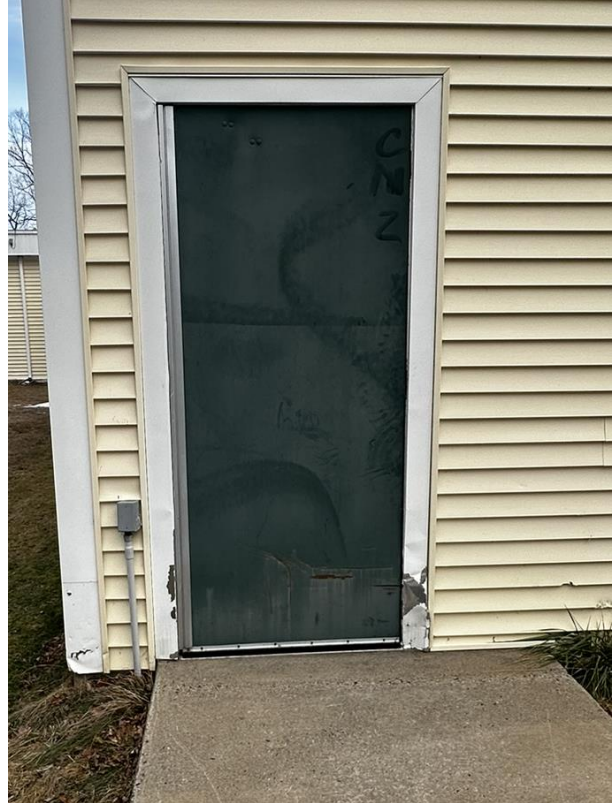
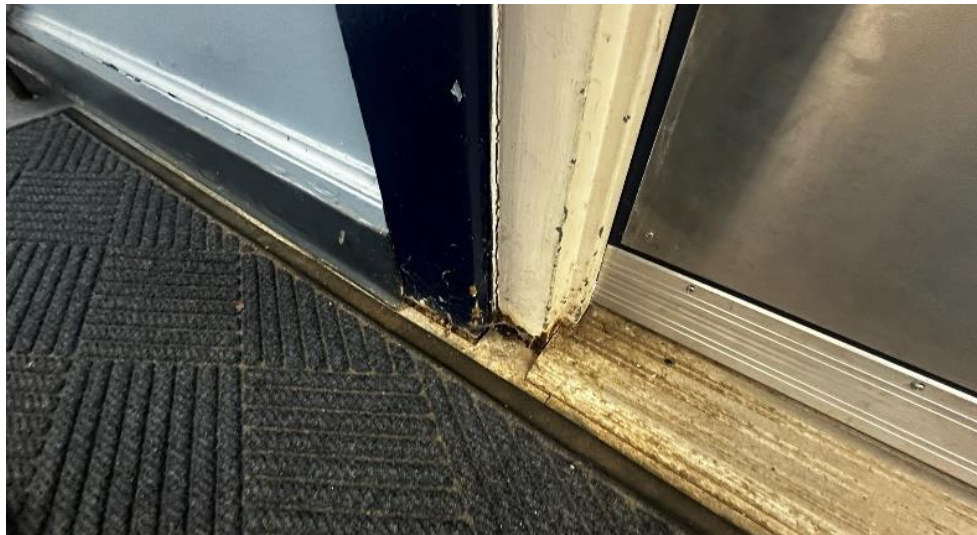
Some doors exhibit exterior damage that may be repairable. Metal pan frame surrounds are dented, deformed, and experiencing finish failure. These panning details can trap moisture, conceal deterioration, and accelerate corrosion of the hollow metal frame if not properly detailed.

Wood trim at doors shows paint failure and deterioration, particularly where wood meets grade. Some hollow metal frames exhibit minor rusting at the base and require repair.

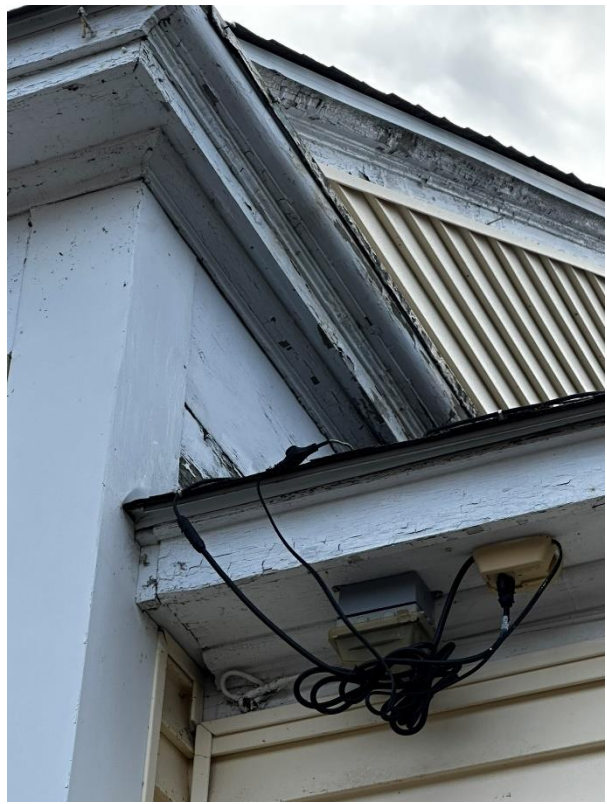
Wood fascia and soffits are in poor condition, with cracking and peeling paint. Repairs and repainting are recommended.

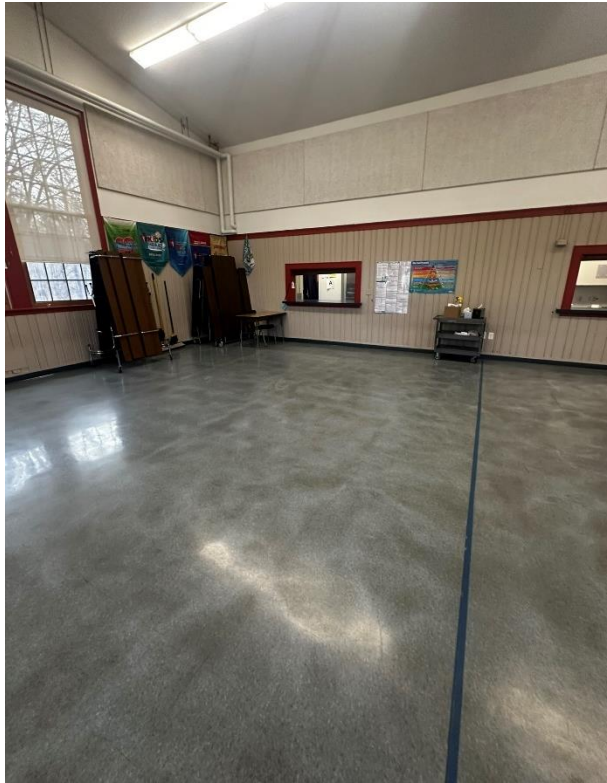
There are a multitude of flooring types throughout this building. Most of these floors are VCT (vinyl composite tile). No major issues such as cracking or chipping or curling were discovered. However, widespread wear, staining, and discoloration are present, particularly in the Multipurpose Room. Given the uneven wear and the visible cloudiness, these floors may need a full chemical strip and seal. However, if those cloudy patches are due to moisture coming up from the slab (likely no vapor barrier), new wax will simply peel off again. Additionally, VCT is not ideal for physical education use due to slip risk. Replacement with a more suitable athletic surface is recommended.

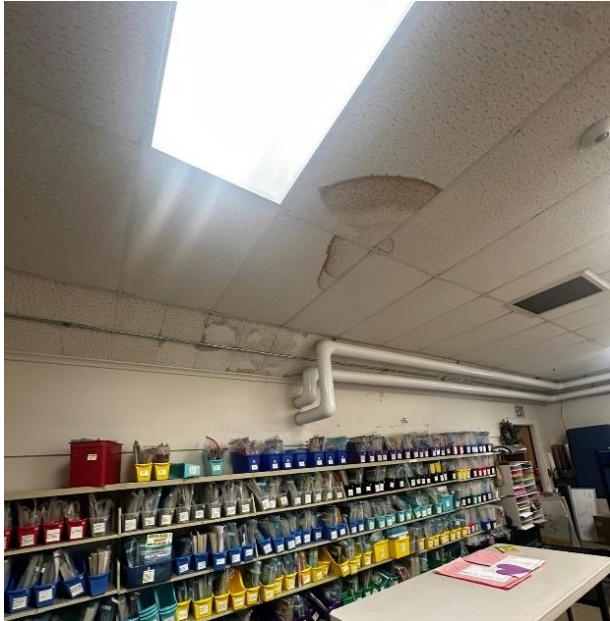
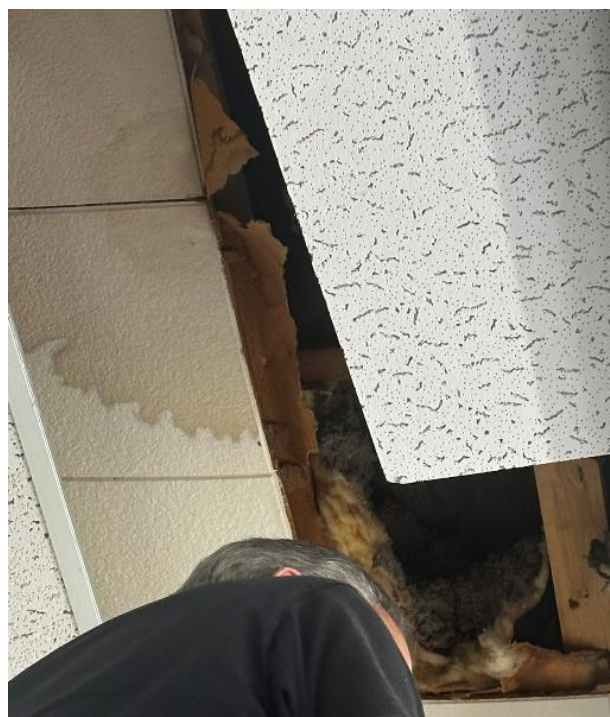
Ceilings at this school 2x4 ACT (acoustical ceiling tiles), spline ceilings and gypsum wallboard assemblies. The 2x4 ACT staining was observed in several areas, possibly related to roof or piping leaks. Many areas have original spline ceilings secured to the structure above the ACT. Some are failing and falling above the ACT. Spline ceilings are undesirable due to limited above-ceiling access. Gypsum board ceilings likely support required 1-hour fire ratings for Type V-A construction. Some ceilings are noted in AHERA documentation as potentially containing asbestos. Replacement of the ACT and spline ceilings with 2x2 ACT systems is recommended especially during any significant fire protection, mechanical or electrical upgrades.

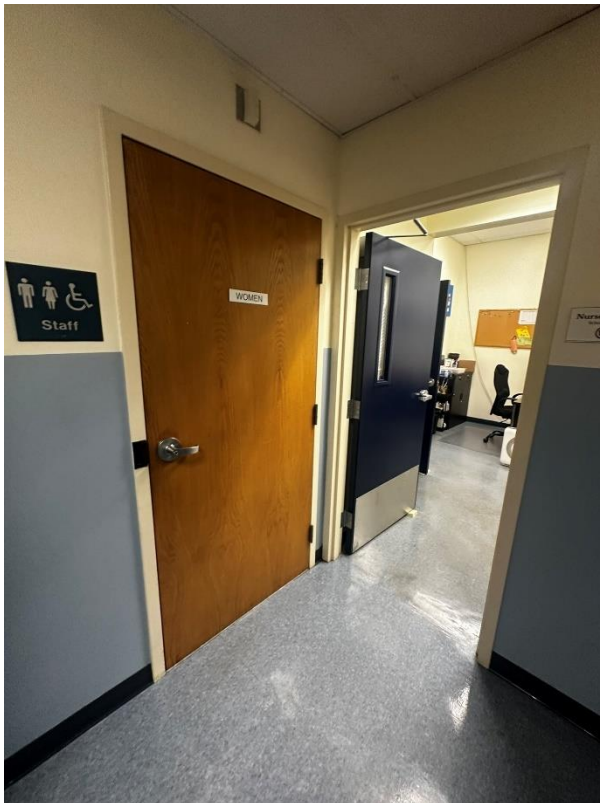
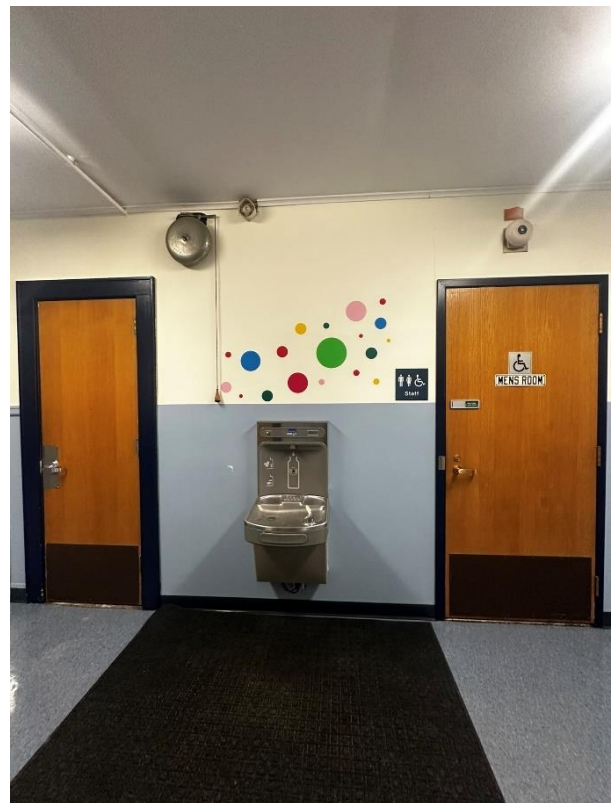
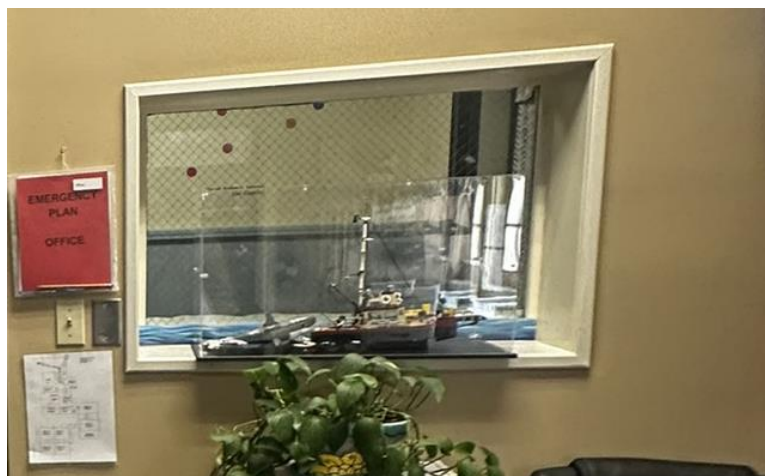
Interior doors throughout the building are wood or hollow metal within wood or hollow metal frames. Most doors have received hardware upgrades. Limited areas do not meet the required accessibility maneuvering clearances. These spaces should be adjusted to accommodate these accessibility clearances. Where they cannot be modified, a power assisted door operator should be installed.

Interior wire glass remains in some doors and sidelights. Wire glass is no longer considered impact-safe and should be replaced with tempered, laminated, or fire-rated safety glazing.

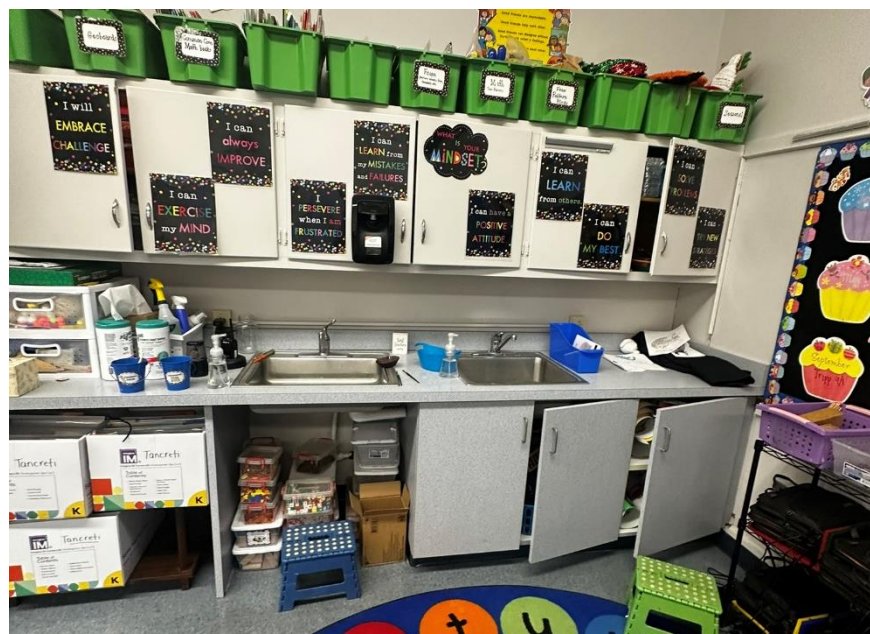
There is a variety of casework located throughout the facility. Most are wood and original to their specific construction. Due to their age none of them provide ADA accessibility. The casework height is too low to meet ADA. There are also no open knee spaces which are required at sinks and work areas. Much of the casework throughout the school should be replaced or at least modified in some areas to meet requirements.

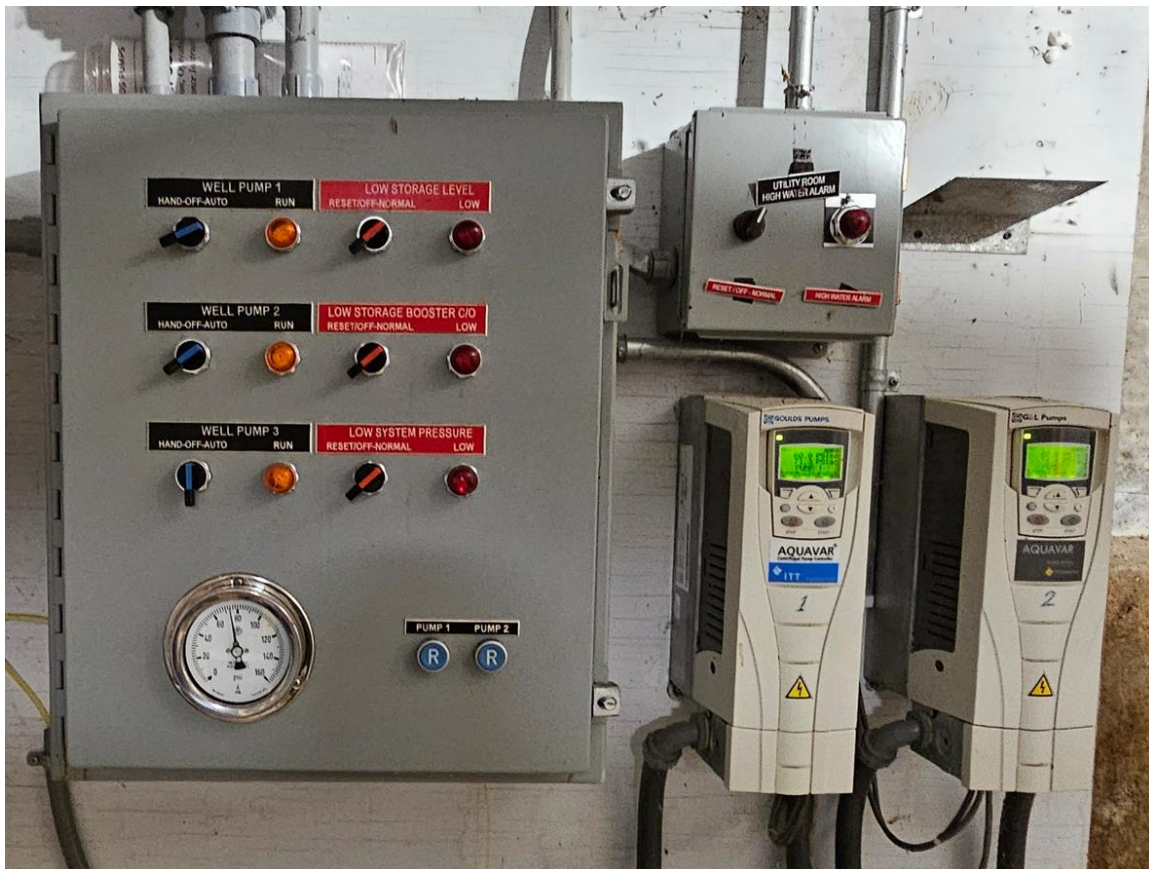
The facility is not provided with a municipal domestic water supply but instead well water via three on site wells. The system consists of a utility vault, horizontal buried 1500 – 2000-gallon water storage tank, three (3) 80-gallon hydropneumatic bladder tanks, a duplex domestic water booster pumping system with multiple tank level and pump controllers. This system is provided to increase water pressure to acceptable levels, so the building's plumbing fixtures operate correctly. System pressure reads 72 PSI and is in working order. The configuration is complex with multiple water meters and valving. Two of the three Well Pumps were in automatic operating mode during the time of the site visit.

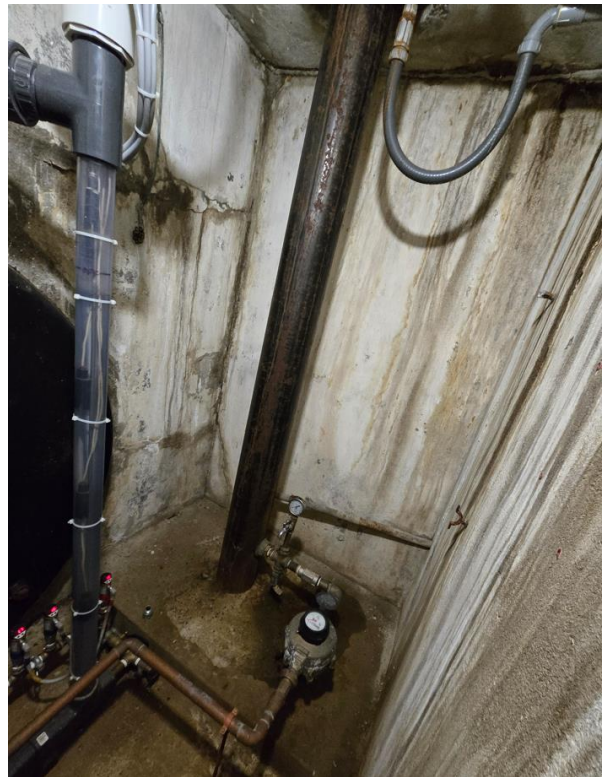
The underground horizontal storage tank is partially buried with end section exposed for service and inspection within a utility vault on the basement level. The tank appears original to the building. It shows signs of age, but no serious rusting or exterior corrosion. A tank level monitoring system is provided with exterior horn strobe. Note that the tank is vented in multiple locations, 2 of which are at grade. These vents / fill ports have now been capped.

Distribution piping is copper with sweated soldered fittings. The lead (Pb) content of the existing domestic water pipe, fittings and solder is unknown, but lead-containing materials may have been used for domestic water systems during the time of construction (pre-1986). Distribution piping is not insulated, nor labeled with service and flow arrows.

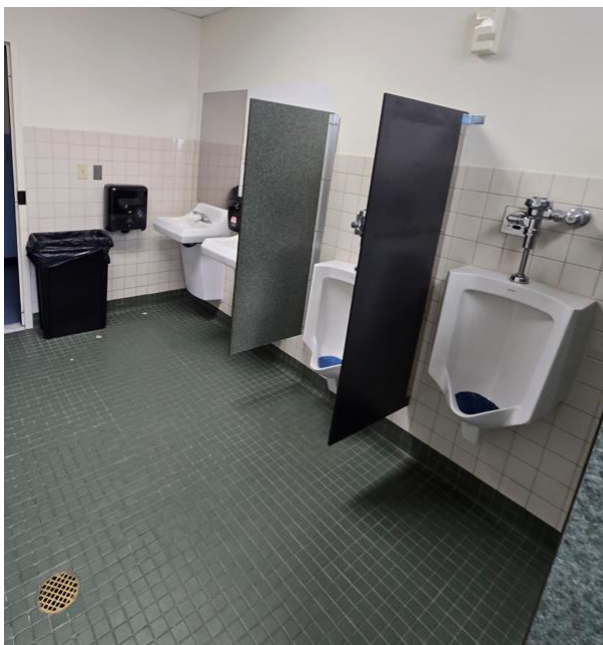
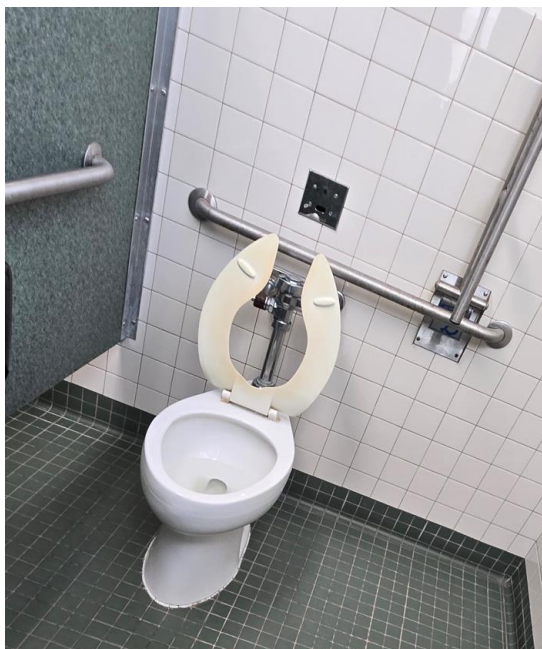
Plumbing fixtures are provided throughout the facility in standard and ADA configurations. Fixtures are commercial grade and are comprised of floor and wall hung water closets with flush valves, wall hung urinals, wall and counter mounted lavatories, classroom sinks, drinking fountain with bottle filler, dual and single type, mop sinks, etc. Some fixtures were installed in recent renovations while others appear original to the building's construction. Floor drains have been provided in the toilet rooms.

Specifically, the 1954 addition toilet fixtures are not original to the addition and have been upgraded to sensor flush valves with ADA toilet stalls. ASSE 1070 rated thermostatic mixing valves were not provided on hand washing lavatories. The Art classroom has been provided with a sink, but a solids interceptor is not provided. Two exterior freeze proof hose bibs have been provided as well.

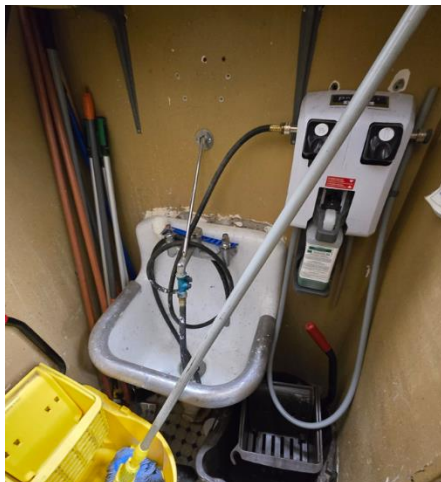
Mop sinks with chemical dispensers have not been provided with a backflow preventer as required by code.

Remove and replace fixtures per the new architectural program. Provide standard and ADA low flow fixtures per International Plumbing Code and State standards. Accessible ADA fixtures will be provided and set in accordance with the applicable codes. Provide new hot water, cold water, sanitary and vent services to new fixtures as indicated in the new Architectural layout. Provide complete with trimmings and fittings, including faucets, carriers, supplies, stops, traps, tailpieces, waste plugs, casings, hangers, plates, brackets, anchors, supports, hardware and fastening devices.

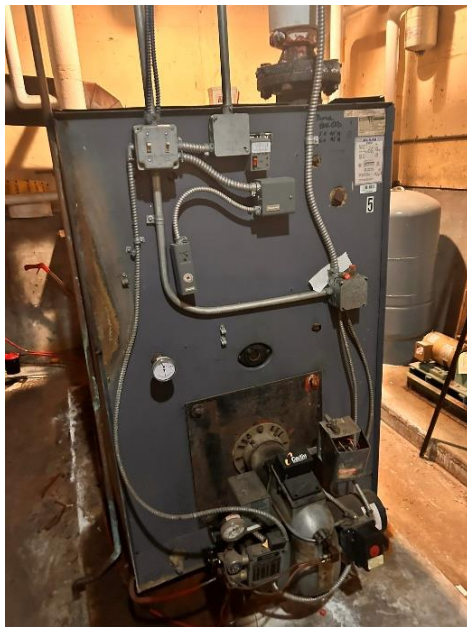
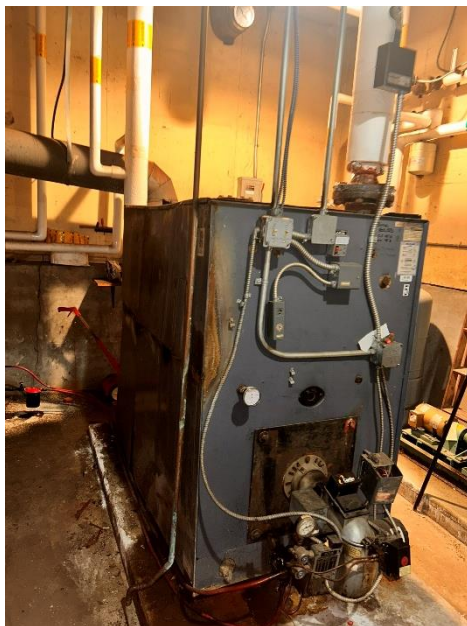
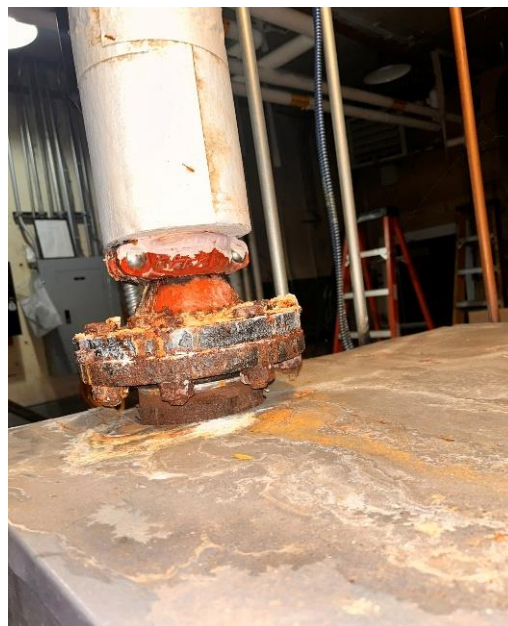
There is one (1) propane fired cast iron hot water boiler that is in poor condition. There is visible rust and damage on the boiler sections themselves. The piping is also in poor condition along with the insulation that is both damaged and missing throughout the hot water system. The burner is also in poor condition and, based on the nameplate, the boiler is about 69% efficient. The boiler flue exhaust support is also in poor condition and has missing supports in the ceiling. The typical lifespan of a cast iron hot water boiler is about 35 years.

SP+A recommends a boiler system replacement including the boiler, pumps, piping and insulation. A propane fired condensing boiler is more efficient than traditional cast iron boilers because they recover some of the heat that would otherwise be lost in the flue gases. The increased system efficiency can provide energy savings as well as increase system reliability. SP+A recommends installing a second condensing boiler as well for redundancy in the event of a boiler being temporarily offline or maintained. With the addition of condensing boilers, SP+A recommends replacing terminal equipment (fin tube radiation, unit heaters, etc.) to make sure they are sized properly for the building's loads. The typical lifespans of these units are; finned-tube radiators (25 years), and unit heaters (20 years for hot water units).

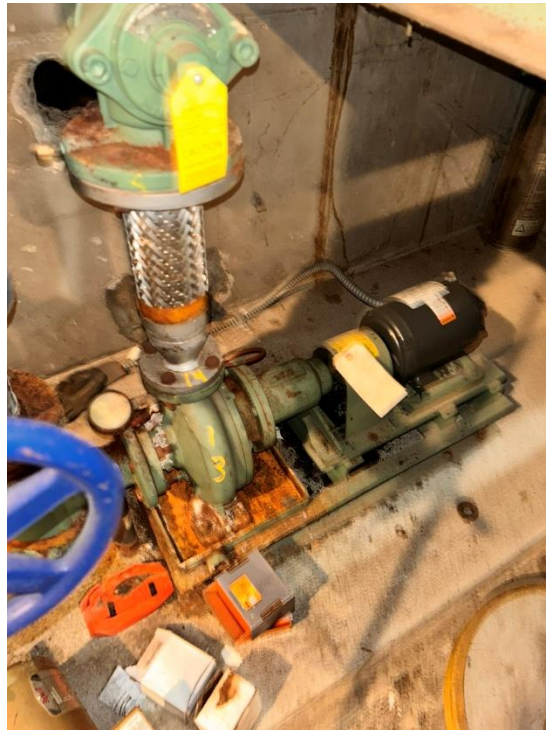
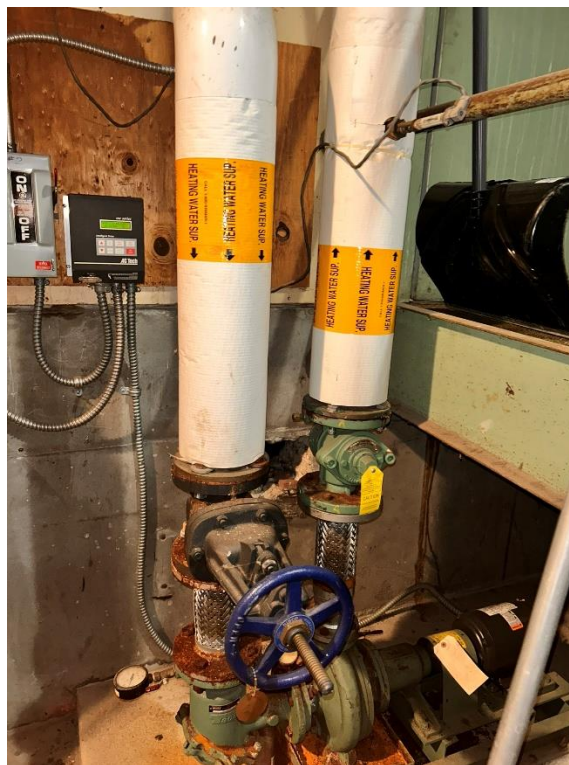
pumps are in poor condition, as are their supports and several sections of the hot water piping. The typical lifespan of a pad mounted hot water pump is about 25 years.

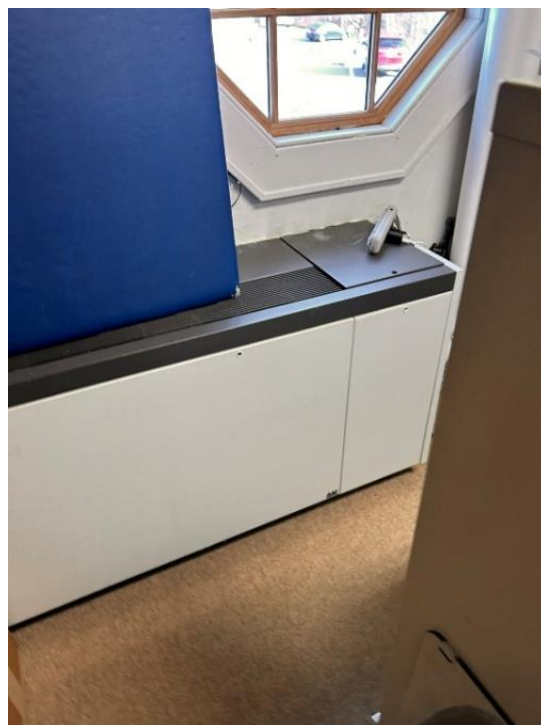
There are also a few unit ventilators in areas such as the Conference Room/Stage area. Unit ventilators are not generally recommended when considering the air quality and noise criteria of the space because they intake return air by pulling air across the floor including dust and debris. They also have the potential to make more noise than is allowable for a conference room or a classroom. The unit ventilator supply grille is also covered with storage materials which also decreases its effectiveness. The typical useful lifespan of a unit ventilator is about 20 years.

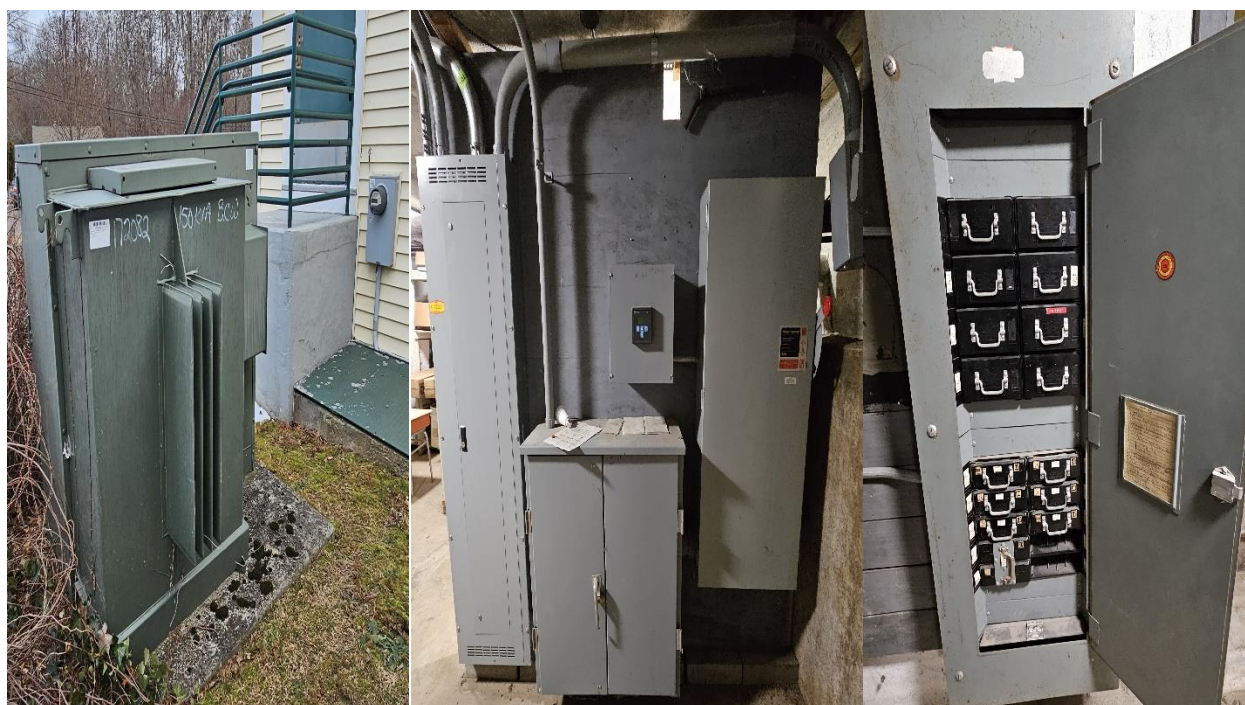
The building is served by an underground electrical service which originates from utility pole #1709 located on Cedar Lane to a pad mounted utility transformer with an exterior building mounted utility meter. From the secondary of the utility transformer the electrical service transforms down to 208Y/120V, 3 Phase, 4-Wire underground into the main disconnect switch rated at 600A, 208Y/120V, 3 Phase, 4-Wire located in the basement. The main switch feeds an adjacent 600A, 208Y/120V, 3 Phase, 4-Wire main distribution panel that feeds multiple panels and equipment located throughout the facility. The main distribution panel, manufactured by Eaton Cutler-Hammer, is in good condition. There is a 400A, 208Y/120V, 3 Phase, 4 Wire fused distribution panel, manufactured by Trumbull Electric, in poor condition and replacement parts may not be readily available. All other panels throughout the facility are newer panels, manufactured by General Electric and Eaton Cutler-Hammer, that replaced existing panels and appear to be in good condition. The electrical panels in the common area corridors were not locked and can be accessed by non-authorized personnel. The circuit breakers serving the fire alarm system, security system, and network system are lacking lock-on breaker devices.

The 400 amp distribution panel should be replaced due to the manufacturer “Trumbull Electric” no longer exist and replacement parts will be difficult to procure or not available. All other panels manufactured by General Electric and Eaton Cutler-Hammer are still supported by the manufacturer and replacement parts are available. All electrical panels in public areas should be locked. Lock-on devices should be installed on all circuit breakers serving security system panel and devices, all network communications equipment, and master intercom control panel to prevent being shut off accidentally or intentionally by non-authority. All panel circuit directories should be typed per current NEC, and all old handwritten directories should be removed. This process will help in problem solving of future electrical issues that may arise. All circuit breakers with no branch circuit wiring should be turned to off position and labeled “spare” on panel circuit directory. While further verification with a preliminary HVAC design will be required to confirm the existing service capacity sufficiency, it appears unlikely that the 600 amp service would be capable of serving a full building air conditioning project. The existing main panel would need to be replaced or supplemented, and this cost has been included in the project estimate.

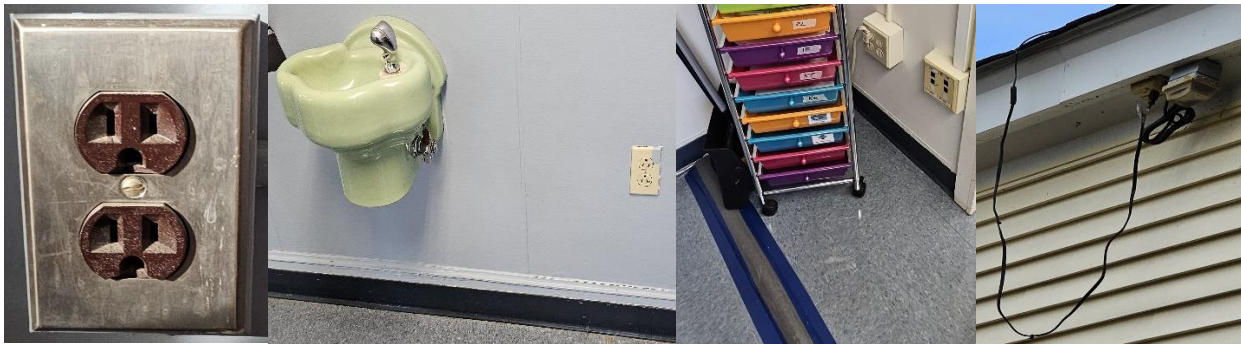
Receptacles throughout the facility consist of both recessed and surface mounted units. The condition of power receptacles throughout the facility varies from good to poor condition. Several occupied rooms appear to utilize window A/C units based on the 20A, 125V, 1-Phase receptacle mounted adjacent to windows. There are several outlets within 6' of a water source that are not GFCI type or not labeled GFCI protected. Disconnect switches for mechanical & plumbing equipment appear to be in fair to poor condition. Exposed wiring in junction/back boxes without cover plates was noticed in several classrooms. There is no emergency shut-off push button at kitchen egress doors for shut-off of gas to cooking equipment. There was no visible sign of any older wiring with cloth insulation. There are several locations around the exterior of the facility that have snow/ice melting for roof edges and downspouts that are plugged into outlets under the eaves with cords/cable hanging.

Tamper-proof receptacles should be considered in classrooms, offices, and corridors as required by the current NEC. The use of extension cords to reach electrical loads from receptacles is a Code violation. Additional receptacles, with a dedicated new branch circuit, should be added to each room in locations as required. Disconnect switches for mechanical, plumbing, and kitchen equipment should be replaced with the replacement of equipment.

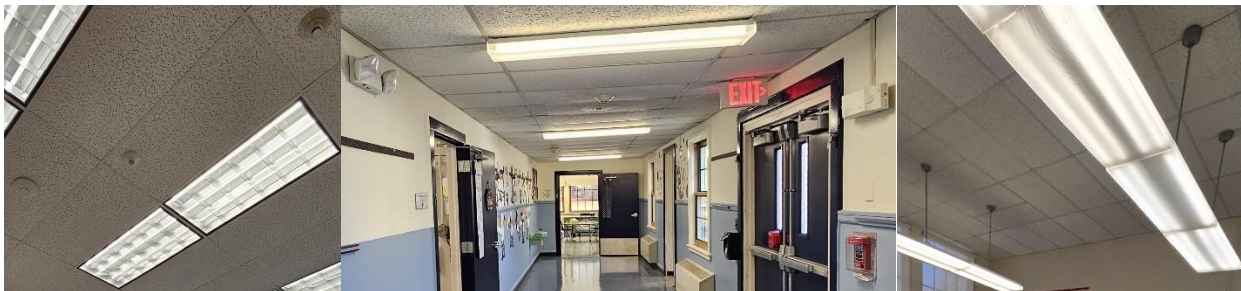
Interior lighting throughout the classrooms, offices, and corridors consists of recessed, surface, and pendant mounted fixtures with LED lamps and either parabolic or acrylic lens style. Gym/Cafeteria has 4' surface mounted LED lamp fixtures with wraparound acrylic lens. Most fixtures throughout were originally fluorescent and have been retrofitted with LED lamps and drivers. Classroom lighting fixtures are controlled via a combination, ceiling occupancy sensors and single pole toggle switches for dual switching of inner & outer lamps. Corridor lighting controls are via 3-way toggle switching at each end of corridors. Utility rooms and basement have RLM type fixtures or surface mounted LED fixtures with manual single pole toggle switches for control. Building exterior perimeter light fixtures are a mix of decorative lantern fixtures with LED lamp and wall pack LED fixtures, controlled via timeclock and appear to be in good to fair condition.

While the LED retrofit condition provides reasonable energy efficiency, the housings are nearing the end of their useful life and additional efficiency could be achieved with the installation of all new LED fixtures. Full replacement of interior lighting should be considered, especially if an upcoming project is planned which would require removal of most existing ceilings. Such a lighting replacement would provide further improvement in lighting efficiency and allow for incorporation of enhanced lighting controls with dimming and daylight harvesting. The attached estimate includes a full replacement of the interior and exterior lighting.

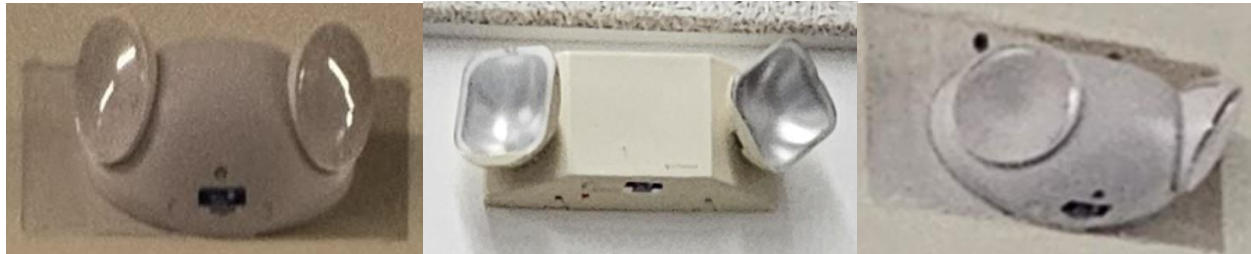
The emergency lighting consists of mainly wall mounted twin-head battery units with remote heads on exterior wall at egress doors. These fixtures appear to be in good condition and appear to be adequate quantities to meet the egress lighting requirements. Electrical panel covers have labels indicating emergency lighting testing dates.

Suggest adding twin-head battery unit emergency light fixtures in basement where main electrical service and water service are located. Also, monthly testing and replacing of emergency light fixtures upon test failure. Emergency light fixtures should be numbered along with a log indicating tested and replacement/installation dates. If the interior and exterior lighting replacement noted above takes place, a superior emergency lighting solution could be included, including central inverter units to provide emergency backup power to some of the normal light fixtures as required for emergency egress coverage or battery pack units integral to these new normal light fixtures.

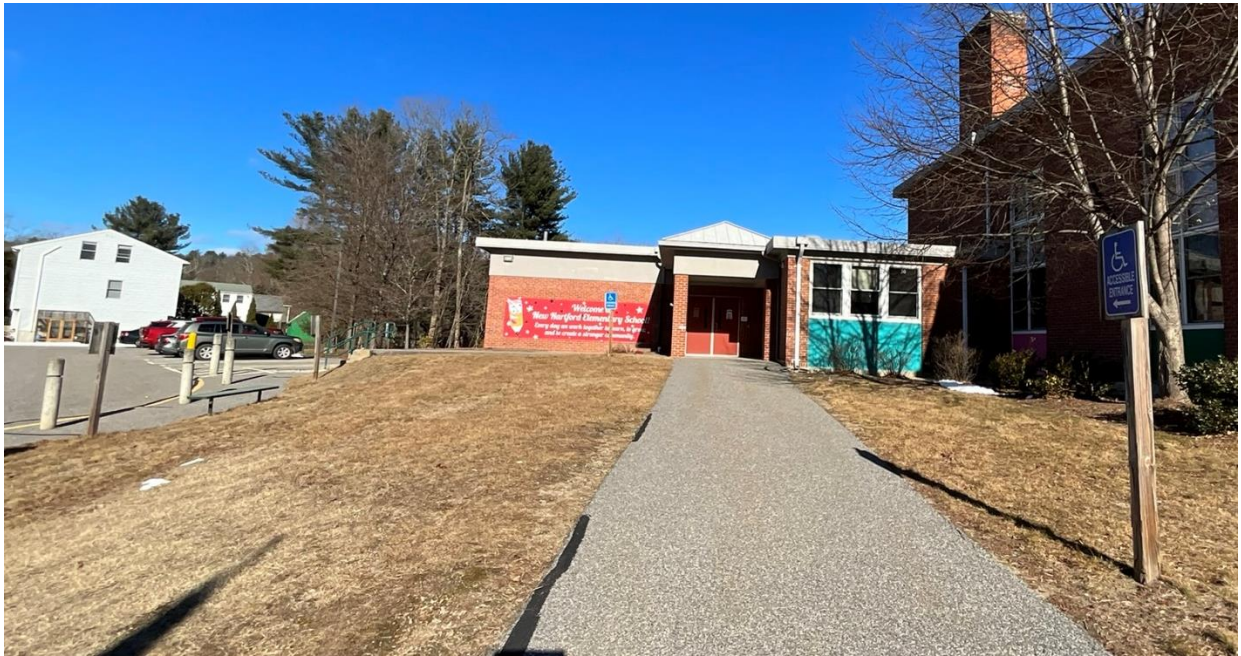
There is currently no direct accessible route from the designated accessible parking spaces to the main entrance. While an existing meandering walkway appears to achieve compliant slopes, it significantly increases travel distance and does not provide the most direct accessible connection. A direct accessible route should be provided from the accessible parking area to the primary entrance in accordance with current accessibility standards. Accessible parking signage should also be updated to meet current ADA requirements.

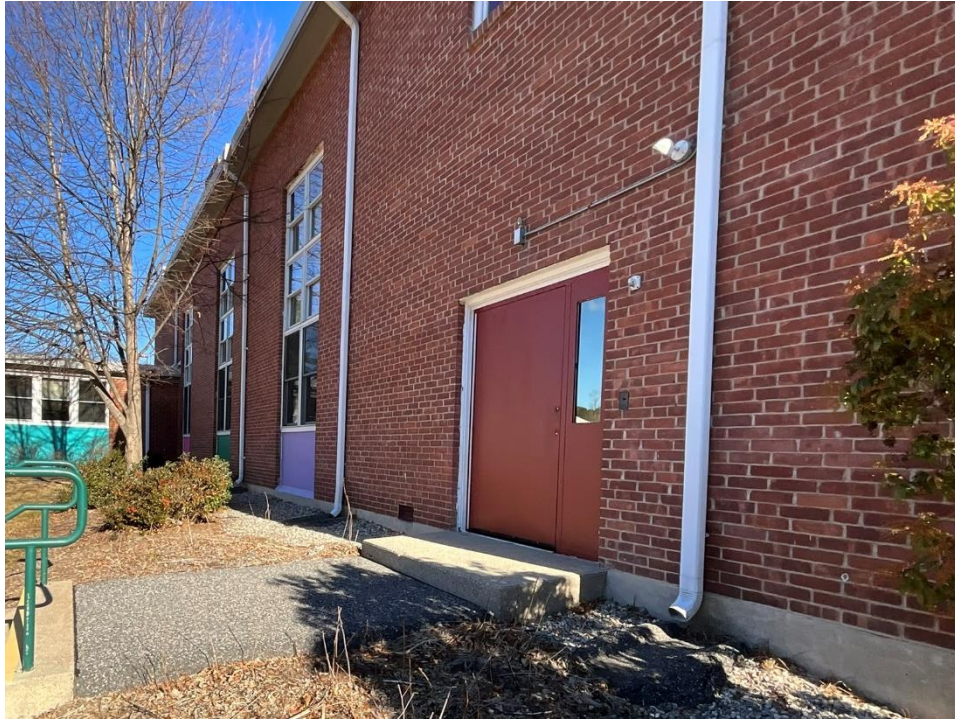
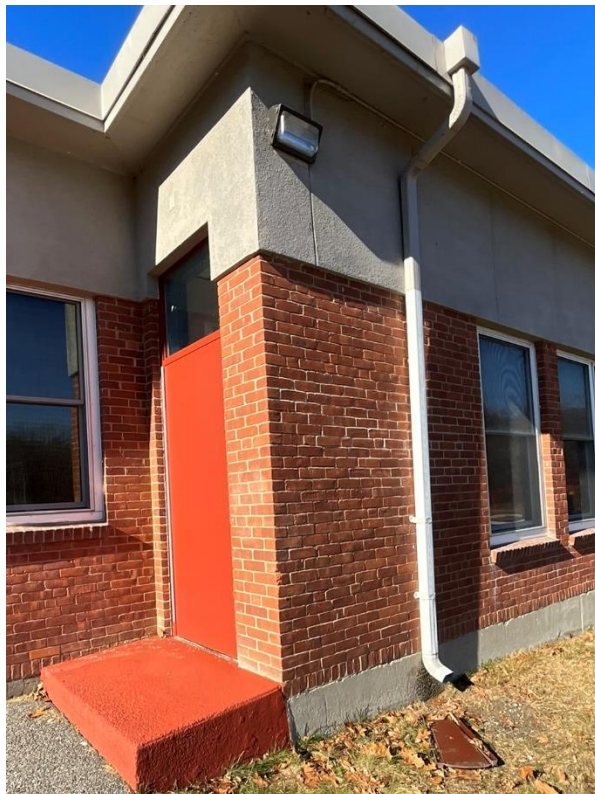
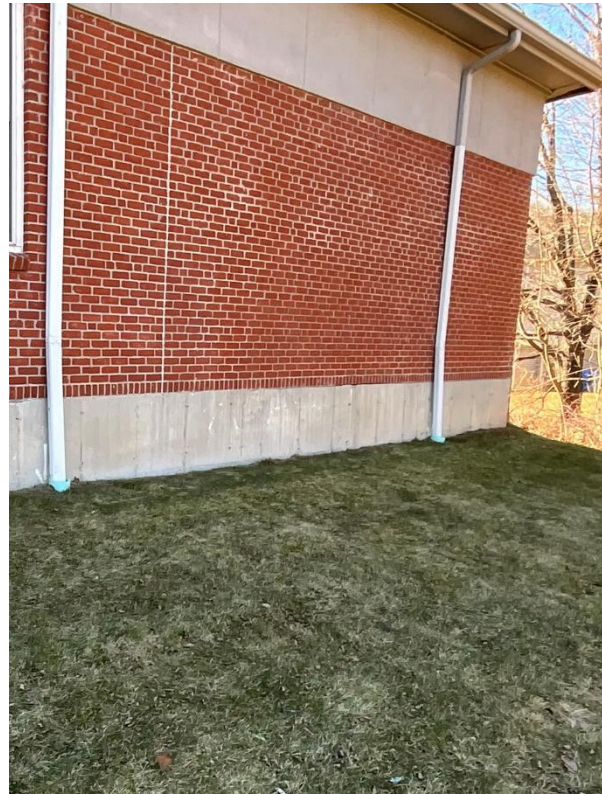
Perimeter drainage conditions vary. Downspouts discharge inconsistently, with some piped underground and others discharging directly at grade, with or without splash blocks. The site would benefit from a coordinated perimeter drainage strategy, potentially including gravel drip edge strips, improved discharge control, and consideration of French drain systems. These improvements should be evaluated in conjunction with future roof replacement work.

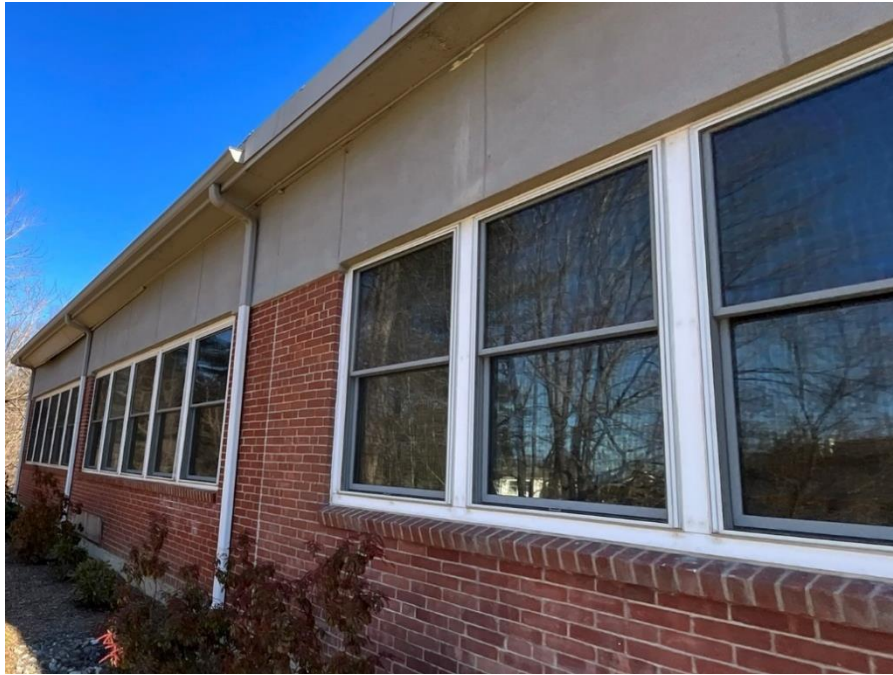
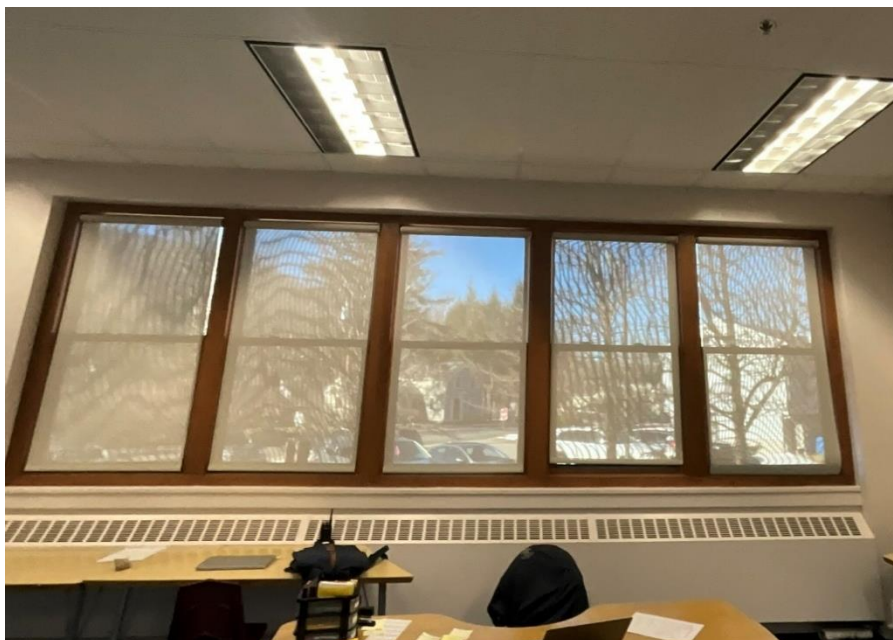
While no major deficiencies were observed, the windows are approaching the latter portion of their expected lifespan. Exterior sealant deterioration was noted at select locations. Although localized recaulking could be performed, full window replacement should be considered in future capital planning efforts.
