# New Hartford Public Schools Utilization Study- Facility Conditions Assessment

MARCH 25, 2026

Prepared for:  
**New Hartford Public Schools**  
**530 Main Street PO Box 315**  
**New Hartford, CT 06057**

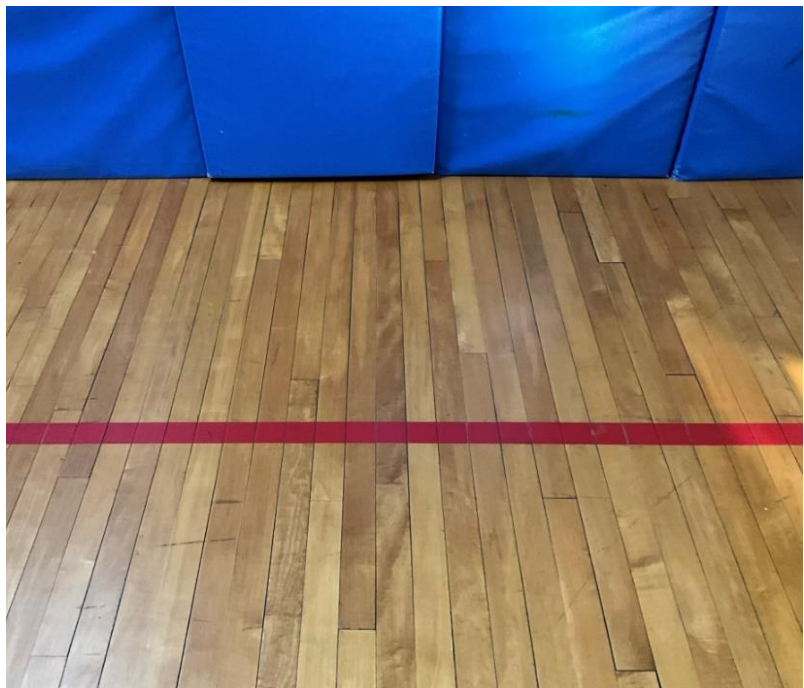
The gymnasium wood floor has been maintained; however, some widening seams and gaps were noted. A maintenance program including screening and recoating—or potentially sanding and refinishing, depending on wear depth—is recommended. Further evaluation, including moisture testing and verification of remaining wear layer thickness, is advised prior to determining final scope.

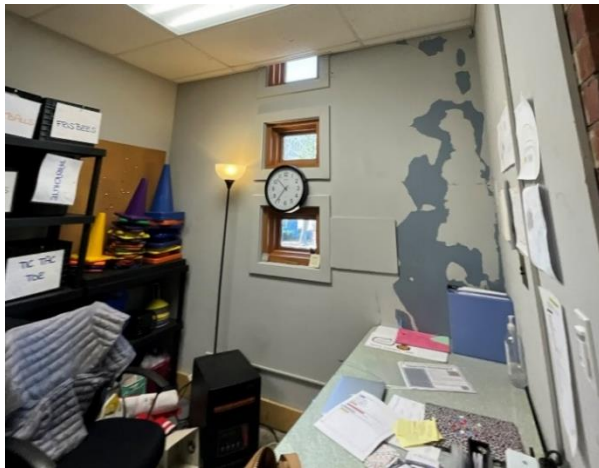
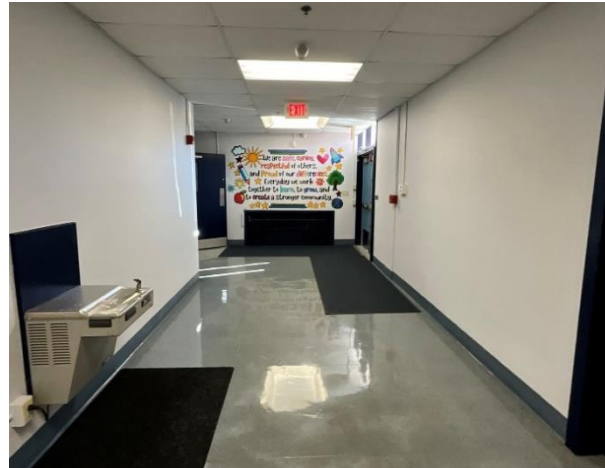
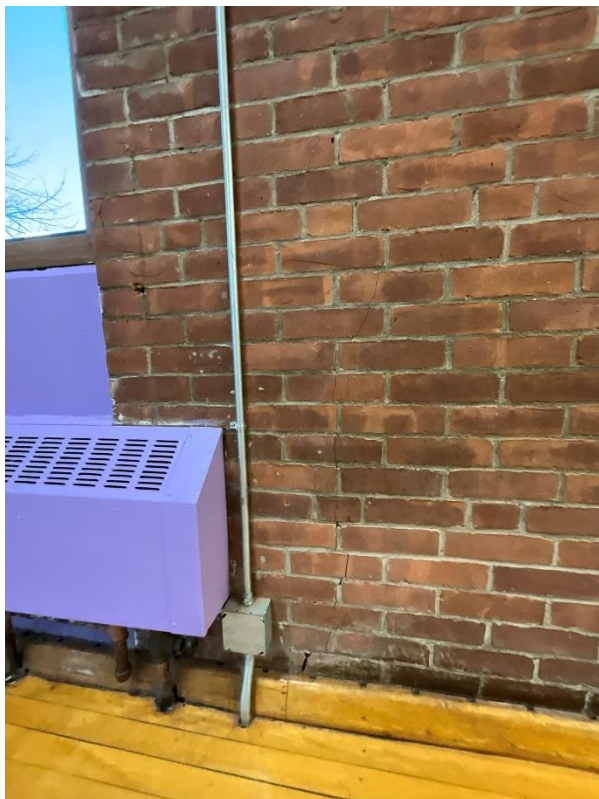
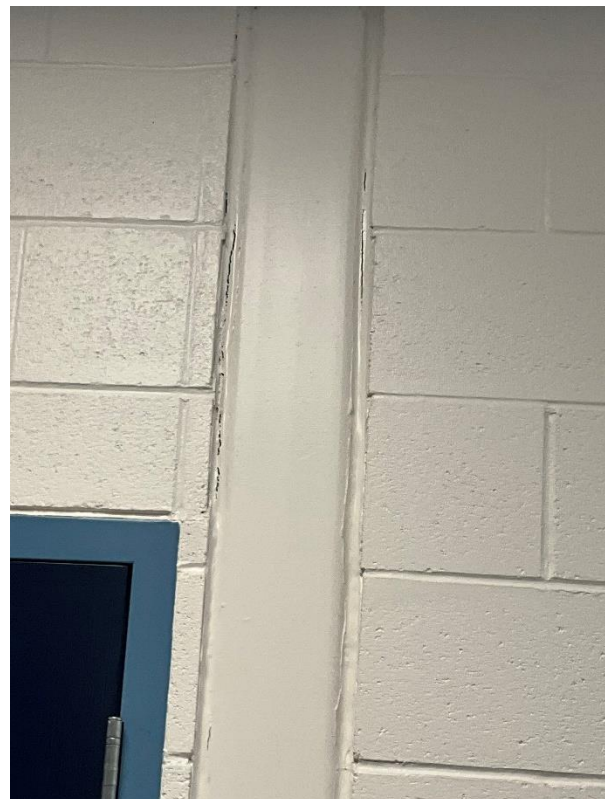
Interior wall construction varies and includes exposed and painted brick, painted CMU (concrete masonry unit), and gypsum wallboard partitions. Brick walls in corridors and the gymnasium are generally in good condition. Minor cracking was observed in the gymnasium masonry along with the basement foundation wall; while no structural displacement was evident, localized investigation and repair may be warranted. Painted CMU walls show minor joint deterioration at steel column interfaces and inside corners. Sealant replacement is recommended. Gypsum wallboard partitions are generally in good condition, with isolated damage likely associated with roof leaks. Following roof replacement, damaged areas should be repaired and repainted. Other walls such as painted gypsum wall board are in good condition. Some areas are damaged, likely due to the roof and once the roof is completed the walls should be repaired and painted.

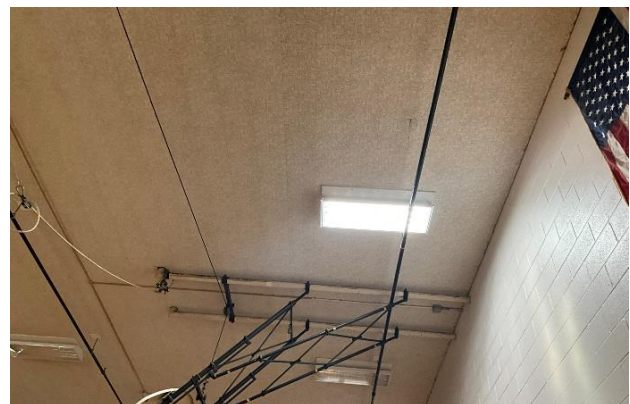
It also should be noted that older ceilings are installed to the structure above the ACT, similar to Bakerville. If roof leaks are causing these to get wet, they will begin to fall too.

Upon roof replacement, all ceilings should be reassessed, and water-damaged tiles replaced.

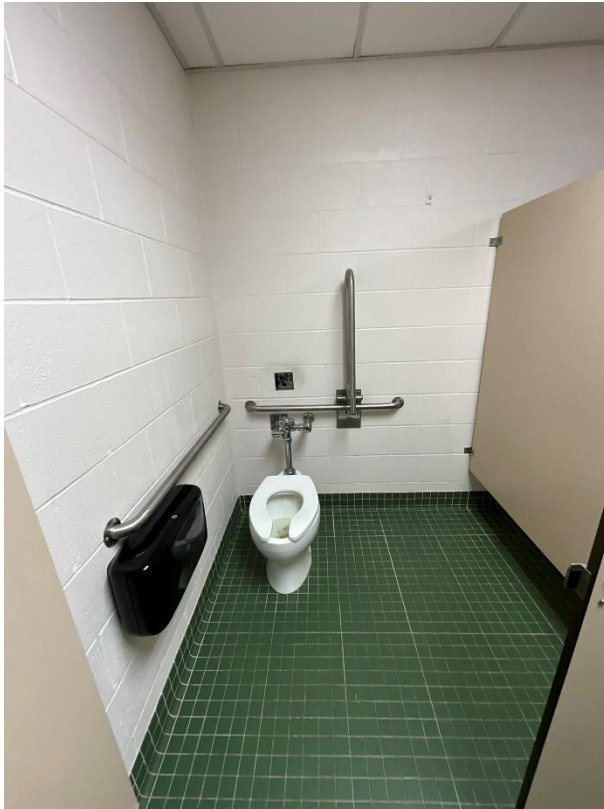
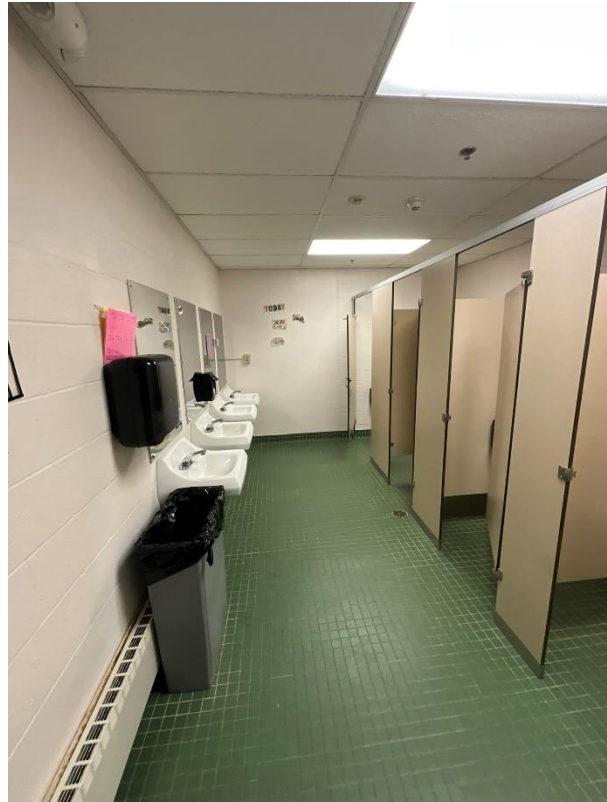
There are a few restrooms throughout the facility. There is only one set of “gang” student restrooms. These were added in the 2004 project. The restrooms are in fair condition with limited issues noted. Accessible toilet compartments do not include required vertical grab bars in accordance with current ADA requirements. The swing up grab bar could be removed as it is no longer required.

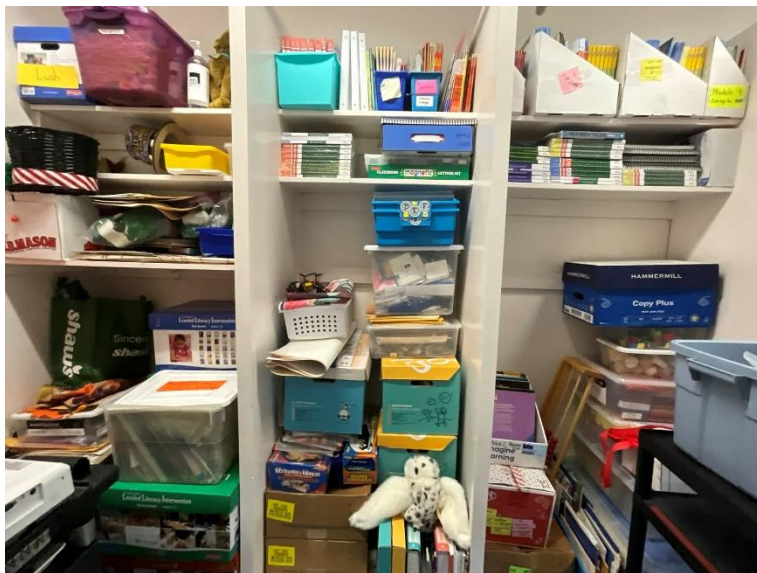
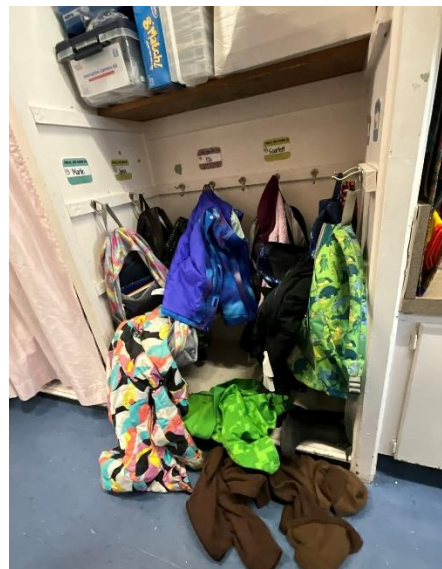
Classroom storage alcoves occupy significant corners of each classroom and, in some configurations, appear to reduce instructional area efficiency. In some of the configurations the student zone appears undersized in this layout. Future renovation projects may consider reconfiguration to optimize classroom layout.

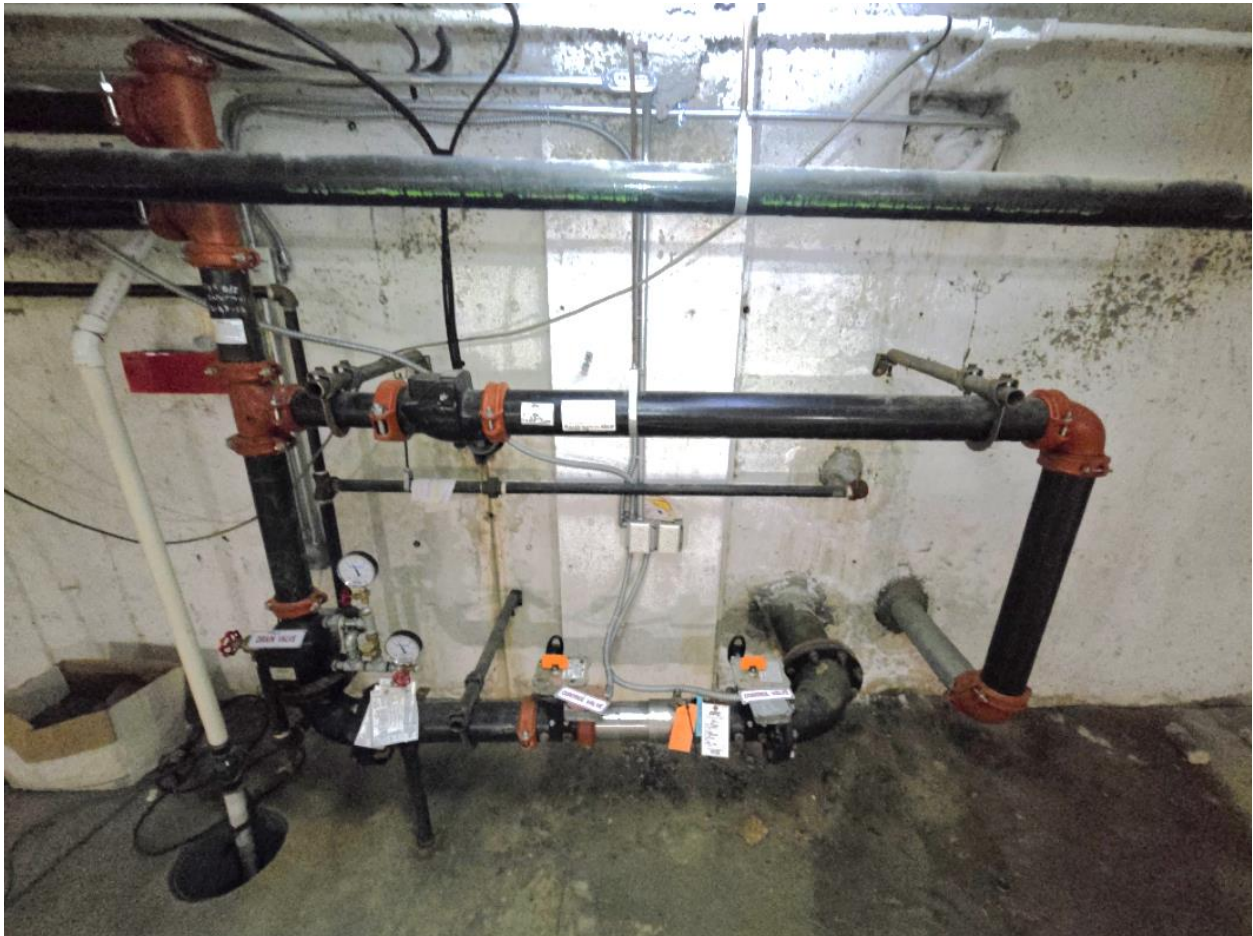
A dedicated 4" fire protection water service is installed in the crawlspace with a 4" supervised butterfly control valve. In accordance with Connecticut Cross contamination regulations, the system is equipped with a 4" double check valve assembly (DCVA) backflow preventer assembly before being routed to a 4" wet riser check valve (RCV) assembly with pressure gauge reading 130 PSI. The system is divided into two separate protection zones, one for the basement / crawlspace, the other for the main level.

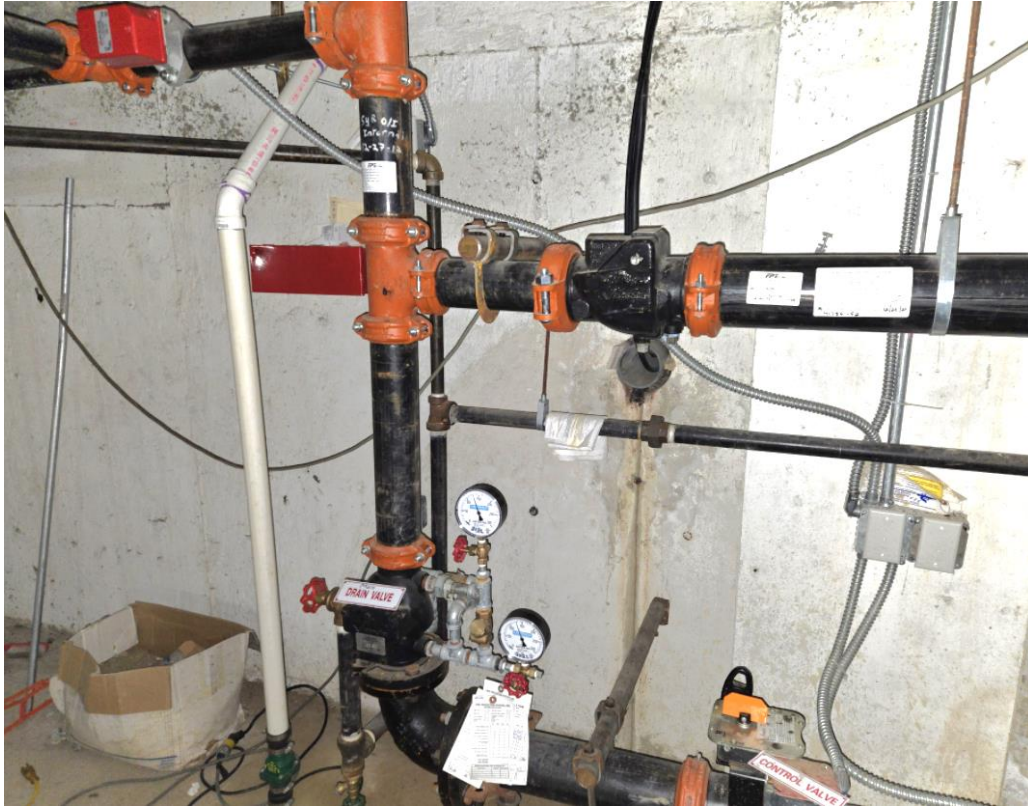
The system inspection tags are dated ranging from 2024 – 2026 citing no issues. All system components are present, including main drain, fire department connection piping with check valve, etc. supervised tamper switches on valve and flow switches are provided accordingly.

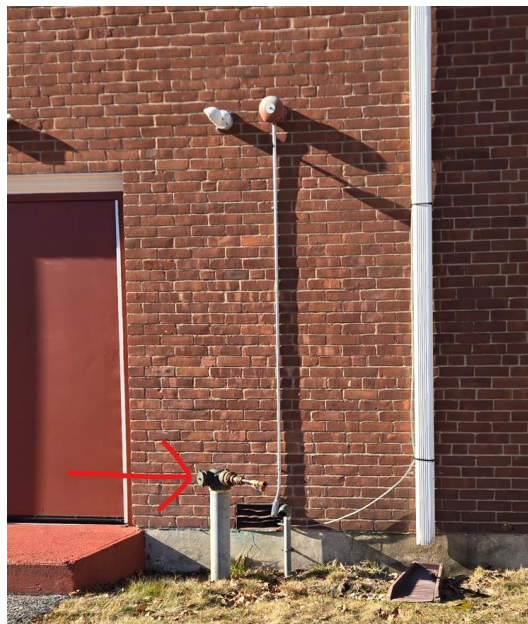
A free-standing fire department connection (FDC) and alarm bell have been provided on the exterior accordingly, though required signage is not present.

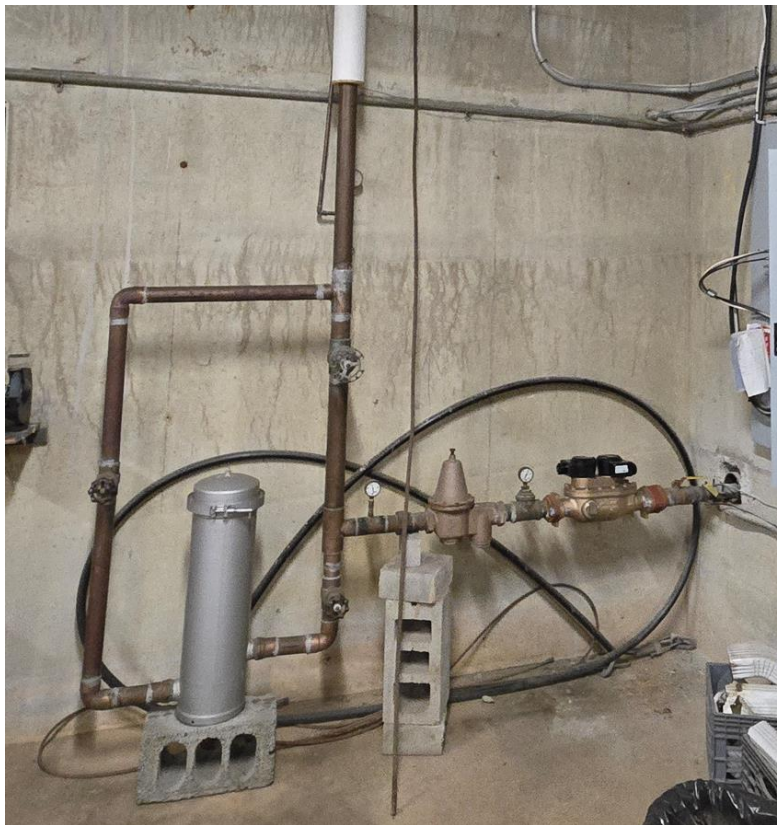
The facility is provided with a 2" domestic water service consisting of the water meter, pressure reducing valve and canister water filter. The incoming pressure reads 120 PSI and is reduced to approximately 90 PSI via a pressure reducing valve. A cross-connection device has not been installed, but likely is not required based on the building low degree of hazard.

The service is slightly undersized for the quantity of flush valve fixtures in regard to recommended velocities during peak demand, but given diversity and adequate available water pressure no further accommodations are required.

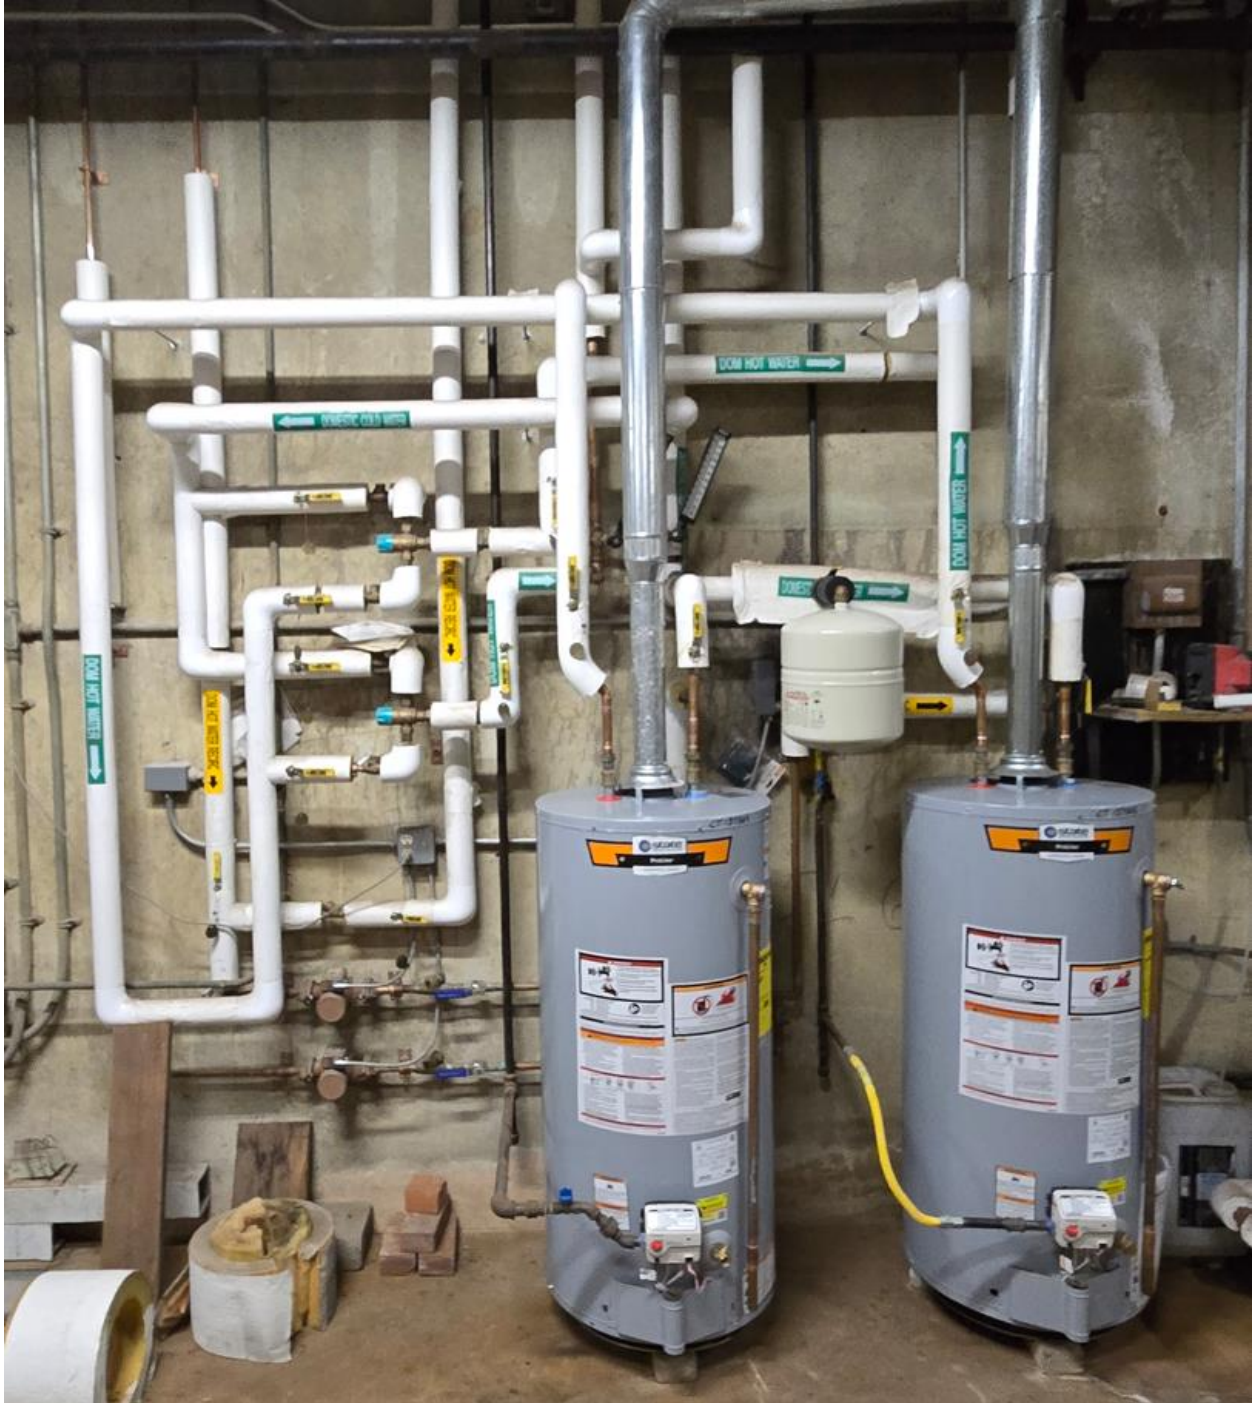
The facility generates domestic hot water via redundant (qty two) mid-efficient, 40 gallon propane fired storage water heaters manufactured by State Water Heater, Proline Model GS6-40-BCS 401 (performance rated at 36 MBH with 37 gal/hr recovery @ 100° rise) each. These were recently installed (01/30/2025) with a serviceable life expectancy of 10 years. The hot water distribution system is equipped with two hot water recirculation piping loops with two circulator pumps. Aquastats are provided on each recirculation system for individual pump control. Two Thermostatic Mixing Valves are provided set to 140F & 110F, with a common thermal expansion tank. A dedicated 140F hot water loop is provided to the kitchen; the 3 bay sink receives 140F hot water while the kitchen's hand-washing sink gets reduced supply temperature via remote thermostatic mixing valve. The second hot water supply loop set to 110F serves the rest of the building.

The water heaters are atmospherically vented (Category I), deriving all combustion air from the mechanical room via outside air intake louvers. Flue gases are then vented to the exterior via the masonry chimney.

For all systems it is recommended to store domestic hot water at 140°F to reduce the growth of legionella. To eliminate potential scald hazards, provide a properly sized thermostatic mixing valve to deliver the required temperature per the following criteria:

- Master Mixer, all water heaters require external temperature controls via ASSE 1017 Thermostatic mixing valve to reduce hot water from 140°F to 120°F.
- Hand washing lavatories (bathroom groups) require Tempered water via ASSE 1070 Thermostatic mixing valve to provide 105°F – 110°F water.

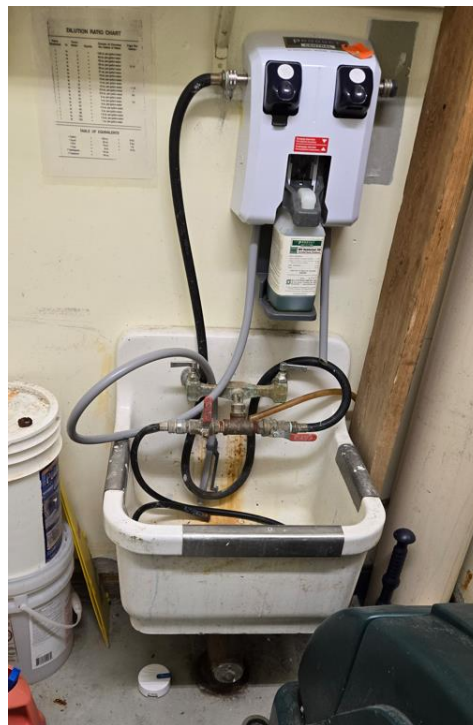
Multiple mop sinks with chemical dispensers have not been provided with a backflow preventer as required by code.

Remove and replace fixtures per the new architectural program. Provide standard and ADA low flow fixtures per International Plumbing Code and State standards. Accessible ADA fixtures will be provided and set in accordance with the applicable codes. Provide new hot water, cold water, sanitary and vent services to new fixtures as indicated in the new Architectural layout. Provide complete with trimmings and fittings, including faucets, carriers, supplies, stops, traps, tailpieces, waste plugs, casings, hangers, plates, brackets, anchors, supports, hardware and fastening devices.

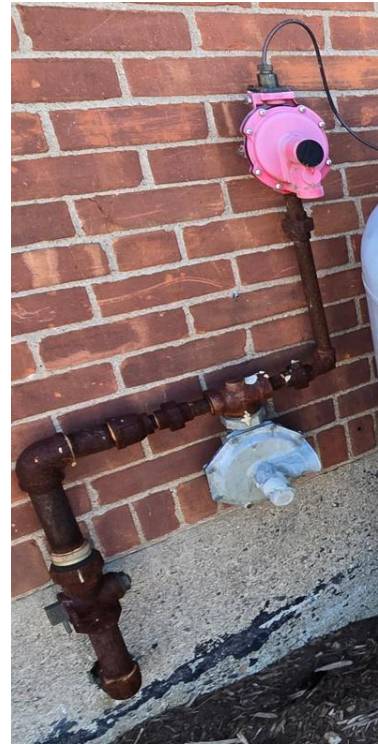
Exterior piping is unpainted threaded Sch. 40 black steel and is heavily corroded. Interior piping is the same material, just not corroded.

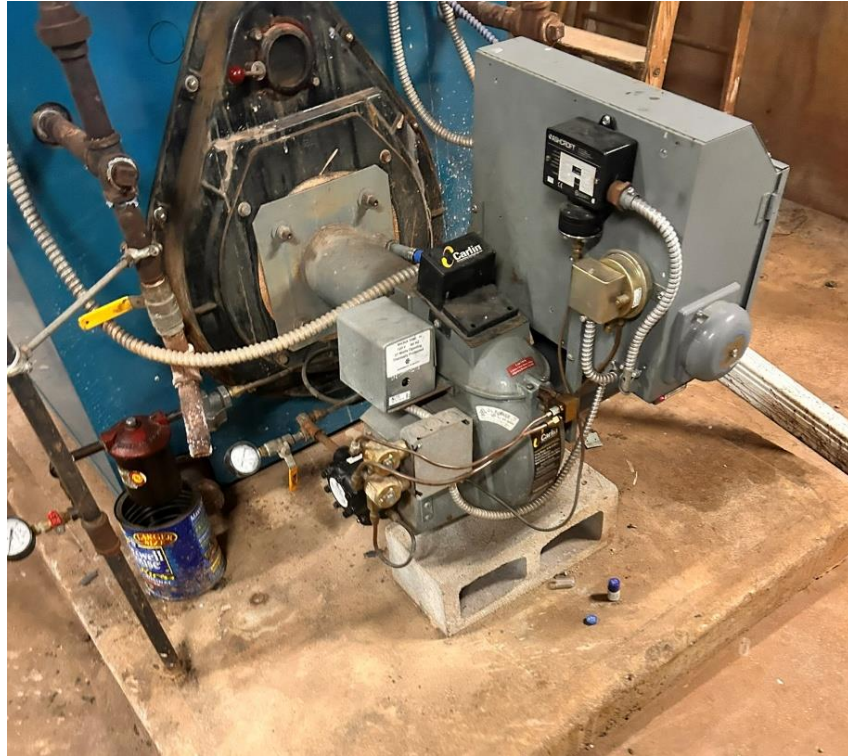
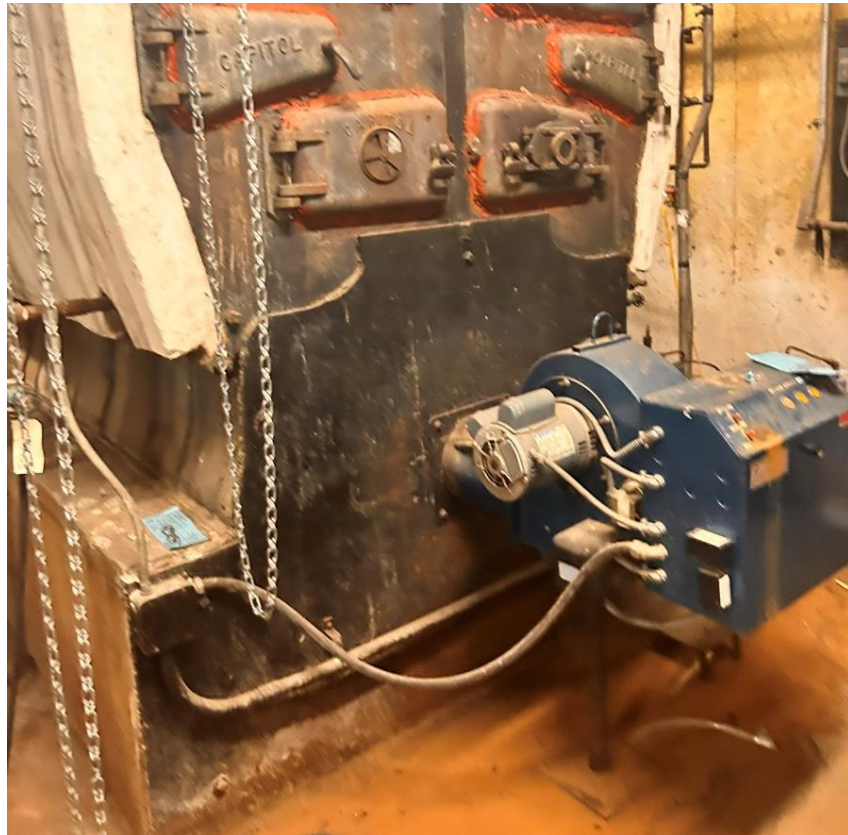
There are two (2) fuel oil fired steam boilers that are in the basement and serve low-pressure steam throughout the school. The Burnham boiler is in good visual condition though the burner is in poor condition and being supported by a masonry block. The older boiler is in fair condition with obvious areas of rust and aging. The burner is also in poor condition. Much of the piping in the boiler room is in poor condition and uninsulated. The condensate recovery system is also in poor condition including the recovery tank and pumps. There are clear areas of rust, dust and lack of insulation. The system is likely inefficient due to the lack of insulation and damage to piping. There are also many areas of clear pipe damage from steam, condensate and chemicals.

SP+A recommends replacing the boilers with propane-fired condensing hot water boilers which would include replacing the boilers, terminal equipment and piping. It would also include provisions for increased propane consumption. Propane fired, condensing boilers are more efficient than the cast iron sectional type because they recover heat from the flue gases.

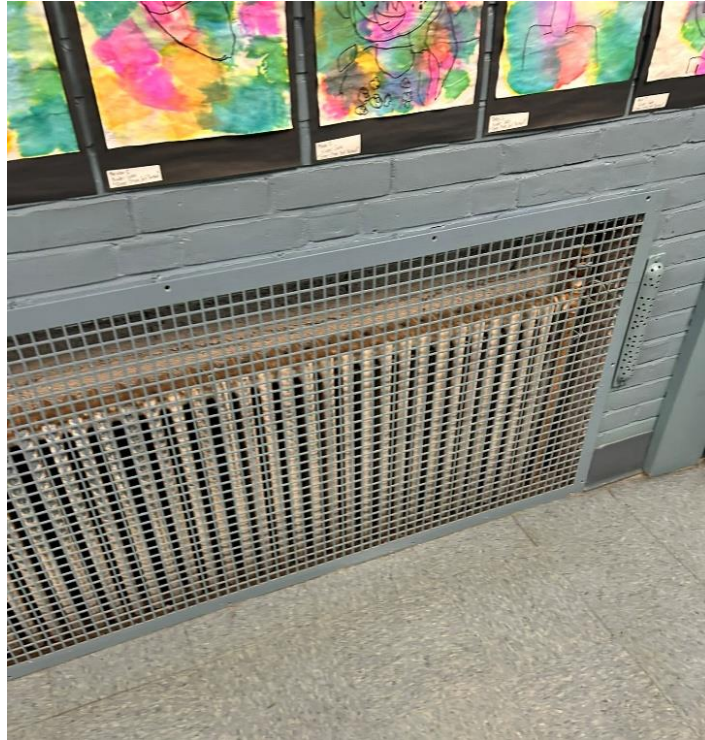
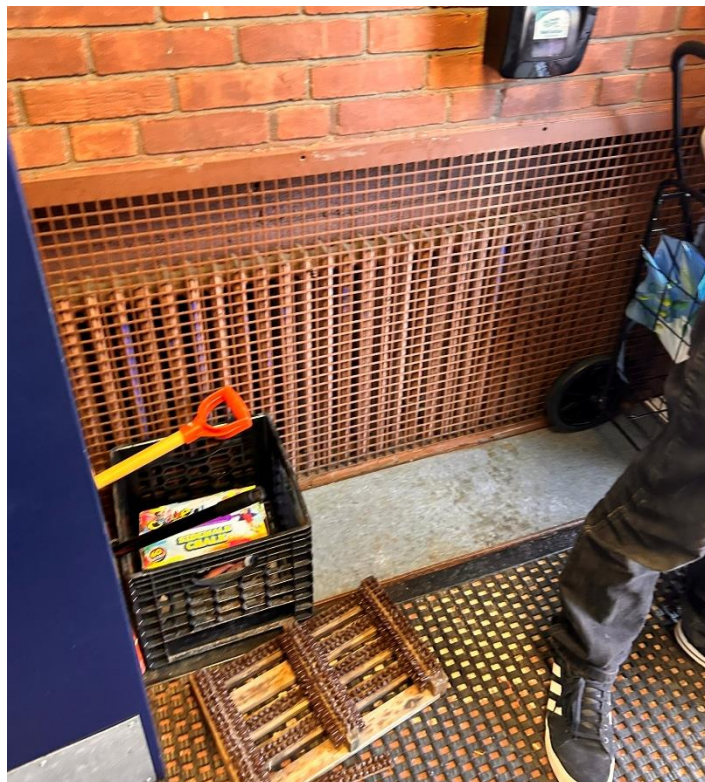
Steam systems can have several potential issues including steam and condensate leaks, steam trap failure, pipe corrosion, and significant heat losses which all affect the performance and efficiency of the system. SP+A observed several areas where steam traps were whistling likely due to failure and steam leaking by them. The terminal equipment, such as the radiators and finned-tube, are also in poor condition.

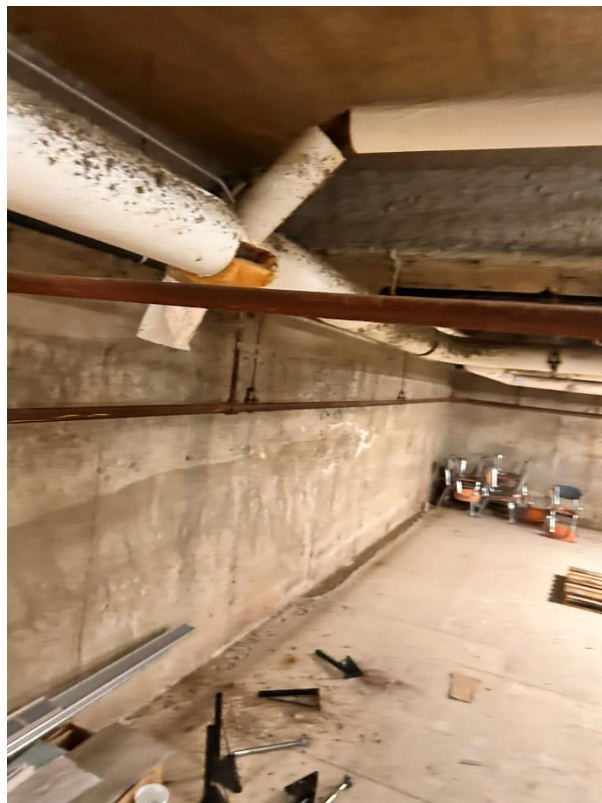
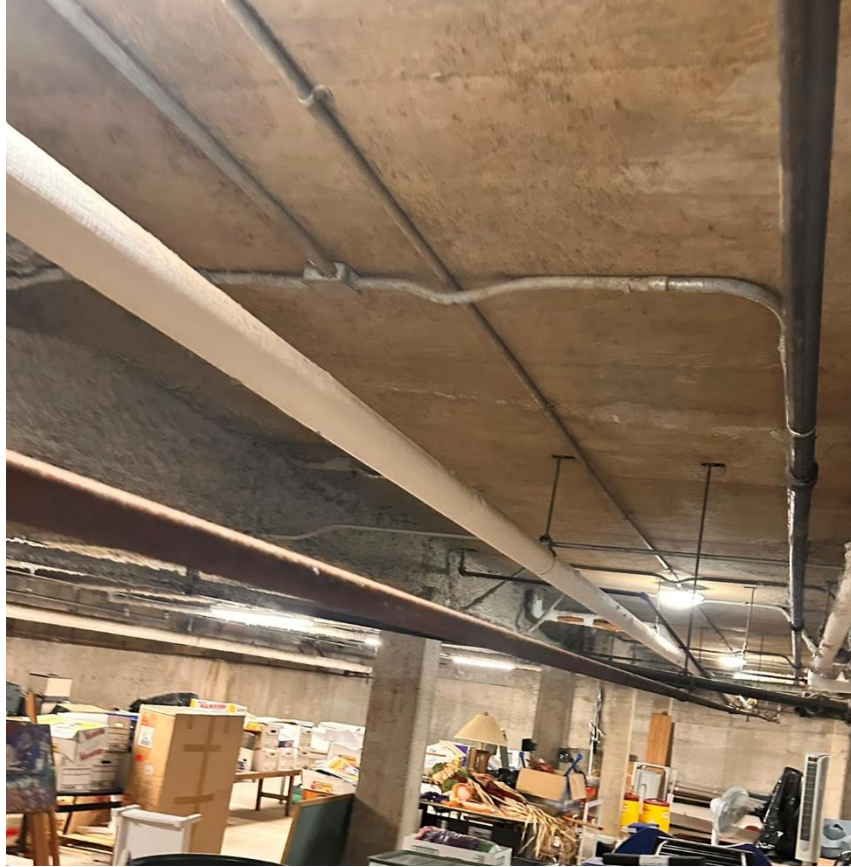
There are several sections of condensate piping in the basement that are uninsulated or have poor and damaged insulation and are losing a significant amount of heat, reducing the steam system efficiency.

This work will include the demolition of the condensate recovery system including the piping, pumps and recovery tank, and insulating the proposed hot water system with energy code compliant insulation including insulation jackets for the fittings.

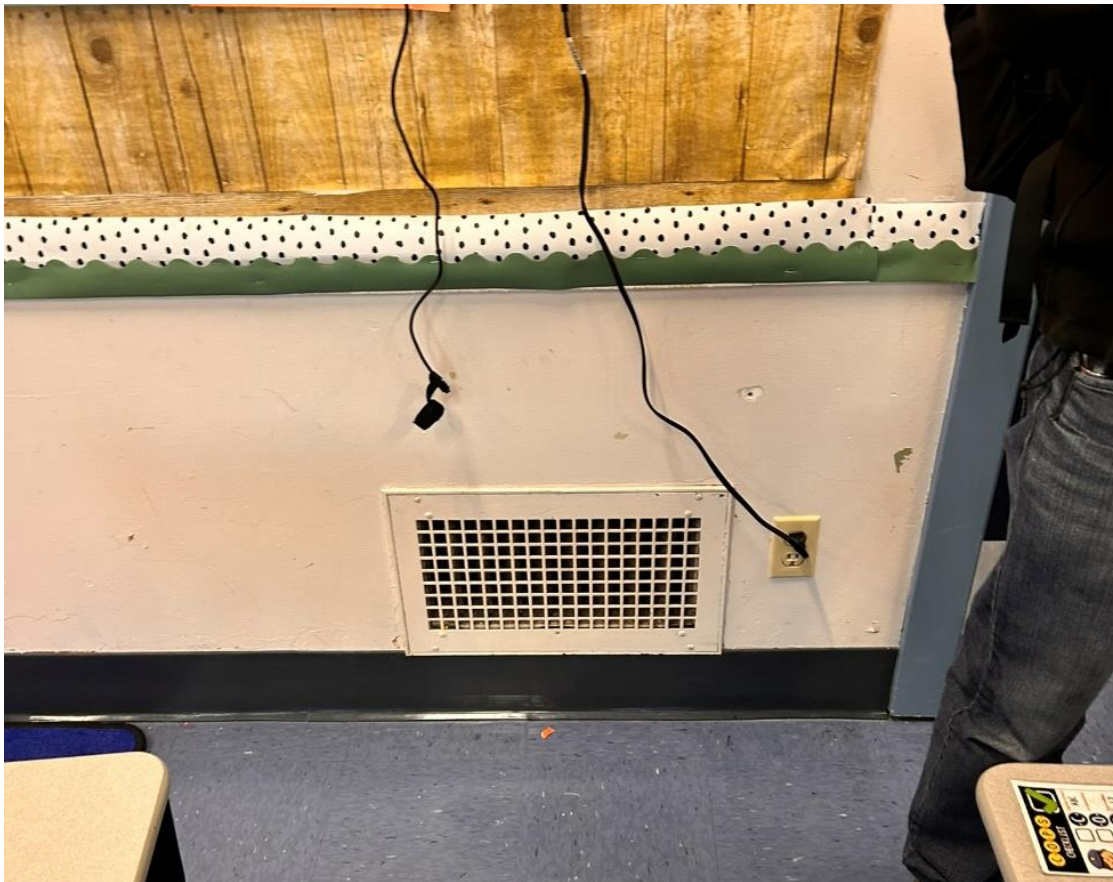
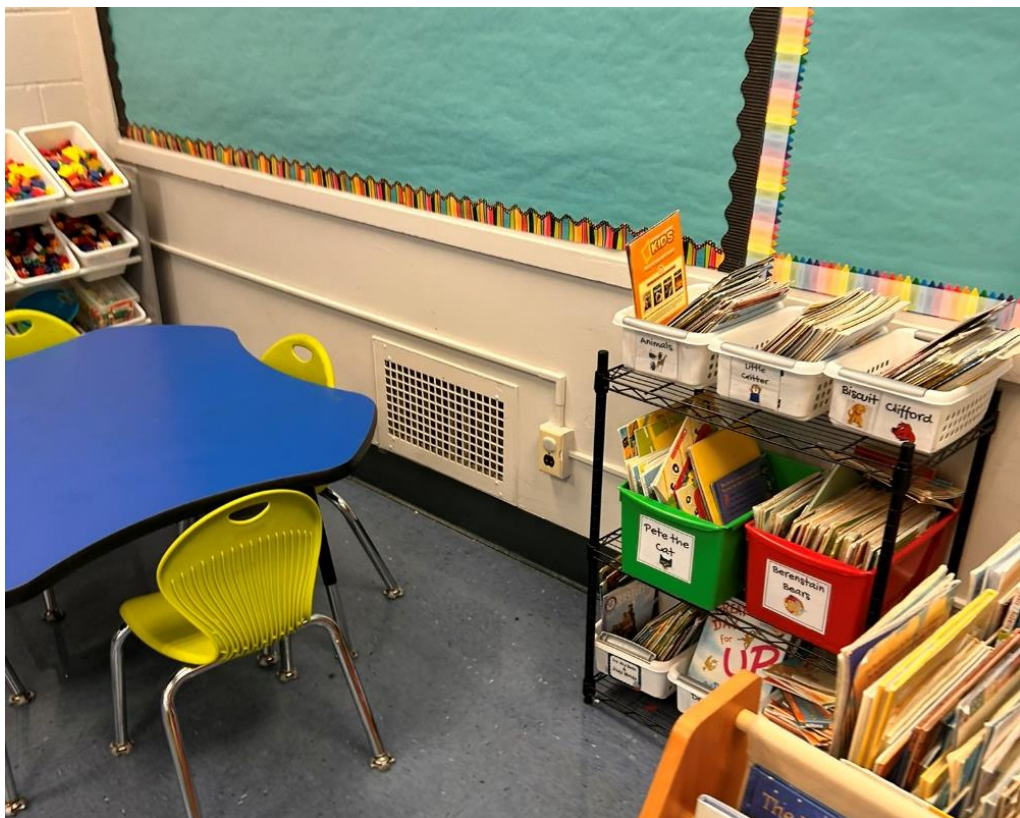
The primary source of ventilation in the school is a series of rooftop exhaust fans that are connected to ceiling and low wall grilles.

SP+A recommends removing and capping all exhaust fans and unit ventilators that serve the classrooms and offices and replacing them with dedicated outdoor air systems (DOAS) and packaged rooftop units. The DOAS can be sized to only serve the classrooms and offices the code required amount of ventilation air. The DOAS can be packaged to handle the heating and cooling of the ventilation air so it would be conditioned as opposed to the unconditioned air currently entering through the windows. DOAS generally have smaller ductwork sizes as well since the only air delivered is the fraction that constitutes code required ventilation. Potential areas for installation of the DOAS include: the perimeter of the building, the crawlspace area and the roof. The packaged rooftop units can serve the offices, Gymnasium and Media Center, to control air flow, temperature and humidity in those spaces.

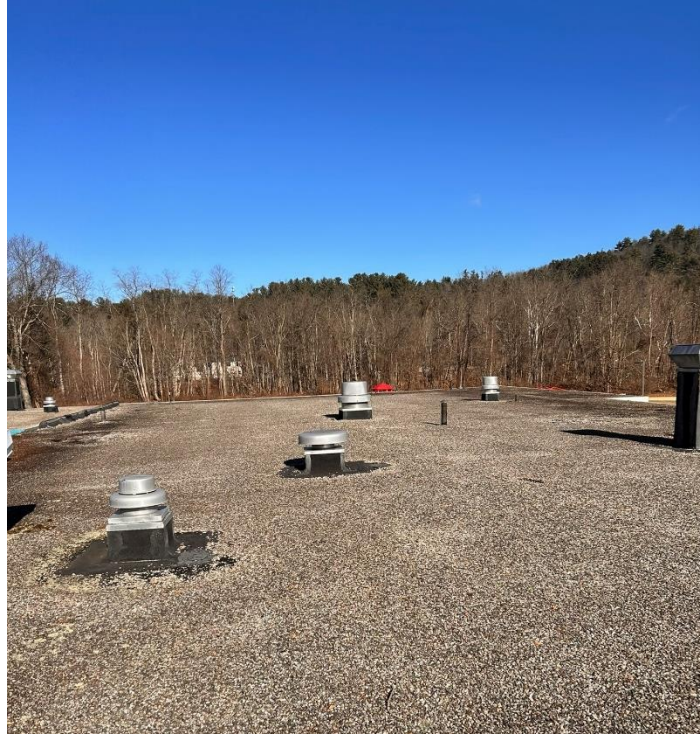
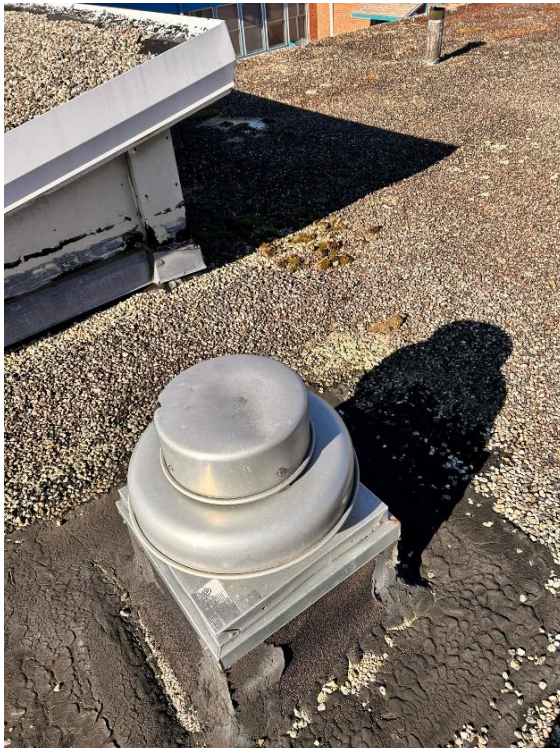
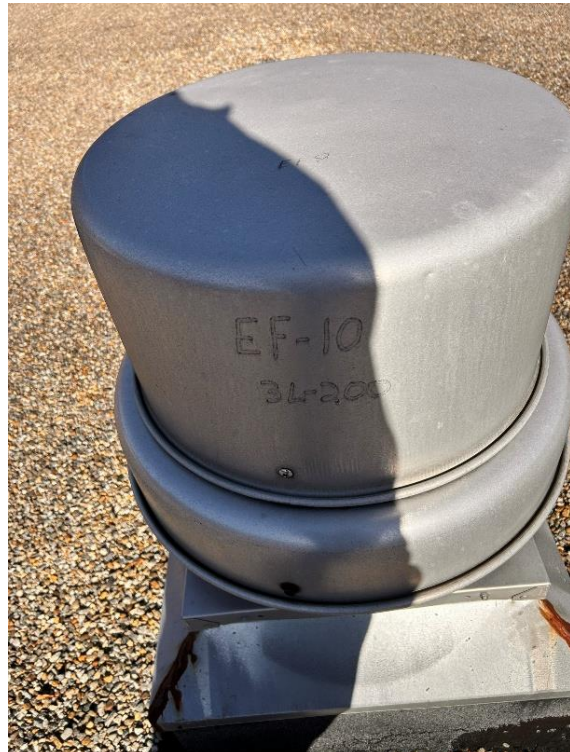
The exhaust fans are all mounted on the roof and in fair condition. SP+A was informed that approximately 33% of the exhaust fans were not operational at the time of the site visit. There is some visible damage on some of the fans as well as rust. SP+A was informed of a planned roof replacement as well.

SP+A recommends replacing the toilet exhausts and setting up controls for them to turn on only when the toilet room is occupied to save energy instead of continuous operation.

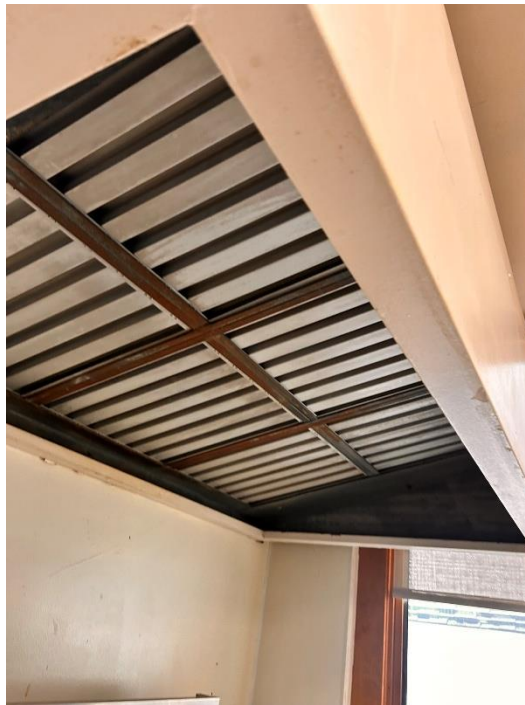
The Kitchen has a commercial-grade grease vent hood that is in fair condition and exhausts air to the exterior of the building. There is no evident fire suppression system integral to the vent hood which would be used to contain cooking related fires and increasing kitchen safety.

SP+A recommends replacing the kitchen hood with a new hood with integrated fire suppression system for extra safety in the cooking area. The unit can include fire detection for emergency situations as well as a propane disconnect in the event of a detected fire.

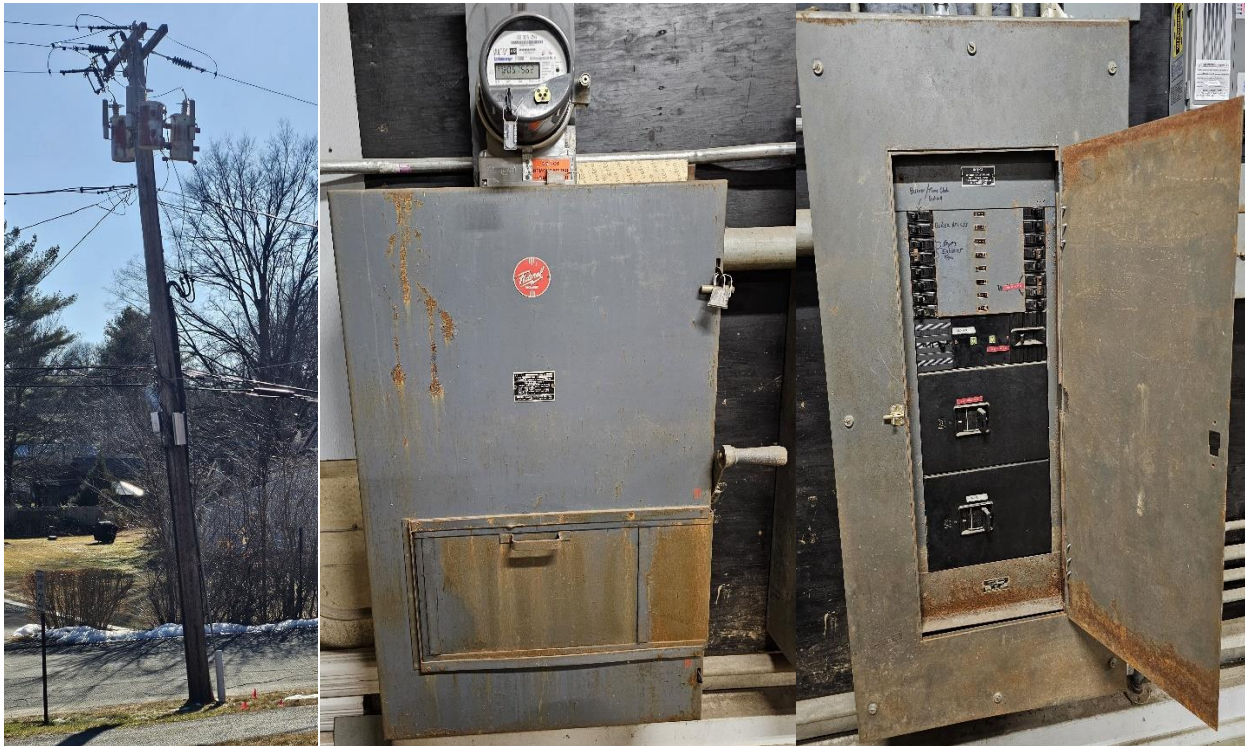
The building is served by an underground 400A, 208Y/120V, 3 Phase, 4-Wire electrical service which originates from pole-mounted utility transformers on Eversource pole #1048 located on Black Bridge Road. From the secondary of the utility transformers the electrical service transforms down to 208Y/120V, 3 Phase, 4-Wire underground into the main disconnect switch rated at 400A, 208Y/120V, 3 Phase, 4-Wire with the utility meter located in the basement. The main switch feeds an adjacent 400A, 208Y/120V, 3 Phase, 4-Wire main distribution panel that feeds multiple panels and equipment located throughout the facility. The main distribution panel and some panels, manufactured by Federal Electric Products, are in poor condition and replacement parts may not be readily available. There are also several newer panels, manufactured by General Electric, that replaced existing panels and appear to be in good condition. The electrical panels in the common area corridors were not locked and can be accessed by non-authorized personnel. The circuit breakers serving the fire alarm system, security system, and network system are lacking lock-on breaker devices.

The 400 amp main service disconnect switch, 400 amp main distribution panel, and (3) panels should be replaced due to the manufacturer “Federal Electric Products” no longer exist and replacement parts will be difficult to procure or not available. All other panels manufactured by General Electric are still supported by the manufacturer and replacement parts are available. All electrical panels in public areas should be locked. Lock-on devices should be installed on all circuit breakers serving security system panel and devices, all network communications equipment, and master clock control bell ringer panel to prevent being shut off accidentally or intentionally by non-authority. All branch circuits in panels should be traced to verify load descriptions and update typed panel circuit directory. This process will help in problem solving of future electrical issues that may arise. All circuit breakers with no branch circuit wiring should be turned to off position and labeled “spare” on panel circuit directory. While further verification with a preliminary HVAC design will be required to confirm the existing service capacity sufficiency, it appears unlikely that the 400 amp service would be capable of serving a full building air conditioning project. The existing main panel would need to be replaced or supplemented, and this cost has been included in the project estimate.

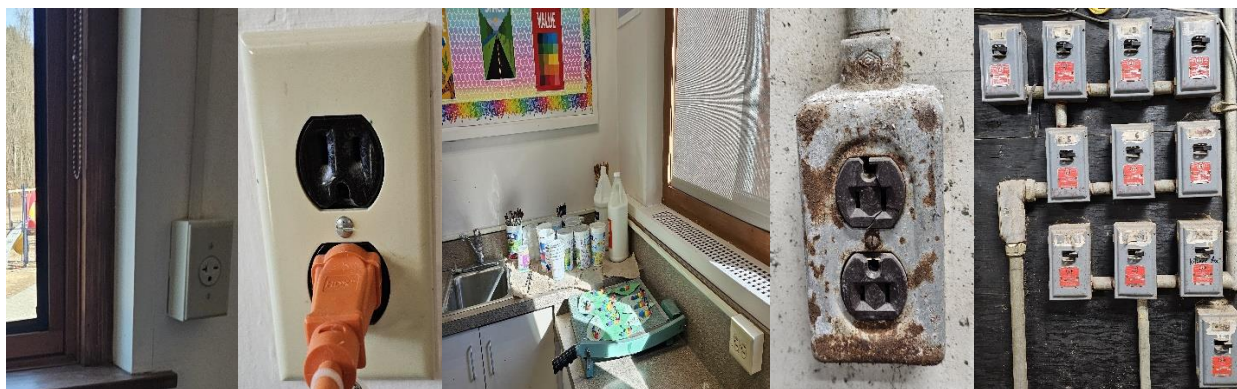
Receptacles throughout the facility consist of both recessed and surface mounted units. The condition of the power receptacles throughout the facility varies from good to poor condition. Most occupied rooms appear to utilize window A/C units based on the 20A, 125V, 1-Phase receptacle mounted adjacent to windows. There are several outlets within 6' of a water source that are not GFCI type or not labeled GFCI protected. Disconnect switches for mechanical & plumbing equipment appear to be in fair to poor condition. There is exposed wiring in junction/back boxes without cover plates in several classrooms. There does not appear to be any "call for aid" for single stall toilet rooms or emergency shut-off push button at kitchen egress doors for shut-off of gas to cooking equipment. There was no visible sign of any older wiring with cloth insulation.

Tamper-proof receptacles should be considered in classrooms, offices, and corridors as required by the current NEC. The use of extension cords to reach electrical loads from receptacles is a Code violation. Additional receptacles, with a dedicated new branch circuit, should be added to

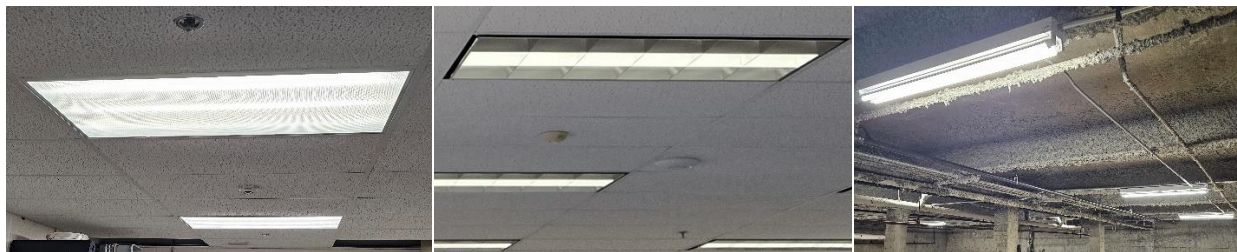
The interior lighting throughout the classrooms, offices, and corridors consists of mostly 2'x4' recessed fixtures with LED lamps in either parabolic or acrylic lens style. The Gym/Cafeteria has 4' surface mounted high-bay LED lamp fixtures with wire guard protection. Most fixtures throughout the facility were originally fluorescent and have been retrofit with LED lamps and drivers. The classroom lighting fixtures are controlled via a combination of ceiling occupancy sensors and single pole toggle switches for dual switching of inner & outer lamps. The corridor lighting controls are via a combination of ceiling occupancy sensors and 3-way toggle switches at each end of corridors. The utility rooms, basement, and crawl spaces have industrial fixtures with LED lamps and manual single pole toggle switches. The building exterior perimeter light fixtures are a mix of full cutoff wall mounted LED fixtures, wall pack LED fixtures, surface mounted fixtures with LED Lamps, controlled via timeclock. These appear to be in fair to poor condition. There is a photocontrol sensor on the exterior wall that we were told was not in use and abandoned.

While the LED retrofit condition provides reasonable energy efficiency, the housings are nearing the end of their useful life and additional efficiency could be achieved with the installation of all new LED fixtures. Full replacement of the interior lighting should be considered, especially if an upcoming project is planned which would require removal of most existing ceilings. Such a lighting replacement would provide further improvement in lighting efficiency and allow for incorporation of enhanced lighting controls with dimming and daylight harvesting. The attached estimate includes a full replacement of the interior lighting and exterior lighting.
