# New Hartford Public Schools Utilization Study- Facility Conditions Assessment

MARCH 25, 2026

Prepared for:  
**New Hartford Public Schools**  
**530 Main Street PO Box 315**  
**New Hartford, CT 06057**

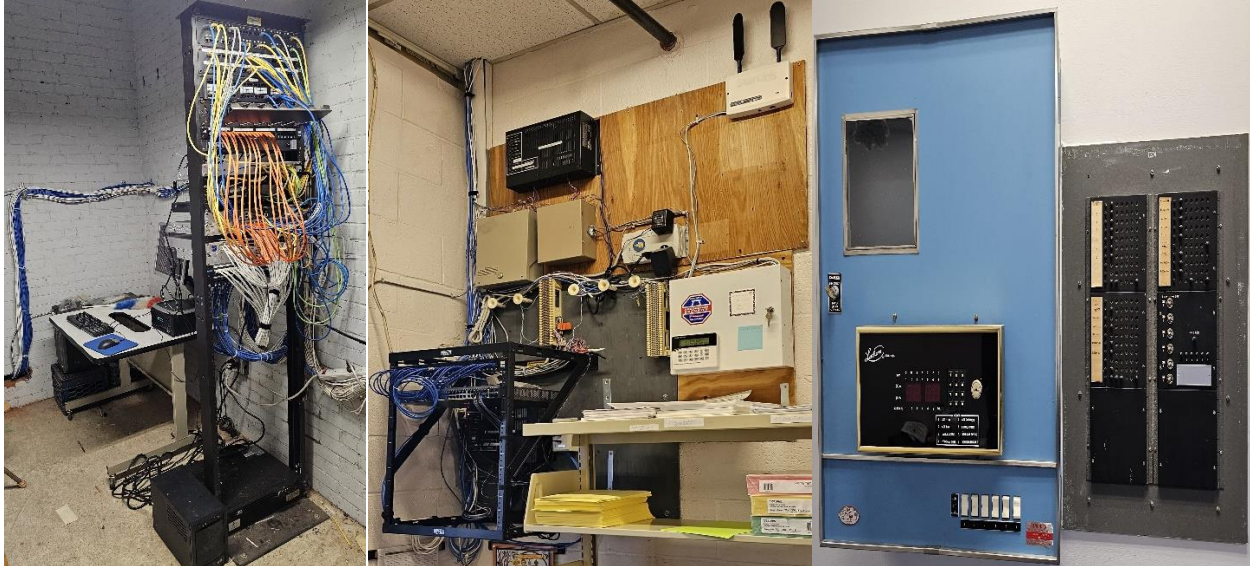
There is a main network rack located on an open mezzanine above gym/café storage. This area is not enclosed and temperature controlled suitable for data networks. Network and wi-fi equipment appear to be regularly upgraded and no significant issues were reported. The building is served by a new cloud-based VOIP telephone system which was installed in 2024. The intrusion detection system manufactured by Gemini and serviced by Associated Security has been upgraded, but many old sensor devices have been abandoned. Video surveillance cameras and access control are by Verkada. These are in good condition. The building has a lockdown system with panic buttons accessible to staff. The Master Clock Control Bell Ringer panel manufactured by Lathem is active and in poor condition. The public address system is reported to be fully operational but is at least 15 years old. Promethean interactive instruction boards are installed in all classrooms and are in good condition.

Based on observation of the main network rack location, the room should be enclosed and climate controlled for best performance and to prevent premature equipment failure.

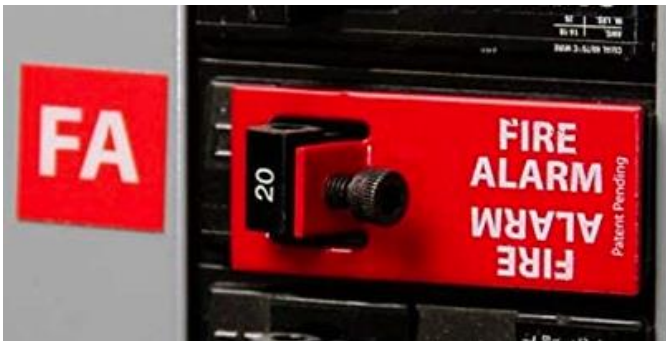
**Lock-on Device**

- Lack of lock-on device on circuit breaker feeding the fire alarm system equipment. Code requires that the breaker must have a lock employed to prevent accidental or intentionally by non-authority.

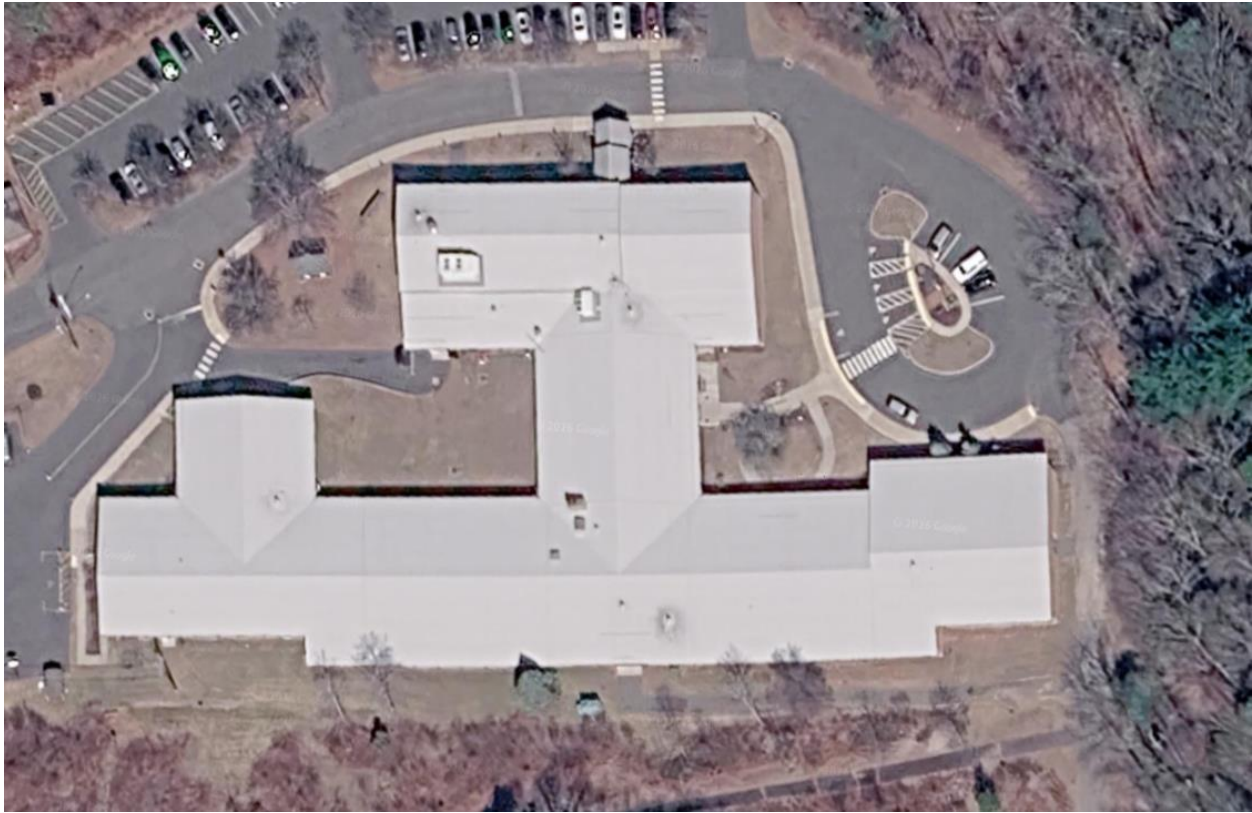
The roofing systems consist primarily of rubber membrane assemblies over sloped roof systems, typically installed over Tectum or metal roof decks. These roofs and associated soffits were replaced in 2016.

Membrane roof systems generally have a service life of 20–30 years. Based on installation date, the roofs likely have 10–20 years of remaining life, depending on warranty conditions and maintenance practices.

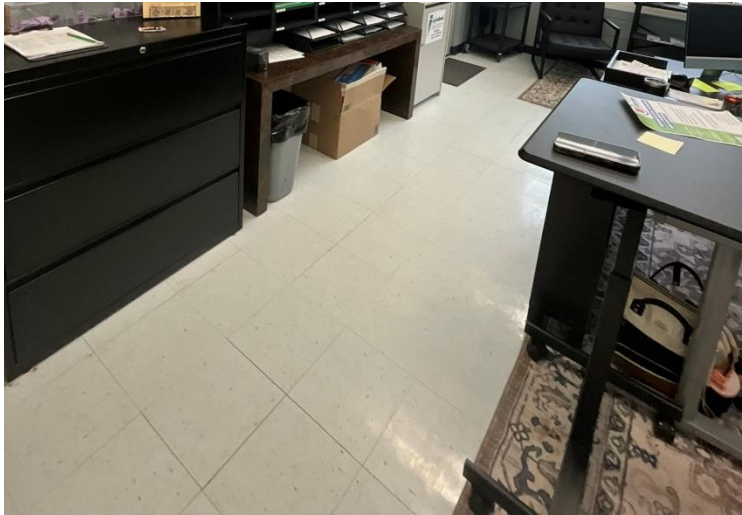
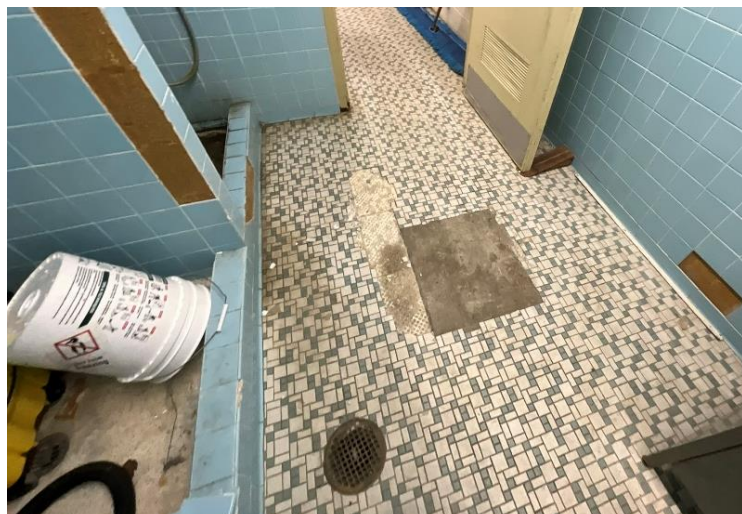
A variety of flooring types are present throughout the facility. Vinyl composition tile (VCT) in most classrooms and corridors. A recently installed sports flooring is in the gymnasium. Ceramic tile flooring in all restrooms. Most flooring is in good condition.

The gymnasium storage and office areas contain original ceramic tile flooring dating to the former locker room configuration. These floors are deteriorating and should be considered for renovation. VCT flooring is in fair condition overall, with localized areas requiring replacement (including the Oak Park rooms). Carpet in the library, offices, and auditorium dates to the 1990s. While currently in fair condition, these areas should be incorporated into a future replacement plan.

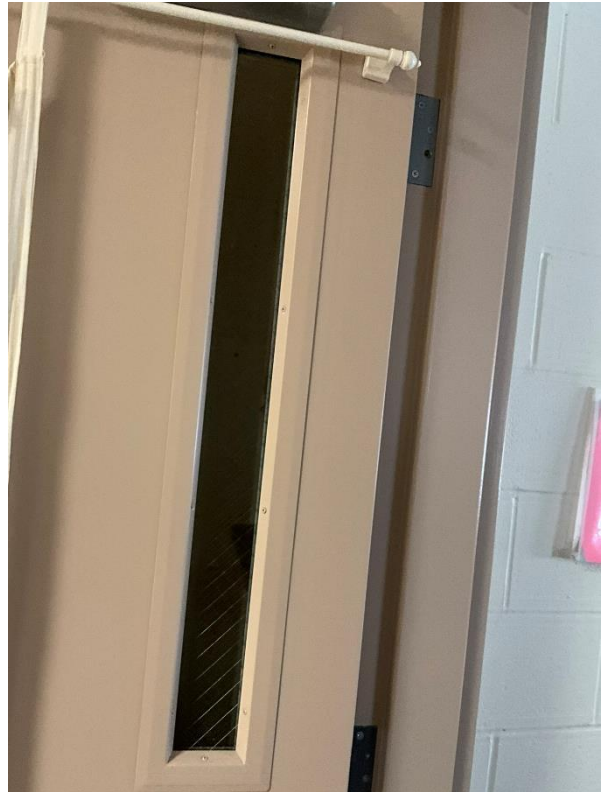
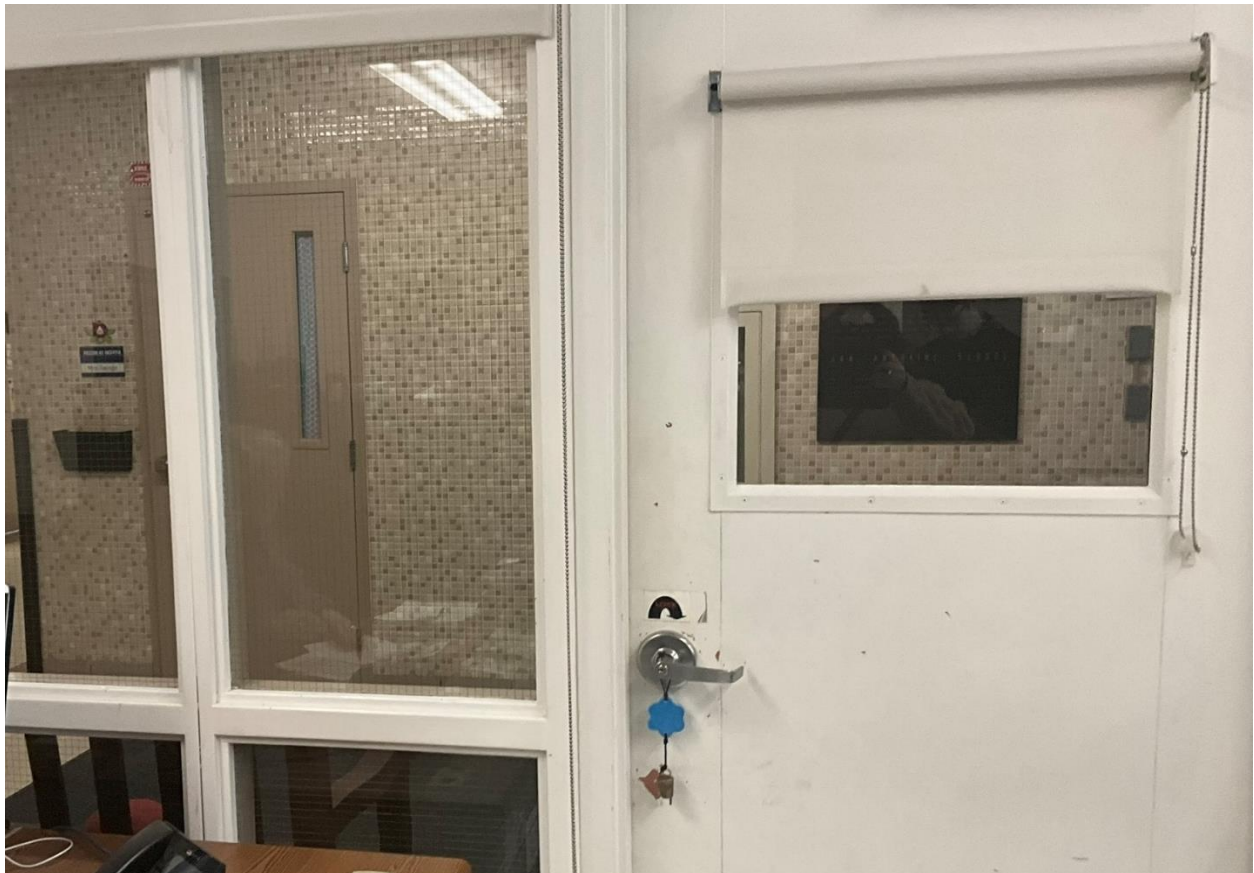
Interior doors are primarily hollow metal in hollow metal frames and are in good condition. Hardware includes lever sets and panic devices where required.

Limited areas of older wired glass were observed and should be replaced to meet current safety standards.

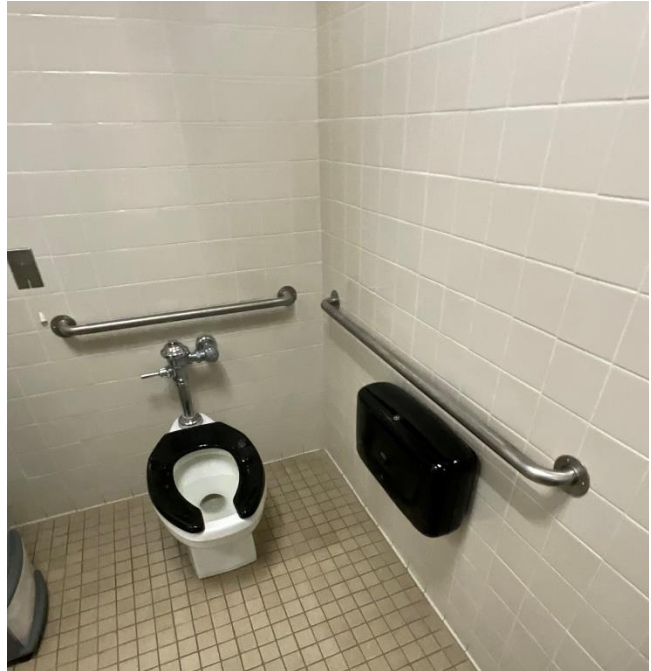
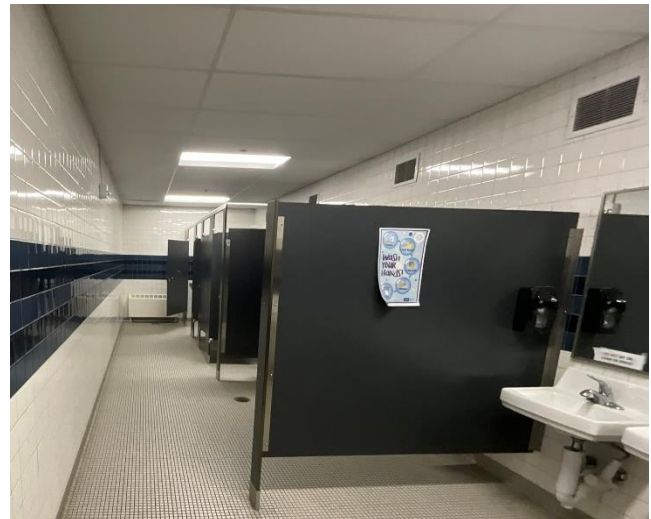
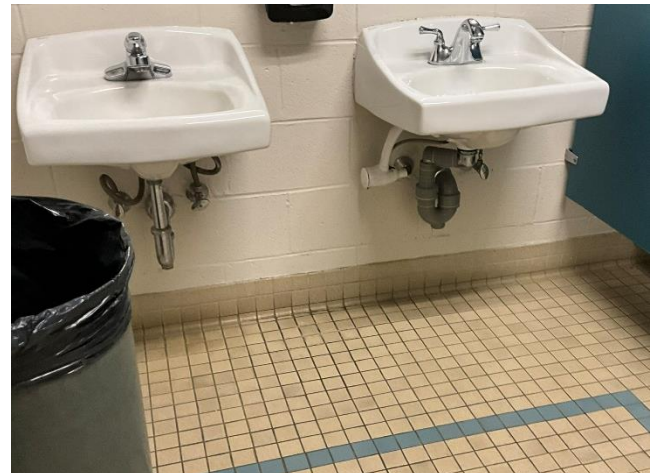
Multiple restroom facilities are provided throughout the building. Student gang restrooms are generally in good condition. Several ADA stalls were observed to contain stored furniture, which should be removed. Some stalls require additional or modified grab bars to achieve compliance. A few lavatories lack protective pipe guards, which should be installed.

Single-user restrooms have been renovated to meet ADA requirements; however, some grab bars and sink pipe guards are improperly configured and should be modified.

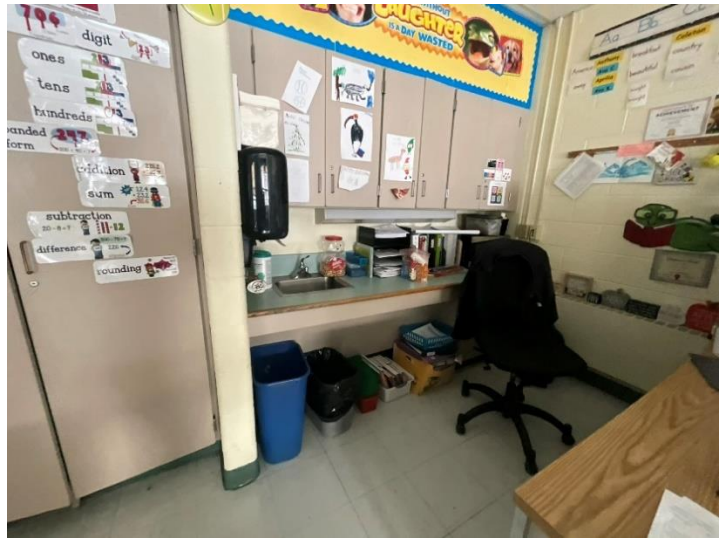
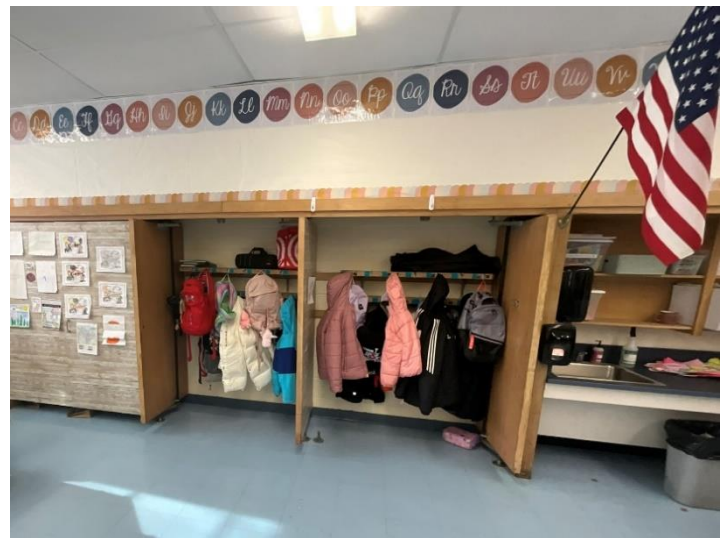
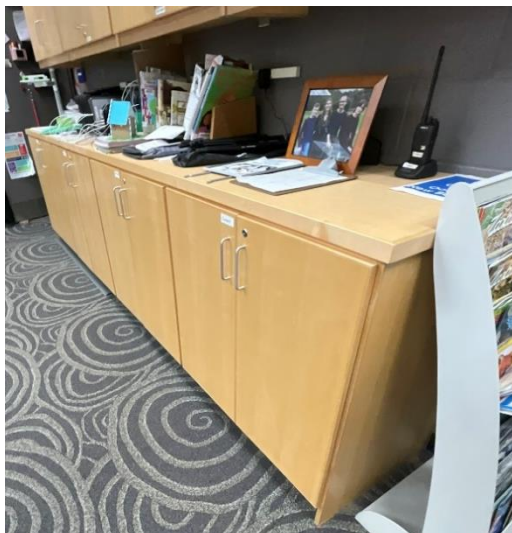
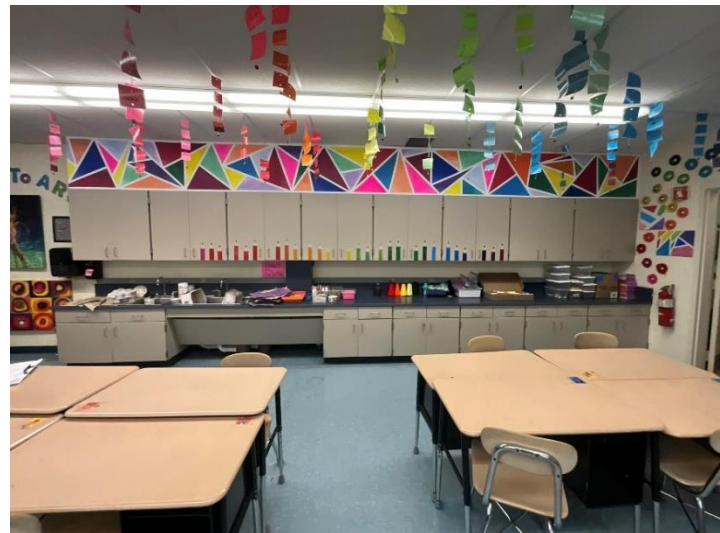
Most casework consists of plastic laminate cabinetry. The 1990s additions fully incorporate plastic laminate systems. Older classrooms retain some original wood components; however, sink bases and associated cabinetry appear to have been replaced with plastic laminate during prior renovations. Some plastic laminate was delaminating and may need replacement in the future.

Cabinet and sink heights in many classrooms are below current ADA requirements. At minimum, one accessible sink with compliant knee clearance per program area should be provided throughout the school.

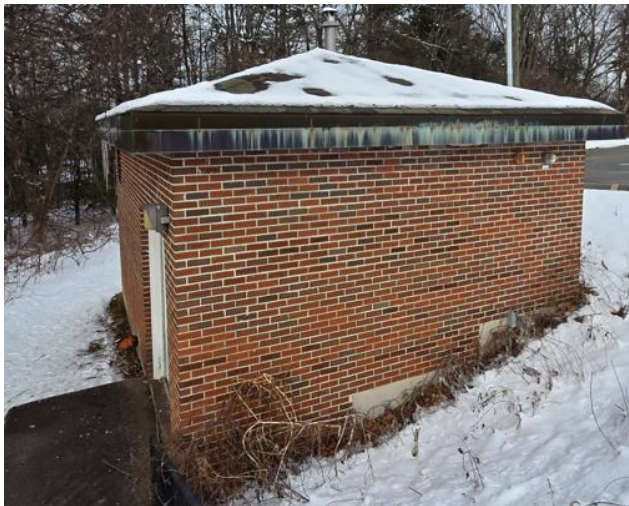
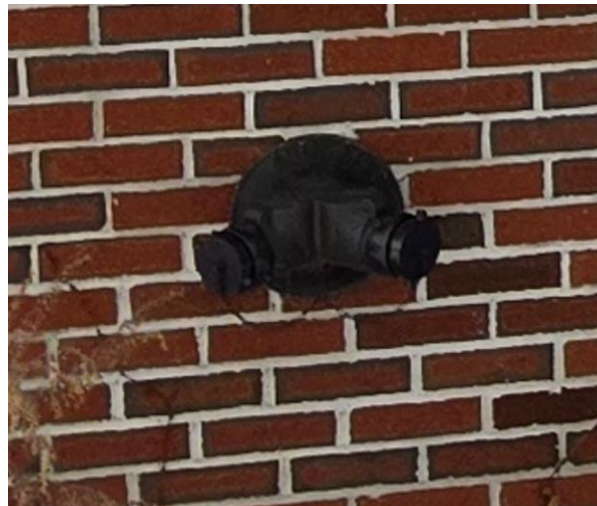
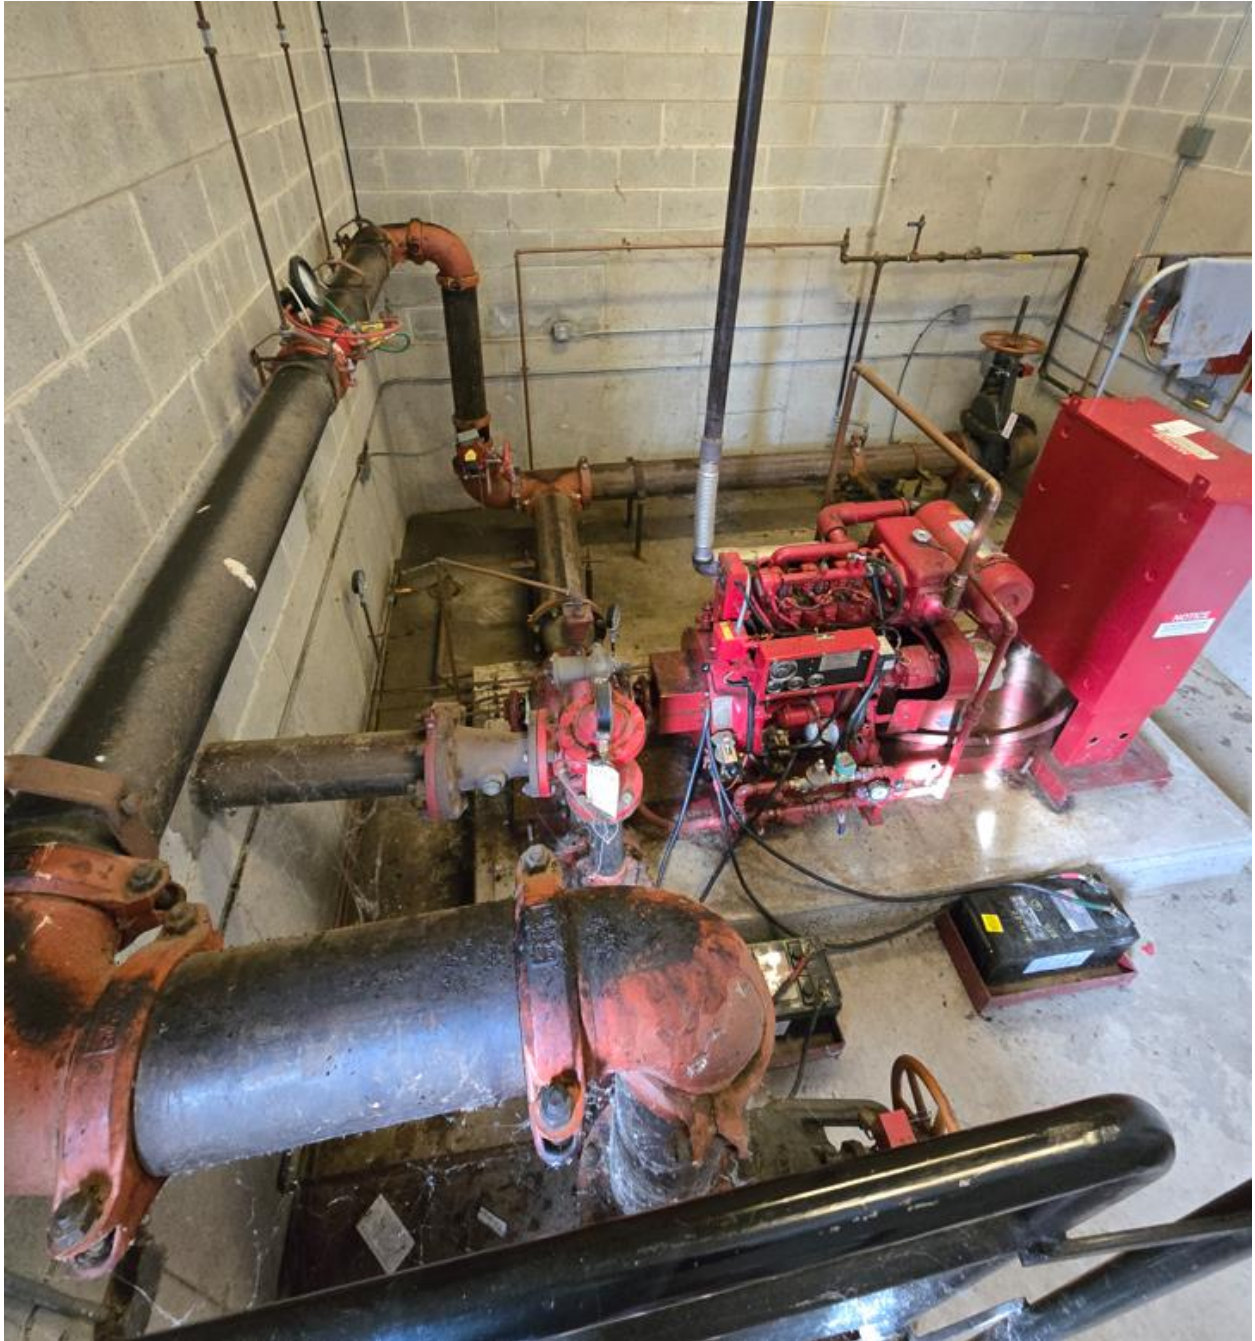
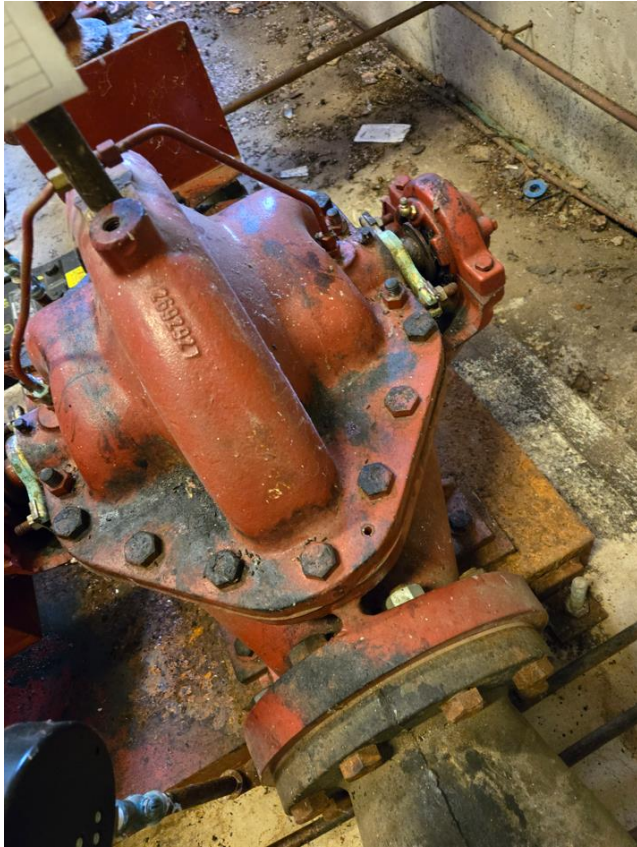
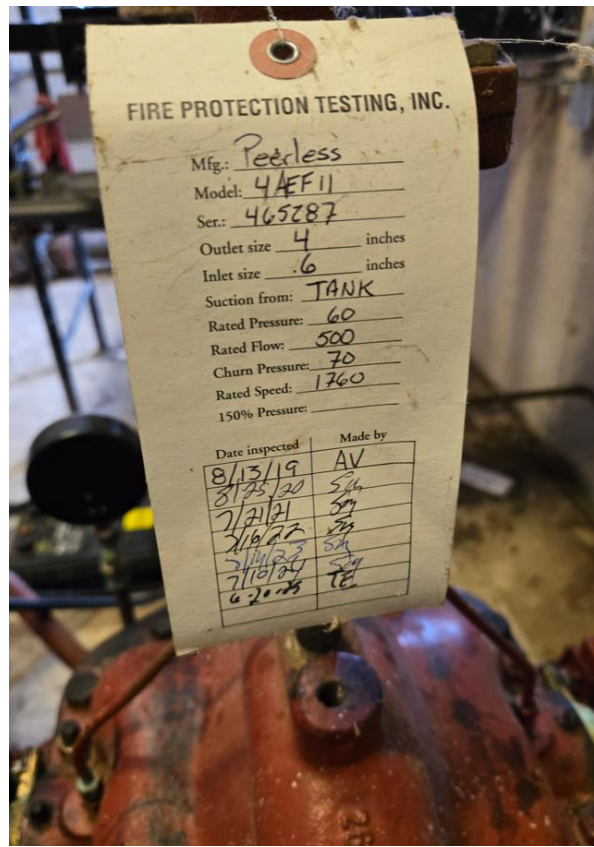
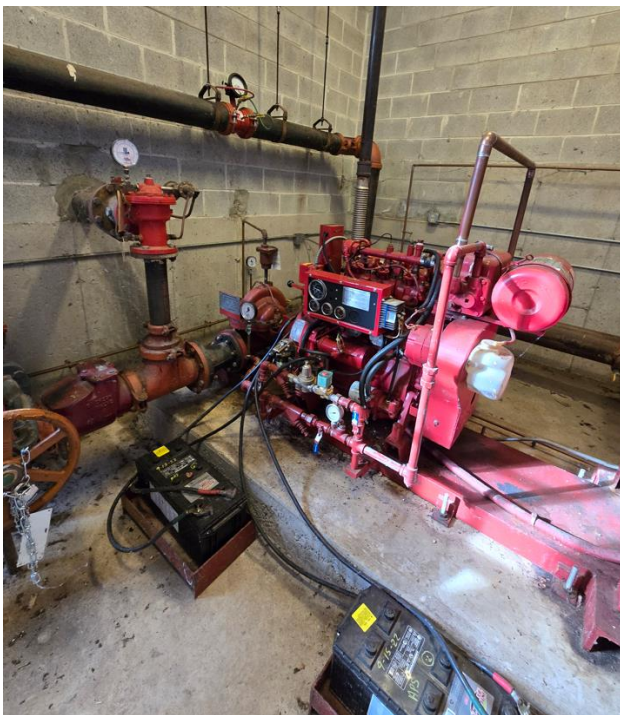
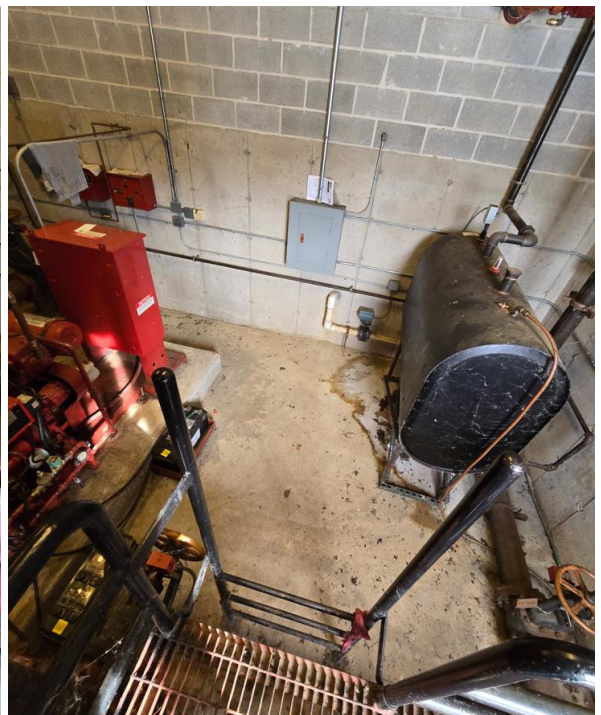
The facility is provided with a fully automatic fire sprinkler system with sprinkler coverage throughout the building. Semi recessed sprinkler heads are provided in areas with ceilings while upright heads are installed in areas without ceilings. The building's fire protection water service originates at a site remote from the building. The facility is not provided with a municipal water supply but instead a well system consisting of a 30,000 gallon underground atmospheric fire protection water storage tank and fire pump. A fire pump house is located detached from the building where a centrifugal horizontal split case fire pump with diesel engine and controller are housed. Inspection tag dated 6-20-25 indicates the system is rated for 60 PSI at 500 GPM, pump manufactured by Peerless, model 4AEF11, citing no issues. The diesel fire pump engine is manufactured by Clarke GM Diesel, inc. Model MD-3 1224, 40 HP @1760 RPM, dated 8/90 making the unit 36 years old. Additional equipment includes a domestic make up water feed to top off the storage tank, level monitoring, diesel fuel tank, muffler, and numerous controllers, valves are primarily OS&Y with tamper switches. The space is heated and ventilated accordingly.

From the pump house a 4" pressurized supply line is routed on site where it enters the building in the outdoor equipment garage, a traditional riser check valve assembly has not been provided though a supervised OS&Y valve is utilized. The storage garage is provided with a local anti-freeze system so the smaller branch piping serving the room does not freeze. Inspection tags indicated all systems pass, last dated 12/23/24. The 4" main then enters the building where main distribution piping feeds all the branches. Individual zones were not present.

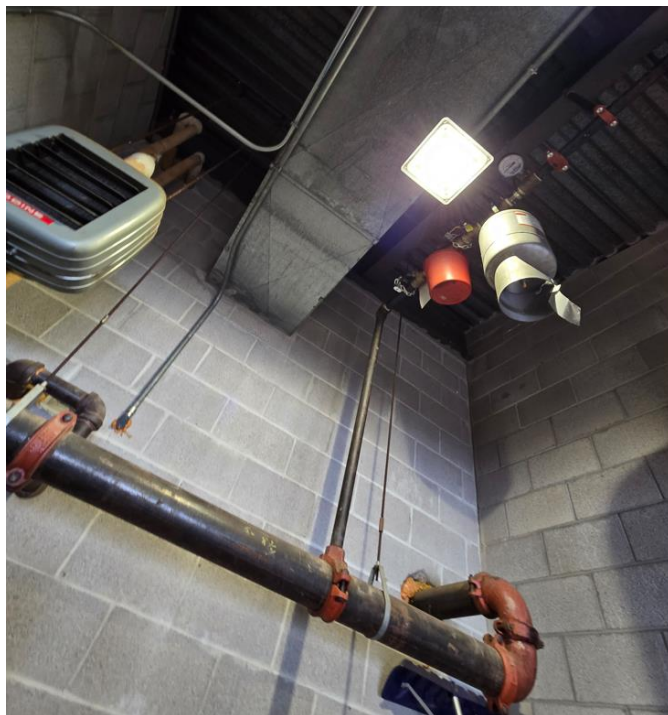
The fire pump system, while dated, is operational but is reaching its fully serviceable life expectancy. Well maintained systems can last 20 to 30 years but will often require component repair or replacement parts. Additionally, environmental conditions should be mitigated to avoid corrosion and humidity. All system components and equipment have tags by FIRE PROTECTION TESTING, INC. These systems should continue to be tested and inspected per the qualified vendor in accordance with NFPA standards before being fully replaced. Specifically, the fire pump shall be tested monthly in accordance with NFPA 25. Quarterly testing of mechanical flow devices, valves, and valve components, low air pressure alarms, and quick opening devices should be performed as well in accordance with NFPA 25.

Some piping, valves, hardware and components show signs of early corrosion as a result of the pump house's environment. It is recommended to clean, sand, prime and paint all components so they are corrosion resistant per NFPA. Replace rusted hangers and supports with hot dipped galvanized components with zinc plated or stainless-steel hardware and threaded rods. The pump house should be cleaned out of leaves, dirt and debris and any penetrations should be sealed to ensure the building is insect and rodent proof. Exterior test heater and FDC are rusted and should be replaced, proper signage should be installed to identify Fire Department connections, fill lines, drains, and test headers per NFPA 13. Water storage tank fill line should have proper identification; the PVC goose neck vent should be painted in accordance with the manufacture's requirements for exterior applications.

- Continue to maintain & test all systems per NFPA 25 and equipment manufacturer's requirements.
- Replace the Fire Pump and Diesel Engine within the next 5 years.
- Paint / touch up corroded piping.

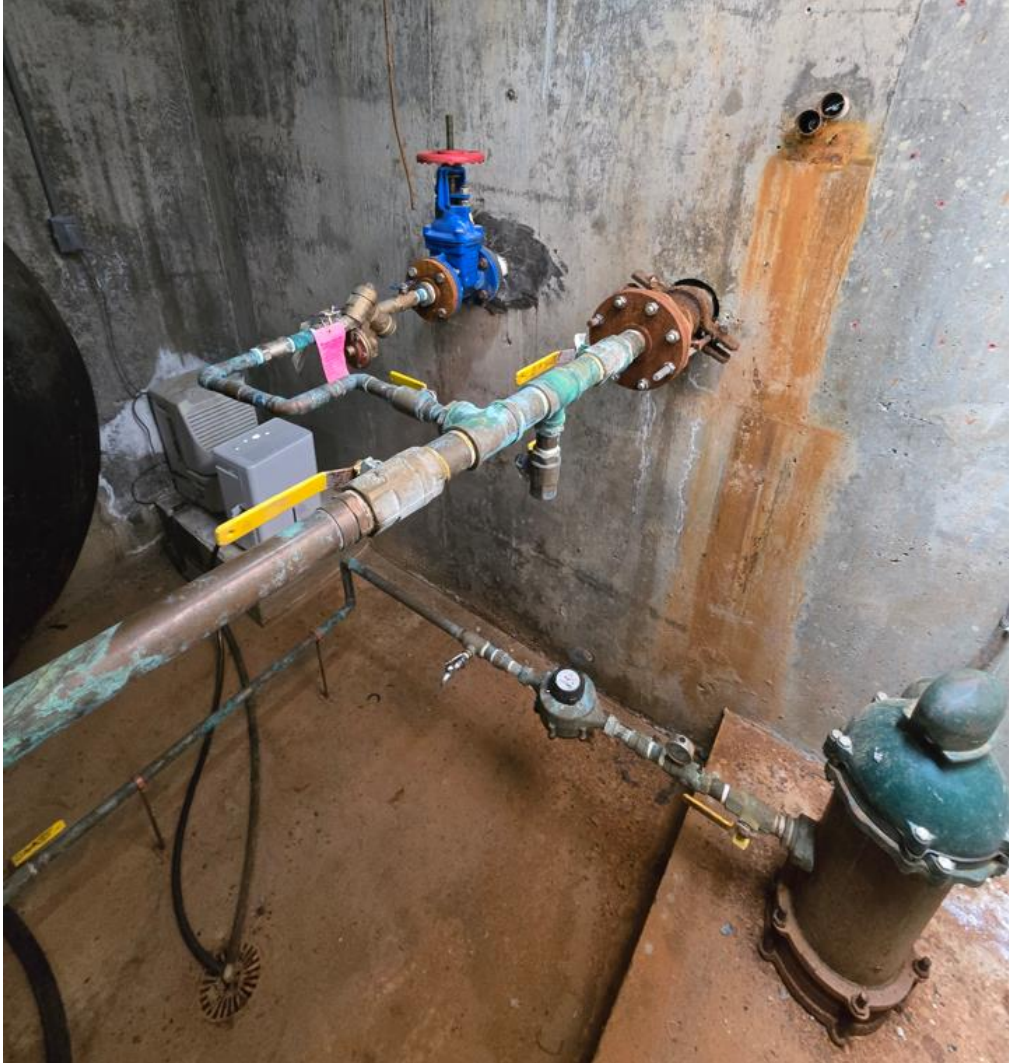
Piping consists of sweated copper joints which have developed a patina, ball valves are installed and exposed metal is rusting. Pipe insulation has not been provided. A residential dehumidifier has been provided and discharges to a floor drain. Humidity is a concern as it affects the electrical controllers and level sensors.

Facility staff indicates that the domestic water system is inspected every two weeks by a third-party contractor. “Avon Plumbing & Heating Water System Division” appears to be the local contractor who performs service and preventative maintenance.

An additional 2” make up water feeds the Fire Protection system. A backflow preventer has been provided accordingly to eliminate cross contamination between the Potable and Fire Protection water supplies.

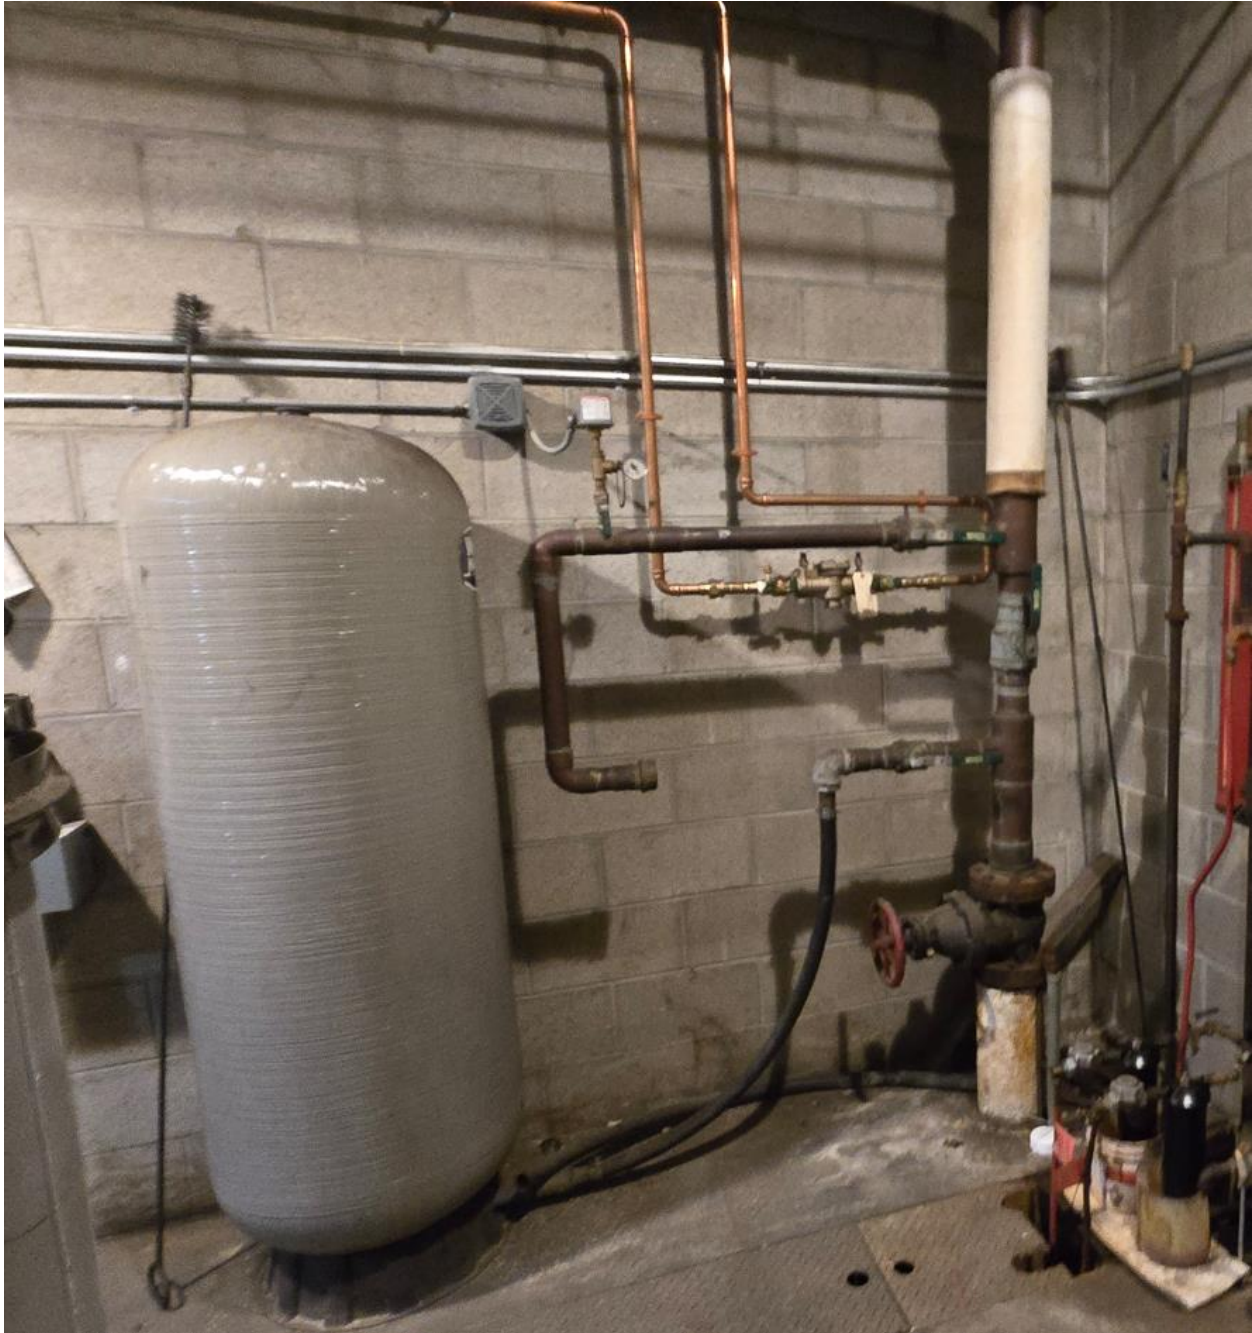
A 4" CW from the utility vault enters the building within the boiler room where a second hydropneumatic tank is located. A pressure monitoring switch has been installed to ensure pressure remains within an acceptable range. This hydropneumatic tank is the same make / model as the unit in the utility vault.

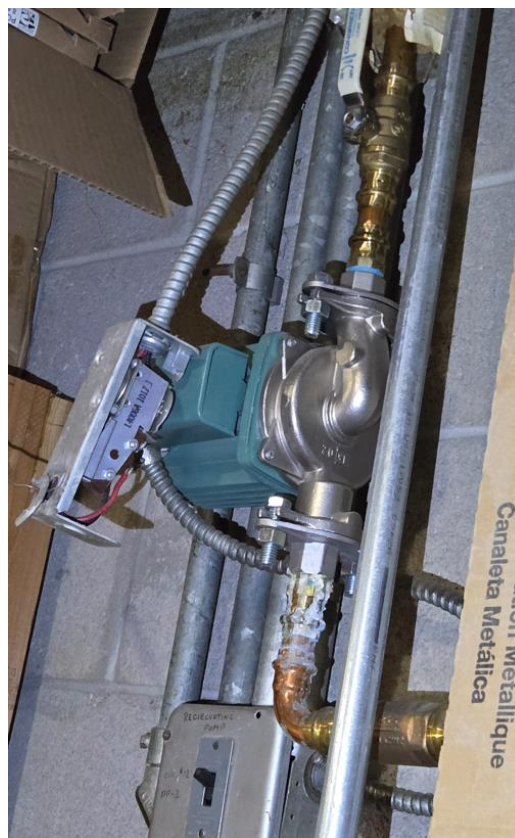
- A. 1x 50-gallon electric water heater, manufactured by State, serves the core building, was recently installed on 10/11/24, and is provided with a hot water recirculation pump per code; but is not provided with a thermostatic mixing valve or thermal expansion tank as required by code. Temperature gauge read 115 deg F. The heater is in good condition with serviceable life expectancy of 10 years.

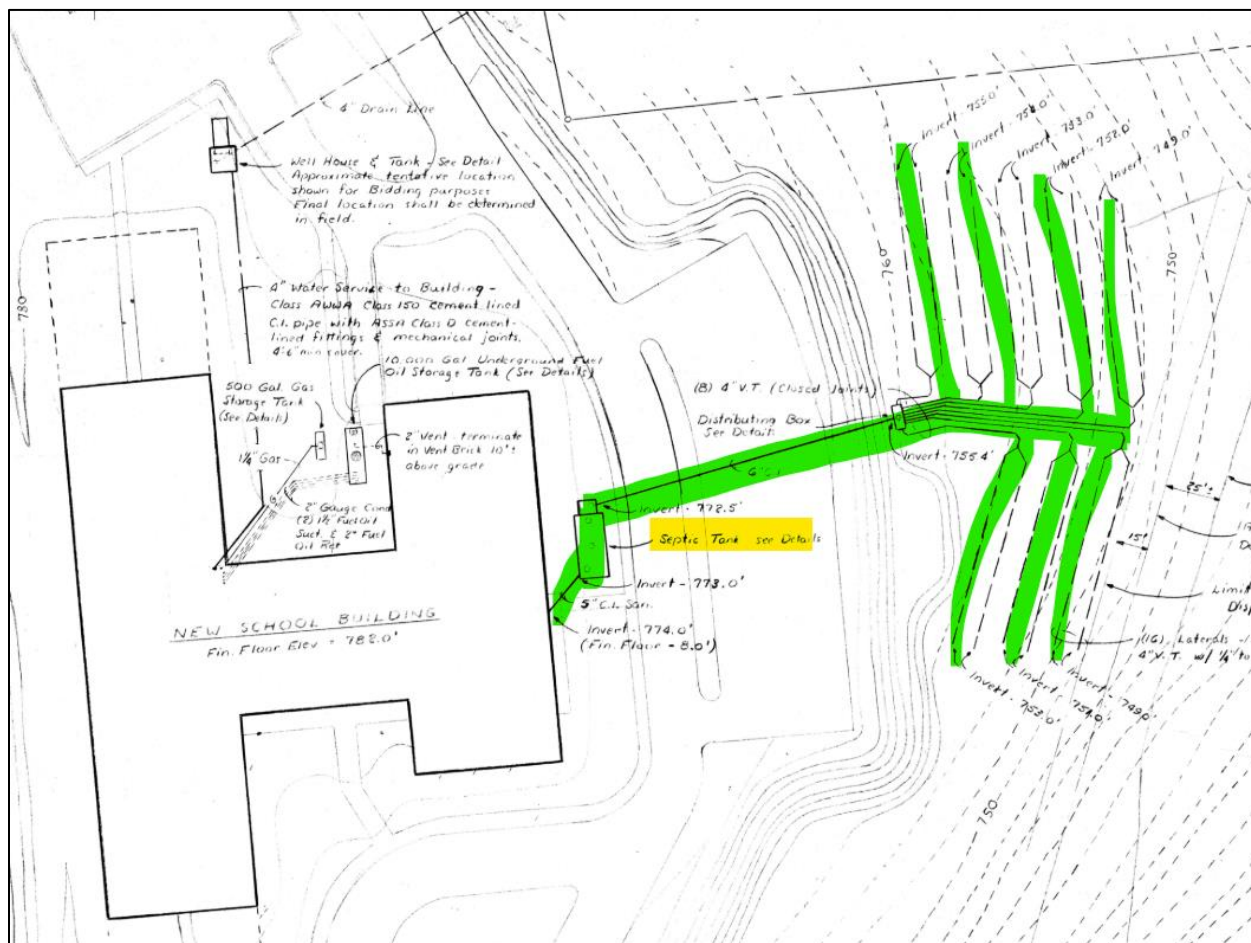
The building is provided with a sanitary and vent system piped throughout the facility in support of all plumbing fixture drainage. Per available plans the building sewer is drained via gravity to a **septic system and leaching field**, with all vent terminations to atmosphere.

Further review of the septic system's capacity will have to be evaluated by a qualified third party to determine compliance. It is recommended to maintain the leaching field yearly via professional inspections with tank pump outs every 3-5 years.

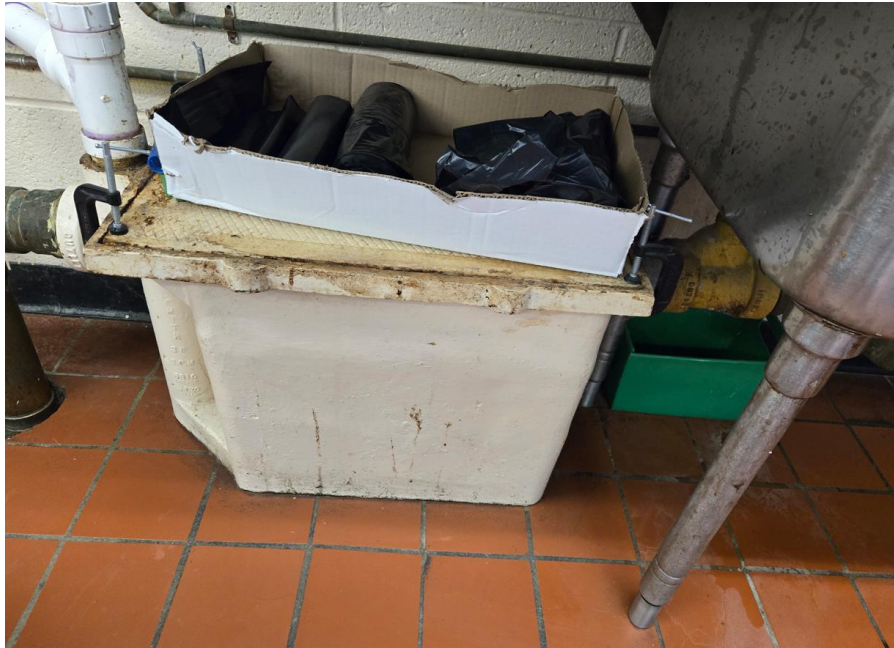
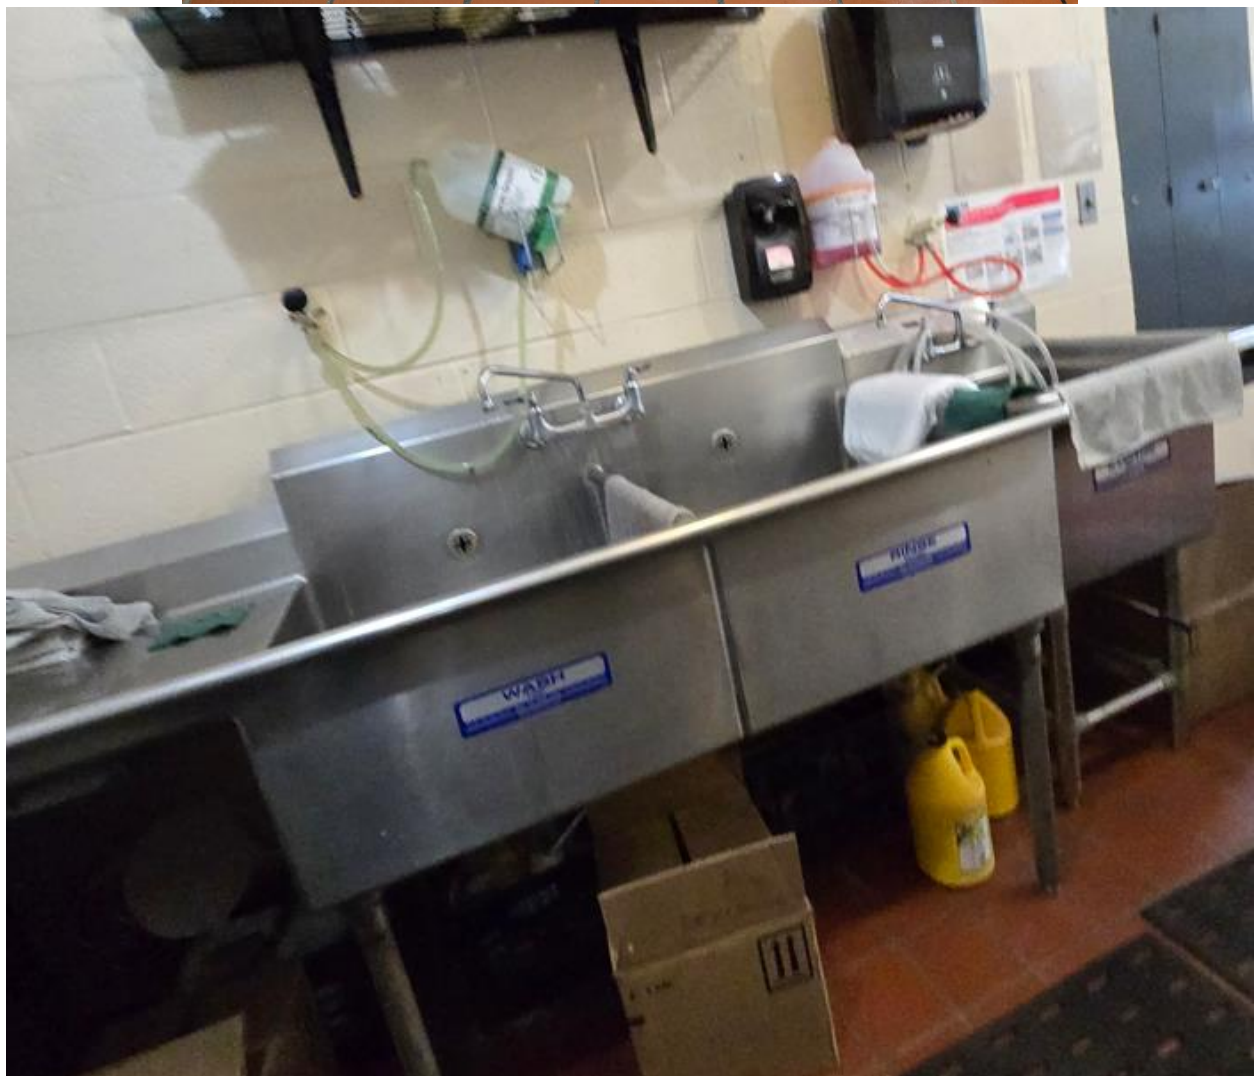
The current grease interceptor is a non-automatic passive type and appears to have been installed at the time of the original construction.

Based on information provided by the facility staff the kitchen is classified as Class IV and prepares food for this facility as well as Bakerville and New Hartford Schools.

Note that the currently installed style grease trap is not compliant with the State of Connecticut's FOG (Fat, oil, & Grease) Permit for Wastewater Discharge for class III & IV commercial kitchen fixtures.

As required, replace the existing grease trap with a properly sized Automatic Grease Recovery Unit (AGRU) which automatically skims grease into a separate container in support of the kitchen sink's waste piping. This will ensure effluent discharge levels not to exceed 100 ppm (100 milligrams per liter).

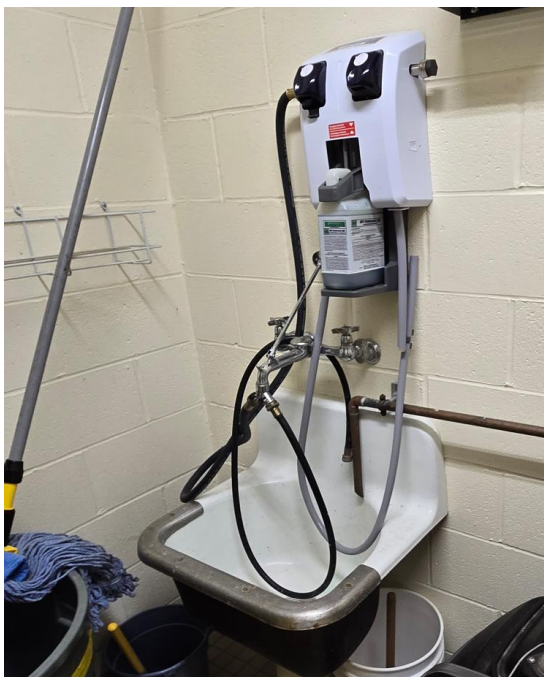
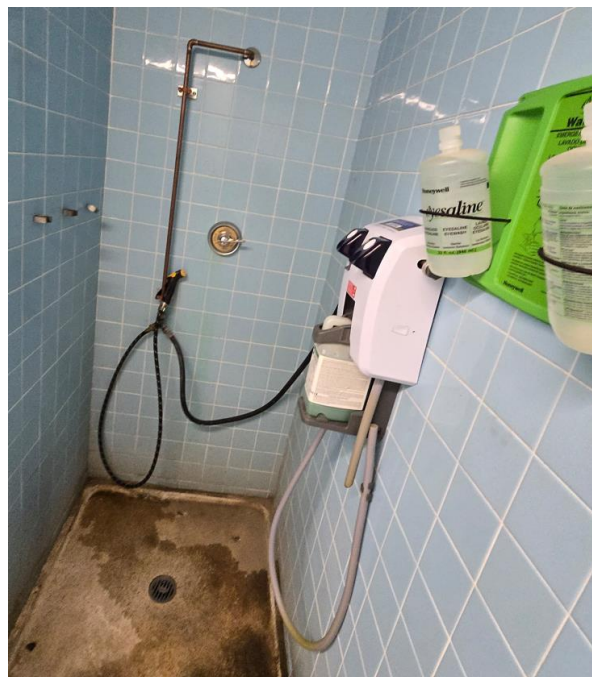
Mop sink with chem dispenser has not been provided with a backflow preventer.

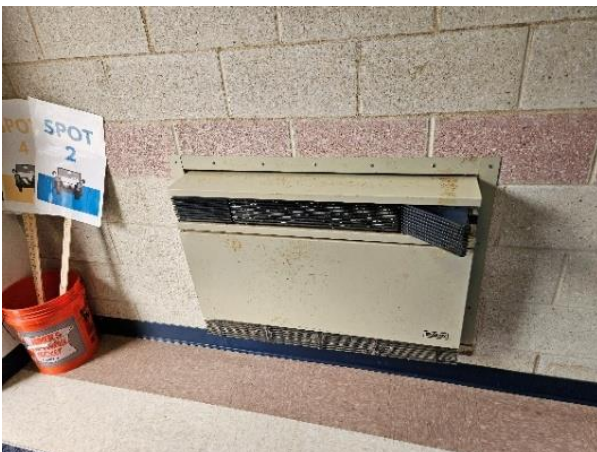
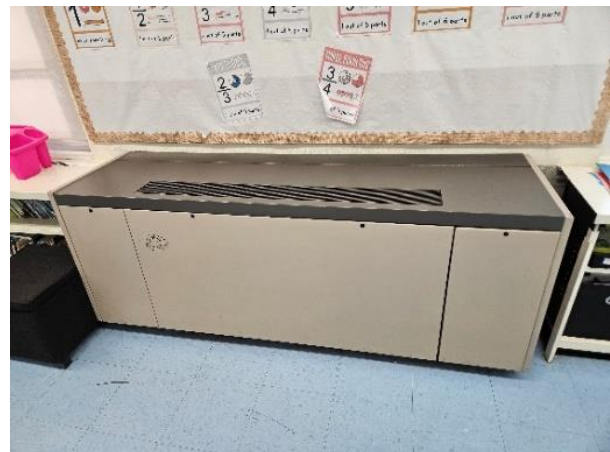
Perimeter heating is provided by means of fin-tube radiation or similar terminal units located along corridors and at building entrances to offset heat loss at the building envelope. These are as old as their respective buildings.

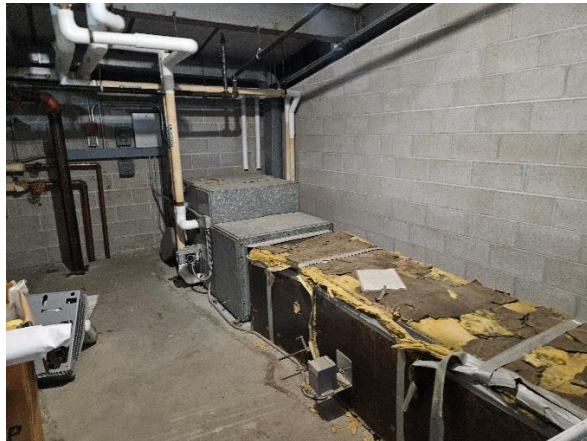
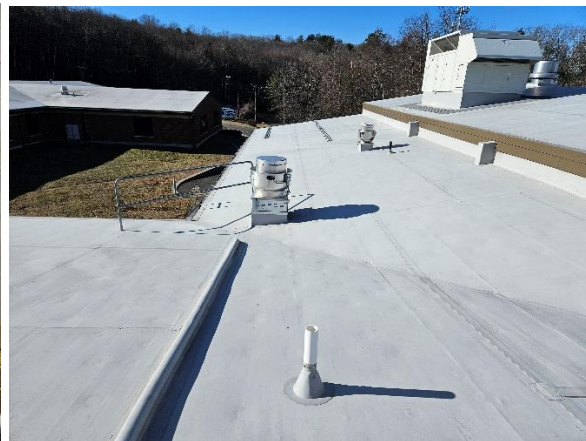
The kitchen is ventilated by an make up air (MAU) unit located in the attic, which was observed to be manufactured in 1968 and in very poor condition. The air is discharged through rooftop exhaust fans installed in 2015. Other rooftop exhaust fans are responsible for the bathrooms spread around the school.

- Provide dedicated outdoor air system (DOAS) units to serve the classrooms, removing the existing unit ventilators, non-functional exhaust fans, and ceiling-mounted air handling units. The DOAS units would be rooftop-mounted, with an estimated five (5) units recommended to maintain smaller zones due to concerns regarding ductwork routing within the crowded ceiling spaces. These units would also serve the adjacent corridors.
- Replace existing hot water radiators throughout the building.
- Remove the existing pneumatic control infrastructure and replace with DDC controls. Centralize all building mechanical systems under a new building management system (BMS).
- Provide variable refrigerant flow (VRF) heat pumps with heat recovery to classrooms that are not currently served by VRF systems.
- Replace the existing air handling unit in the attic serving the cafeteria.
