# New Hartford Public Schools Utilization Study- Facility Conditions Assessment

MARCH 25, 2026

Prepared for:  
**New Hartford Public Schools**  
**530 Main Street PO Box 315**  
**New Hartford, CT 06057**

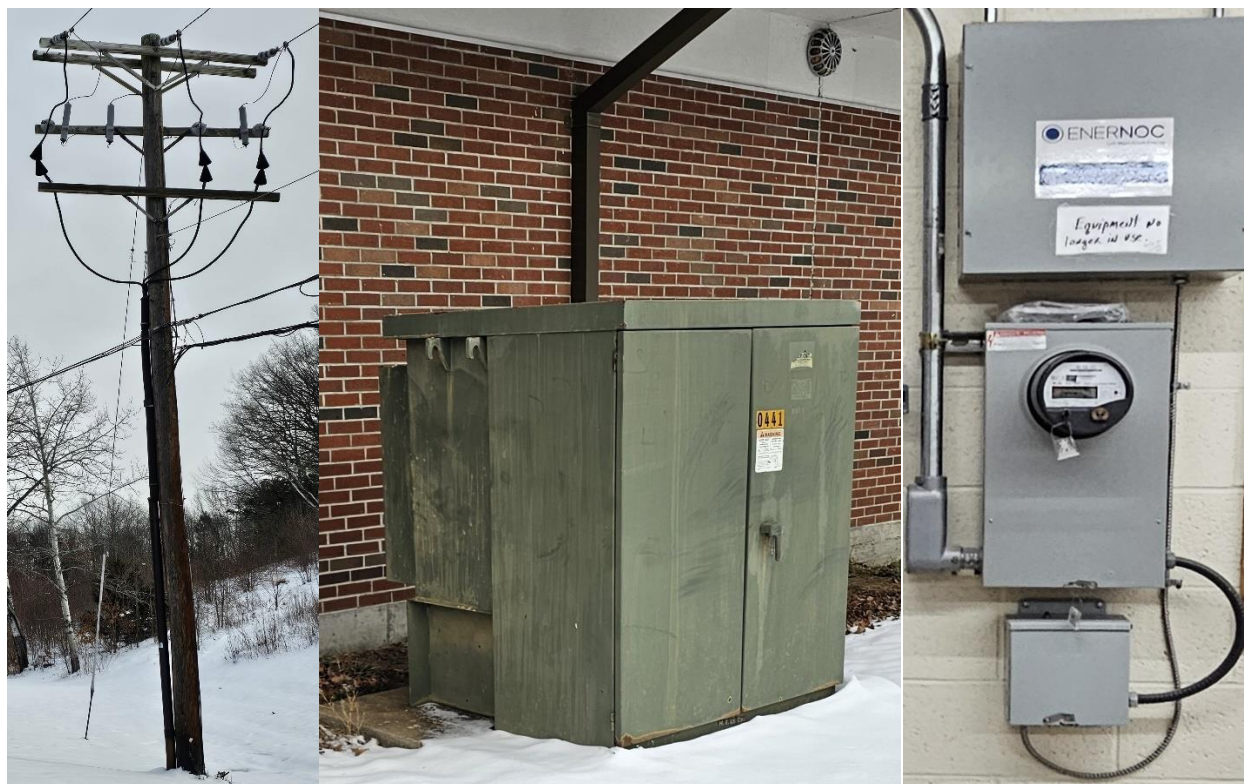
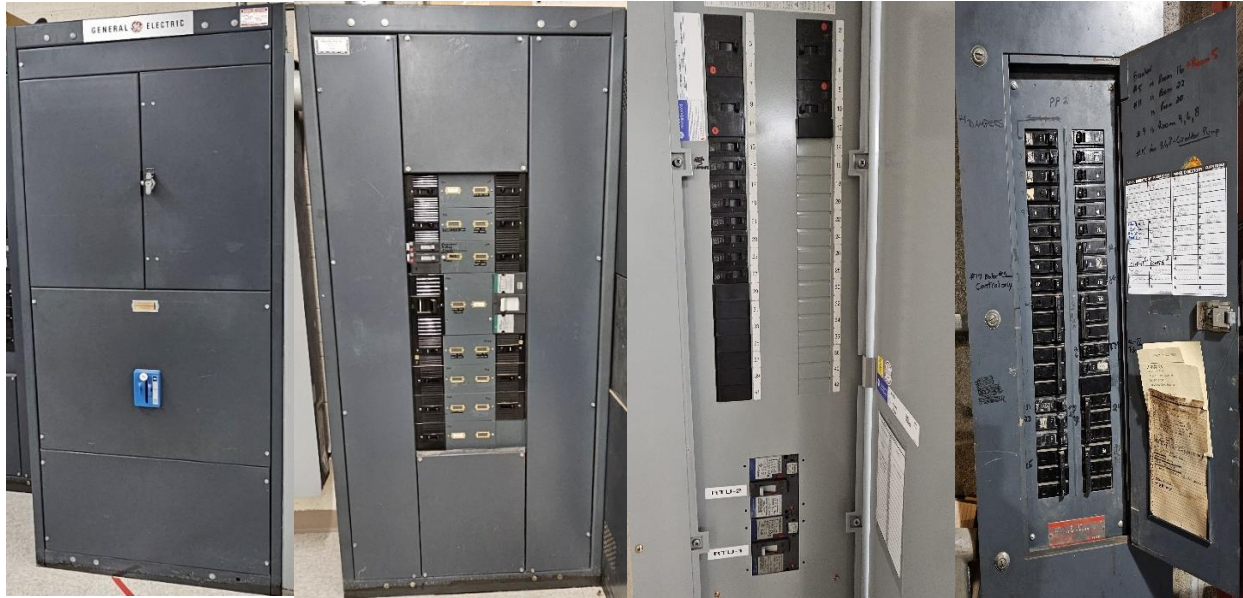
The school is served by an underground electrical service which originates from a utility pole located at rear of school to a pad mounted utility transformer. From the secondary of utility transformer, the electrical service transforms down to 208Y/120V, 3 Phase, 4-Wire underground into the main disconnect switch rated at 800A, 208Y/120V, 3 Phase, 4-Wire located in the main electrical room with an adjacent wall mounted utility meter. The main switch feeds an adjacent 800A, 208Y/120V, 3 Phase, 4-Wire main distribution panel that then feeds multiple panels and equipment located throughout the facility. The main distribution panel, manufactured by General Electric, is in fair condition. Boiler room panel and recessed panels throughout the facility in corridors and kitchen manufactured by General Electric are NLAB models and are in fair condition. All other panels that are newer throughout the facility manufactured by General Electric are A-Series models and appear to be in good condition. The electrical panels in the common area corridors were not locked and can be accessed by non-authorized personnel. The circuit breakers serving the fire alarm system, security system, and network system lack lock-on breaker devices.

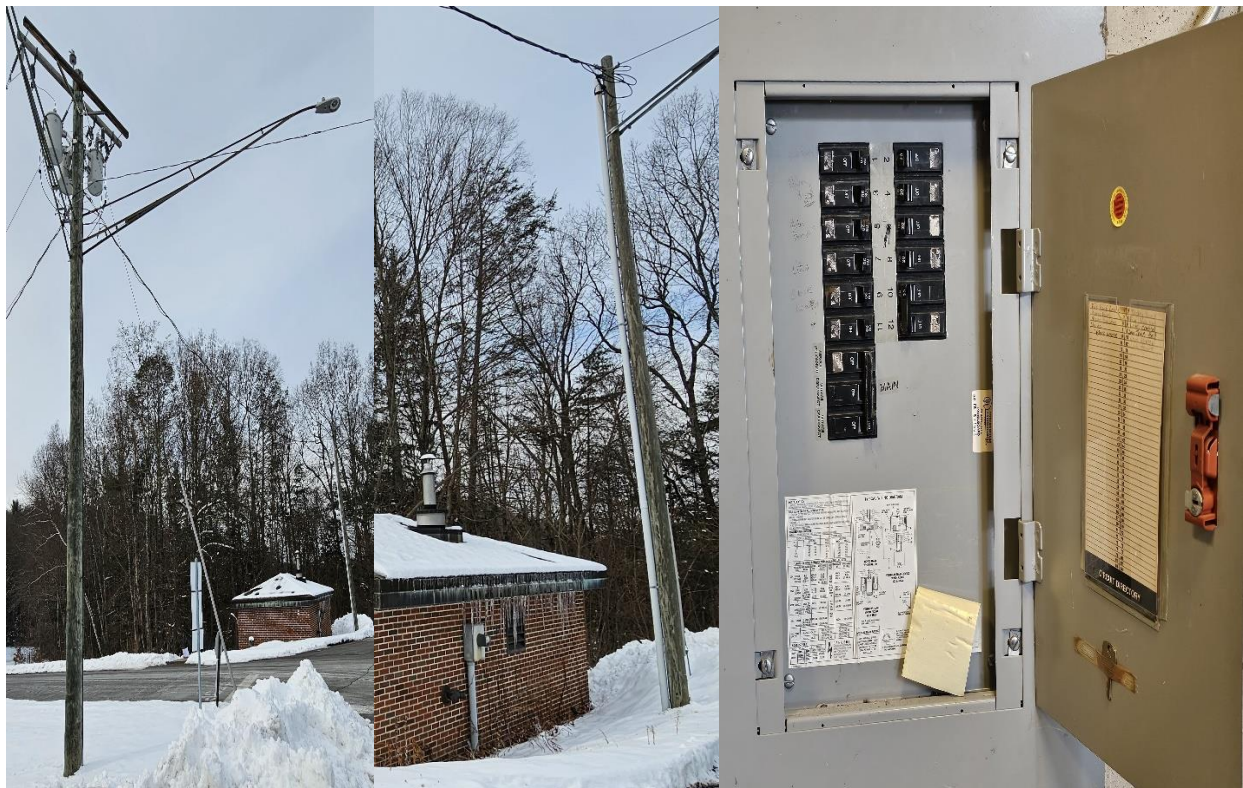
The fire pump building has a separate electrical service and is served by an underground 208Y/120V, 3 Phase, 4-Wire electrical service which originates from pole-mounted utility transformers on Eversource pole #2475 located across the street from fire pump house. From the secondary of utility transformers, the electrical service transforms down to 208Y/120V, 3 Phase, 4-Wire and goes overhead to another utility pole adjacent to fire pump house then underground to an exterior wall mounted utility meter and into the building to 100A main circuit breaker in a 208Y/120V, 3 Phase, 4-Wire panel manufactured by General Electric A-Series model and appears to be in good condition.

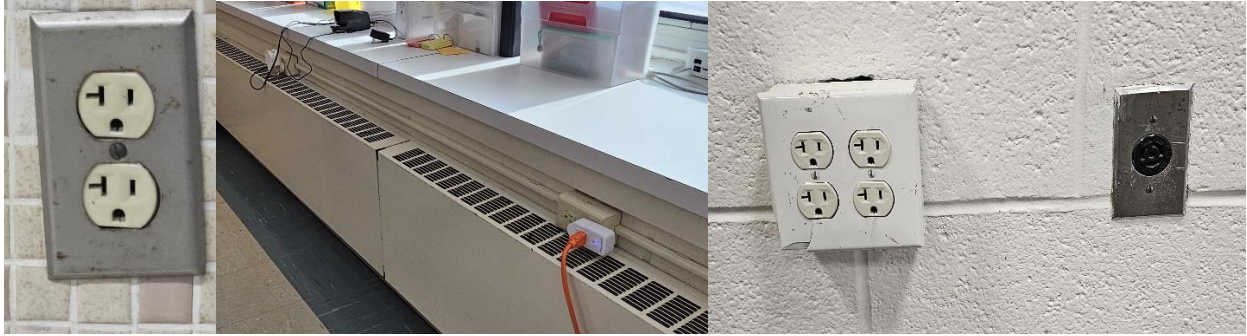
Receptacles throughout the facility consist of both recessed and surface mounted units. The condition of power receptacles throughout the facility varies from good to poor condition. There are several outlets within 6' of a water source that are not GFCI type and not labeled GFCI protected. The use of some extension cords was noted due to a lack of receptacle coverage. Disconnect switches for mechanical & plumbing equipment appear to be in fair to poor condition. Exposed wiring in junction/back boxes without cover plates was noticed in several classrooms. There was no visible sign of any older wiring with cloth insulation.

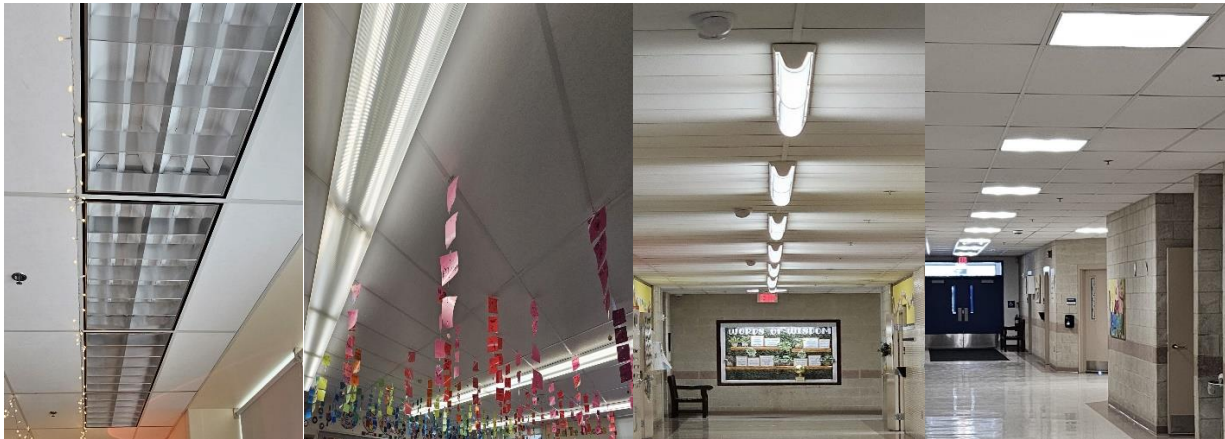
Interior lighting throughout the classrooms, offices, and corridors consists of recessed, surface, and pendant mounted fixtures in library with LED lamps with either parabolic or acrylic lens style. Gym/Cafeteria has 4' surface mounted LED lamp fixtures with acrylic lens. Most fixtures throughout the facility were originally fluorescent and have been retrofit with LED lamps and drivers. Classroom lighting fixtures are controlled via a combination of ceiling occupancy sensors and single pole toggle switches for dual switching of inner & outer lamps. Corridor lighting controls are via 3-way toggle switching at each end of corridors. Mechanical rooms have RLM type fixtures or surface mounted LED fixtures with manual single pole toggle switches for control. Building exterior perimeter light fixtures are a mix of wall pack LED fixtures with a few flood lights, controlled via timeclock and appear to be in good to fair condition.

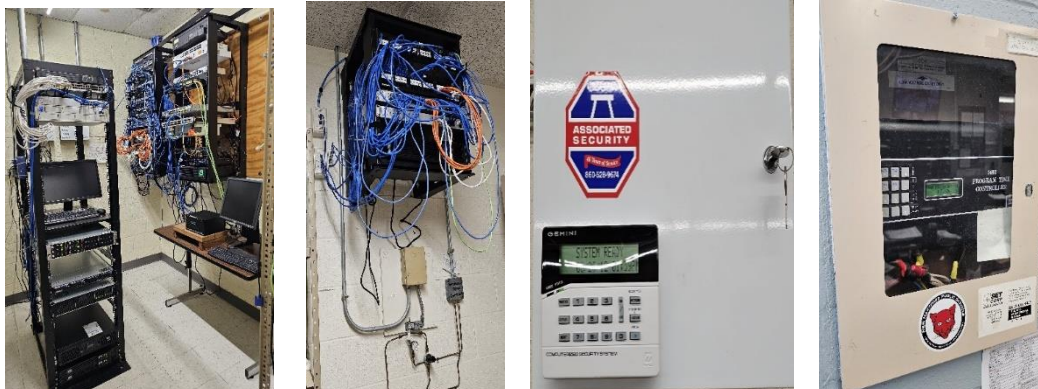
There is a main network rack located in an enclosed and temperature-controlled room suitable for data networks. Network and wi-fi equipment appear to be regularly upgraded and no significant issues were reported. The building is served by a new cloud-based VOIP telephone system which was installed in 2024. The intrusion detection system manufactured by Gemini is in the main electrical room and serviced by Associated Security has been recently upgraded. Video surveillance cameras and access control are by Verkada. These are in good condition. The building has a lockdown system with panic buttons accessible to staff. The Program Time Controller panel located in main office, which is manufactured by Standard Faraday is active and appears to be in good condition. The public address system is reported to be fully operational but is at least 15 years old. Promethean interactive instruction boards are installed in all classrooms and are in good condition.
