Underground Infiltration Chambers (parking lot)

Davis Educational Service Center
 1250 Broadway Ave W,
 Minneapolis MN,
 BMP ID: 8453

Stormwater Planters (in front of building)

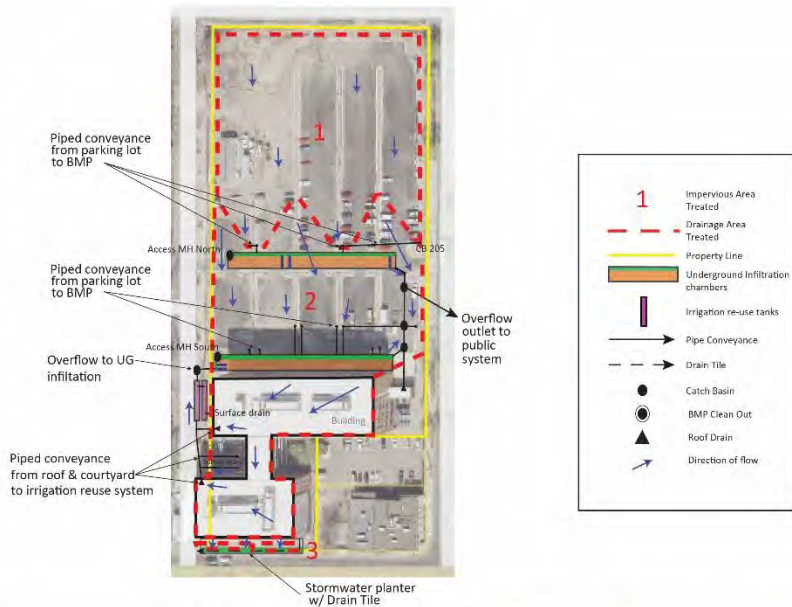
North Infiltration chamber

South infiltration chamber

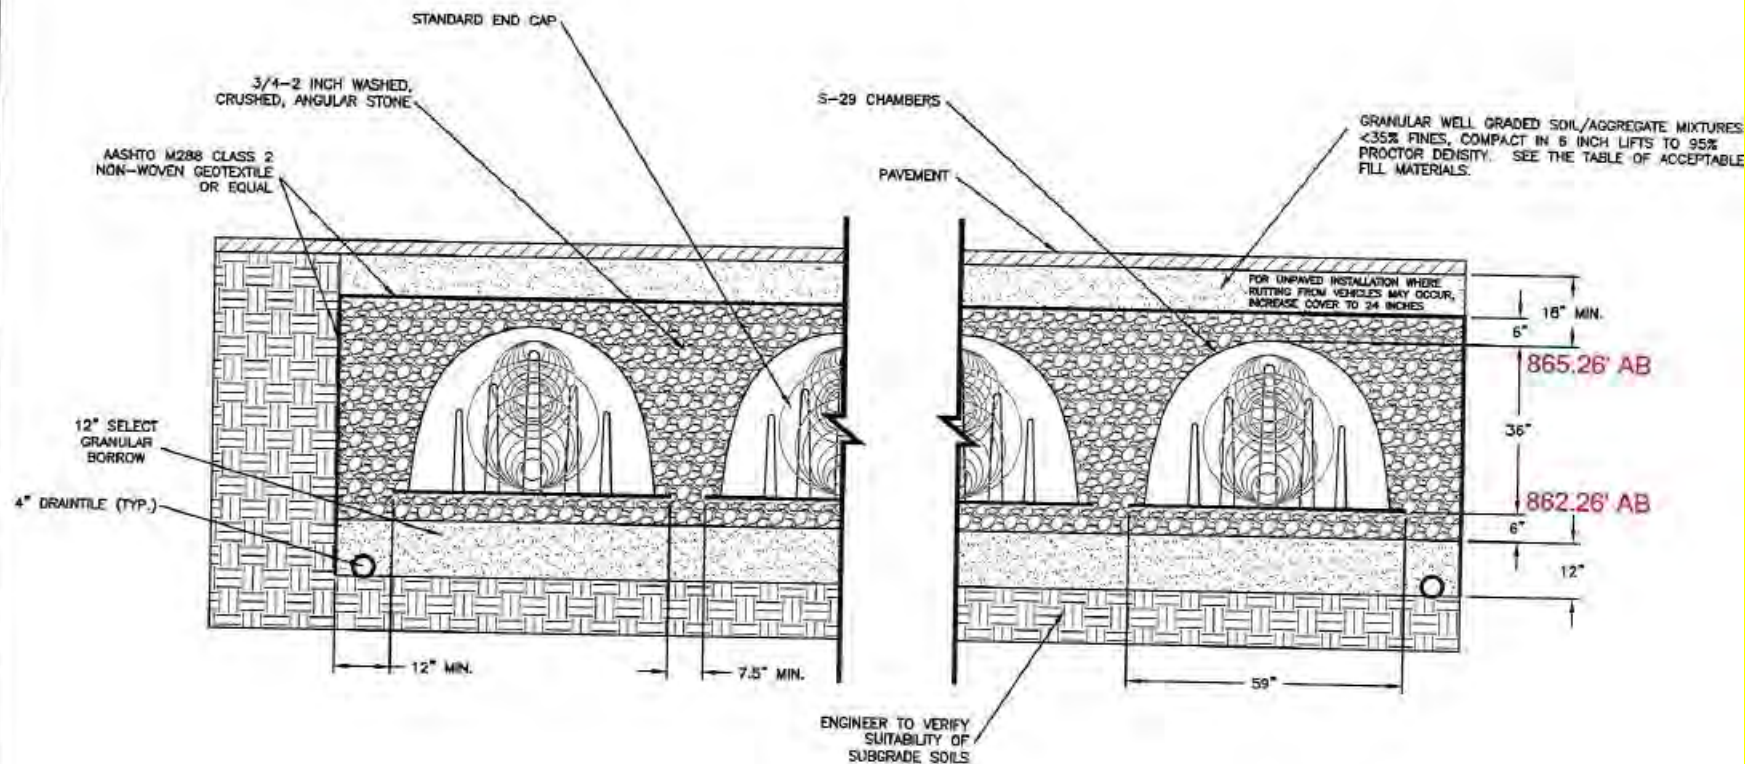
Stormwater runoff from the roof of the building is routed to the south infiltration chambers via an irrigation re-use system. The irrigation system consists of two corrugated metal pipes that fill up with water, and then overflow to the south infiltration chambers. The irrigation system is controlled by a nearby and waters landscaped areas throughout the property.
