# TOWN OF SUFFIELD

## CONDITIONS ASSESSMENT & MASTER PLAN

## SUFFIELD MIDDLE SCHOOL - 350 MOUNTAIN RD, SUFFIELD, CT

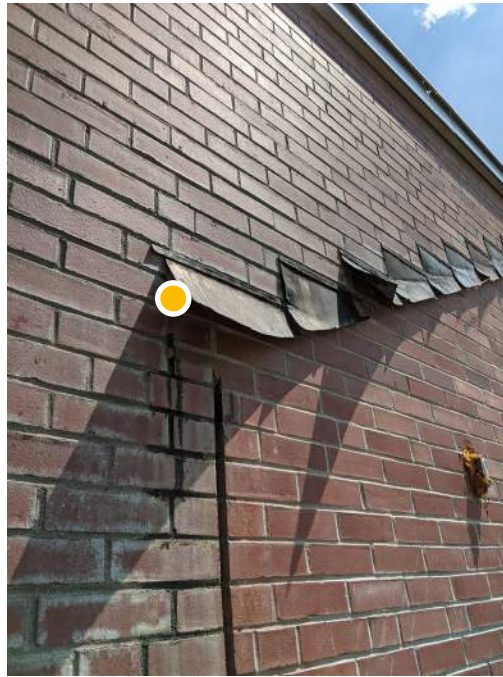
● D1. 23: Detail view of the step flashing that remains from the former greenhouse, part of the 1965 Vo-ag addition.

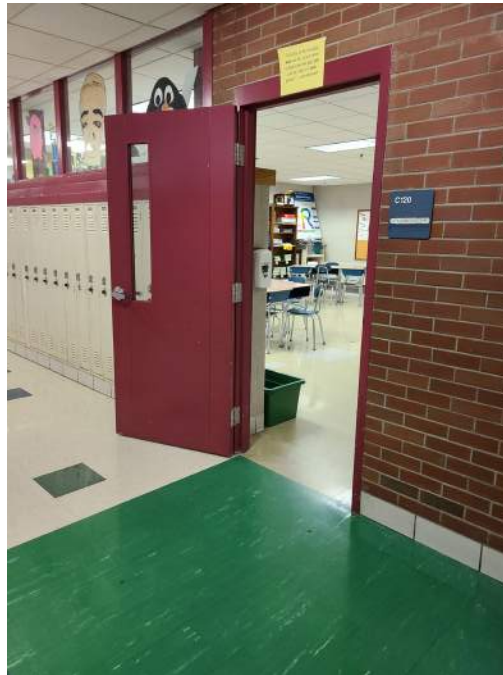
● D1. 55: Typical entry door into classrooms

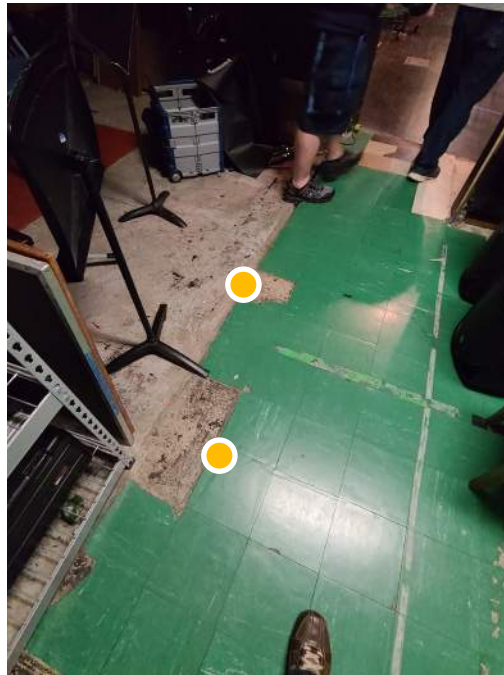
● D1. 61: Detail view of IT storage and server room with VAT flooring retrofits.

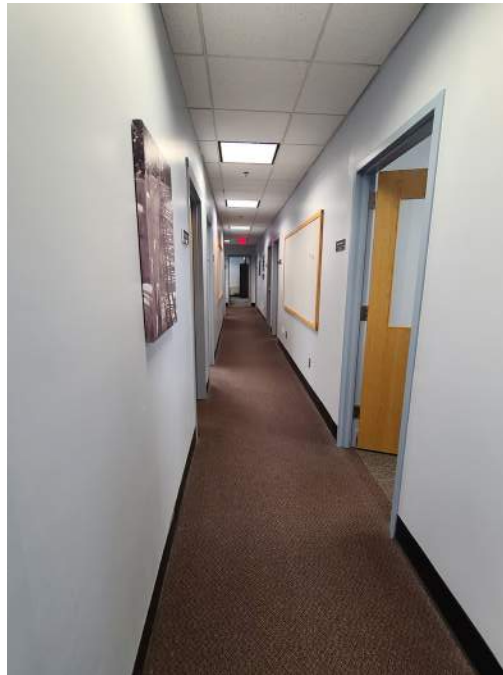
● D1. 63: Detail view of corridor in central office administration retrofit.

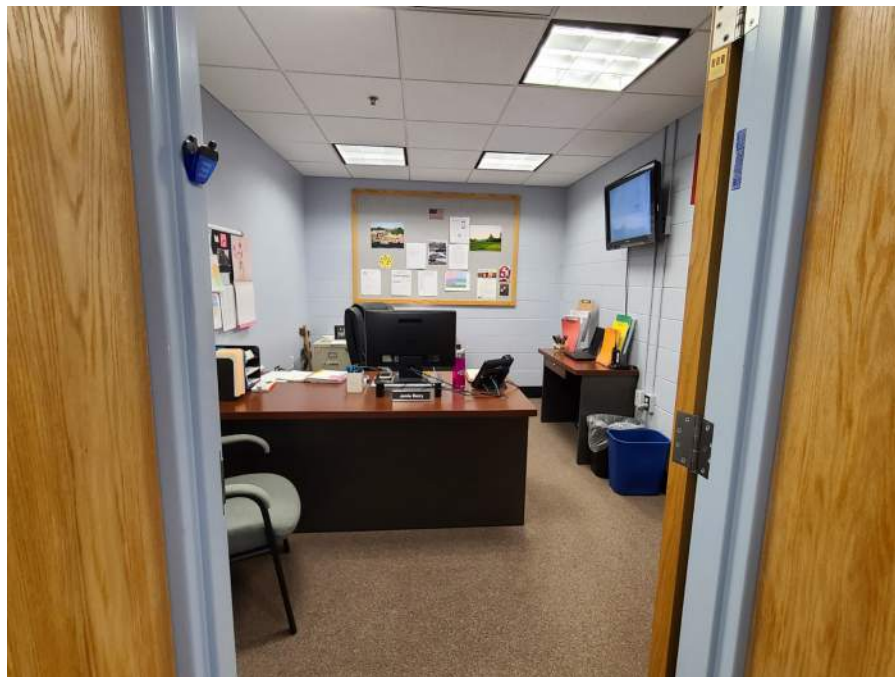
● D1. 64: Detail view of typical office in IT office and administration retrofit.

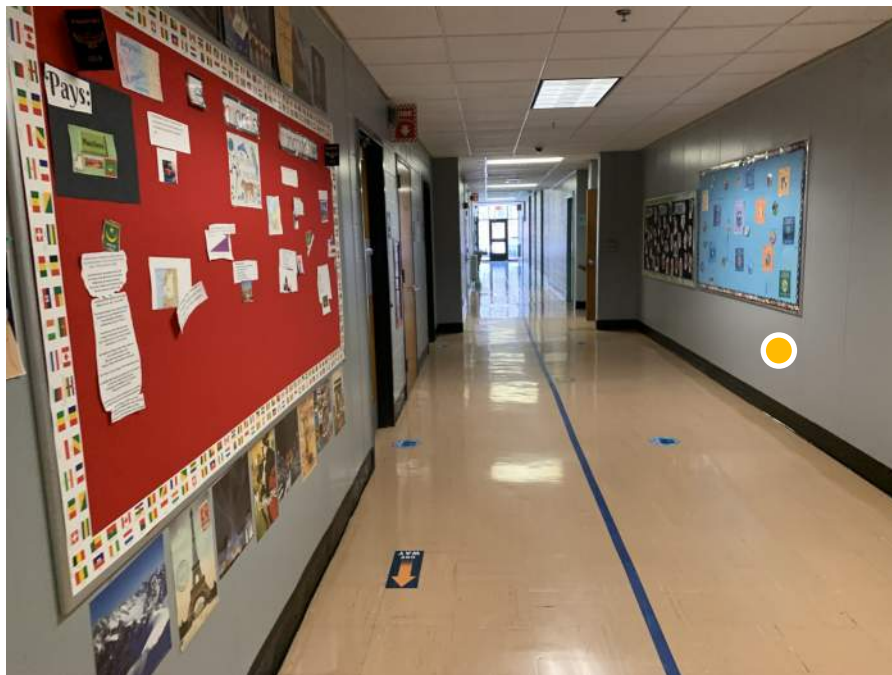
● D1. 66: View of typical corridor in 1972 addition, note the modular wall construction.

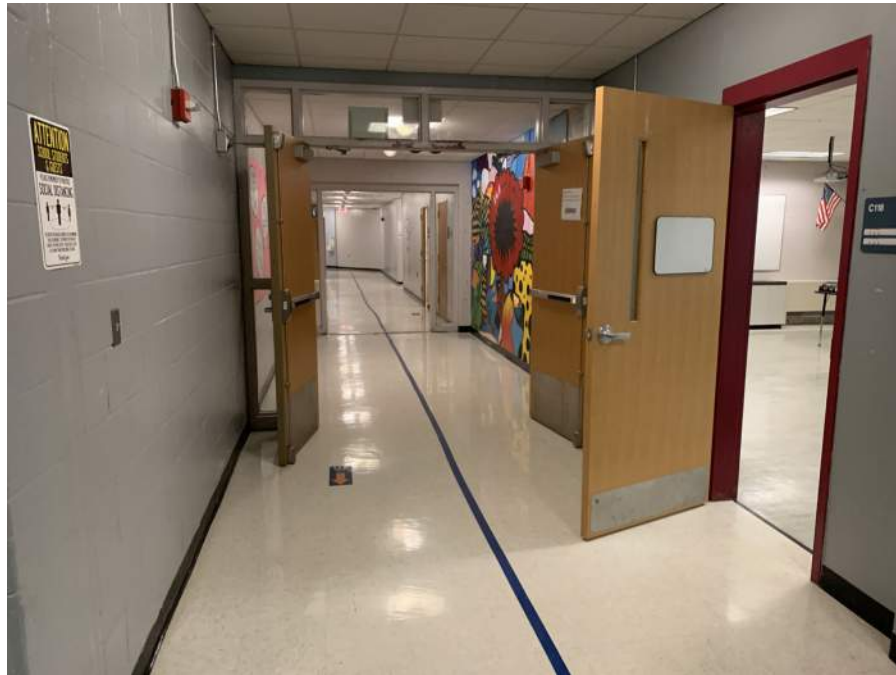
● D1. 71: View of typical corridor in original 1964 building.

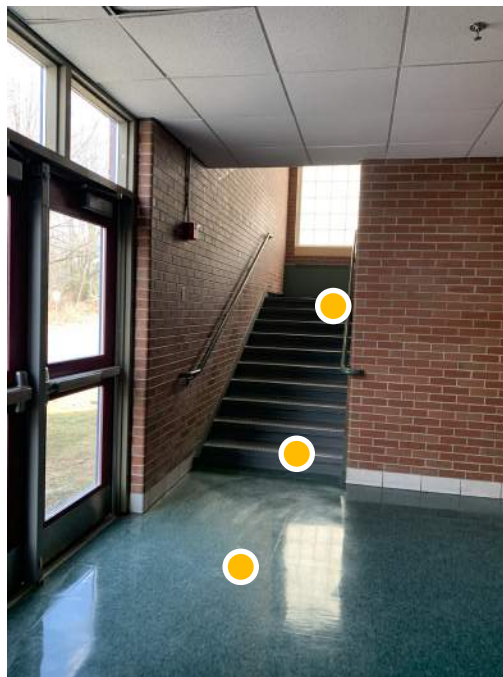
● D1. 72: View of retrofit and upgrades to the north egress stair in original building

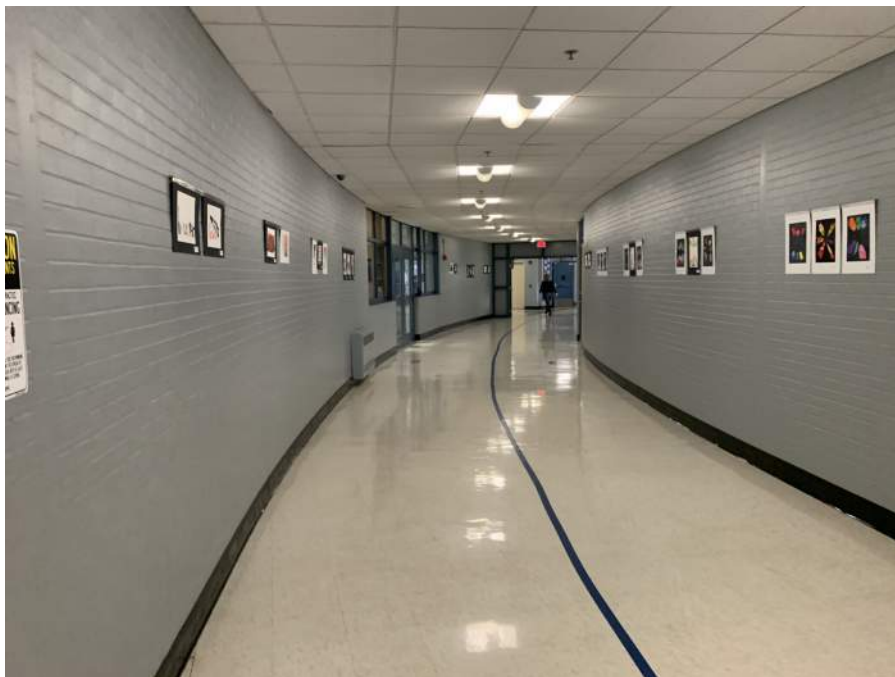
● D1. 78: View of curved connecting corridor in original 1964 building.

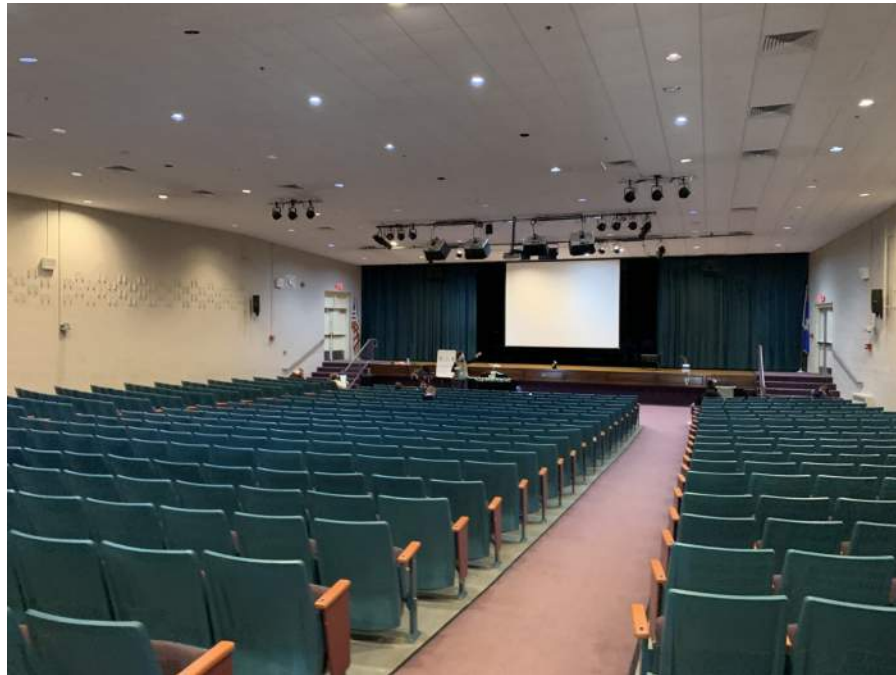
● D1. 79: View of existing auditorium, original 1964 construction.

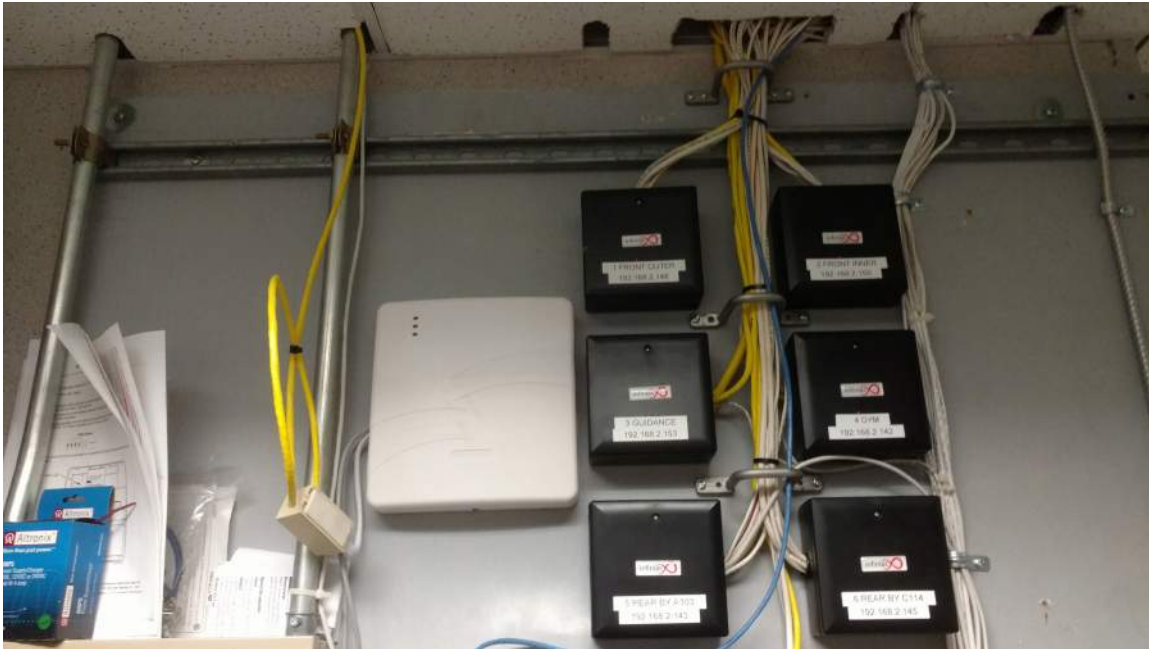
● D2. 1: Access Control Equipment.

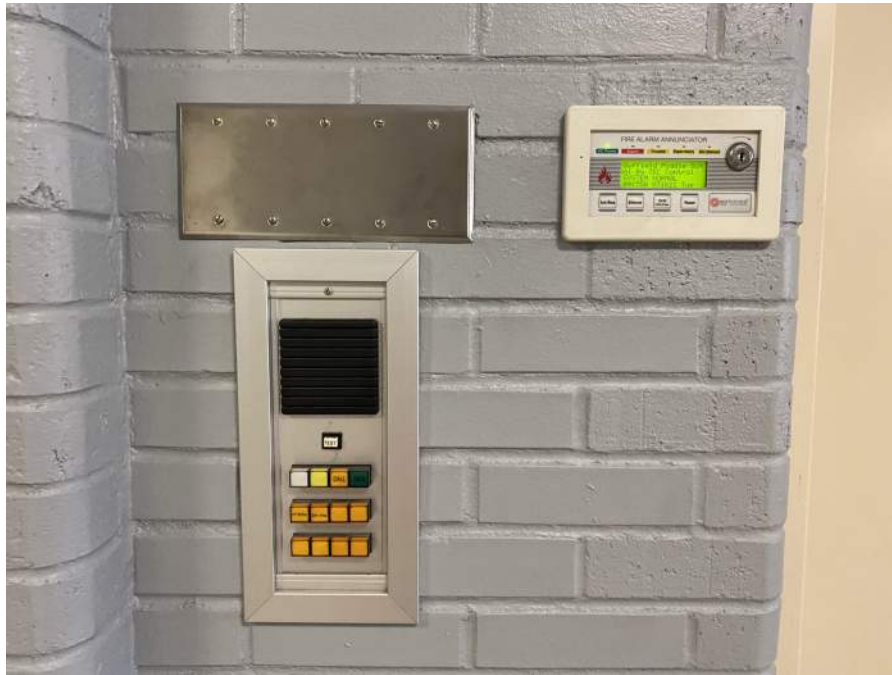
● D2. 5: Area of Rescue Assistance Intercom.

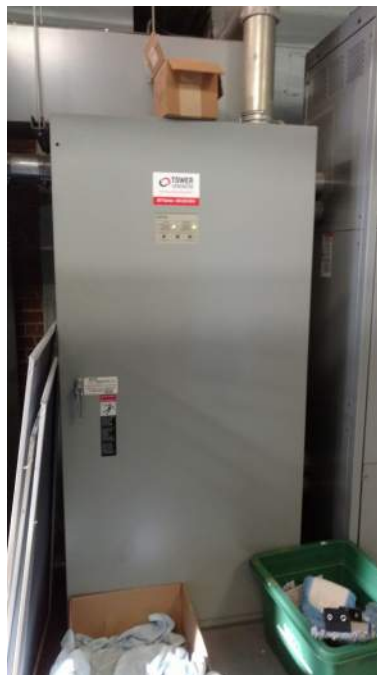
● D2. 12: Electrical Automatic Transfer Switch.

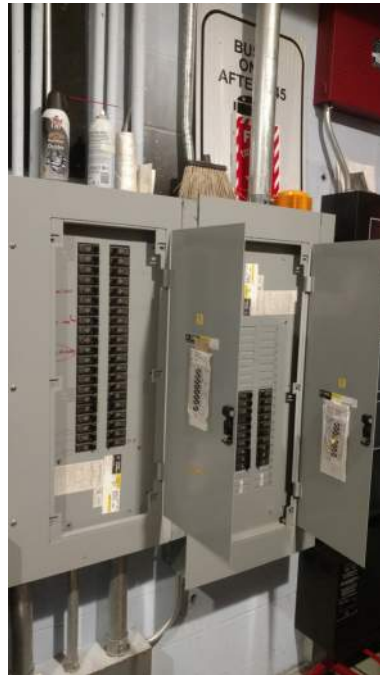
● D2. 13: Electrical Branch Circuit Panels.

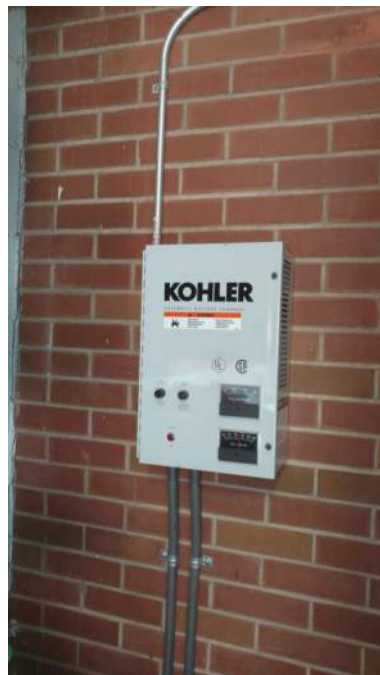
● D2. 14: Electrical Generator Remote Battery Charger.

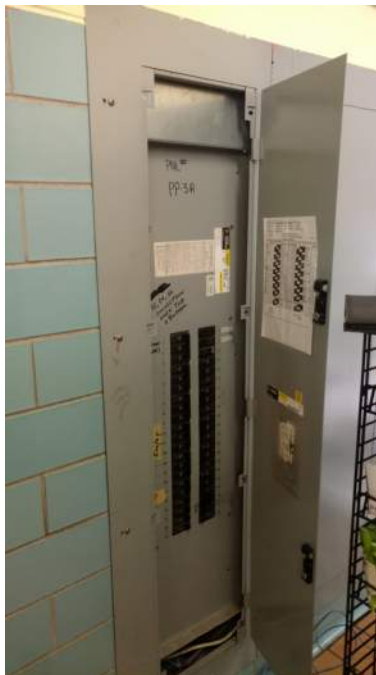
● D2. 15: Electrical Kitchen Branch Circuit Panel.

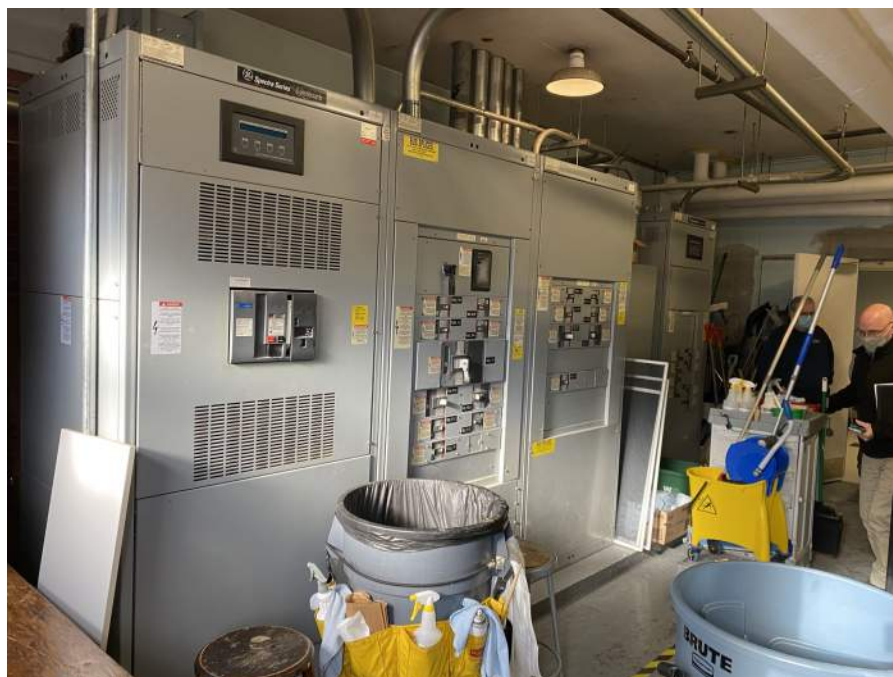
The main electric service for the building is rated 2,500 Amps, 208/120 volts, 3-phase, 4-wire, and includes a service switchboard with a main circuit breaker disconnect switch, utility company metering compartment, and (3) distribution sections. This service and main switchboard were installed in the 2002 renovation/conversion. The service equipment is in good working condition and replacement parts for the GE Spectra Series equipment are readily available. Utility demand records indicate this service has peaked with approximately 800 amperes of continuous load therefore any proposed expansion on the existing 2500 ampere service should not be an issue.

● D2. 16: Electrical Main Service Switchboard.

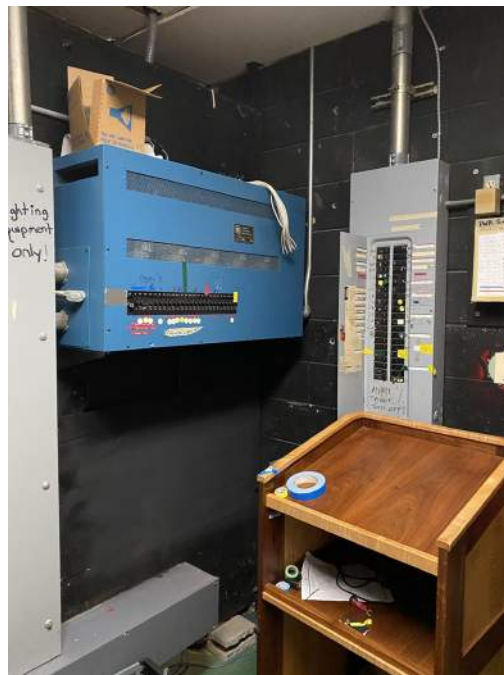
● D2. 18: Electrical Stage Power and Control.

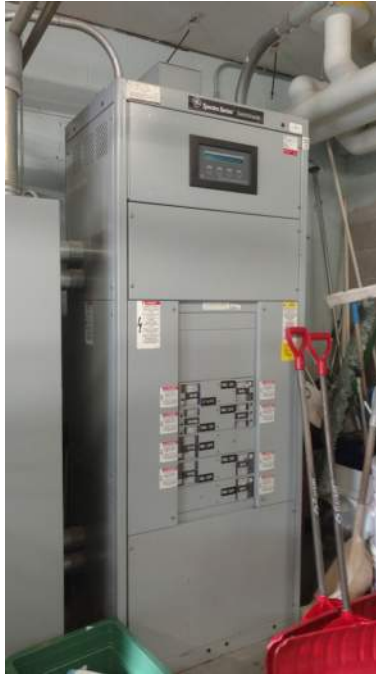
● D2. 19: Electrical Standby Power Distribution Panel.

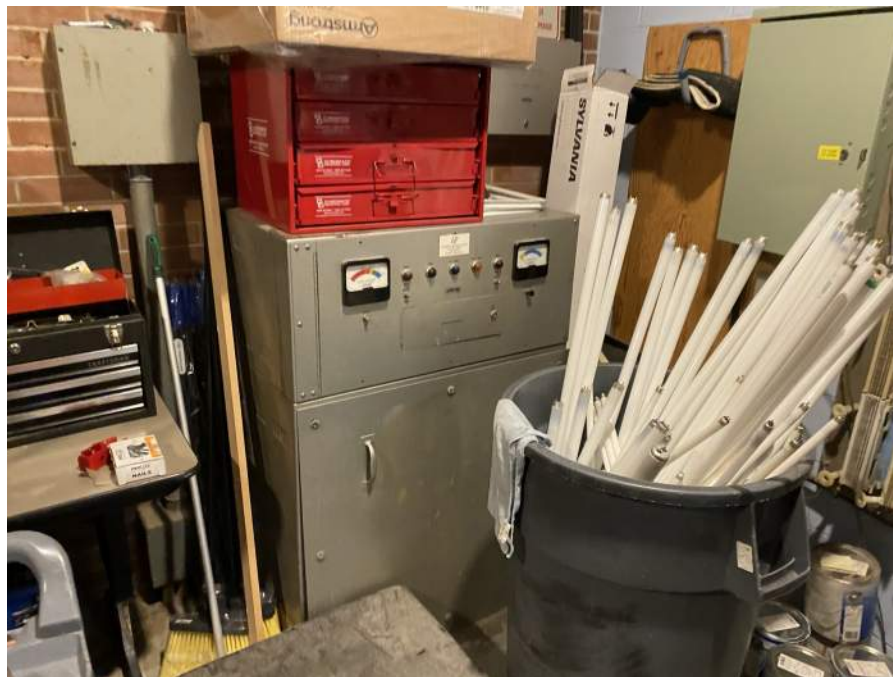
● D2. 20: Emergency Lighting Inverter System #1.

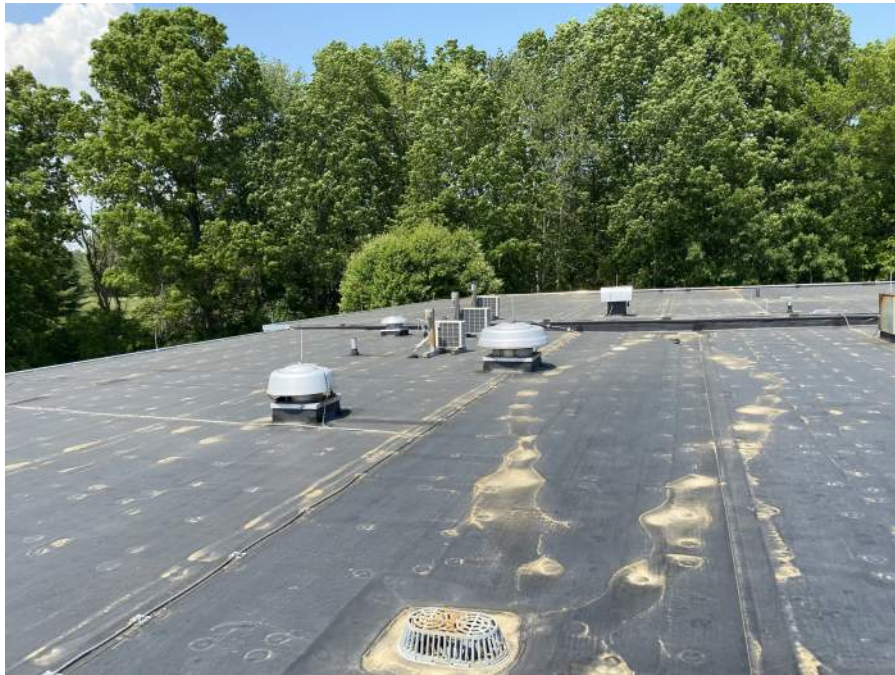
● D2. 21: Exhaust Fans and Condensing Units on Roof.

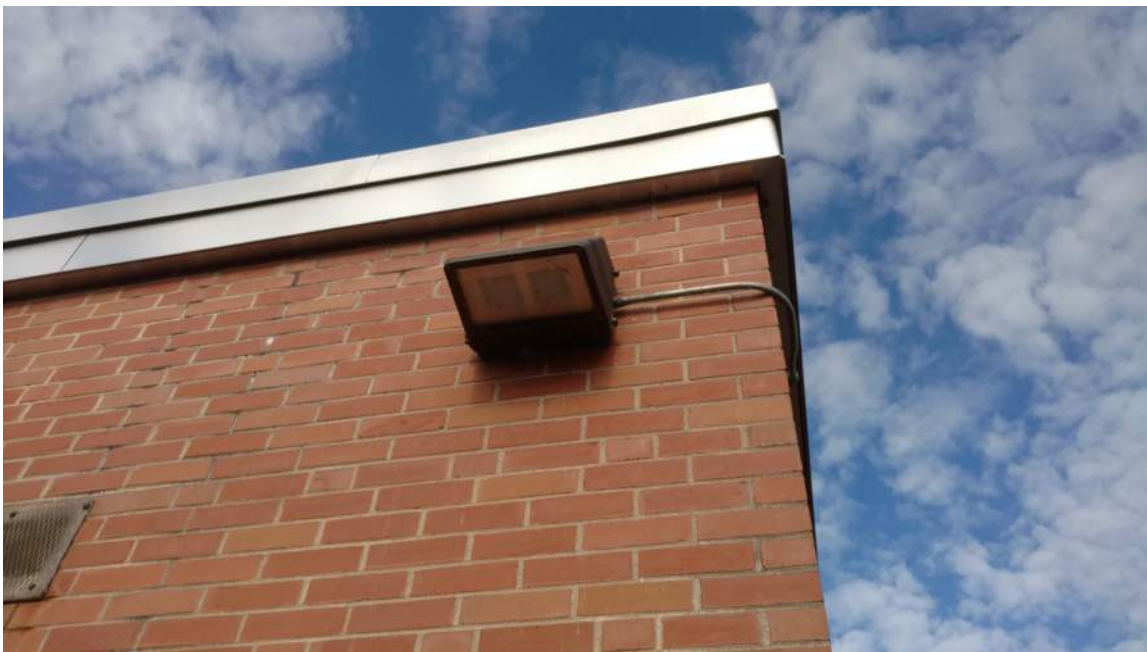
● D2. 22: Exterior LED Wallpack Lighting.

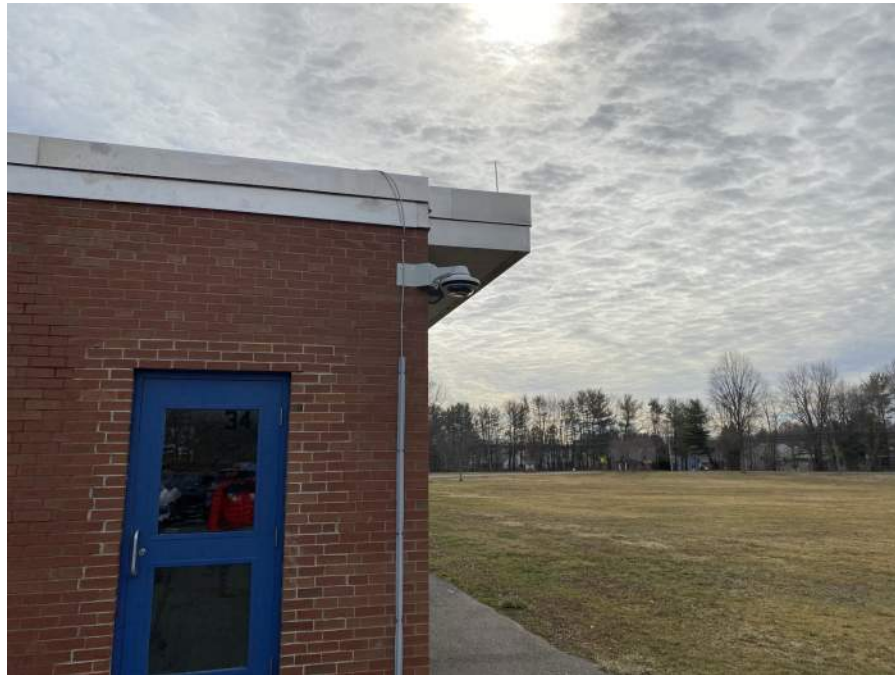
● D2. 23: Exterior Security Camera.

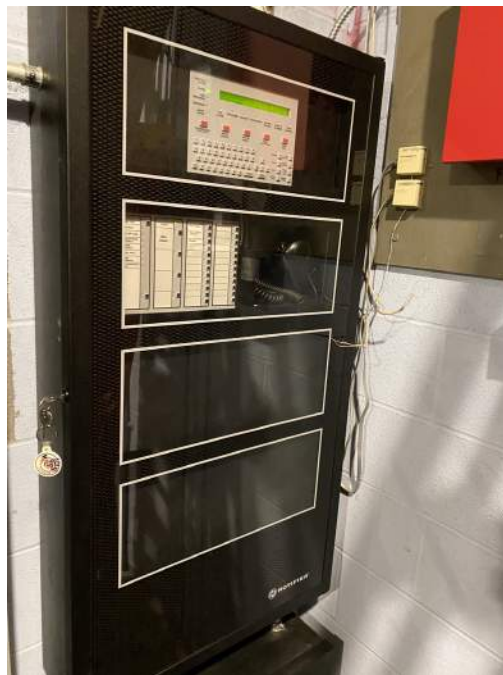
● D2. 24: Fire Alarm Control Panel.

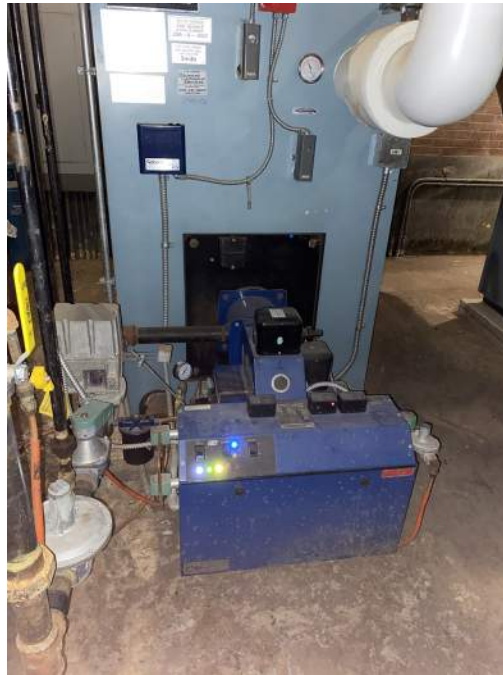
● D2. 31: Hot Water Boiler and Burner in Mechanical Room.

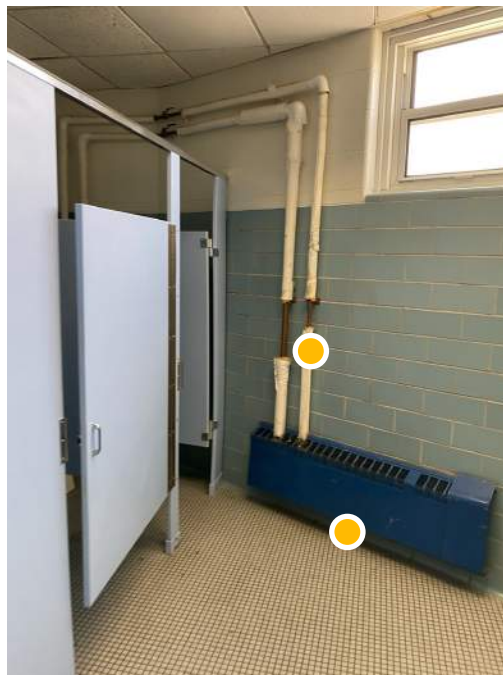
● D2. 32: Boys toilet room with exposed heating pipes to unit cabinet heater, adjacent to gymnasium, original construction 1964.

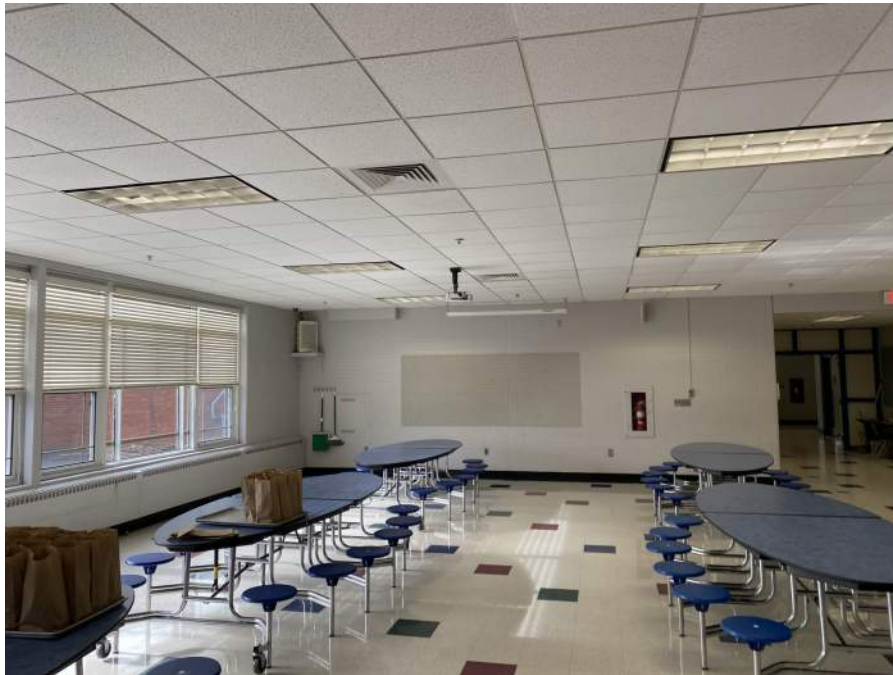
● D2. 41: View of existing cafeteria, original construction 1964.

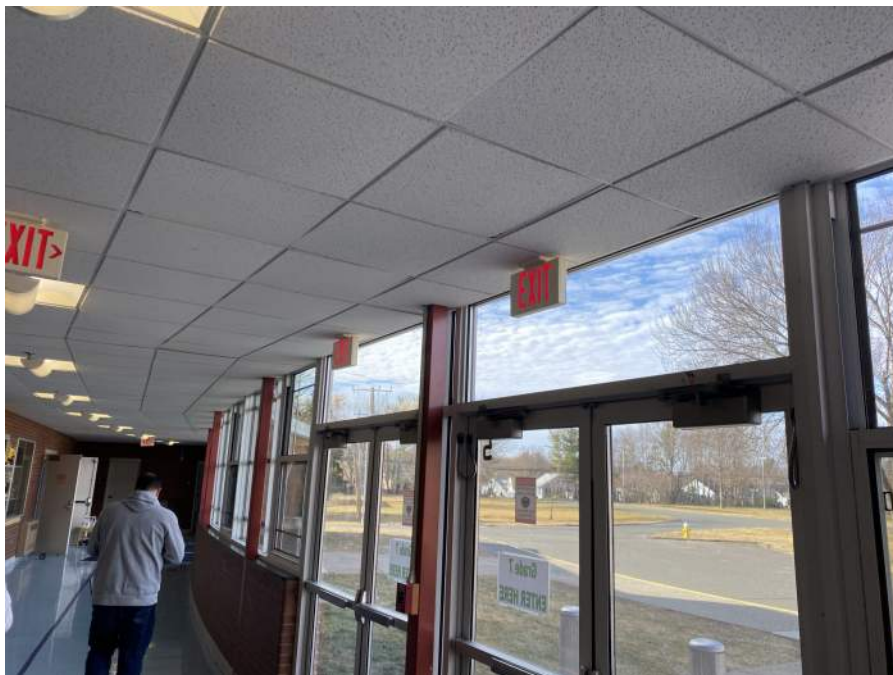
● D2. 42: View of entry vestibule area adjacent to the gymnasium, original construction 1964.

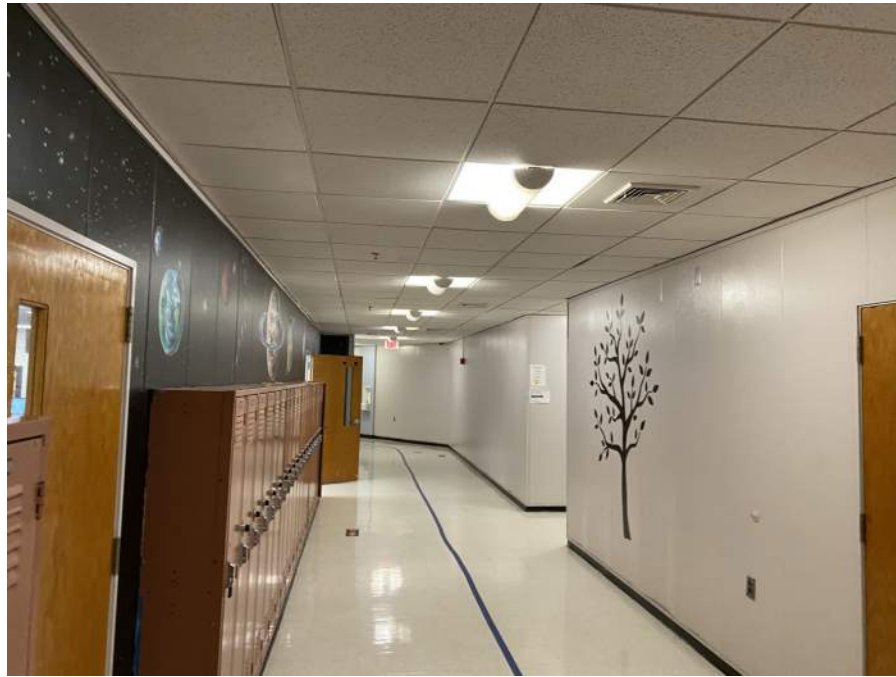
● D2. 43: View of connecting corridor in the 1972 addition.

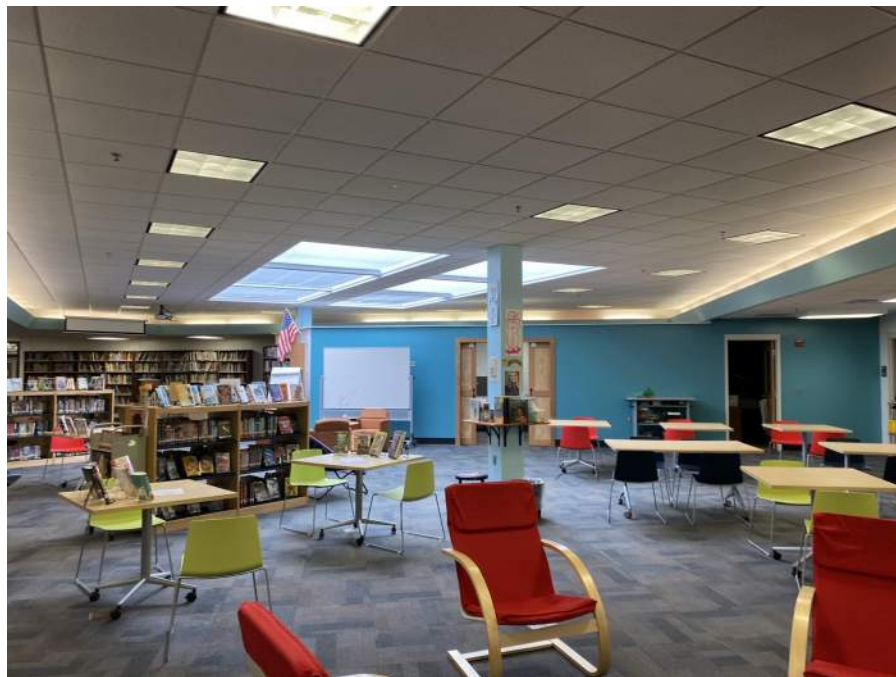
● D2. 44: General view of the media center, 1972 infill addition.

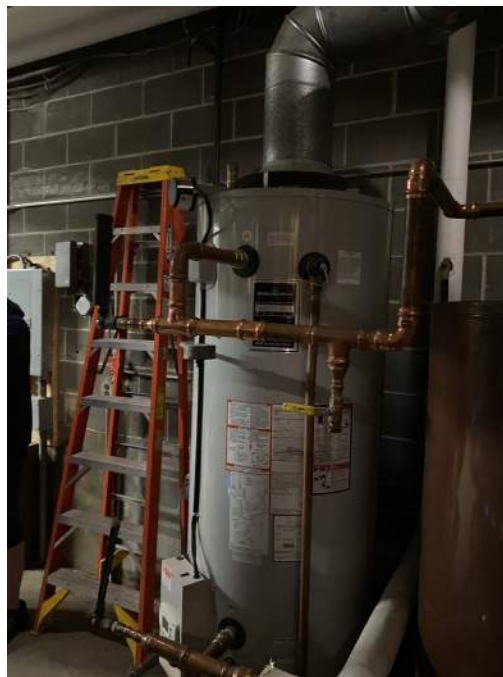
● D2. 48: Natural Gas Domestic Hot Water Tank in Mechanical Room.

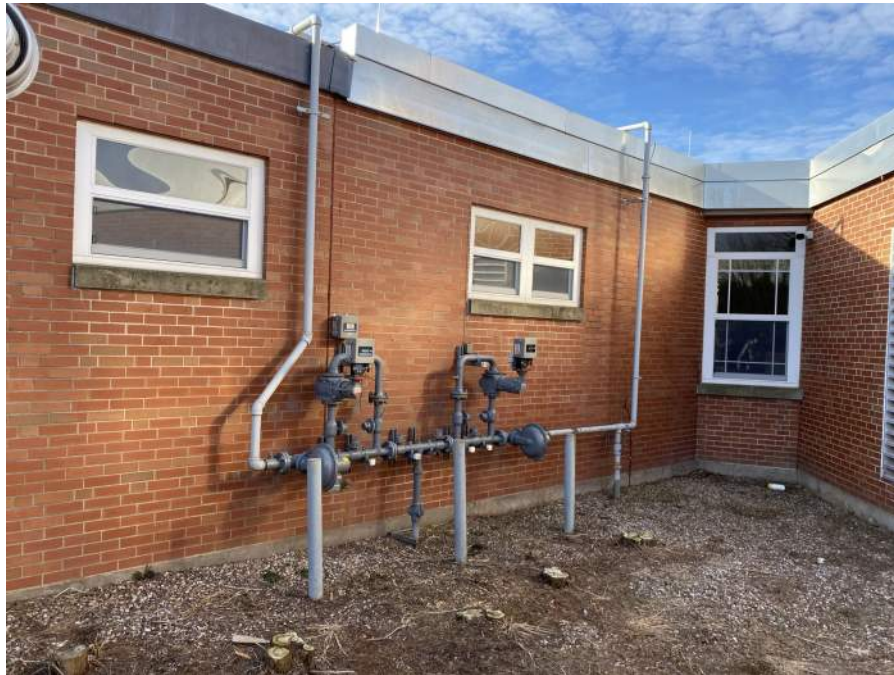
● D2. 49: Natural Gas Service.

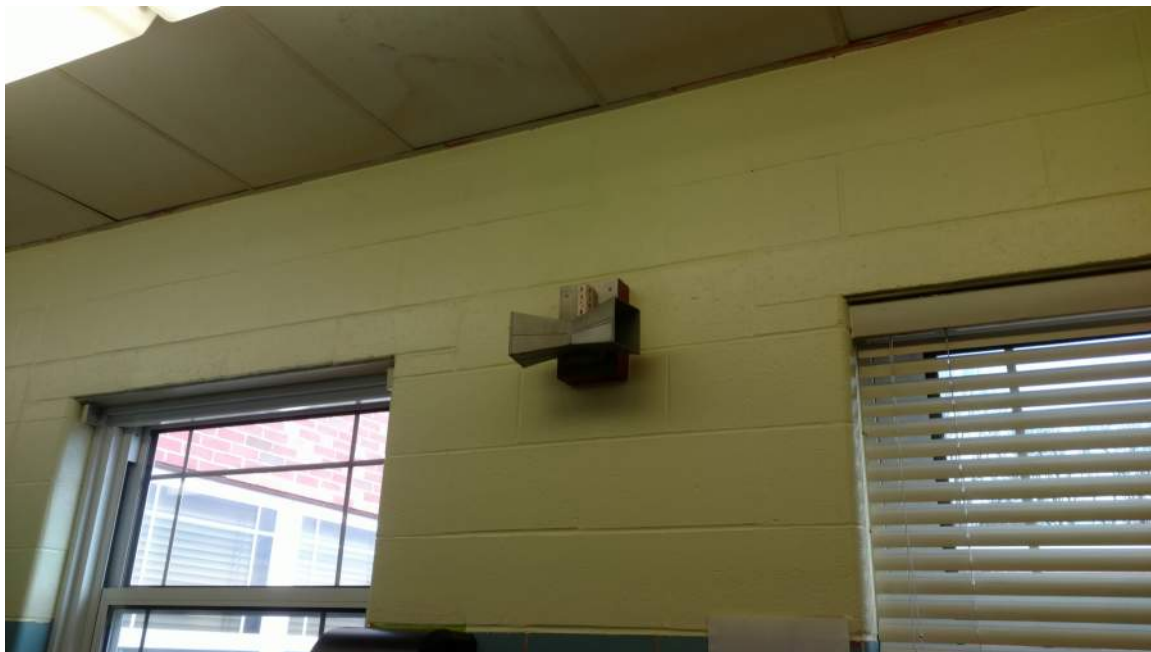
● D2. 50: Old School Fire Alarm.

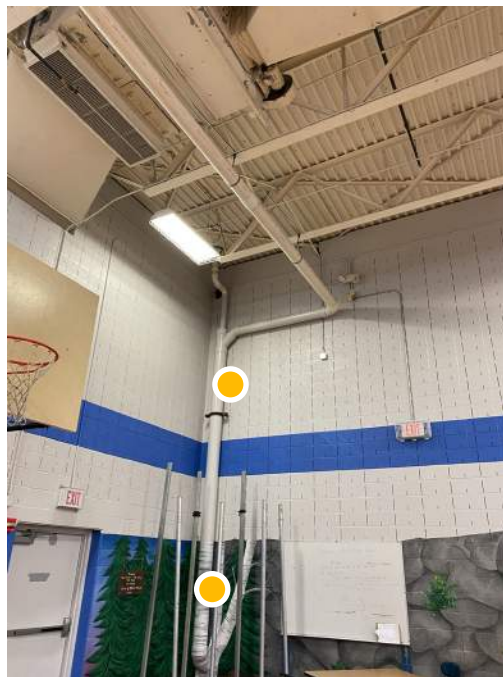
● D2. 52: detail view of exposed piping in auxiliary gymnasium.

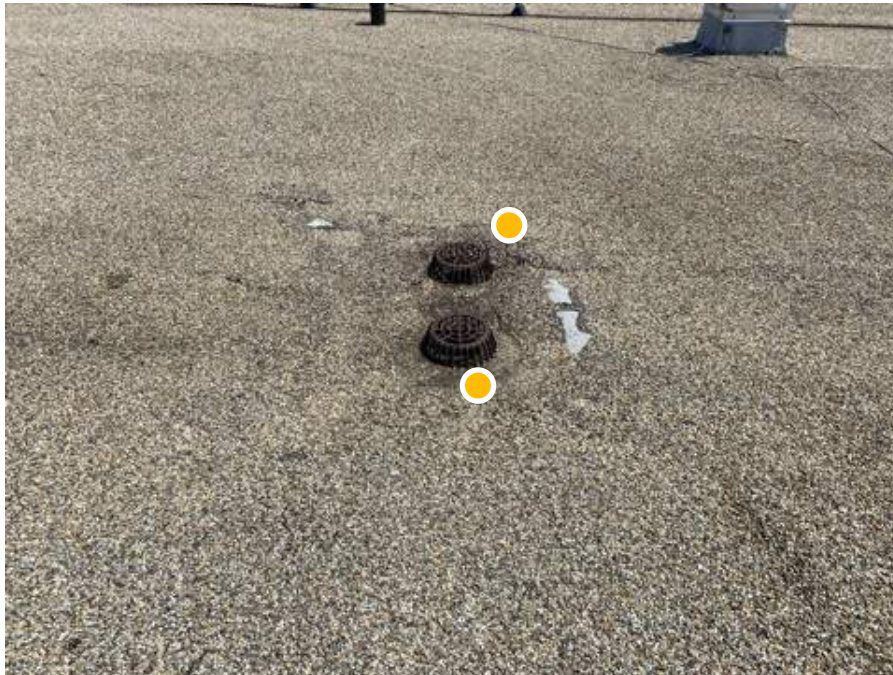
● D2. 53: View of typical roof drain.

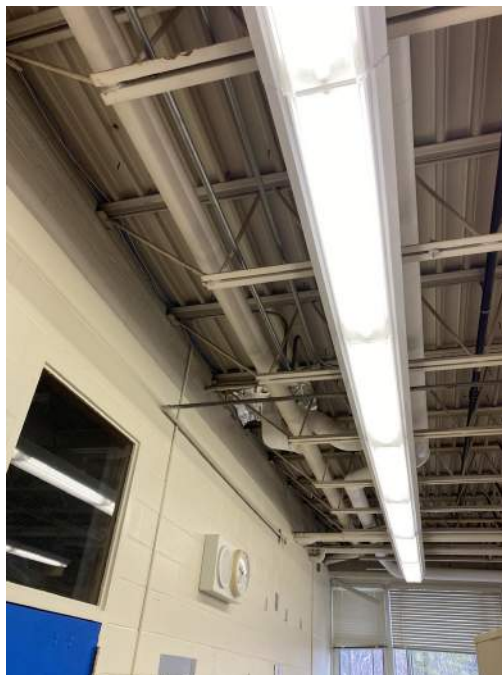
● D2. 58: Storm Piping from Roof Drain in Fair Condition.

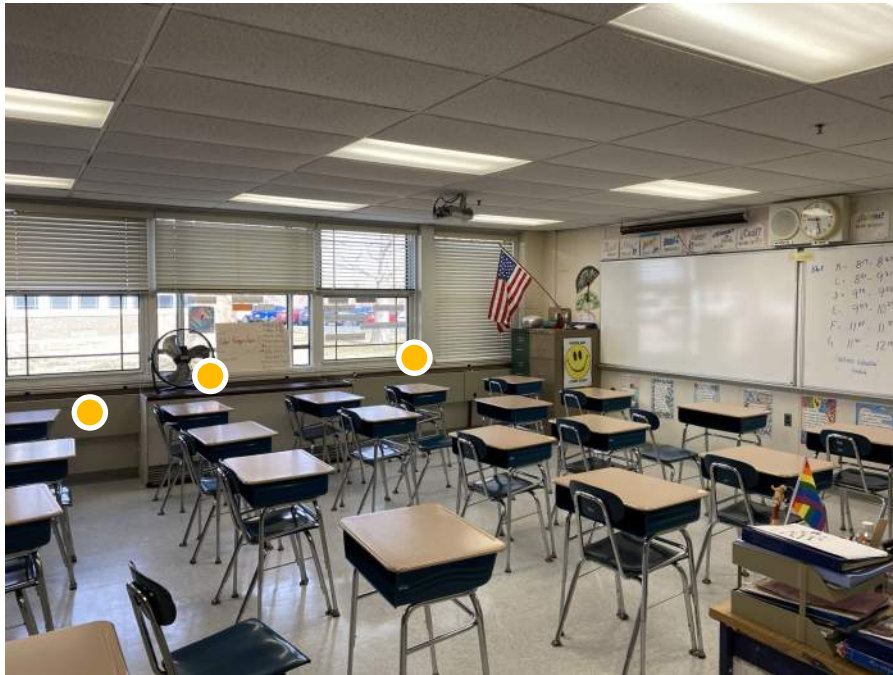
● D2. 61: View of typical classroom with unit ventilator and perimeter radiation units at exterior wall.

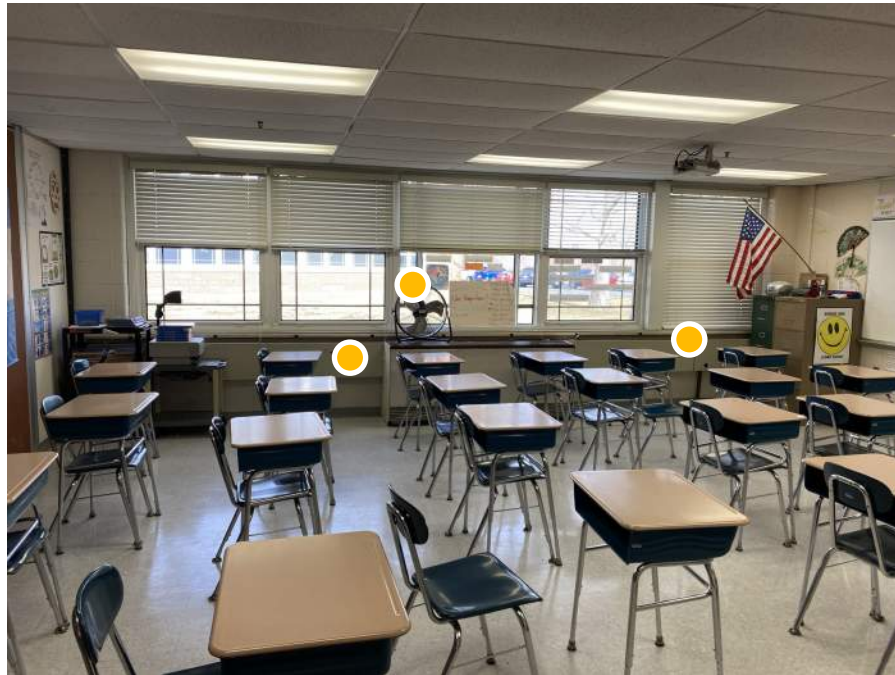
● D2. 63: View of typical classroom with unit ventilator and perimeter radiation units at exterior wall, note the fan to compensate for additional air circulation.

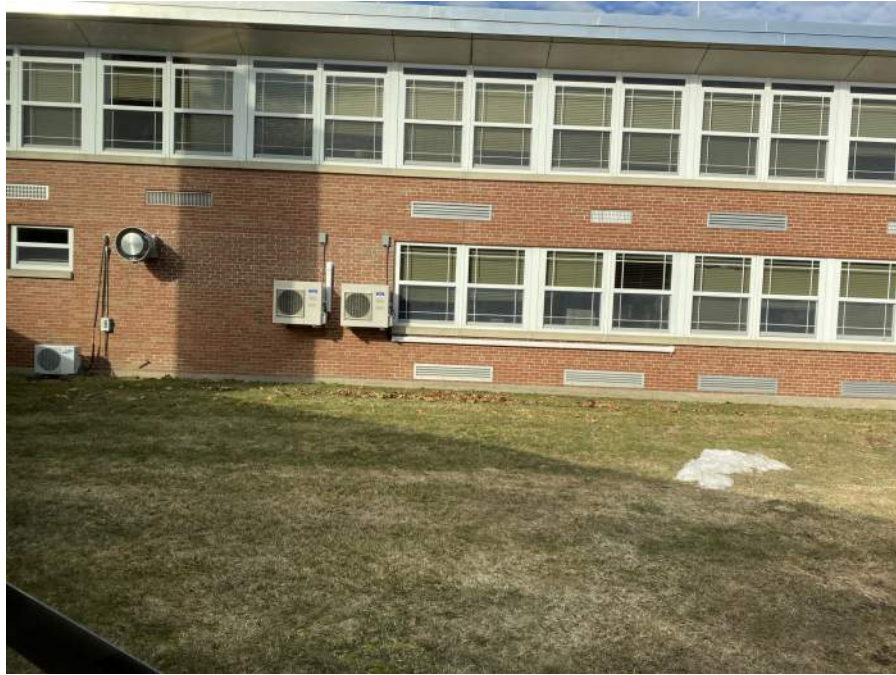
● D2. 65: Unit Ventilator and PTAC Unit Outdoor Air Intakes Along Wall.

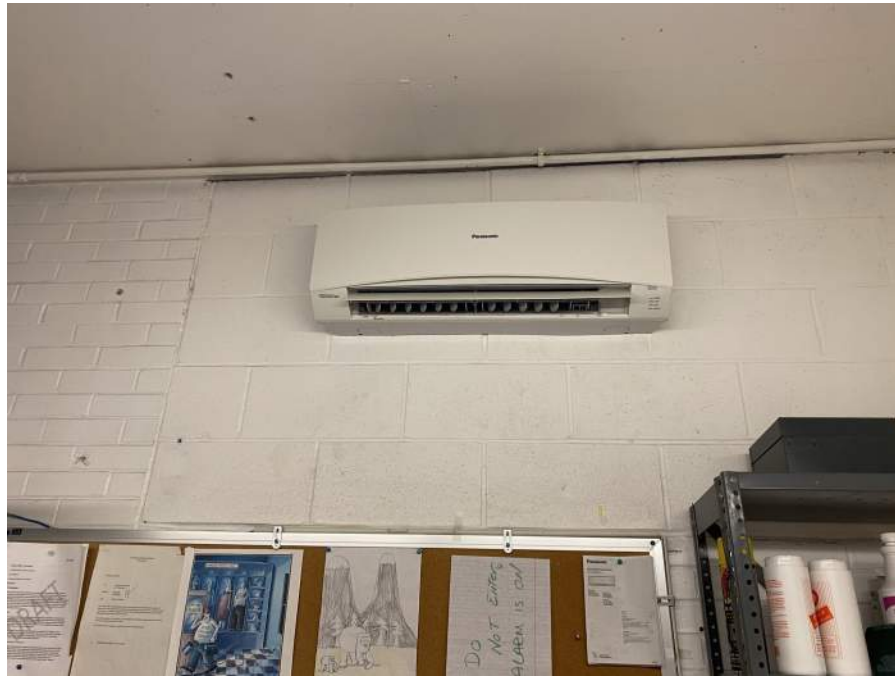
● D2. 67: Wall Mounted Split Unit For Cooling in IDF Room.

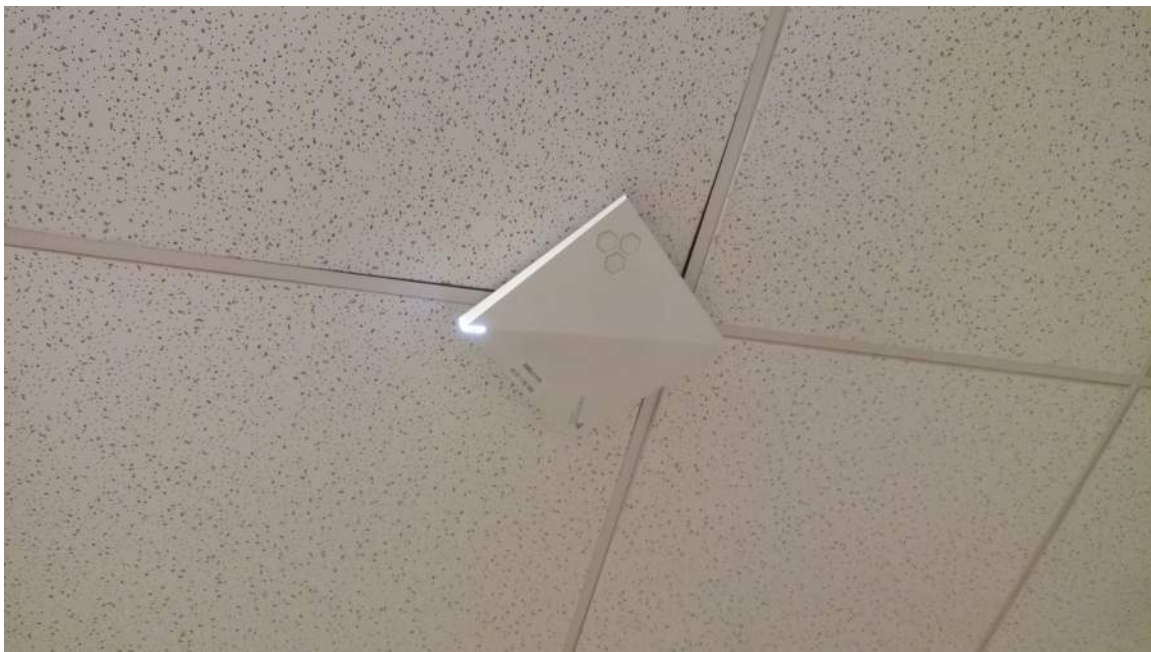
● D2. 68: Wireless Access Point.

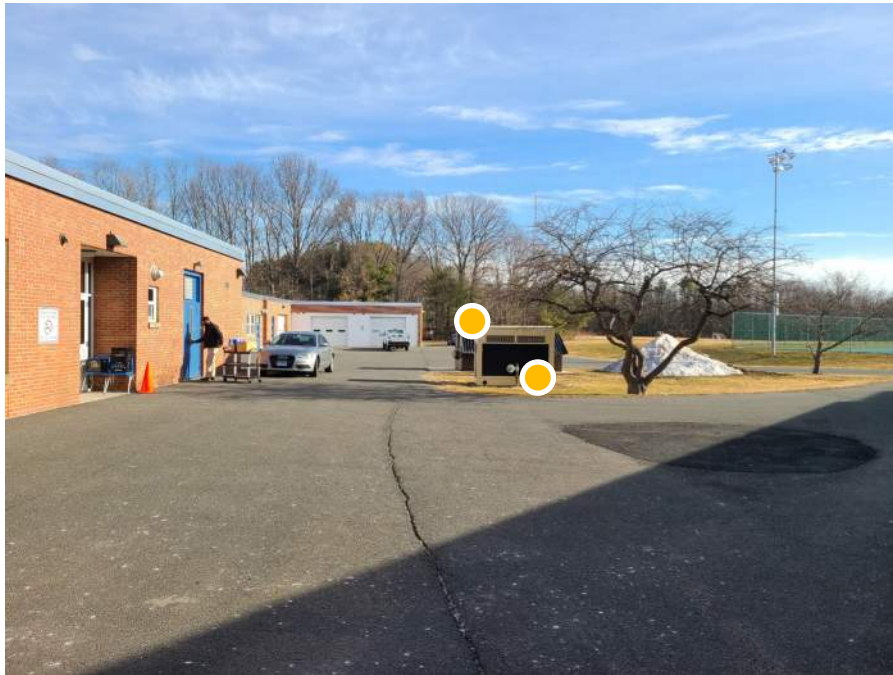
D3. 1: View of dumpster area along with generator, note no protection around ground mounted generator.

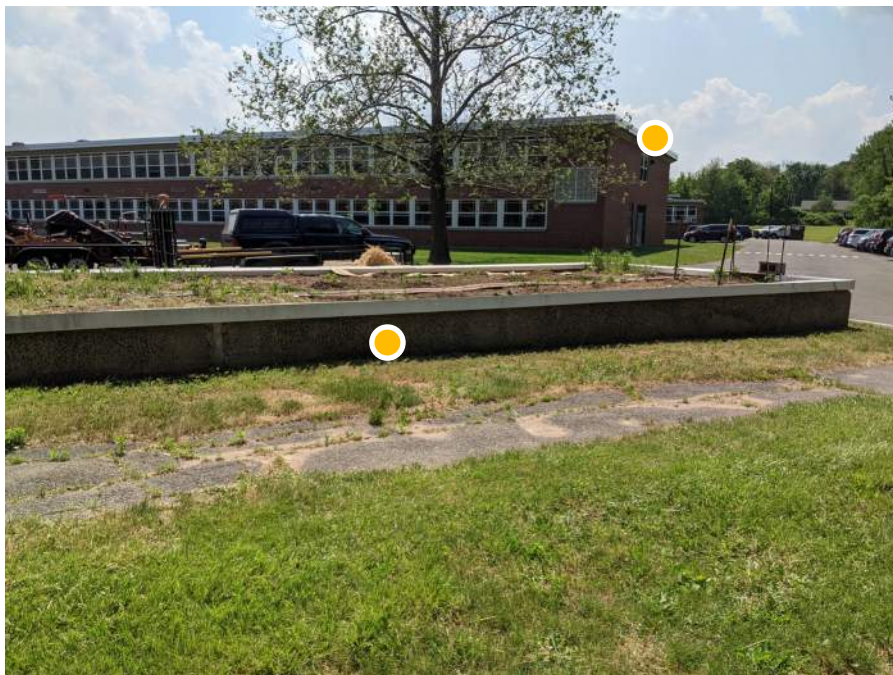
D3. 2: View of former greenhouse foundation wall in foreground, two story classroom wing shown beyond.

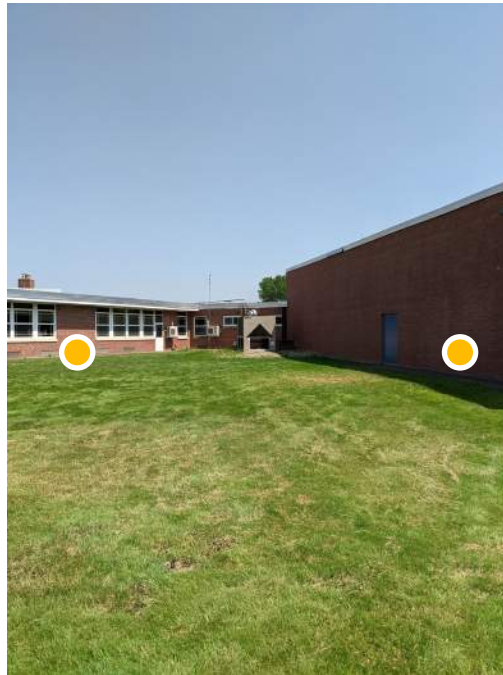
● D3. 3: View of courtyard between existing auditorium and classroom wing.
