**DOTHAN CITY BOE**

**KELLY SPRINGS ELEMENTARY  
SCHOOL  
MANAGEMENT PLAN**

**ASBESTOS-CONTAINING  
MATERIALS**

Updated  
June 2, 2026  
By

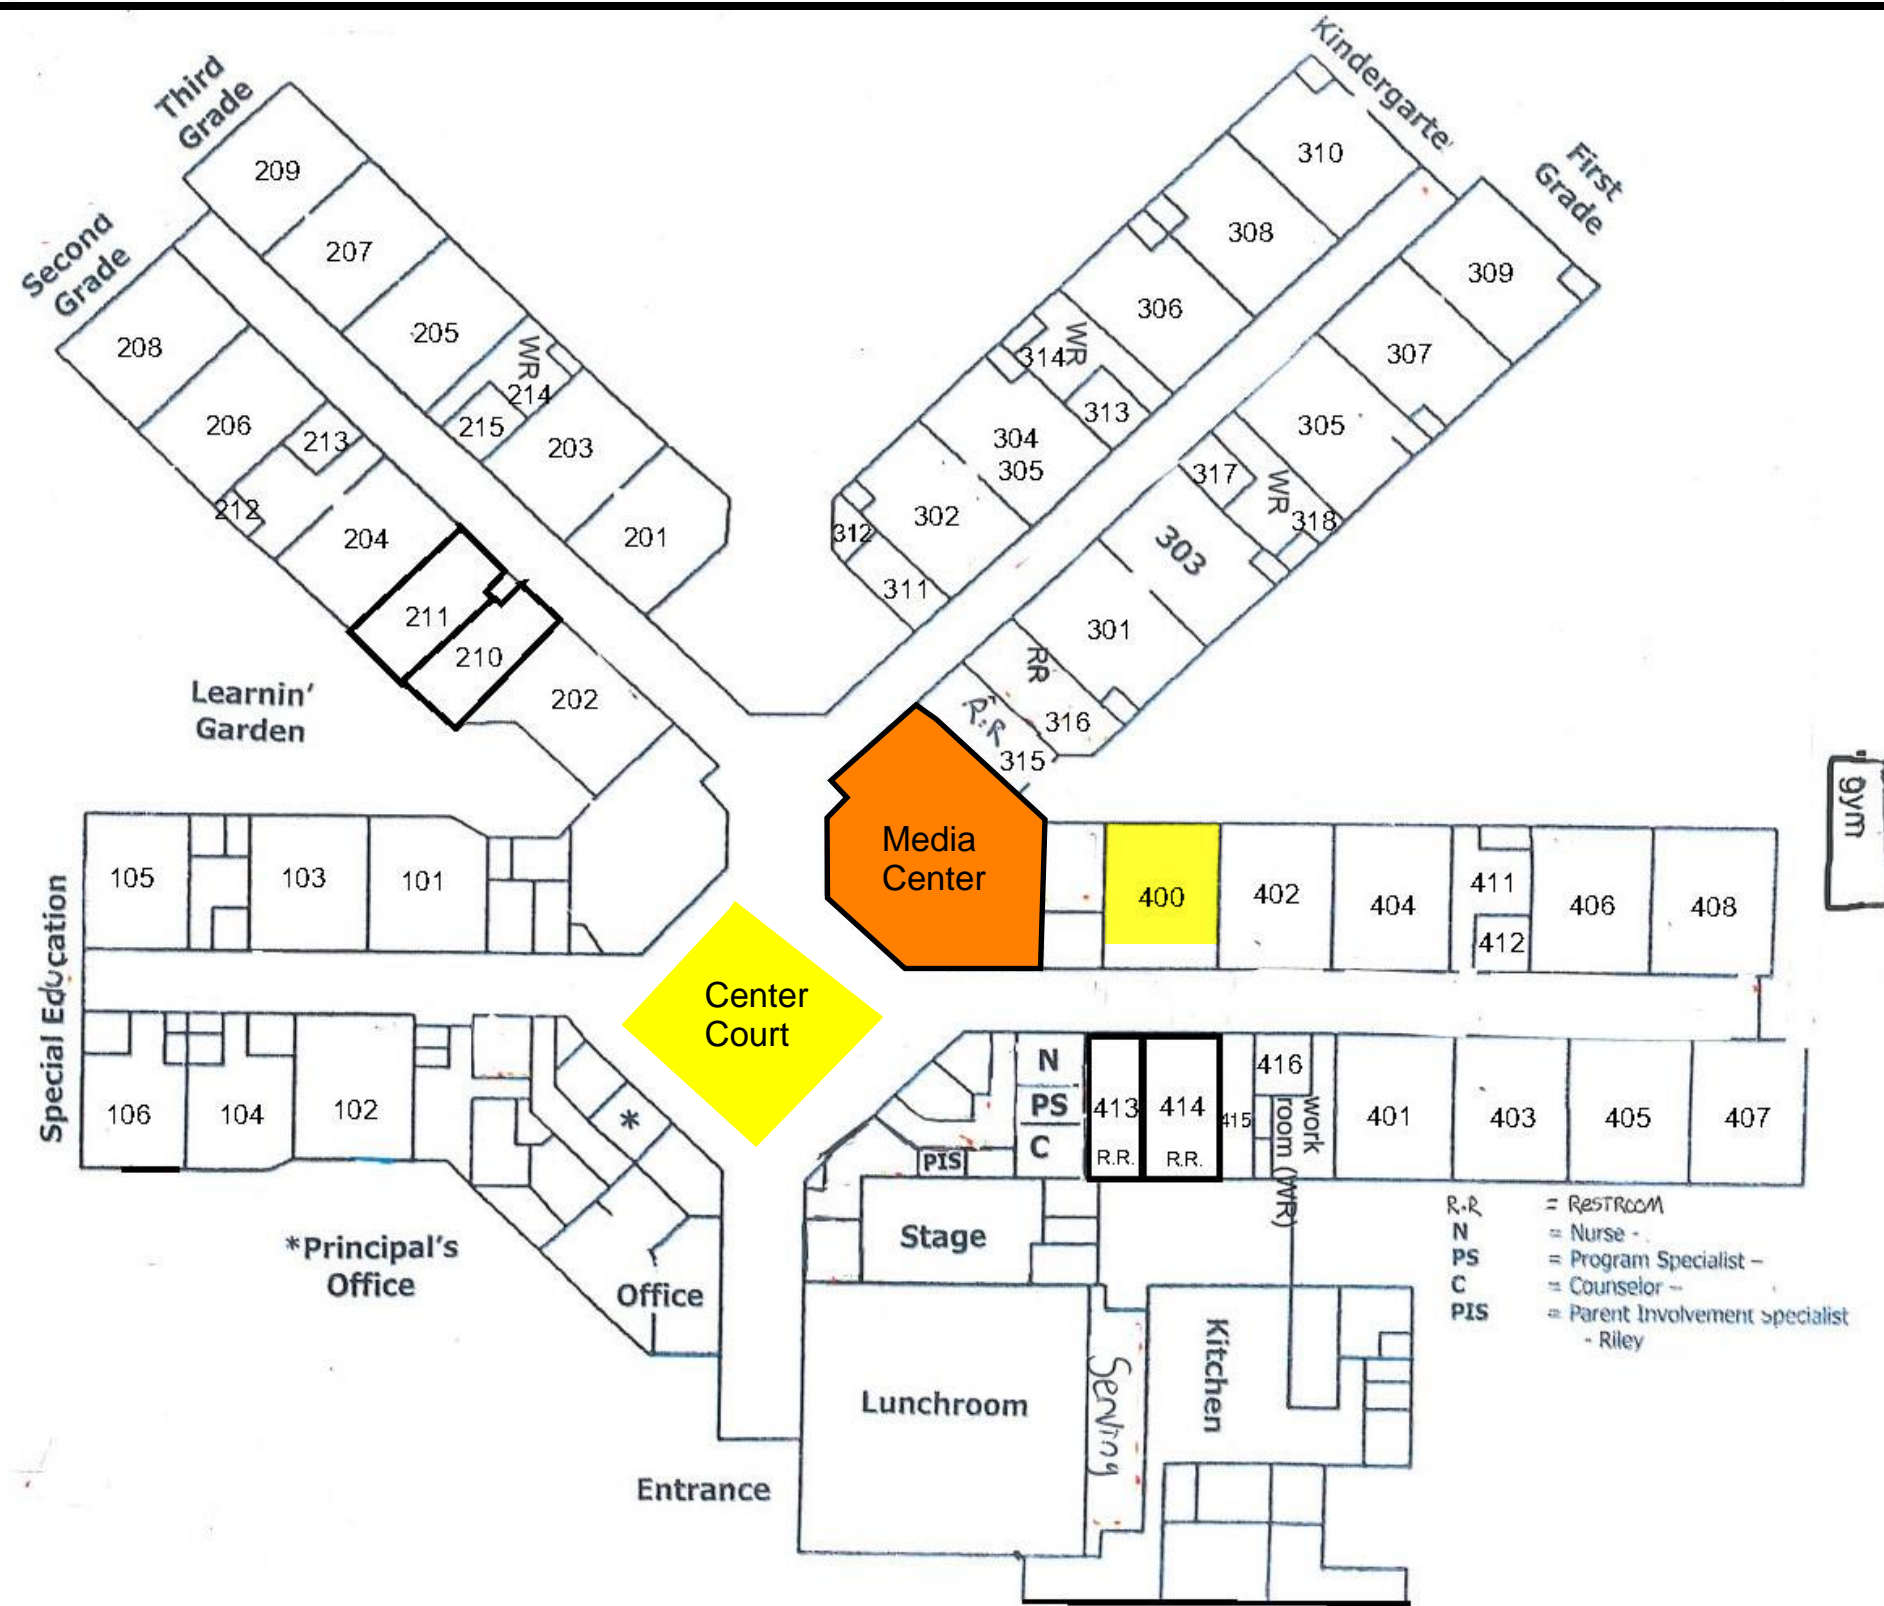
**APPENDIX III**  
**CURRENT 3-YEAR ASBESTOS CONTAINING BUILDING MATERIALS**  
**SITE MAP**

brown LVT observed in the media center is assumed ACBM until testing proves otherwise. This assumed material will be added to the updated site map.

- III. Gray/brown/tan circular pattern carpet was observed in the central common area and computer lab room 400 that was not previously sampled during the 2019 asbestos inspection report. No analytical data is present to confirm this material is non-detect for asbestos. Therefore, the gray/brown/tan circular pattern carpet in the central commons area and room 400 is assumed ACBM until testing proves otherwise. This assumed material will be added to the updated site map.
