# 2025 FACILITY MASTER PLAN REPORT

FACILITY CONDITION / NEEDS ASSESSMENT - LIST & PHOTOS

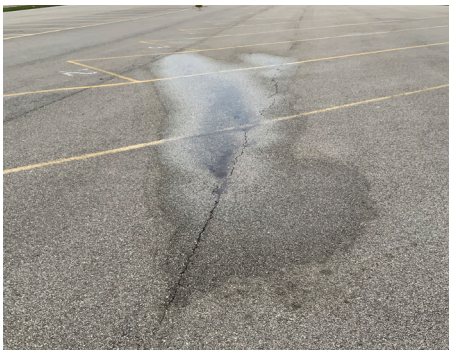
Building Site - Parking Lot

| 1. Building Site, Landscaping etc. | | |
|---|---|---|
| | Parking Lot | The parking lot pavement is generally in good condition, with only a few low spots that could potentially cause issues in the future. These do not require immediate attention. There is minimal cracking observed. |

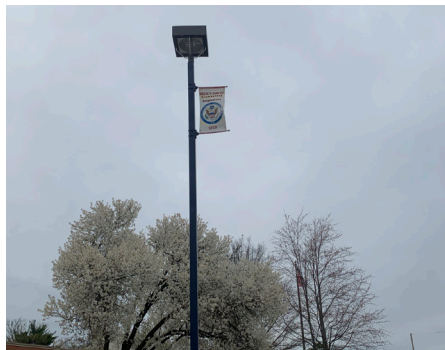
Building Site - Site Lighting

| 1. Building Site, Landscaping etc. | | |
|---|---|---|
| | Site Lighting | Some HID fixtures appeared to be retrofitted with LED bulbs. Would recommend full led fixture replacement for existing pole mounted light fixtures and building mounted light fixtures. |

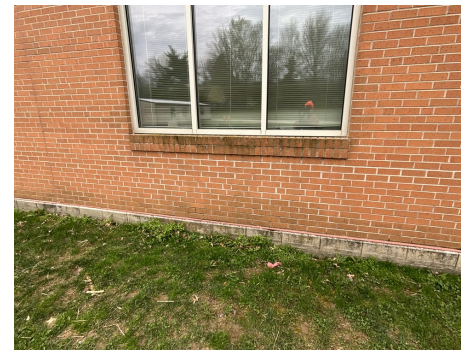
Building Structure / Exterior - Exterior Facade

| 1. Building Site, Landscaping etc. | | |
|---|---|---|
| | Exterior Façade | EIFS around windows is beginning to crack, hairline cracks throughout façade, some localized areas of mortar gaps and degrading brick. Will need to be repaired in 3-5 years. |

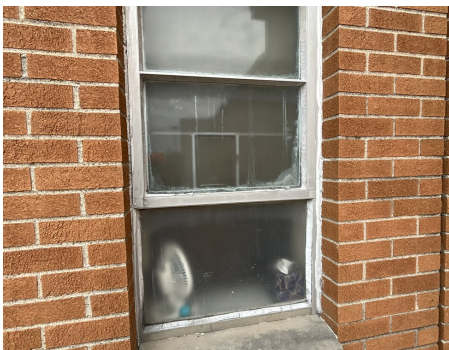
Building Structure / Exterior - Exterior Window

| 1. Building Site, Landscaping etc. | | |
|---|---|---|
| | Exterior Window | Two cases of single pain with deteriorating glazing at the dock that should be replaced. All window sealant besides the new addition, of the media center, is that half-life or worse and should be replaced within the next 3 to 5 years. |

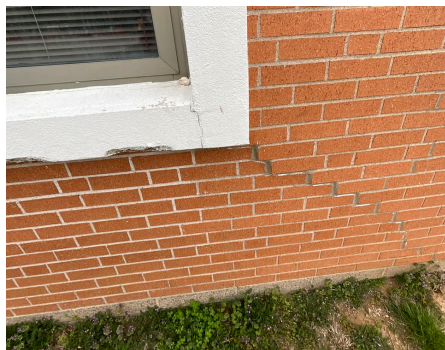
Building Structure / Exterior - Structural System

| 1. Building Site, Landscaping etc. | | |
|---|---|---|
| | Building Structural System | Stair-stepped brick cracking indicates settlement. Appears to have been repaired in past. Tuckpoint new exterior brick cracks. Monitor for future needs. |

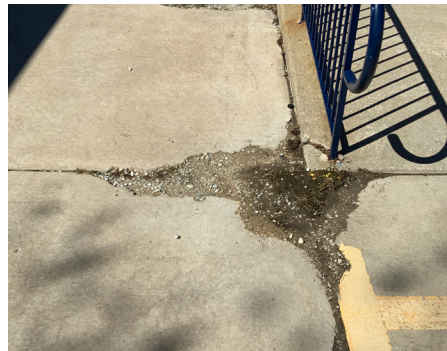
Building Site - Sidewalk

| 1. Building Site, Landscaping etc. | | |
|---|---|---|
| | Sidewalk | Sidewalks are in good shape and need minimal improvements. Area near ADA ramp on east side of building is showing the most damage. |

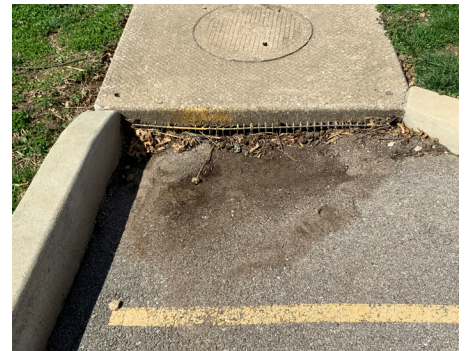
Building Site - Inlets

| 1. Building Site, Landscaping etc. | | |
|---|---|---|
| | Inlets | The inlets are in good condition overall; however, the trench inlet is filled with small rocks and requires cleaning. Additionally, the inlet at the west end of the middle play area also needs to be cleared of debris. |

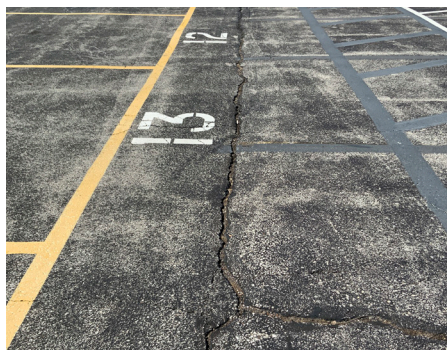
Building Site - Parking Lot

| 1. Building Site, Landscaping etc. | | |
|---|---|---|
| | Parking Lot | Similar to the driveways, parking lot pavement exhibits significant longitudinal and transverse cracking, alligator cracking, and surface weathering, indicating structural fatigue and aging of the pavement. |

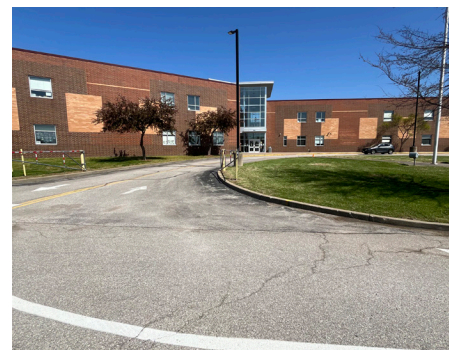
Building Site - Entrances to City ROW

| 1. Building Site, Landscaping etc. | | |
|---|---|---|
| | Entrances to City ROW | Entrance to site is shared with Hollenbeck Middle School and Central Elementary. It is in poor condition and portions will require reconstruction. |

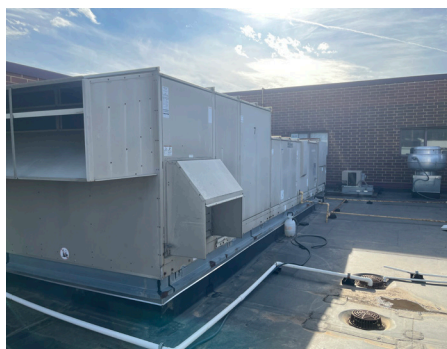
Building Systems - Mechanical Systems

| 1. Building Site, Landscaping etc. | | |
|---|---|---|
| | Mechanical System | Rooftop units are 22 years old. Cafeteria unit is 21 years old. Typical lifespan is 15-20 years. Recommend replacing |

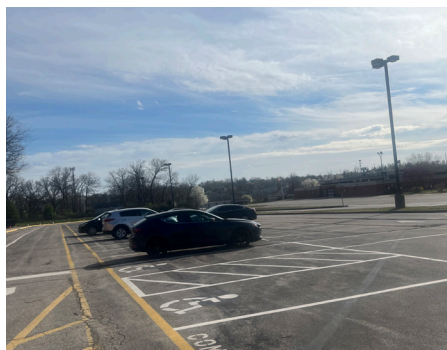
Building Site - Site Lighting

| 1. Building Site, Landscaping etc. | | |
|---|---|---|
| | Site Lighting | Would recommend full led fixture replacement for existing pole mounted light fixtures and building mounted light fixtures with new controls meeting current energy code. |

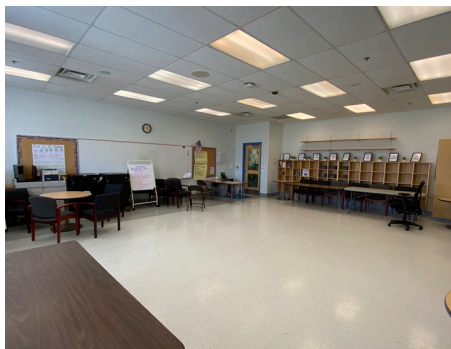
Building Systems - Interior Lighting (Classrooms)

| 1. Building Site, Landscaping etc. | | |
|---|---|---|
| | Interior Lighting - Classrooms | Recommend upgrade to LED. |

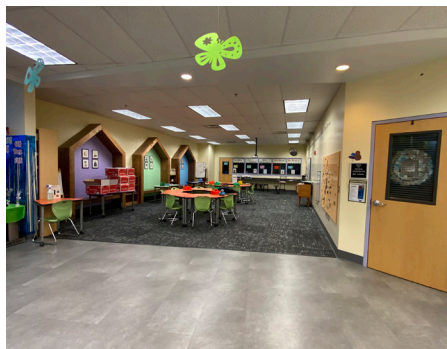
Building Systems - Interior Lighting (Public Areas)

| 1. Building Site, Landscaping etc. | | |
|---|---|---|
| | Interior Lighting - Public areas | Recommend upgrade to LED. |

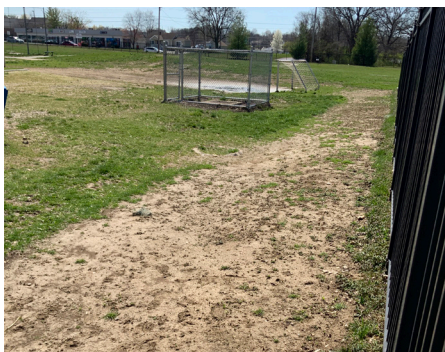
Building Site - Turf Grass

| 1. Building Site, Landscaping etc. | | |
|---|---|---|
| | Turf Grass | Site contains multiple areas where turf grass is either absent or in need of re-seeding. Evidence of previous seeding, such as straw cover, was observed on the north side of the building. While some sparse areas may improve naturally with the changing season, other sections will require additional attention to achieve full cover. |

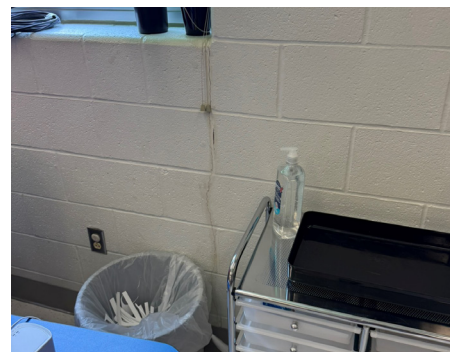
Building Structure / Exterior - Structural System

| 1. Building Site, Landscaping etc. | | |
|---|---|---|
| | Building Structural System | Minor crack in CMU below window in room 301. Route & seal crack. |

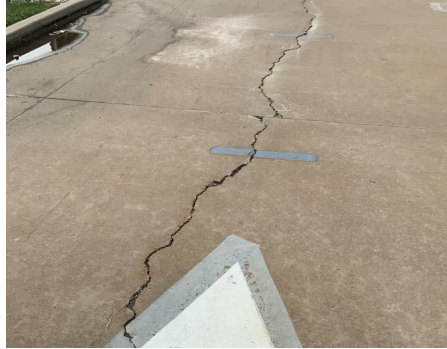
Building Site - Drive Surface

| 1. Building Site, Landscaping etc. | | |
|---|--|---|
| Drive Surface | | Concrete driveway located on the south side of the school is in relatively good condition with only one large crack and low spot identified. The asphalt drive area to the west of the school is in need of repairs. |

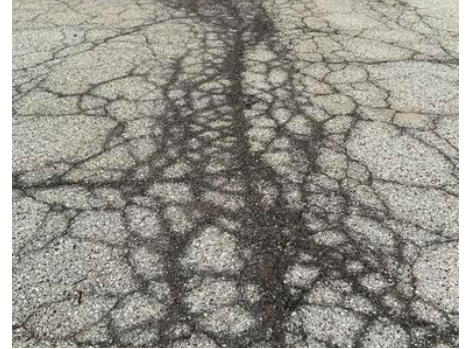
Building Site - Parking Lot

| 1. Building Site, Landscaping etc. | | |
|---|--|---|
| Parking Lot | | Asphalt parking areas located west of the school are in poor condition. Removal and replacement is recommended. The remaining portions should be crack-sealed. |

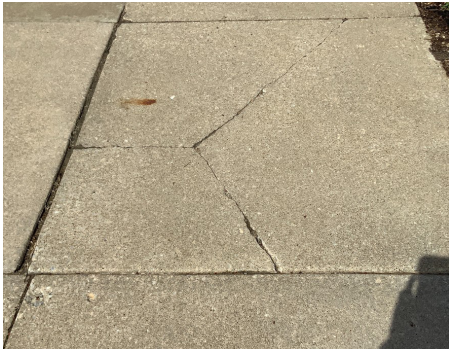
Building Site - Sidewalk

| 1. Building Site, Landscaping etc. | | |
|---|--|---|
| Sidewalk | | Sidewalk conditions across the site are generally good; however, some sections exhibit cracking and deteriorated joints that require repair. The sidewalk on the east side near the play area shows signs of undermining and should be filled to prevent potential collapse. |

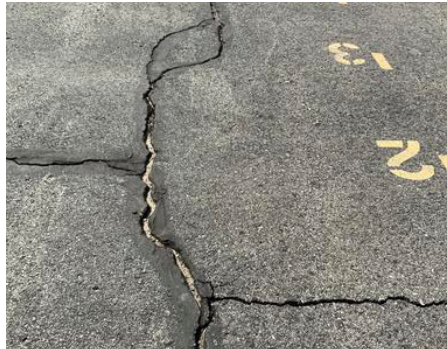
Building Site - Hardscape Play

| 1. Building Site, Landscaping etc. | | |
|---|--|---|
| Hardscape Play | | Playground equipment area is new and in very good condition. Hardscape play area exhibits very large cracks. They appear to have been previously filled but are in need of repair again. It is recommended that these areas be patched and new cracks filled. |

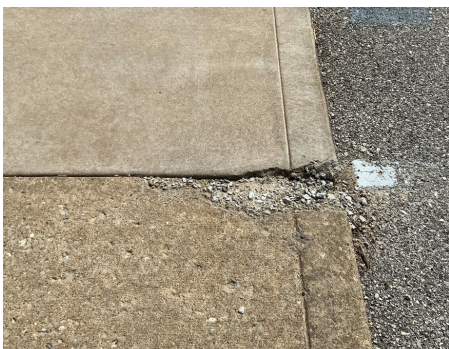
Building Site - Curbs

| 1. Building Site, Landscaping etc. | | |
|---|--|---|
| Curbs | | The concrete curbing is generally in good condition, with the exception of a few areas along the west side where joint deterioration is occurring in alignment with the adjacent sidewalk. The asphalt curbing on the east side of the school near the playground is deteriorating and requires repair. |

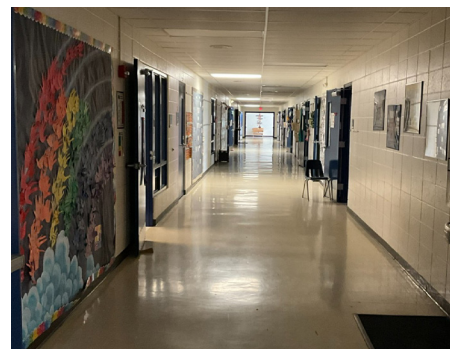
Building Systems - Interior Lighting (Public Areas)

| 1. Building Site, Landscaping etc. | | |
|---|--|---|
| Interior Lighting - Public areas | | Recommend upgrade to LED. |

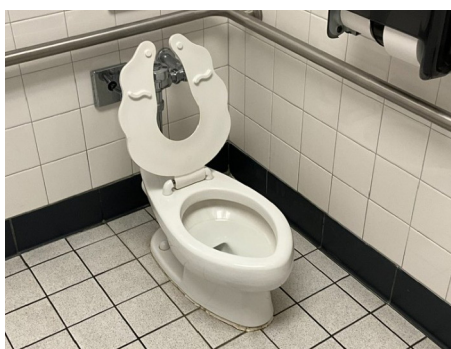
Interior Environment - Plumbing Fixtures

| 1. Building Site, Landscaping etc. | | |
|---|--|---|
| Plumbing Fixtures | | Restroom fixtures are beginning to show age, would recommend replacement in the near future |

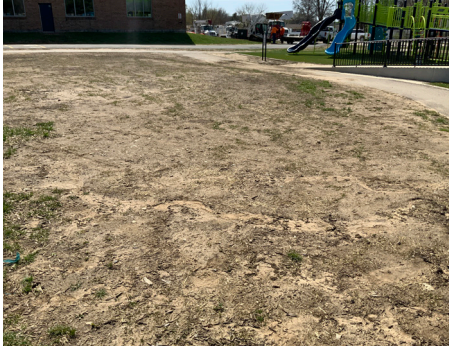
Building Site - Drainage System

| 1. Building Site, Landscaping etc. | | |
|---|---|---|
| | <b>Drainage System</b> | Site drains well, but erosion is occurring in areas of missing turf and areas under construction. |

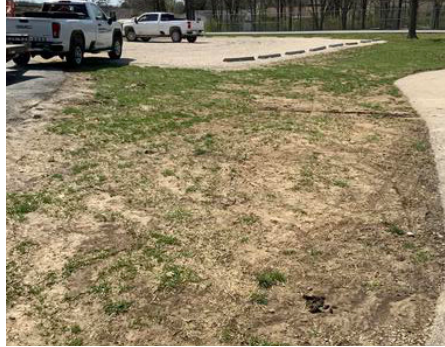
Building Site - Turf Grass

| 1. Building Site, Landscaping etc. | | |
|---|---|---|
| | <b>Turf Grass</b> | The turf surrounding the building is in very poor condition or completely absent in some areas. These sections will require seeding or sodding to restore adequate ground cover. |

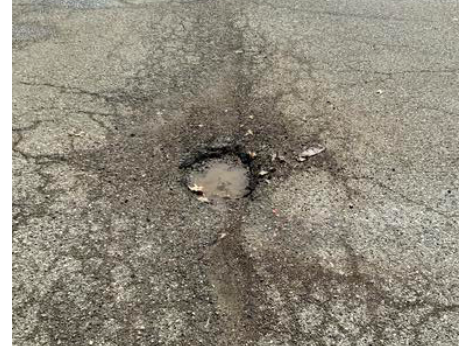
Building Site - Drive Surface

| 1. Building Site, Landscaping etc. | | |
|---|---|---|
| | <b>Drive Surface</b> | Pavement is in poor condition - alligator cracking, potholes, raveling and deteriorated patching were all observed. |

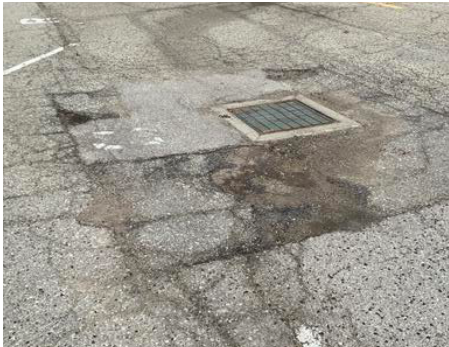
Building Site - Parking Lot

| 1. Building Site, Landscaping etc. | | |
|---|---|---|
| | <b>Parking Lot</b> | Pavement is in poor condition - alligator cracking, potholes, raveling and deteriorated patching were all observed. |

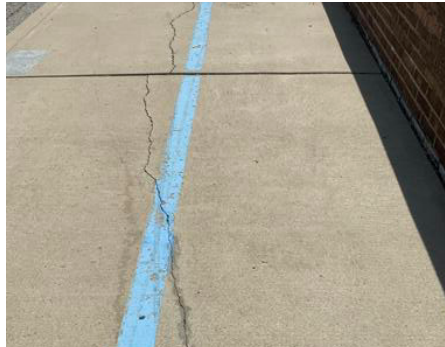
Building Site - Sidewalk

| 1. Building Site, Landscaping etc. | | |
|---|---|---|
| | <b>Sidewalk</b> | The asphalt pathway is showing signs of edge cracking; however, no raveling is present. The Portland cement concrete (PCC) sidewalk along the northeast side of the building is cracked and has been patched with asphalt. Cracking is also observed in other areas, though these do not currently require immediate maintenance. |

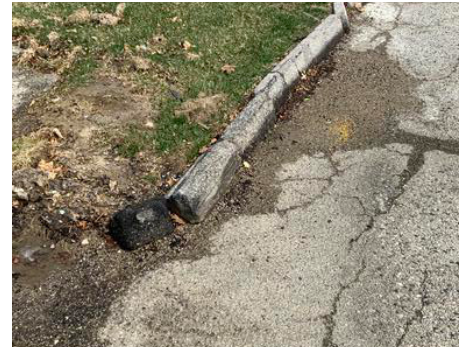
Building Site - Curbs

| 1. Building Site, Landscaping etc. | | |
|---|---|---|
| | <b>Curbs</b> | PCC curbs are in generally good condition with a few areas of chipping; however, asphalt curbs throughout the site are deteriorated and need to be replaced. |

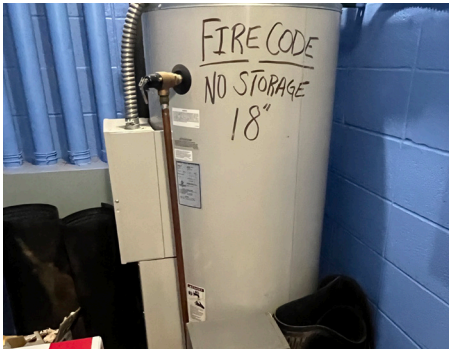
Building Systems - Water Heaters

| 1. Building Site, Landscaping etc. | | |
|---|---|---|
| | <b>Water Heaters</b> | Water heaters are 20 years old. Typical lifespan is 10-15 years. Recommend replacing |

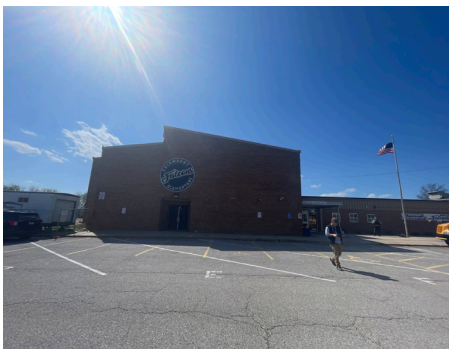
Building Site - Site Lighting

| 1. Building Site, Landscaping etc. | | |
|---|---|---|
| | <b>Site Lighting</b> | Majority of parking lot does not have light fixture coverage. Would recommend additional pole mounted LED light fixtures surrounding parking lot. |

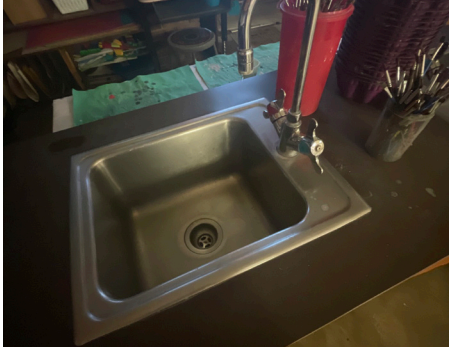
Building Systems - Plumbing Fixtures (Classrooms)

| 1. Building Site, Landscaping etc. | | |
|---|---|---|
| | <b>Plumbing Fixtures - Classroom</b> | Classroom sinks are older, stainless steel undermount sink and lacking thermostatic mixing valves and trap guards. |

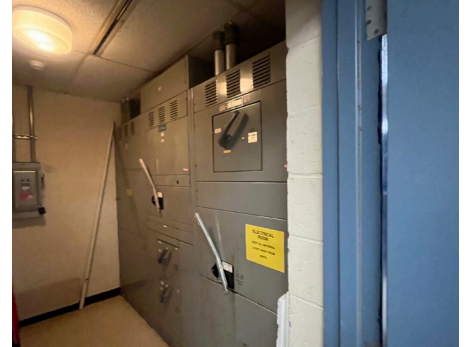
Building Systems - Main Electrical Service

| 1. Building Site, Landscaping etc. | | |
|---|---|---|
| | <b>Main Electrical Service</b> | No additional capacity in main switchboard. Existing gear will not be able to be expanded for future additional needs. Existing gear is old and utilizes fuse buckets, which are difficult to replace if needed. Existing gear appears to be operational. While on site it appeared that some electrical work was being done on existing services. |

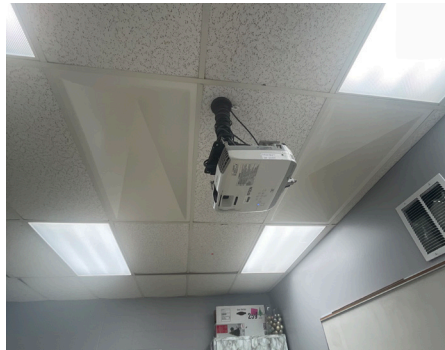
Building Systems - Interior Lighting (Classrooms)

| 1. Building Site, Landscaping etc. | | |
|---|---|---|
| | <b>Interior Lighting - Classrooms</b> | Recommend upgrade to LED |

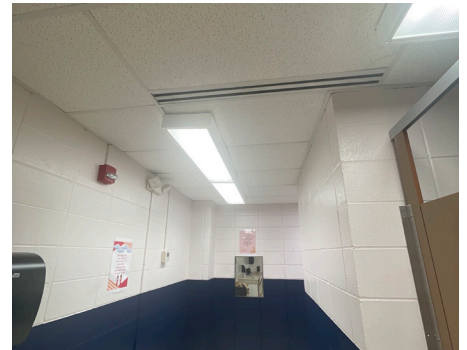
Building Systems - Interior Lighting (Public Areas)

| 1. Building Site, Landscaping etc. | | |
|---|---|---|
| | <b>Interior Lighting - Public areas</b> | Recommend upgrade to LED |

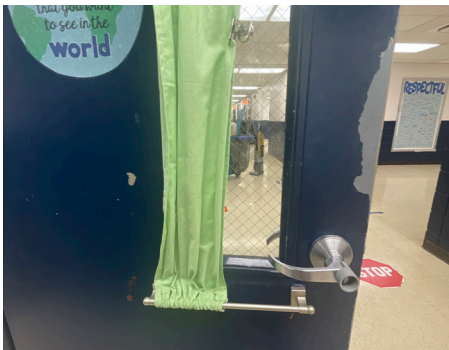
Interior Environments - Interior Doors

| 1. Building Site, Landscaping etc. | | |
|---|---|---|
| | <b>Interior Door</b> | Doors have general wear and tear, chipping of paint on frames and minimal damage to doors. Recommend full door replacement in the future |

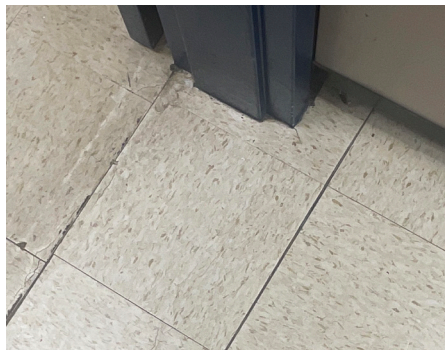
Interior Environments - Flooring

| 1. Building Site, Landscaping etc. | | |
|---|---|---|
| | <b>Flooring</b> | Floor is generally in fine condition, is beginning to age with some bubbling, scuffs and wear. Recommend replacement in the future |

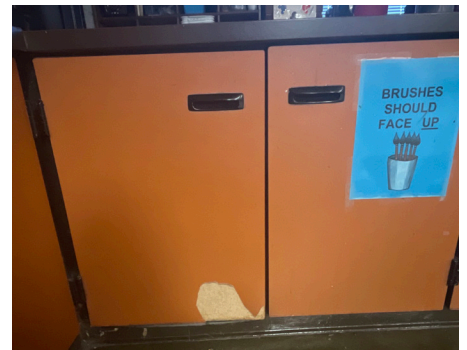
Interior Environments - Casework

| 1. Building Site, Landscaping etc. | | |
|---|---|---|
| | <b>Casework</b> | Casework is in fine condition, just older so would possibly need replacement in the future |

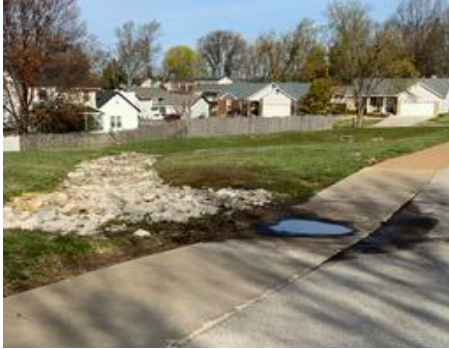
Building Site - Drainage System

| 1. Building Site, Landscaping etc. | | |
|---|---|---|
| | <b>Drainage System</b> | The site has sufficient storm sewer outlets; however, several areas of erosion require attention. Ponding was observed in low-lying sections, particularly where stormwater is directed toward the ball field on the east side of the school. |

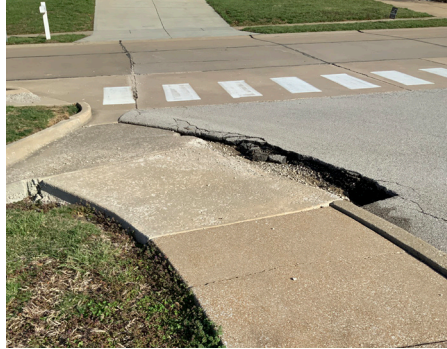
Building Site - Drive Surface

| 1. Building Site, Landscaping etc. | | |
|---|---|---|
| | <b>Drive Surface</b> | Asphalt at entrance drive needs repair. |

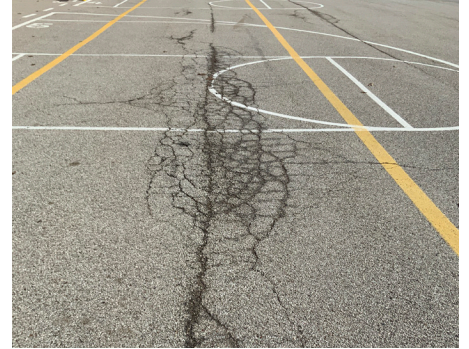
Building Site - Parking Lot

| 1. Building Site, Landscaping etc. | | |
|---|---|---|
| | <b>Parking Lot</b> | Several areas require asphalt patching to address surface deterioration, and routine crack sealing is recommended to prevent water infiltration and extend the pavement's lifespan. |

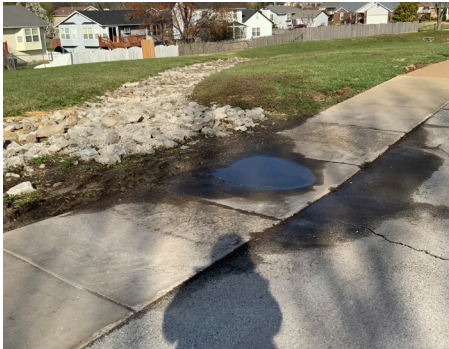
Building Site - Sidewalk

| 1. Building Site, Landscaping etc. | | |
|---|---|---|
| | <b>Sidewalk</b> | The walkways are generally in good condition, with the exception of the west side, where a drainage issue is present, and the entrance area, where the pavement has deteriorated and requires repair. |

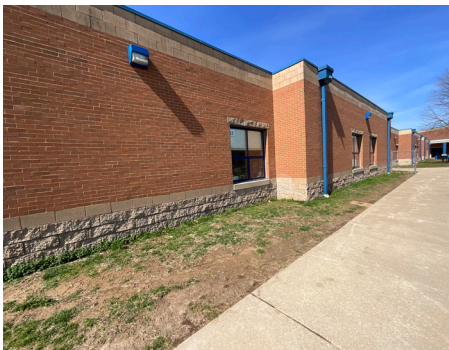
Building Site - Site Lighting

| 1. Building Site, Landscaping etc. | | |
|---|---|---|
| | <b>Site Lighting</b> | Would recommend full led fixture replacement for existing pole mounted light fixtures and building mounted light fixtures with new controls meeting current energy code and to achieve better parking lot illumination. |

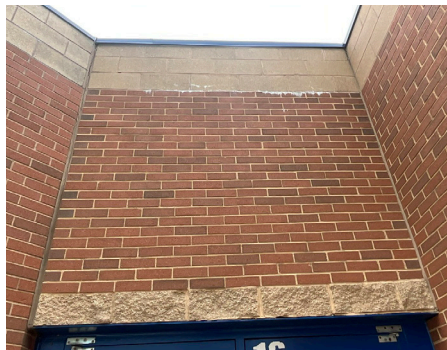
Building Structure / Exterior - Exterior Facade

| 1. Building Site, Landscaping etc. | | |
|---|---|---|
| | <b>Exterior Façade</b> | There are a few minor cases of efflorescence and areas that need to be repointed, but the majority of the brick itself is in fair shape. However, there are many cracks need to be repaired. |

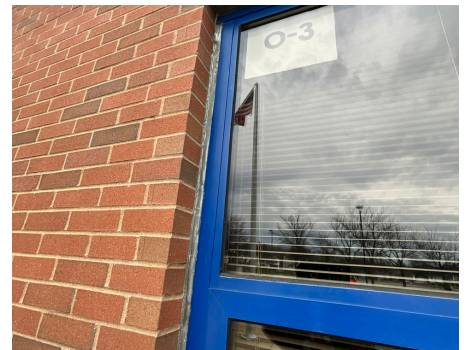
Building Structure / Exterior - Exterior Window

| 1. Building Site, Landscaping etc. | | |
|---|---|---|
| | <b>Exterior Window</b> | The vast majority of the window sealant is in poor and failing condition. Few areas have been repaired incorrectly with clear silicone instead of proper window sealant. |

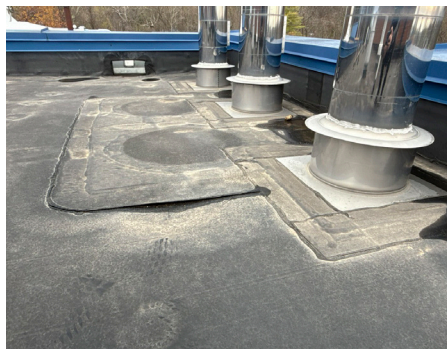
Building Structure / Exterior - Roof

| 1. Building Site, Landscaping etc. | | |
|---|---|---|
| | <b>Roof</b> | Generally speaking, the roof is in good condition except for some ponding, minor mole runs, and repairs needed in the membrane itself. The blue metal seam roofing has lots of sealant and is showing as though there may be issues to be addressed in the near future. |

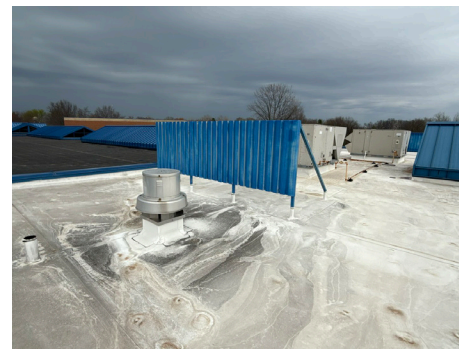
Building Structure / Exterior - Roof Screen

| 1. Building Site, Landscaping etc. | | |
|---|---|---|
| | <b>Roof Screen</b> | Repaint of roof screen is recommended in the near future |

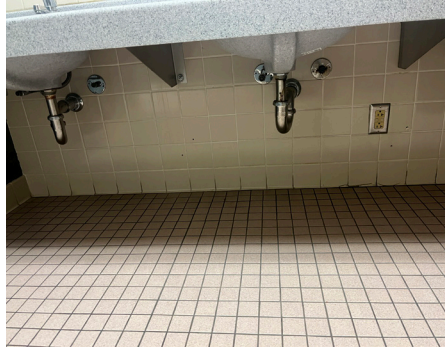
Building Systems - Plumbing Fixtures (Restroom)

| 1. Building Site, Landscaping etc. | | |
|---|---|---|
| | <b>Plumbing Fixtures - Restroom</b> | Fixtures look worn but still functional. Restroom lavatories are lacking trap guards and thermostatic mixing valves. |

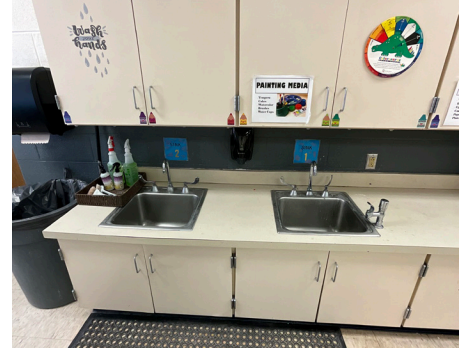
Building Systems - Plumbing Fixtures (Classroom)

| 1. Building Site, Landscaping etc. | | |
|---|---|---|
| | <b>Plumbing Fixtures - Classroom</b> | Fixtures look worn but still functional. |

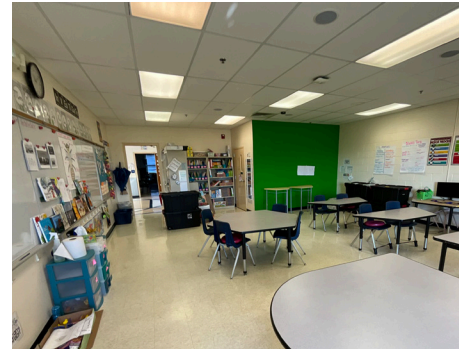
Building Systems - Interior Lighting (Classrooms)

| 1. Building Site, Landscaping etc. | | |
|---|---|---|
| | <b>Interior Lighting - Classrooms</b> | Recommend upgrade to LED |

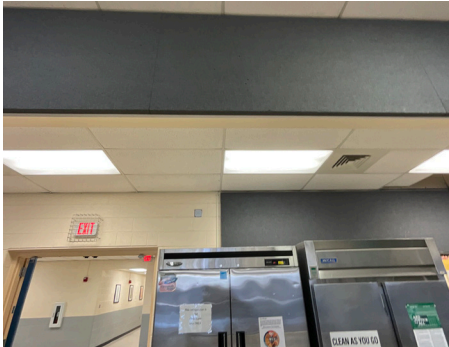
Building Systems - Interior Lighting (Public Areas)

| 1. Building Site, Landscaping etc. | | |
|---|---|---|
| | <b>Interior Lighting - Public areas</b> | Recommend upgrade to LED |

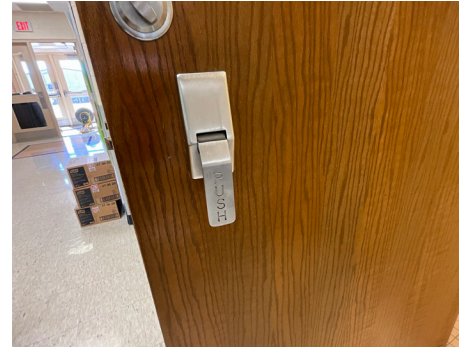
Interior Environment - Interior Doors

| 1. Building Site, Landscaping etc. | | |
|---|---|---|
| | <b>Interior Door</b> | Doors have general wear and tear, chipping of paint on frames and minimal damage to doors. Recommend full door replacement in the future |

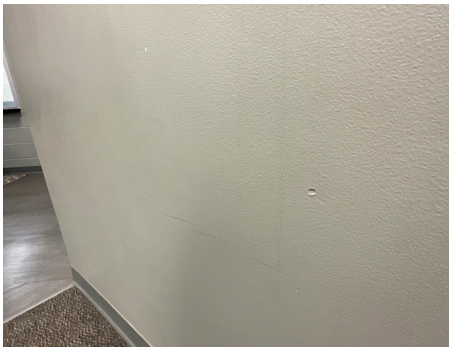
Interior Environment - Interior Walls

| 1. Building Site, Landscaping etc. | | |
|---|---|---|
| | <b>Interior Wall</b> | Overall walls are in fine condition, general wear and tear is occurring, would recommend painting in the future |

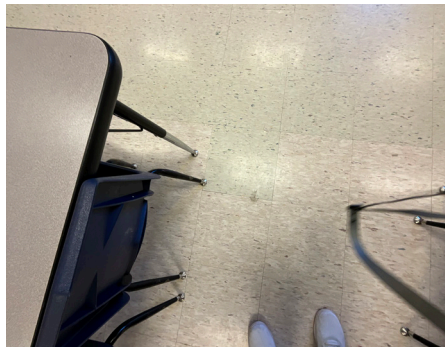
Interior Environment - Flooring

| 1. Building Site, Landscaping etc. | | |
|---|---|---|
| | <b>Flooring</b> | Floor has general wear and tear, scuffing, staining, but is in fine condition. Recommend full floor replacement in the future |

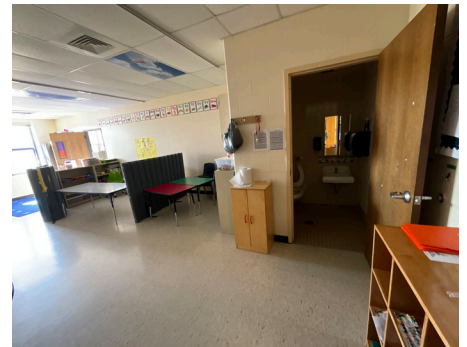
Interior Environment - Ceiling

| 1. Building Site, Landscaping etc. | | |
|---|---|---|
| | <b>Ceiling</b> | Media Center and cafeteria have staining/wear and tear, would recommend replacement in future |

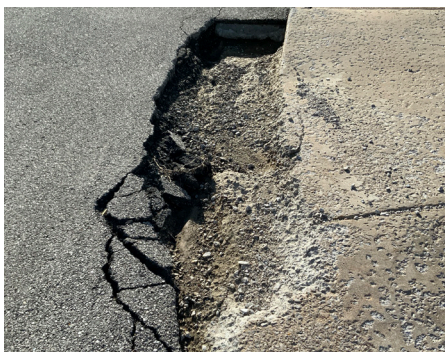
Building Site - Entrances to City ROW

| 1. Building Site, Landscaping etc. | | |
|---|---|---|
| | <b>Entrances to City ROW</b> | The pavement at the right-of-way entrance requires repair, as it is also impacting the adjacent sidewalk in this area. |

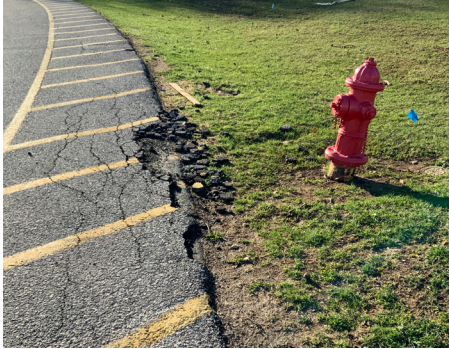
Building Site - Drive Surface

| 1. Building Site, Landscaping etc. | | |
|---|---|---|
| | Drive Surface | The driveway is experiencing spalling along the edges due to the lack of curbs. |

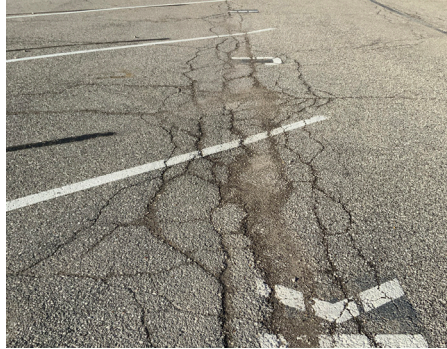
Building Site - Parking Lot

| 1. Building Site, Landscaping etc. | | |
|---|---|---|
| | Parking Lot | The parking lot displays several areas of alligator (fatigue) cracking and block cracking, along with visible signs of weathering on the pavement. |

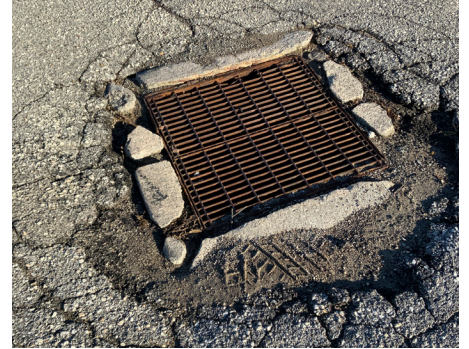
Building Site - Inlets

| 1. Building Site, Landscaping etc. | | |
|---|---|---|
| | Inlets | Most inlets on the site are in good condition, with the exception of those located within the drive aisles. These inlets should be reset in conjunction with any planned pavement improvements. |

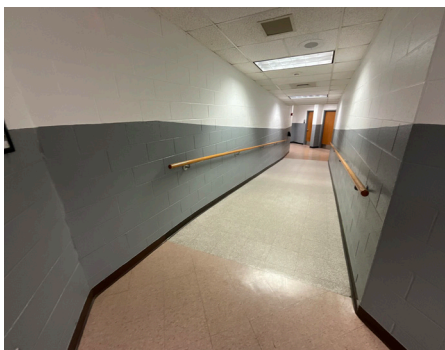
Building Systems - Interior Lighting (Public Areas)

| 1. Building Site, Landscaping etc. | | |
|---|---|---|
| | Interior Lighting - Public areas | Recommend upgrade remainder of fluorescent fixtures to LED. |

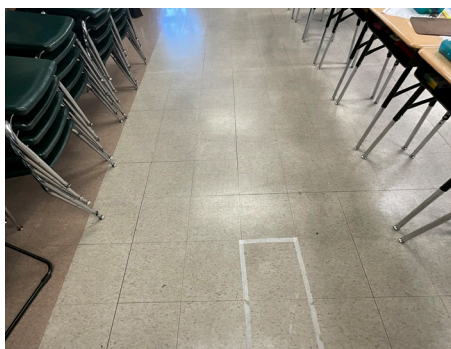
Interior Environment - Flooring

| 1. Building Site, Landscaping etc. | | |
|---|---|---|
| | Flooring | Floor is generally in fine condition, is beginning to age with some bubbling, scuffs and wear. Recommend replacement in the future |

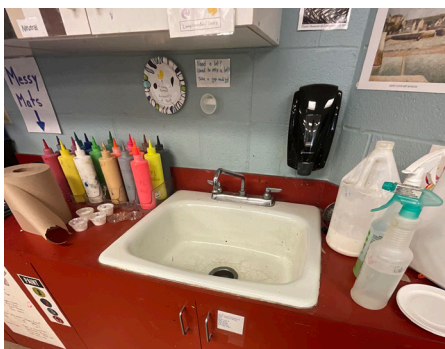
Interior Environment - Casework

| 1. Building Site, Landscaping etc. | | |
|---|---|---|
| | Casework | Special rooms like Art and Music have casework that is functional but worn, recommend replacement in the future |

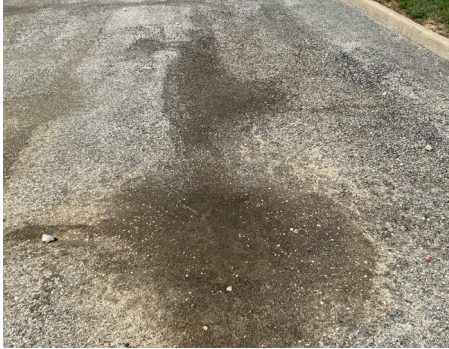
Building Site - Drive Surface

| 1. Building Site, Landscaping etc. | | |
|---|---|---|
| | Drive Surface | Driveways exhibit significant cracking and weathering. |

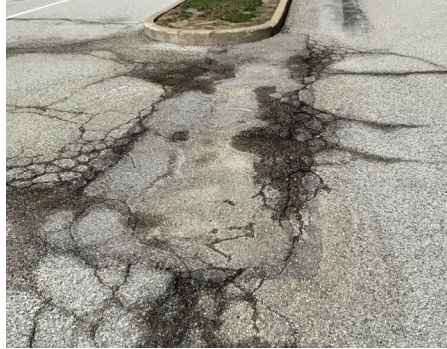
Building Site - Parking Lot

| 1. Building Site, Landscaping etc. | | |
|---|---|---|
| | Parking Lot | Parking lot is in generally poor condition. Longitudinal and transverse cracking, fatigue cracking and weathering. |

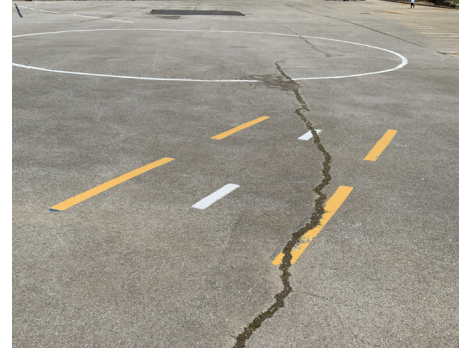
Building Site - Hardscape Play

| 1. Building Site, Landscaping etc. | | |
|---|---|---|
| | Hardscape Play | The playground equipment areas are in excellent condition and have been recently updated. In contrast, the hardscape play areas show signs of deterioration similar to those observed in the driveway and parking areas and are in need of maintenance. |

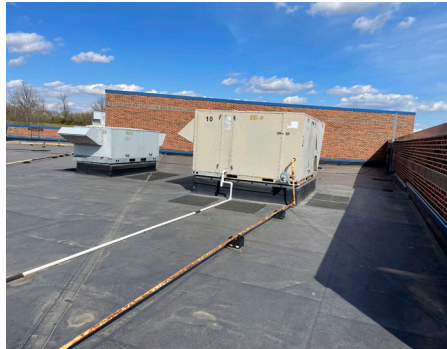
Building Systems - Mechanical System

| 1. Building Site, Landscaping etc. | | |
|---|---|---|
| | Mechanical System | Rooftop units are 27 years old. Typical lifespan is 10-15 years. Terminal units are 27 years old. Heat Recovery units are 27 years old. Typical lifespan is 10-15 years. Mechanical equipment replacement planned. |

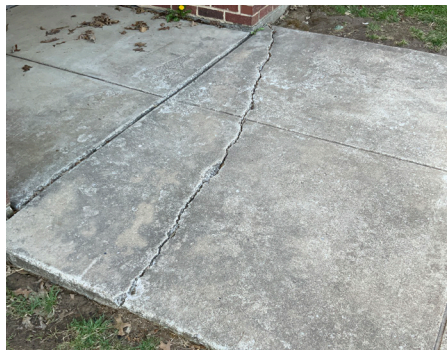
Building Site - Sidewalks

| 1. Building Site, Landscaping etc. | | |
|---|---|---|
| | Sidewalk | The sidewalks are in generally good condition, with some isolated cracking observed; however, no immediate repairs are necessary at this time. |

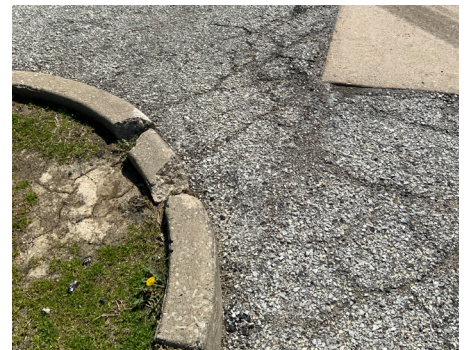
Building Site - Curbs

| 1. Building Site, Landscaping etc. | | |
|---|---|---|
| | Curbs | The concrete curbs are generally in good condition, with some sections exhibiting cracking and chipping. While immediate repairs are not necessary, deteriorated sections should be replaced in conjunction with future pavement work. |

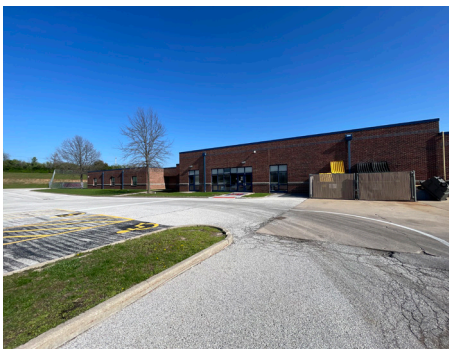
Building Site - Entrances to City ROW

| 1. Building Site, Landscaping etc. | | |
|---|---|---|
| | Entrances to City ROW | Pavement in ROW at entrance is currently in good condition but cracking. No prompt action needed. |

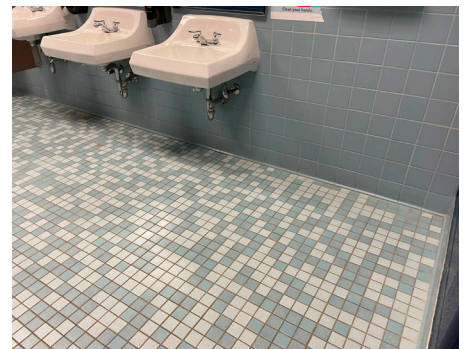
Building Systems - Plumbing Fixtures (Restrooms)

| 1. Building Site, Landscaping etc. | | |
|---|---|---|
| | Plumbing Fixtures - Restroom | Fixtures appear worn; some discoloration, slight surface defects. Restroom lavatories lack trap guards and thermostatic mixing valves. |

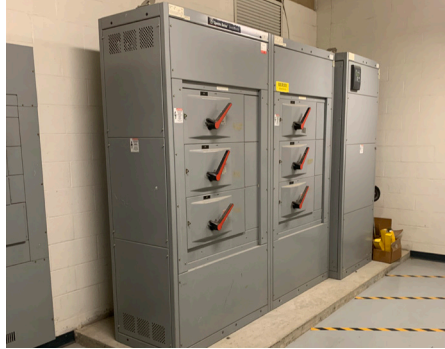
Building Systems - Main Electrical Service

| 1. Building Site, Landscaping etc. | | |
|---|---|---|
| | Main Electrical Service | No additional capacity in main switchboard. Existing gear will not be able to be expanded for future additional needs. Existing gear utilizes fuse buckets, which are difficult to replace if needed. No main disconnect observed serving the electric service entrance and switchboard appears to be at the maximum 6 service disconnects. |

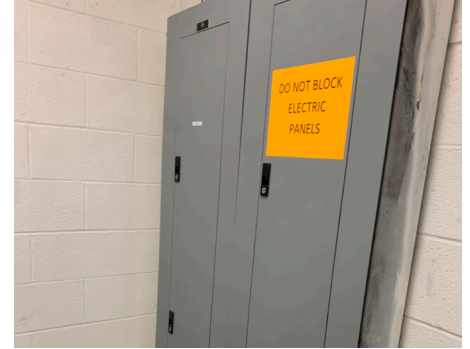
Building Systems - Panelboards

| 1. Building Site, Landscaping etc. | | |
|---|---|---|
| | Panelboards | Existing panelboards appear to have average level of additional capacity. Existing panels appear to be in a good working condition. |

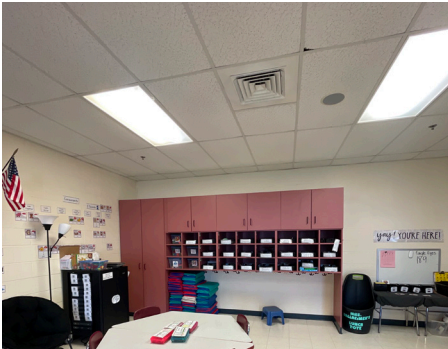
Building Systems - Interior Lighting (Classrooms)

| 1. Building Site, Landscaping etc. | | |
|---|---|---|
| | Interior Lighting - Classrooms | Recommend upgrade to LED fixtures. |

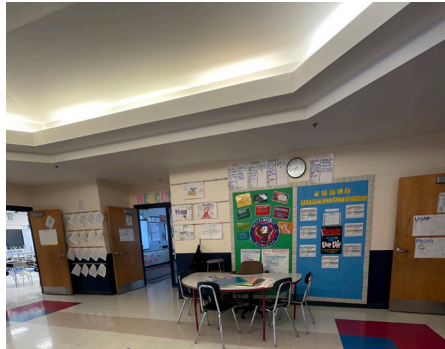
Building Systems - Interior Lighting (Public Areas)

| 1. Building Site, Landscaping etc. | | |
|---|---|---|
| | Interior Lighting - Public areas | Recommend upgrade to LED fixtures. |

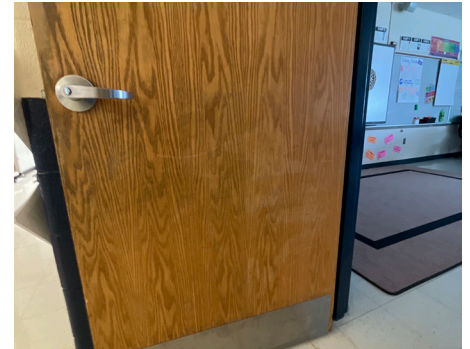
Interior Environment - Interior Doors

| 1. Building Site, Landscaping etc. | | |
|---|---|---|
| | Interior Door | Doors have general wear and tear, chipping of paint on frames and minimal damage to doors. Recommend full door replacement in the future |

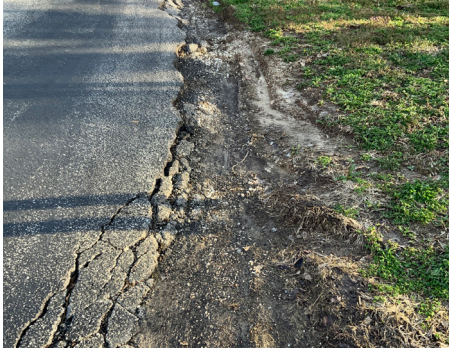
Building Site - Drive Surface

| 1. Building Site, Landscaping etc. | | |
|---|--|---|
| Drive Surface | | Driveway pavement exhibits longitudinal and transverse cracking and weathering. Severe edge cracking was observed in several locations. |

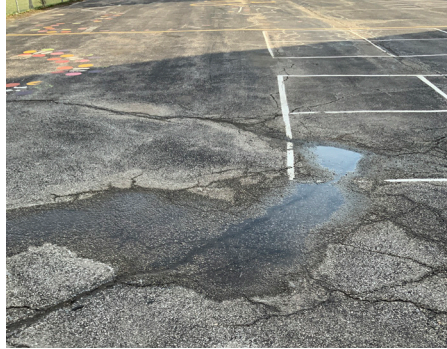
Building Site - Parking Lot

| 1. Building Site, Landscaping etc. | | |
|---|--|---|
| Parking Lot | | Similar to driveways, parking lots have longitudinal and transverse cracking, weathering and some block and fatigue cracking. |

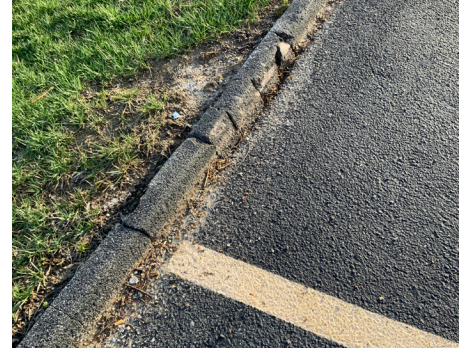
Building Site - Curbs

| 1. Building Site, Landscaping etc. | | |
|---|--|---|
| Curbs | | The asphalt curbing is in poor condition and requires removal and replacement. While the concrete curbing is generally in better condition, the flag/gutter section at the front entrance should be replaced. |

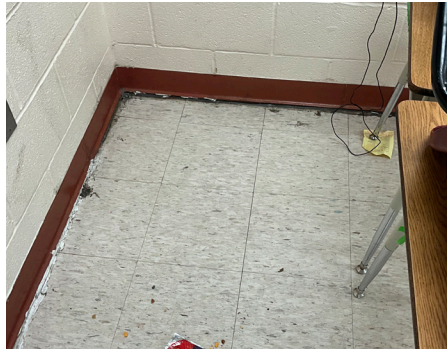
Interior Environment - Flooring

| 1. Building Site, Landscaping etc. | | |
|---|--|---|
| Flooring | | Flooring as a whole is in fine condition, some areas have some cracking/slab concerns that needs to be repaired |

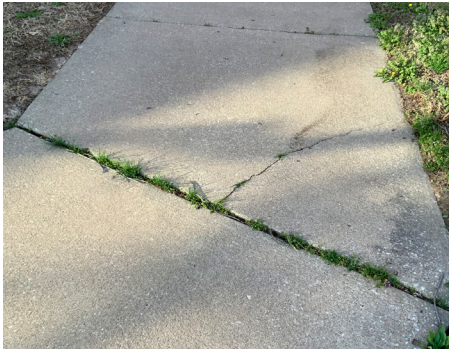
Building Site - Sidewalk

| 1. Building Site, Landscaping etc. | | |
|---|--|---|
| Sidewalk | | The concrete sidewalks are in good condition with the exception of a few panels that have edge cracking; however, the asphalt walkways exhibit significant edge cracking and are likely to deteriorate further if not addressed in a timely manner. |

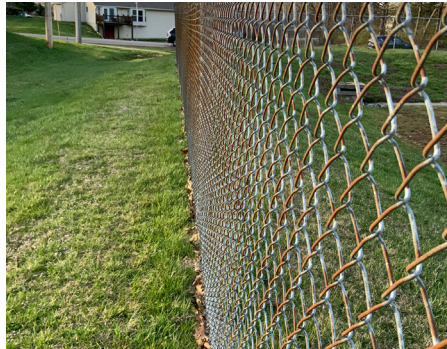
Building Site - Fencing

| 1. Building Site, Landscaping etc. | | |
|---|--|---|
| Fencing | | Chain link fencing is in good condition. Fencing around the detention basins is showing signs of rust, but not in prompt need of repair. |

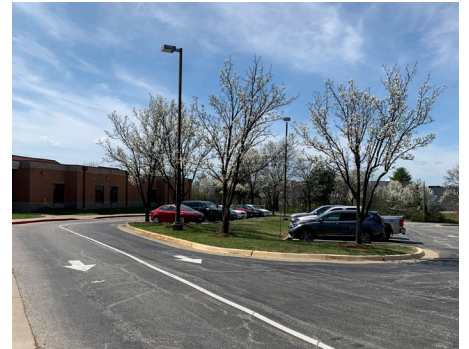
Building Site - Site Lighting

| 1. Building Site, Landscaping etc. | | |
|---|--|---|
| Site Lighting | | Pole locations appear to be adequate at main parking area. Would recommend LED head replacements and control upgrades to meet energy code compliance and improve night time illumination. There also appears to be adequate building mounted light locations, would recommend an LED fixture replacement. |

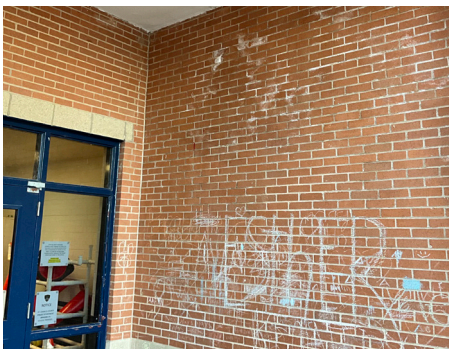
Building Structure / Exterior - Exterior Facade

| 1. Building Site, Landscaping etc. | | |
|---|--|---|
| Exterior Façade | | Building shows signs of past repair throughout, joints show cracking/have completely separated, some areas of efflorescence/water damage, could use a good clean in general. |

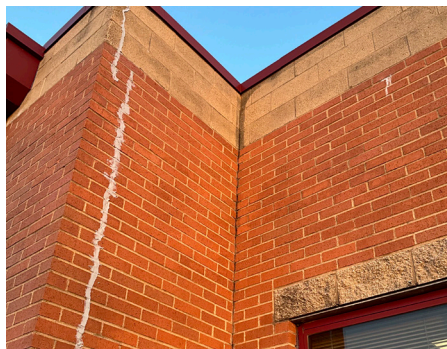
Building Structure / Exterior - Structural System

| 1. Building Site, Landscaping etc. | | |
|---|--|---|
| Building Structural System | | North wall of gym may be settling. Re-seal cracks and gym and monitor. Wide-spread slab settlement without significant impacts on load bearing elements. Consider poly-jacking floor to level in future. |

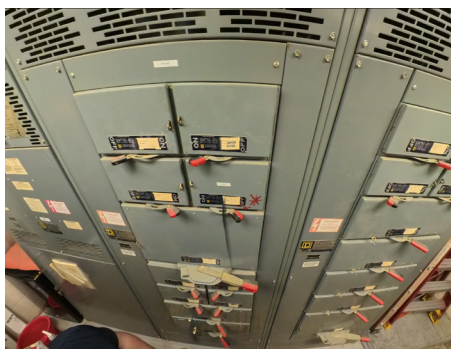
Building Systems - Main Electrical Service

| 1. Building Site, Landscaping etc. | | |
|---|--|---|
| Main Electrical Service | | Switchboard will need to be upgraded if any future projects require additional panels to be fed from service. Service appears to be in good operational condition. Fuse buckets are used for overcurrent protection. |

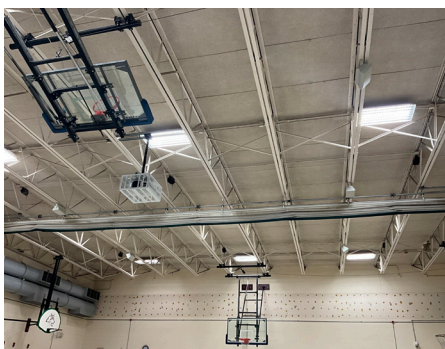
Building Systems - Interior Lighting (Public Areas)

| 1. Building Site, Landscaping etc. | | |
|---|--|---|
| Interior Lighting - Public areas | | Recommend upgrade to LED. |

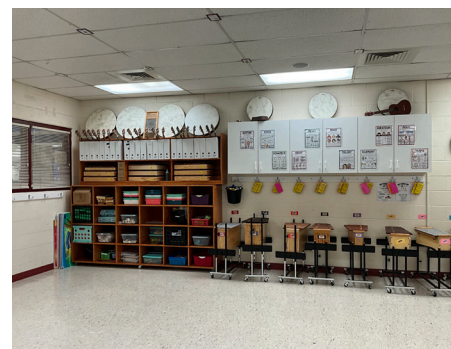
Building Systems - Interior Lighting (Classrooms)

| 1. Building Site, Landscaping etc. | | |
|---|--|---|
| Interior Lighting - Classrooms | | Recommend upgrade to LED. |

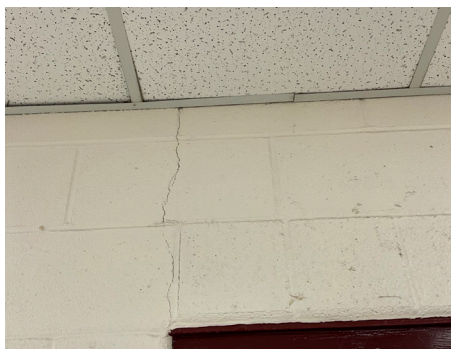
Interior Environment - Interior Wall

| 1. Building Site, Landscaping etc. | | |
|---|--|---|
| Interior Wall | | Some areas have some cracking that needs repair, otherwise walls just have general wear and tear |

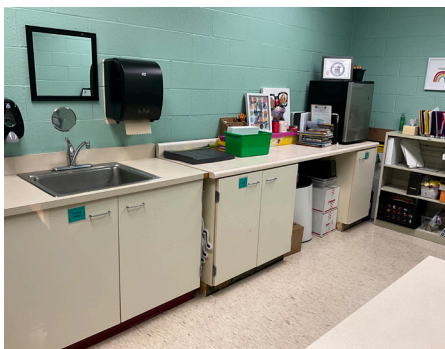
Interior Environment - Casework

| 1. Building Site, Landscaping etc. | | |
|---|--|---|
| Casework | | Casework is beginning to age with general wear and tear, recommend replacement in future |

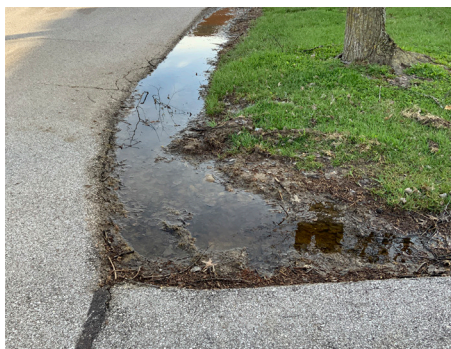
Building Site - Drainage System

| 1. Building Site, Landscaping etc. | | |
|---|--|---|
| Drainage System | | Erosion within the pond does not currently require urgent attention; however, maintenance is recommended at the outlet structures and the immediately surrounding area to remove large rocks obstructing flow into the inlet. Energy dissipater at south side of parking near playground needs to be repaired. |

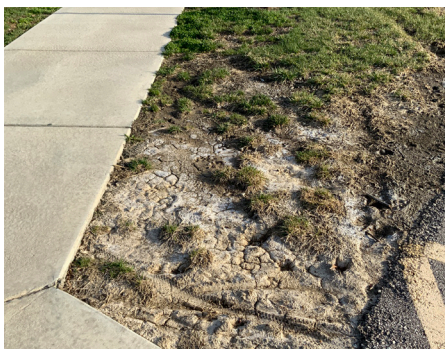
Building Site - Turf Grass

| 1. Building Site, Landscaping etc. | | |
|---|--|---|
| Turf Grass | | Overall, the turf throughout the site is in good condition; however, selective infill through seeding—and potentially sodding—is needed along cracked pavement edges and adjacent to sidewalks. Additionally, areas affected by recent construction on the southeast side of the school require reseeding. |

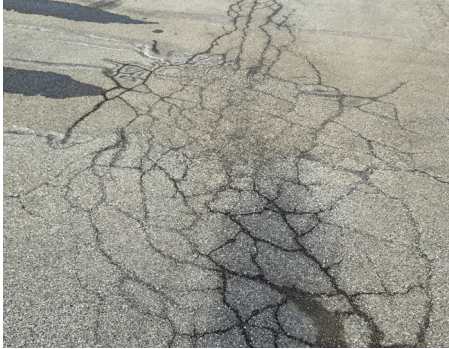
Building Site - Drive Surface

| 1. Building Site, Landscaping etc. | | |
|---|--|---|
| Drive Surface | | Driveway along the west side of the building exhibits serious alligator (fatigue) cracking. |

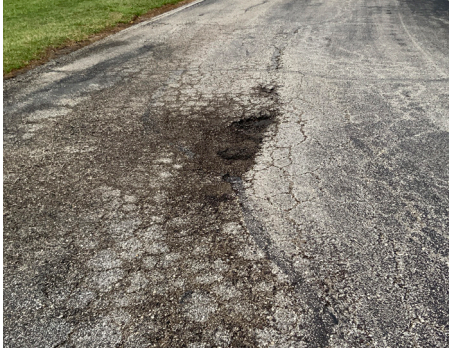
Building Site - Drive Surface

| 1. Building Site, Landscaping etc. | | |
|---|--|---|
| Drive Surface | | While there are a few areas that need attention, the driveways into the site are generally in good condition. Driveway improvements should be coordinated and completed in conjunction with the parking lot improvements for efficiency and consistency. |

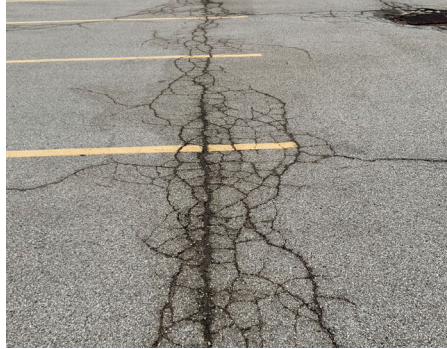
Building Site - Parking Lot

| 1. Building Site, Landscaping etc. | | |
|---|--|---|
| Parking Lot | | The parking areas are in poor condition, with multiple sections requiring removal and replacement, along with widespread crack sealing to address surface deterioration. |

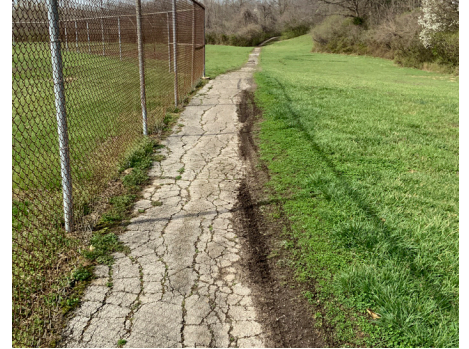
Building Site - Sidewalk

| 1. Building Site, Landscaping etc. | | |
|---|--|---|
| Sidewalk | | Concrete sidewalks are generally in good condition - just a few locations that need to be patched. There is an existing asphalt walk/path to the northwest of the building that needs to be removed and replaced if it is to be used. |

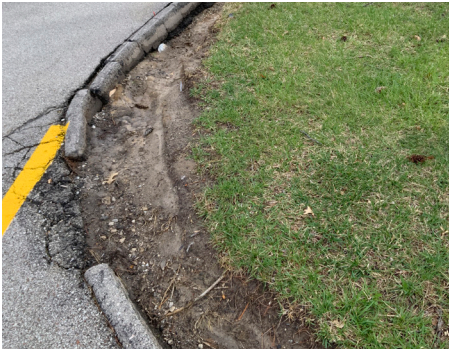
Building Site - Curbs

| 1. Building Site, Landscaping etc. | | |
|---|--|---|
| Curbs | | Most asphalt curbs on site are in very poor condition and need to be removed and replaced. Portland Concrete Cement is recommended for curbs throughout the site. |

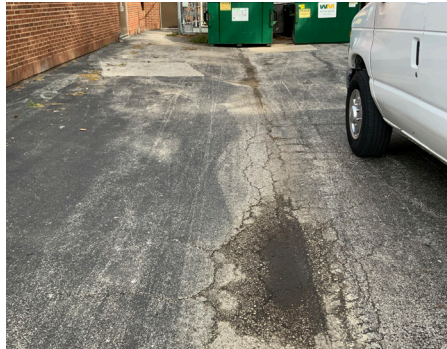
Building Site - Loading Area

| 1. Building Site, Landscaping etc. | | |
|---|--|---|
| Loading Area | | The loading area requires patching, but a full removal and replacement is recommended. Using concrete for the replacement would be ideal, particularly given the location of the dumpsters. |
