# 2025 FACILITY MASTER PLAN REPORT

FACILITY CONDITION / NEEDS ASSESSMENT - LIST & PHOTOS

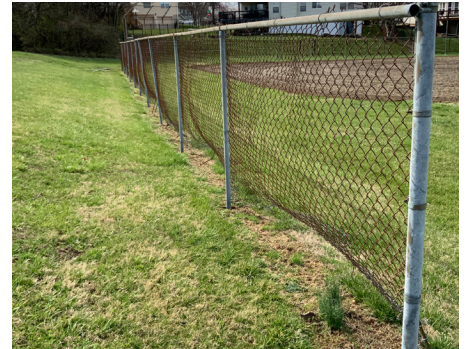
Building Site - Fencing

| 1. Building Site, Landscaping etc. | | |
|---|--|---|
| Fencing | | Fence is rusting and not anchored in some areas. Replacement is recommended. |

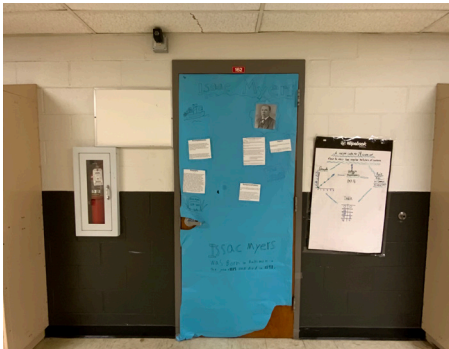
Interior Environment - Interior Doors

| 1. Building Site, Landscaping etc. | | |
|---|--|---|
| Interior Door | | Door are significantly damaged, recommend door replacements. Common spaces do not have panic hardware currently |

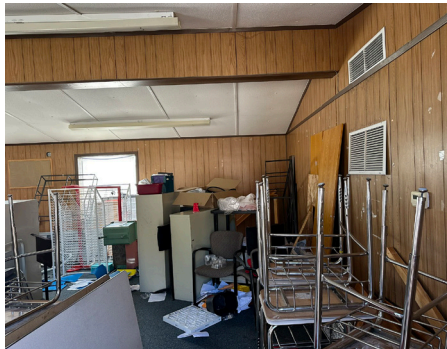
Interior Environment - Interior Walls

| 1. Building Site, Landscaping etc. | | |
|---|--|---|
| Interior Wall | | Walls have significant peeling, recommend repair and refinish |

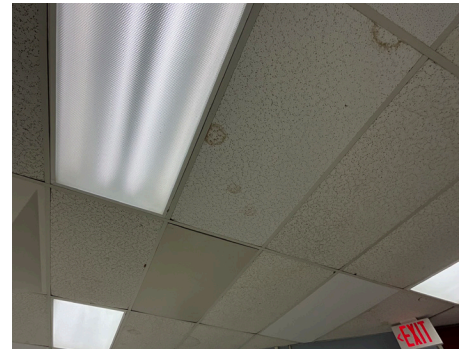
Interior Environment - Ceiling

| 1. Building Site, Landscaping etc. | | |
|---|--|---|
| Ceiling | | Ceiling is damaged, 75% of ceiling needs to be replaced |

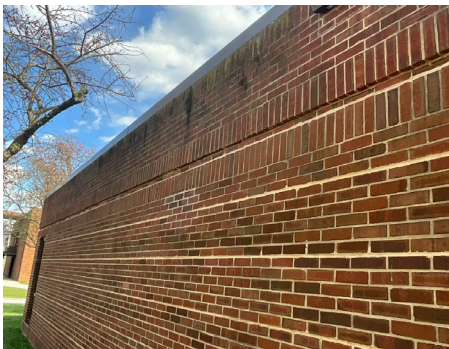
Building Structure / Exterior - Exterior Facade

| 1. Building Site, Landscaping etc. | | |
|---|--|---|
| Exterior Façade | | Organic growth spots throughout, control joints are at half-life life or worse, major past brick repairs through out, expansion joints are in poor condition and need to be replaced completely |

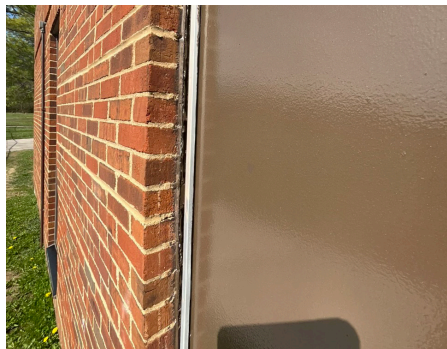
Building Structure / Exterior - Exterior Door

| 1. Building Site, Landscaping etc. | | |
|---|--|---|
| Exterior Door | | Door 12 complete sealant failure at head and jamb, steel at head is rusting |

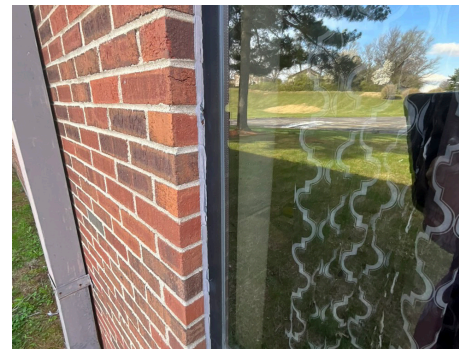
Building Structure / Exterior - Exterior Window

| 1. Building Site, Landscaping etc. | | |
|---|--|---|
| Exterior Window | | Sealant failure at most windows, most sealant is at half life but are failing due to poor install (to thinly applied) |

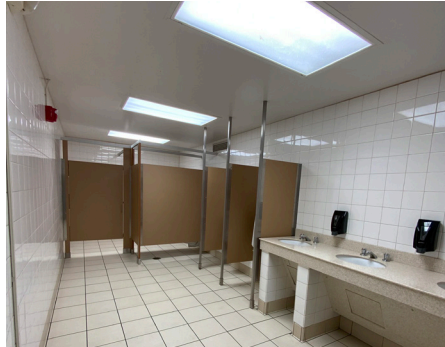
Building Systems - Plumbing Fixtures (Restrooms)

| 1. Building Site, Landscaping etc. | | |
|---|--|---|
| Plumbing Fixtures - Restroom | | Fixtures appear to be in good condition. Some of the sinks are lacking trap guards. None appear to have thermostatic mixing valves. |

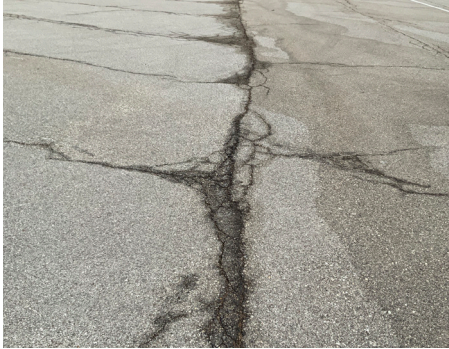
Building Site - Drive Surface

| 1. Building Site, Landscaping etc. | | |
|---|---|---|
| | Drive Surface | Driveway exhibits longitudinal and transverse cracking along with some alligator (fatigue) and block cracking. |

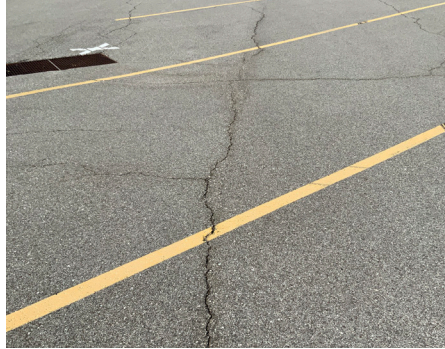
Building Site - Parking Lot

| 1. Building Site, Landscaping etc. | | |
|---|---|---|
| | Parking Lot | Similar to the driveway area, both longitudinal and transverse cracking were observed, though they are less prevalent in comparison. |

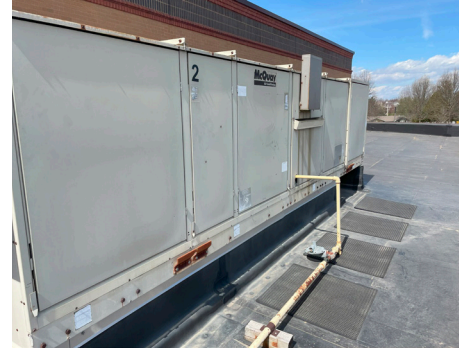
Building Systems - Mechanical System

| 1. Building Site, Landscaping etc. | | |
|---|---|---|
| | Mechanical System | Energy recovery units are 42 years old. Typical lifespan is 10-15 years. Cooling towers are 27 years old. Typical lifespan is 20-25 years. Boilers are 21 years old. Typical lifespan is 20-25 years. Heat loop pumps appear to 39 years old. Typical lifespan is 20-25 years. Mechanical equipment replacements scheduled/ongoing. |

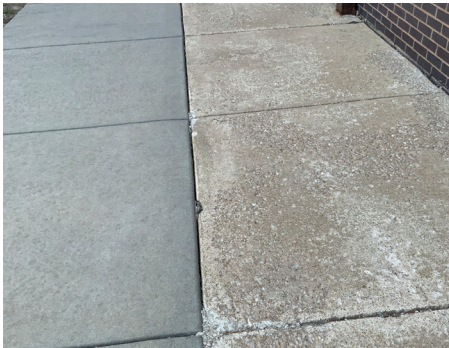
Building Site - Sidewalk

| 1. Building Site, Landscaping etc. | | |
|---|---|---|
| | Sidewalk | The sidewalks are generally in good condition, with some intermittent cracking observed. No immediate repairs are necessary at this time |

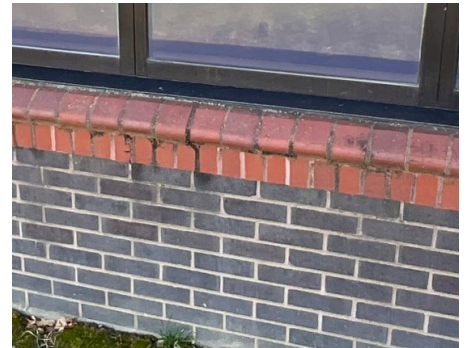
Building Structure / Exterior - Exterior Facade

| 1. Building Site, Landscaping etc. | | |
|---|---|---|
| | Exterior Façade | Bricks are dirty, some areas, heavier, grime others. The front entrance soffit shows minor cracking at edge. About 50% of the control joints are starting to crack and separate at half-life or worse. Some control joints have completely failed especially at the upward facing detailed brick elements. |

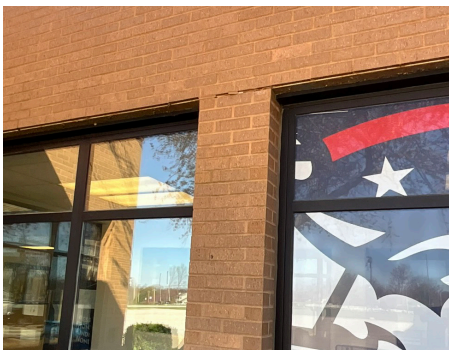
Building Structure / Exterior - Exterior Window

| 1. Building Site, Landscaping etc. | | |
|---|---|---|
| | Exterior Window | 2/3rds of steel at window heads show peeling paint and beginning spots of rust. Most windows sealant is at half-life or worse, those that are in the shade or in better shape than those that are not, most sealant at the sides of the cell have failed and cracked. |

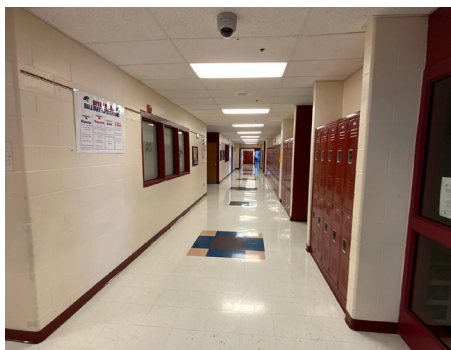
Interior Environment - Interior Walls

| 1. Building Site, Landscaping etc. | | |
|---|---|---|
| | Interior Wall | Overall walls are in fine condition, repaint is recommended in the future |

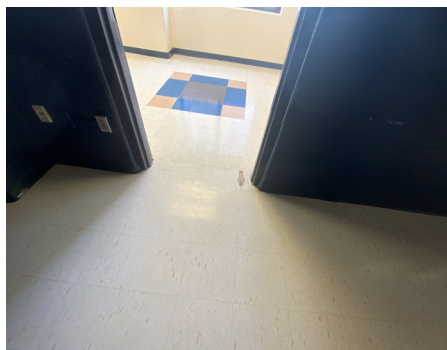
Interior Environment - Flooring

| 1. Building Site, Landscaping etc. | | |
|---|---|---|
| | Flooring | VCT is cracking in multiple areas, recommend repair |

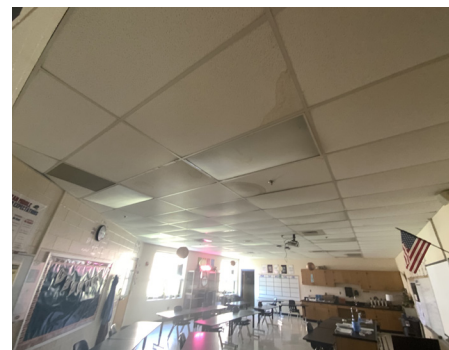
Interior Environment - Ceiling

| 1. Building Site, Landscaping etc. | | |
|---|---|---|
| | Ceiling | Overall ceiling is fine, but multiple tiles are damaged and need of repair throughout |

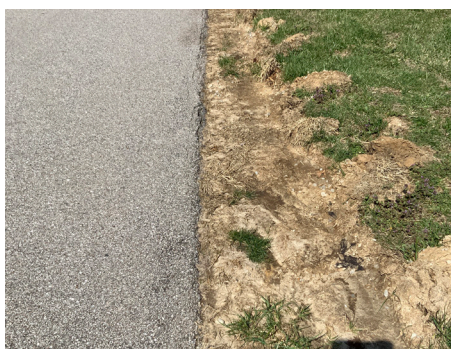
Building Site - Turf Grass

| 1. Building Site, Landscaping etc. | | |
|---|---|---|
| | Turf Grass | The turf is generally in good condition, aside from a few sparse areas. Sections located behind pavement and sidewalks require seeding or sodding, and areas affected by erosion should be addressed accordingly. |

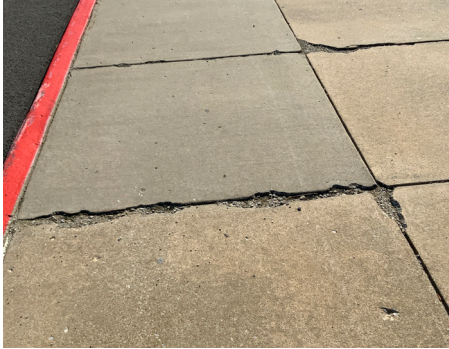
Building Site - Sidewalk

| 1. Building Site, Landscaping etc. | | |
|---|--|---|
| Sidewalk | | Sidewalks are in generally good condition. Other areas exhibit cracking and weathering at joints. Maintenance is required to prevent further erosion of the concrete. Sidewalks between parking levels show significant settling and the creation of a tripping hazard that should be addressed. |

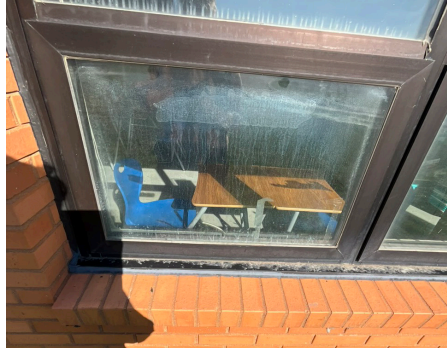
Building Structure / Exterior - Window

| 1. Building Site, Landscaping etc. | | |
|---|--|---|
| Exterior Window | | Most window sealant is beyond half-life cracked, and breaking. Replacement recommended. Majority of window head steel is pin holing and starting to rust. Three cases of window damage at frame and gasket. Insulated glass windows showing moisture or signs of previously trapped moisture. Repairs needed immediately. |

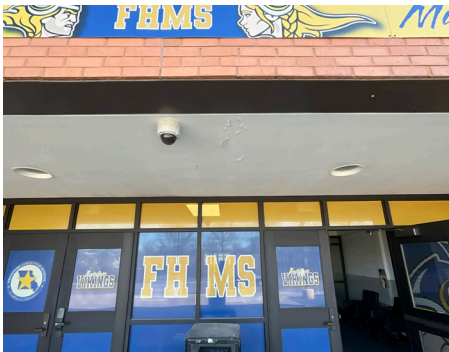
Building Site - Site Lighting

| 1. Building Site, Landscaping etc. | | |
|---|--|---|
| Site Lighting | | Would recommend upgrading existing pole mounted fixtures / building mounted fixtures to be LED. Would also recommend adding a few additional light poles on North end of parking lot to achieve full parking lot coverage. |

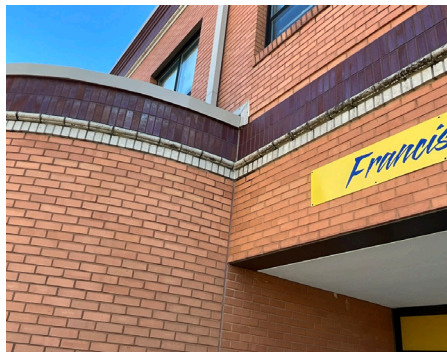
Building Structure / Exterior - Exterior Facade

| 1. Building Site, Landscaping etc. | | |
|---|--|---|
| Exterior Façade | | Brick is dirty, especially at the brick detail. Cleaning recommended. Control joints are at half-life or worse. The vast majority of the brick is in good condition. There are a handful of large significant cracks along the soldier course dark brown brick. Small cracks are visible throughout the whole building. |

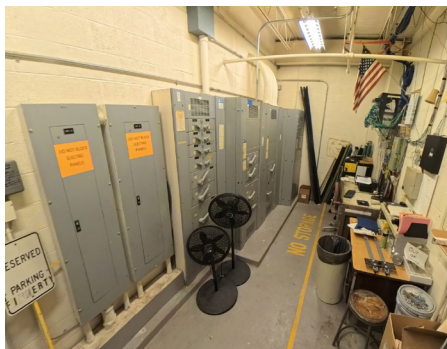
Building Systems - Main Electrical Service

| 1. Building Site, Landscaping etc. | | |
|---|--|---|
| Main Electrical Service | | No main disconnect, appear to be at code maximum of 6 service disconnects. Fuse buckets are used in main gear and fuse buckets are becoming obsolete and difficult to retrofit. Would recommend replacement of main electrical switchgear at / or before next building renovation requiring extra capacity. |

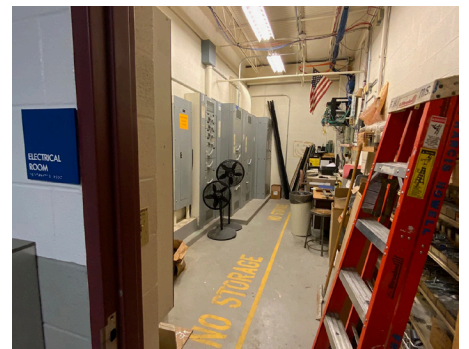
Building Systems - Panelboards

| 1. Building Site, Landscaping etc. | | |
|---|--|---|
| Panelboards | | Majority of existing panels appear to be in a good, operational condition. Majority of branch panels appear to be getting low on additional capacity. |

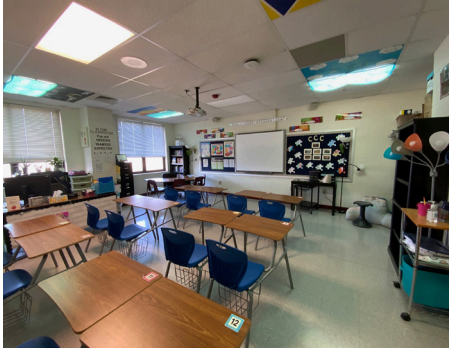
Building Systems - Interior Lighting (Classrooms)

| 1. Building Site, Landscaping etc. | | |
|---|--|---|
| Interior Lighting - Classrooms | | Would recommend upgrading to LED |

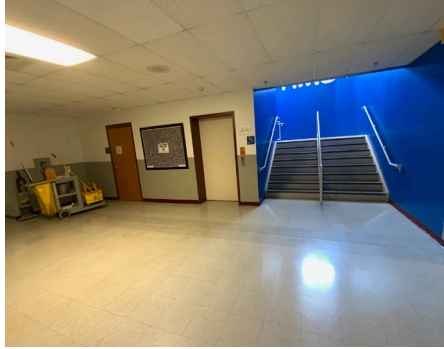
Building Systems - Interior Lighting (Public Areas)

| 1. Building Site, Landscaping etc. | | |
|---|--|---|
| Interior Lighting - Public areas | | Would recommend upgrading to LED |

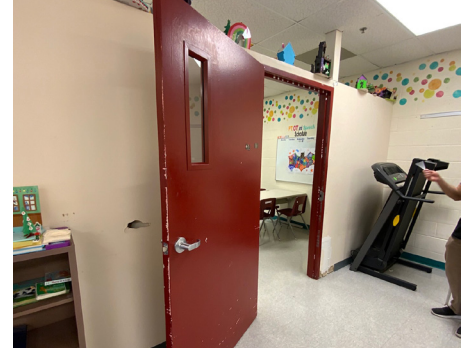
Interior Environment - Interior Doors

| 1. Building Site, Landscaping etc. | | |
|---|--|---|
| Interior Door | | Doors/hardware have general wear and tear, chipping of paint on frames and minimal damage to doors. Recommend door replacement in the future |

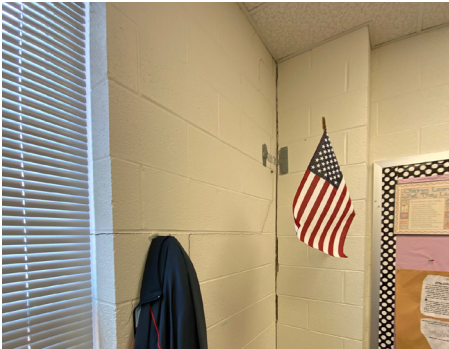
Interior Environment - Interior Walls

| 1. Building Site, Landscaping etc. | | |
|---|--|---|
| Interior Wall | | Paint and maintenance is recommended throughout |

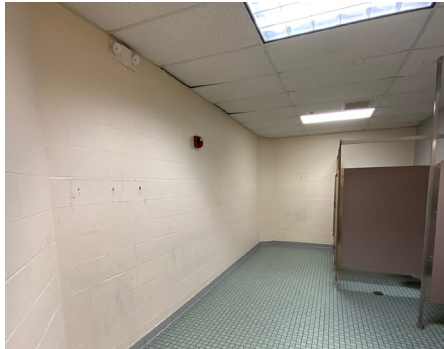
Interior Environment - Ceiling

| 1. Building Site, Landscaping etc. | | |
|---|--|---|
| Ceiling | | Overall ceiling is fine, but multiple tiles are damaged and need of repair throughout |

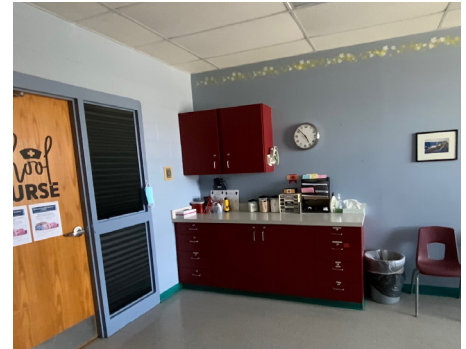
Interior Environment - Casework

| 1. Building Site, Landscaping etc. | | |
|---|--|---|
| Casework | | Core classrooms have metal casework that is outdated and worn, recommend replacement |

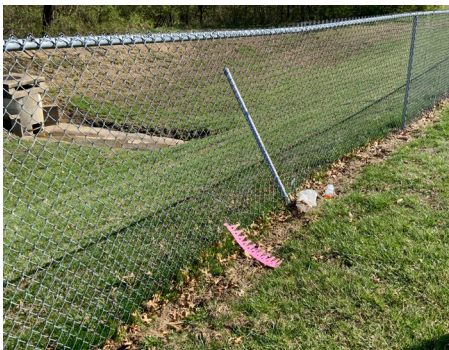
Building Site - Fencing

| 1. Building Site, Landscaping etc. | | |
|---|--|---|
| Fencing | | Fence in good condition. One support pole needs to be reset and attached to mesh. |

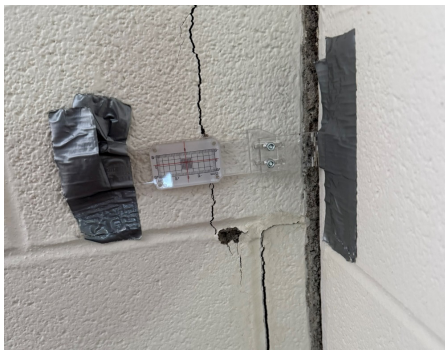
Building Structure / Exterior - Structural System

| 1. Building Site, Landscaping etc. | | |
|---|--|---|
| Building Structural System | | Minor cracking in room A213 non-load bearing exterior wall. Route and seal crack, then monitor for future. |

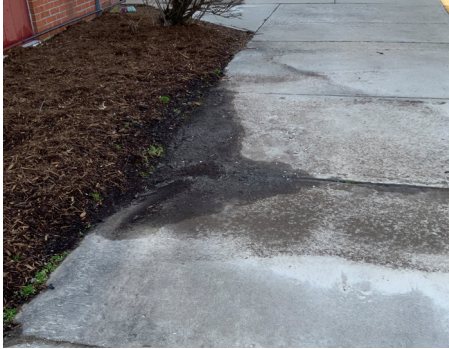
Building Site - Drainage System

| 1. Building Site, Landscaping etc. | | |
|---|--|---|
| Drainage System | | The site has limited drainage structures, and the area to the southwest, where runoff is directed, is in very poor condition and is not draining off the site properly. |

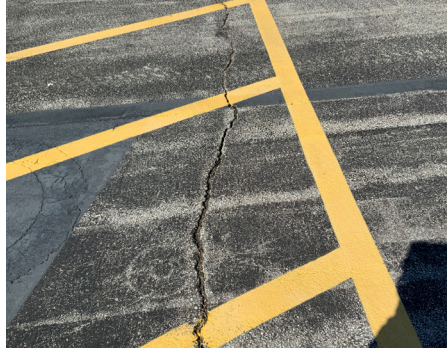
Building Site - Drive Surface

| 1. Building Site, Landscaping etc. | | |
|---|--|---|
| Drive Surface | | Front driveway has large transverse and longitudinal cracks and areas of alligator (fatigue) and block cracking. Large cracks should be filled and other areas patched. |

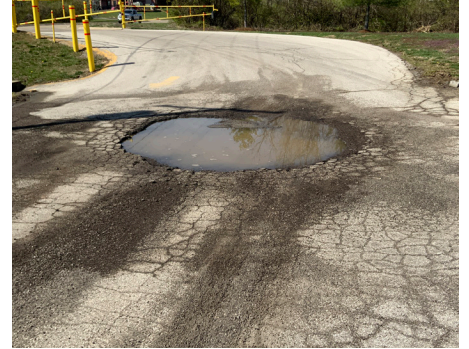
Building Site - Parking Lot

| 1. Building Site, Landscaping etc. | | |
|---|--|---|
| Parking Lot | | The north and southwest parking lots are in very poor condition, with a large pothole in the southwest lot that requires immediate attention. It is recommended to fully remove and replace both parking lots. |

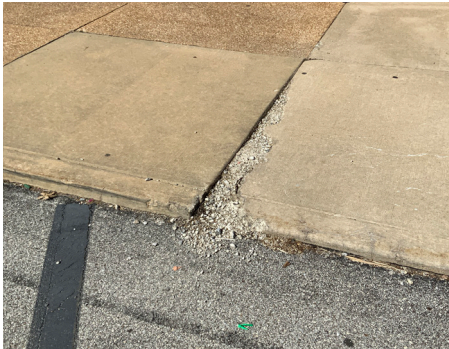
Building Site - Sidewalk

| 1. Building Site, Landscaping etc. | | |
|---|--|---|
| Sidewalk | | The sidewalks show multiple areas of cracking that require repair. |

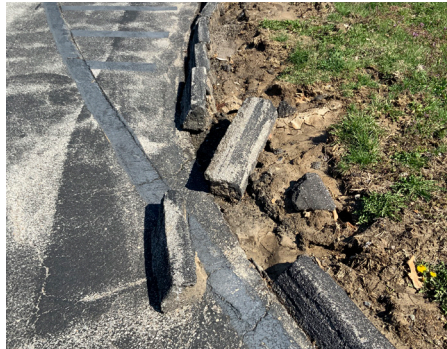
Building Site - Curbs

| 1. Building Site, Landscaping etc. | | |
|---|--|---|
| Curbs | | Concrete curbs are in good condition with the exception of a few locations of deterioration. Asphalt curb is failing and needs to be replaced. Would recommend concrete curbs throughout. |

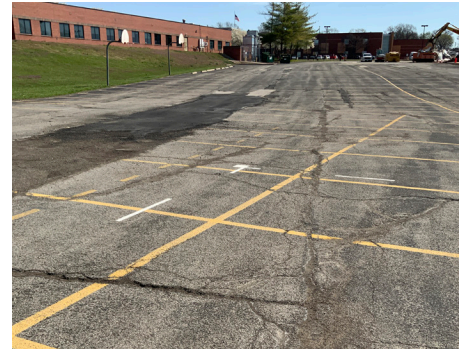
Building Site - Hardscape Play

| 1. Building Site, Landscaping etc. | | |
|---|--|---|
| Hardscape Play | | Hardscape play is limited to the north parking lot which is in need of significant repairs. |

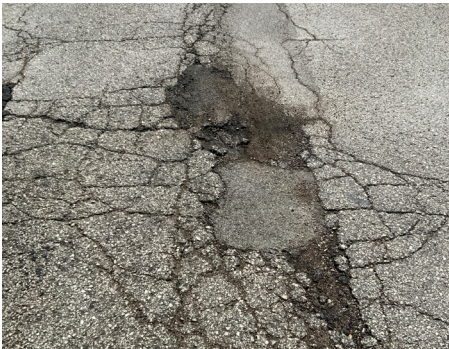
Building Site - Entrances to City ROW

| 1. Building Site, Landscaping etc. | | |
|---|--|---|
| Entrances to City ROW | | Area needs crack-filling and patching. Shared entrance with other school facilities. |

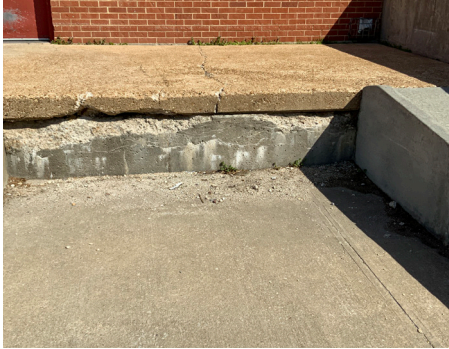
Building Site - Loading Area

| 1. Building Site, Landscaping etc. | | |
|---|--|---|
| Loading Area | | Raised loading area is deteriorating and should be considered for improvement in the next few years |

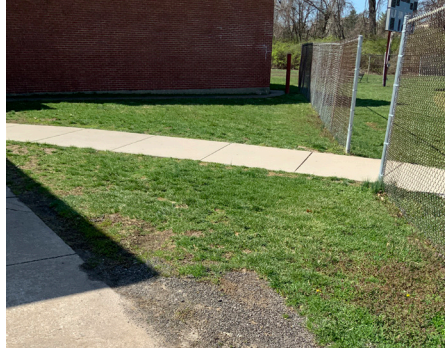
Building Site - Fencing

| 1. Building Site, Landscaping etc. | | |
|---|--|---|
| Fencing | | Starting to rust in some areas. |

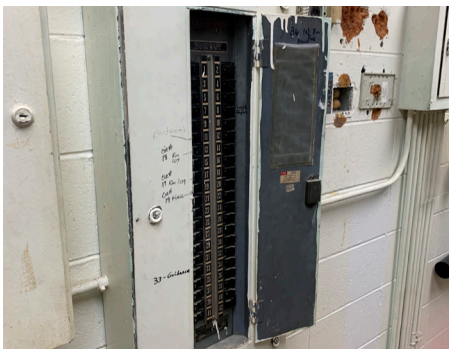
Building Systems - Panelboards

| 1. Building Site, Landscaping etc. | | |
|---|--|---|
| Panelboards | | Panelboards are old, recommend replacement of existing Zinsco and Federal Pacific panels. |

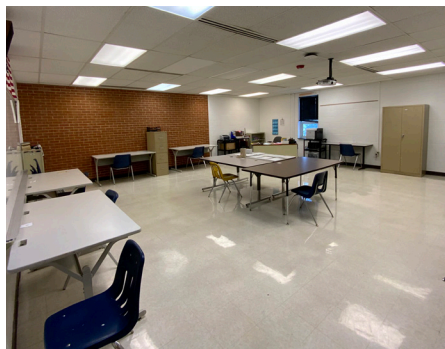
Building Systems - Interior Lighting (Classrooms)

| 1. Building Site, Landscaping etc. | | |
|---|--|---|
| Interior Lighting - Classrooms | | Recommend upgrade to LED. |

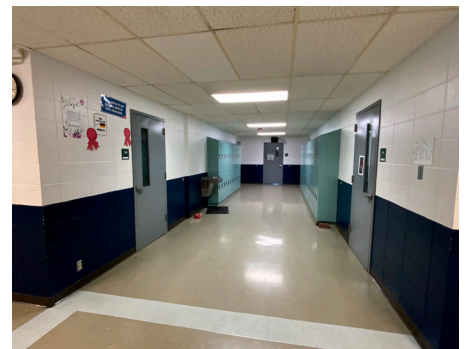
Building Systems - Interior Lighting (Public Areas)

| 1. Building Site, Landscaping etc. | | |
|---|--|---|
| Interior Lighting - Public areas | | Recommend upgrade to LED for all non-LED fixtures. |

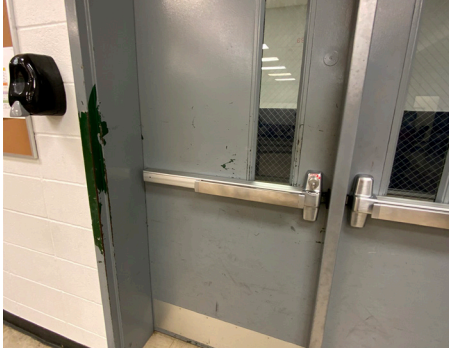
Interior Environment - Interior Door

| 1. Building Site, Landscaping etc. | | |
|---|--|---|
| Interior Door | | Hardware is old and not functioning, recommend updating doors |

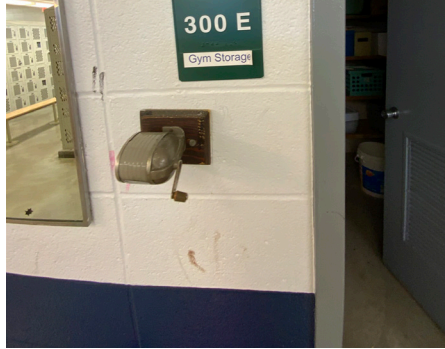
Interior Environment - Interior Wall

| 1. Building Site, Landscaping etc. | | |
|---|--|---|
| Interior Wall | | Recommend paint refinish throughout |

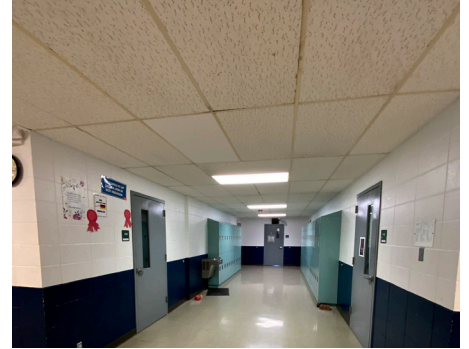
Interior Environment - Ceiling

| 1. Building Site, Landscaping etc. | | |
|---|--|---|
| Ceiling | | Recommend ceiling replacement in the future, very old ACT throughout |

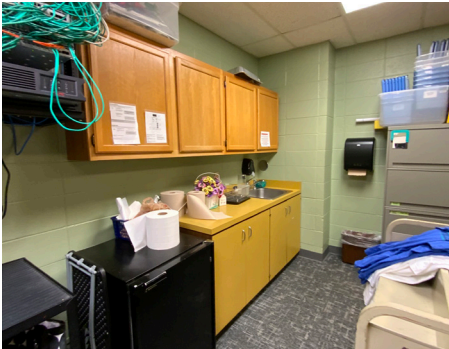
Interior Environment - Casework

| 1. Building Site, Landscaping etc. | | |
|---|--|---|
| Casework | | Casework is not standardized, recommend updating |

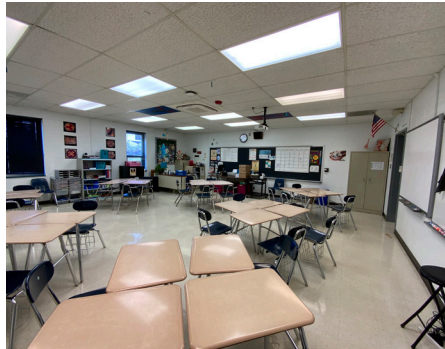
Interior Environment - Furniture

| 1. Building Site, Landscaping etc. | | |
|---|--|---|
| Furniture | | Furniture is not standardized throughout and is old, recommend future replacement |

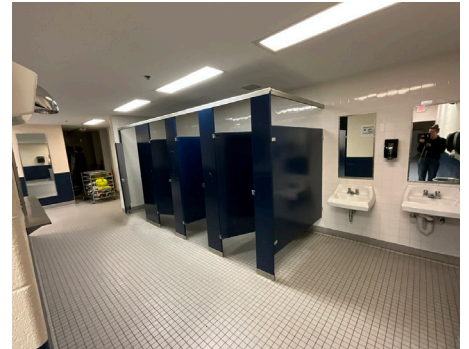
Interior Environment - Plumbing Fixture

| 1. Building Site, Landscaping etc. | | |
|---|--|---|
| Plumbing Fixtures | | Fixtures are old, recommend updating in near future |

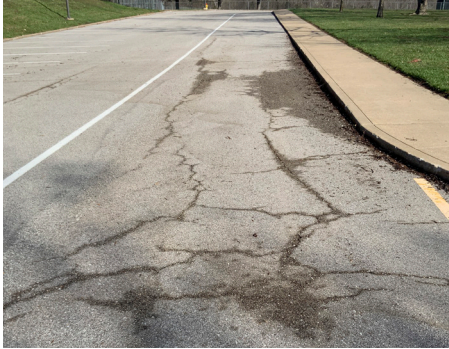
Building Site - Drive Surface

| 1. Building Site, Landscaping etc. | | |
|---|---|---|
| | Drive Surface | Several areas show significant longitudinal and transverse cracking, along with spalling and fatigue cracking. Removal and replacement of these damaged sections is recommended. Smaller, isolated cracks can be sealed to prevent further deterioration. |

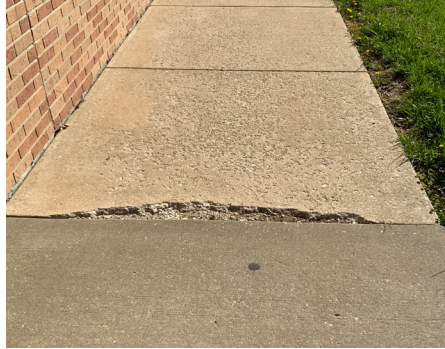
Building Site - Sidewalk

| 1. Building Site, Landscaping etc. | | |
|---|---|---|
| | Sidewalk | Several walkway areas require removal and replacement to prevent further deterioration. The walk and step near the northeast entrance need to be backfilled, and the use of flowable fill or mud jacking may be necessary to eliminate underlying voids and ensure stability. |

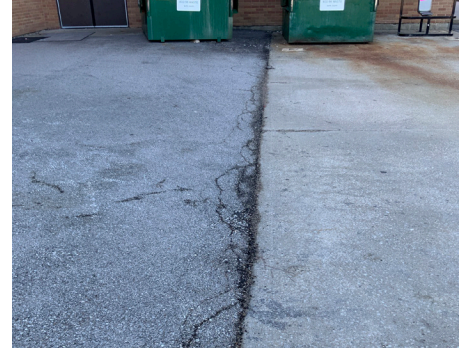
Building Site - Loading Area

| 1. Building Site, Landscaping etc. | | |
|---|---|---|
| | Loading Area | Although not a designated loading area, the trash dumpster area has deteriorating asphalt pavement. Given the frequent heavy vehicle traffic, replacing the asphalt with concrete would provide a more durable and long-term solution. |

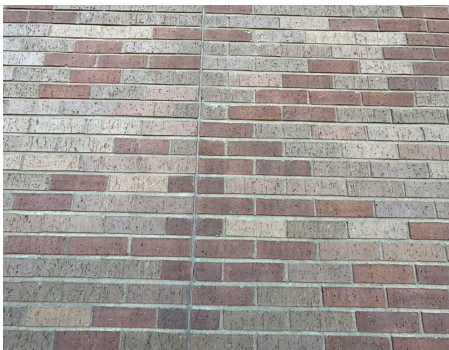
Building Structure / Exterior - Exterior Facade

| 1. Building Site, Landscaping etc. | | |
|---|---|---|
| | Exterior Façade | Control joints and lower sealant are at half-life or worse. Select areas have organic growth, ~1/4 of the control joints have completely failed. Minimal cracking, a few busted corners in need of repair. |

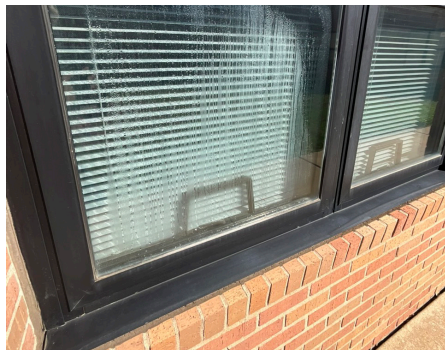
Building Structure / Exterior - Exterior Window

| 1. Building Site, Landscaping etc. | | |
|---|---|---|
| | Exterior Window | Steel at header is starting to rust. 1 Insulated glass is in complete failure in need of repair. Most sealant is at half life, some complete failure. Repair is needed in future. |

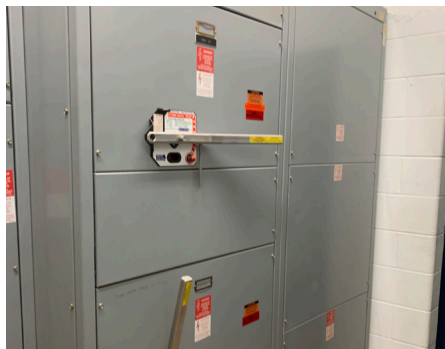
Building Systems - Main Electrical Service

| 1. Building Site, Landscaping etc. | | |
|---|---|---|
| | Main Electrical Service | Additional capacity may only use the existing spares in the switchboard, if more space required, then existing switchboard will need to be upgraded to a new circuit breaker style with additional spaces. - (1) 480v 200A spare left in existing switchgear. No main shutoff observed for electrical service. |

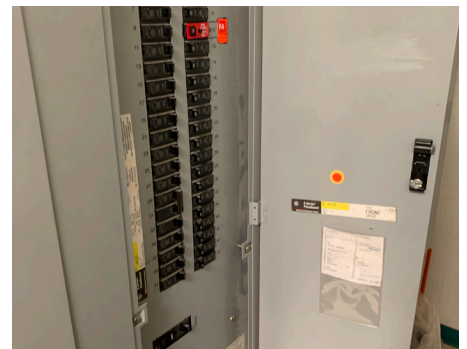
Building Systems - Panelboards

| 1. Building Site, Landscaping etc. | | |
|---|---|---|
| | Panelboards | Panels appear to be in good working condition, with majority of panels having at least a few spares / spaces for future needs. |

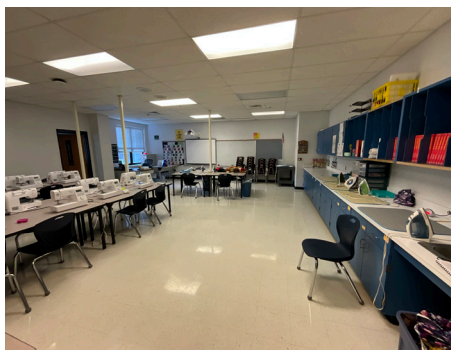
Building Systems - Interior Lighting (Classrooms)

| 1. Building Site, Landscaping etc. | | |
|---|---|---|
| | Interior Lighting - Classrooms | Recommend upgrade to LED. |

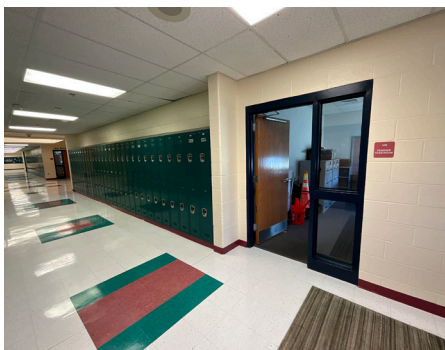
Building Systems - Interior Lighting (Public Areas)

| 1. Building Site, Landscaping etc. | | |
|---|---|---|
| | Interior Lighting - Public areas | Recommend upgrade to LED. |

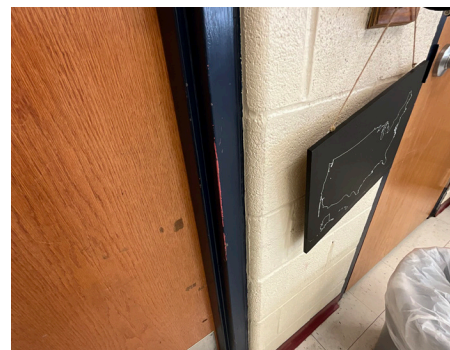
Interior Environment - Interior Door

| 1. Building Site, Landscaping etc. | | |
|---|---|---|
| | Interior Door | Doors have general wear and tear, chipping of paint on frames and minimal damage to doors. Recommend full door replacement in the future |

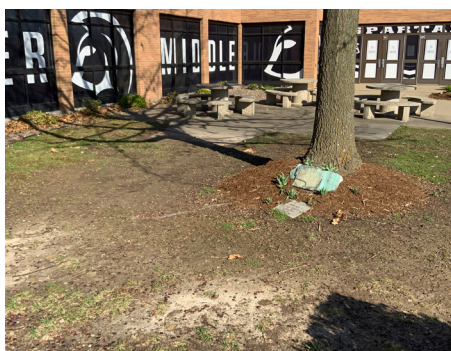
Building Site - Turf Grass

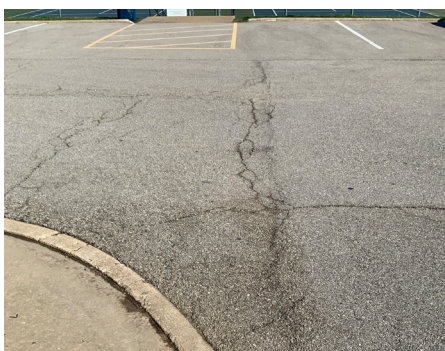
Building Site - Parking Lot

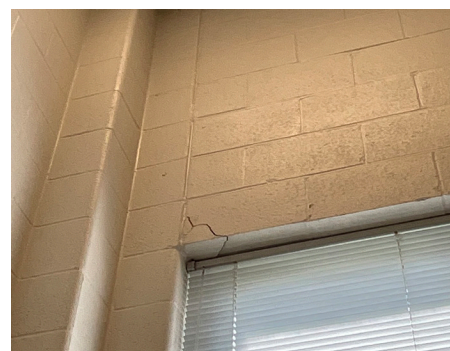
Building Structure / Exterior - Structural System

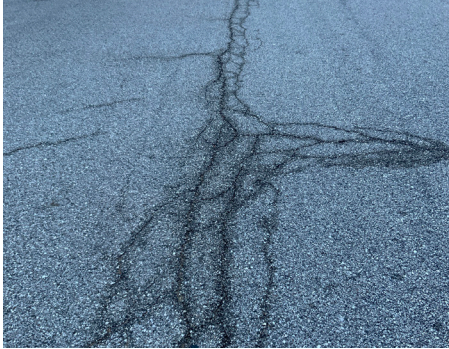
| 1. Building Site, Landscaping etc. | | |
|---|---|---|
| | Drive Surface | Pavement exhibits longitudinal and transverse cracking. Smaller cracks need to be filled and several areas with larger cracking and block cracking need to be patched. - Concrete trash enclosure area is in poor condition and should be repaired. |

Building Site - Drive Surface

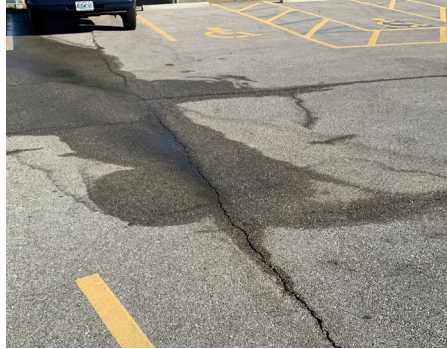
| 1. Building Site, Landscaping etc. | | |
|---|---|---|
| | Parking Lot | Smaller cracks need to be filled and several other areas need to be patched due to spreading and block and fatigue cracking. |

Building Site - Parking Lot

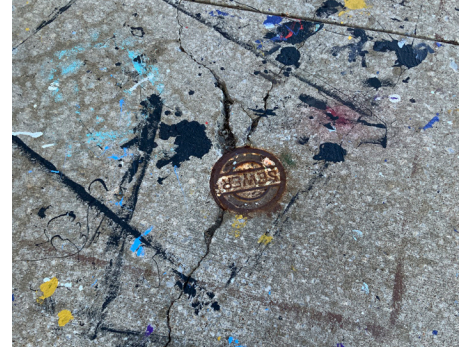
| 1. Building Site, Landscaping etc. | | |
|---|---|---|
| | Sidewalk | Certain sidewalk areas require immediate repair, while others can be addressed over the next few years as part of a phased maintenance plan. - The walks show considerable spalling, which isn't an urgent issue at the moment but will continue to worsen over time if not addressed. |

Building Sites - Sidewalk

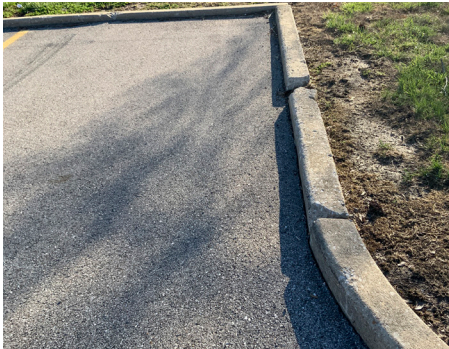
| 1. Building Site, Landscaping etc. | | |
|---|---|---|
| | Curbs | There are several areas of curb cracking and deterioration, which extend into the sidewalk. Additionally, the curb near the handrail on the north side of the school is deteriorating around the posts. |

Building Site - Curbs

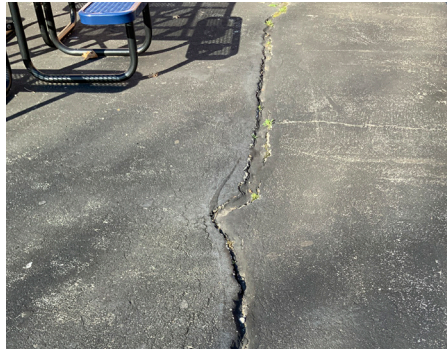
| 1. Building Site, Landscaping etc. | | |
|---|---|---|
| | Hardscape Play | There are significant, wide cracks in the outdoor commons area that need to be addressed. These cracks have been filled previously but are now allowing weeds to grow through. |

Building Site - Hardscape Play

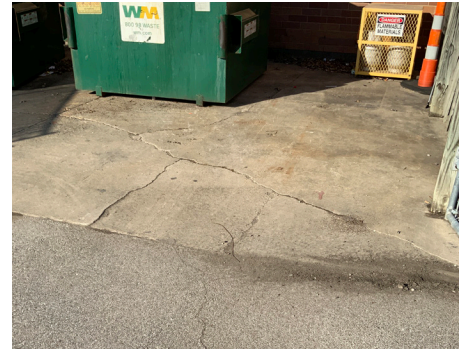
| 1. Building Site, Landscaping etc. | | |
|---|---|---|
| | Loading Area | Alligator (fatigue) cracking is present in several areas, and the concrete at the trash enclosure is cracked and requires replacement. |

Building Site - Loading Area

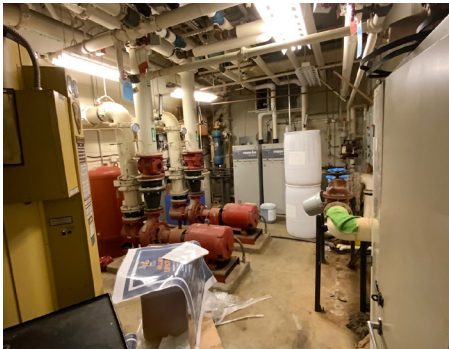
Building Systems - Water Heaters

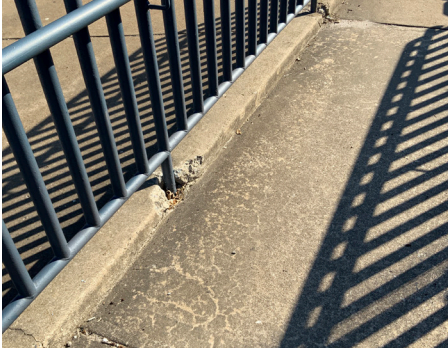
| 1. Building Site, Landscaping etc. | | |
|---|---|---|
| | Fencing | The fencing is in good condition, but the railings on the north side of the school leading to the athletic fields are beginning to rust, and the curb is deteriorating. These issues will need attention in the near future. |

Building Site - Fencing

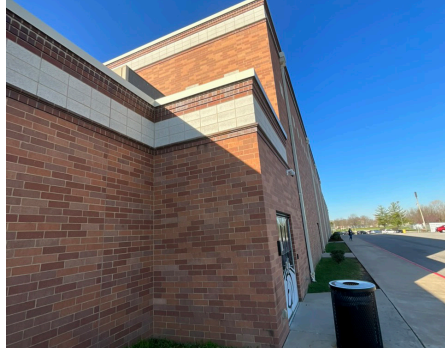
| 1. Building Site, Landscaping etc. | | |
|---|---|---|
| | Exterior Façade | Reseal control joints is recommended in approximately 6 years. Minor mortar cracks on the roof and select location through out. Minor cleaning needed at several locations |

Building Structure / Exterior - Exterior Facade

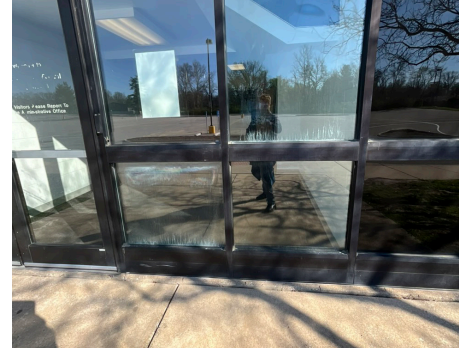
| 1. Building Site, Landscaping etc. | | |
|---|---|---|
| | Exterior Window | Moisture is visible in approximately 10% of panes, need to be replaced. |

Building Structure / Exterior - Exterior Window

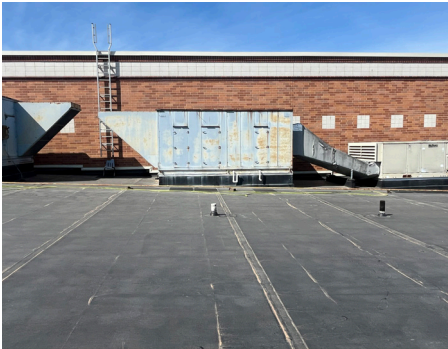
| 1. Building Site, Landscaping etc. | | |
|---|---|---|
| | Mechanical System | Boilers are 13 years old. Typical lifespan is 20-25 years. Cooling Towers are 4 years old. Typical lifespan is 15-20 years. Pumps are between 13-19 years old. Typical lifespan is 15-20 years. DOAS units are 27-29 years old. Typical lifespan is 10-15 years. Expansion tank is 29 years old and in poor condition. |

Building Systems - Mechanical System

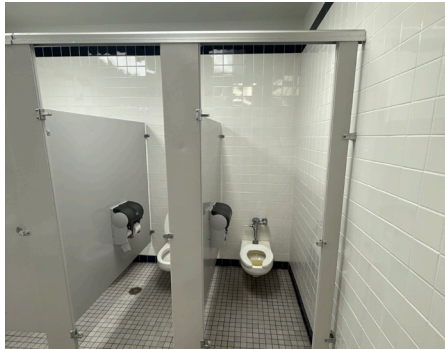
Building Systems - Plumbing Fixtures (Restrooms)

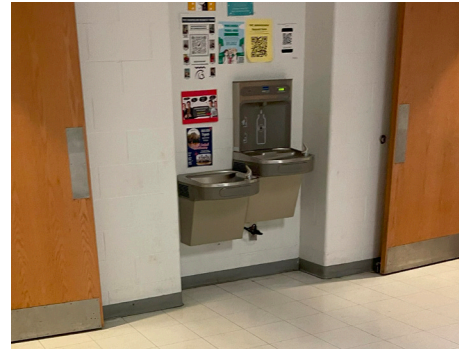
Building Systems - Drinking Fountains

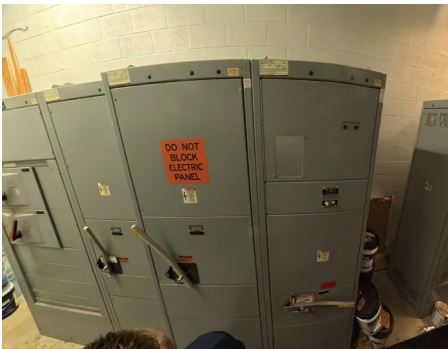
| 1. Building Site, Landscaping etc. | | |
|---|---|---|
| | Main Electrical Service | Appears to be existing space/spares in switchboard, but existing switchboard utilizes fused switches which may be difficult to retrofit/replace. Replacement of existing switchboard(s) may be required and upgraded to new circuit breaker style switchboards for future expansion. Existing switchgear appears to be in good working order. |

Building Systems - Main Electrical Service

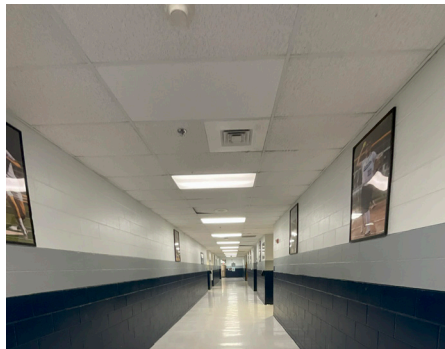
| 1. Building Site, Landscaping etc. | | |
|---|---|---|
| | Interior Lighting - Public areas | Recommend upgrade all outstanding fluorescent lighting to LED |

Building Systems - Interior Lighting (Public Areas)

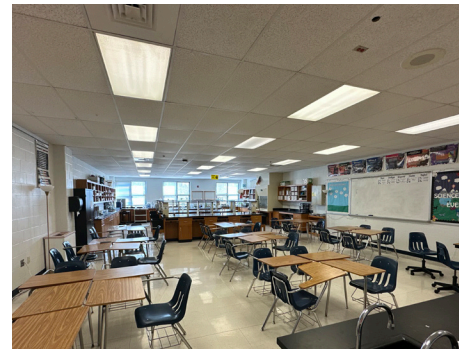
| 1. Building Site, Landscaping etc. | | |
|---|---|---|
| | Interior Lighting - Classrooms | Recommend upgrade to LED |

Building Systems - Interior Lighting (Classrooms)

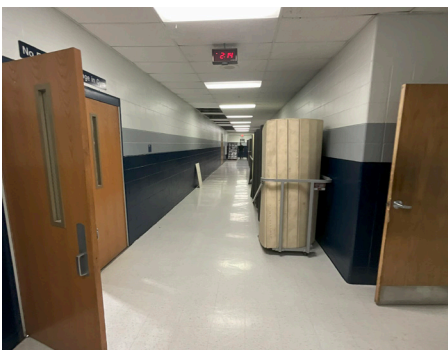
| 1. Building Site, Landscaping etc. | | |
|---|---|---|
| | Interior Door | Doors have general wear and tear, chipping of paint on frames and minimal damage to doors. Recommend full door replacement in the future |

Interior Environment - Interior Doors

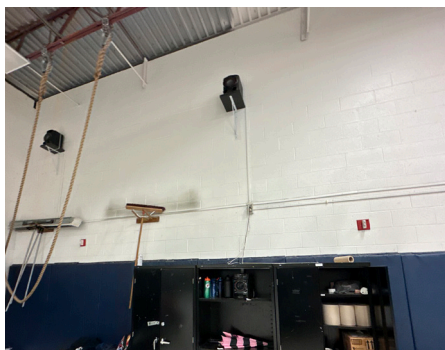
| 1. Building Site, Landscaping etc. | | |
|---|---|---|
| | Interior Wall | Demountable walls are in poor condition, recommend replacing in future. Remainder of school need general paint refinsh |

Interior Environment - Interior Walls

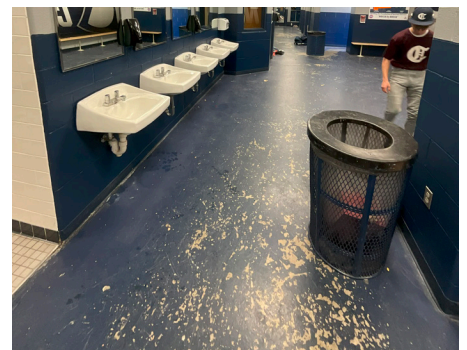
| 1. Building Site, Landscaping etc. | | |
|---|---|---|
| | Flooring | VCT is yellowing starting to wear, recommend floor replacement in future |

Interior Environment - Flooring

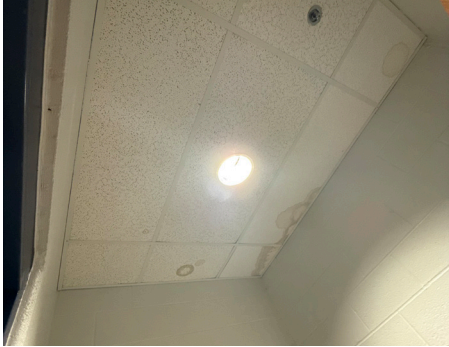
| 1. Building Site, Landscaping etc. | | |
|---|---|---|
| | Ceiling | Overall ceiling is in fine shape, areas of water damage need to be addressed |

Interior Environment - Ceiling

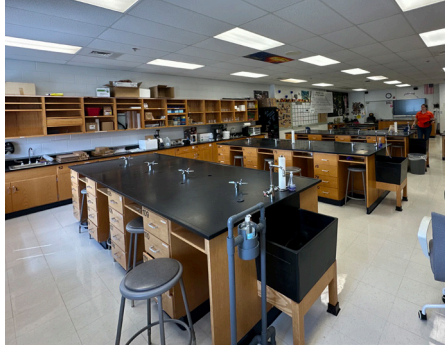
| 1. Building Site, Landscaping etc. | | |
|---|---|---|
| | Casework | Spaces with countertops having peeling laminate, recommend replacement in future |

Interior Environment - Casework

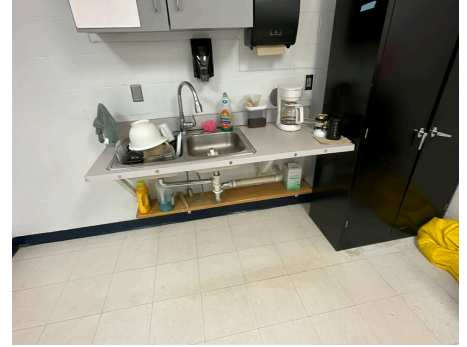
| 1. Building Site, Landscaping etc. | | |
|---|---|---|
| | Plumbing Fixtures | Some of the fixtures are old, or have exposed pipes, recommend updating |

Interior Environment - Plumbing Fixtures

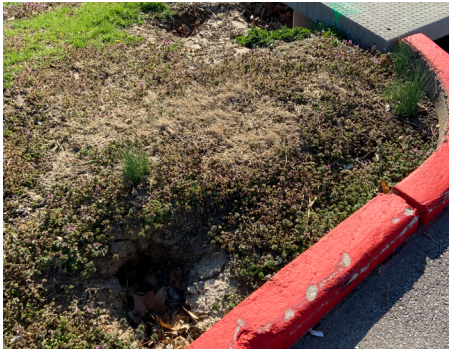
Building Site - Turf Grass

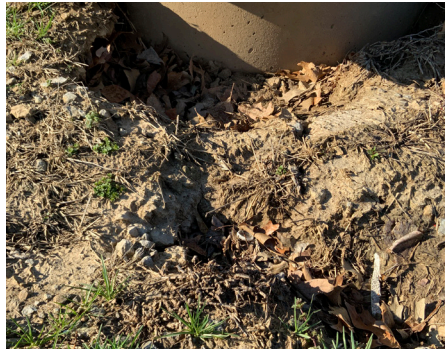
Building Site - Inlets

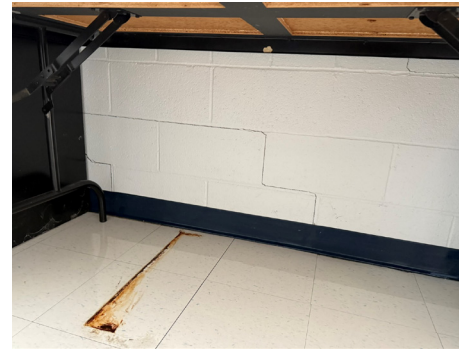
| 1. Building Site, Landscaping etc. | | |
|---|---|---|
| | Building Structural System | Non-load bearing wall settlement at east wall of south classroom wing. Recommend routing and sealing cracks and monitor for future. |

Building Structure / Exterior - Building Structural System

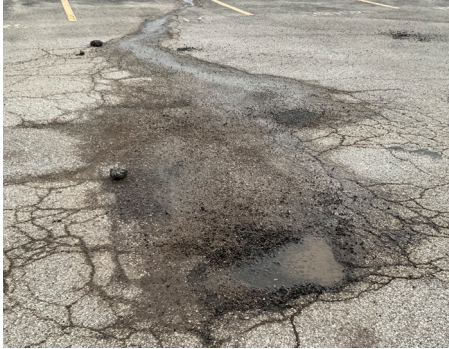
Building Site - Parking Lot

| 1. Building Site, Landscaping etc. | | |
|---|---|---|
| | Parking Lot | Significant areas of transverse and longitudinal cracking, fatigue and block cracking and spalling have created deterioration and poor conditions. Full removal and replacement recommended in many areas. |

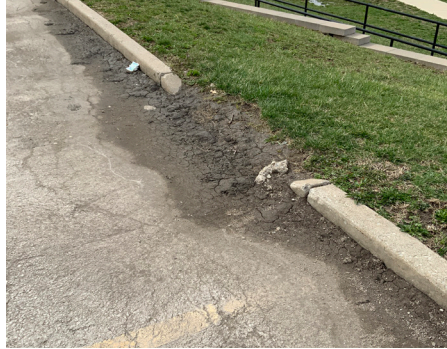
Building Site - Curbs

| 1. Building Site, Landscaping etc. | | |
|---|---|---|
| | Curbs | Curbs are in good condition throughout the site, with only a few minor exceptions. The asphalt curb is failing and should be replaced, but the concrete curbs are generally in good condition. |

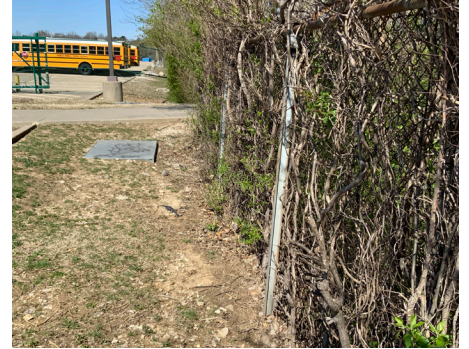
Building Site - Fencing

| 1. Building Site, Landscaping etc. | | |
|---|---|---|
| | Fencing | The fencing is showing signs of rust and is completely overgrown with brush and vines. The fence will continue to deteriorate and should either be replaced or have the vegetation removed to help prolong its lifespan before replacement. |

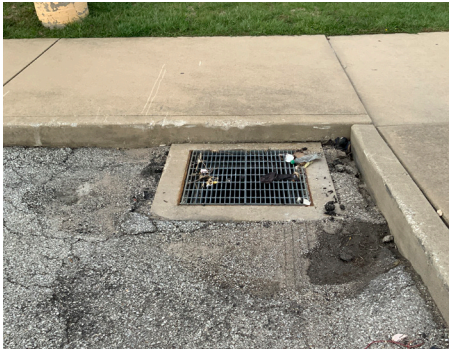
Building Site - Inlets

| 1. Building Site, Landscaping etc. | | |
|---|---|---|
| | Inlets | The inlets appear to be functioning properly, but siltation and pavement failure around those in the pavement may be hindering their full capacity. The inlets near the east-west stairs on the north side of the school need to be lowered, as water is not entering them and is instead causing erosion around the inlet and down the slope. |

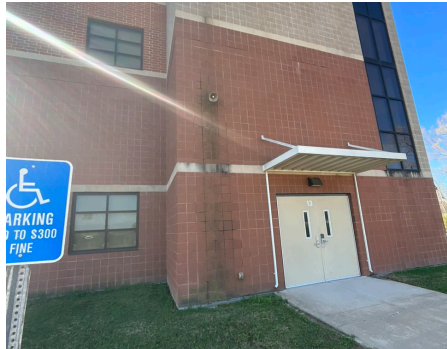
Building Structure / Exterior - Exterior Facade

| 1. Building Site, Landscaping etc. | | |
|---|---|---|
| | Exterior Façade | Small gym flashing- not allowing positive drainage. Control joints have failed, beyond half-life. Minimal Spalding and efflorescence visible. Dirt/grime below lambs tongue is causing deterioration. Far east EIFS is showing major deterioration/discoloration, chipped finish, showing mesh behind multiple locations, repair or replace |

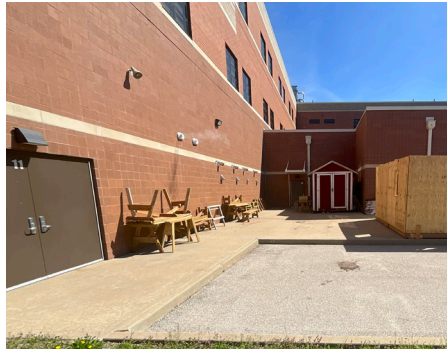
Building Site - Site Lighting

| 1. Building Site, Landscaping etc. | | |
|---|---|---|
| | Site Lighting | Recommend replacement of existing pole mounted fixtures and building mounted exterior lighting to be LED for improved site illumination and updated exterior controls to meet current energy codes. Existing pole mounted light locations appear adequate. |

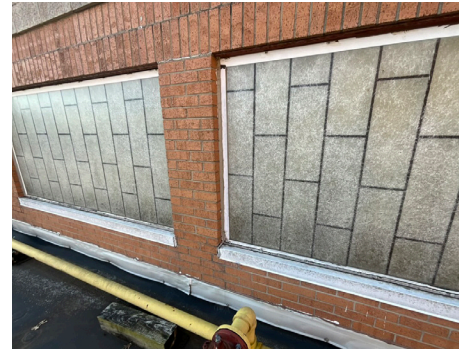
Building Structure / Exterior - Exterior Window

| 1. Building Site, Landscaping etc. | | |
|---|---|---|
| | Exterior Window | Kalwall showing signs of deterioration. (1) storefront has .5" gap in opening. Some instances of window repair/replacement recommended due to moisture or cracking. Insulation visible at storefront and mismatch repair of spandrel/opaque glass at auditorium entrance. All storefronts on the east angled wall have rusted headers |

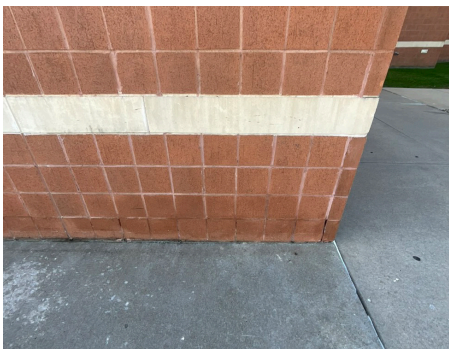
Building Structure / Exterior - Exterior Building Structural System

| 1. Building Site, Landscaping etc. | | |
|---|---|---|
| | Building Structural System | Signs of settling throughout, problem areas in Auditorium were resolved in Summer 2025. Additional cracking/settling throughout school should be monitored |

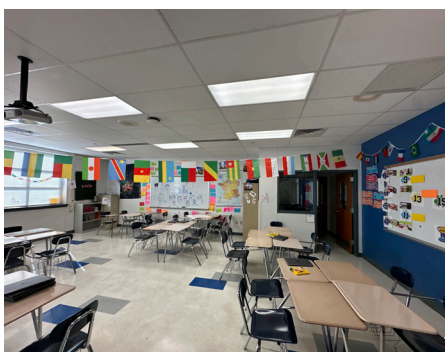
Building Systems - Interior Lighting (Classrooms)

| 1. Building Site, Landscaping etc. | | |
|---|---|---|
| | Interior Lighting - Classrooms | Recommend upgrade to LED. |

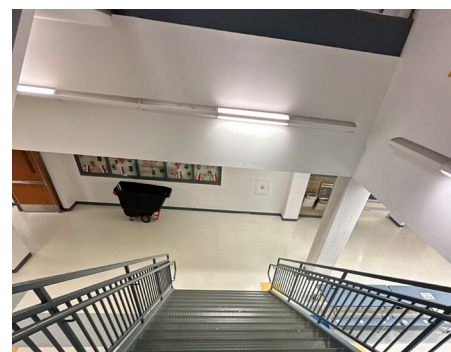
Building Systems - Interior Lighting (Public Areas)

| 1. Building Site, Landscaping etc. | | |
|---|---|---|
| | Interior Lighting - Public areas | Recommend upgrade to LED. |

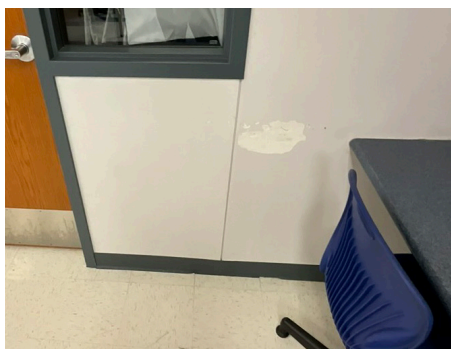
Interior Environment - Interior Walls

| 1. Building Site, Landscaping etc. | | |
|---|---|---|
| | Interior Wall | Walls have damage that needs to be repair, and paint refinishing is recommended in future |
