# 2025 FACILITY MASTER PLAN REPORT

FACILITY CONDITION / NEEDS ASSESSMENT - LIST & PHOTOS

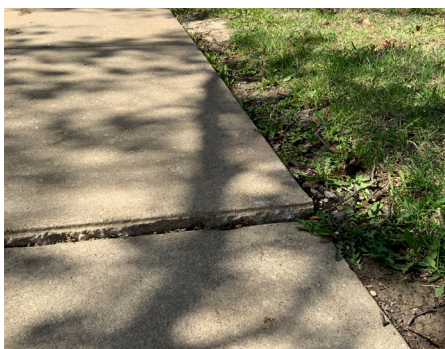
Building Site - Sidewalk

| 1. Building Site, Landscaping etc. | | |
|---|---|---|
| | Sidewalk | Sidewalk is generally in good condition. One panel is unlevel and could be a tripping hazard |

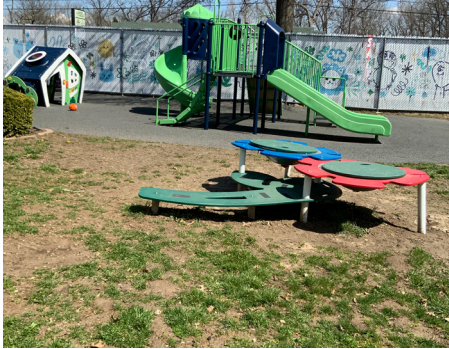
Building Site - Turf Grass

| 1. Building Site, Landscaping etc. | | |
|---|---|---|
| | Turf Grass | Shaded conditions may hinder the healthy turf/ground cover in certain areas. Several locations, particularly within the playground area, require reseeding or sodding. Additionally, extending the existing manmade playground surfacing to cover worn sections within the fenced area could help improve durability and reduce |

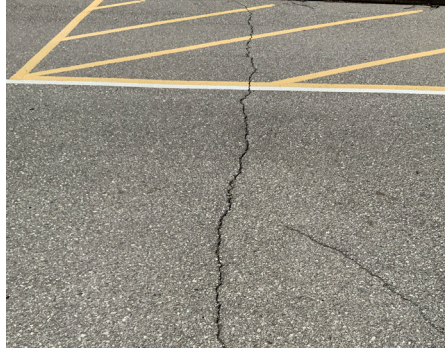
Building Site - Drive Surface

| 1. Building Site, Landscaping etc. | | |
|---|---|---|
| | Drive Surface | Entrance drive is in generally good condition, but at the front building entrance cracking needs to be filled and sealed. |

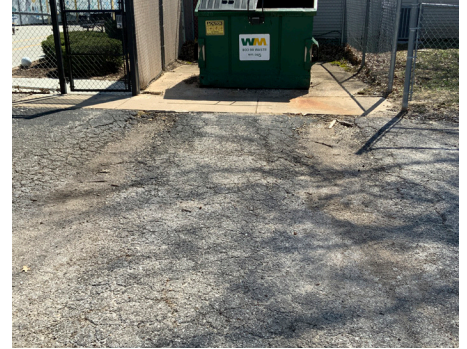
Building Site - Parking Lot

| 1. Building Site, Landscaping etc. | | |
|---|---|---|
| | Parking Lot | Parking lot pavement at north side of building needs to be removed and replaced. Recommend installing concrete in the area of dumpster access if not entire lot. Concrete in dumpster area will need attention soon. |

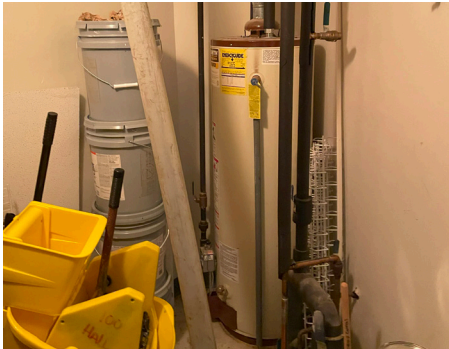
Building Systems - Water Heaters

| 1. Building Site, Landscaping etc. | | |
|---|---|---|
| | Water Heaters | Water heater is 34 years old. Typical lifespan is 10-15 years. Recommend replacing |

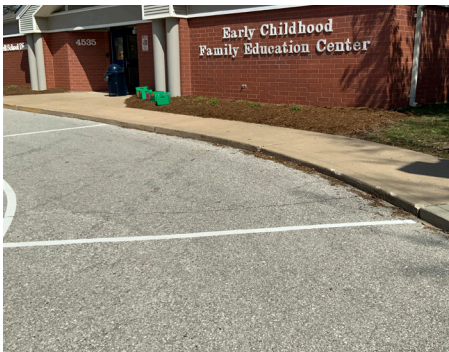
Building Site - Curbs

| 1. Building Site, Landscaping etc. | | |
|---|---|---|
| | Curbs | Minor chipping and cracking |

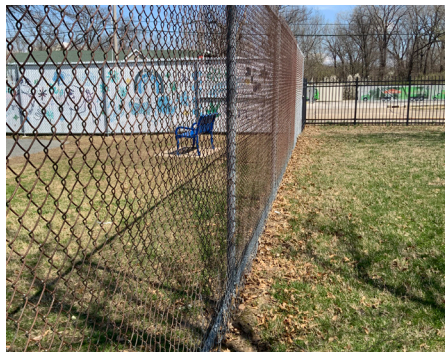
Building Site - Fencing

| 1. Building Site, Landscaping etc. | | |
|---|---|---|
| | Fencing | Exhibiting initial signs of rust but remains fully functional at this time. |

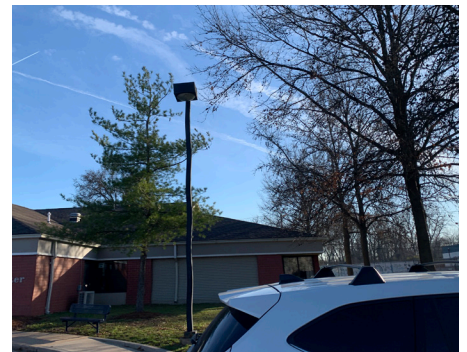
Building Site - Site Lighting

| 1. Building Site, Landscaping etc. | | |
|---|---|---|
| | Site Lighting | Recommend upgrade existing pole and building mounted exterior fixtures to be LED and add additional lighting for front entry / Southwest parking area. |

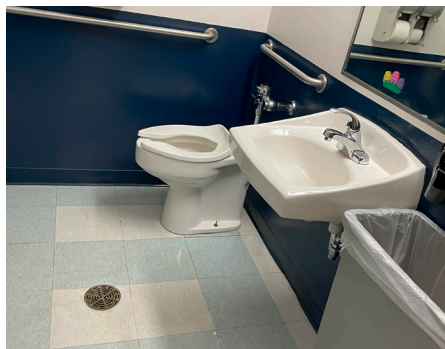
Building Systems - Plumbing Fixtures (Restrooms)

| 1. Building Site, Landscaping etc. | | |
|---|---|---|
| | Plumbing Fixtures - Restroom | Plumbing fixtures appear somewhat worn. Restroom lavatories lack thermostatic mixing valves and trap guards. |

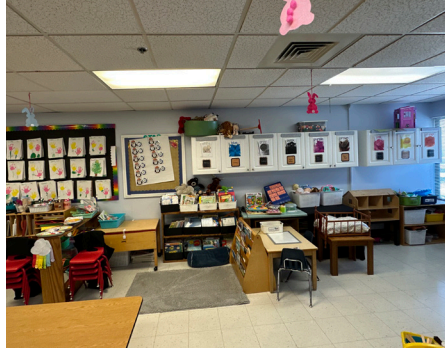
Building Systems - Interior Lighting (Classrooms)

| 1. Building Site, Landscaping etc. | | |
|---|---|---|
| | Interior Lighting - Classrooms | Recommend upgrade to LED |

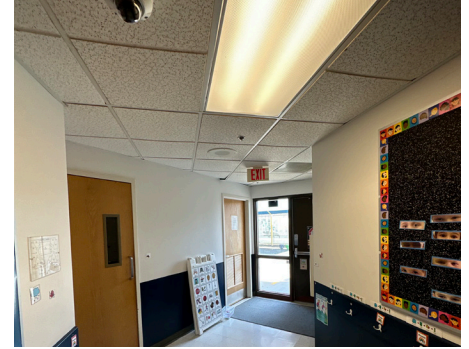
Building Systems - Interior Lighting (Public Areas)

| 1. Building Site, Landscaping etc. | | |
|---|---|---|
| | Interior Lighting - Public areas | Recommend upgrade to LED |

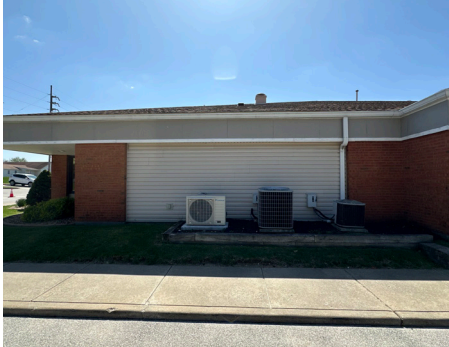
Building Systems - Mechanical System

| 1. Building Site, Landscaping etc. | | |
|---|---|---|
| | Mechanical System | Didn't see evidence of outside air being provided to the inside units; does not meet mechanical code requirements for ventilation. Approximately 30% of the condensing units have been replaced within the last five years. The rest appear to be past life. |

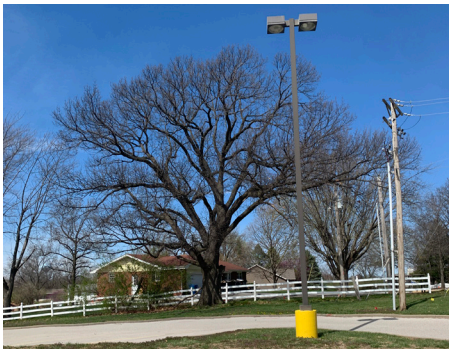
Building Site - Site Lighting

| 1. Building Site, Landscaping etc. | | |
|---|---|---|
| | Site Lighting | Recommend upgrade existing pole and building mounted exterior fixtures to be LED and add additional lighting in parking area behind building. |

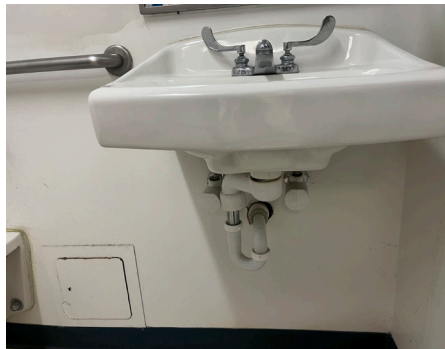
Building Systems - Plumbing Fixtures (Restrooms)

| 1. Building Site, Landscaping etc. | | |
|---|---|---|
| | Plumbing Fixtures - Restroom | Fixtures look a little worn but sufficient for current use. Restroom lavatories are lacking trap guards and thermostatic mixing valves. |

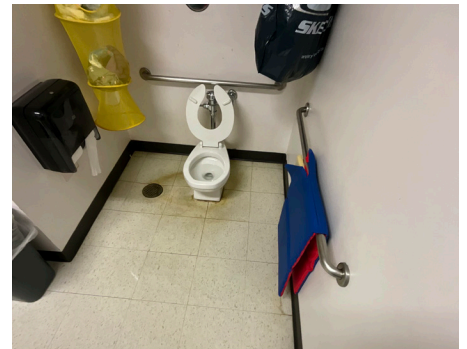
Building Systems - Plumbing Fixtures (Classrooms)

| 1. Building Site, Landscaping etc. | | |
|---|---|---|
| | Plumbing Fixtures - Classroom | Fixtures look a little worn but sufficient for current use. Restroom lavatories are lacking trap guards and thermostatic mixing valves. |

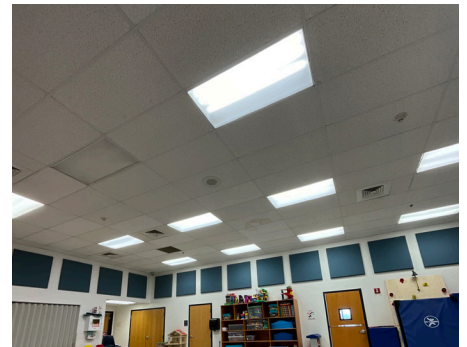
Building Systems - Interior Lighting (Classrooms)

| 1. Building Site, Landscaping etc. | | |
|---|---|---|
| | Interior Lighting - Classrooms | Recommend upgrade to LED |

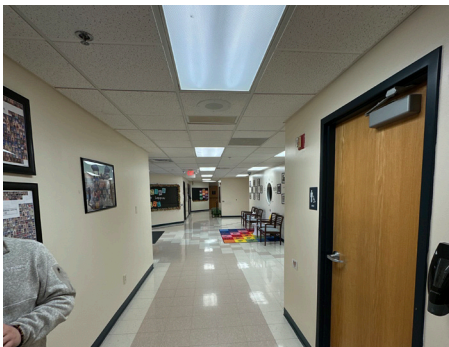
Building Systems - Interior Lighting (Public Areas)

| 1. Building Site, Landscaping etc. | | |
|---|---|---|
| | Interior Lighting - Public areas | Recommend upgrade to LED |

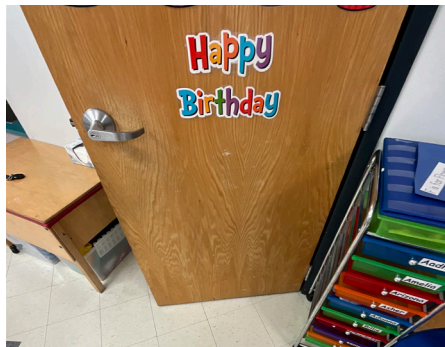
Interior Environment - Interior Doors

| 1. Building Site, Landscaping etc. | | |
|---|---|---|
| | Interior Door | Doors have general wear and tear, chipping of paint on frames and minimal damage to doors. Recommend full door replacement in the future |

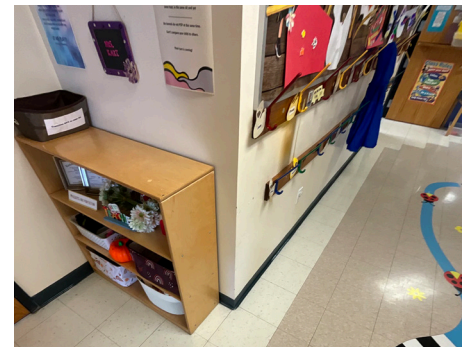
Interior Environment - Interior Wall

| 1. Building Site, Landscaping etc. | | |
|---|---|---|
| | Interior Wall | Walls have general wear and tear, may need refinish in future |

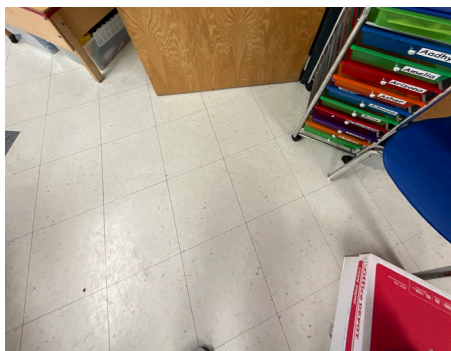
Interior Environment - Flooring

| 1. Building Site, Landscaping etc. | | |
|---|---|---|
| | Flooring | Overall flooring is in fine condition, some areas in need of repair |

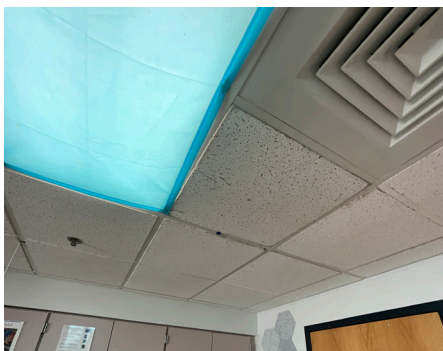
Interior Environment - Ceiling

| 1. Building Site, Landscaping etc. | | |
|---|---|---|
| | Ceiling | Overall ceiling is in fine shape, areas of water damage need to be addressed |

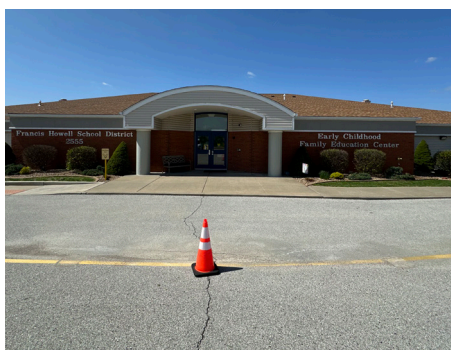
Building Site - Parking Lot

| 1. Building Site, Landscaping etc. | | |
|---|---|---|
| | Parking Lot | Some cracking at rear parking area. Crack filling and patching recommended. |

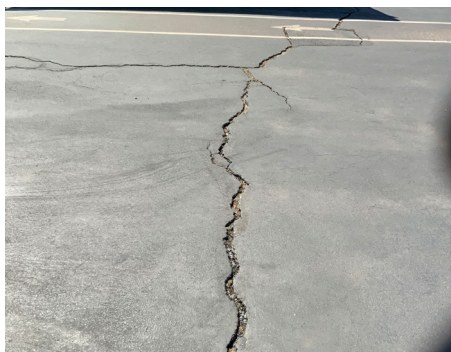
Building Site - Hardscape Play

| 1. Building Site, Landscaping etc. | | |
|---|---|---|
| | Hardscape Play | The hardscape play area is in generally fair condition; however, several large cracks have developed and should be sealed in the near term. Full replacement should be considered within a 3-5 year timeframe. |

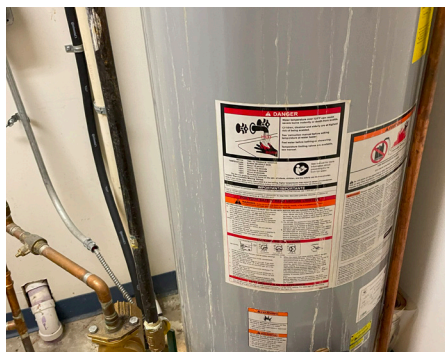
Building Systems - Water Heaters

| 1. Building Site, Landscaping etc. | | |
|---|---|---|
| | Water Heaters | Water heater is 15 years old. Typical lifespan is 10-15 years. Recommend replacing |

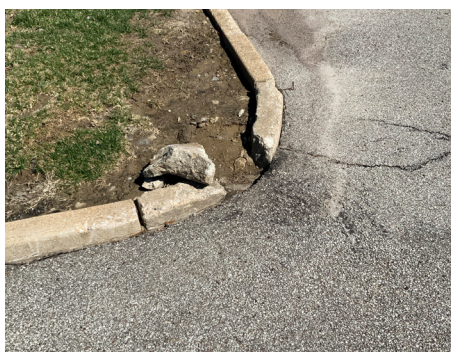
Building Site - Curbs

| 1. Building Site, Landscaping etc. | | |
|---|---|---|
| | Curbs | Curb has a couple of areas of separation and cracking, but generally in good condition. |

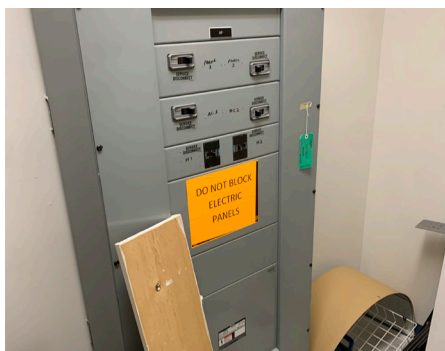
Building Systems - Main Electrical System

| 1. Building Site, Landscaping etc. | | |
|---|---|---|
| | Main Electrical Service | Appear to be no main disconnect for main panel. Panel has reached the maximum of 6 service disconnects. If future renovation / addition requires additional capacity, main panel will need to be replaced. |

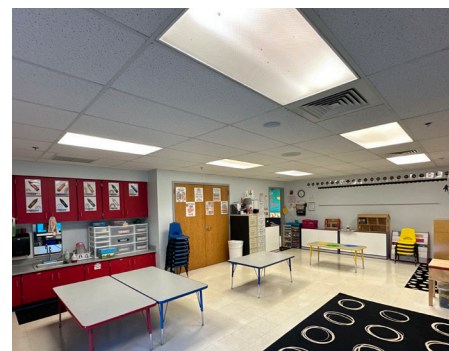
Building Systems - Interior Lighting (Classrooms)

| 1. Building Site, Landscaping etc. | | |
|---|---|---|
| | Interior Lighting - Classrooms | Recommend upgrade to LED |

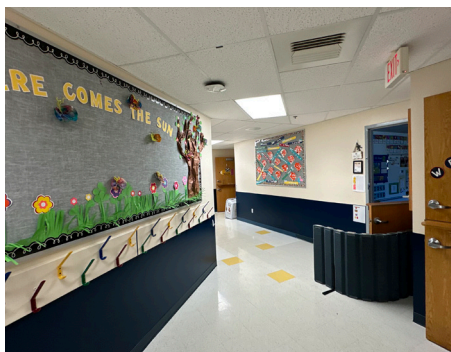
Building Systems - Interior Lighting (Public Areas)

| 1. Building Site, Landscaping etc. | | |
|---|---|---|
| | Interior Lighting - Public areas | Recommend upgrade to LED |

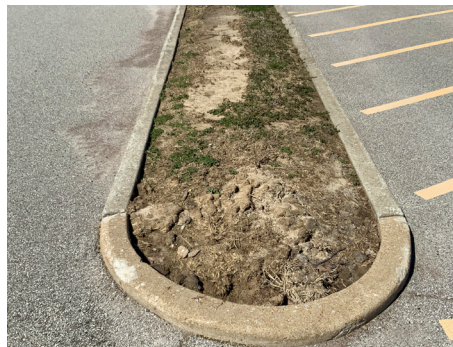
Building Site - Landscaping

| 1. Building Site, Landscaping etc. | | |
|---|---|---|
| | Landscaping | Landscaping near building is in good condition with recently placed mulch. Parking lot island is lacking grass and/or landscape materials. |

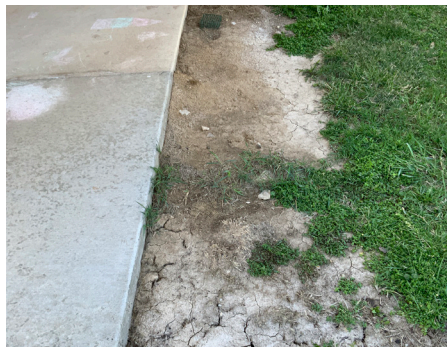
Building Site - Turf Grass

| 1. Building Site, Landscaping etc. | | |
|---|---|---|
| | Turf Grass | Sparse turf areas may require seeding or sodding, though the seasonal timing of the photographs may influence the perceived condition. Specific attention is needed in areas adjacent to sidewalks and behind curbs. |

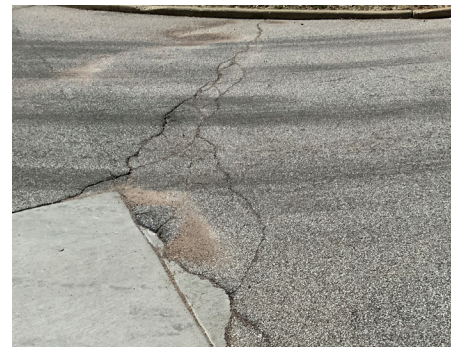
Building Site - Parking Lot

| 1. Building Site, Landscaping etc. | | |
|---|---|---|
| | Parking Lot | Crack sealing and minor patching areas. |

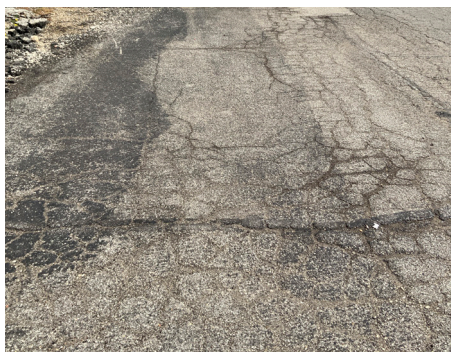
Building Site - Drive Surface

| 1. Building Site, Landscaping etc. | | |
|---|---|---|
| | Drive Surface | Access drive at south side of building needs to be removed and replaced. |

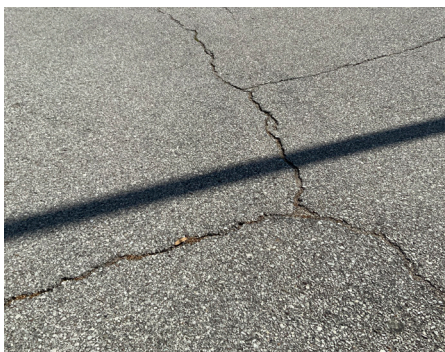
Building Site - Parking Lot

| 1. Building Site, Landscaping etc. | | |
|---|---|---|
| | Parking Lot | Certain sections of the parking lot show transverse, longitudinal, and block cracking. These areas should be patched, and other sections should be treated with crack sealing. |

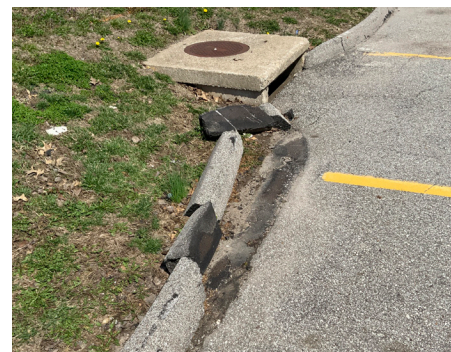
Building Site -Curbs

| 1. Building Site, Landscaping etc. | | |
|---|---|---|
| | Curbs | The asphalt curbing is deteriorating and breaking apart, while the concrete curb is generally in good condition, aside from a few limited locations that require removal and replacement. |

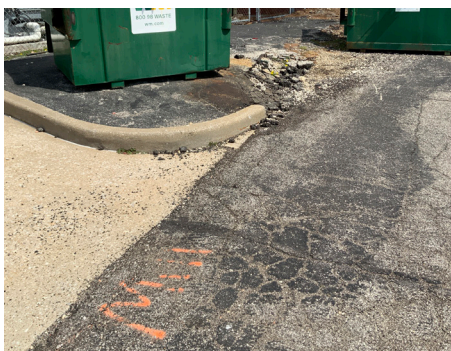
Building Site - Loading Area

| 1. Building Site, Landscaping etc. | | |
|---|---|---|
| | Loading Area | The loading area is generally in good condition; however, the section where the trash dumpsters are located requires repair. It is recommended that this area be reconstructed with concrete instead of asphalt to enhance durability. |

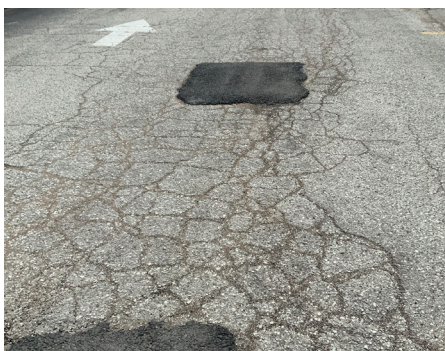
Building Site - Entrance to ROW

| 1. Building Site, Landscaping etc. | | |
|---|---|---|
| | Entrances to City ROW | Entrance to site is shared with Hollenbeck Middle School and Central Elementary. It is in poor condition and portions will require reconstruction. |

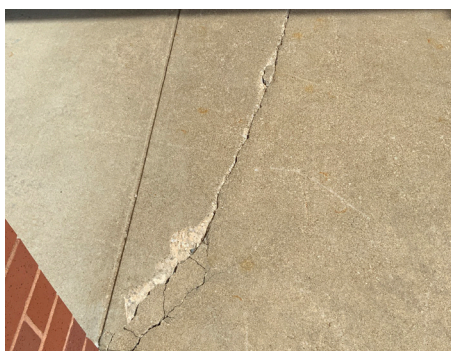
Building Site - Sidewalk

| 1. Building Site, Landscaping etc. | | |
|---|---|---|
| | Sidewalk | The sidewalks adjacent to the building are generally in good condition, though some areas exhibit cracking. While not urgent, these areas should be repaired or replaced to prevent further deterioration. |

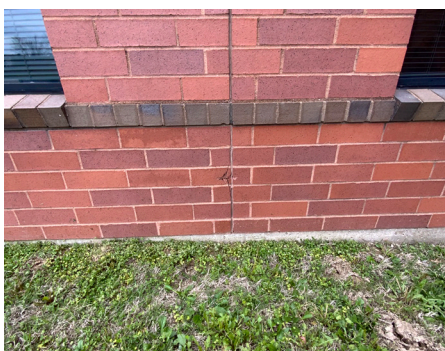
Building Structure / Exterior - Exterior Facade

| 1. Building Site, Landscaping etc. | | |
|---|---|---|
| | Exterior Façade | Many areas have organic growth, minimal cracking, a few busted corners in need of repair. Some of the control joint sealant has cracked and is in need of future replacement |

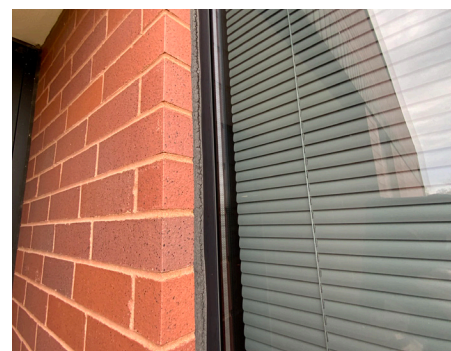
Building Structure / Exterior - Exterior Window

| 1. Building Site, Landscaping etc. | | |
|---|---|---|
| | Exterior Window | Sealant around frames getting starting to degrade in some instances |

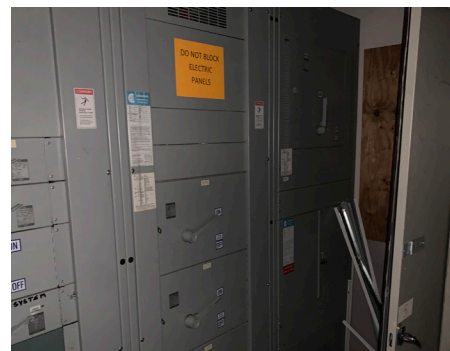
Building Systems - Main Electrical Service

| 1. Building Site, Landscaping etc. | | |
|---|---|---|
| | Main Electrical Service | Main electrical gear is equipped with fuse switches and may be hard to retrofit for future expansion. Existing switchgear may need to be replaced for future expansion. Light fixtures in electrical room appear to be burnt out. Light bulbs in electrical room shall be replaced as soon as possible to meet building code. |

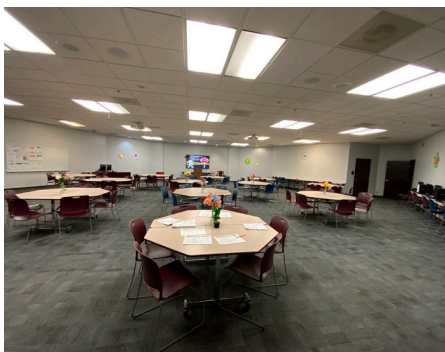
Building Systems - Interior Lighting (Public Areas)

| 1. Building Site, Landscaping etc. | | |
|---|---|---|
| | Interior Lighting - Public areas | Recommend upgrade to LED. |

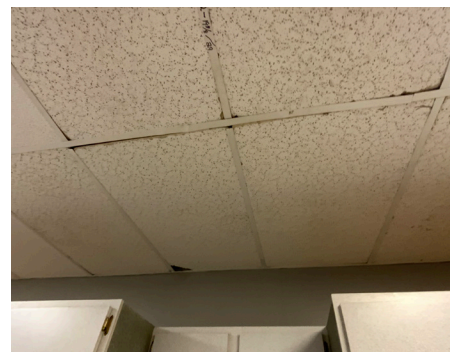
Interior Environment - Ceilings

| 1. Building Site, Landscaping etc. | | |
|---|---|---|
| | Ceiling | Half of the ACT tiles are showing wear, and may need to be replaced in the future |

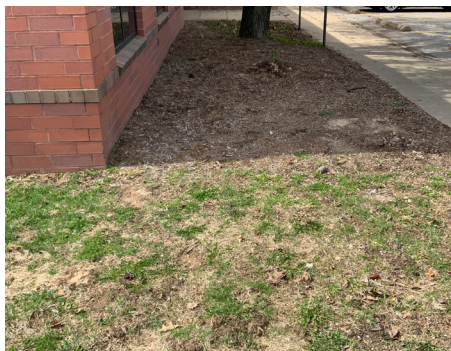
Building Site - Turf Grass

| 1. Building Site, Landscaping etc. | | |
|---|---|---|
| | Turf Grass | The turf grass across the site is generally in good condition. However, some shaded areas are unable to sustain healthy growth, while other sections require re-seeding or sodding to address sparsity. |

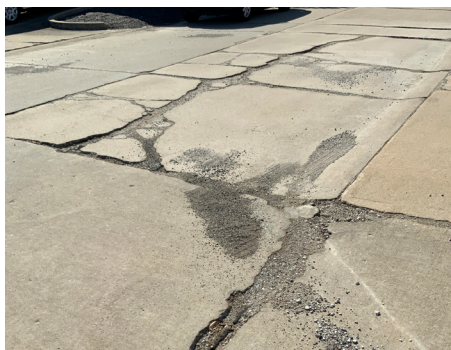
Building Site - Drive Surface

| 1. Building Site, Landscaping etc. | | |
|---|---|---|
| | Drive Surface | The entrance driveway is in poor condition and requires full replacement. Ownership and maintenance responsibility are unclear, as the driveway appears to be shared with an adjacent property owner. |

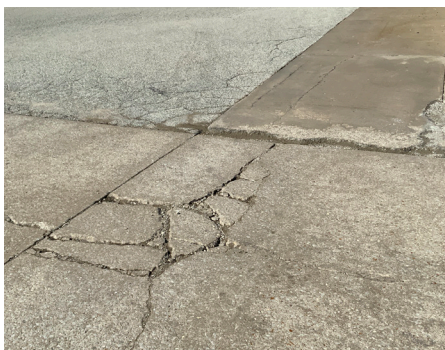
Building Site - Parking Lot

| 1. Building Site, Landscaping etc. | | |
|---|---|---|
| | Parking Lot | The parking areas consist of both concrete and asphalt surfaces. Portions of the concrete have cracked and deteriorated, while the asphalt sections exhibit extensive alligator (fatigue) cracking. |

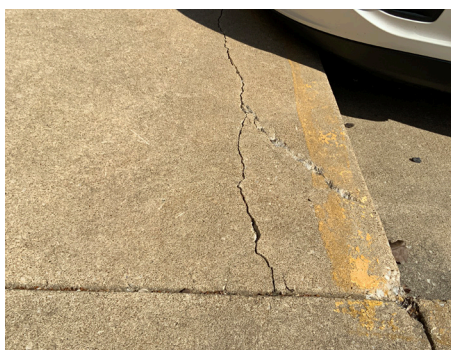
Building Site - Sidewalk

| 1. Building Site, Landscaping etc. | | |
|---|---|---|
| | Sidewalk | There is minimal sidewalk along the building, with a small section of cracked concrete that, while not currently a tripping hazard, should be monitored for future deterioration. |

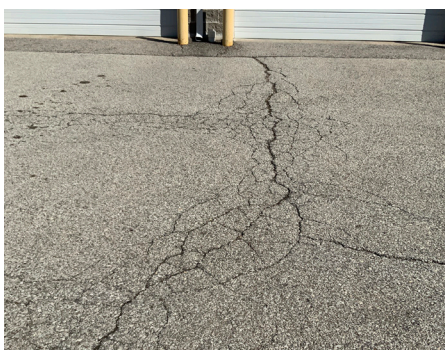
Building Site - Loading Area

| 1. Building Site, Landscaping etc. | | |
|---|---|---|
| | Loading Area | Overhead door areas are in good condition other than adjoining pavement. Doors on east side of building have concrete with one small area of cracking. |

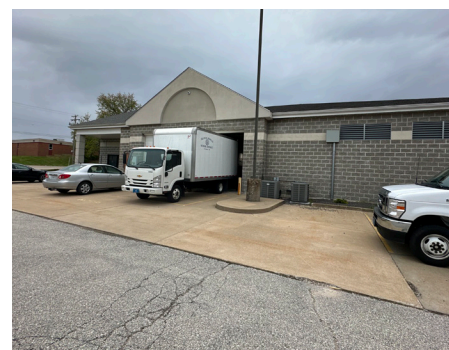
Building Site - Site Lighting

| 1. Building Site, Landscaping etc. | | |
|---|---|---|
| | Site Lighting | Recommend upgrade to LED fixtures. |

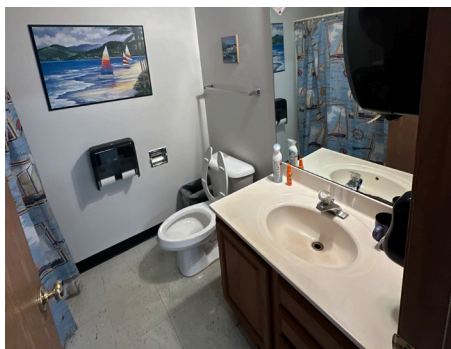
Building Systems - Plumbing Fixtures (Restrooms)

| 1. Building Site, Landscaping etc. | | |
|---|---|---|
| | Plumbing Fixtures - Restroom | Fixtures are worn; lavatory lacking thermostatic mixing valve. |

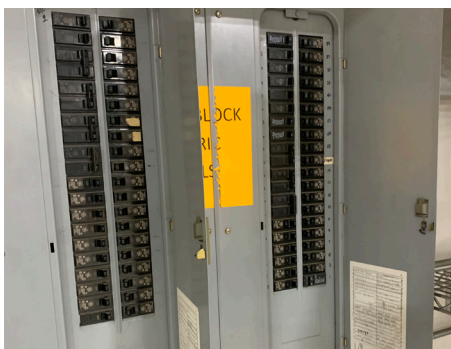
Building Systems - Panelboards

| 1. Building Site, Landscaping etc. | | |
|---|---|---|
| | Panelboards | Panelboards do not appear to have room for additional capacity. Will need to replace existing panelboards for future expansion. |

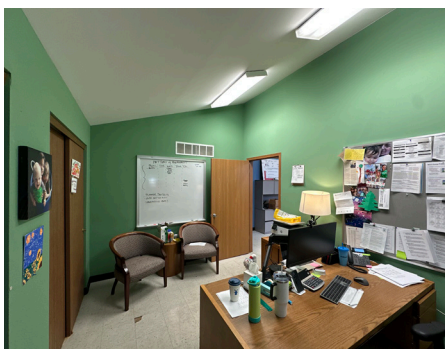
Building Systems - Interior Lighting (Public Areas)

| 1. Building Site, Landscaping etc. | | |
|---|---|---|
| | Interior Lighting - Public areas | Recommend upgrade to all non-led fixtures. |

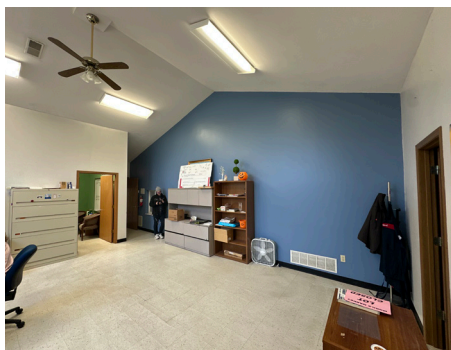
Interior Environment - Flooring

| 1. Building Site, Landscaping etc. | | |
|---|---|---|
| | Flooring | Floor is worn and scratched, showing wear and tear, may need to be replaced in the future |

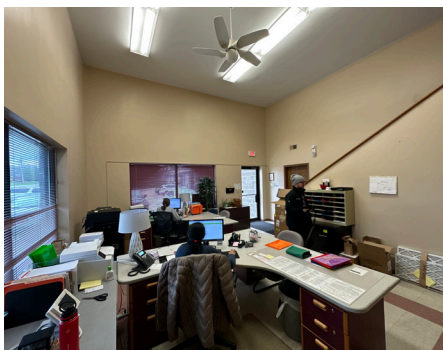
Interior Environment - Furniture

| 1. Building Site, Landscaping etc. | | |
|---|---|---|
| | Furniture | Furniture is dated and may need to be replaced in the future |

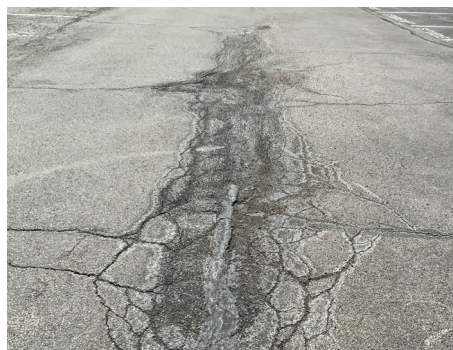
Building Site - Drive Surface

| 1. Building Site, Landscaping etc. | | |
|---|---|---|
| | Drive Surface | Driveway exhibits signs of longitudinal and transitional cracking, alligator (fatigue) cracking and weathering. |

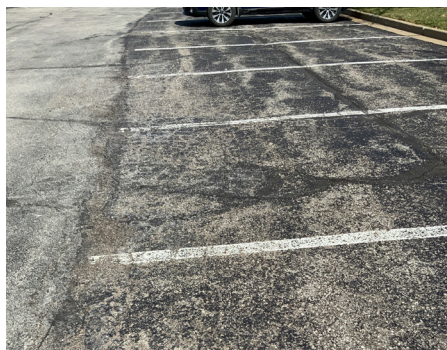
Building Site - Parking Lot

| 1. Building Site, Landscaping etc. | | |
|---|---|---|
| | Parking Lot | Parking areas also exhibit signs of longitudinal and transitional cracking, alligator (fatigue) cracking and weathering. |

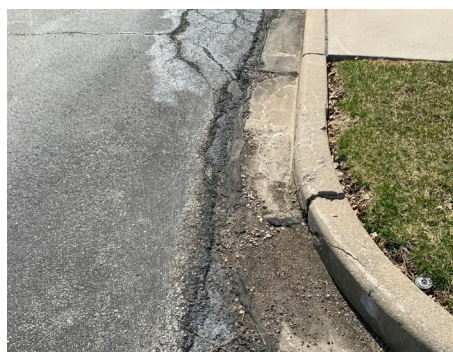
Building Site - Curbs

| 1. Building Site, Landscaping etc. | | |
|---|---|---|
| | Curbs | The concrete curbing shows signs of cracking and chipping in several areas. While repairs are necessary, they are not considered urgent at this time. |

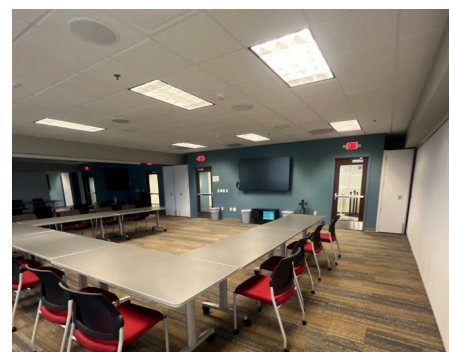
Building Systems - Interior Lighting (Public Areas)

| 1. Building Site, Landscaping etc. | | |
|---|---|---|
| | Interior Lighting - Public areas | Recommend upgrade to LED. |

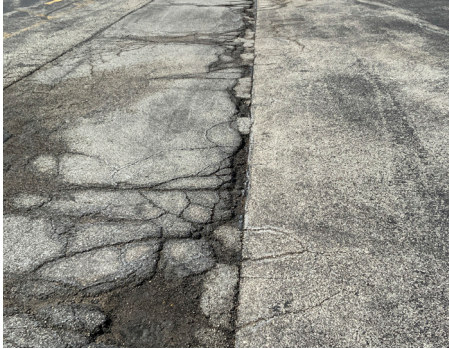
Building Site - Drive Surface

| 1. Building Site, Landscaping etc. | | |
|---|---|---|
| | Drive Surface | Driveway is in very poor condition. Previously patched - recommend full removal and replacement. |

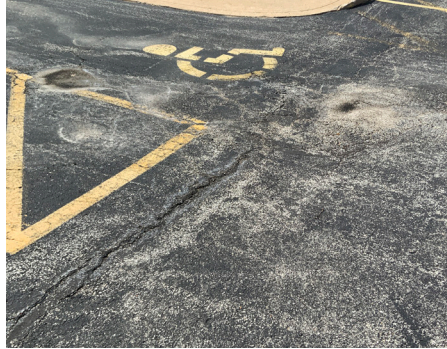
Building Site - Parking Lot

| 1. Building Site, Landscaping etc. | | |
|---|---|---|
| | Parking Lot | Parking area in very poor condition. Previously patched - recommend full removal and replacement. |

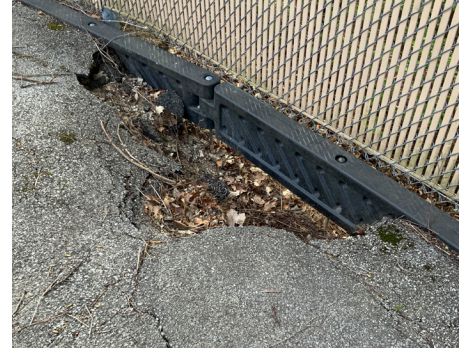
Building Site - Hardscape Play

| 1. Building Site, Landscaping etc. | | |
|---|---|---|
| | Hardscape Play | Areas of pavement failure and sinking. Pavement patching and crack sealing recommended. |

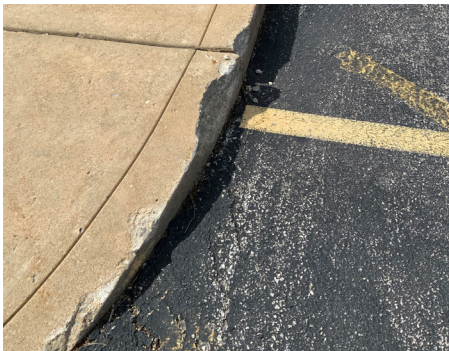
Building Site - Curbs

| 1. Building Site, Landscaping etc. | | |
|---|---|---|
| | Curbs | Curb in good condition other very limited chipping. No need for immediate action. |

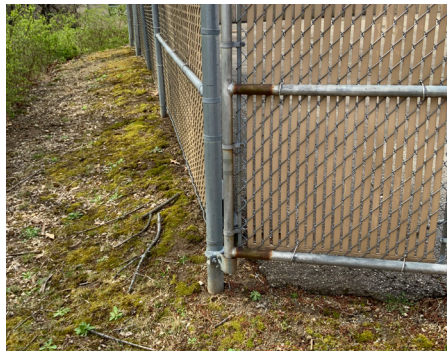
Building Site - Fencing

| 1. Building Site, Landscaping etc. | | |
|---|---|---|
| | Fencing | The fence is currently in fair condition, though it is beginning to show signs of rust. |

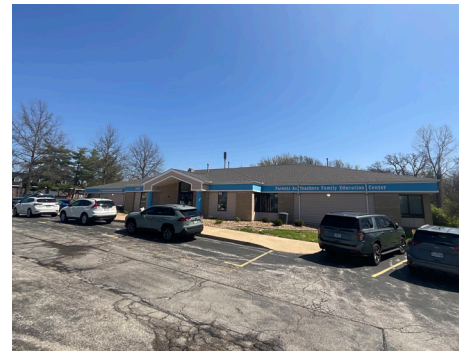
Building Site - Site Lighting

| 1. Building Site, Landscaping etc. | | |
|---|---|---|
| | Site Lighting | Recommend upgrade existing pole and building mounted exterior fixtures to be LED and add additional pole lighting for Northwest parking area. |

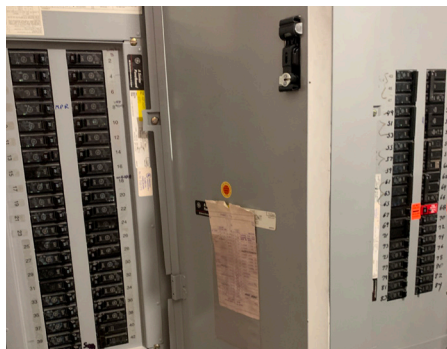
Building Systems - Panelboards

| 1. Building Site, Landscaping etc. | | |
|---|---|---|
| | Panelboards | May need to upgrade / replace panels in the future if additional capacity is required as existing panels do not have much additional capacity. |

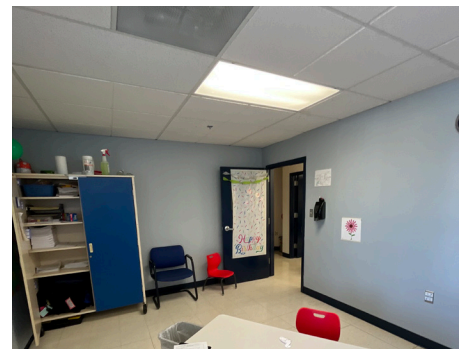
Building Systems - Interior Lighting (Classrooms)

| 1. Building Site, Landscaping etc. | | |
|---|---|---|
| | Interior Lighting - Classrooms | Recommend upgrade to LED |

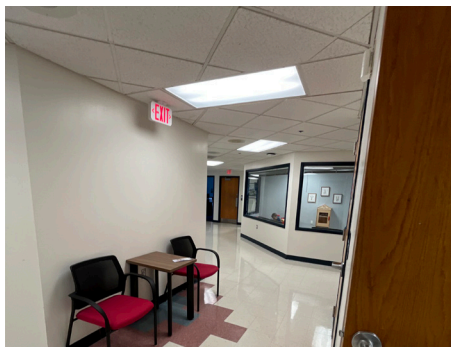
Building Systems - Interior Lighting (Public Areas)

| 1. Building Site, Landscaping etc. | | |
|---|---|---|
| | Interior Lighting - Public areas | Recommend upgrade to LED |

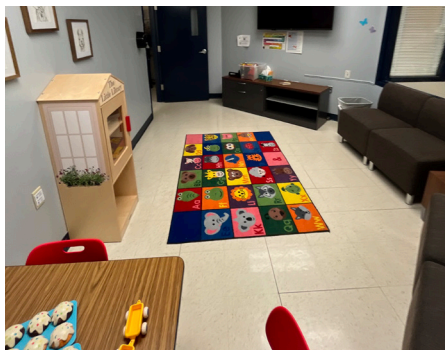
Interior Environment - Flooring

| 1. Building Site, Landscaping etc. | | |
|---|---|---|
| | Flooring | Some areas of VCT showing signs of separation and wear and tear |

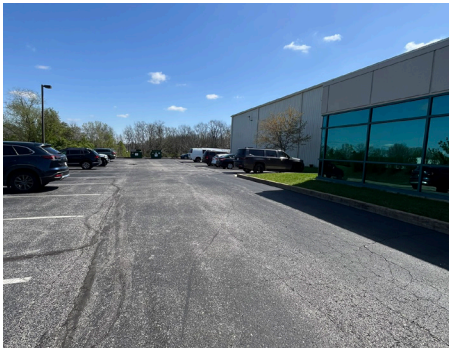
Building Site - Site Lighting

| 1. Building Site, Landscaping etc. | | |
|---|---|---|
| | Site Lighting | Recommend full led fixture replacement for existing pole mounted light fixtures and building mounted light fixtures with new controls meeting current energy code. Existing pole locations appear to be sufficient. |

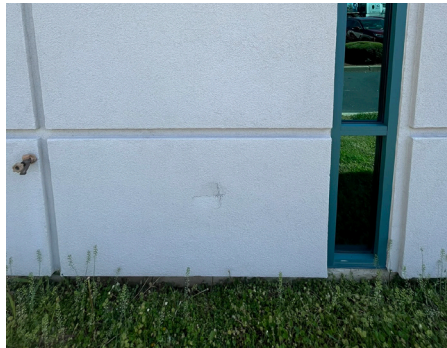
Building Structure / Exterior - Exterior Facade

| 1. Building Site, Landscaping etc. | | |
|---|---|---|
| | Exterior Façade | At least one dent/crack in the envelope. Some of the metal panel looks in poor condition, unclear if it is dirty or something internal needs to be evaluated. |

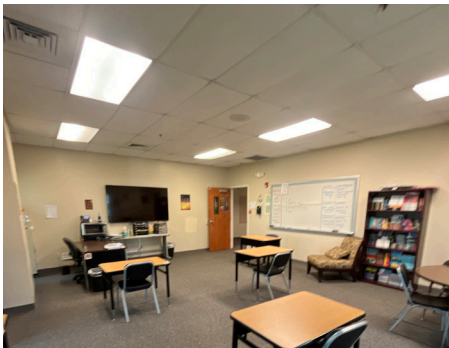
Building Systems - Interior Lighting (Classrooms)

| 1. Building Site, Landscaping etc. | | |
|---|---|---|
| | Interior Lighting - Classrooms | Recommend upgrade remaining fluorescent fixtures to LED |

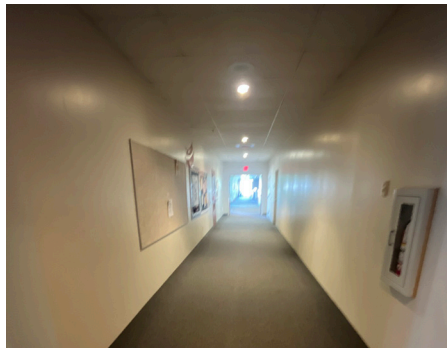
Building Systems - Interior Lighting (Public Areas)

| 1. Building Site, Landscaping etc. | | |
|---|---|---|
| | Interior Lighting - Public areas | Recommend upgrade fixtures to LED |

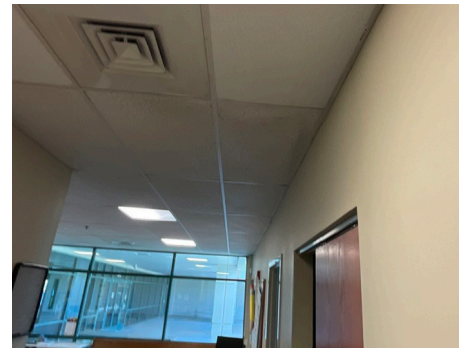
Interior Environment - Ceiling

| 1. Building Site, Landscaping etc. | | |
|---|---|---|
| | Ceiling | Multiple areas of ACT water damage that needs to be evaluated and resolved |

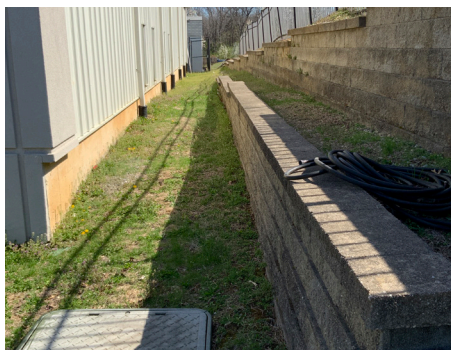
Building Site - Turf Grass

| 1. Building Site, Landscaping etc. | | |
|---|---|---|
| | Turf Grass | The turf is generally in good condition, but there are sparse areas, such as behind curbs and on the south side near the retaining wall, that should be seeded or sodded. These conditions may be due to the season of the photograph. The area near the wall is also experiencing some weed growth. |

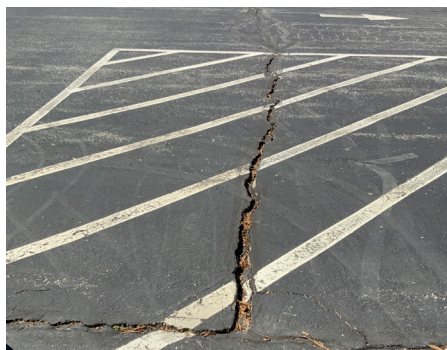
Building Site - Drive Surface

| 1. Building Site, Landscaping etc. | | |
|---|---|---|
| | Drive Surface | Pavement exhibits large longitudinal and transverse cracking. In need of crack sealing and some areas of patching. Alligator (fatigue) cracking, block cracking and weathering are also present. |

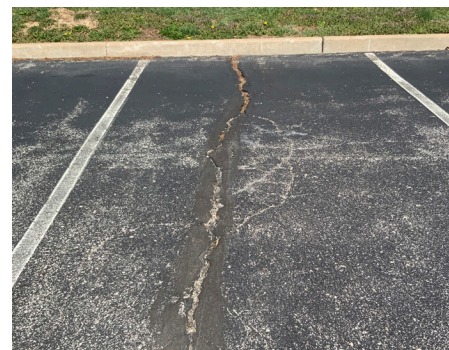
Building Site - Parking Lot

| 1. Building Site, Landscaping etc. | | |
|---|---|---|
| | Parking Lot | Pavement exhibits large longitudinal and transverse cracking. In need of crack sealing and some areas of patching. Alligator (fatigue) cracking, block cracking and weathering are also present. |

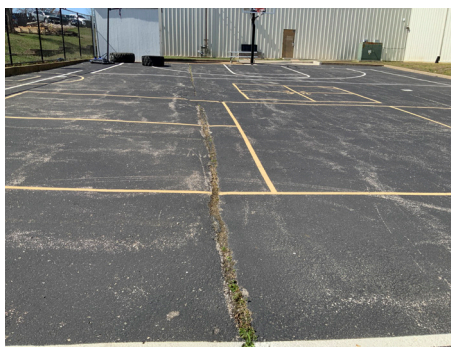
Building Site - Hardscape Play

| 1. Building Site, Landscaping etc. | | |
|---|---|---|
| | Hardscape Play | Hardscape play area in need of crack sealing or patching. |
