# POUDRE SCHOOL DISTRICT DUNN ELEMENTARY SCHOOL

## FACILITY CONDITION ASSESSMENT

FORT COLLINS, CO

OCTOBER 2023

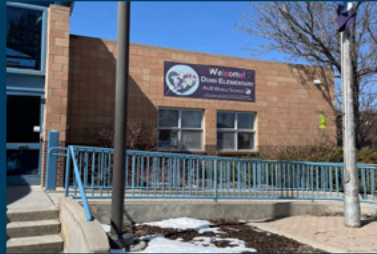
## PRIORITY SCORE SUMMARY - DUNN ES

| | | <b>DUNN ES</b><br><b>BUILDING TYPE:</b> Elementary School<br><b>YEAR BUILT:</b> 1949<br><b>GROSS AREA (SF):</b> 45,957<br><b>DATE ASSESSED:</b> July 19, 2023<br><b>PRIORITY SCORE:</b> 15.7 |
|---|---|---|
| B20 - Ext. Enclosure | The exterior façade of this building is primarily masonry (brick and CMU). There are several periods of construction (1948, 1987, 1992, 2006) with most of the masonry matching in color, size, and texture. The 2006 addition has a different color masonry. There are four different canopy assemblies on the exterior of the building. Glazing is primarily aluminum framed, although the glazing is from different periods of construction. | 12.1 |
