# POUDRE SCHOOL DISTRICT EYESTONE ELEMENTARY SCHOOL NORTH

## FACILITY CONDITION ASSESSMENT

WELLINGTON, CO

OCTOBER 2023

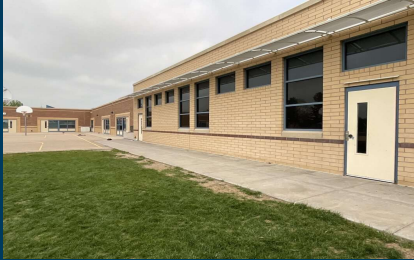
| | | <b>EYESTONE ES - NORTH</b><br>BUILDING TYPE: Elementary School<br>YEAR BUILT: 1973<br>GROSS AREA (SF): 64,228<br>DATE ASSESSED: May 24, 2023<br>PRIORITY SCORE: 16.1 |
|---|---|---|
| B20 - Ext. Enclosure | While the building has had several additions, the exterior finishes are fairly consistent. The 1972, 1988, and 1992 additions have been reclad in two tone brick which is in pretty good shape while the 2002 addition is a blonde brick in good shape. Metal and Aluminum windows are in good shape. | 13.0 |
