# POUDRE SCHOOL DISTRICT

## RIFFENBURGH ELEMENTARY SCHOOL

### FACILITY CONDITION ASSESSMENT

OCTOBER 2023

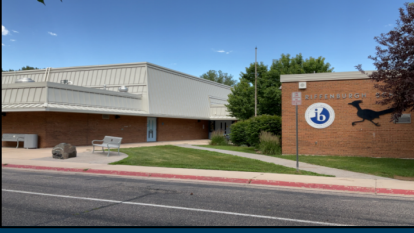
## PRIORITY SCORE SUMMARY - RIFFENBURGH, IB WORLD SCHOOL ES

| | | <b>RIFFENBURGH, IB WORLD SCHOOL ES</b><br>BUILDING TYPE: Elementary School<br>YEAR BUILT: 1968<br>GROSS AREA (SF): 48,433<br>DATE ASSESSED: July 10, 2023<br>PRIORITY SCORE: 16.3 |
|---|---|---|
| B20 - Ext. Enclosure | The building's exterior walls consists of a combination of brick masonry and concrete masonry unit (CMU). The walls are original to the building's initial construction in 1967, as well as the addition of the gymnasium in 2002. Exterior doors consist of metal single and double doors, as well as glass storefront doors for the main entrance. The building's exterior windows include a combination of metal and vinyl construction. There are three (3) mobile classrooms located to the west of the main building. These structures were constructed within the last 10-15 years and are primarily of wood construction. | 12.6 |
