POUDRE SCHOOL  
DISTRICT  
TAVELLI  
ELEMENTARY  
SCHOOL

FACILITY CONDITION ASSESSMENT

FORT COLLINS, CO

OCTOBER 2023

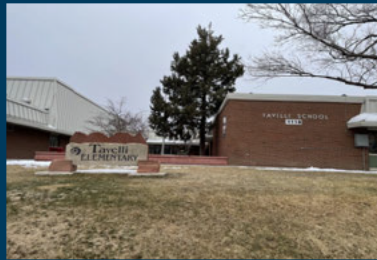
## PRIORITY SCORE SUMMARY - TAVELLI ES

| | | <b>TAVELLI ES</b><br>BUILDING TYPE: Elementary School<br>YEAR BUILT: 1968<br>GROSS AREA (SF): 62,537<br>DATE ASSESSED: July 7, 2023<br>PRIORITY SCORE: 16.4 |
|---|---|---|
| B20 - Ext. Enclosure | This facility has a primarily masonry façade. While the building has several additions the exterior brick matches in color, size, and texture. Standing Seam metal mansard roofing is present at most entry conditions (main building and classrooms) as well as wraps the elevated gym exterior. Exterior glazing is primarily 1968-built metal framed windows and 1968-built metal doors. One modular building was constructed in 2012. | 13.8 |
