Cache La Poudre Middle School

CACHE LA POUDRE  
MIDDLE SCHOOL

FACILITY CONDITION ASSESSMENT

OCTOBER 2023

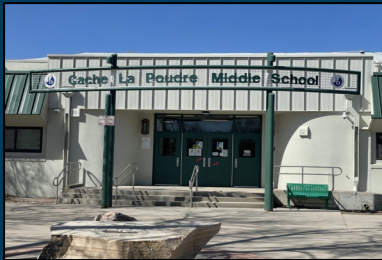
## PRIORITY SCORE SUMMARY - CACHE LA POUDRE, IB WORLD MS & GYM

| | | <b>CACHE LA POUDRE, IB WORLD MS &amp; GYM</b><br>BUILDING TYPE: Middle School<br>YEAR BUILT: 1949<br>GROSS AREA (SF): 44,255<br>DATE ASSESSED: July 21, 2023<br>PRIORITY SCORE: 16.3 | |
|---|---|---|--|
| B20 - Ext. Enclosure | The original (with additions) building is primarily stucco with a metal panel mansard element on the East and West facades. Windows are Storefront. Exterior elements are in good condition. The newer Gym Building is Brick with Storefront and Glass Block windows. There are several metal canopies on the South facade of the Gym. The gym exterior elements are in good condition. | 12.8 | |
