# FACILITY CONDITION ASSESSMENT

Longfellow Elementary  
1065 East Washington Boulevard  
Pasadena, California 91104

154554.22R000-006.354

September 7, 2022

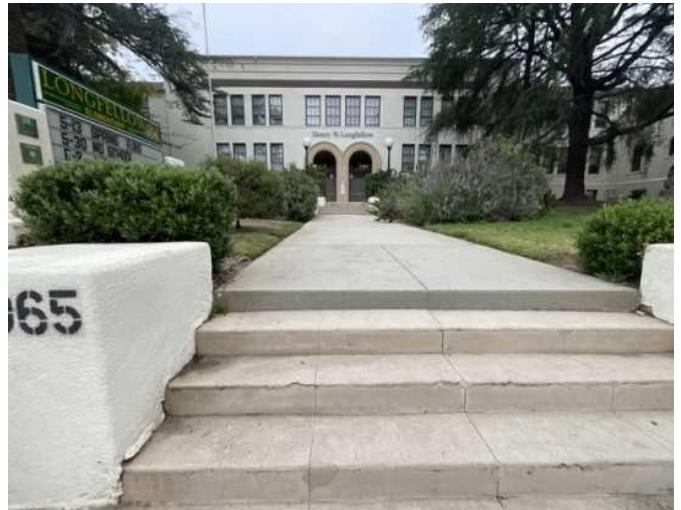
34 - STAIRS AND CONCRETE WALKWAYS

| UF L3 Code | Location | Condition | Asset/Component/Repair | Quantity | RUL | ID |
|---|---|---|---|---|---|---|
| B1080 | East of entrance | Failed | Stairs, Concrete, Exterior | 400 SF | 0 | 3854864 |
