# FACILITY CONDITION ASSESSMENT

## **DLR Group**

Washington STEAM Multilingual Academy  
1505 Marengo Avenue  
Pasadena, California 91103

154554.22R000-017.354

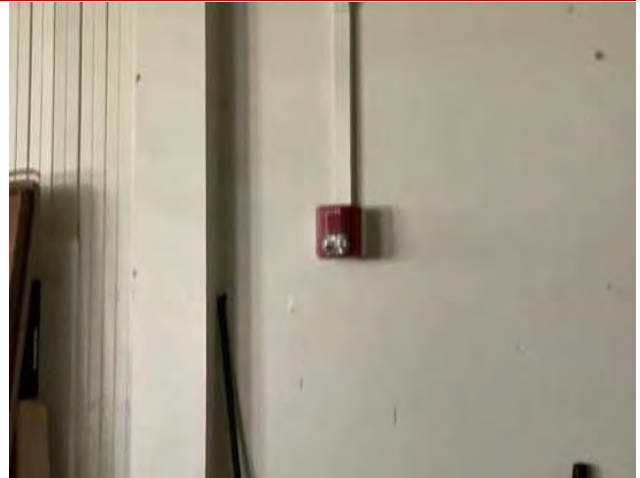
26 - FIRE ALARM SYSTEM

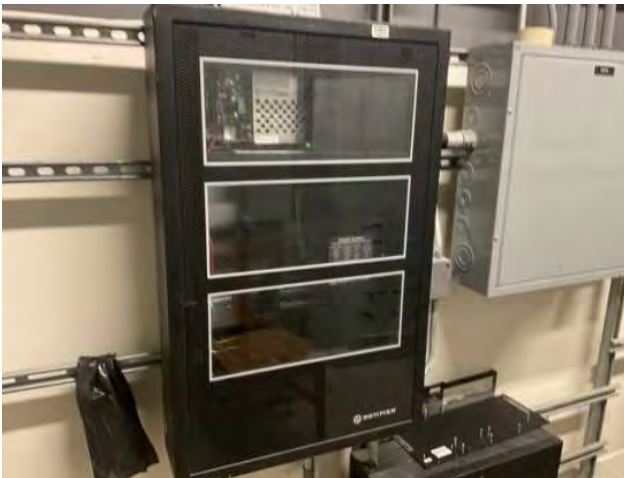
27 - FIRE ALARM PANEL

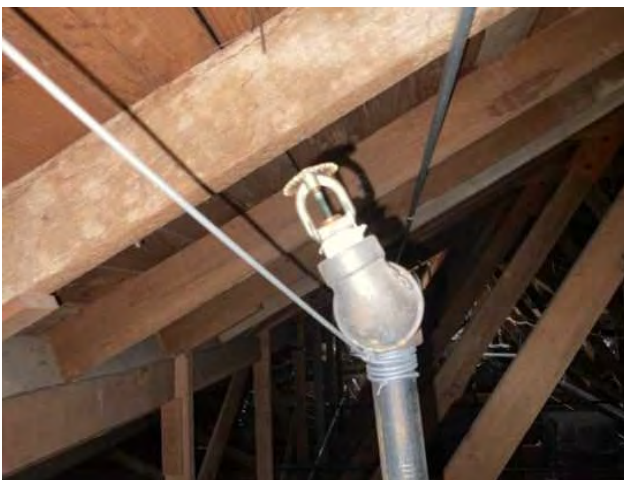
29 - FIRE SPRINKLER SYSTEM

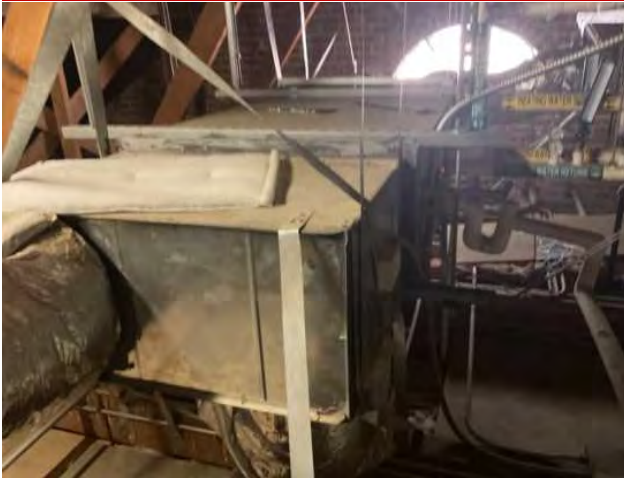
31 - INTERIOR AIR HANDLER

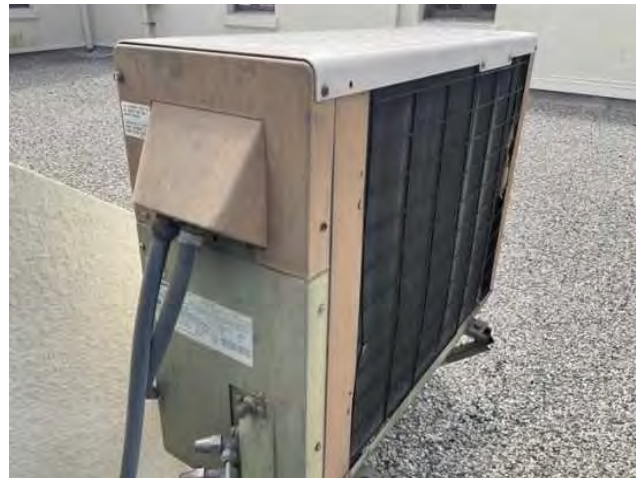
34 - SPLIT SYSTEM DUCTLESS

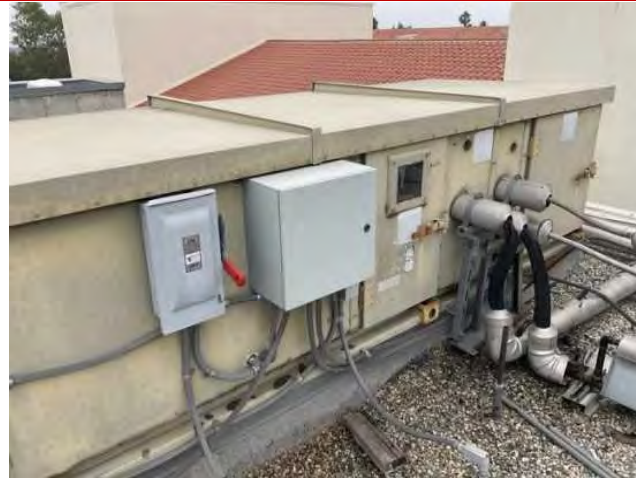
38 - EXTERIOR AIR HANDLER

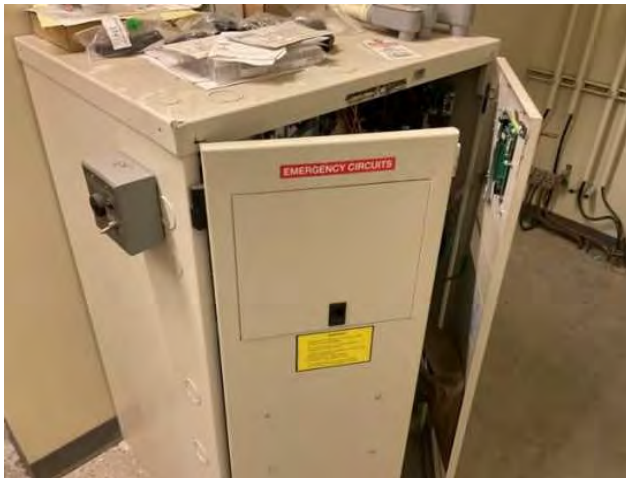
39 - UNINTERRUPTIBLE POWER SUPPLY
