# FACILITY CONDITION ASSESSMENT

San Rafael Elementary  
1090 Nithsdale Road  
Pasadena, California 91105

154554.22R000-009.354

September 8, 2022

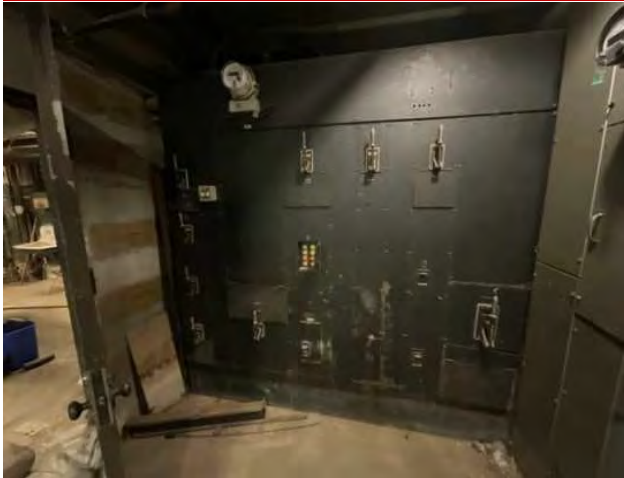
19 - MAIN ELECTRICAL EQUIPMENT

The main electrical panel may date back to 1931, and uses screw-in plug fuses. The secondary panel is likewise from an older vintage. They are past their expected useful life and an electrical system modernization is recommended. Heat is provided via boilers and radiators; air conditioning is provided in classrooms using window hung A/C units. The latter are outside of the scope of this report. The boilers are in fair condition and the radiators are functioning, but a steam leak in an area where students walk should be addressed immediately. The overall HVAC system should be considered for modernization. Plumbing supply and waste lines appear to have had sections replaced as needed. The buildings are plumbed for a wet fire sprinkler system and modern fire control panels provide detection and alarm.

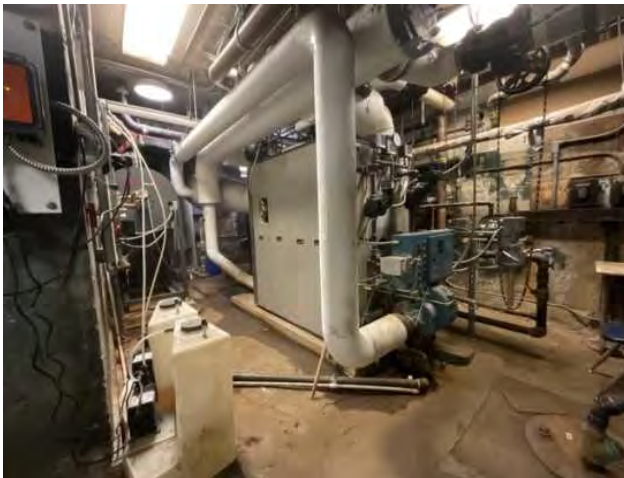
21 - HEATING MAIN COMPONENTS

The HVAC system is in poor condition. There is no central air conditioning, and the steam lines and radiators are old. The main electrical panels are past their useful life. A consultant must be retained to analyze the existing condition, provide recommendations and, if necessary, estimate the scope and cost of any required repairs. The cost of this study is included in the cost tables. A budgetary cost allowance to repair the steam leak is also included.
