# FACILITY CONDITION ASSESSMENT

## **DLR Group**

Sierra Madre Elementary  
141 West Highland Avenue  
Sierra Madre, California 91024

September 8, 2022

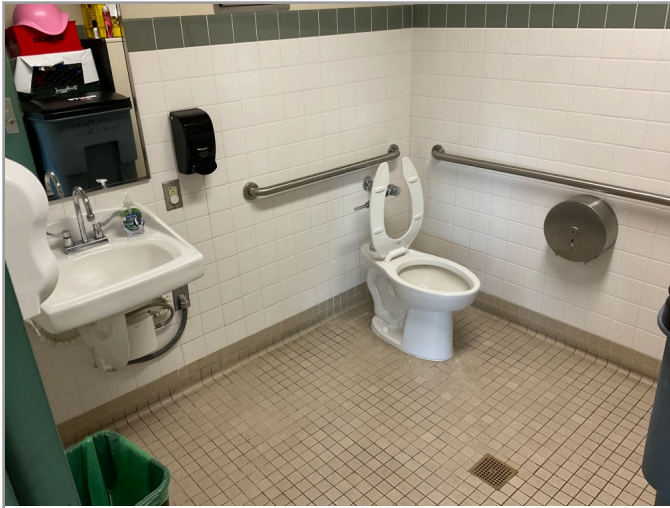
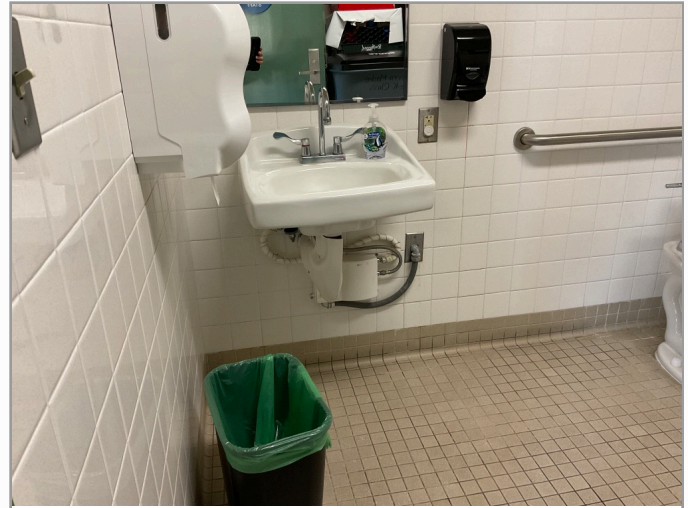
| Question | | Yes | No | NA | Comments |
|---|---|---|---|---|---|
| 4 | Is the plumbing piping under lavatories configured to protect against contact ? | ✗ | | | Some restrooms with assessable signage are missing protection from plumbing underneath the sink. |
