# FACILITY CONDITION ASSESSMENT

Washington Elementary Stem Magnet  
1520 North Raymond Avenue  
Pasadena, California 91103

154554.22R000-011.354

September 8, 2022

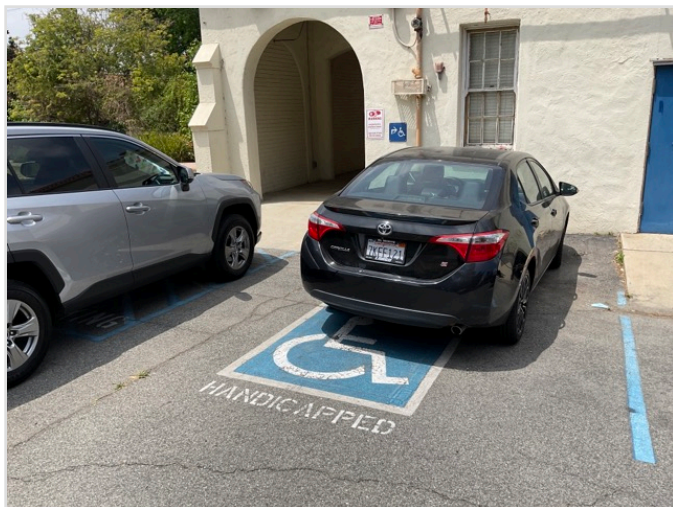
OVERVIEW OF ACCESSIBLE PARKING AREA

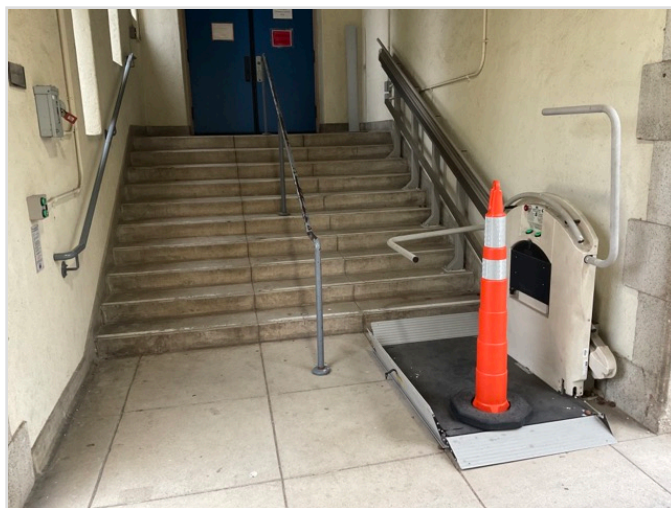
ACCESSIBLE EXTERIOR LIFT

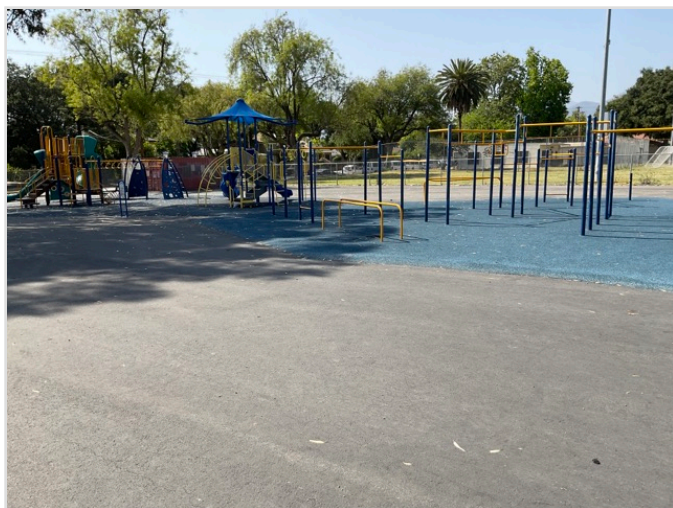
ACCESSIBLE ROUTE TO PLAYGROUND
