# FACILITY CONDITION ASSESSMENT

Madison Elementary  
515 Ashtabula Street  
Pasadena, California 91105

154554.22R000-007.354

September 8, 2022

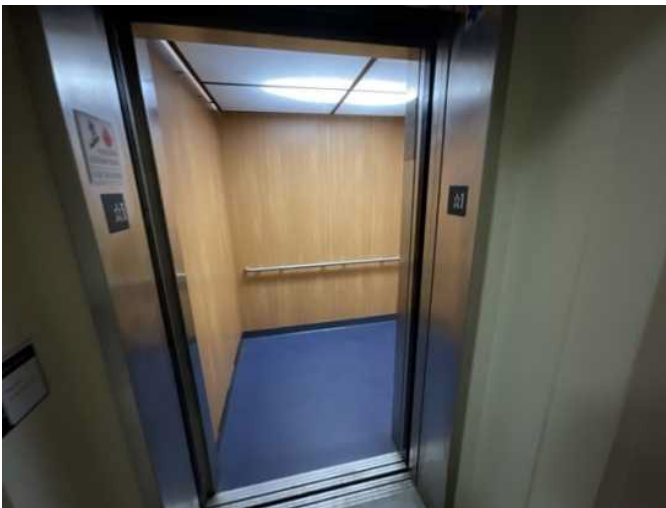
The main building has an elevator to access the second floor; the hydraulic system for the elevator is leaking a significant amount of fluid and experiences downtime every few months. Building A is temperature controlled via a four-pipe hydronic system located primarily in the basement. Two boilers provide the heating whilst a cooling tower outside the building enables air conditioning. Fire alarm systems are antiquated, and replacement is highly recommended. Plumbing is original to the buildings and could be updated.

Elevator hydraulic controls is leaking an excessive amount of oil, point of contact has stated oil has been replenished numerous times over the past couple years. Elevator will shake while in use, and is showing signs of extreme wear. - AssetCALC ID: 3806231

27 - PASSENGER ELEVATOR BUILDING A

The Elevator is in poor condition. A professional engineer must be retained to analyze the existing condition, provide recommendations and, if necessary, estimate the scope and cost of any required repairs. The cost of this study is included in the cost tables. A budgetary cost allowance to replace the Elevator is also included.

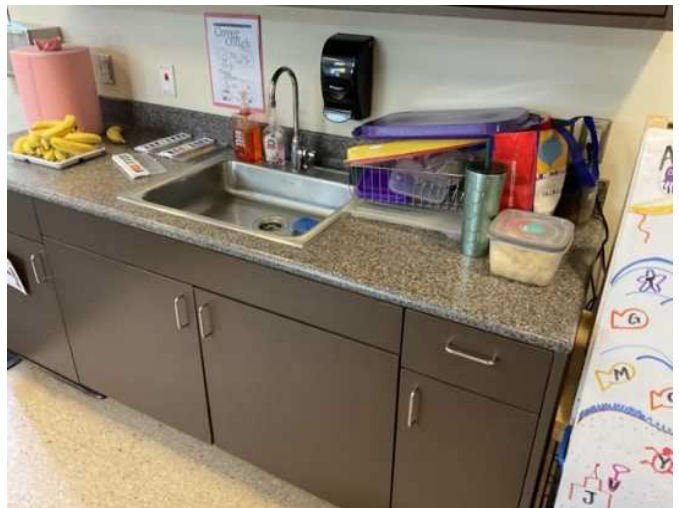
34 - FURNISHINGS COUNTERTOP BUILDING C
