# FACILITY CONDITION ASSESSMENT

Norma Coombs Elementary  
2600 Paloma Street  
Pasadena, California 91107

154554.22R000-008.354

September 8, 2022

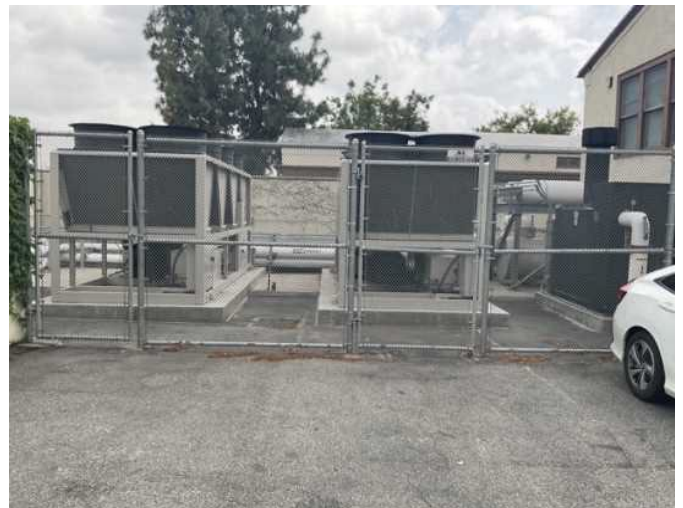
22 - CHILLERS AND BOILER
